FAIRFAX COUNTY PARK AUTHORITY

White Gardens

MEP Assessment

**3301 Hawthorne Lane
Falls Church, VA 22042**

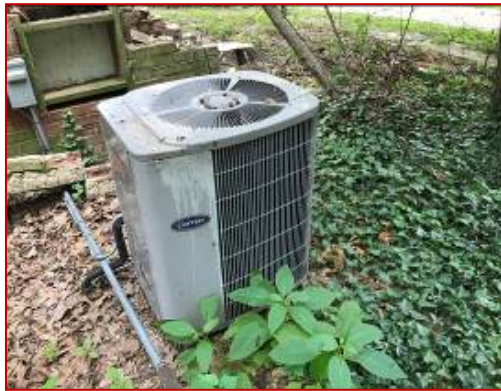
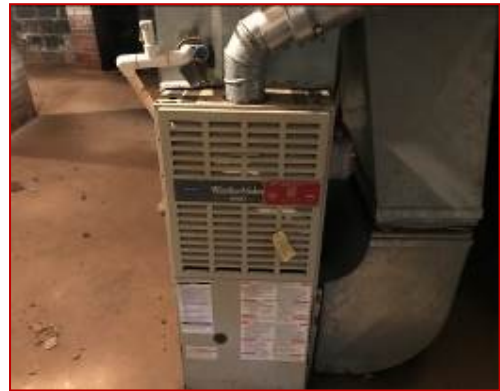
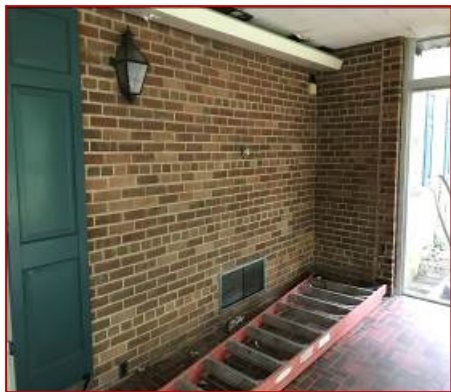
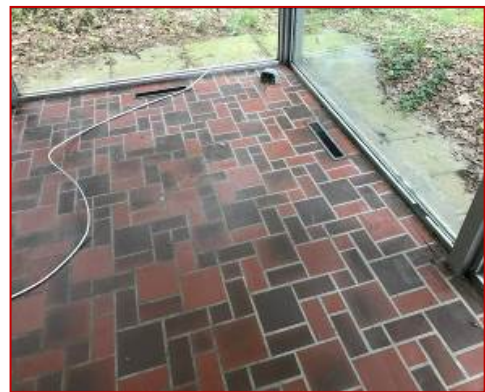
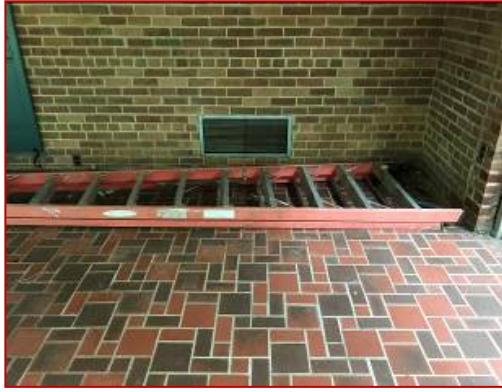
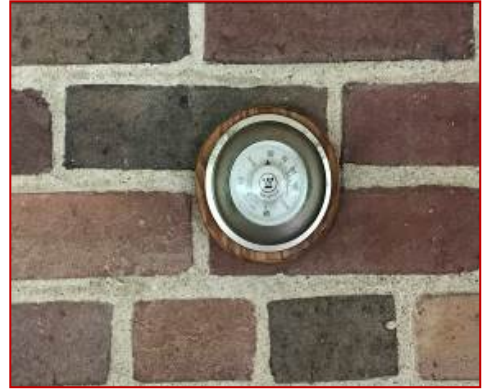
The first system serves the enclosed patio and consists of a nominal 36 MBH (3 ton) Carrier outdoor air conditioner, located at the far left side of the house near a demolished greenhouse building, that is connected to a Carrier Weathermaker 8000 furnace located in the basement. The outdoor unit appears to be dated 1999 and installed in 2000. The furnace appears to have been installed in 1997. A dial-type mechanical wall-mounted thermostat is located in the enclosed patio. The system was not operational. The ductwork is comprised of galvanized steel mains with flexible duct runouts to the floor-mounted supply diffusers. The return is ducted to a large wall grille in the patio. The last service on the equipment was in October 2004. This HVAC system is past its useful life.

- Mechanical recommendations are only if the house is structurally repaired, all leaks repaired, and all contaminants throughout remediated.
- Remove and replace HVAC system 1 with a new split system to condition the enclosed patio area.
- Remove and replace HVAC system 2 with a new split system. The humidifier should be replaced. The electronic air filter can be replaced or a high efficiency filter can be provided as an option.
- Remove and replace all existing supply and return grilles.
- Provide an exhaust fan for each bathroom.
- Provide a range hood in the kitchen.
- Replace the flexible clothes dryer exhaust duct.
- Provide a separate dehumidifier just for the basement area.
- Clean the existing ductwork.

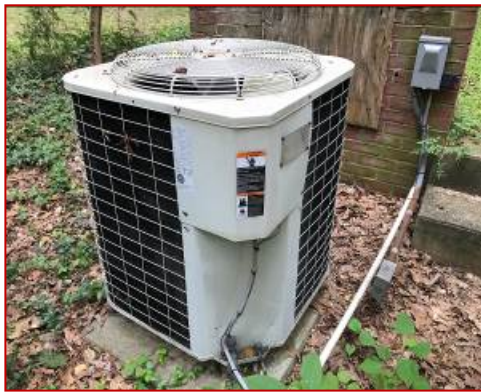
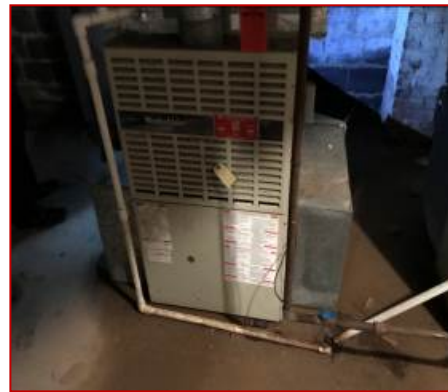
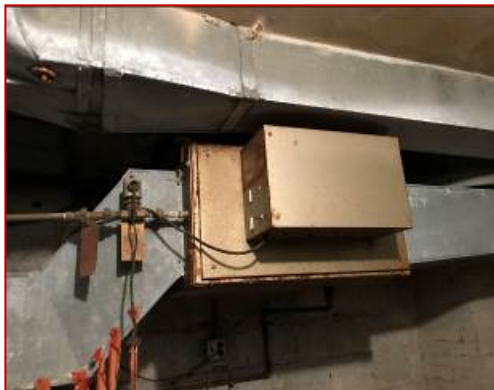
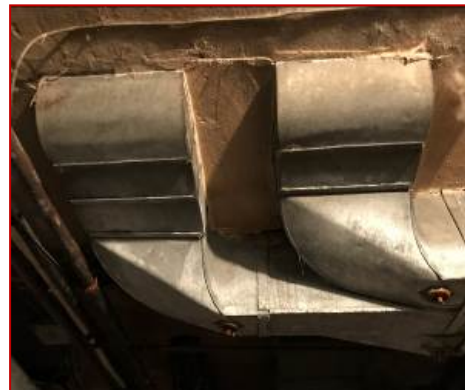
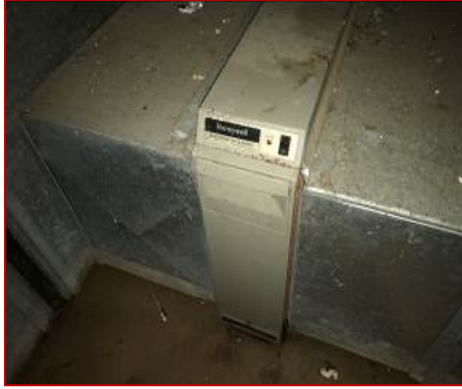
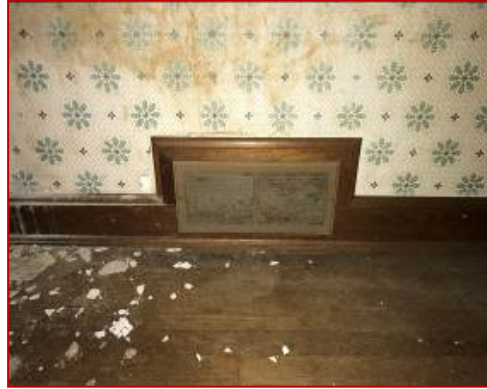
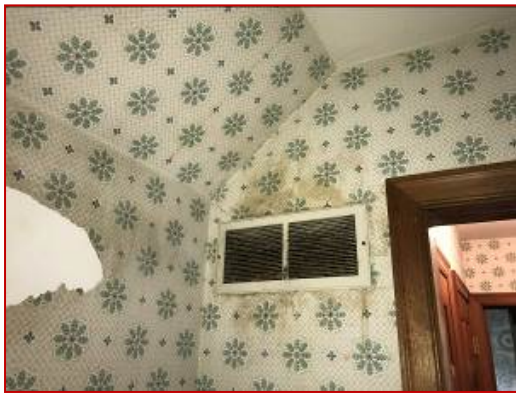
The second system serves the house and consists of a nominal 60 MBH (5 ton) Bryant outdoor air conditioner system connected to a Carrier Weathermaker 8000 furnace in the basement. There is a Honeywell electronic air cleaner located in the return ductwork and a duct-mounted humidifier for this system. A dial-type mechanical wall-mounted thermostat is located in the living room. The furnace is ducted up to floor-mounted supply registers in the dining room, main entry hall, living room, bathroom, kitchen, as well as the three bedrooms and three bathrooms on the second floor. The return is ducted to a large wall grille in the living room. There are no supply registers in the basement. The ductwork is comprised of galvanized steel mains with flexible duct runouts to the floor and wall diffusers. The outdoor unit, furnace, electronic air cleaner, and the humidifier were not working. The equipment was installed October 1994 which puts it way past its useful life.

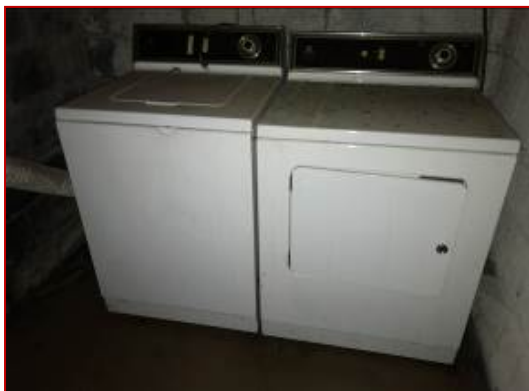
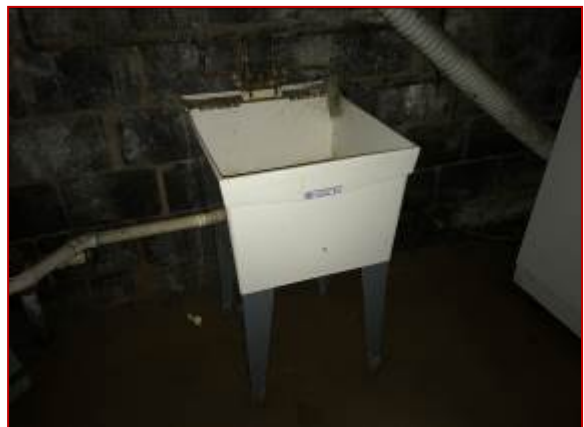
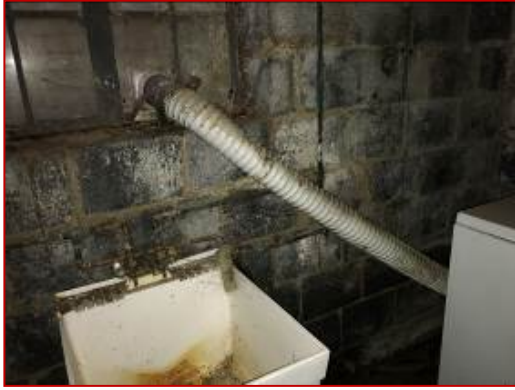
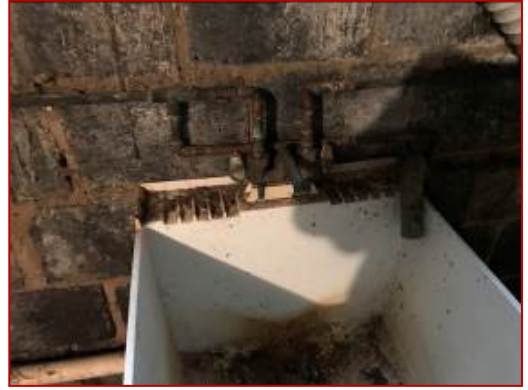
The laundry area is in the basement. There is a clothes washer, electric clothes dryer, and a plastic utility sink. The clothes dryer vent piping is flexible duct that is routed through the window to a vent on the exterior wall.

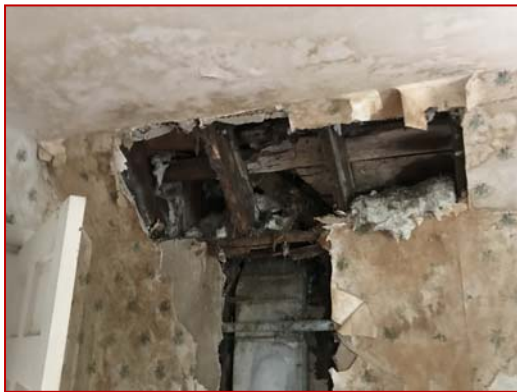
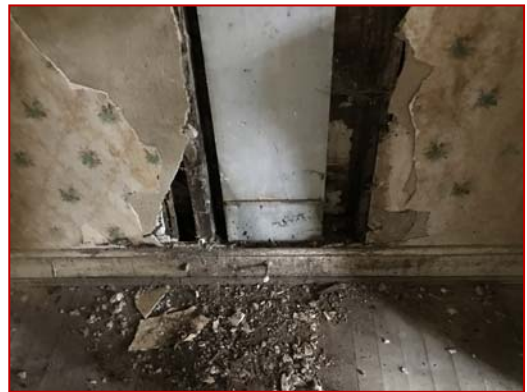
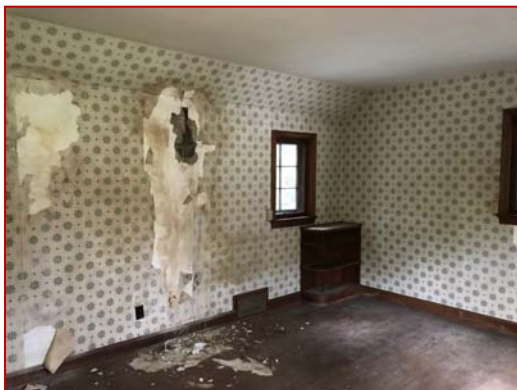
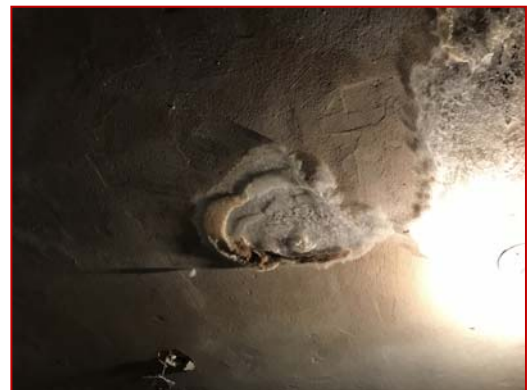
There appears to be mold throughout the house. There are also some areas with severe water damage on the second floor, including at ductwork that is located within the walls.

Due to the concerns with the mold, water, and structural damage, SWSG is not comfortable with occupancy of the house without extensive and invasive testing and repairs. An environmental testing company should inspect and take samples for testing throughout the entire house. This includes opening up walls anywhere near and below water damage. Structural repairs are also necessary for the damaged areas. The leaks must be repaired to prevent further damage.

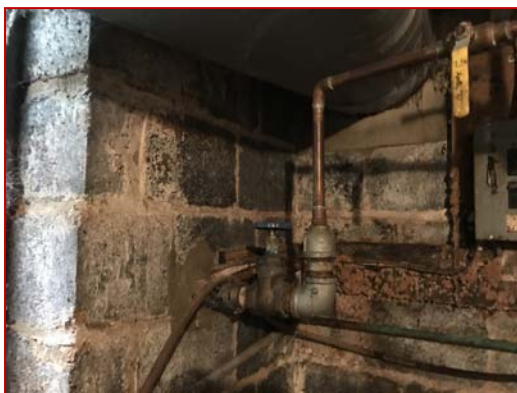
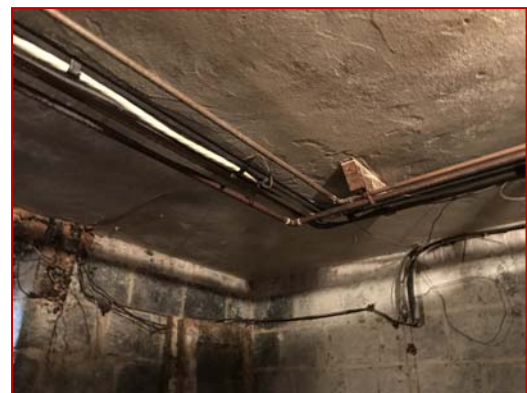
The utility-provided domestic water service enters the basement as 1 ¼” pipe and is reduced to ¾” pipe after a gate valve. A ball valve has been added just downstream of the pipe reduction. The domestic water piping is copper with soldered fittings. None of the domestic water piping in the basement is insulated.

- Plumbing recommendations are only if the house is structurally repaired, all leaks repaired, and all contaminants throughout remediated.
- Replace the water heater.
- Insulate the domestic hot and cold water piping in the basement.
- Provide new faucet and sink for the kitchen and install a garbage disposal.
- Replace the dishwasher.
- Provide new clothes washer and dryer.
- Replace the utility sink and faucet.
- Replace faucets and sinks in all toilet/bath rooms.
- Replace flapper and fill valves in all toilets.
- Replace the shower and bathtub controls and the shower heads.
- Clean gutters and downspouts to verify they are clear.
- Provide splashblocks at all downspouts.
- Make arrangements with the gas utility to relocate the gas meter from the basement to an outdoor location.

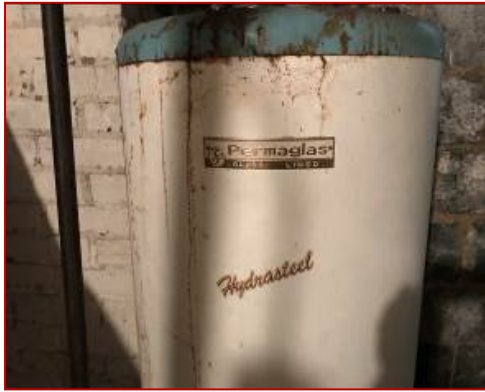
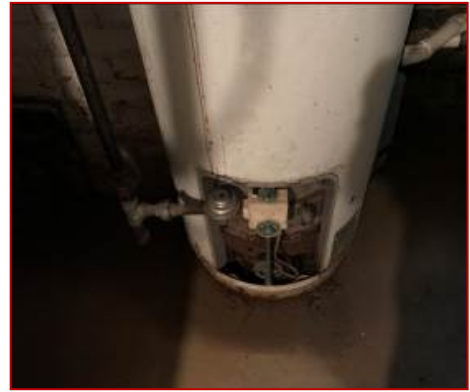
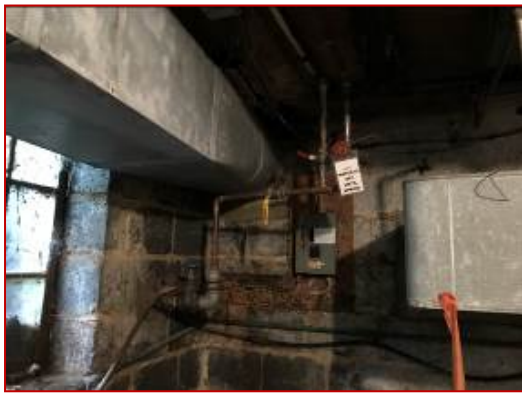
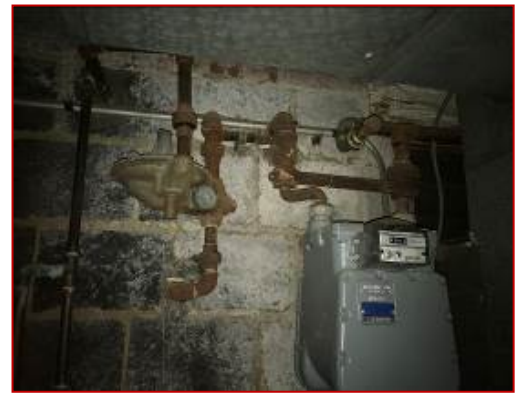
The natural gas powered 50 gallon glass-lined domestic water heater is not working and it appears this model was advertised sometime before 1958. The gas meter is located in the basement along with the service regulator that is not vented.

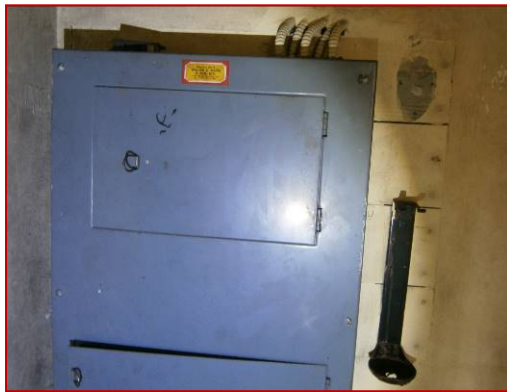
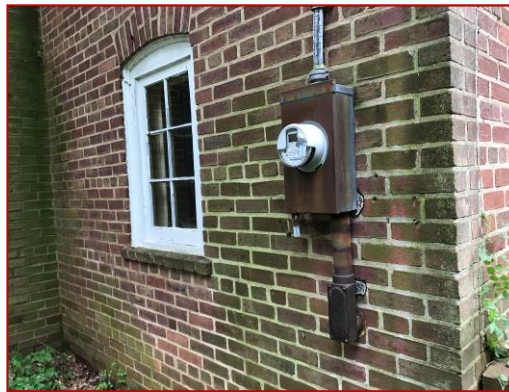
Electrical power is brought to the building by an overhead 120/240V, single-phase, three-wire service connected to an electric meter on the outside corner of the building on the wall opposite the interior stairs leading to the basement. From the meter, the utility service feeds the 200A main electric distribution panel located on the interior south wall of the stair landing leading to basement.

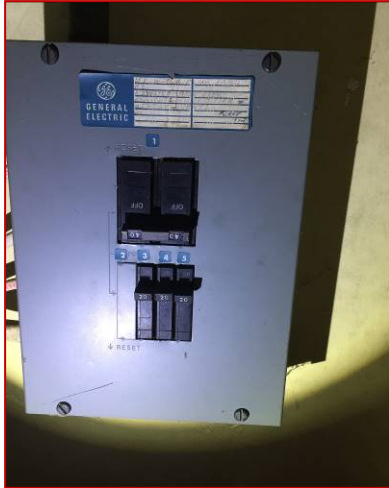
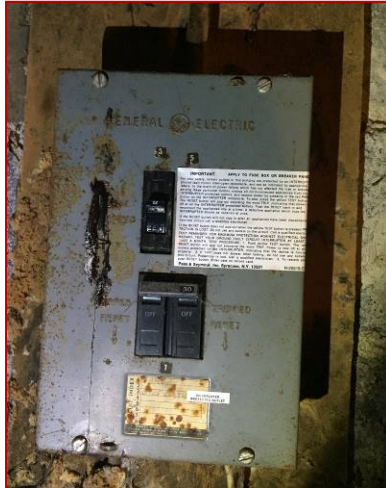
The main distribution panel and sub-panelboards are estimated to be 40 years old. Their useful life is contingent upon maintenance practices and environmental conditions. The main distribution panel contains circuit breakers that are no longer manufactured; therefore, this panel will need to be replaced if a circuit breaker fails, possibly within 5 to 10 years. The sub panel in the basement supplying exterior equipment has visible rust and suspected water damage and should be replaced immediately.

The building wiring is a mixture of types which have been installed at various times in the buildings history. These types include AC cable, conduit, and BX cable. The insulation on the cables, though not tested, does not appear to be damaged. The telephone company entrance box location was not found although several telephone jacks were observed in the space.

- Electrical recommendations are only if the house is structurally repaired, all leaks repaired, and all contaminants throughout remediated.
- Replace (1) 200A (24 pole) panelboards in stair landing with GFI and AFCI circuit breakers.
- Replace (2) sub-panelboards in stair landing and basement with GFI and AFCI circuit breakers
- Replace non-functioning light fixtures
- Replace non-grounded receptacles

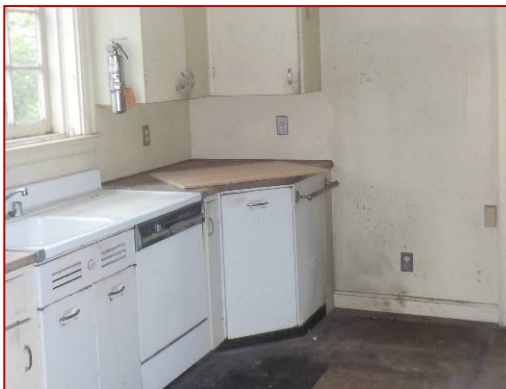
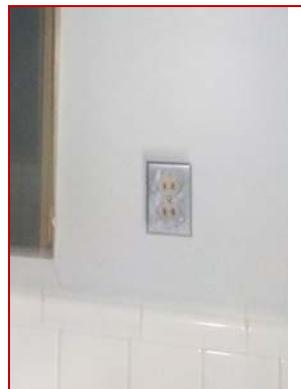
In general, receptacles are present in sufficient numbers and locations to provide adequate power to the space. The 2017 National Electric Code (NEC) has been released, but not adopted in Virginia where the 2014 code is currently in use. The NEC requires Ground Fault Protection (GFI) in Bathrooms, Garages, Outdoors, Kitchens, Basements, and Laundry areas. The NEC also requires Arc-Fault Circuit Interruption Protection (AFCI) in most other areas in a dwelling unit. Protection can be provided by individual receptacles or be provided on the branch circuit breakers supplying the receptacles. While upgrading is not code required, it is recommended to provide GFI and AFCI circuit breakers in the panelboards that have been recommended for replacement.

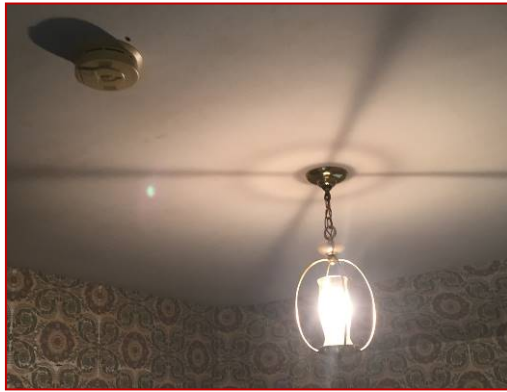
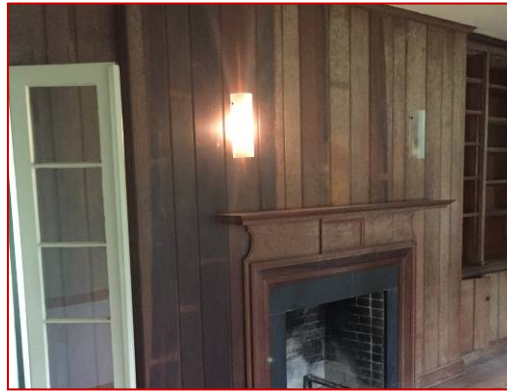
Although not all light fixtures were functional (the cause was not determined) NEC requirements appear to have been met. In general, incandescent wall sconces are used in hallways and bathrooms with overhead light fixtures found in the basement, kitchen, living room, and dining areas. Cove lighting is used in the glass porch area.
