FAIRFAX COUNTY PARK AUTHORITY

Ellmore Farmhouse

MEP Assessment

Date Prepared:
December 1, 2017

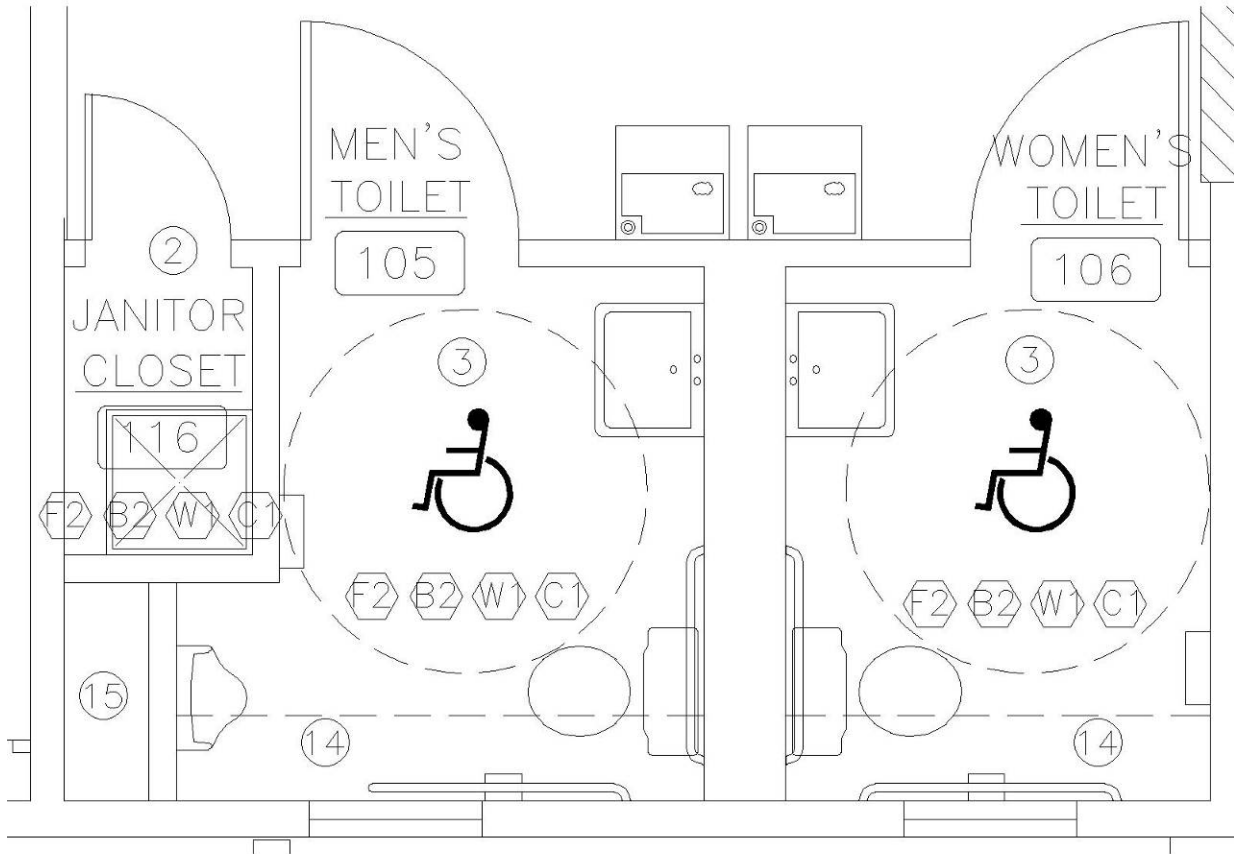
Image 1: Toilet Room Space Plan, 2010

In 2010, SWSG prepared design development plans to adaptively reuse the house for office space on the first and second floors. The layout of the toilet rooms, which would utilize the existing first-floor toilet room and laundry room, would be applicable for the museum/office use.

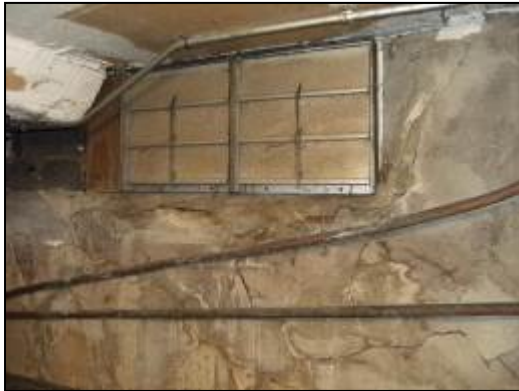
Image 2: Uninsulated Copper Piping

Heating water is pumped through uninsulated copper piping throughout the house to floor-mounted radiators in a series layout. There are two thermostats on the first floor and two thermostats on the second floor; however, there are only three hydronic zone valves controlling three heating zones. It is unknown if the controls are operational.

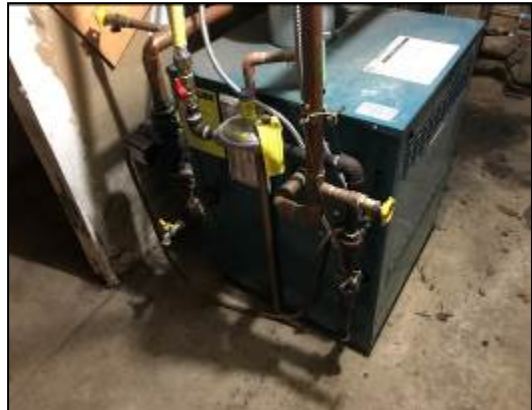
The house is heated by a gas-fired boiler located in the basement. There is a single 28x12 combustion air intake (assume 80% free area) which provides for approximately 800 MBH heating capacity based on the 2009 International Fuel Gas Code (one square inch of free area is rated for 3000 BTU/hr.). We believe the capacity of the boiler to be between 100 MBH and 150 MBH, therefore the combustion air intake is adequately sized. The age of the boiler is unknown, but seven years ago the boiler was an oil-fired unit. The boiler flue is connected to a masonry chimney. The boiler is not in use at the current time and it is unknown if it is operational. A gas meter is installed and flexible Corrugated Stainless Steel Tubing (CSST gas piping) has been extended into the basement.

Image 3: Gas-fired Hydronic Boiler

- The existing hydronic heating water piping may be reused for heating; however, non-functioning radiators need to be replaced. The piping shall be pressure tested, cleaned, and repaired as required. Since the existing gas-fired boiler is less than 8 years old, there is no need to replace within the next few years. The average lifespan of a gas-fired boiler is 12-15 years.

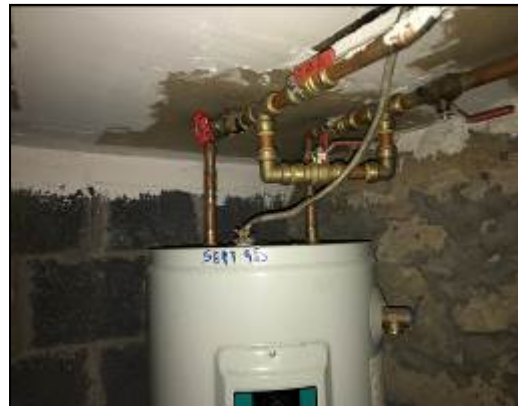
Image 5: Electric water heater

A 40-gallon electric water heater in the basement, with an installation date of September 1995, provides domestic hot water to the house. It appears to be in fair condition but has reached the end of its expected lifespan.

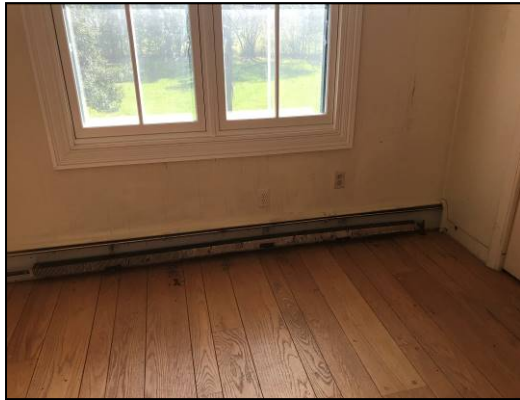
All of the radiator panel covers on the first floor have significant damage. On the second floor in Bedroom 201, 204, and Office 209 there is significant damage to the radiator fins and many of the radiator panel covers have been removed.

Image 6: Typical Damaged Radiator

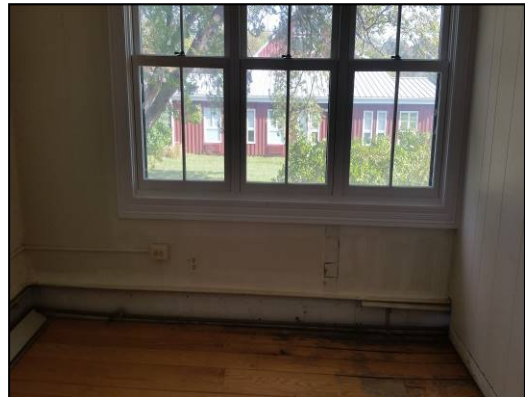
Image 7: Another Damaged Radiator, 2nd floor bedroom

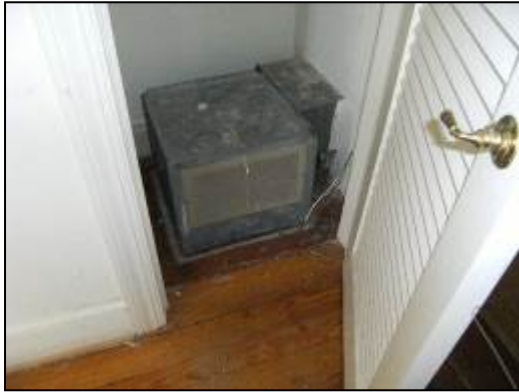
There are fireplaces located throughout the house that are not in use. The basement has ducts that drop into the crawl space and resurface in the family room closet. During the survey there was no evidence of a HVAC unit; the purpose of the ducts is unknown.

Image 8: Ductwork in Closet 112

- Clean any ducts that may be reused.

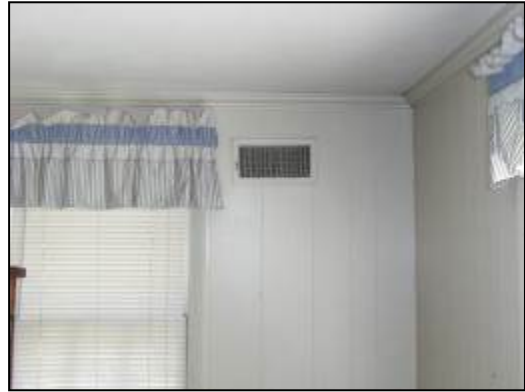
There are several wall grilles installed in the house on the first and second floors. The purpose/function of these grilles is unknown since they do not stack from floor to floor and there was no ductwork found connected to them.

Image 9: Wall Grille

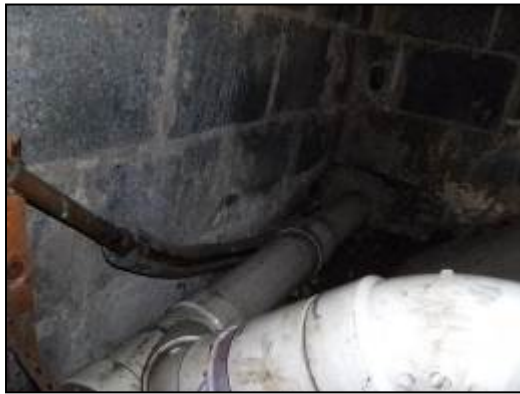
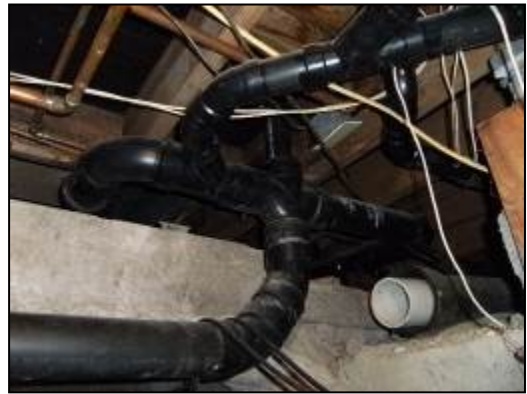
The existing utility-provided domestic water service enters the house through the basement wall adjacent to the sanitary sewer. Copper domestic water piping in the basement distributes water to the plumbing fixtures. The sanitary sewer is connected to the utility and not a septic system. The sanitary sewer piping is comprised of cast iron, PVC, and ABS piping. It appears that it may have once been connected to a septic system and that some of the piping is abandoned in place.

Image 10: Sanitary Sewer Piping

Image 11: Sanitary Sewer Piping

- The domestic water piping entrance to the building shall be rerouted to maintain the code required separation from the sanitary sewer piping. The abandoned piping in the basement should be removed.
- It is recommended to test the sump pumps to verify proper operation.
- The water heater is past its useful life. It is recommended to replace the water heater in kind.
- The gutters and downspouts should be cleaned, repaired, and splash blocks added.
- Optional addition of toilet on second floor and connection of existing lavatory to water and sewer.

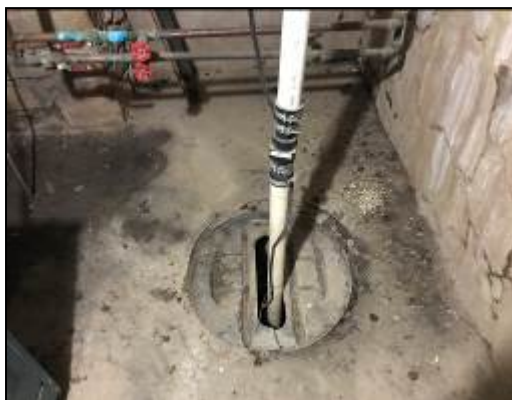
The basement has two sump pumps along with floor drains. The sump pumps are located on opposite sides of the basement and discharge out of the southeast side of the house to an open yard inlet.

Image 12: Sump Pump Basement

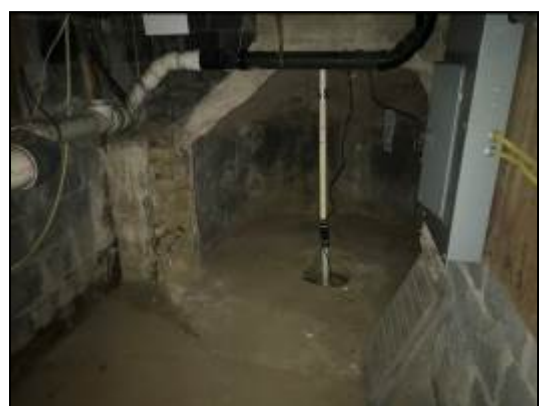
Image 13: Sump Pump Within Floor Drain

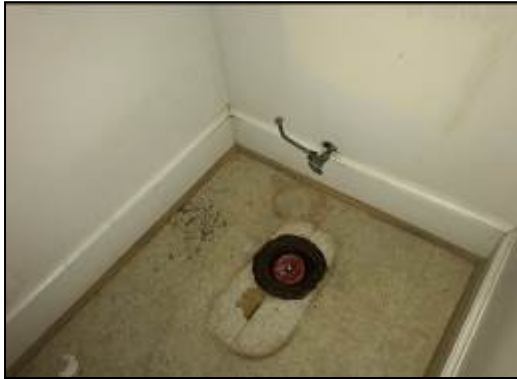
The second-floor bathroom has a counter-mounted lavatory and a connection for a water closet. The drain trap for the lavatory has been removed and its sanitary sewer line has been capped. The water closet has been removed and its sanitary sewer line has been capped at the floor. A drinking fountain, once installed on the wall behind the water closet, is no longer present. The drinking fountain was removed and the sanitary sewer piping was capped.

Image 14: Capped Sanitary Sewer Line

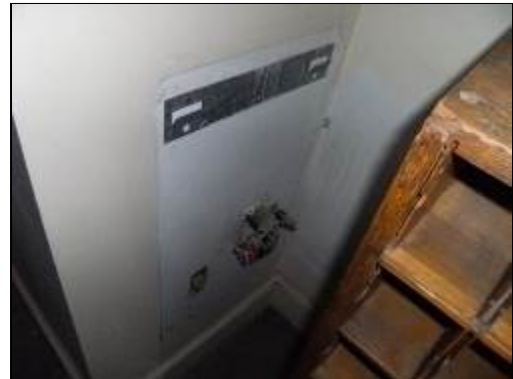
Image 15: Earlier Location of Drinking Fountain

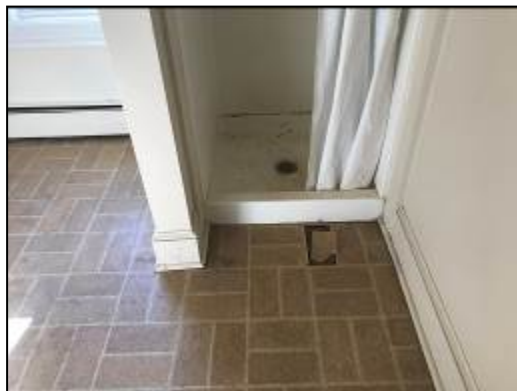
The first floor has a bathroom with a shower, water closet, and counter-mounted lavatory. The toilet, shower fixtures, shower stall, and lavatory fixture are in poor condition.

Image 16: Stall shower

- Replace dishwasher
- Replace kitchen faucet
- Replace existing shower stall, shower head, and controls
- Replace first-floor water closet
- Replace first-floor lavatory faucet

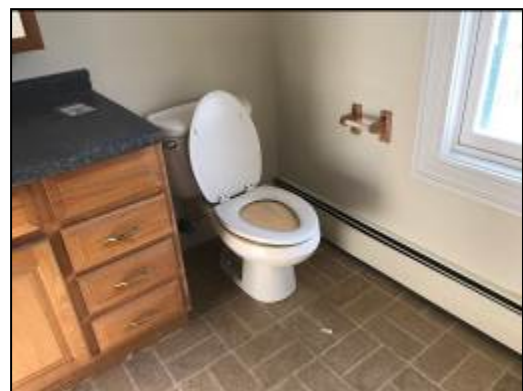
Image 17: Water closet

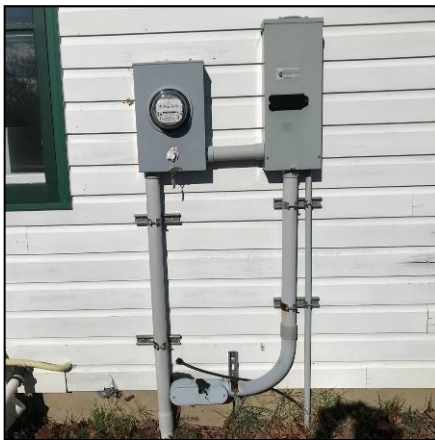
Electrical power is brought to the building by an underground 200A, 120/240V, single-phase, three-wire service from a pole-mounted utility transformer at the east side of the property approximately 100 feet from the house. The underground utility feeder is connected to an electric meter on the outside corner of the building on the wall opposite the first-floor laundry room. From the meter, the utility service feeds the enclosed circuit breaker located on the building exterior next to the meter. The service cable then runs to the 200A main electric distribution panelboard located in north east corner of the basement.

Image 18: Meter and Enclosed Circuit Breaker

The electrical service size will need to be increased to a 320A, 120/240V, single-phase, three-wire service if additional mechanical cooling is provided. This will require an increase in the utility service size to the house, replacement of the existing meter, and a new larger feeder

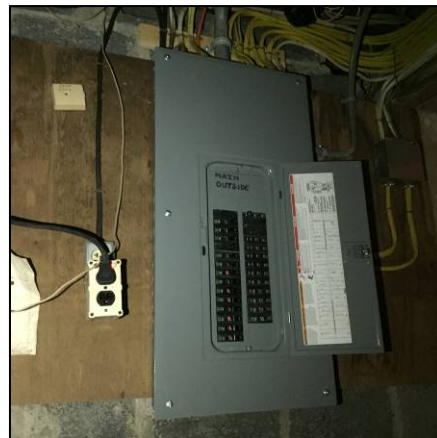
Image 19: Main Electrical Distribution Panelboard

The main distribution panel feeds the HVAC (240V loads), kitchen, lighting, and receptacle loads. The panelboard has no signs of visible damage and should be able to be reused.

- Provide AFCI replacement circuit breakers in the existing panelboard.
- Provide a new 400A120/240V, single-phase, three-wire panelboard to provide power to the following mechanical equipment as well as the existing panelboard:

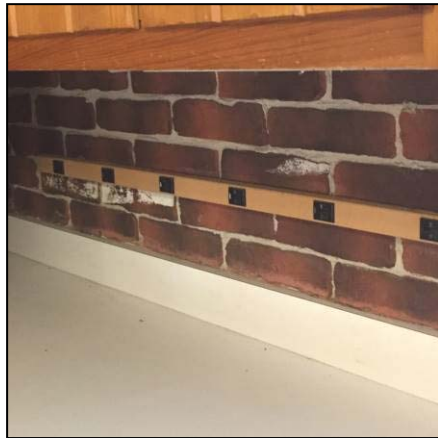
The NEC also requires one receptacle per 12 linear feet of wall space in dwelling units, which appears to have been met in the building. Two dedicated above-counter kitchen circuits are also required by the NEC. Above counter receptacles and surface mounted ‘Wiremold’ strip is in place; dedicated circuiting was indicated on the panelboard schedules. It is recommended to replace two above-counter kitchen receptacles with GFI receptacles.

Image 20: Wiremold Strip in Kitchen

- Replace above-counter receptacles with GFCI receptacles. Replace exterior receptacle with GFCI receptacle.
- Provide GFI receptacles at exterior adjacent to proposed mechanical equipment.

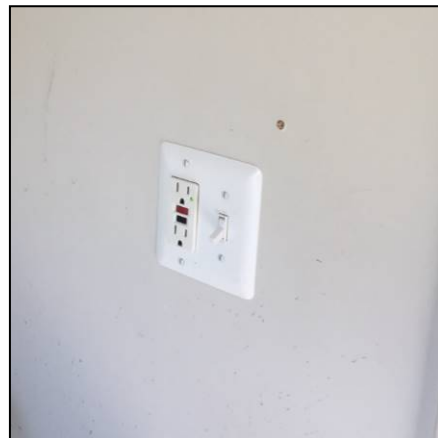
Image 21: GFI Receptacle

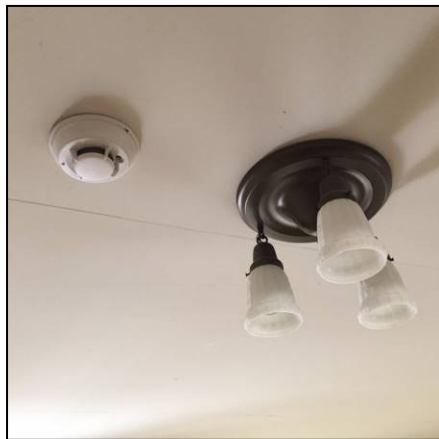
Although not all light fixtures were functional (the cause was not determined) NEC requirements appear to have been met. In general, the house contains a mixture of light fixtures types. Fluorescent screw-in fixtures controlled by a light switch or pull chain were found in the basement. Recessed incandescent lights are in the hallway and stair entrance. A three-lamp incandescent ceiling-mounted fixture is in the front entrance with surface-mounted fluorescent fixtures of various styles found in some of the rooms and kitchen. Wall-mounted fixtures are in the bathroom and several of the second-floor bedrooms are provided with surface-mounted fluorescent fixtures.

Image 22: Ceiling-Mounted Light Fixture

- Salvage and reuse existing light fixtures in the basement and where possible throughout the house.
- Replace existing light fixtures in the kitchen.
- Replace or repair non-functioning light fixtures in basement (2), 1st floor (3) and 2nd floor (5).

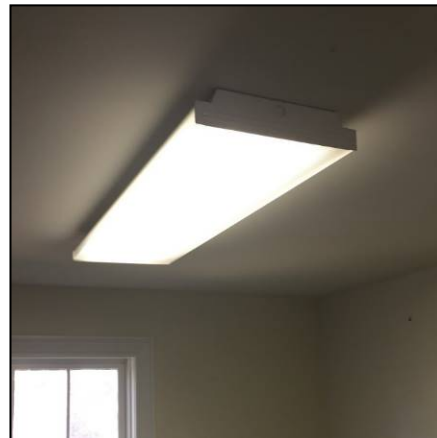
Image 23: Surface-Mounted Fluorescent Light Fixture
