FAIRFAX COUNTY PARK AUTHORITY
Hannah P. Clark/ Enyedi House
MEP Assessment

10605 Furnace Road
Lorton, VA 22079

Date Prepared:
September 15, 2017

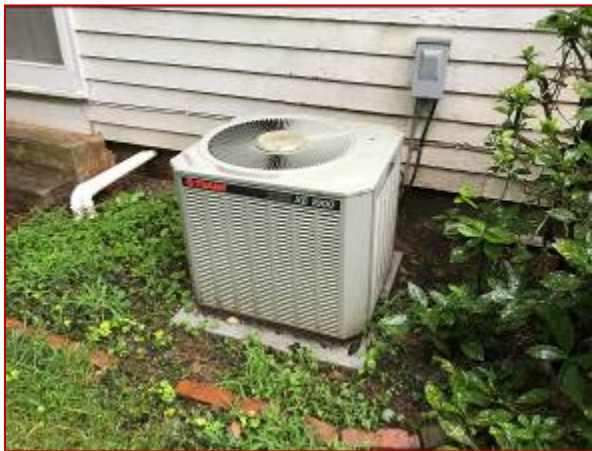
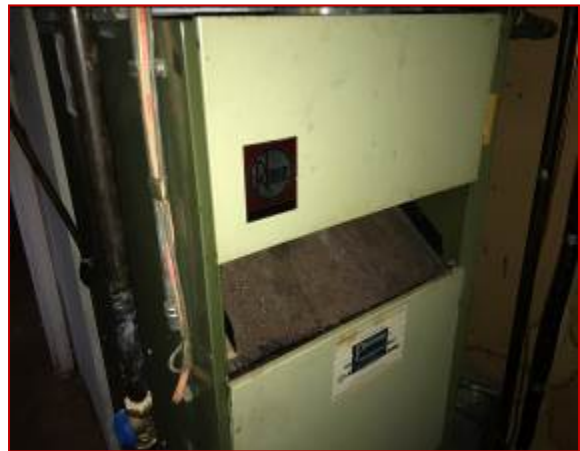
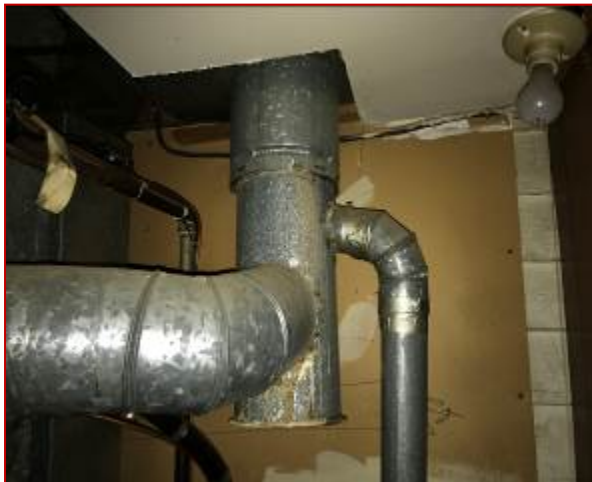
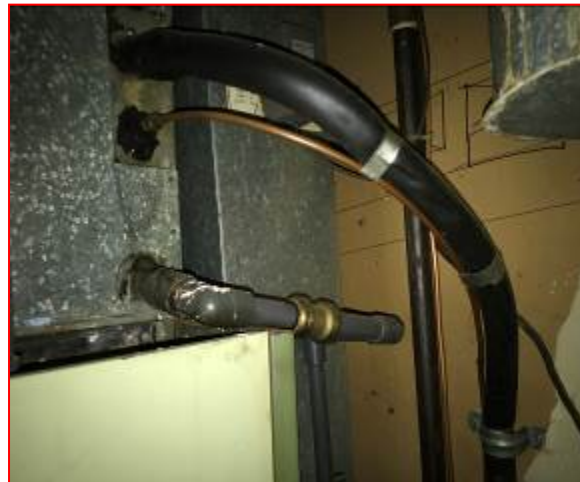
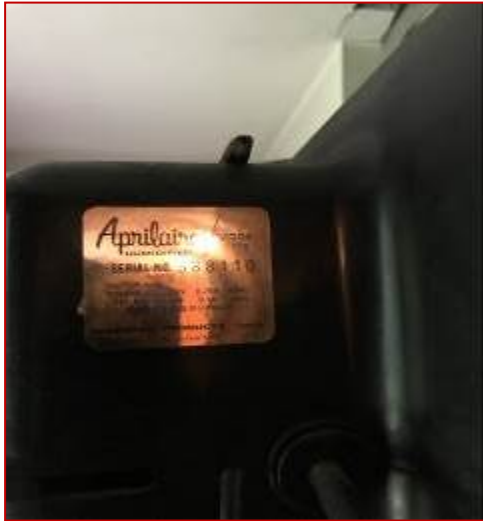
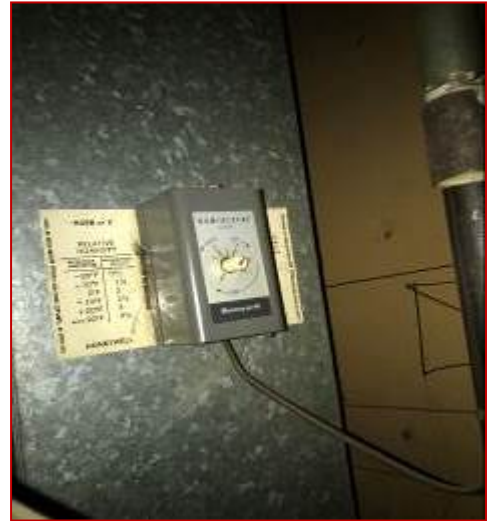
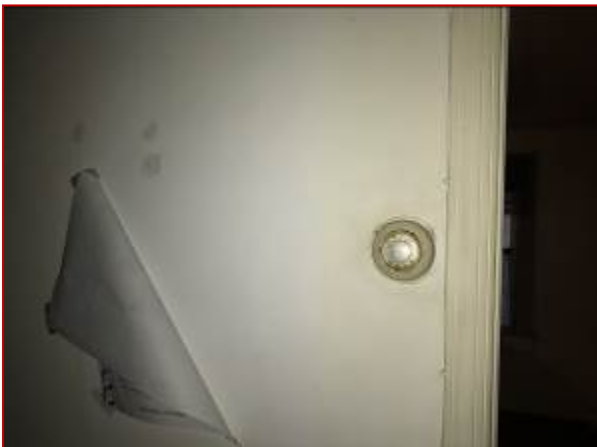
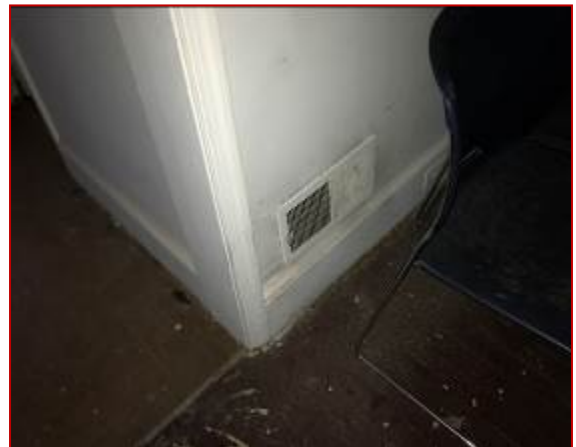
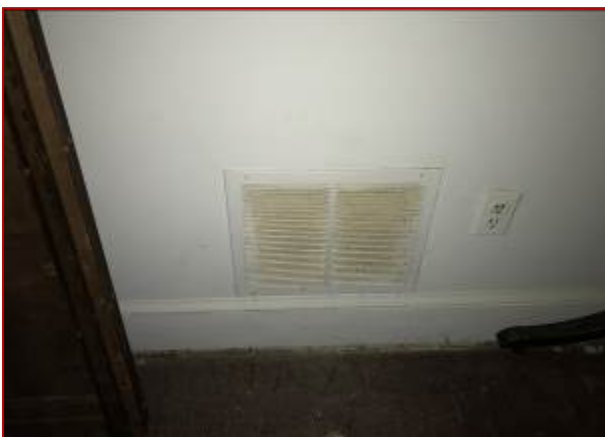
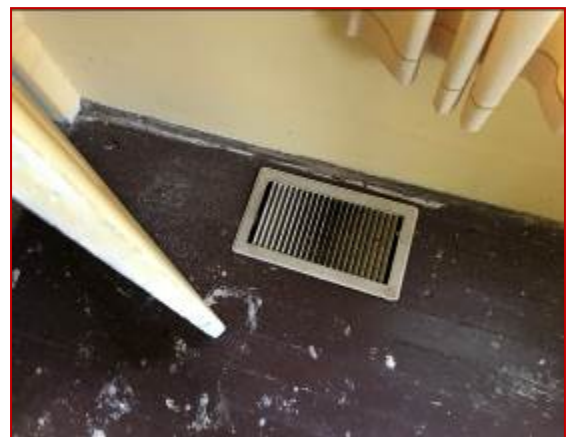
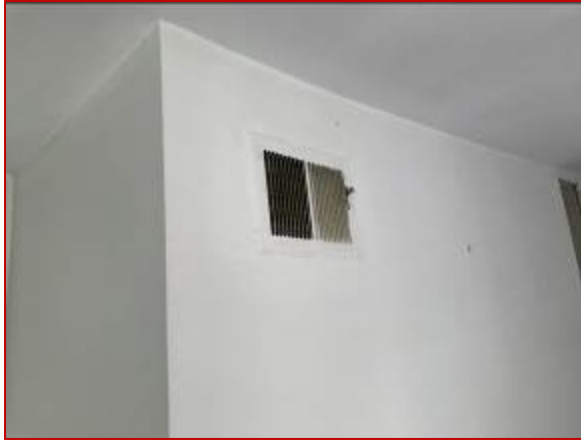
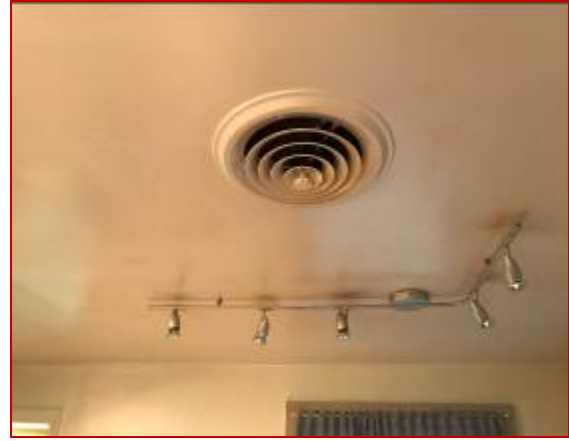
The house is conditioned by a single nominal 36 MBH (3 ton) Trane XE 1000 split system outdoor heat pump located at the left side of the house that is connected to a Rheem furnace with an Aprilaire 110 humidifier located on the first floor near the family room. This system was installed in October 2000. A wall-mounted dial-type mechanical thermostat is located in the first floor living room area. Wall and floor supply registers distribute air to each space and appear to be in fair condition. The wall-mounted return grille is located in the living room. The system is operational and the thermostat was set at 75F. The heat pump and furnace are past their useful life timeframes.

- Remove and replace existing HVAC system (outdoor unit, indoor furnace, humidifier, and thermostat).
- Clean and inspect all existing supply and return ductwork and registers/grilles.
- Provide an exhaust fan for all the bathrooms.
- Replace kitchen hood as it was not working during inspection.
- Provide a dehumidifier for the basement.

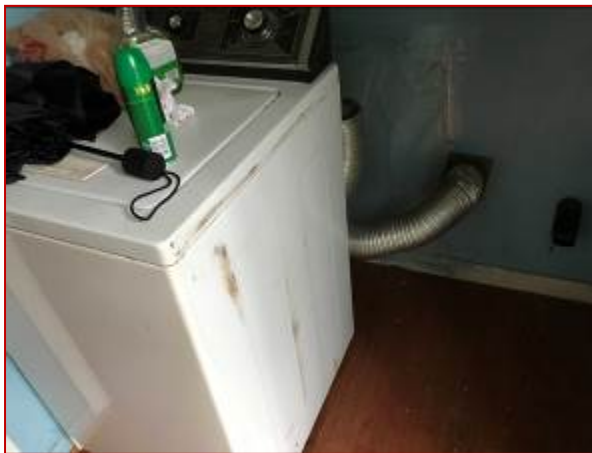
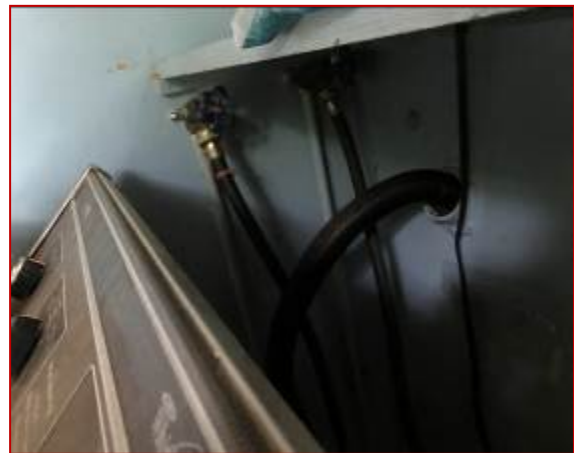
There is a clothes washer, however there is not a clothes dryer. Vent ductwork with wall hood and power outlet are available for an electric clothes dryer.

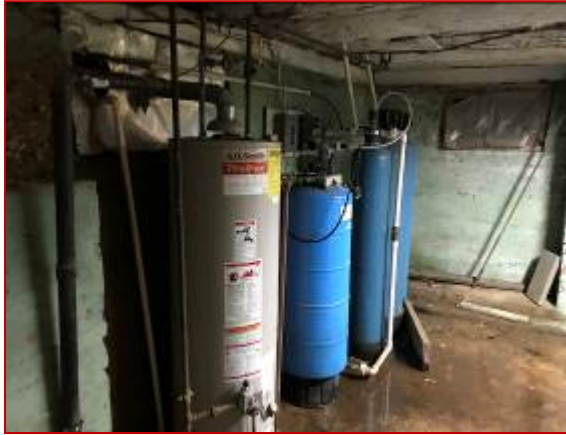
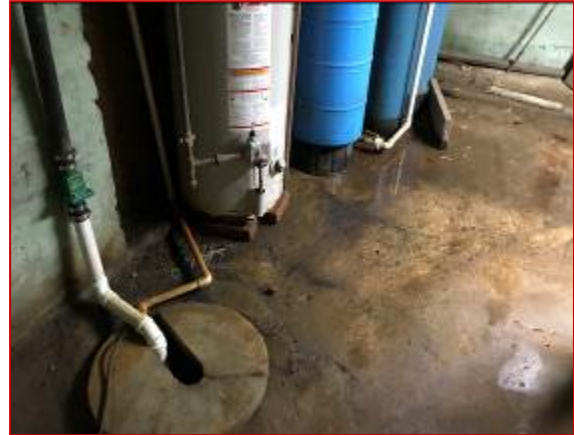
Domestic water is provided to the house by a waterline connected to a well. The pressure tank and filtration system are located in the basement along with a 40 gallon gas-fired water heater and a sump pump. The water heater age is unknown. It is unknown if the sump pump is operational. The domestic water piping consists of PVC at the well equipment and copper throughout the house. The domestic water piping is not insulated.

- Insulate exposed domestic hot and cold water piping.
- Replace all bathroom faucets.
- Provide new clothes dryer.
- Replace all of the water closets.
- Replace the shower and bathtub controls and the shower heads.
- Clean gutters and downspouts to verify they are clear.
- Provide splash blocks at all downspouts.
- Inspect the septic system by a septic company.
- Inspect the well water system by a plumbing contractor.
- Test the well water to verify the safety and correct water treatment.

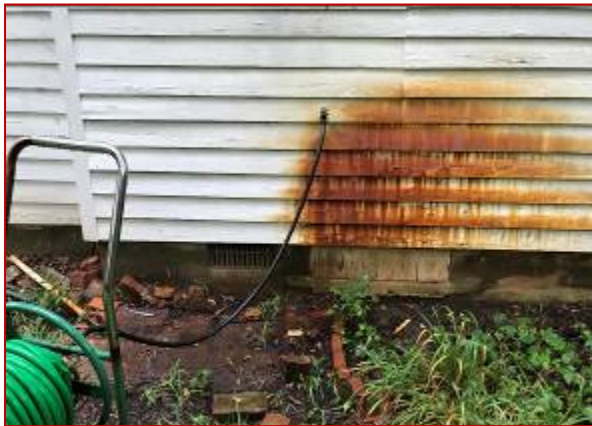
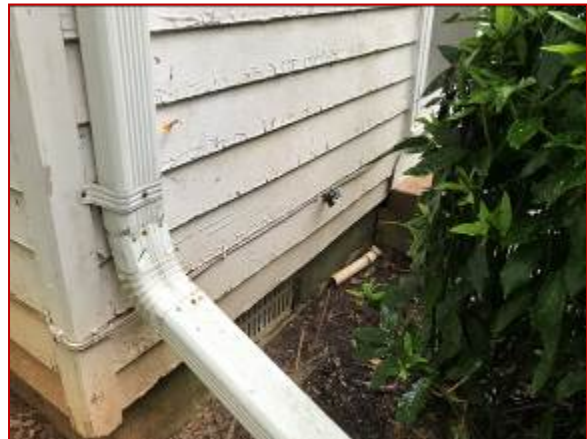
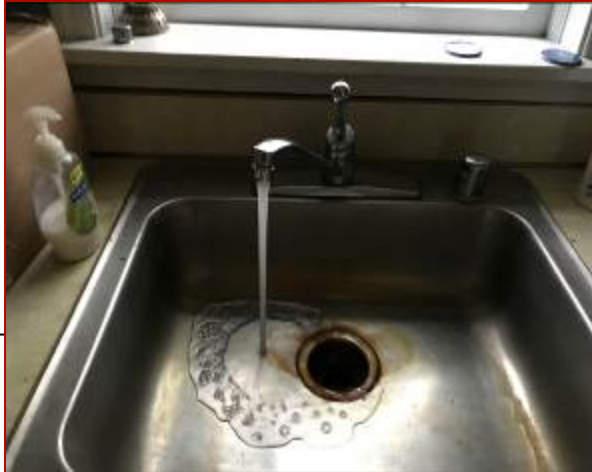
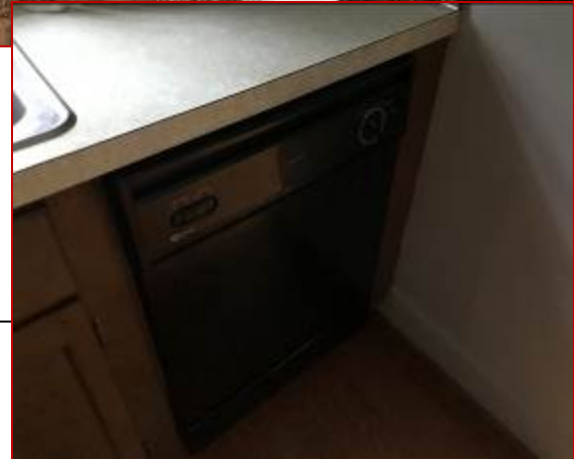
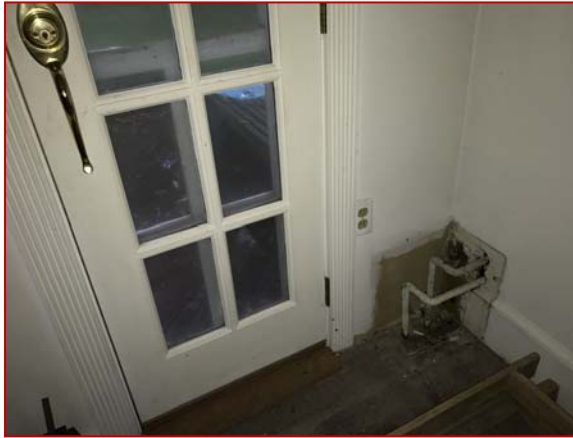
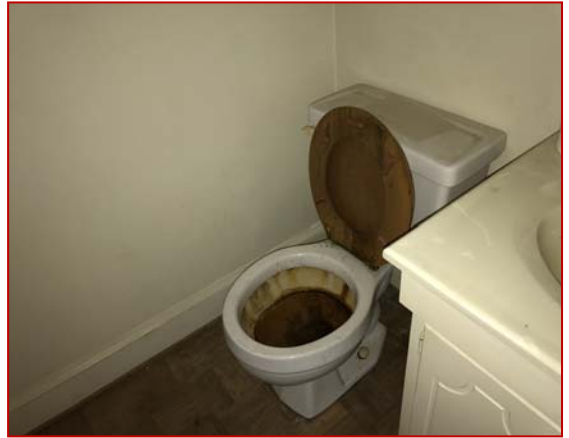
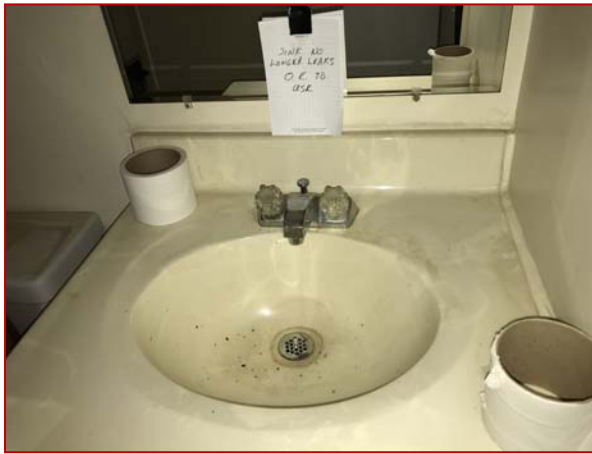
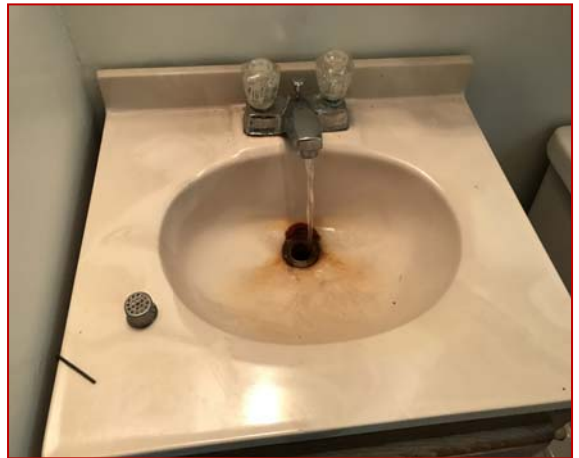
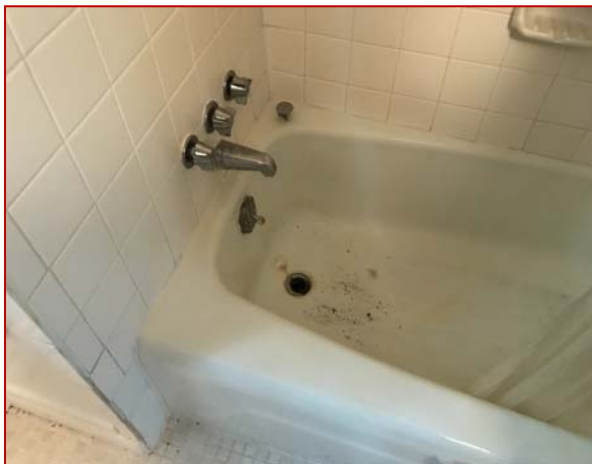
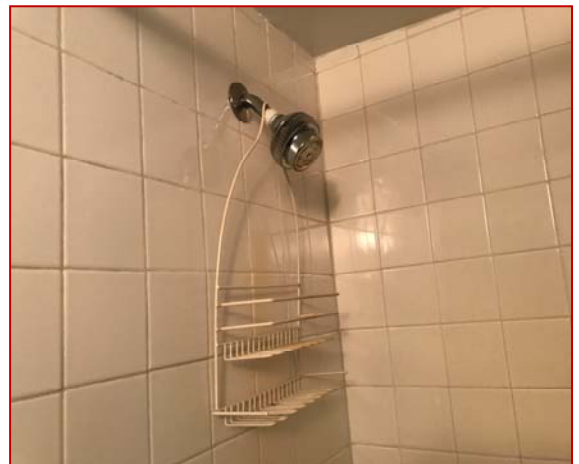
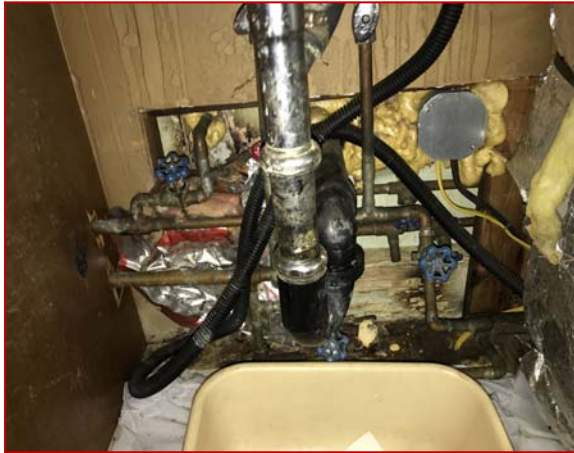
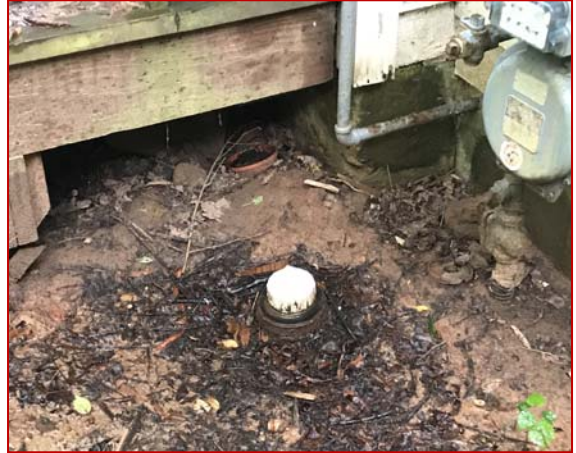
All of the faucets and water closets in each of the 1-1/2 bathrooms were operational. There are two hose bibbs located on the exterior wall of the house. The kitchen sink does not have a garbage disposer because the house is served by a septic system. All of the toilet bowls and one sink lavatory on the second floor bathroom have severe water stains.

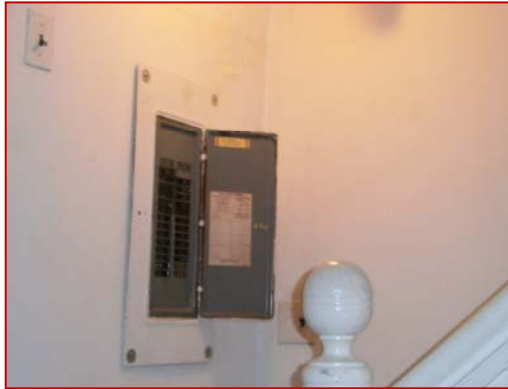
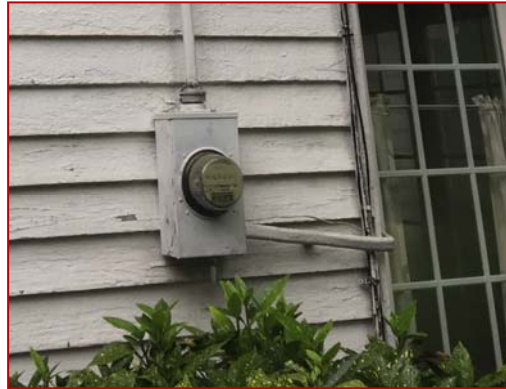
Electrical power is brought to the house by an overhead 120/240V, single-phase, three-wire service connecting to a an electric meter located on the outside corner of the work room. The work room is adjacent to the stairs. From the meter, the utility service feeds a 60A main electric distribution panel located on the north face wall of the stair landing leading to second floor.

The panelboard feeds the HVAC/Furnace (two pole loads), kitchen, and other building receptacle loads. The cables and conduits connected to the panelboard are not visible and their condition needs to be assessed. The telephone company entrance box location was not found. The panelboard, which appears to be dated from the 1980s, is nearing the end of its useful life and should be replaced. It is recommended to upgrade the existing panelboard with a 100A main 120/240V panelboard to provide capacity for required dedicated kitchen receptacles and other added loads.

- Replace (1) 100A 120/240V panelboard in stair landing with GFI and AFCI circuit breakers.
- Replace non-functioning light fixtures.
- Replace non-grounded receptacle.
- Replace four above-counter receptacles with GFCI receptacles. Provide two of these receptacles with dedicated circuits.
- Replace smoke detectors. Fairfax County recommends installing smoke detectors in each sleeping room, outside each sleeping area and in the immediate vicinity of sleeping rooms, and on each story, including the basement. Recommend installing wireless interconnected building-powered smoke detectors with battery back-up in lieu of battery powered only smoke detectors.
- Feeders to HVAC may be reused if sized correctly for the proposed equipment.
- Provide power for proposed dehumidifier in basement.
- Add GFCI receptacles in toilet rooms off the main bedrooms.

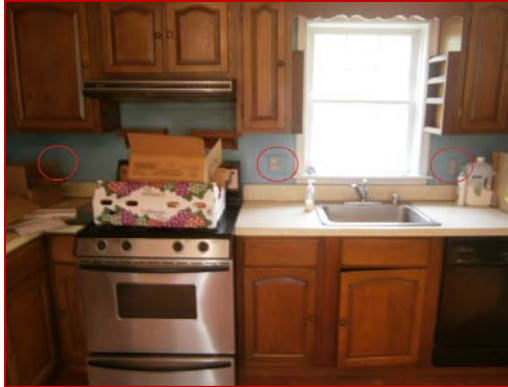
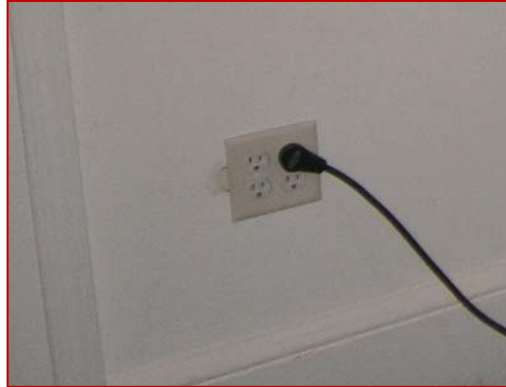
In general, receptacles are present in sufficient numbers and locations to provide adequate power to the spaces. The 2017 National Electric Code (NEC) has been released, but not adopted in Virginia where the 2014 code is currently in use. The NEC requires Ground Fault Protection (GFI) in bathrooms, garages, outdoors, kitchens, basements, and laundry areas. The NEC also requires Arc-Fault Circuit Interruption Protection (AFCI) in most other areas in a dwelling unit. Protection can be provided by individual receptacles or be provided on the branch circuit breakers supplying the receptacles. While upgrading is not code required, it is recommended to provide GFI and AFCI circuit breakers in the panelboards that are recommended for replacement.

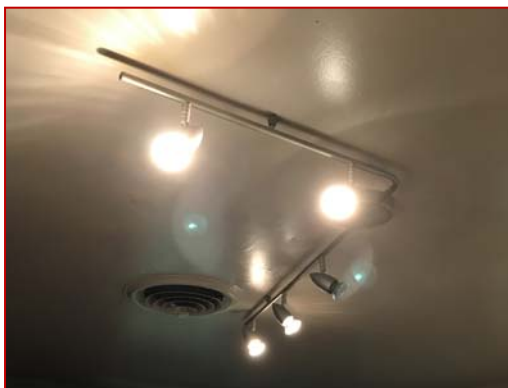
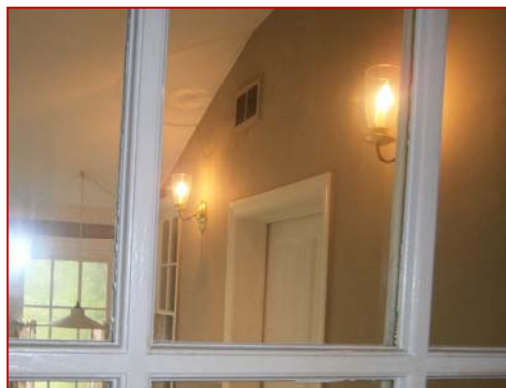
Wall sconces are used in the sunroom and bathrooms with overhead light fixtures found in the laundry, living, bedrooms, and workrooms. Track lights are used in the kitchen, living room and one bedroom.

Two exterior flood lights and the exterior lighting for the main dwelling front and rear entrances were observed to be non-functioning; however, it is unknown if this is due to non-functioning light bulbs or the fixtures themselves. One exterior wall-mounted fixture was observed on the south face of the house and it was operational.
