Physical Assessment of Selected Rain Gardens in Fairfax County, Virginia

August 2007

**Prepared By
Asad Rouhi
Daniel Schwartz**

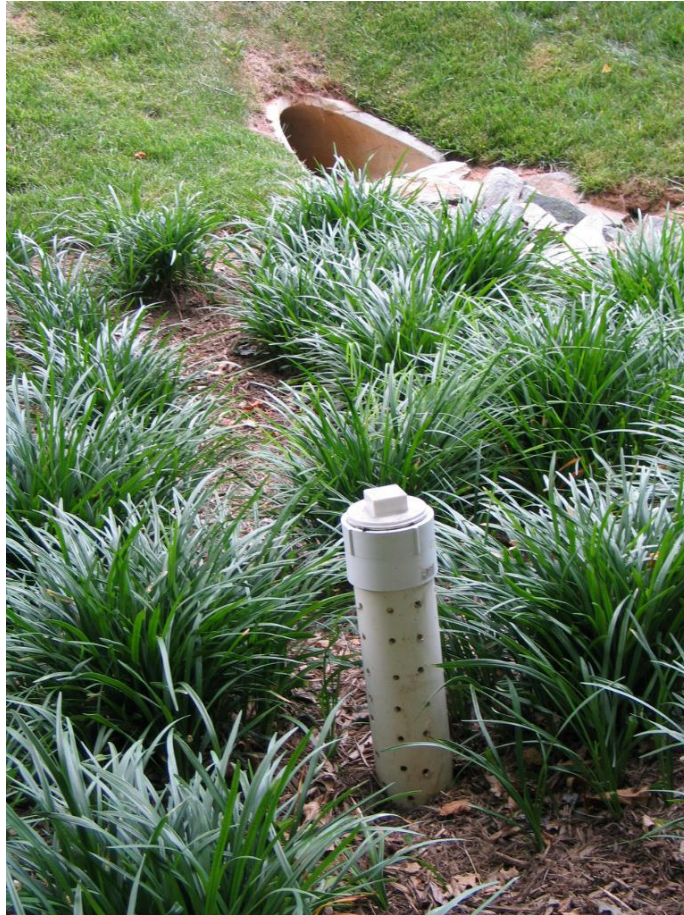
Cover:

At first glance, the cover is a picture of a beautiful rain garden. However, the perforated pipe prevents the rain garden to function as expected.

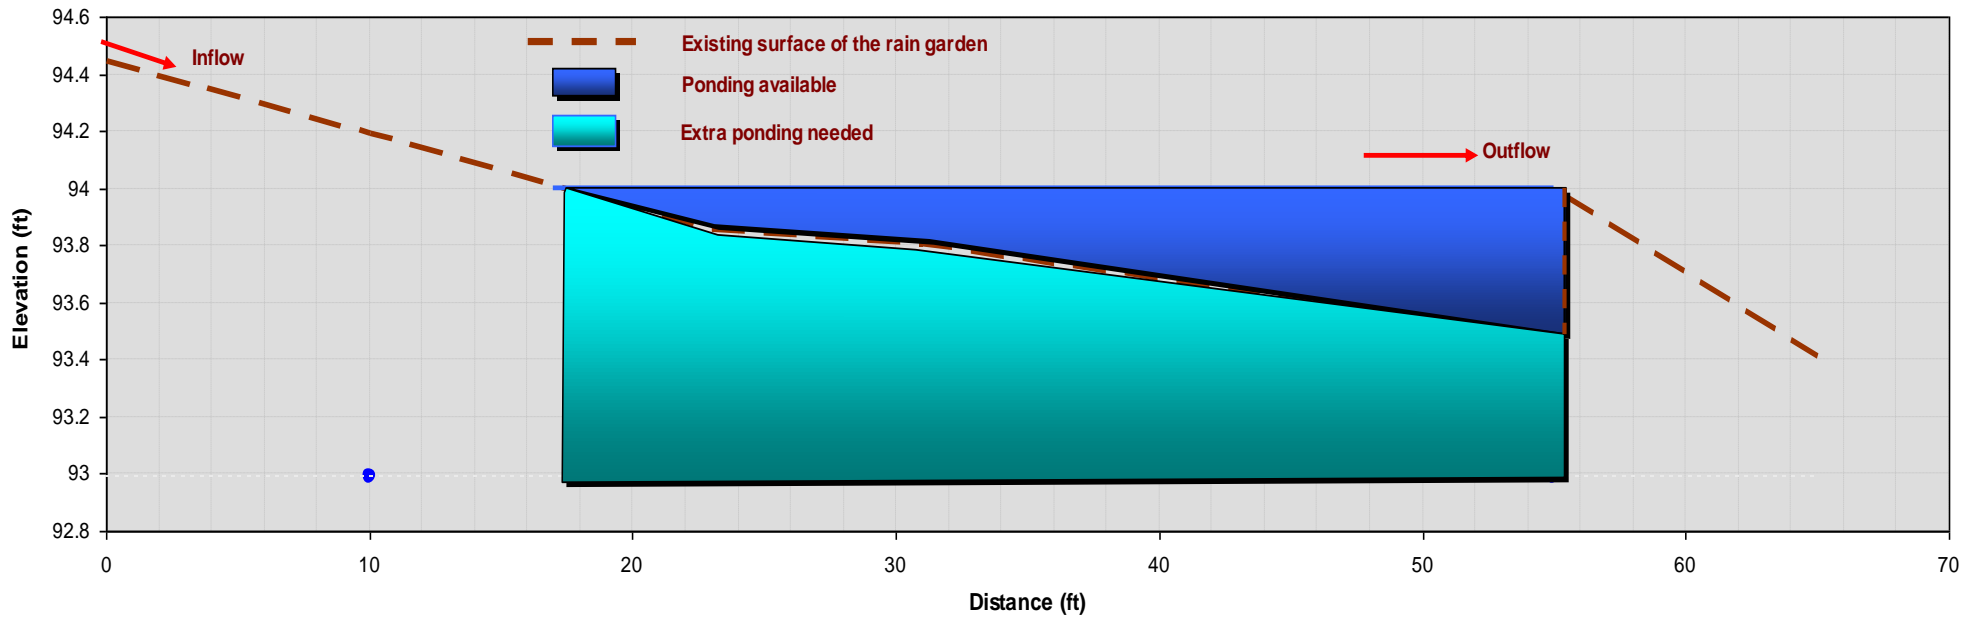
Based on the analysis of the surveyed profiles, 13 out of the 20 rain gardens did not have the proper ponding depth. In the worst cases almost none or very little ponding was provided at all. This was the case for RG-2, RG-7, RG-10, RG-11, and RG-14, or almost 25% of the sites investigated. In less severe cases, some portions of the rain garden would feature the required ponding depth, while other parts would not (Fig. 2); or all parts of the rain garden would have ponding, but the depth would not be deep enough to satisfy the requirements set forth in the original plans (Fig.3). This is the case for RG-4, RG-8, RG-9, RG-12, RG-15, RG-18, RG-19, and RG-20. In cases where the facility has no ponding depth or the ponding depth is not adequate, smaller storms would not create the volume of runoff necessary to cause surface ponding and outflow through the overflow structure. During these storms, the rain gardens would filter all the runoff that flows into the rain garden. However, during larger storms where ponding does occur, the rain gardens would quickly fill to the level of the overflow. After that point, subsequent runoff entering the rain garden would almost immediately be channeled untreated into the overflow. This is especially true for the facilities with almost no ponding depth. During

Fig. 3: Example of a longitudinal profile of a rain garden (RG-9) showing inadequate ponding depth

heavy sustained rainfall, the only infiltration and treatment that would occur in these rain gardens would be provided by the small amount of water that could quickly infiltrate into the soil before ponding began to occur.

The reason for inadequate ponding depth can be due to inadequate construction oversight, lack of adequate maintenance, or both.

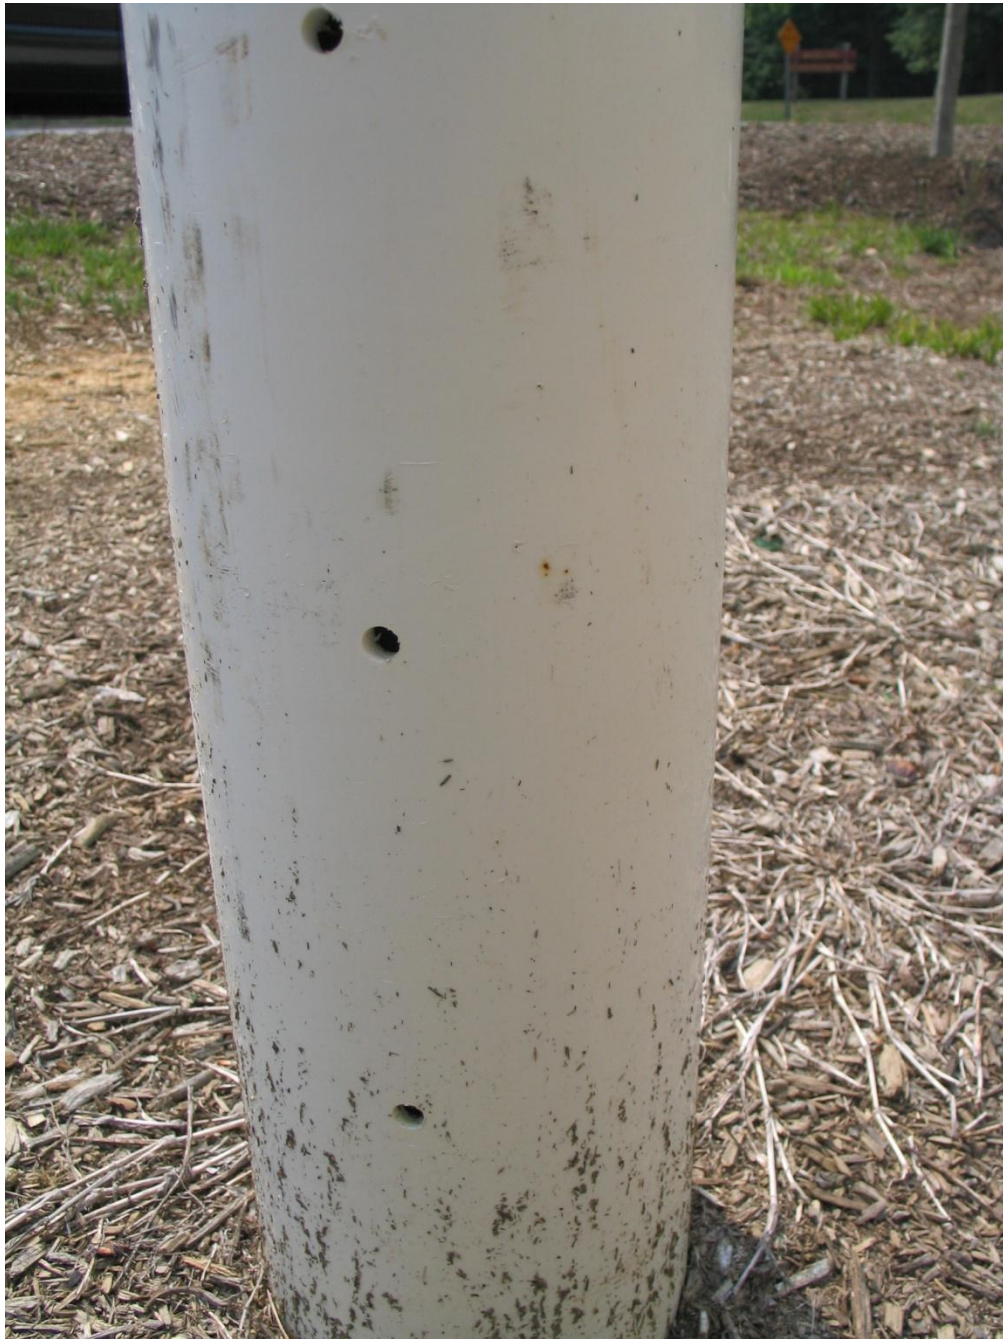
Fig. 4: Example of a perforated observation well (cleaning well) in one of the surveyed rain gardens (RG-11)

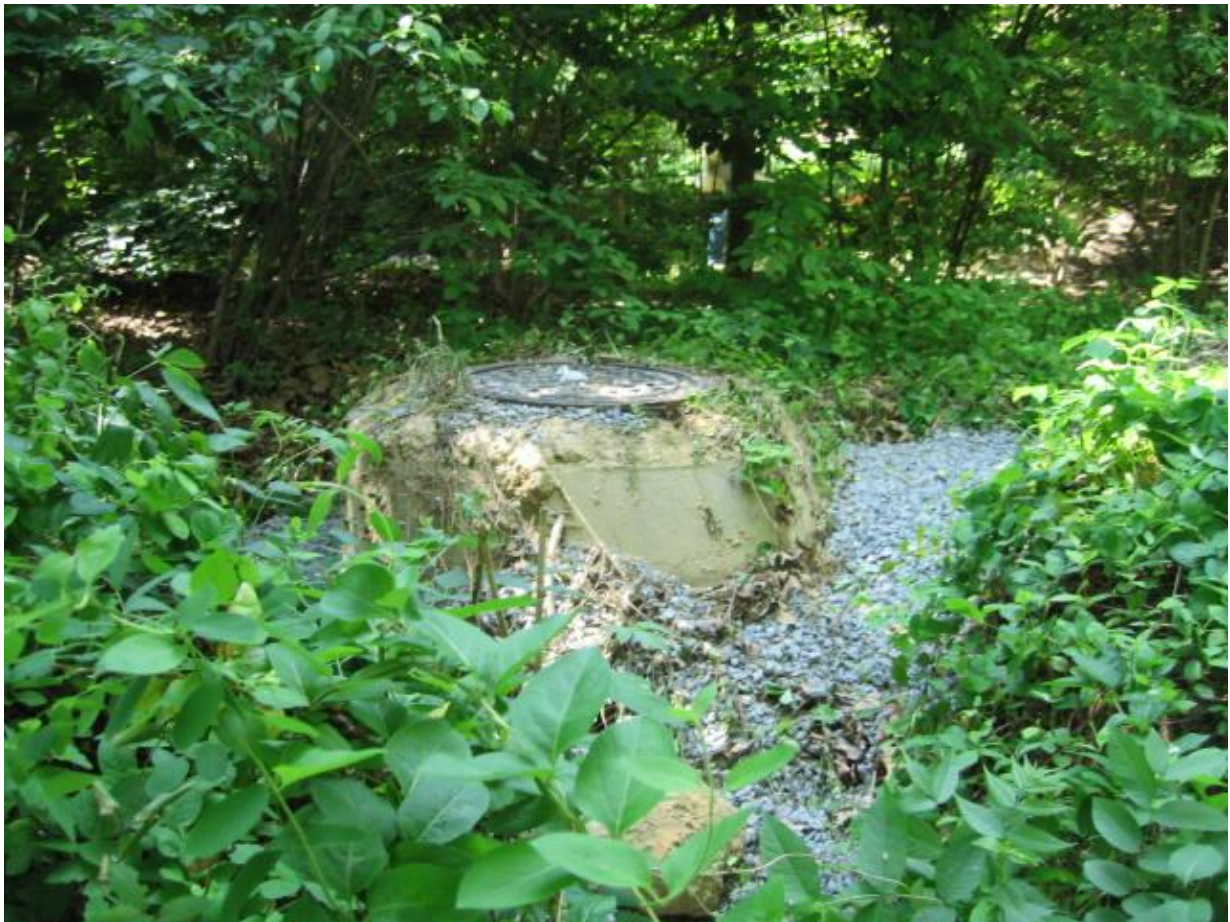
The soil at RG-10 appeared to be crusted on the surface. Crusting occurs when the surface soil is bare and directly exposed to the force of rainfall or runoff. Rain drops and fast runoff carry enough force to break down the soil aggregates into their individual particles of sand, silt and clay. The loose soil particles and moisture create a muddy slurry on the surface that clogs pores and hardens into a brittle crust when dry. This crust can prevent future infiltration.

Lack of adequate maintenance was evident at RG-10, a privately maintained facility. Erosion along the embankment is quite evident (Fig. 5). The erosion resulted in the formation of a breach in the berm which provided a path for runoff to exit the rain garden while eliminating nearly all of the designed ponding depth. Evidence of erosion was also found in the planting soil. Large areas of bare soil were evident in the lower lying areas of the rain garden. It appeared that water was preferentially flowing through and eroding the low areas. A surface crust was forming on the bare soil which could affect infiltration (see section 1.3).

Fig. 5: Example of severe erosion at the rain garden's embankment (RG-10)

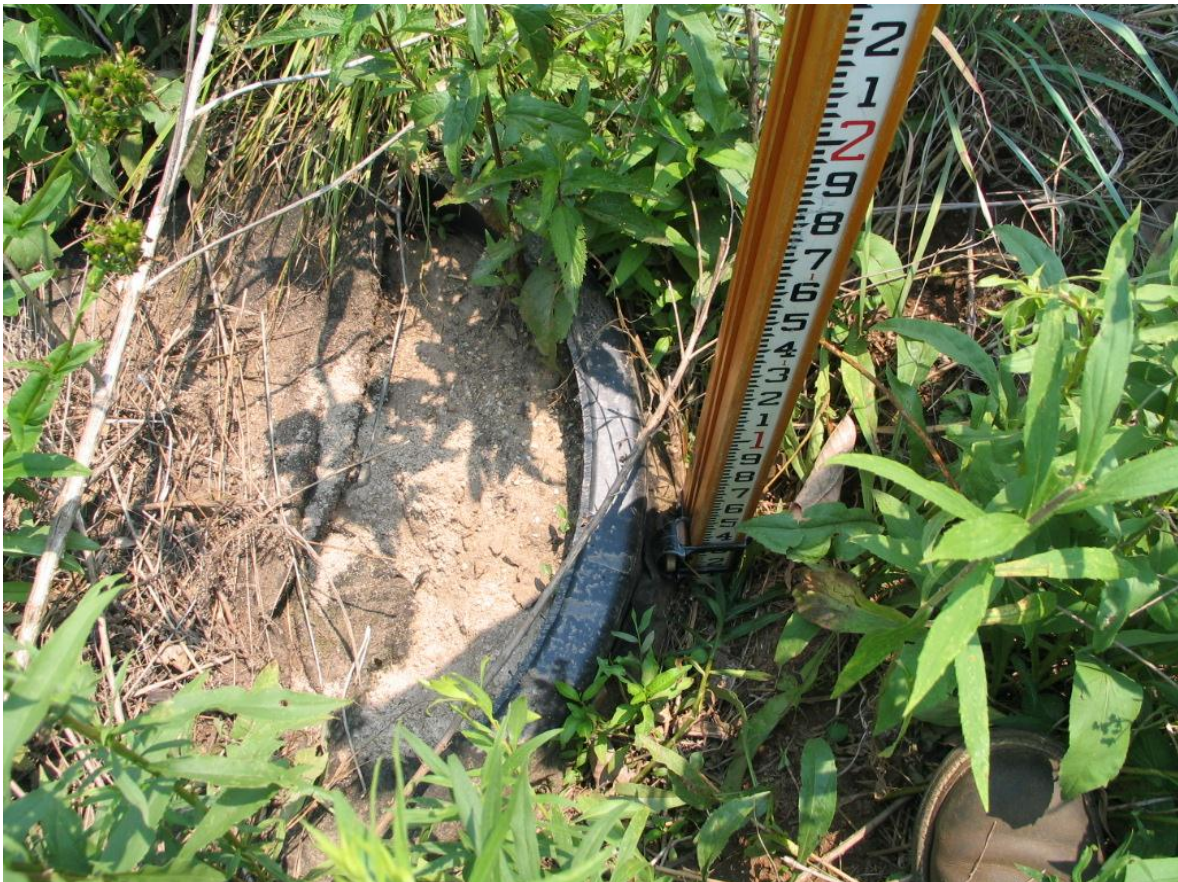
In rain gardens RG-10 and RG-18 – both privately maintained - columns of pure sand were installed that reached from the soil surface down to the under-drain and gravel storage layer beneath the planting soil. In RG-10, the sand columns surrounded the two monitoring wells and were included in the original design specifications. In RG-18, 15-inch PVC pipes were filled with sand and buried in the rain garden. These sand columns were not part of the original design and appeared to have been installed after completion of the rain garden, perhaps to alleviate excessively long ponding after large storms. At both of these sites, any water that did pond on the rain garden could be quickly infiltrated through the sand columns rather than through the planting soil, thus negating some of the pollutant filtering capacity of the facility.

Fig. 7: Example of a modified rain garden where ponding area is directly connected to the gravel sump through a sand column

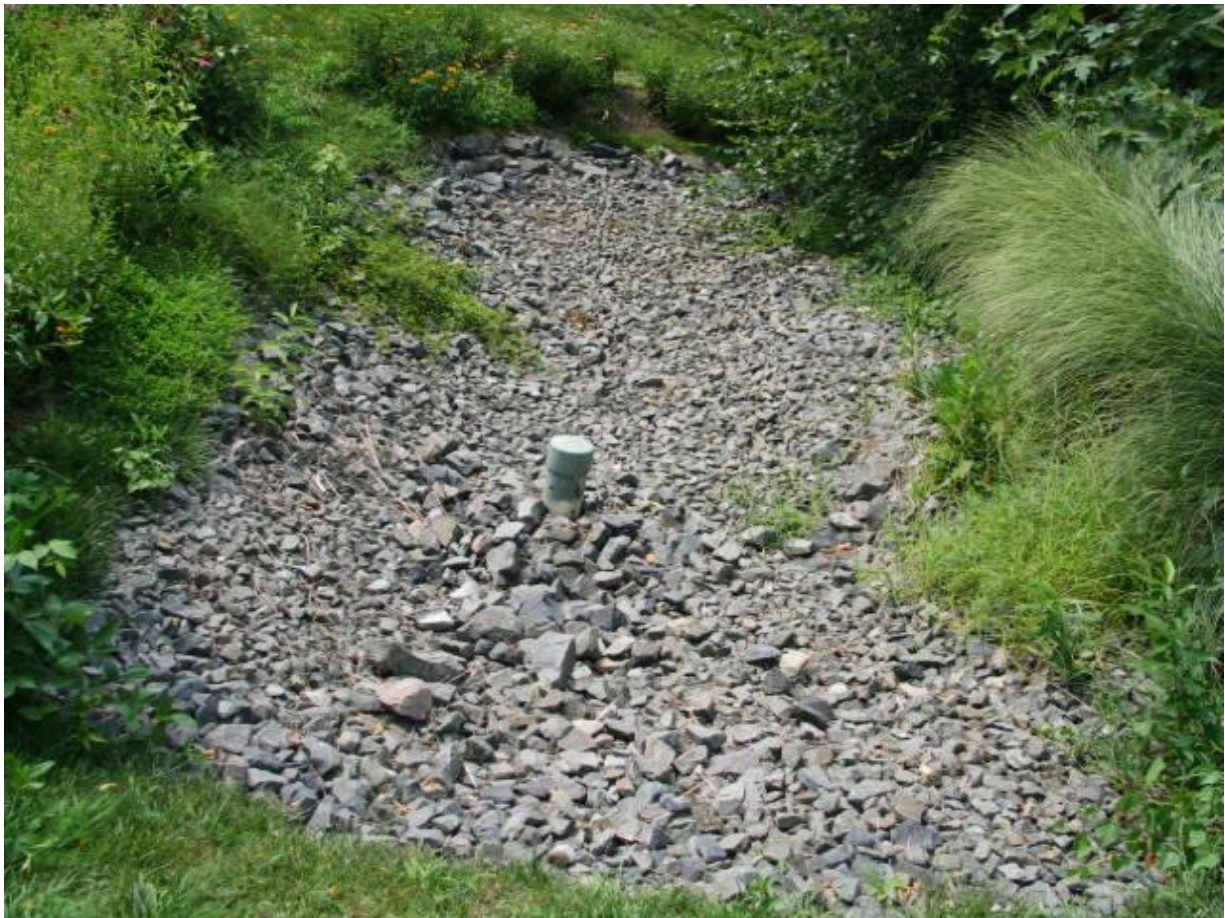
RG-20, a privately maintained garden, included a relatively large gravel filled forebay in the original plans. The original forebay did not include an observation well. However the existing forebay has a 6-inch perforated observation well. The observation well was connected to the rain garden's under drain system (Fig. 8). Some runoff did flow directly into the rain garden, but the majority of the runoff flowed into the forebay through an 18-inch stormwater pipe. The infiltration capacity and size of the forebay and the porosity of the perforated pipe are such that only the largest storm would cause it to fill and overflow into the rain garden. Thus the rain garden, despite being well designed, was only being used to treat a small fraction of the runoff coming from the site.

Fig. 8: Example of a modified forebay where a perforated observation well has been added (RG-20)
