## **2.15 Mainstem 7**

### **2.15.1 General Characteristics**

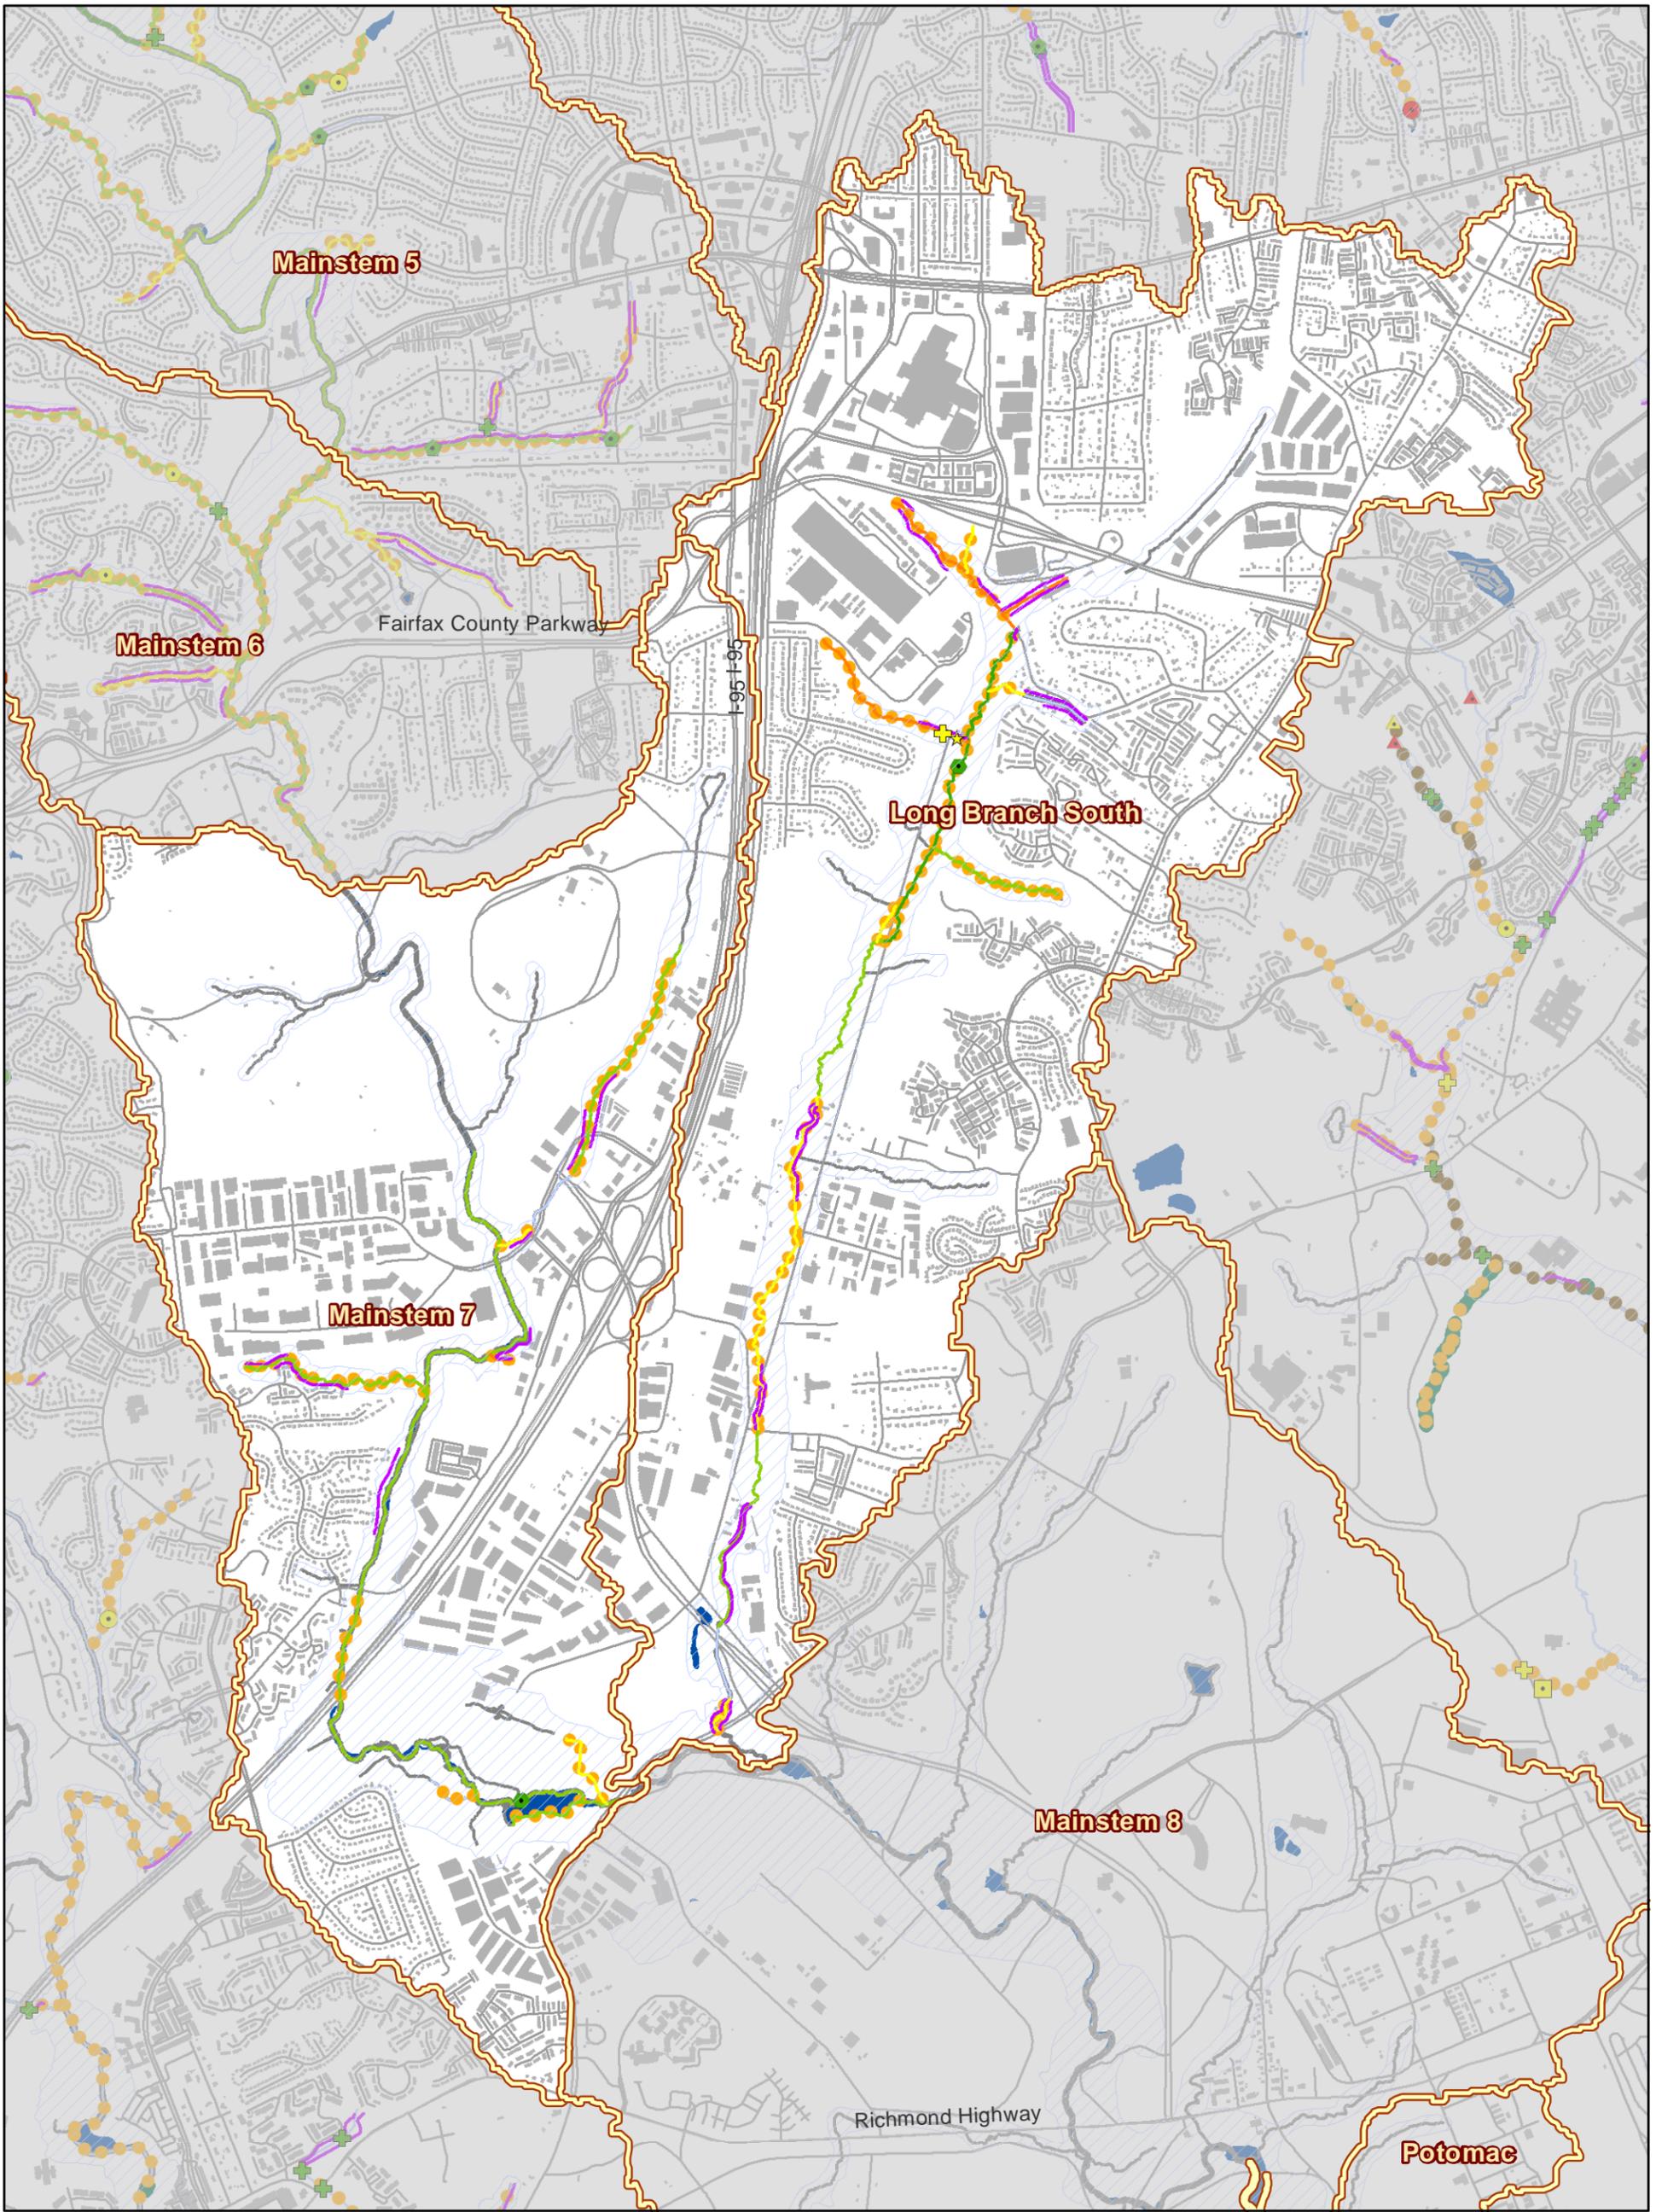
Map 2-19

There was a total of 50 linear feet of erosion identified on the right stream bank in the WMA at one specific erosion location south of Boston Boulevard. This erosion site has moderate restoration potential.

There are two obstruction sites located in the Mainstem 7 WMA, one which is trees and the other a beaver dam. The obstruction site with the trees, located west of Telegraph Road, is thought to be impacting fish movement within the stream.

All of the stream buffers within the Mainstem 7 WMA are lawns and pavement. There were eight deficient buffer points. Severe encroachment is not present in any of these stream buffers.
