3.31 Little Difficult Run – Subwatershed Condition

3.31.1 Subwatershed Characteristics

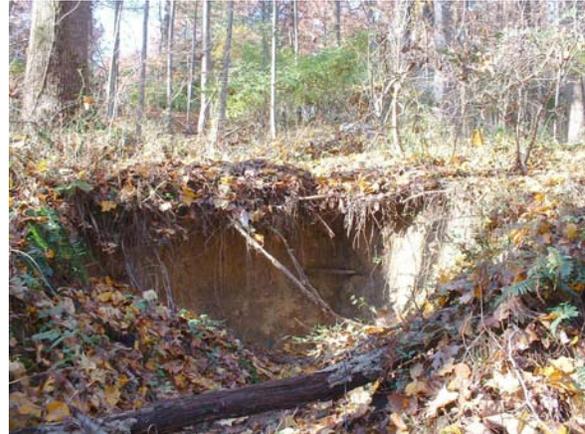
The storm drainage system connects the developed portions of the land to the stream system. Stormwater outfalls are located where the stormwater system ends and the natural channel begins. Outfalls may be sources of pollutants and excessive stormflow from pipes can cause erosion at the outfall and downstream. During the Stream Physical Assessment, field crews located 11 **outfall** pipes discharging into the Little Difficult Run subwatershed. Most of the pipes were causing minor or no erosion to the streambed or banks; however, one pipe discharging from a neighborhood road was creating major erosion.

Photo 3.93 Pipe near the end of Checkerberry Court near Blue Smoke Trail (DFLD014.P001)

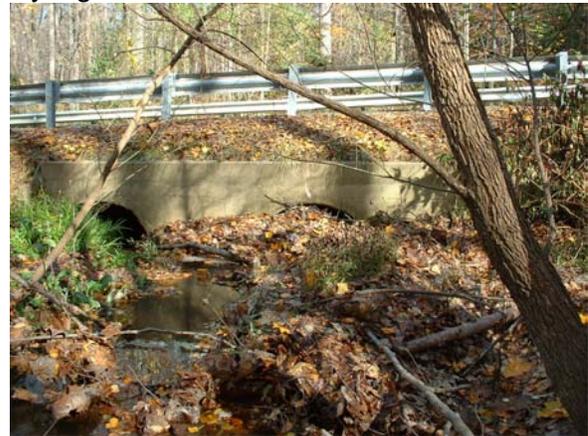
Photo 3.94 Crossing under Fox Mill Road north of Shady Mill Lane. Crossing has excessive sedimentation (DFLD015.C002).

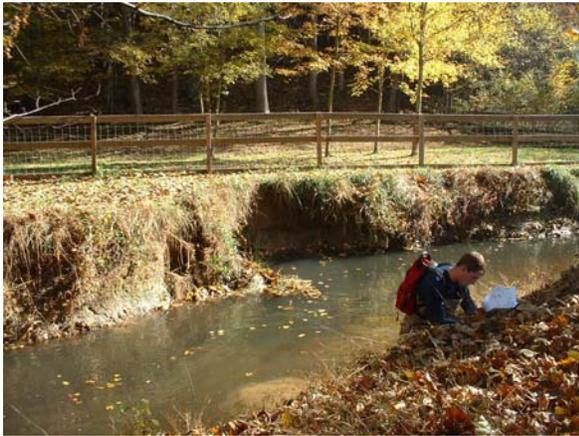
Photo 3.95 Eroding bank directly north of the terminus of Hollybrook Place in the Hollybrook subdivision (DFLD004.E001).

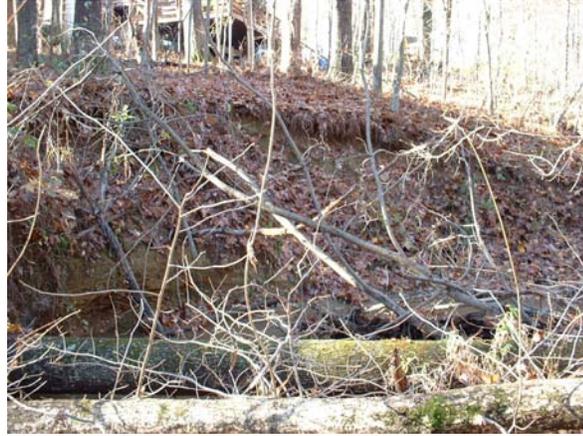
Photo 3.96 Erosion area at the end of Millstream Court, in Little Difficult Run Stream Valley Park (DFLD024.E001).

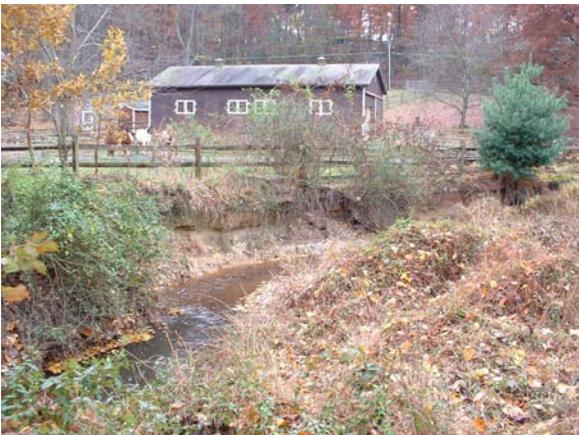
Photo 3.97 Erosion located on the mainstem of Little Difficult Run, directly east of Colt Run Road in the Roan Stallion Estates subdivision (DFLD013.E001).

- S114 Erosion located on the mainstem of Little Difficult Run, directly east of Colt Run Road in the Roan Stallion Estates subdivision (Photo 3.97).
- S115 Stream Physical Assessment found erosion and riparian buffer problems north of the terminus of Hollybrook Place in the Hollybrook subdivision (Photo 3.95)
- S116 Buffer encroachment on the mainstem of Little Difficult Run along Stuart Mill Road in the Difficult Stream Valley Park (Photo 3.99).

DF92114 (Streambank Stabilization) The proposed project would involve grading the eroded streambanks and excavating a floodplain bench at the channel forming elevation. The new floodplain would be planted with native woody vegetation and grasses.

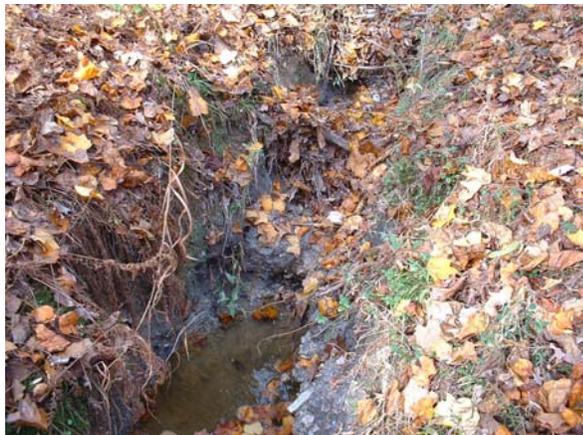
Photo 3.98 Headcut located northwest of Fox Mill District Park in the Fox Mill Woods subdivision. Directly east of the intersection of Steeplechase Drive and Aintree Lane (DFLD023.H001).

slight potential for erosion at flood stages. There were four specific stream erosion points noted in the Little Difficult Run subwatershed. The combined length of the erosion points is approximately 230 feet. Three of the erosion points are considered severe indicating that erosion may be damaging property and causing instream degradation. All erosion points are considered to have moderate to high restoration potential. These erosion points are shown in Photos 3.95 to 3.97. Photo 3.95 is candidate site S115, 3.96 is candidate site S113, and 3.97 is candidate site S114. There was one **headcut** identified as having a significant impact with a height of 2.5 feet (Photo 3.98).

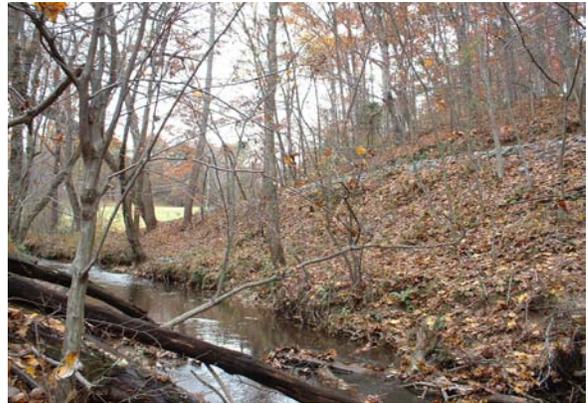
Photo 3.99 Severe buffer encroachment (in background) Little Difficult Run Stream Valley Park, directly south of Stuart Mill Road on the mainstem (DFLD011.B001)

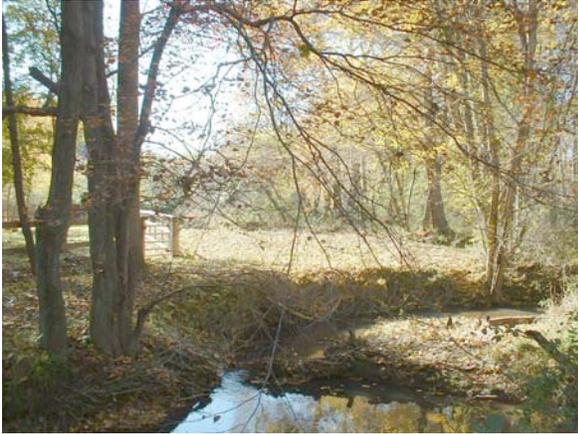
Photo 3.100 Buffer encroachment in the Little Difficult Run Stream Valley Park. Directly east of Mill Road and Stuart Mill Road (DFLD003.B001).

- S36 There are significant riparian buffer impacts over 1,000 feet in length in the Little Difficult Run Stream Valley Park directly east of Mill Road and Stuart Mill Road (Photo 3.100).
- S65 The reach between two overtopping culverts (culvert 13 and culvert 30) is exhibiting poor bank stability and has several crossing impacts.
- S113 Erosion area at the end of Millstream Court, in Little Difficult Run Stream Valley Park (Photo 3.96).

DF9236 (Stream Restoration) The proposed restoration would involve excavating a new floodplain and re-meandering the stream to provide a pattern, dimension, and profile more consistent with a natural stream. This would prevent further mass erosion associated with channel widening and bank failure, would improve instream habitat, and provide access to a functional floodplain. The new floodplain would be planted with native woody vegetation and grasses. A forested buffer would be established. *S-36 and S-115 would be combined as a single project.*

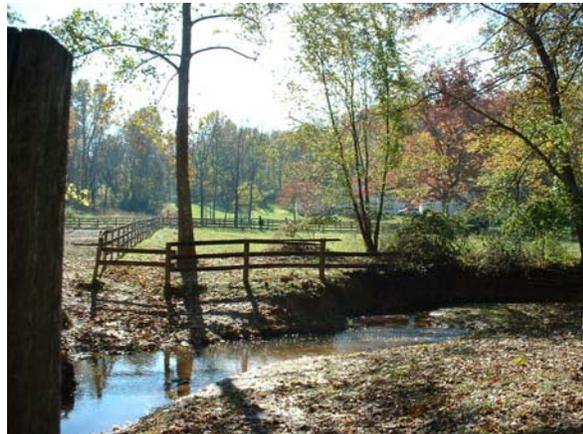
Photo 3.101 Buffer impact in the Hollybrook community, directly north of the terminus of Hollybrook Place, mainstem of Little Difficult Run (DFLD003.B002).

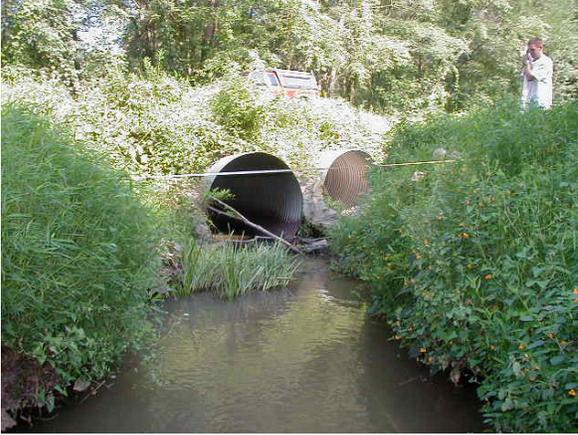
Photo 3.102 Little Difficult Run at Stuart Mill Road

Culvert #3 (Photo 3.102) overtopped for all events except the one-year. Stuart Mill Road can be considered a primary road, which requires it to pass the 25-year event.

- F03 The bridge carrying Stuart Mill Road over the Mainstem of Little Difficult Run overtops for all events except the 1-year storm. It is required to pass the 25-year event (Photo 3.102).
- F06 The culvert conveying Mainstem of Little Difficult Run under Colt Run Road overtops for all events. It is required to pass the 10-year event (Photo 3.103).

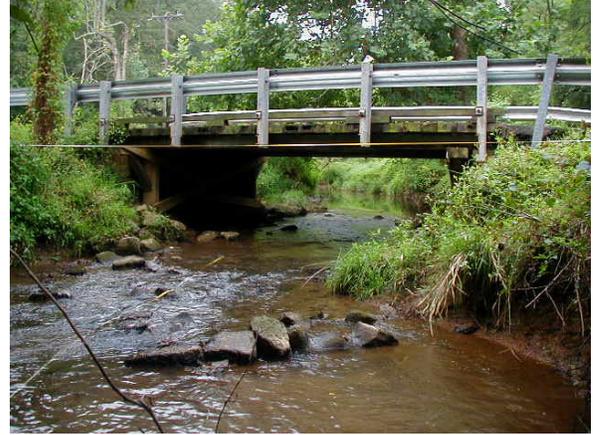
Photo 3.103 Little Difficult Run at Colt Run Road

Culvert #6 (Photo 3.103) overtopped for all events. Colt Run Road is a residential access road, classified as local, requiring the culvert to pass the 10-year event. This culvert is candidate site F06.

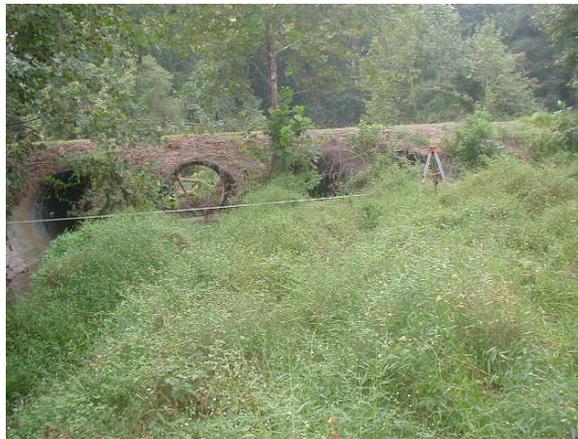
Photo 3.104 Little Difficult Run tributary at Polo Pointe Drive.

Culvert #12 (Photo 3.104) overtopped for the 25, 50, and 100-year events. The culvert at Polo Pointe Drive, a local road, is required to pass the 10-year event. This culvert is not a candidate site.

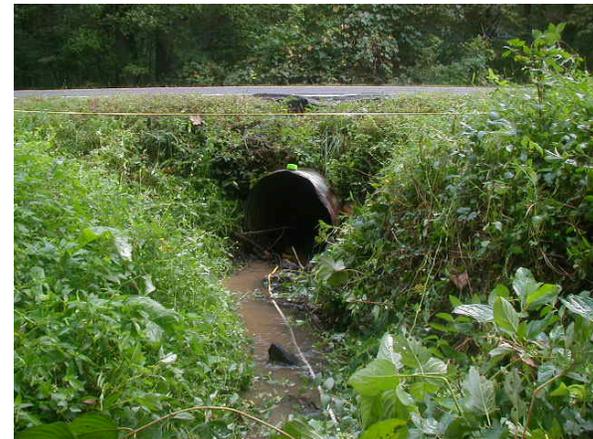
Photo 3.105 Little Difficult Run mainstem at Fox Mill Road North

Culvert #13 (Photo 3.105) overtopped for all events except the one-year. Fox Mill Road is a primary road, and is therefore required to pass the 25-year event.

- F13 The culvert conveying a tributary of Little Difficult Run under Fox Mill Road overtops for all events except the 1-year storm. It is required to pass the 25-year event (Photo 3.105).
- F15B The culvert conveying Little Difficult Run under Stuart Mill Road overtops for all events except the 1-year and 2-year storms. It is required to pass the 25-year event (Photo 3.106).
- F16 The culvert conveying a tributary of Little Difficult Run under Fox Mill Road overtops for all events except the 1-year and 2-year storms. It is required to pass the 25-year event. (Photo 3.107).
- F30 The culvert conveying a tributary of Little Difficult Run under Thoroughbred Road overtops for all events except the 1-year and 2-year storms. It is required to pass the 20-year event (Photo 3.108).

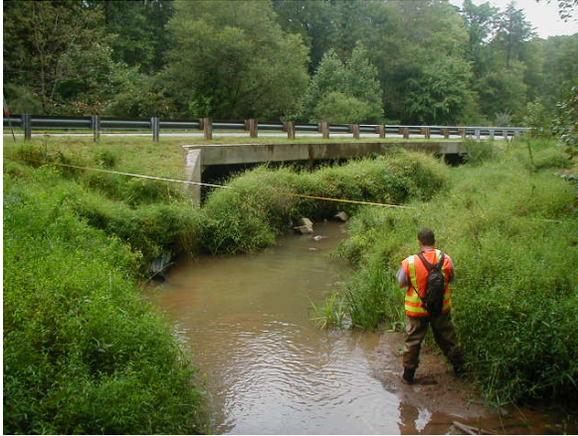
Photo 3.106 Little Difficult Run mainstem at Stuart Mill Road

Culvert #15-B (Photo 3.106) overtopped for all events except the one and two-year. Stuart Mill Road, as mentioned above, can be considered a primary road, requiring it to pass the 25-year event.

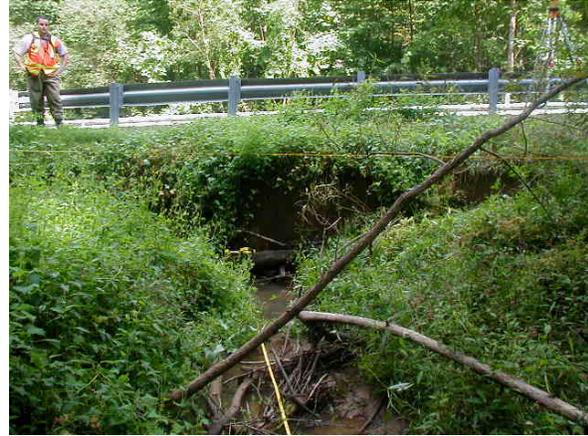
Photo 3.107 Little Difficult Run mainstem at Fox Mill Road South

Culvert #16 (Photo 3.107) overtopped for all events except the one and two-year. Fox Mill Road, also mentioned above, can be considered a primary road and must pass the 25-year event.

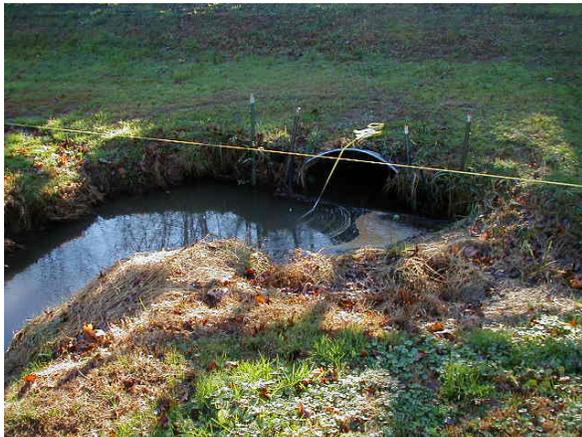
Photo 3.108 Little Difficult Run tributary at Westwood Hills Drive

Culvert #30 (Photo 3.108) overtopped for all events except the one and two-year. The

culvert at Westwood Hills Drive, a local road, is expected to pass the 10-year event.
