### 3.15 Rocky Run – Subwatershed Condition

#### 3.15.1 Subwatershed Characteristics

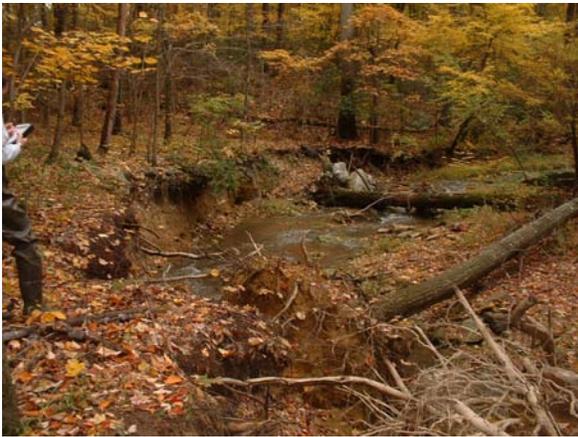
Channel incision was especially notable on several tributaries to Rocky Run and on a segment of the mainstem of Rocky Run in the central portion of the subwatershed. Field crews noted and photographed five erosion points that were having a severe impact on Rocky Run and its tributaries. Four of these erosion points are located on the mainstem of Rocky Run and one on a minor tributary in the upper reaches of Rocky Run. An example is shown in Photo 3.38, which is stream restoration candidate site S92.

*Photo 3.38 Significant erosion on the mainstem between Woodside Drive and Orlo Drive (DFRR013.E001).*

- S91 The Stream Physical Assessment identified this site as having severe erosion all with moderate restoration potential near Bellview Road.
- S92 This site was identified as having significant erosion and a deficient buffer, where houses are built close to the stream (Photo 3.38).
- S93 This site, located near the culvert at Towlston Road, was identified as having a deficient buffer, again because of the proximity to houses.

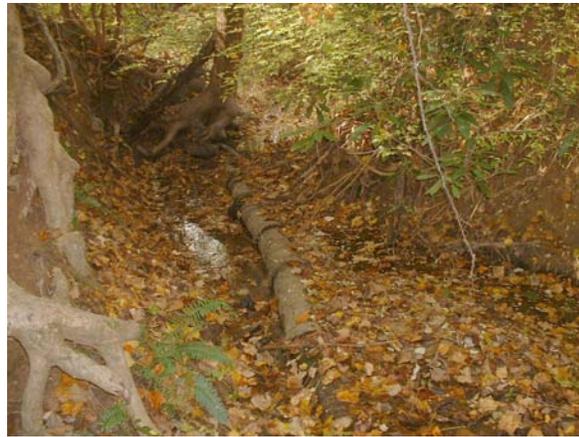
*Photo 3.39 Exposed utility located northeast of Old Dominion Drive near Tebbs Lane.*

There was one utility pipe of an unknown type in reach on a tributary to Rocky Run as shown in Photo 3.39. This utility pipe is partially buried and did not appear to be causing erosion in the stream channel.

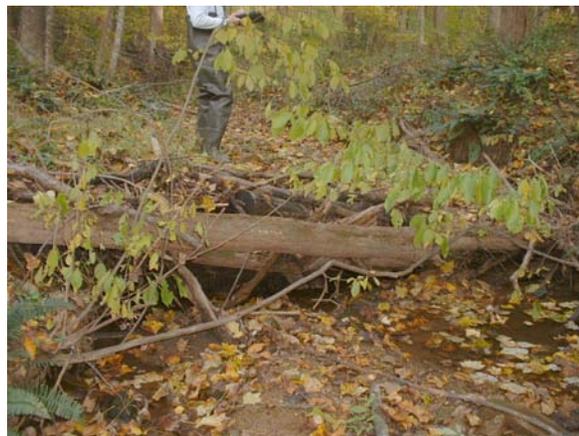
There were 16 sites along the stream within the subwatershed where trees and debris were obstructing flow. Of these, nine were considered significant enough to affect fish passage and three of the 16 had a greater than moderate impact. Photo 3.40 shows a representative blockage on a Rocky Run tributary that may be impeding fish passage.

*Photo 3.40 Obstruction located between Tebbs Lane and Cilicia Street (DFRR001.T002).*

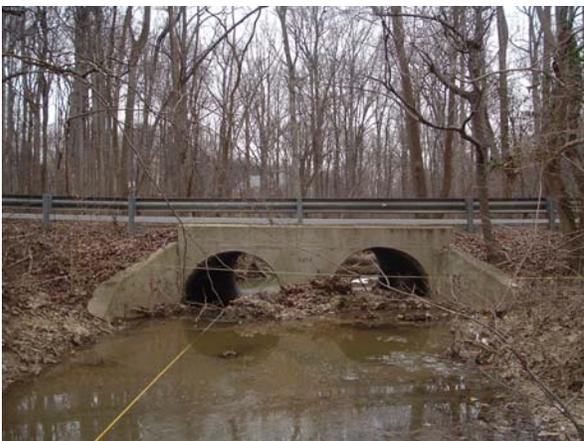
Culvert #74 (Photo 3.41) overtopped for the 25, 50, and 100-year events. Since Brook Road does not allow through traffic, it is classified as a local road, which has to pass the 10-year flow. Since it does pass the 10-year flow, this culvert is not considered a candidate site.

*Photo 3.41 Culvert 74 at Brook Road on Rocky Run mainstem.*

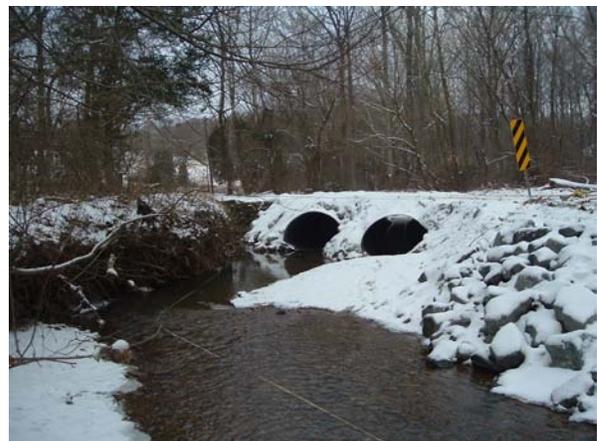
*Photo 3.42 Culvert 75 at Bellview Road on Rocky Run mainstem.*

Culvert #75 (Photo 3.42) overtopped for all events except the one and two-year. Bellview Road is a primary road and so must pass the 25-year event.

- F75 The crossing at Bellview Road overtopped for 5-year and greater events. To meet standards, however, it must pass the 25-year event because it is a primary road (Photo 3.42).
- F76 The bridge on Towlston Road, a primary road, overtopped for all events except the one-year. This bridge must pass the 25-year event to meet requirements (Photo 3.43).
- F79 The crossing at Old Dominion Drive overtopped for 25, 50, and 100-year events. Old Dominion Drive is classified as a primary road, so it must pass the 25-year event (Photo 3.44).

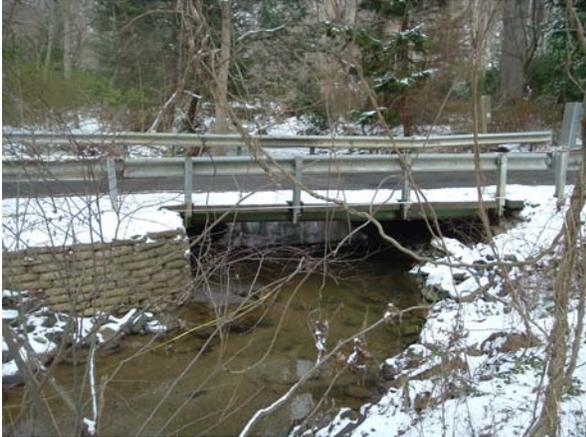
Culvert #76 (Photo 3.43) overtopped for all events except for the one-year. Primary roads, the classification for Towlston Road, must pass the 25-year event.

*Photo 3.43 Culvert 76 on Rocky Run mainstem at Old Towlston Road*

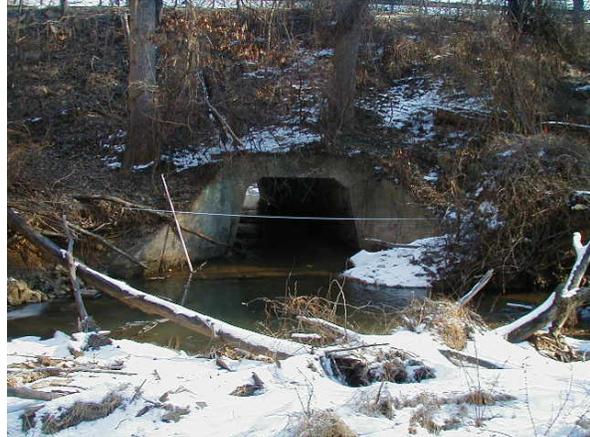
Culvert #79 (Photo 3.44) overtopped for the 25, 50, and 100-year events. Old Dominion Drive allows through traffic and is classified as a primary road. This means it must pass the 25-year event.

*Photo 3.44 Culvert 79 on Rocky Run mainstem at Old Dominion Drive*
