3.25 Wolftrap Creek – Subwatershed Condition

3.25.1 Subwatershed Characteristics

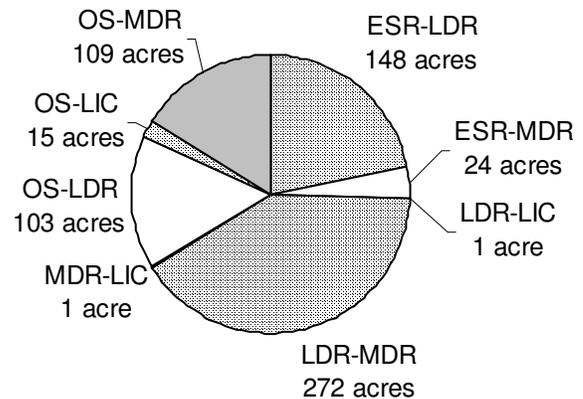
Figure 3.22: Changed Land Use

According to Figure 3.22, 272 acres are projected to shift from low-density residential in the existing land use to medium-density residential in the future land use. One hundred and forty-eight acres will shift from estate residential to low-density residential. One hundred and nine acres shifted from open space in the existing land use to medium-density residential in the future land use. One hundred and three acres are anticipated to shift from open space to low-density residential. Cumulatively, 227 acres, or 33 percent of all land use changes, are projected to shift from open space to a higher density use. This does not guarantee that the open space will become developed – it suggests that these areas of open space can be used for development/ redevelopment in the future.

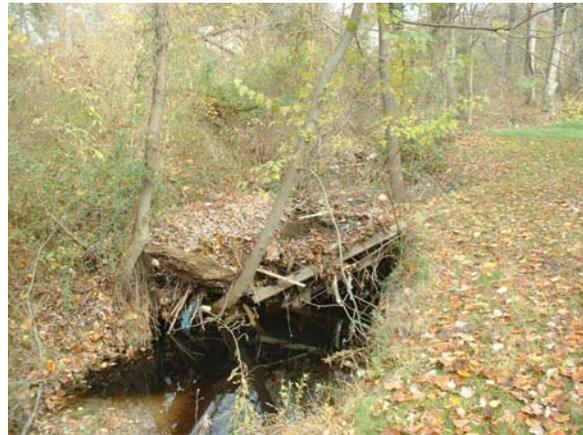
- There were five stream blockages, primarily trees. Four of these blockages are likely restricting fish movement within the stream system. All stream obstructions were having a significant impact on stream condition. Photo 3.79 shows an obstruction that is candidate site S124.

Photo 3.79 A severe obstruction located upstream of Chain Bridge Road near Echols Street (DFWC028.T001).

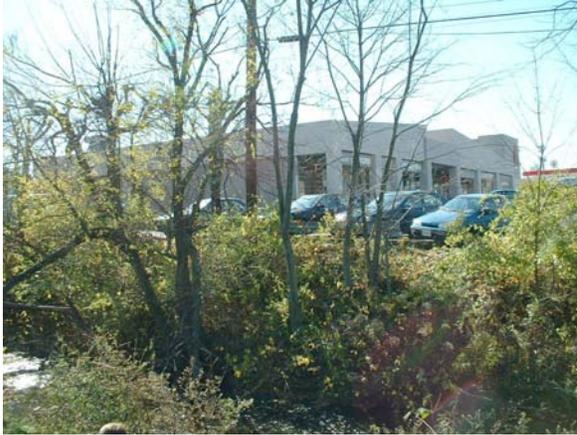
- 7,725 feet of the buffer encroachment is having a significant impact on the stream condition and habitat quality. Photos of an example are shown below in Photos 3.80 and 3.81 that are located at candidate site S123.
- Most (66 percent) of the total buffer encroachment has good restoration potential.

Photo 3.80 Buffer encroachment with high impact near Maple Avenue. (DFWC019.B002).

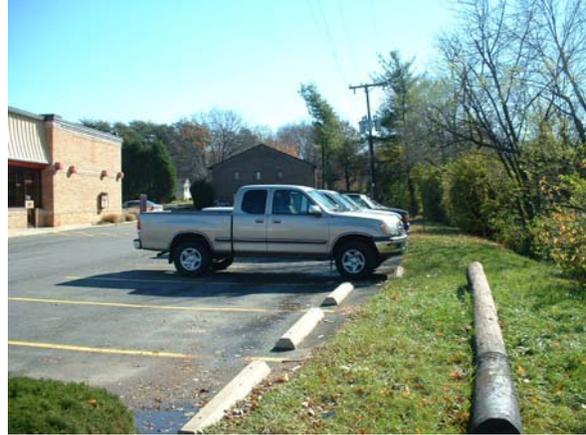
Photo 3.81 Buffer impact near Maple Avenue (DFWC019.B001).

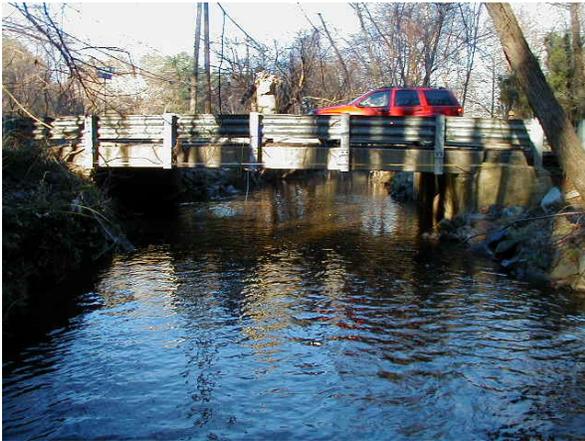
Photo 3.82 Wolftrap Creek Mainstem at Beulah Road.

Culvert #28 (Photo 3.82) overtopped for all events. As Beulah Road is a through road, it can be classified as a primary road. This means that it must pass the 25-year event.

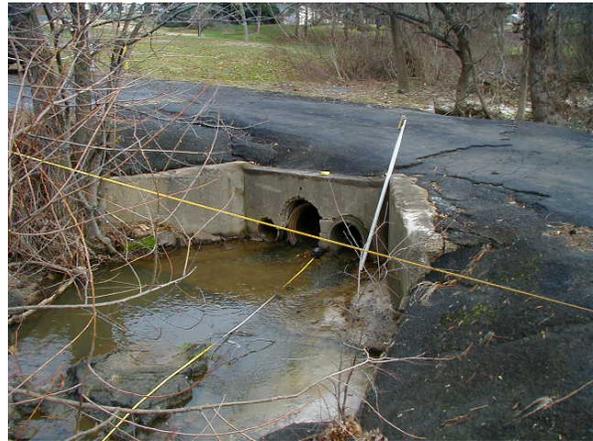
Photo 3.83 Wolftrap Creek Tributary at Creek Crossing Road.

Culvert #48-A (Photo 3.83) overtopped for all events. Creek Crossing Road can also be used as a through road, so it too can be classified as a primary road. Primary roads must pass the 25-year event.

DF9531B (Culvert Retrofit) This site is located at the outlet of this catchment, above Creek Crossing Road. The retrofit could take advantage of the dual culverts under the road as well as the relatively flat floodplain area. The design should take into account any improvements necessary to eliminate overtopping of Creek Crossing Road (Site F48).

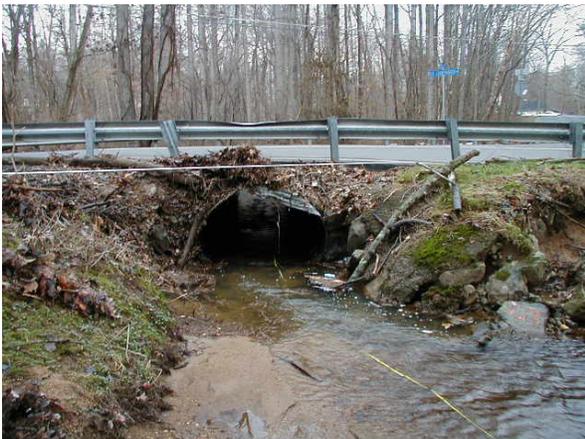
Photo 3.84 Wolftrap Creek Mainstem at Old Courthouse Road.

Culvert #49 (Photo 3.84) also overtopped for all events. Classified as a primary road, Old Courthouse Road is required to pass the 25-year event.
