## Chapter 3: Subwatershed Condition

### 3.1 North Little Hunting Creek Subwatershed

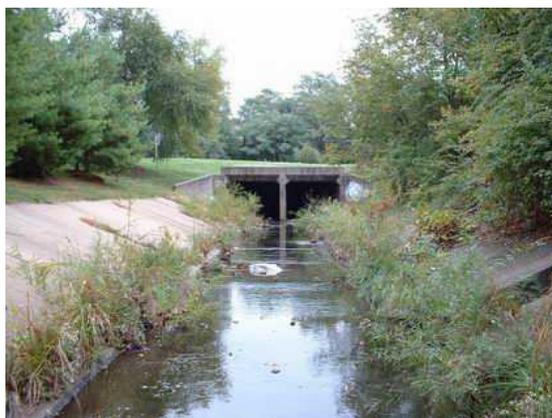
- Fordson Road: Stormwater runoff from neighborhood areas of Mount Vernon Square, Millway Meadows, and Hybla Valley Farms is collected and conveyed through a storm drain pipe system and the outfall, a double eight-foot by eight-foot box culvert, is located under Fordson Road. No impact on the stream was observed due to concrete lined channels on the downstream side as shown in Photo 3.1.

*Photo 3.1 Double 8' x 8' outfall box culvert located under Fordson Road*

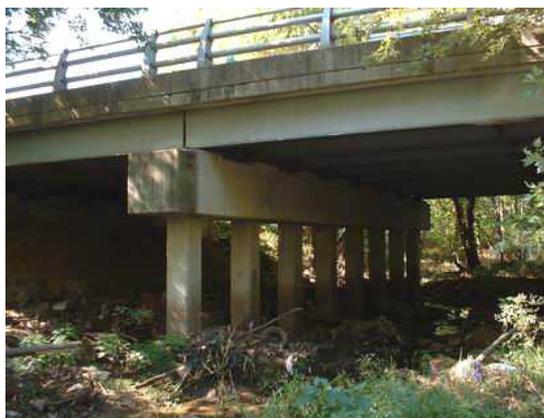
*Photo 3.2 Sediment and debris causing a moderate impact downstream of Janna Lee Avenue bridge crossing*

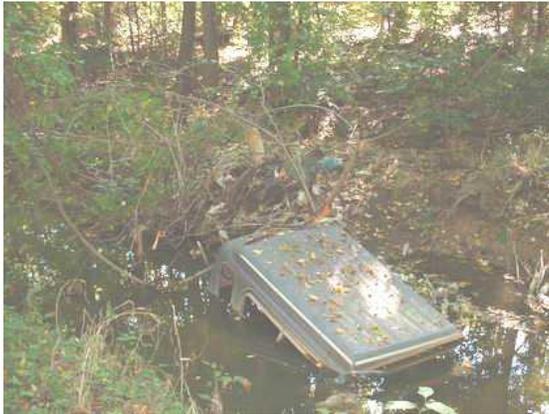
Map 3.3 shows the stream segment CEM type in the subwatershed. Fallen trees and debris obstructing the flow were observed at two locations in the upstream reaches. The impact of this debris on the stream is moderate and can be seen in Photo 3.3. In the downstream stream segment, the stream is littered with shopping carts, trash, and a camper shell. Photos

*Photo 3.3 Dump observed in the downstream channel near Richmond Highway*

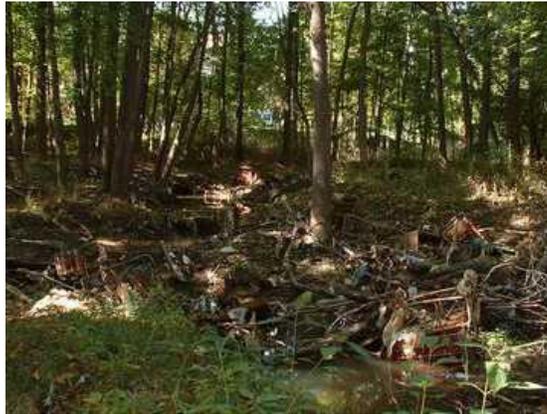
3.4 and 3.5 show dumpsites in the downstream segments. The locations of the dumpsites identified during the stream physical assessment are shown on Map 3.3. Two additional dumpsites have been identified in the area behind the Hybla Valley Shopping Center. A partially buried 12-inch sanitary sewer pipe crosses the stream in the downstream segment and does not cause a significant impact. A raised sanitary sewer manhole is located in the upstream stream segment north of Audubon Avenue and has little impact on the stream as shown in Photo 3.6.

*Photo 3.4 Trash dump and littering in the downstream segment near Richmond Highway*

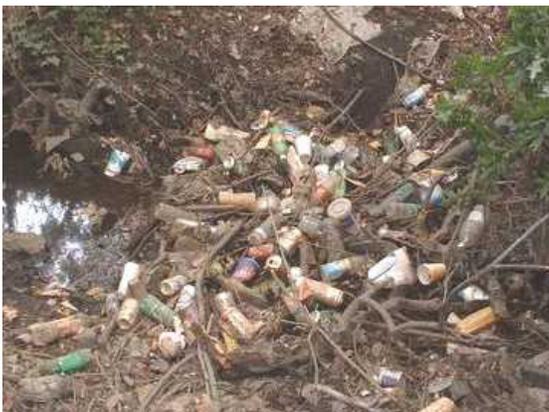
*Photo 3.5 Trash located upstream of Fordson Road*

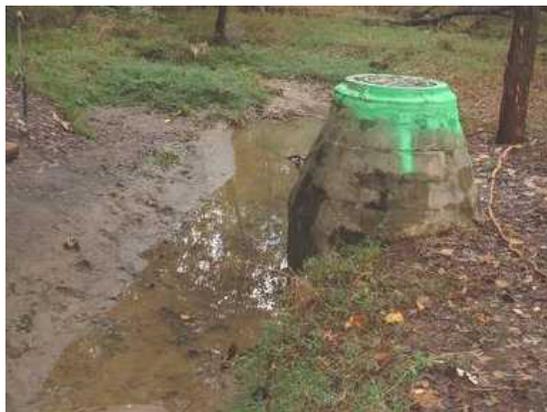
*Photo 3.6 Raised manhole obstructing the flow of the tributary located north of Audubon Avenue*

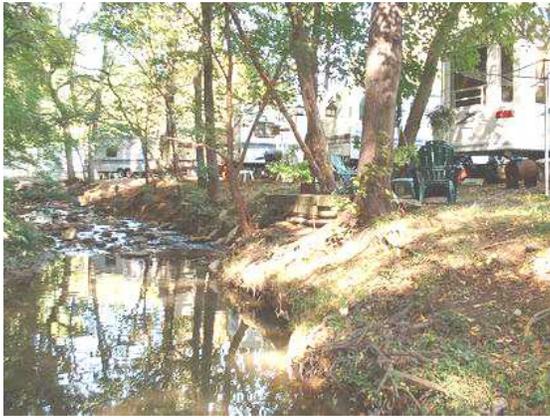
At several locations in the downstream stream segments, there is a severe to extreme impact due to a lack of natural forested buffer as shown in Photo 3.7. At one location in the upstream stream segments, the buffer zone is covered with a parking lot and roadway, causing the severe impact shown in Photo 3.8. Overall, North Little Hunting Creek does not have adequate natural buffer widths of 100 feet. The locations of deficient buffer areas along the stream corridor are shown on Map 3.4.

Photo 3.7 Lack of natural forested buffer upstream of Richmond Highway

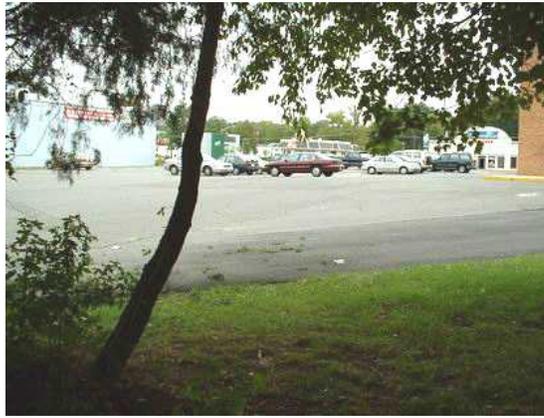
Photo 3.8 Paved surface in the buffer zone upstream of Fordson Road crossing

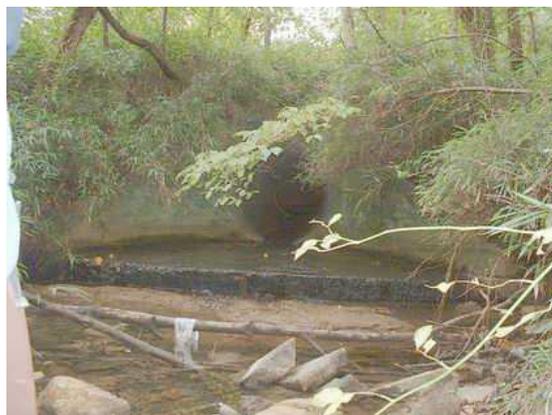
- Brady Street: The five-foot diameter concrete pipe drains to the tributary located on the west side of South Little Hunting Creek as shown in Photo 3.10.
- Linton Lane: Five-foot and three-foot (diameter) concrete pipes drain to South Branch as shown in Photo 3.11.
- Linton Lane: A triple six-foot by three-foot concrete box culvert drains to South Branch.
- East of Linton Lane: Two wooden foot bridges, each 12 feet long with four-foot openings, and four wooden foot bridges, each eight feet long with four-foot openings, are located on South Branch between Linton Lane and Vernon View Drive.

Photo 3.10 5' diameter concrete pipe located under Brady Street

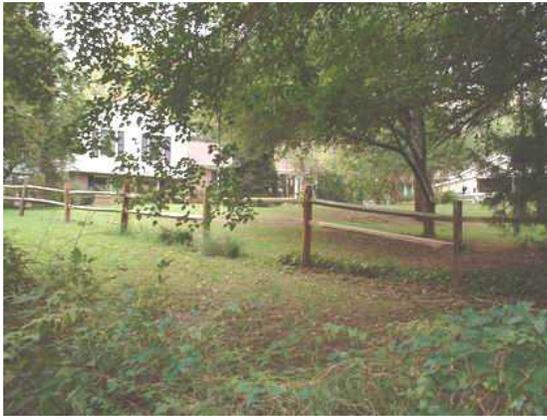
*Photo 3.14 Deficient buffer zone with planted lawn grass west of Linton Lane along the north branch of South Branch*

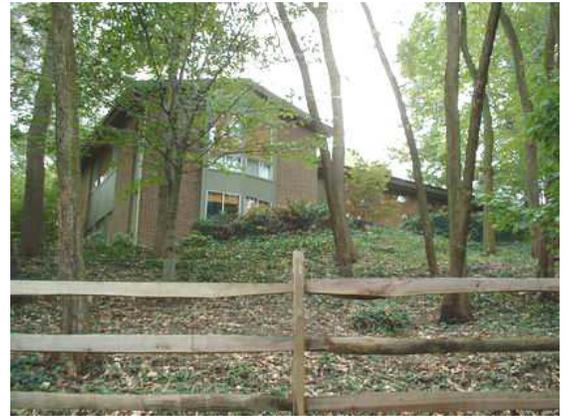
*Photo 3.15 Deficient buffer zone along the tributary LHLH012 located on the west side of South Little Hunting Creek*

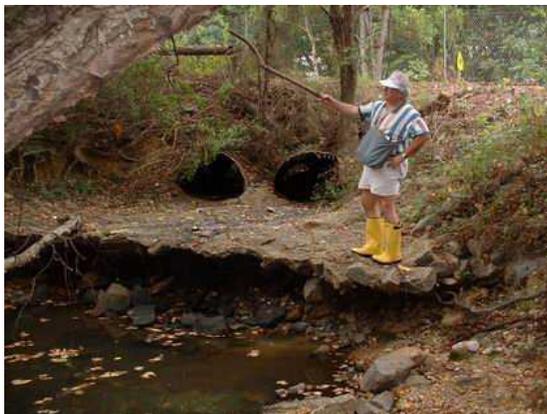
*Photo 3.16 Severe erosion downstream of the Mary Baldwin Drive crossing*

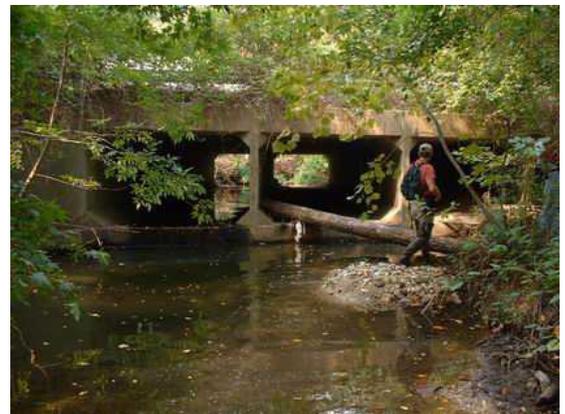
- Sherwood Hall Lane: Four 10-foot by six-foot concrete box culverts, shown in Photo 3.17, with downstream bank erosion of four feet in height, cause a moderate impact on the stream.

*Photo 3.17 Four 10'x 6' concrete box culverts located under Sherwood Hall Lane*

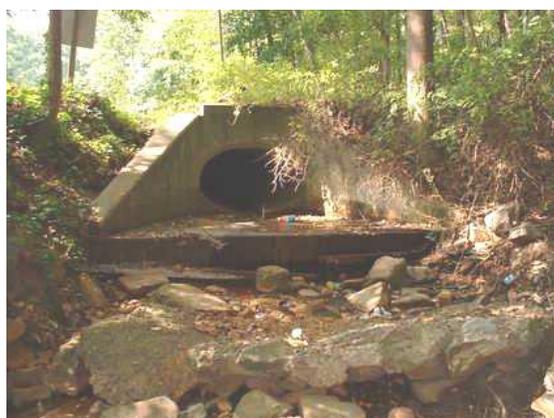
*Photo 3.18 Discharge from 53"x 34" elliptical pipe outfall north of Devonshire Road caused moderate erosion on the downstream side*

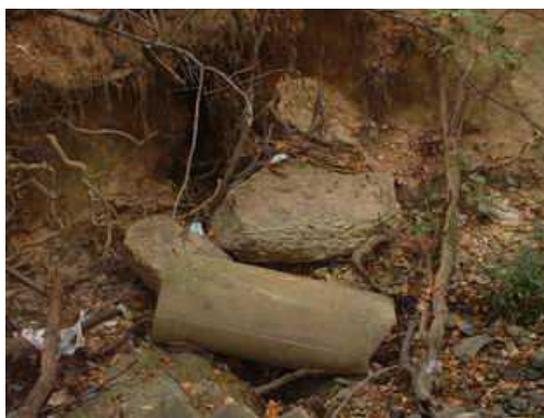
*Photo 3.19 Severe erosion caused by discharge from an 18" pipe outfall west of the Mary Baldwin Drive crossing*

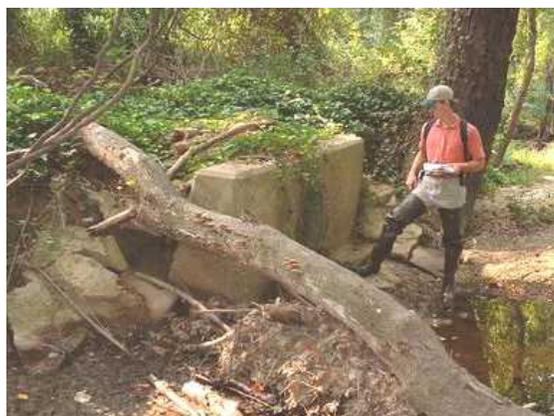
*Photo 3.20 Severe erosion caused by discharge from 24" pipe outfall located north of Wellington Road*

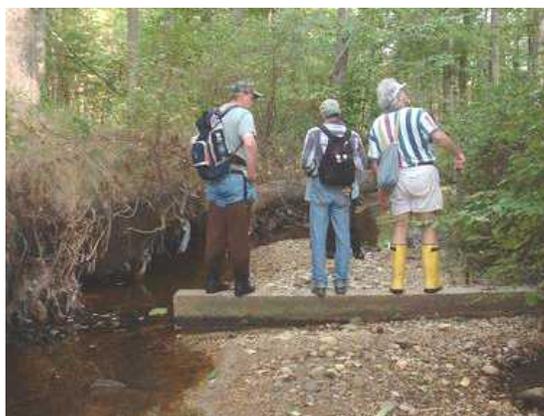
Discharges from four pipe outfalls have caused moderate erosion to the stream, and discharges from the remaining eight outfall pipes have caused minor erosion. The sites of severe to extreme erosion are of significant concern and will need immediate attention. The four ditches that discharge to Paul Spring Branch have caused minor to moderate erosion of the stream, and as an example, the ditch outfall located near the intersection of Paul Spring Road and Pickwick Lane is shown in Photo 3.21.

*Photo 3.21 Minor erosion of the right bank at the ditch outfall north of the intersection of Paul Spring Road and Pickwick Lane*

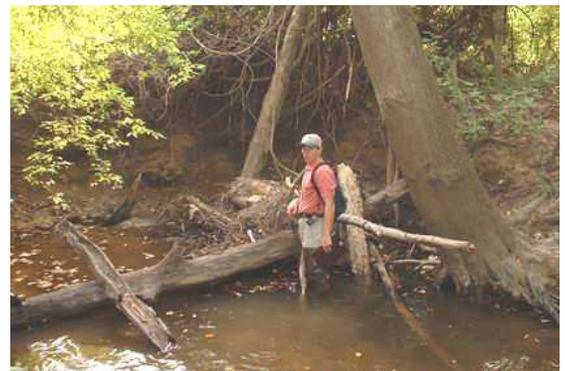
*Photo 3.22 Fallen trees and eroding banks causing severe impact to Paul Spring Branch north of Fairfax Road*

Fallen trees, dumps, and debris obstructing the flow were observed at many locations in Paul Spring Branch as shown in Photo 3.22. The stream corridor is also littered with lawn waste and

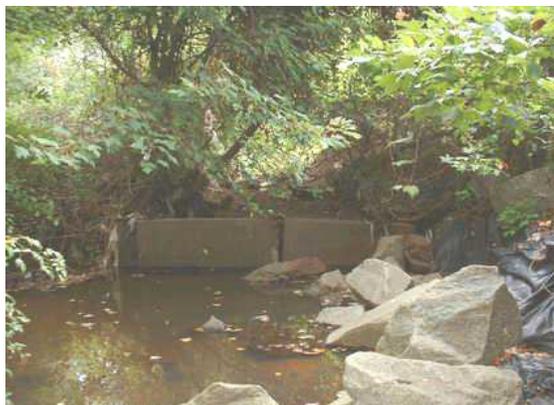
*Photo 3.23 Concrete blocks obstructing the flow south of the intersection of Rollins Drive and Radcliff Drive*

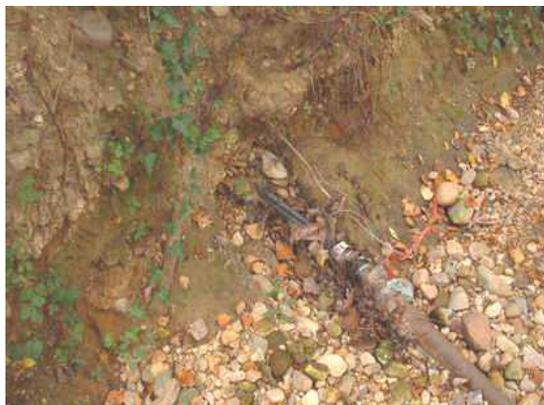
*Photo 3.24 Partially buried telephone line south of the intersection of Rollins Drive and Radcliff Drive*

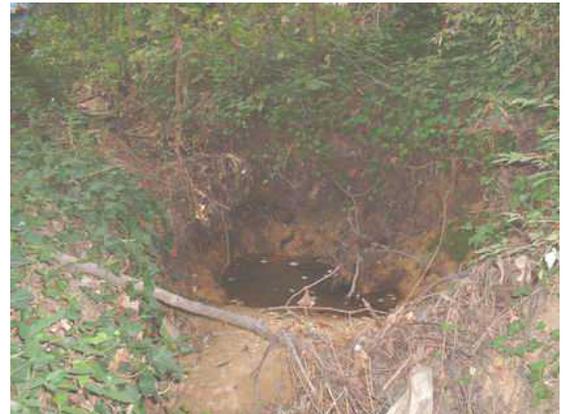
*Photo 3.25 Head cutting of 2' of stream bed on the tributary to Paul Spring Branch west of Lyndale Drive*

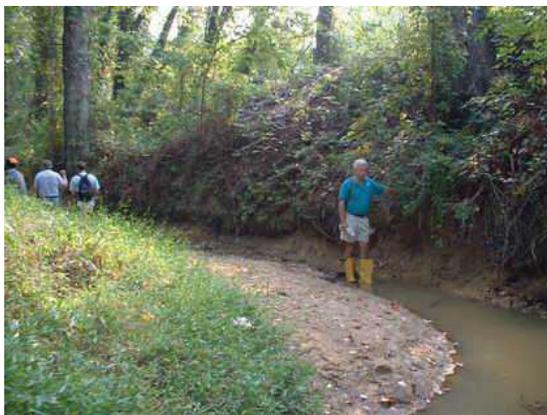
Approximately 1,500 feet upstream of its confluence with North Branch, there is severe erosion of the left bank (six feet high) as shown in Photo 3.26. Downstream of Mason Hill Drive and upstream of the tributary flowing into Paul Spring Branch, moderate to severe erosion with four- to six-foot height of bank erosion was observed at three locations (as shown at one location in Photo 3.27). Downstream of Mary Baldwin Drive, severe erosion of the right bank with eight-foot height of erosion was observed. This erosion problem will require immediate attention.

*Photo 3.26 Severe erosion of 6' height was observed west of Admiral Drive*

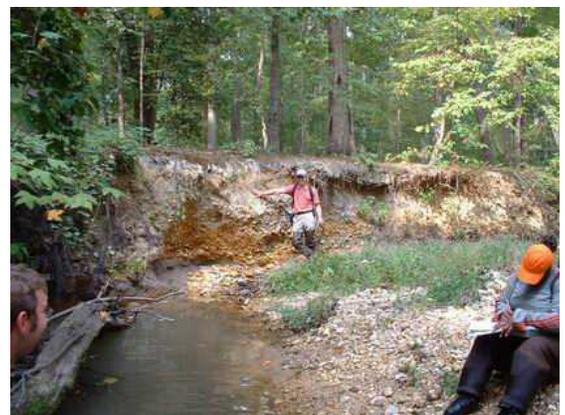
*Photo 3.27 Severe erosion of 6' height observed upstream of confluence with North Branch*

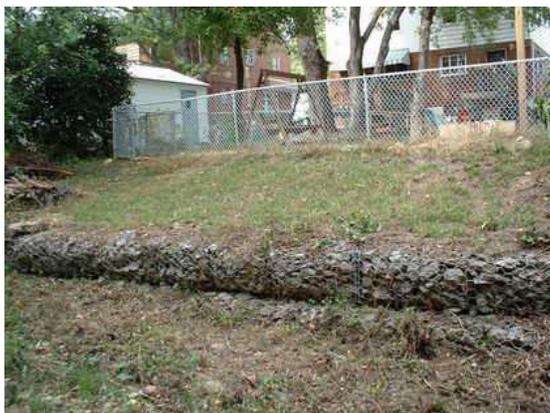
*Photo 3.28 Deficient buffer area at the upstream segment of Paul Spring Branch west of Kenyon Drive*

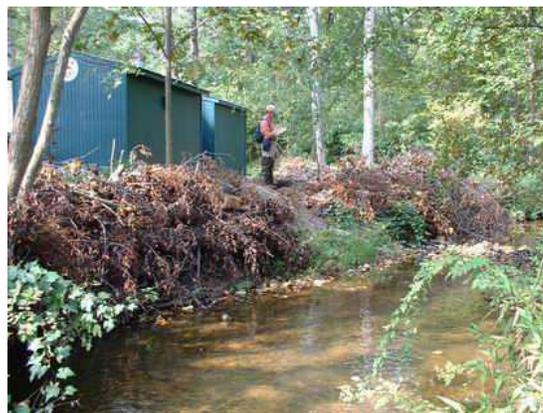
*Photo 3.29 Deficient buffer area along the downstream segment of Paul Spring Branch north of Sherwood Hall Lane*

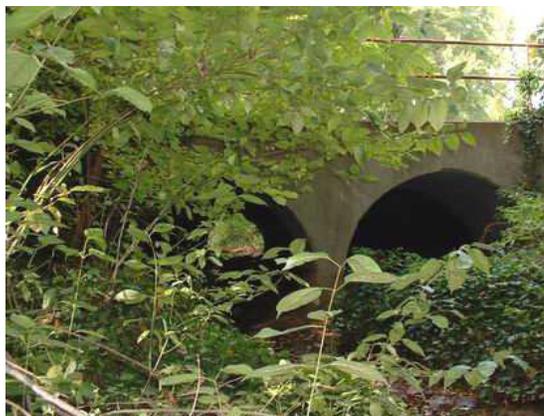
- Sherwood Hall Lane: Two 72-inch (diameter) corrugated metal pipe culverts have no impact on the stream as shown in Photo 3.31.
- Collingwood Road: Five 12-foot by eight-foot box culverts, shown in Photo 3.32, cause minor stream bed erosion upstream of the crossing.
- Collingwood Road: Four 10-foot by 15-foot concrete box culverts, shown in Photo 3.33, with sedimentation upstream of the crossing, are causing a moderate impact on the stream.
- Stacey Road: Four elliptical, five-foot by three-foot corrugated metal pipe culverts are causing minor downstream bed erosion.

*Photo 3.31 Double 72" corrugated metal pipe culverts located under Sherwood Hall Lane*

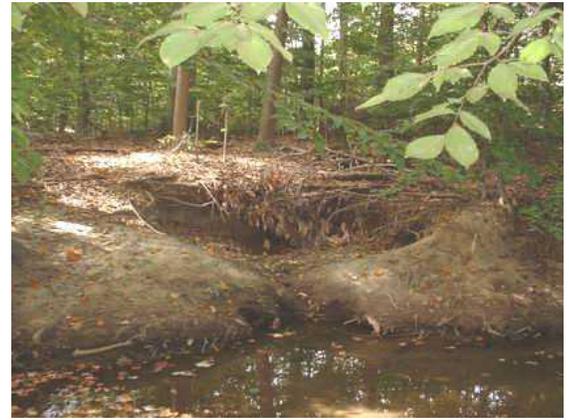
Fifteen concrete pipe outfalls discharge to North Branch and its tributaries. They range in size from 12 to 72 inches in diameter. Photo 3.34 shows a 60-inch concrete pipe outfall located at the headwaters of the tributary LHNB001 to North Branch. Discharges from the majority of pipe outfalls are causing only minor erosion and their locations are shown on Map 3.14. Downstream of the confluence with Paul Spring Branch, a small ditch with an 18-inch width discharges into the stream and causes moderate erosion (shown in Photo 3.35).

Photo 3.35 A small ditch, 18' wide, discharges to North Branch just south of the confluence with Paul Spring Branch

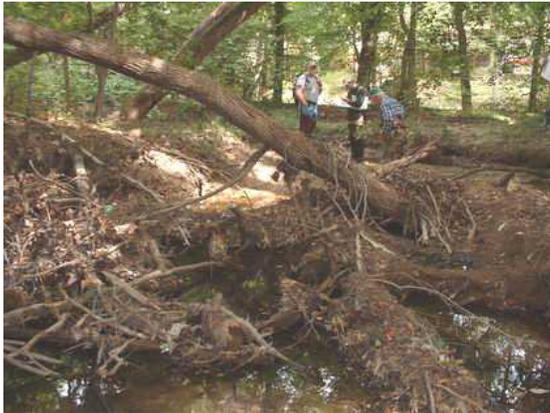
Downstream of the North Branch confluence with Paul Spring Branch, a fallen tree obstructed the fish passage without much of an impact on the stream (shown in Photo 3.36). Tributary LHNB001 has fallen trees obstructing the channel flow at two locations as shown in Photo 3.37. In the upstream segments of North Branch, the channel is littered with lawn waste consisting of grass and leaves. Partially buried or fully encased sanitary sewer pipes cross North Branch at four different locations and cause minor impacts on the stream. The location of all obstructions, dumpsites, and utility crossings impacting the stream are shown on Map 3.15.

*Photo 3.36 Flow obstruction downstream of the North Branch/Paul Spring Branch confluence*

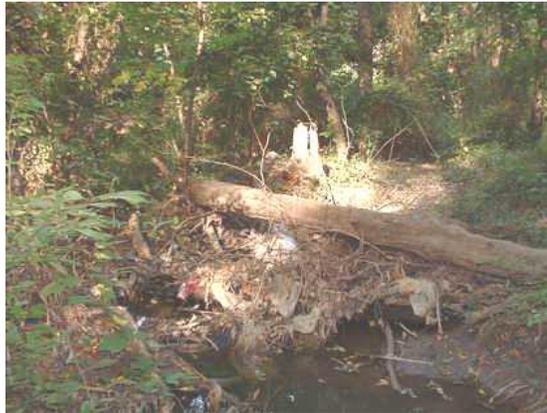
*Photo 3.37 Flow obstruction in Tributary LHNB001 upstream of North Branch outfall to Little Hunting Creek*

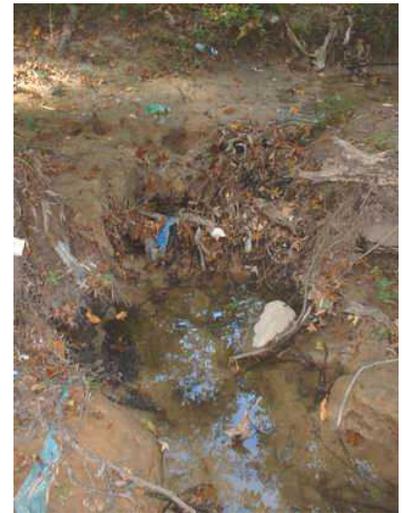
*Photo 3.38 Head cutting of the stream bed on Tributary LHNB001*

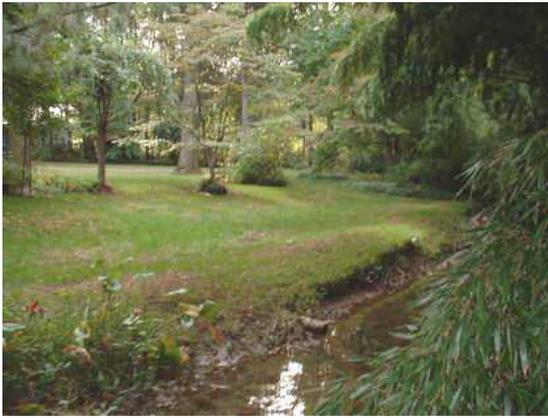
In the North Branch stream segments located immediately upstream and downstream of the North Branch/Paul Spring Branch confluence, the buffer area is covered with lawn causing a severe to extreme impact as shown in Photo 3.39. The downstream segments of Tributary LHNB001 have inadequate buffers adjoining pavement, causing a severe impact on the stream as shown in Photo 3.40. Overall, the North Branch stream segments do not have adequate natural buffer widths of 100 feet. The locations of deficient buffer areas along the stream corridor are shown on Map 3.16.

Photo 3.39 Lawn in the buffer zone downstream of Paul Spring Branch confluence

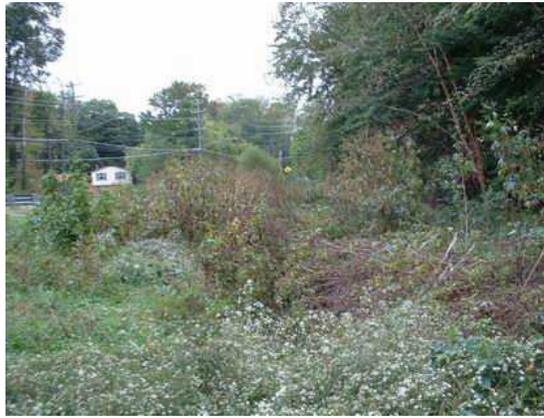
Photo 3.40 Buffer zone next to Collingwood Road on the eastern tributary to North Branch

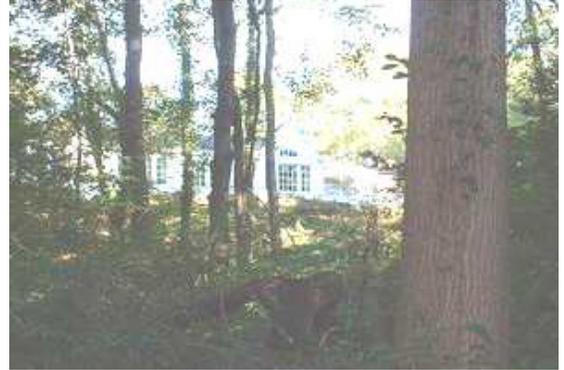
The natural buffer zone has been altered with planted lawns causing minor impacts on the stream as shown in Photo 3.43.

*Photo 3.43 Lawn grass in the buffer zone along the stream located south of Eaglebrook Court*
