# LAUREL HILL HOUSE—CONDITION ASSESSMENT AND TREATMENT OPTIONS

FAIRFAX, VIRGINIA

September, 2011

Prepared By:  
**FRAZIER ASSOCIATES**  
ARCHITECTURE ■ COMMUNITY PLANNING ■ WAYFINDING

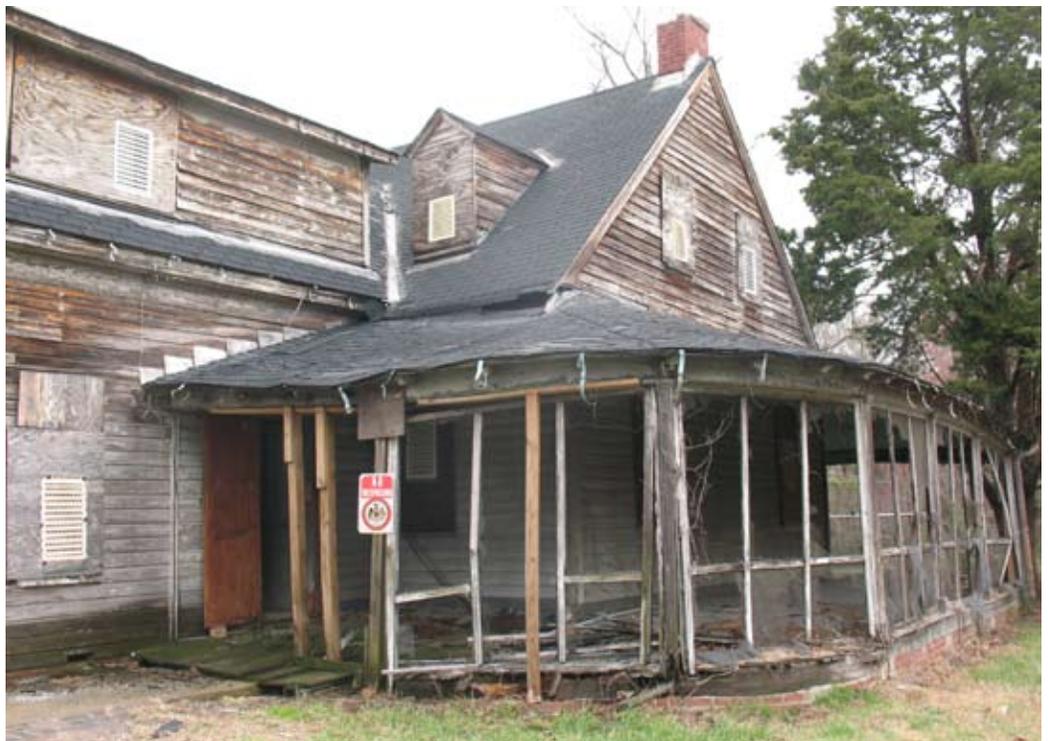
1. The porch that wraps around the south and west sides of the house is severely deteriorated, and there is the possibility that sections of it may collapse. Gaps into the house have opened up where the porch has moved.
2. The bathroom addition on the south side of the house is severely deteriorated after receiving moisture infiltration for many years. The foundation in this area is also in poor condition. The floor in this area is collapsing.
3. The existing asphalt shingle roof is reaching the end of its serviceable life span with moisture being allowed into the building in a number of locations. Deteriorated and missing shingles were noted. Gutters and downspouts are typically missing which increases the exposure of the building to moisture.

Laurel Hill House – April 2011 view from northwest showing deteriorated porch.

2. Demolish the existing porch (#5 on Building Sequence Plan) and deteriorated bathroom addition (#10 on Building Sequence Plan, previous page). Seal resulting openings in the building. Undertake additional photographic documentation during the dismantling as eighteenth-century elements are uncovered.

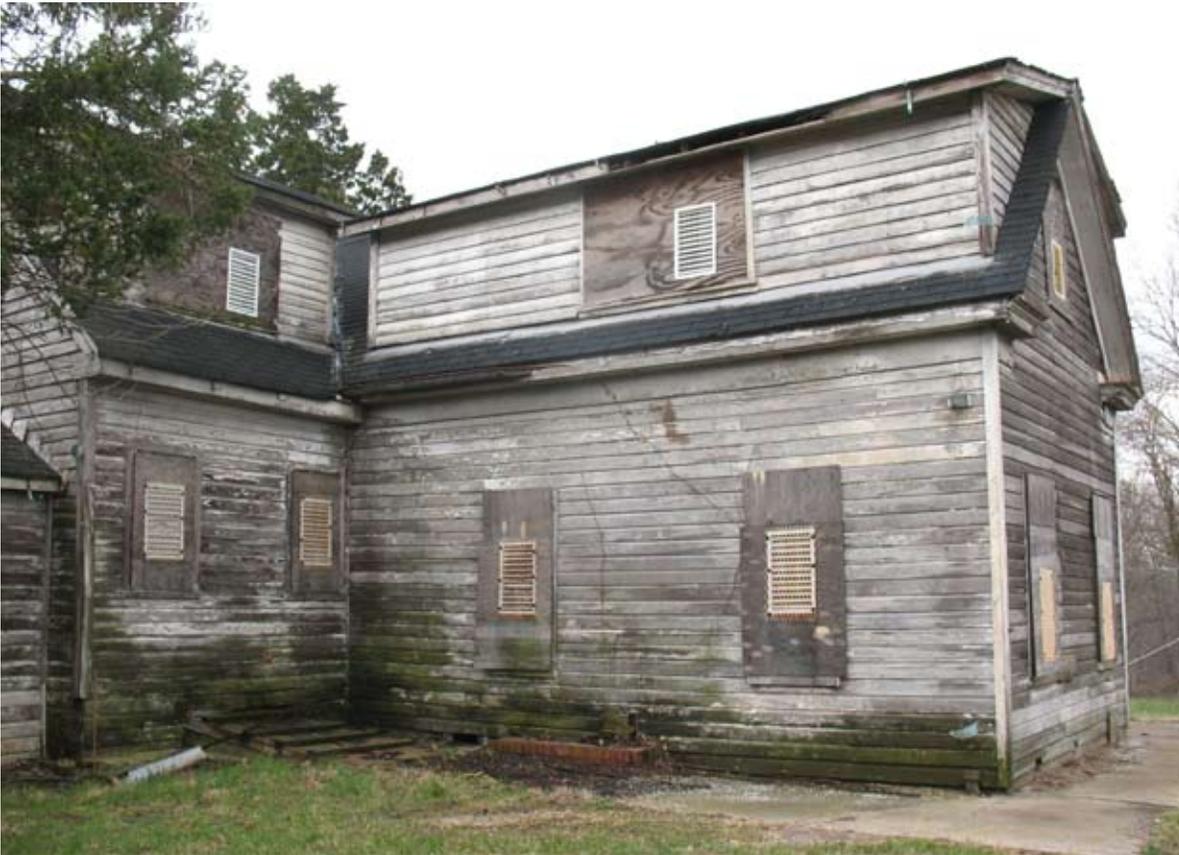
6. Most of the paint has flaked off the existing wood siding and trim. Much of the siding is beginning to deteriorate with the worst sections at grade and at intersections with the roof. In some places, moisture is beginning to enter the house where the siding is deteriorated, broken or missing. Rotten sill plates can be anticipated where moisture saturation is evident near grade.

Laurel Hill House – April 2011 view from northeast. Note moisture saturation of wood siding at base.

6. Remove deteriorated wood siding, and replace it with matching materials. Repair any deteriorated structure exposed in the process. Seal any holes in the building envelope as required to prevent water infiltration. Paint exterior siding.

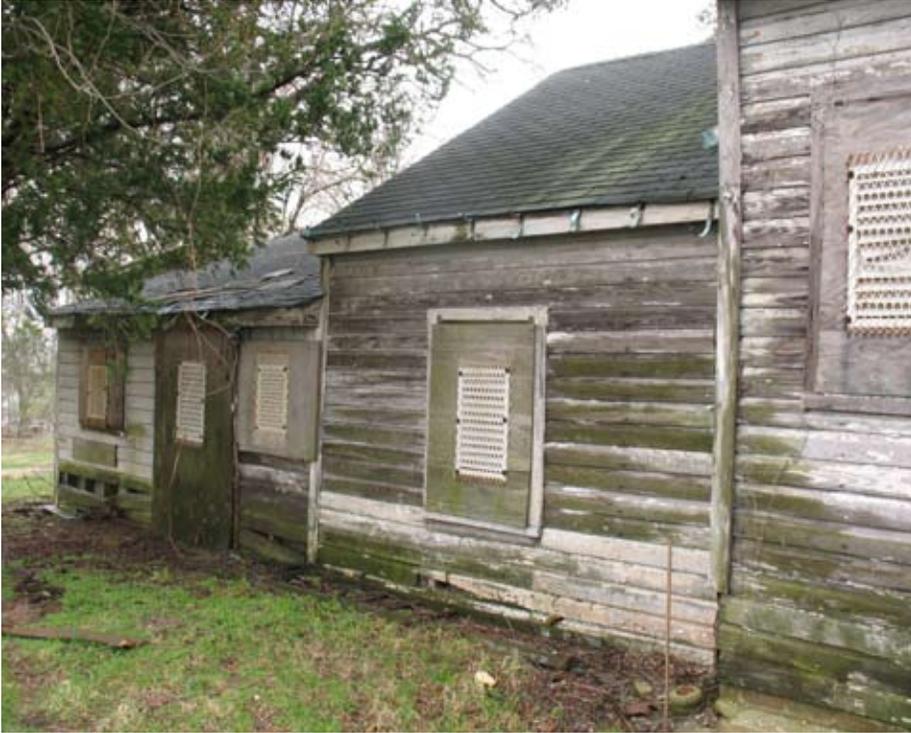
4. Considerable moisture infiltration was noted in the northeast room on the second floor of the original house.
5. The entrance foyer into the north side of the one-story addition is taking on substantial water through the roof. Numerous patches to the roof are evident in this area.

Laurel Hill House – April 2011 view from north side. Note poor condition of roof above entrance.

5. Remove existing roof. Patch deteriorated roof deck and repair deteriorated roof structure. Provide new fiberglass shingle roof and associated flashing. Provide new gutters and downspouts as required to take water away from the building.

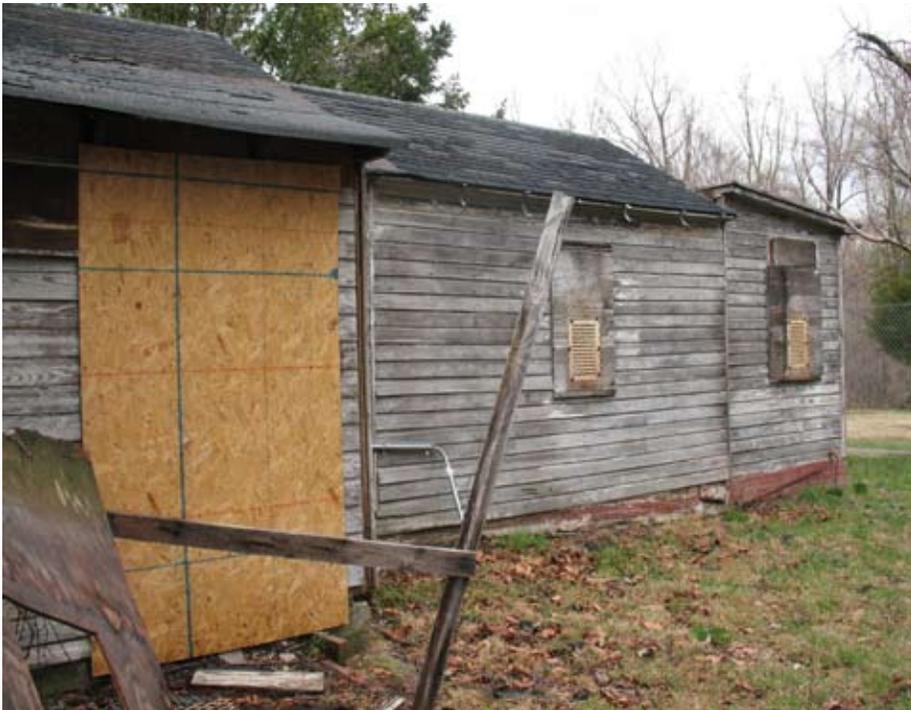
Laurel Hill House – April 2011 view from south with deteriorated bathroom addition in foreground.
