Colvin Run Mill Historic Site Cultural Landscape Report

John Milner Associates, Inc.

May 2012

Great Falls, Virginia

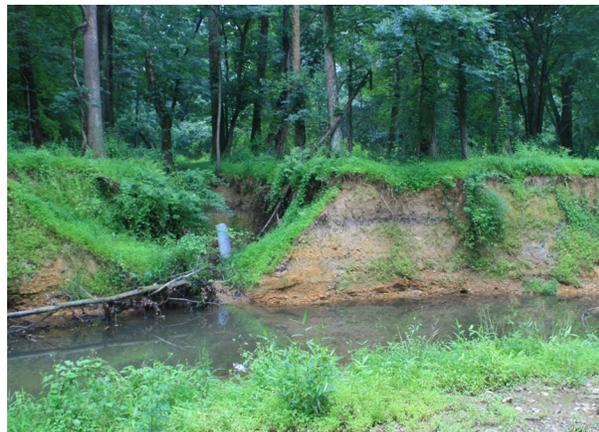
Figure 3-24. The banks of Colvin Run are severely eroded in several locations. *JMA, 2010.*

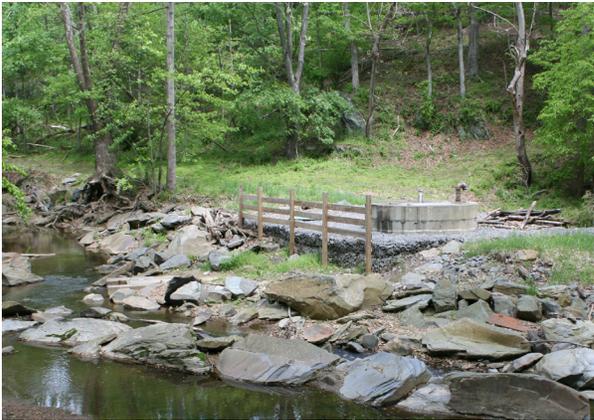
Figure 3-28. A pumping system was installed along Colvin Run to feed the mill headrace after the restoration of the mill. The pump equipment was replaced in 2006. *JMA, 2010.*

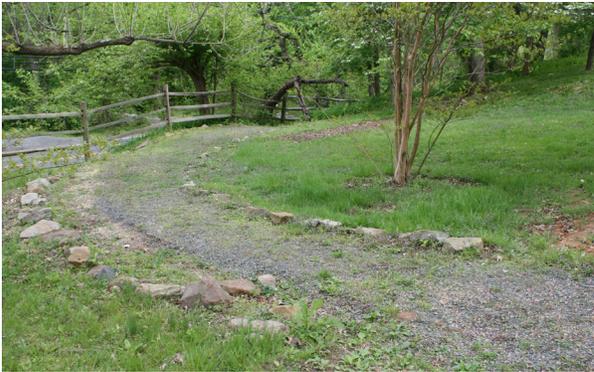
Figure 3-56. A stone-lined gravel path leads around the northeast side of the Miller's House and is in poor condition. *JMA, 2010.*

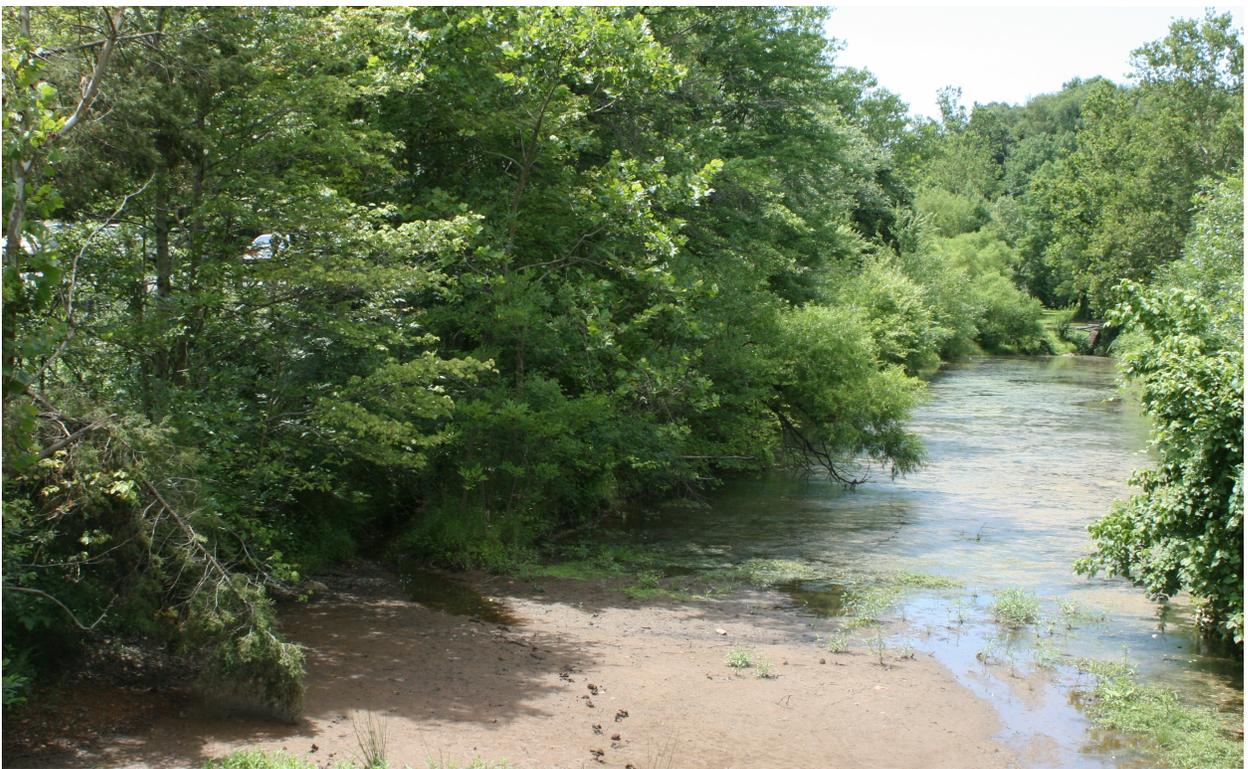
Figure 4-12. The same view in 2010; the tailrace has widened significantly, and surrounding vegetation has thickened so that Route 7 is no longer visible. *JMA 2010. 1*
