TREATMENT PLAN

ARCHITECTURAL CONDITION ASSESSMENT AND TREATMENT PLAN

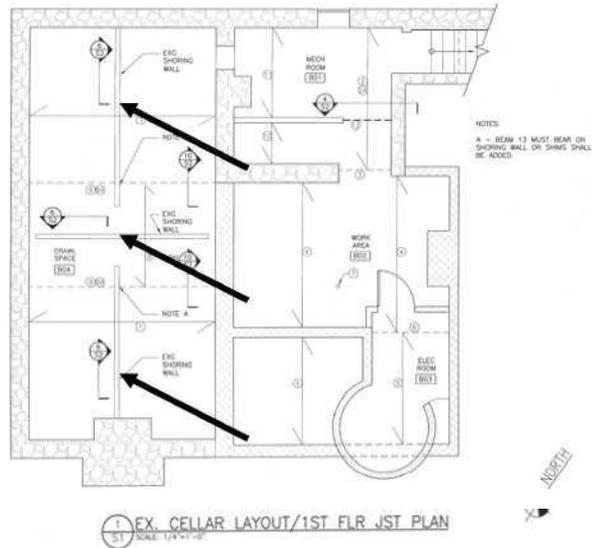
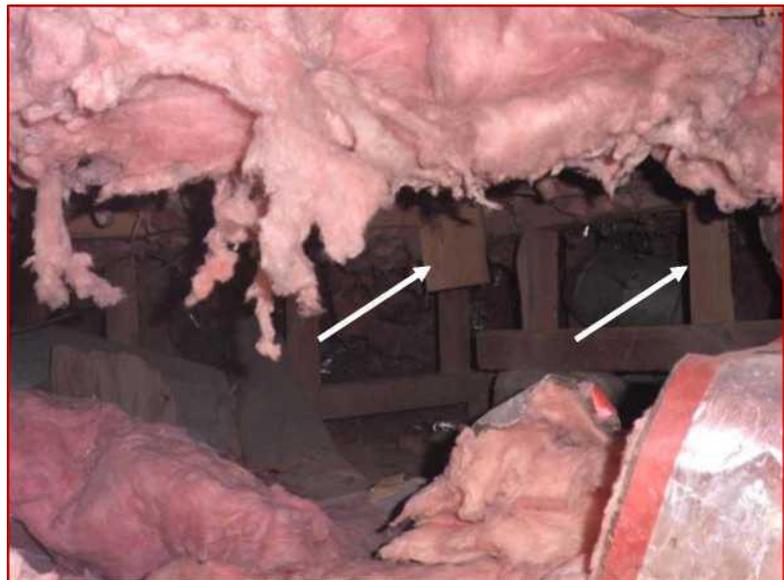
The walls consist of two horizontal continuous beams, vertical timbers between the two beams, and stone piers below the bottom beam. It appears these were added after original construction, possibly to stiffen up an otherwise bouncy and sagging floor system. The shoring walls are potentially unstable because the timbers are not securely fastened to each other and the stones, which are placed loosely without mortar, are stacked up to three pieces high.

Image 4.1: Crawl Space Shoring Walls

Image 4.2: Crawl Space Shoring Walls

Recommendations: Add stabilization bracing to the shoring walls to be located at each stone pier. The stabilization framing will include four horizontal 2x4's secured to the existing vertical posts, two vertical 2x6's fastened to the new 2x4's, and blocking between the vertical members and the existing stone support piers to prevent roll-over, tilting, or buckling of the shoring walls. Refer to Details 6 to 9/S2 of the Design Development plans for more information.

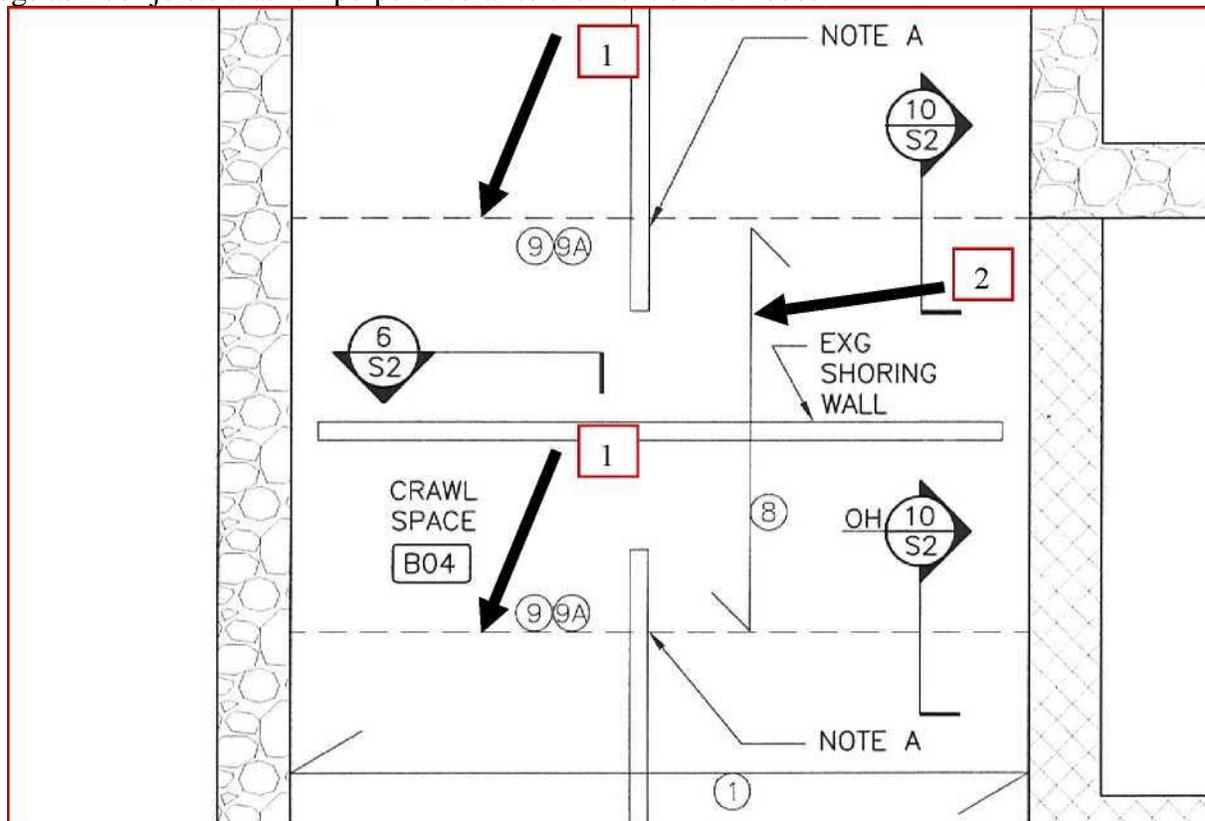
Image 4.3: First Floor Joist Headers

Issue: On the first floor below the stairs (between the dashed lines indicated by Arrow 1 in the sketch below) the joist framing (direction indicated by Arrow 2) is parallel to the front of the house, and is comprised of dimensional lumber. This area is between the two front rooms that have round logs as floor joists that run perpendicular to the front of the house.

The dimensional lumber joists are 2x6's and are supported at their mid-points by the shoring wall that is perpendicular to the front of the house. They are adequate in size, but are attached at their ends to single 2x6 headers (at the Arrow 1's) that are severely undersized.

Recommendations: The single header members shall be doubled in size and shall be provided with solid blocking at their mid-points so as to bear on the shoring walls that are parallel to the front of the house.

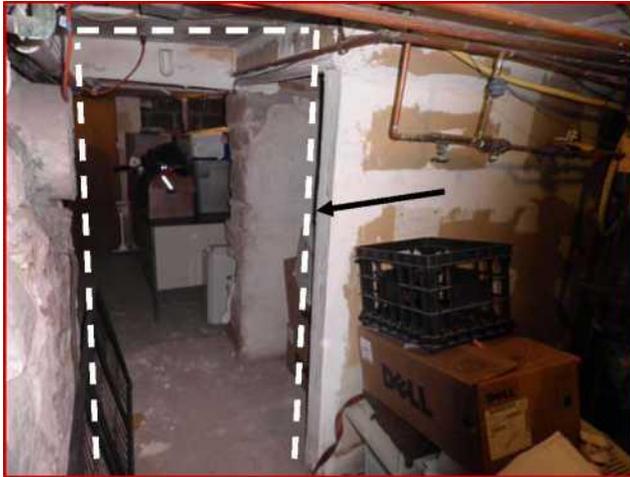
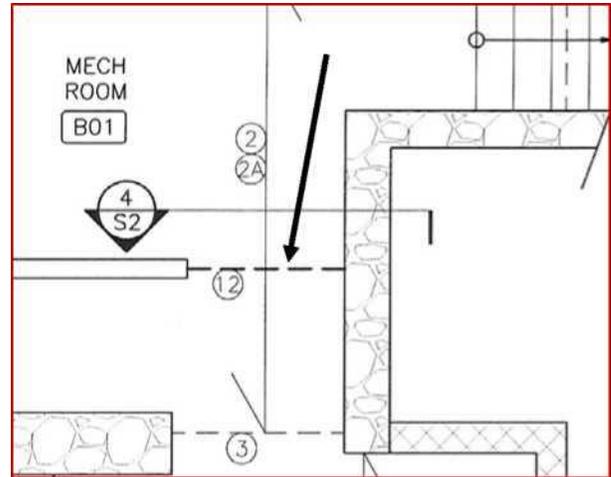
Issue: There are 2x6 joists under the rear area of the kitchen that are undersized because a bearing wall that bisects the joists at the front of the kitchen does not extend all the way back to the rear of the kitchen. The undersized joists are indicated by the number 2 in a circle in the sketch below.

Image 4.4: Rear Joists Below Kitchen

Image 4.5: Rear Joists Below Kitchen

Recommendations: A beam shall be added at the end of the bearing wall so the joists do not have to span their full length without any intermediate supports. The beam shall be supported by jack studs and king studs at each end. The required location of the posts and beam are indicated by the dashed lines in the photo above at the left.

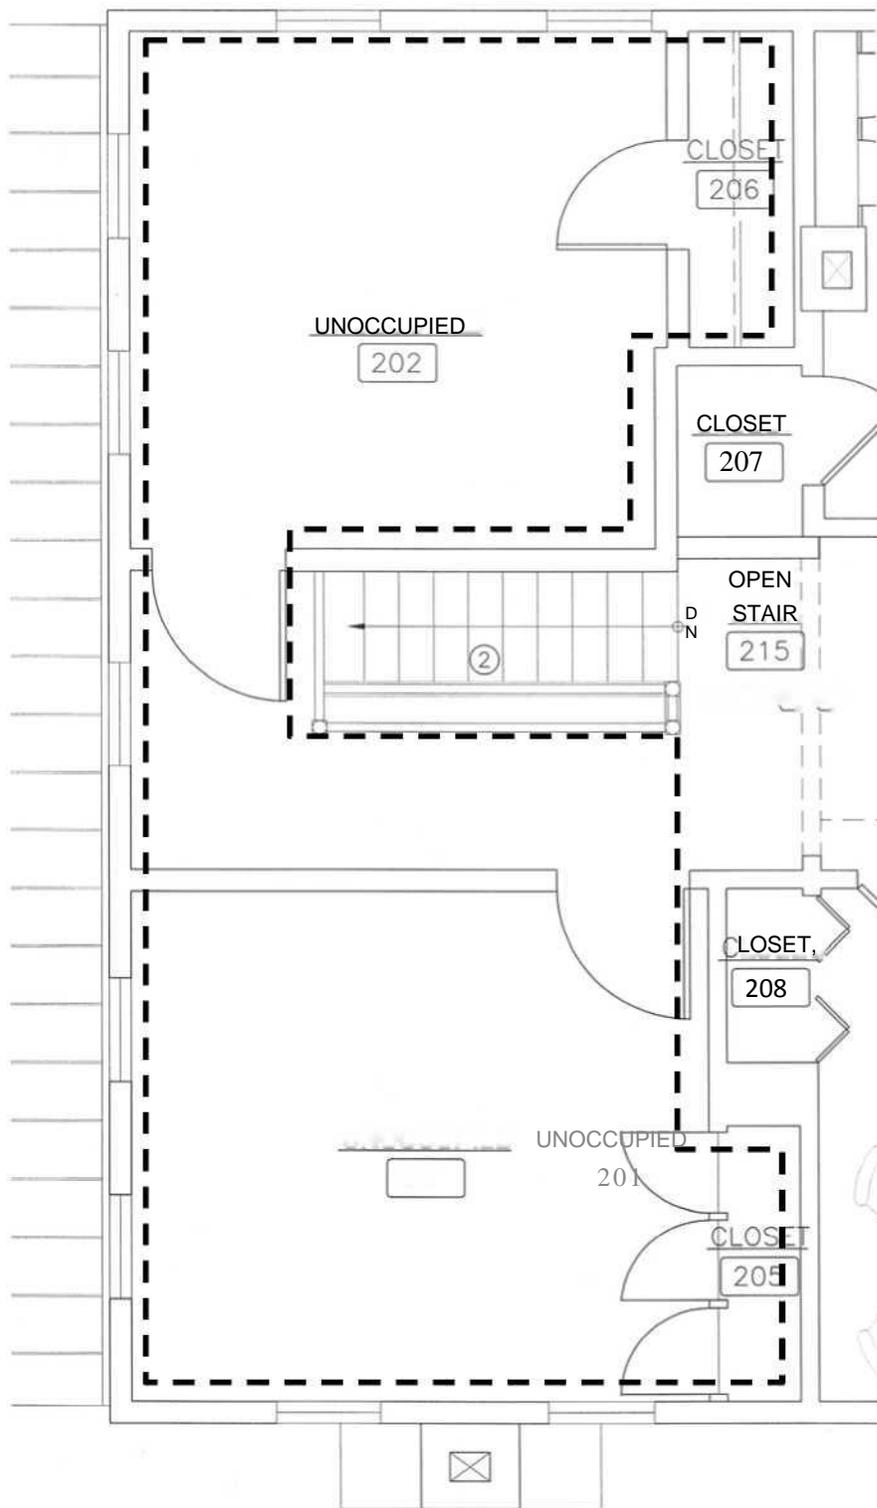
Image 4.6: Second Floor Joists Below Front Bedrooms Are Inadequate

Recommendations: No repairs are to be performed to this area at this time. Therefore, the areas shall not be used for office. Existing items stored in these rooms shall be removed and the rooms shall not be used for light storage.

see sketch next page. The area within the dashed line shall not be used for office or storage.

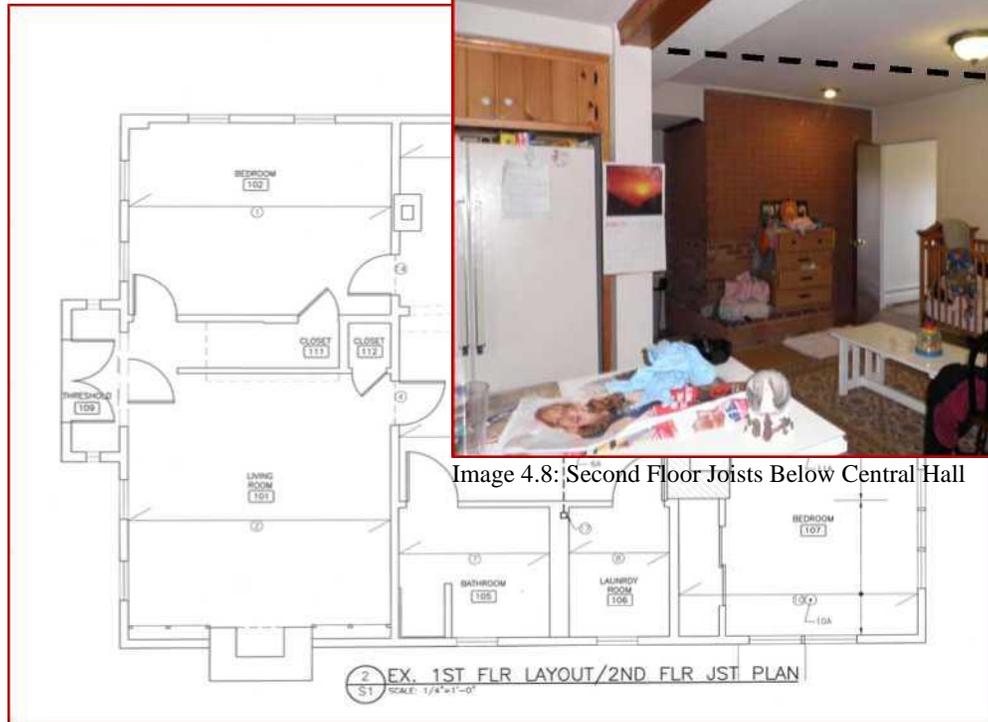
Issue: The second-floor joist framing above the family room spans over 16'-0" and is oriented from the front to the back of the house. It is not sufficient to carry the proposed office

Image 4.8: Second Floor Joists Below Central Hall

Recommendations: Add a beam below the joists that will span from the demising wall at the kitchen to the wall near the bathroom and Laundry Room. Refer to item 16 in the sketch above for the required location of the beam. The beam size shall follow the recommendations in the design development drawings in the Framing Table at Detail 5/S1. See dashed line in photo to the left for proposed location.

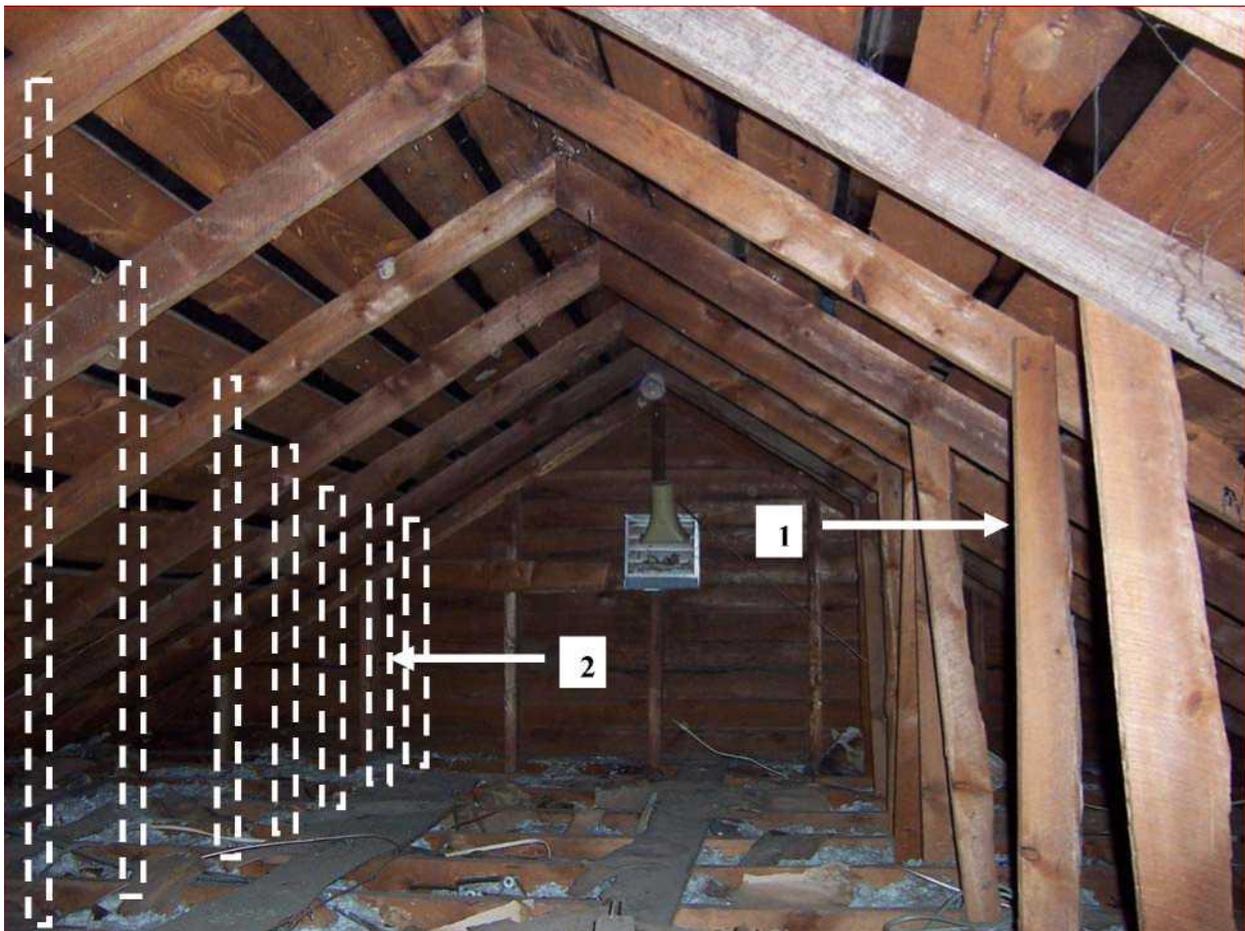
Image 4.9: Roof Rafters Above Bedroom 202

Issue: The rafters above Bedroom 202 have vertical support studs toward the rear side of the house (Arrow 1) but do not have vertical support studs at the front side of the house.

Recommendations: Vertical supports studs as indicated by Arrow 1 shall be added to the rafters toward the front side of the house above Bedroom 202.

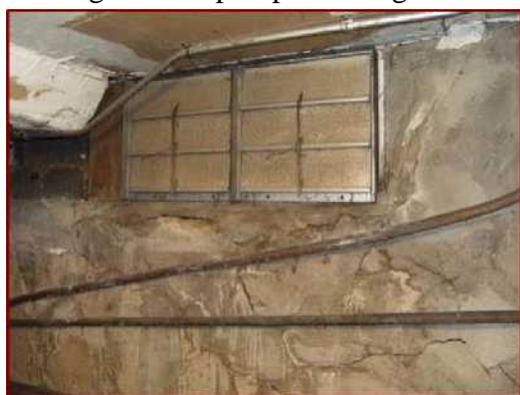
Heating water is pumped through uninsulated copper piping throughout the house to floor-mounted

Image 4.10: Uninsulated Copper Piping

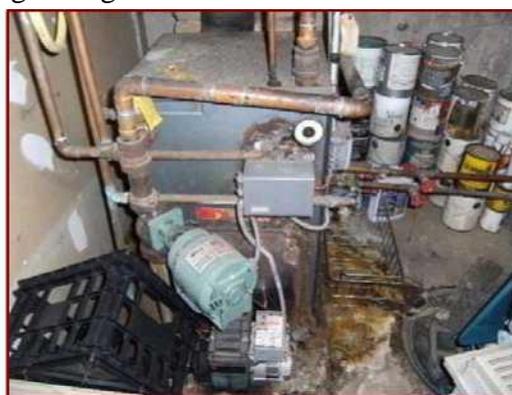
The house is heated by an oil-fired hydronic boiler located in the basement. The nameplate information is illegible. There is a single 28x12 combustion air intake (assume 80% free area) which provides for approximately 800 MBH heating capacity based on the 2009 International Fuel Gas Code (one square inch of free area is rated for 3000 BTU/hr). We believe the capacity of the boiler to be between 100 MBH and 150 MBH, therefore the combustion air intake is adequately sized. The age of the boiler is unknown, and there is significant surface rust on the casing. The boiler flue is connected to a masonry chimney. The boiler is not in use at the current time and it is unknown if it is operational. A new gas meter was recently installed and flexible cssT gas piping has been extended into the basement and capped near the existing boiler.

Image 4.11: Oil-fired Hydronic Boiler

Completed now Natural Gas Remove the underground oil storage tank and oil-fired boiler. A new high-efficient gas-fired boiler with sealed combustion is proposed. The existing hydronic heating water piping and radiators will be reused for heating. The piping and radiators shall be pressure tested, cleaned, and repaired as required.

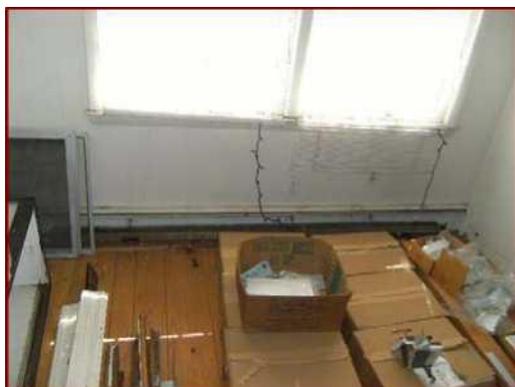
The radiator panel covers on the first floor are intact and have minimal damage. on the second floor in Bedroom 201, 204, and Office 209 there is significant damage to the fins and many of the panel covers have been removed.

Image 4.12: Typical Damaged Radiator

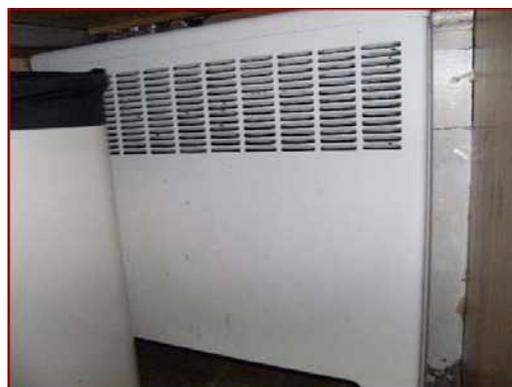
A single radiator, installed in the kitchen, is a Multifin Type K freestanding floor radiator. It was likely installed at the same time as the baseboard radiators; however, due to its location, this type of radiator was appropriate.

Image 4.13: Freestanding Floor Radiator in Kitchen

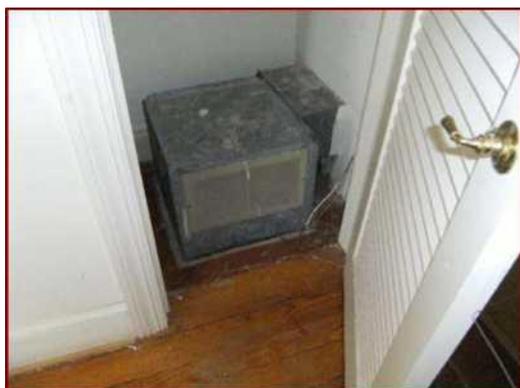
There are fireplaces located throughout the house which are not in use. The tenants are currently using electric space heaters throughout the first floor to provide heat. The basement has ducts that drop into the crawl space and resurface in the family room closet. During the survey there was no sign of an HVAC unit; the purpose of the ducts is unknown.

Image 4.14: Ductwork in Closet112

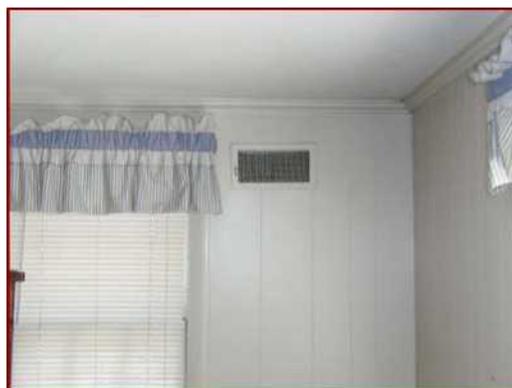
There are several wall grilles installed in the house on the first and second floors. The purpose/function of these grilles is unknown since they do not stack from floor to floor and there was no ductwork found connected to them.

Image 4.15: Wall Grille

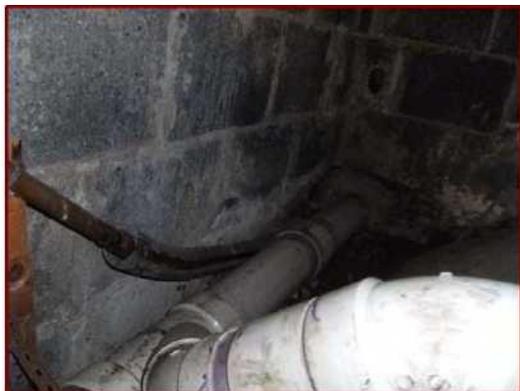
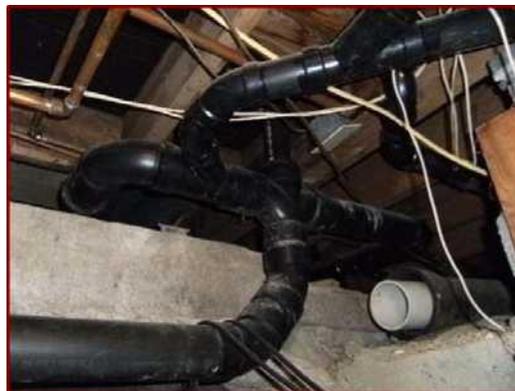
The existing utility-provided domestic water service enters the house through the basement wall adjacent to the sanitary sewer. Copper domestic water piping in the basement distributes water to the plumbing fixtures. Sanitary sewer is connected to the utility and not a septic system. The sanitary sewer piping is comprised of cast iron, PVC, and ABS piping. It appears that it may have once been connected to a septic system and some of the piping is abandoned in place.

Image 4.16: Sanitary Sewer Piping

Image 4.17: Sanitary Sewer Piping

The domestic water piping entrance to the building shall be rerouted to maintain the code required separation from the sanitary sewer piping. The abandoned piping in the basement will be removed. It is recommended to test the sump pumps to verify proper operation.

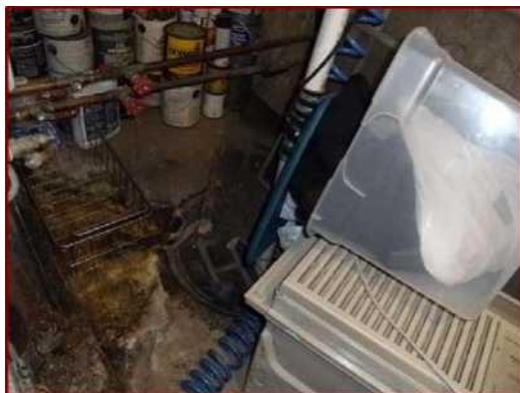
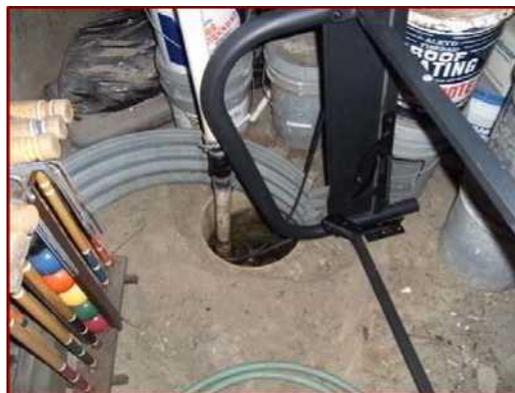
The basement has two sump pumps along with floor drains. The sump pumps are located on opposite sides of the basement and discharge out of the southeast side of the house to an open yard inlet.

Image 4.18: Sump Pump Within Floor Drain

Image 4.19: Sump Pump Within Floor Drain

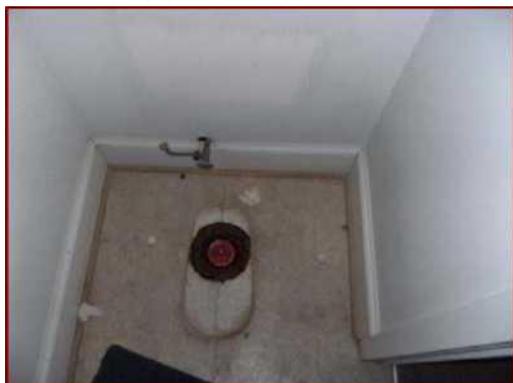
The second floor bathroom has a counter-mounted lavatory and a connection for a water closet. The drain trap for the lavatory has been removed and its sanitary sewer line has been capped. The water closet has been removed and its sanitary sewer line has been capped at the floor. A drinking fountain, once installed on the wall behind the water closet, is no longer installed. The drinking fountain has been removed and the sanitary sewer piping has been capped.

Image 4.20: Capped Sanitary Sewer Line Fountain

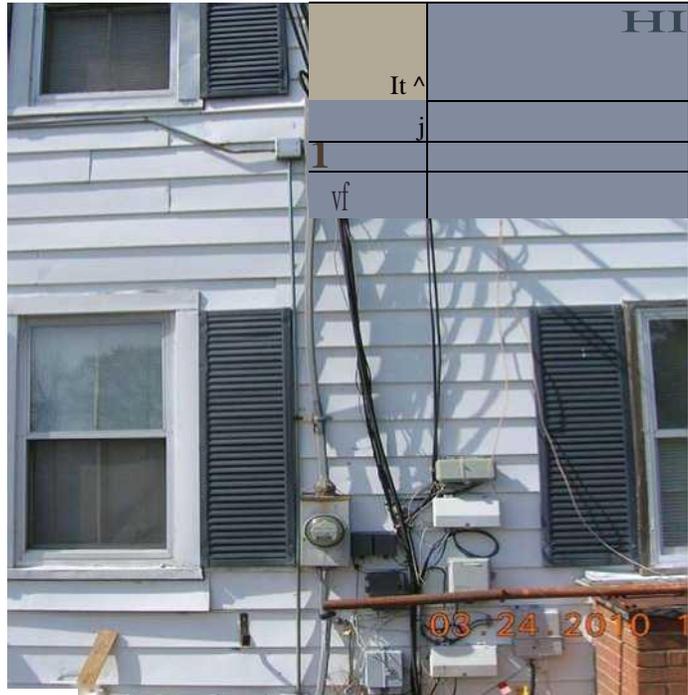
The power line is run separately from the other conductors approximate 15 feet above the ground. The guy line from the power is supported by an eyelet screwed into the side of the building between the windows, approximately 18" from the closest window which is a violation of the National Electric Code (NEC).

Image 4.22: Exterior Electrical Service Entrance

There is no weather head to protect the service conductors and terminations where the utility conductors are spliced to a USE cable. The USE cable is not in conduit but attached directly to the building which is also a violation of the NEC. The USE cable runs down the side of the building to the electrical meter. This is acceptable for residential use but commercial services should be in conduit.

- **Completed Service now underground** Remove the existing over head service and replace the panelboard.
- **Completed** Install two 4" conduits 24" below grade from the building to the existing utility pole for the electrical service. one for the service wires from the pole mounted transformer to the building and the other as a utility required spare.

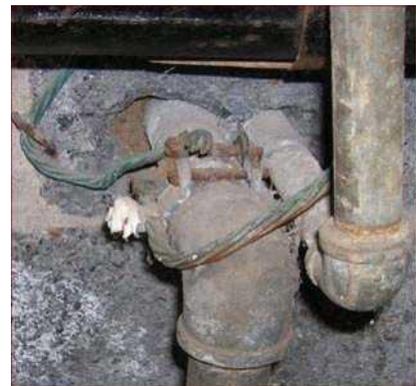
A ground wire connects several of the communications/fiber cables to the electric meter housing, but no ground wire to a ground rod was found. A ground rod is required by the NEC. A ground wire is connected to the domestic water pipe entrance and the panelboard providing buildings ground. The connection is rusted and should be cleaned and reconnected.

Image 4.23: Ground Connection

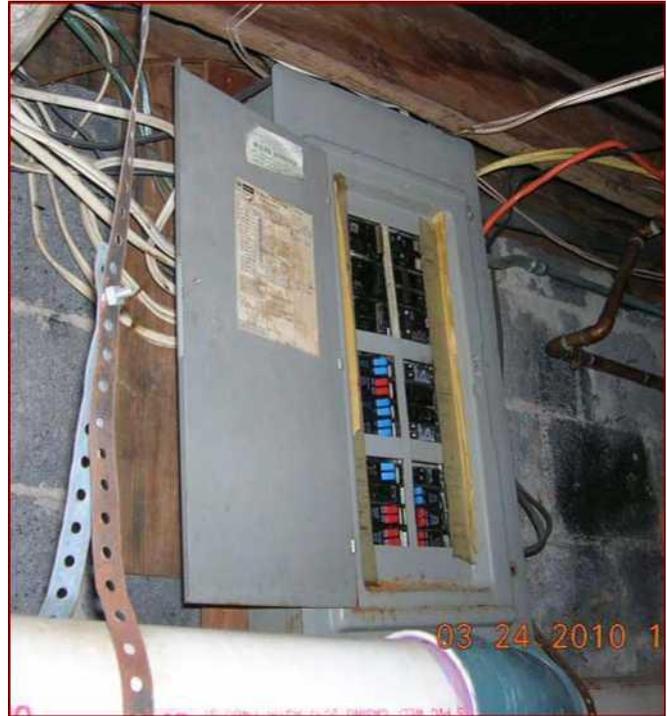
This location is in violation of the NEC which requires a service disconnecting means within five feet of the service's entrance into the building. The panelboard does contain main circuit breakers which qualify as the service disconnecting means. It also contains a dozen double circuit breakers, is very old and is at the end of its useful life. A waste pipe runs directly underneath the panelboard which is a violation of the NEC. The basement room where the panelboard is located has a very low ceiling and does not meet the requirements of the National Electric code.

Image 4.24: Basement Panelboard

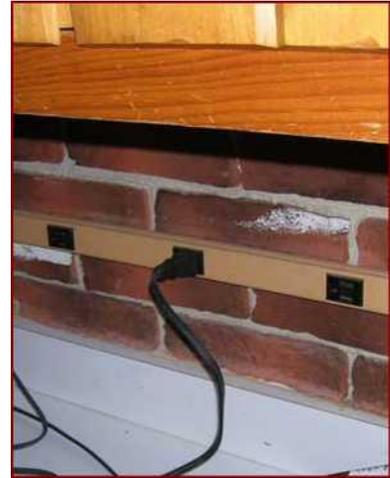
Image 4.25: Kitchen 'Wiremold';

A surface mounted 'Wiremold' strip is mounted underneath the counter in the kitchen and appears supply the only receptacles at the counter. The NEC requires two 20A circuits in residential kitchens and it appears only one is furnished. Two receptacles are not required if the building is changed to commercial use.

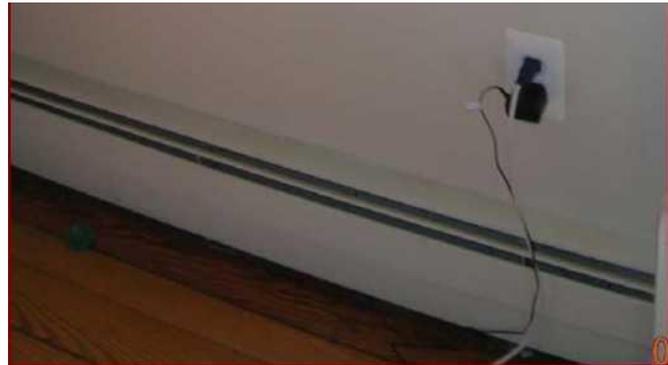
in several rooms electric baseboard heaters are installed continuously at exterior walls with receptacles are installed above the baseboard. This is an NEC violation.

Image 4.26: Receptacle above Baseboard

- Replace all existing branch wiring. Remove all exposed wiring and abandon in place all concealed wiring. Install new circuits in EMT, rigid metallic conduit and flexible metallic conduit.
- Install branch circuits for general receptacles at the basement ceiling where possible directly to the device to minimize wall perforations.
- Branch circuits for general lighting shall be running from the basement up to the attic or ceiling space in flexible metallic conduit. provide rigid conduit for lighting circuits in the basement space to protect wire from physical damage. install junction boxes in ceiling space as necessary to facilitate the work.
- Provide supporting electrical service for proposed mechanical equipment.
- Install supporting telephone and fiber service to the space as required to support the proposed conversion to office use.
