TURNER FARM
Turner Farm Treatment Report

10609 Georgetown Pike
Great Falls, Virginia 22066

Draft Report
July 8, 2016
WJE No. 2015.3162.2

Prepared for:
Fairfax County Park Authority
12055 Government Center Parkway, Suite 927
Fairfax, Virginia 22035

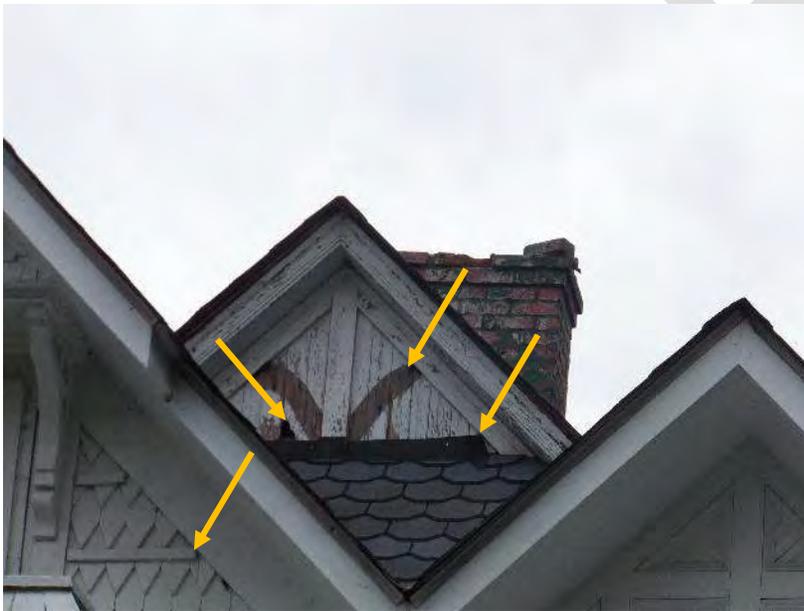
Based upon site observations, it is apparent that some repair work has been completed since the 2011 HSR; mainly to the porch, siding, and roof. At the northeast corner of the 1905 structure roof, a course of six asphalt shingles near the gutter are lifted and out of plane. There are isolated areas of deteriorated flaking paint and exposed wood throughout the exterior, most notably at the secondary gables. The secondary gable to the north of the deteriorated wood has resulted in a hole, as well as general flaking of paint that does not appear to have been addressed in any recent work. The roof termination at this secondary gable also appears to be inadequate with black roof felt attached to the gable and asphalt shingles serving as some sort of seam lap. (Figure 5)

Figure 5. Roof felt at the secondary gable and roof shingles. Note hole in wood and profile from previous decorative trusses as well as miscellaneous horizontal wood boards on forefront gable.

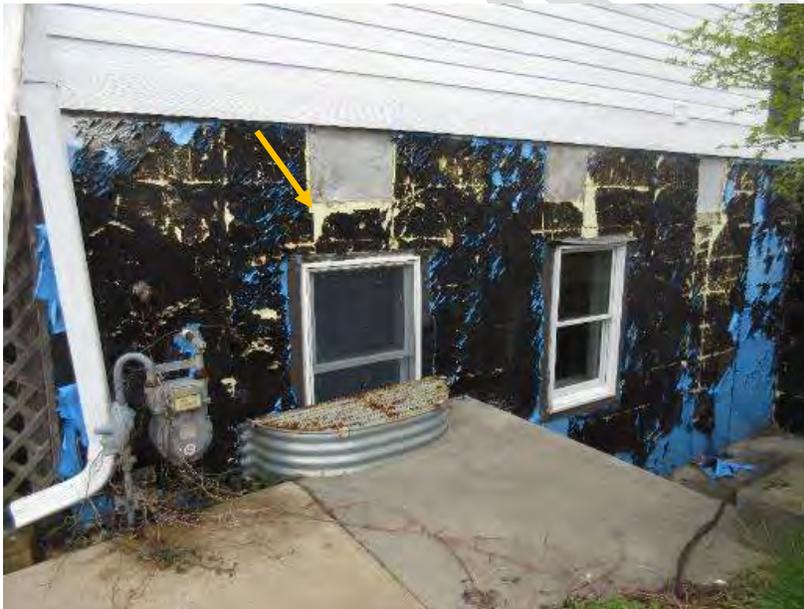
With the lifting of the house in 2002, expanded polystyrene insulation form boards and poured concrete were used to form the cellar walls. A WRB was applied to the exterior of the foam and new windows installed. The WRB was left exposed and has resulted in significant deterioration of the WRB and all tie-in details around the windows and the top of the insulation foam. (Figure 6) The insulation foam has become visible in numerous areas because of this. Typically, insulation foam should not be exposed to UV for longer than 30 days and a WRB should not be exposed for longer than six weeks.^{17, 18} As part of the cellar wall installation, exterior sheathing (such as siding) should have been installed. A wide unpainted wood cellar door is located at the east corner of the south facade. A CMU retaining wall was constructed adjacent to the steps leading to the cellar door, which has exposed reinforcement and heavy biological staining.

Figure 6. Deteriorated WRB and exposed insulation form where WRB is no longer in place.

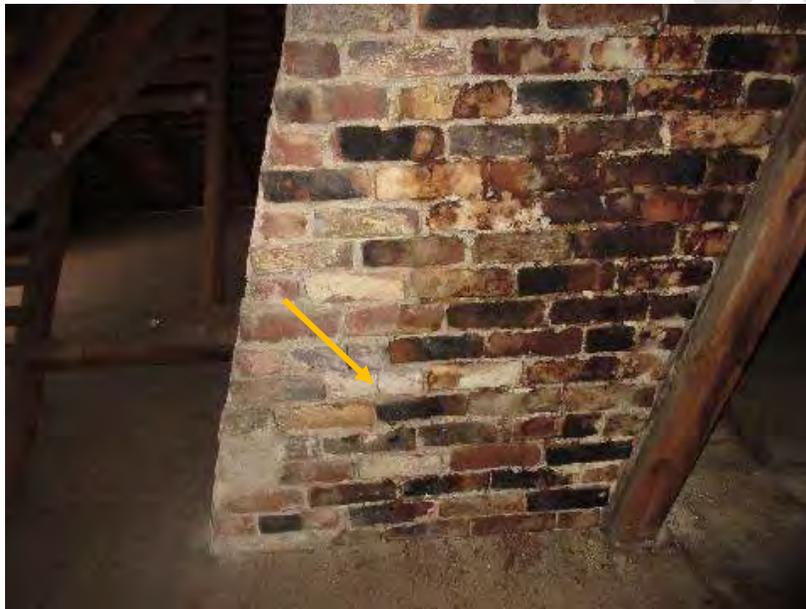
Figure 7. Vertical crack in the north face of the chimney in the attic.

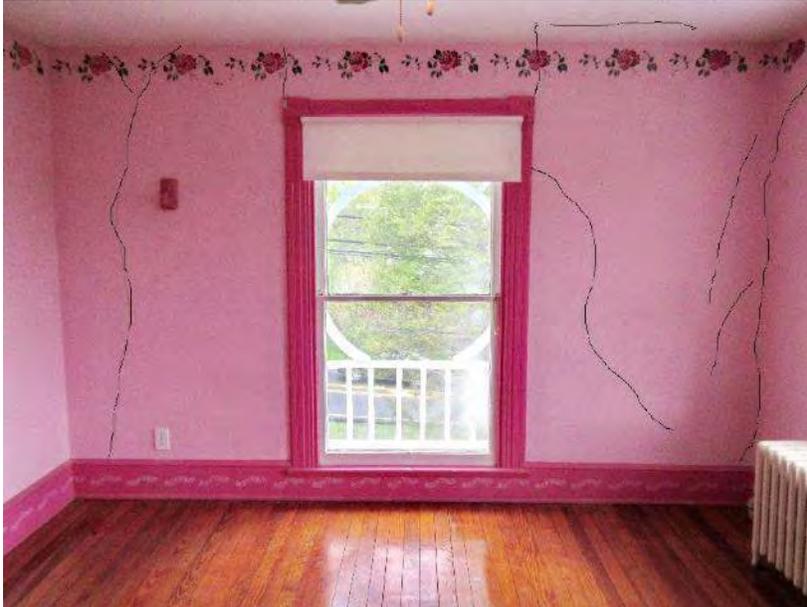
Figure 8. Example cracking in Room 201 at the north wall. Cracks have been traced for clarity.

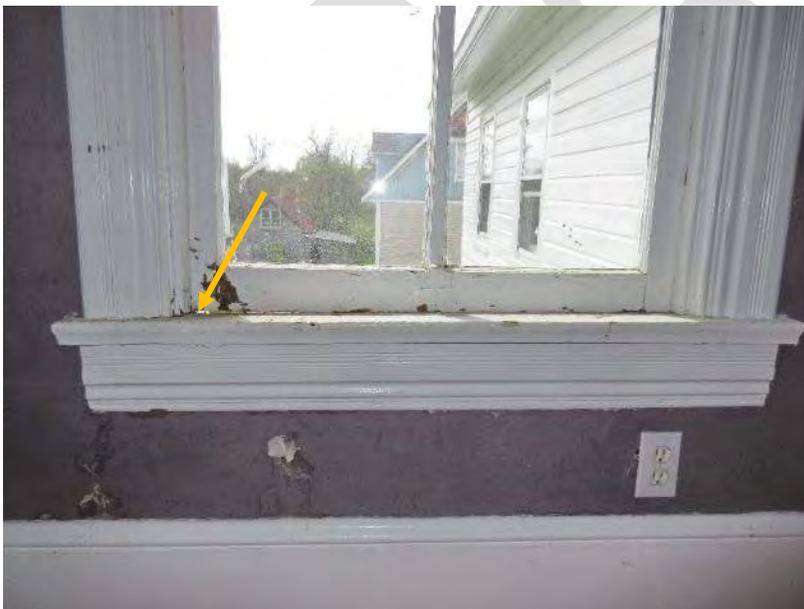
Figure 11. Typical staining and cracking below original window. Note this window is racked with visible daylight below the sash.

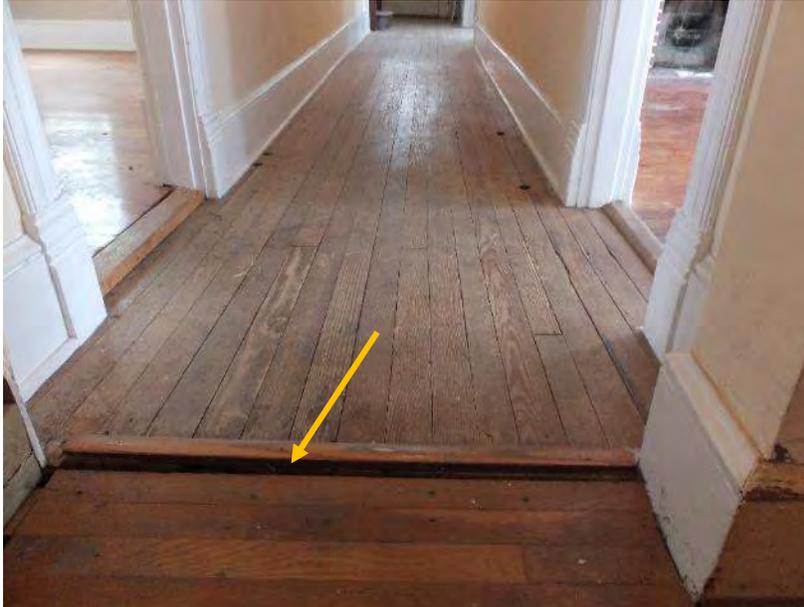
Figure 12. Transitions between Hallway (100) and adjacent rooms. Note gap between the rear hall to the Hallway (100).

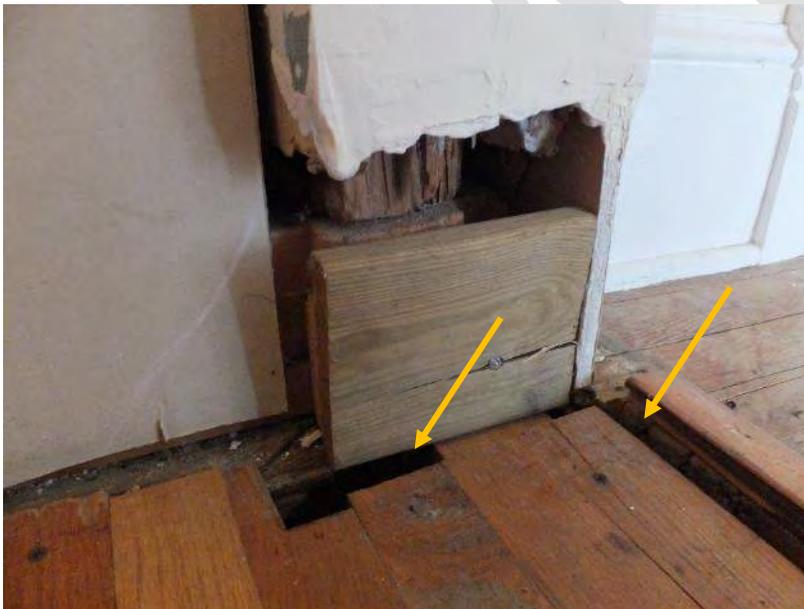
Figure 13. Voids in the floor at the rear hall allowing the below cellar to be visible. Note the missing baseboard and interior finishes at this location.

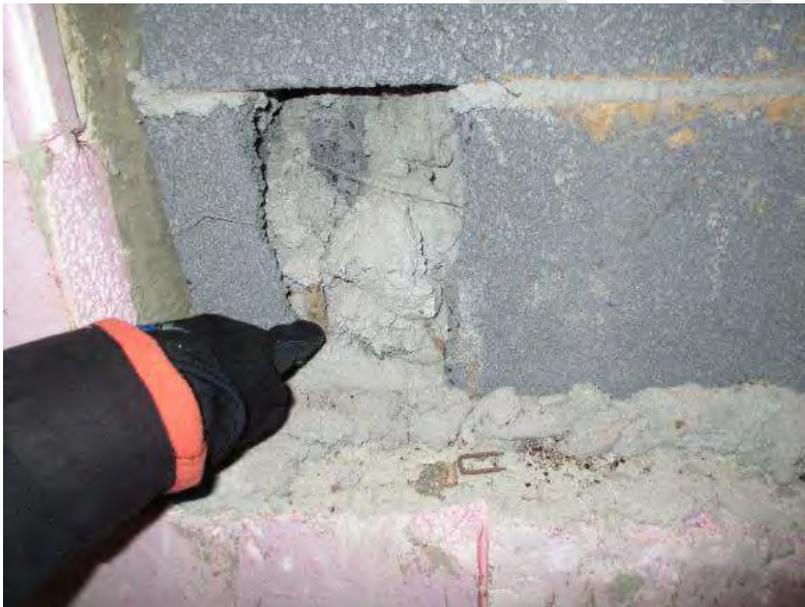
Figure 15. CMU infill at blockout in cellar wall. Note the reinforcing bar present inside the damaged cell.

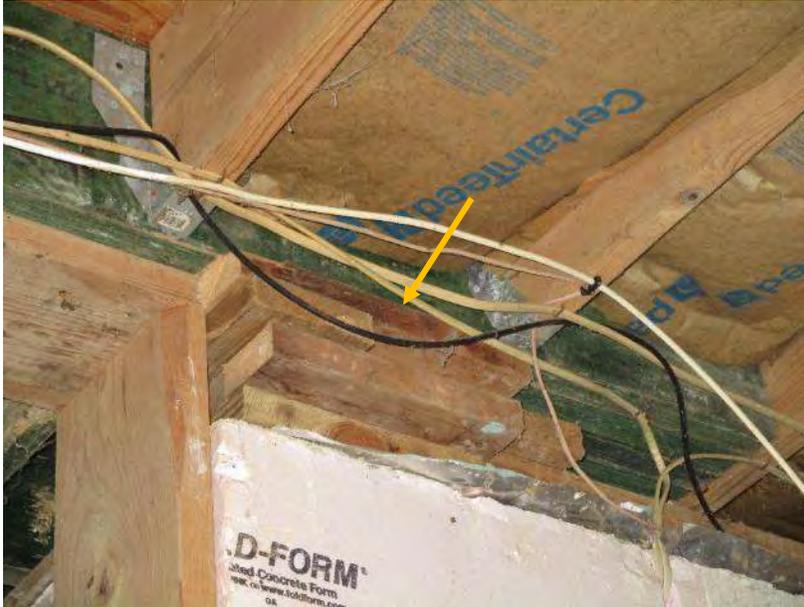
Figure 17. Built up wood blocking.

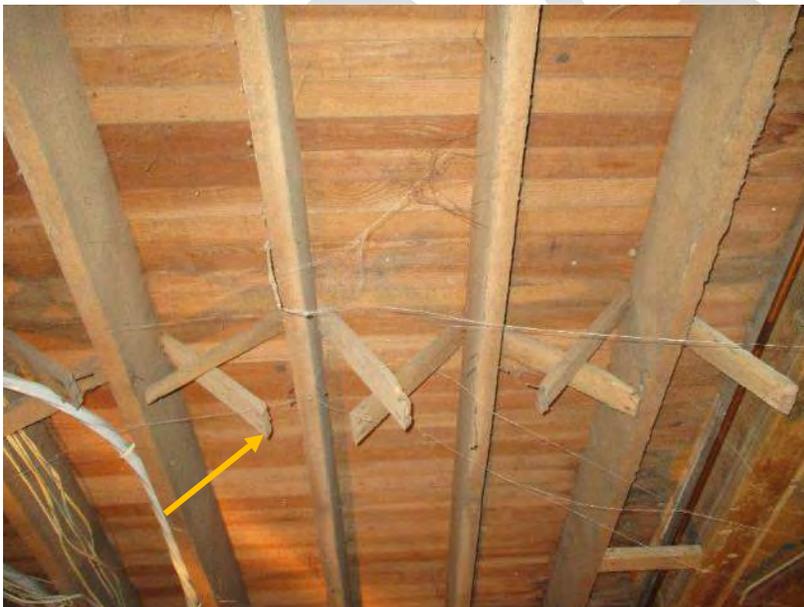
Figure 22. Disengaged and missing wood bridging between first floor joists (typical at original first floor framing).

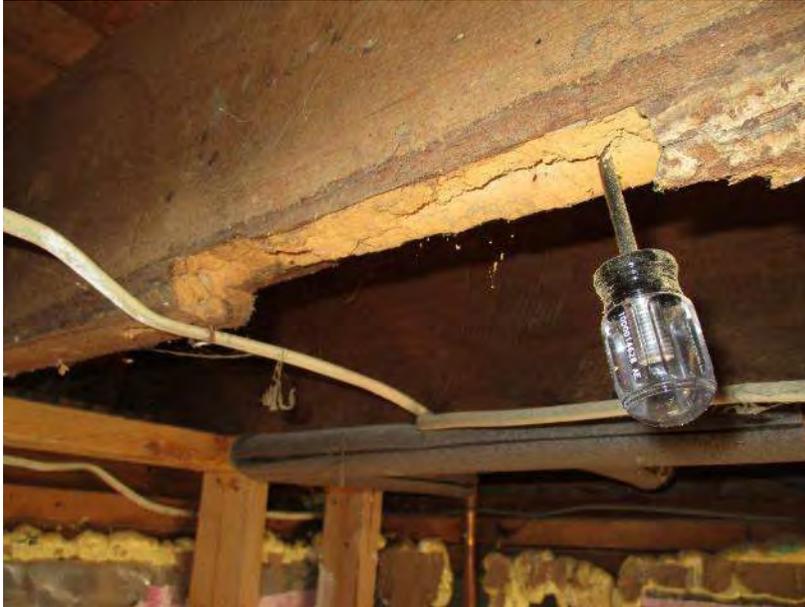
The majority of the first floor wood framing is in fair condition; however, decay is present at isolated locations along several of the original joists (Figure 24 and Figure 25). The extent of the damage observed was limited and does not suggest that the joists are structurally undermined. WJE took limited moisture readings at the original joists using a handheld moisture meter and measured an average moisture content of thirteen percent, which is on the high side for interior wood members not exposed to weather, but less than the twenty percent threshold which is the general value recognized to support the initiation of decay. Since the house has not been occupied for several years, we anticipate that it has not been conditioned, i.e. heated and cooled, like typical interior spaces and that this has contributed increased humidity levels in the below-grade space and higher moisture readings in the wood framing. Water stains and deteriorated floor boards are present at isolated locations along the edge of the original farmhouse (Figure 26).

Figure 24. Deterioration at first floor joist in original farmhouse.

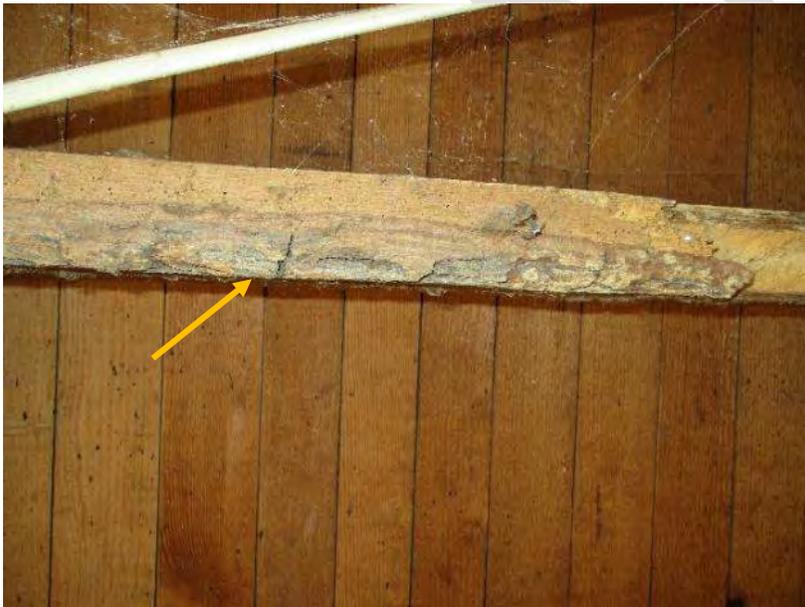
Figure 25. Deterioration at first floor joist in original farmhouse.

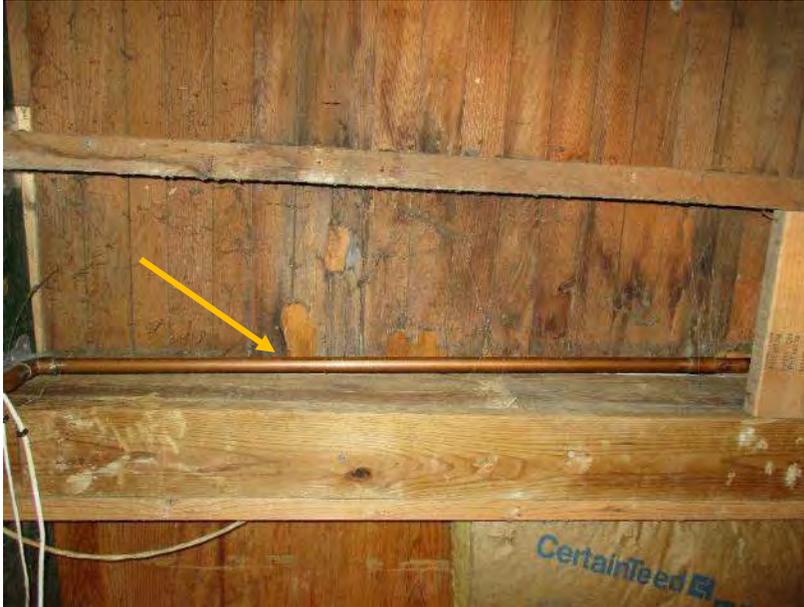
Figure 26. Staining and deterioration at first floor boards at the west edge of original farmhouse footprint

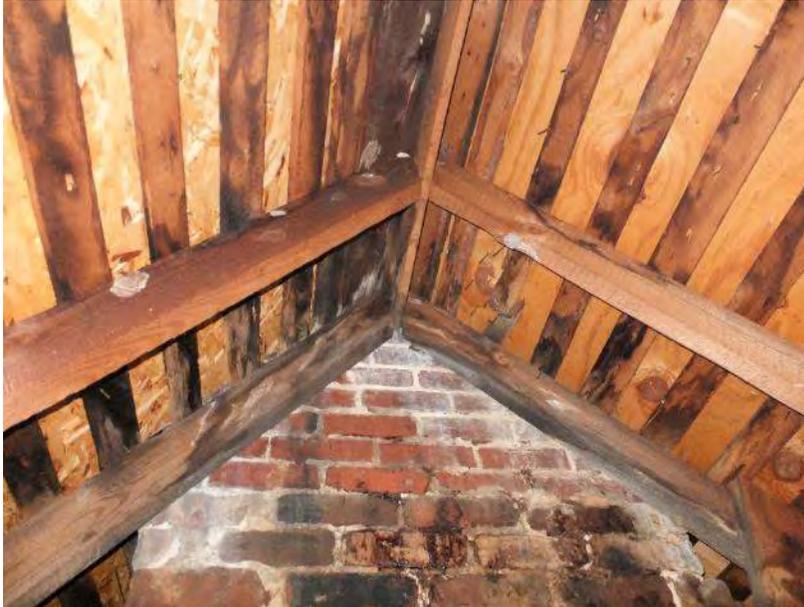
Water stains are present on wood sheathing and roof framing members adjacent to the chimney as well as several other isolated areas of the roof framing (Figure 28). Despite the staining, the roof framing appears to be in fair condition.

Figure 28. Staining in original roof wood framing adjacent to the chimney. Note the two types of brick indicating that the chimney may have been extended at one point.

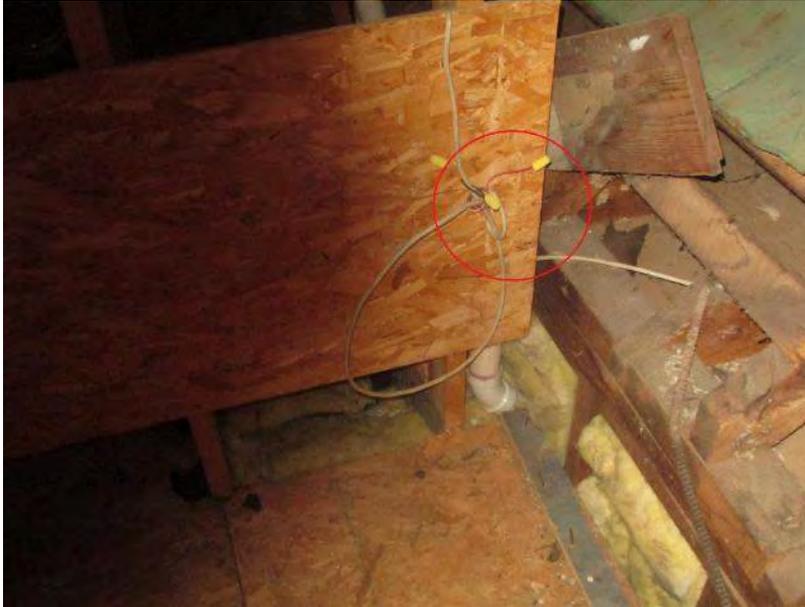
Figure 29. Unsecured wires in the attic. Photo courtesy of MBP.

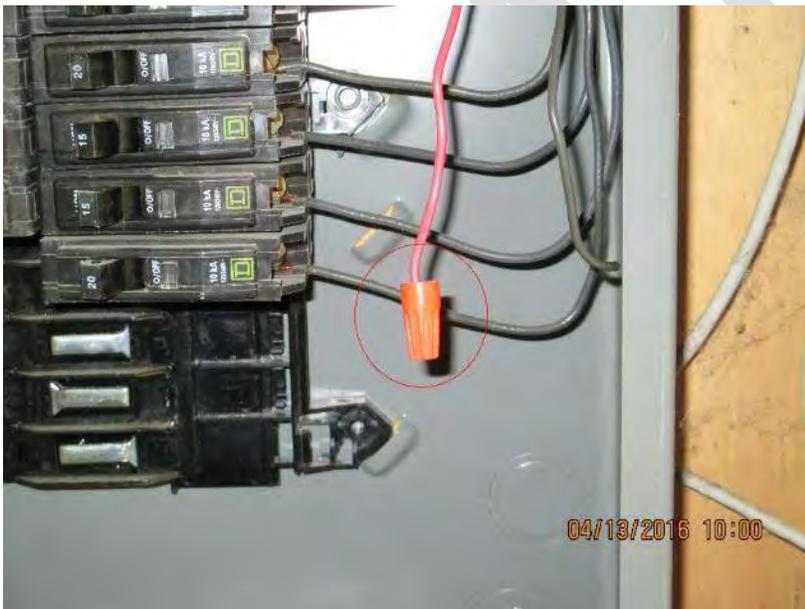
Figure 30. Electrical wire that was improperly terminated. MBP installed the wire nut. Photo courtesy of MBP.

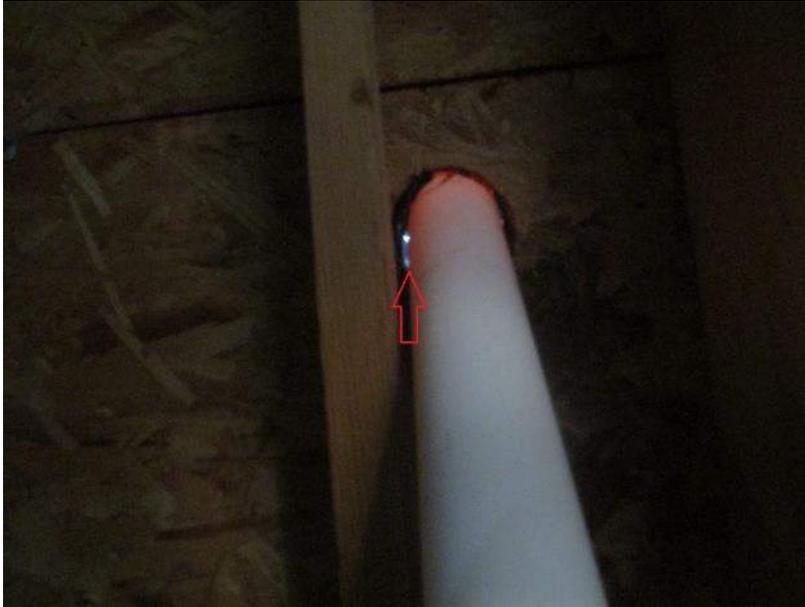
Figure 31. Daylight visible in attic around plumbing vent. Photo courtesy of MBP.

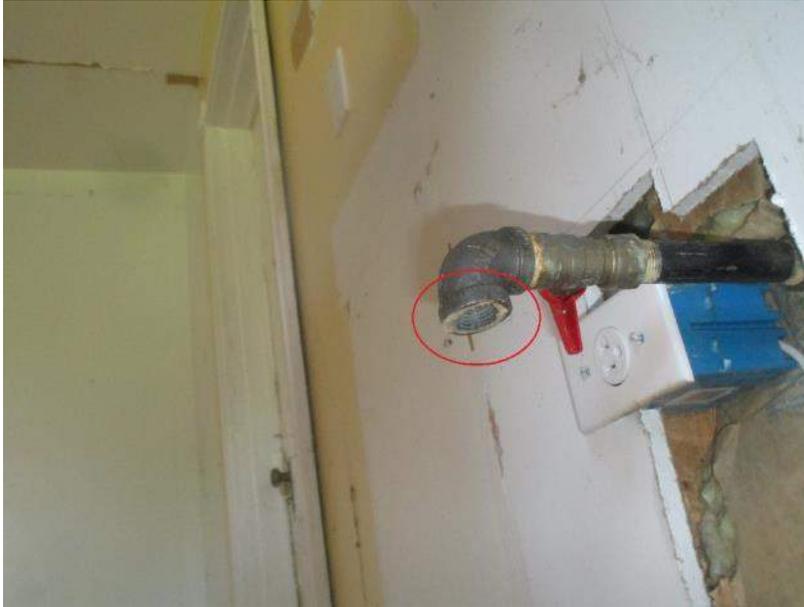
Figure 32. Gas piping improperly terminated in the kitchen. Photo courtesy of MBP.

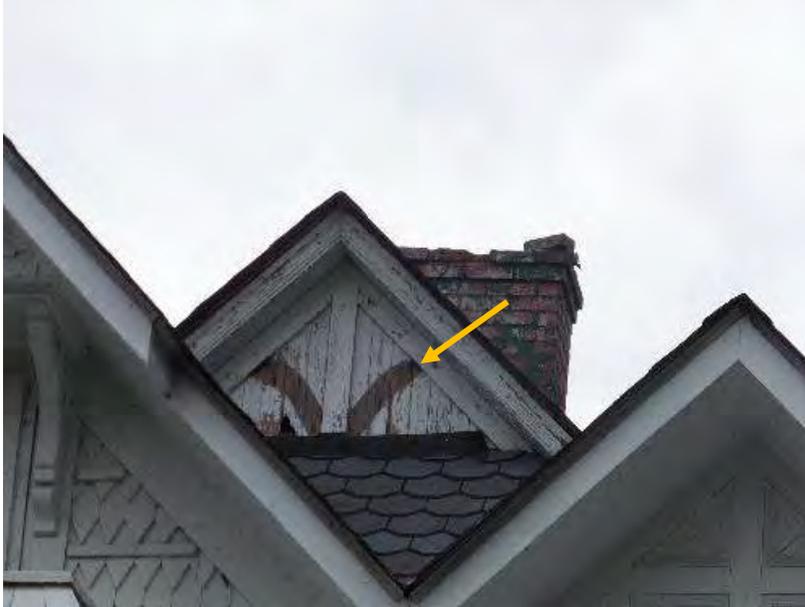
Figure 33. Deteriorated paint with evidence of previous decorative trusses at the secondary gable.

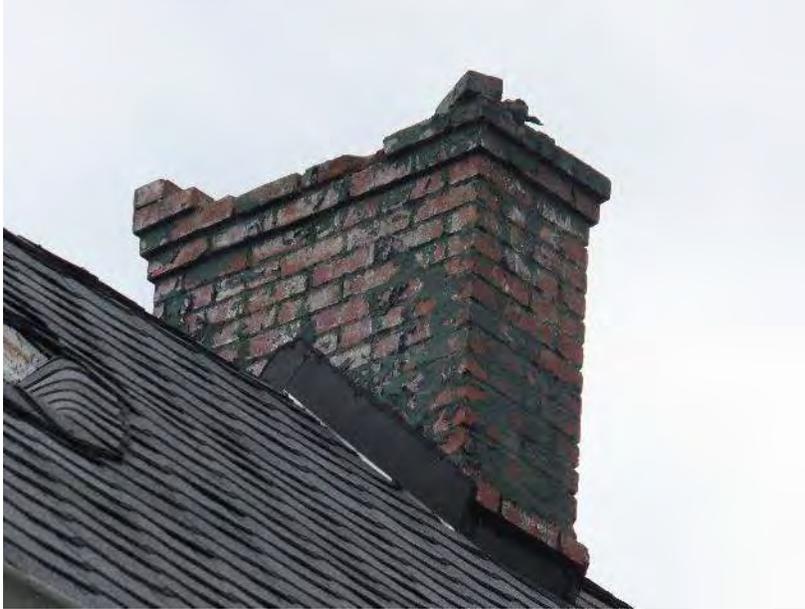
Figure 35. Missing and loose bricks at the chimney.

- Re-secure or replace door handle at the non-historic door of the Kitchen (104) on the west facade.
- Engage a local chimney inspector to inspect the interior of the firebox and chimney. Do not use chimney until inspection and any recommended repairs have been completed. Once chimney repairs have been completed as recommended by the chimney inspector (if any), repoint 100% of the exposed chimney mortar as it is at the end of its life cycle, rebuild and reset the upper courses of the chimney, and install chimney cap. (Figure 35)

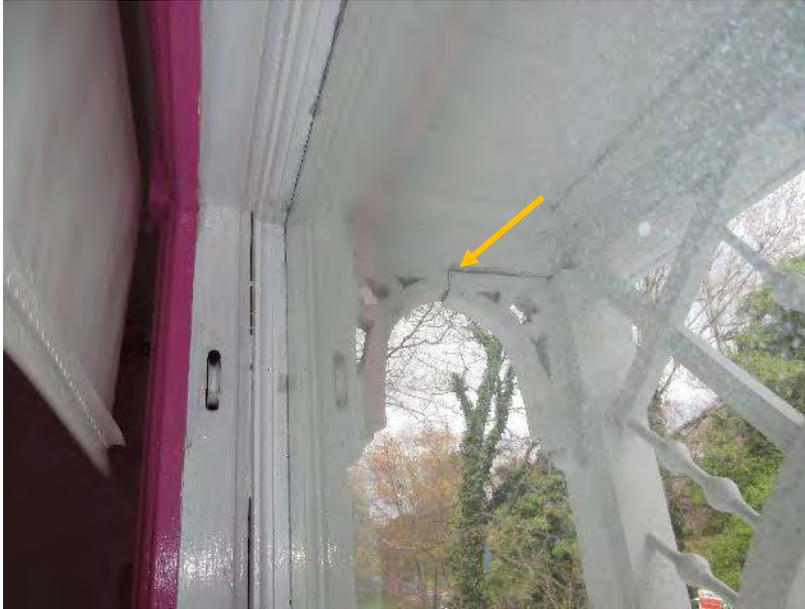
Figure 38. Cracked decorative element at the Juliet balcony.

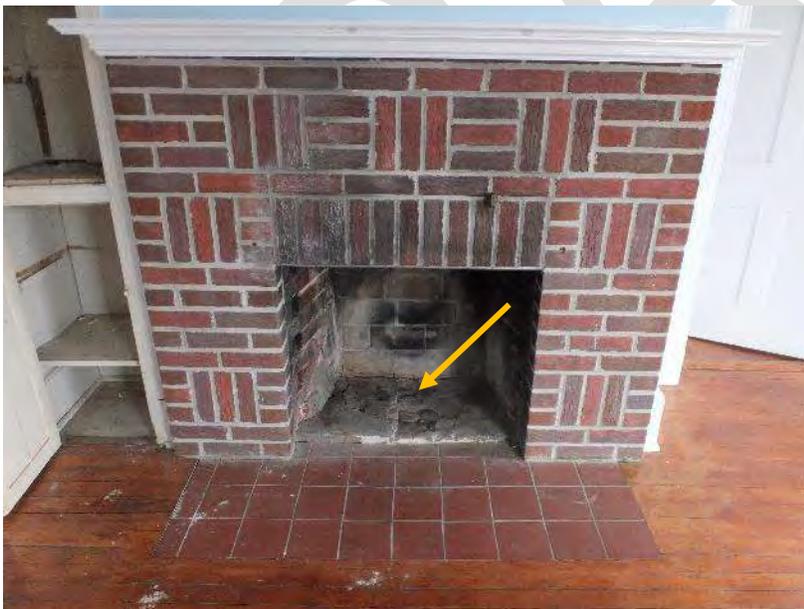
Figure 39. Cracked firebox in the fireplace of Room 102.

- Monitor cracks in concrete floor slab at east wall and near mechanical room. Route and seal if no movement is observed.
- Engage a local chimney inspector to inspect firebox and chimney. Do not use chimney until inspection and any recommended repairs have been completed. (Figure 39)

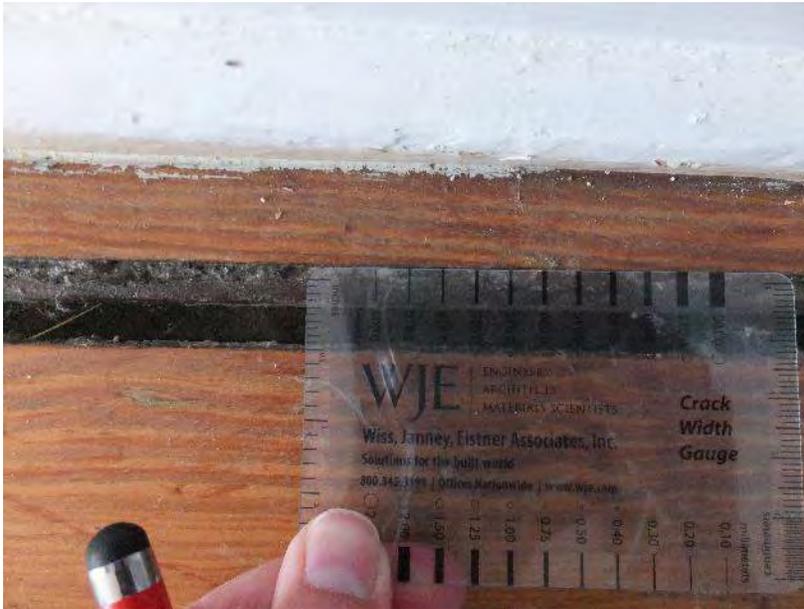
Figure 41. Split in flooring at the south wall of Room 102.

- Inspect stained wood flooring for any soft wood that should be repaired. The staining typically occurring near radiators. As such, the radiators may need to be removed to fully inspect and perform any repairs and cleaning.
- Repair crack in wood flooring along south wall in the Formal Dining Room (102) with similar wood species and finish. (Figure 41)

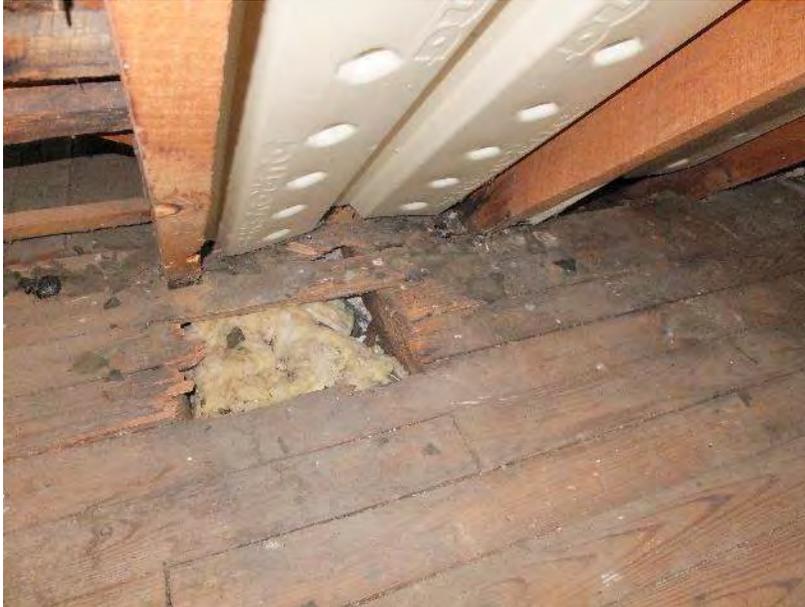
Figure 42. Deteriorated wood flooring in the attic.

- Repair any cracked tiles and tile grout in the Bathroom (105).
- Repair crack in baseboard between stair treads in rear hall stairs.
- Remove soft and damaged wood at the hole in the attic floor and repair. (Figure 42)

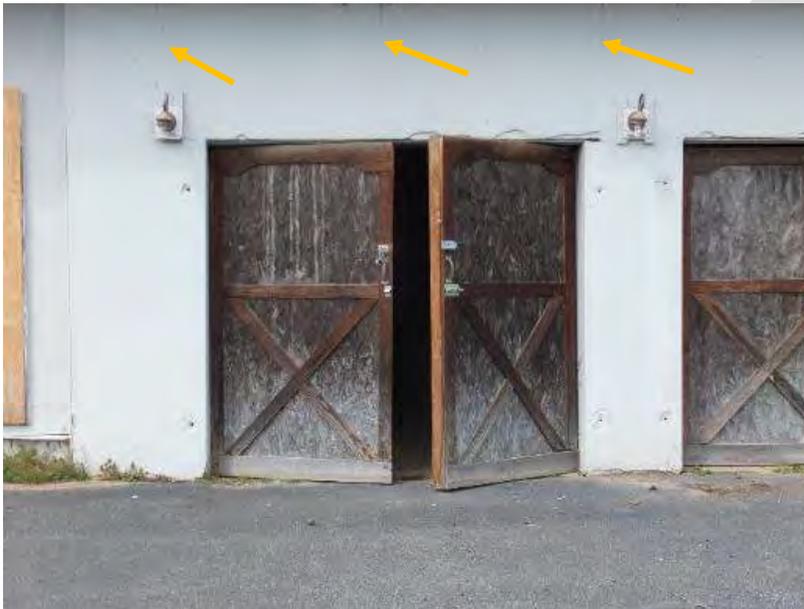
Figure 45. Cracking in the first floor parge coating of the garage.

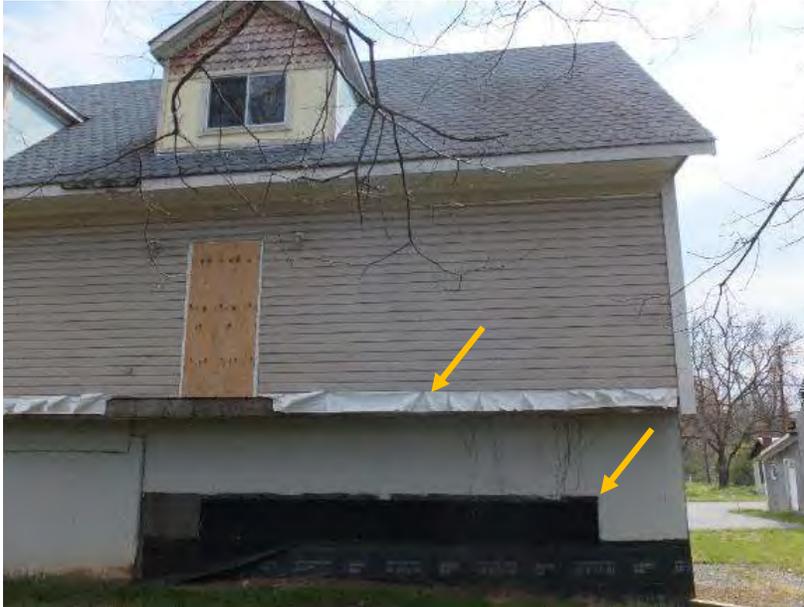
Figure 46. Exposed roof underlayment (black) and building paper (white).

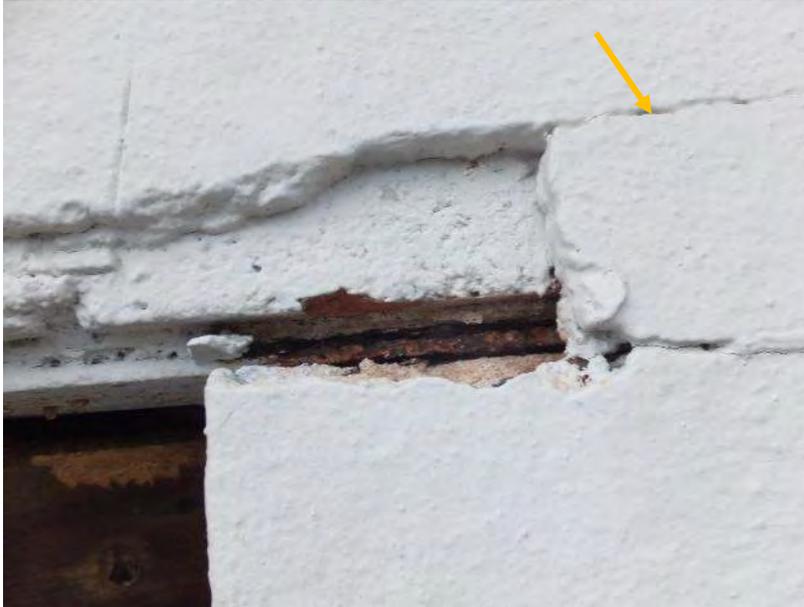
Figure 48. Corroded steel lintel and adjacent cracking in parge coat (orange arrow).

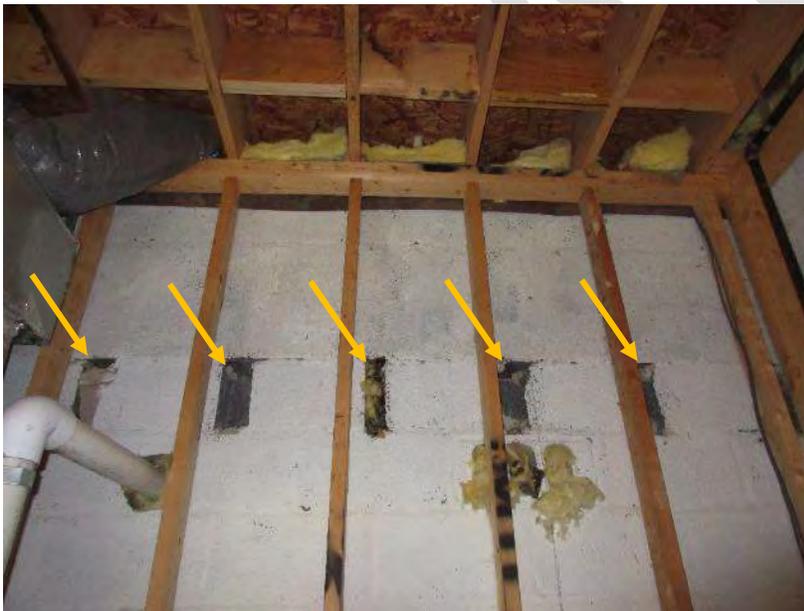
Figure 49. Joists have been removed leaving behind pockets in the CMU walls.

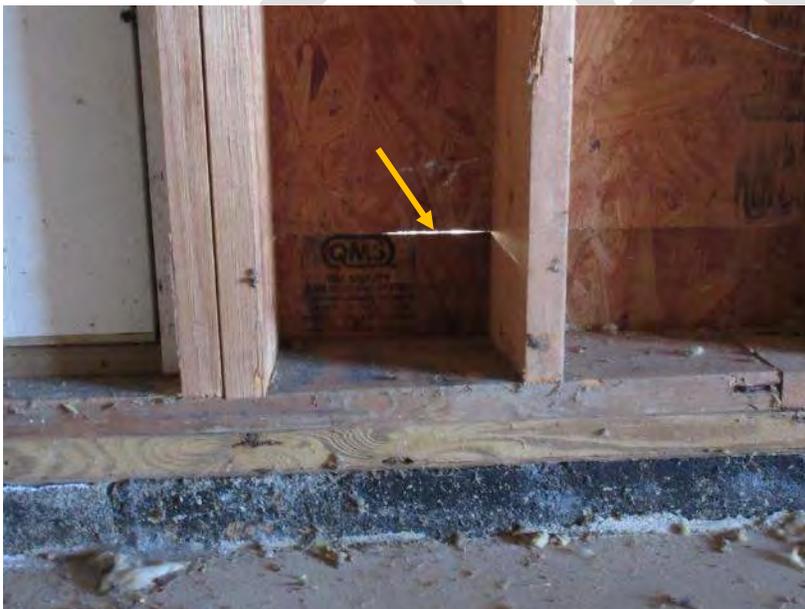
The south portion of the first level features a concrete slab on grade, which is in good condition, and a combination of CMU and modern wood framed walls. Painted plywood is installed on the exterior of the walls. The plywood is deteriorated at isolated locations and daylight can be seen on the interior between the bottom of the plywood and the wall framing. (Figure 51)

Figure 51. Daylight is visible between exterior wall sheathing panels in south portion of the first level.

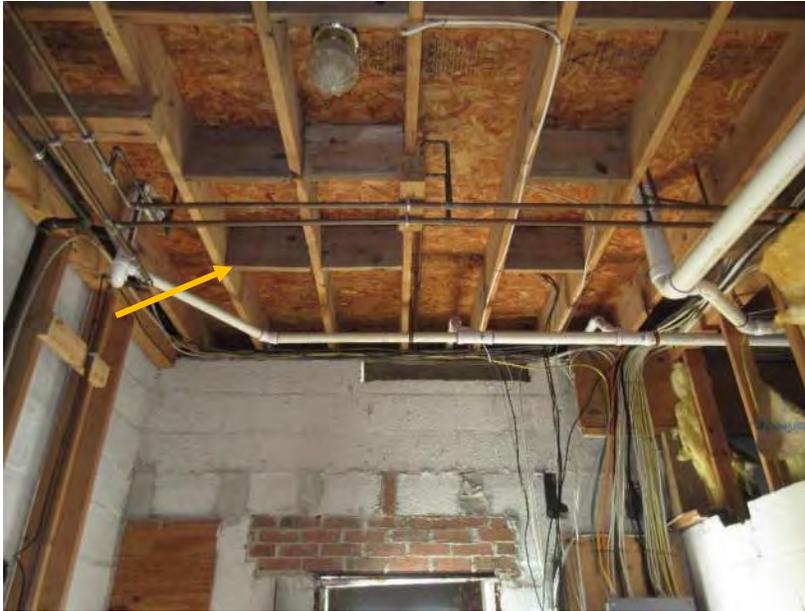
between wood joists (Figure 52) and gaps are present between the ends of the wood bridging and the joists at multiple locations. (Figure 53) Since the interior of the second level was not accessible during our site visits, a review of the interior space should be completed to determine if there is distress resulting from lifting a portion of the house similar to what was observed at the farmhouse. No structural analysis was performed as a part of our evaluation as it is outside of our current scope. In general, the load distribution is difficult to follow as a result of the different additions to the structure. Connections between the first level and second level along with the framing should be further documented and evaluated.

Figure 52. Wood bridging is sporadically installed between joists.

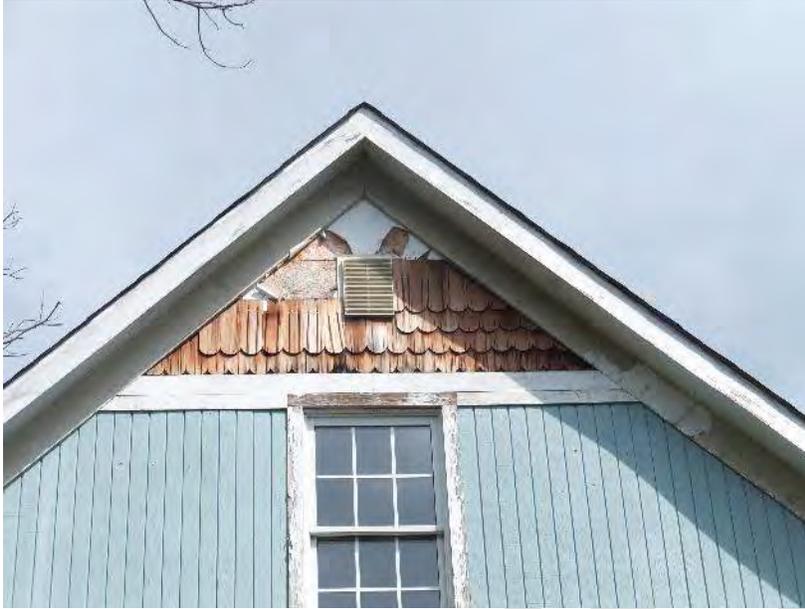
Figure 55. Missing shingles and deteriorated paint.

- Inspect wood shingles at dormer gables for deterioration and repair. Install new patterned wood shingles at south side gable to match existing and half-timbered decorative truss following paint outline (if possible). Paint. (Figure 55)

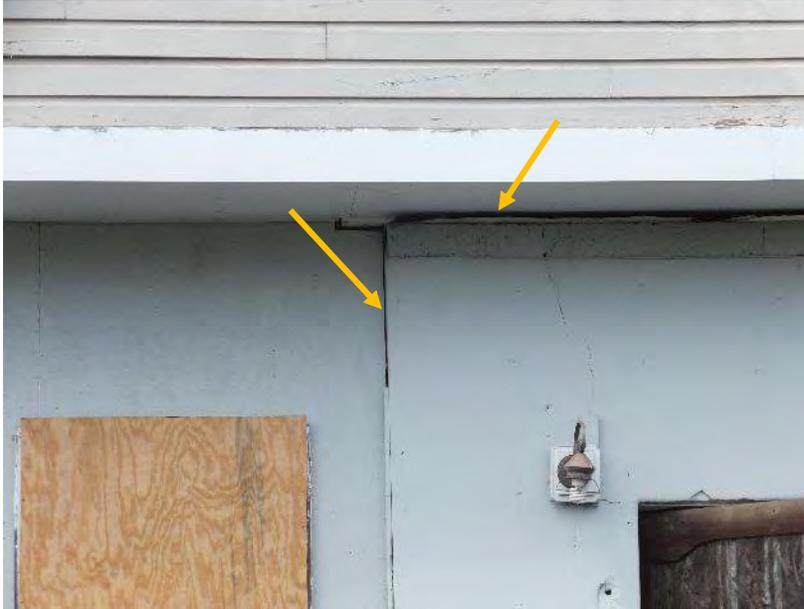
Figure 56. Gaps between the first and second floor and at the south addition.

- Replace broken glass at dormer window.
- Inspect area for any deterioration caused by missing wood under dormer and repair (as appropriate). Install new wood and paint.
- Remove miscellaneous boards and repair/paint underneath wood members unless archival documentation reveals the historic use of these elements.
- Install sealant at gap between the first and second floor and at the east facade of the south addition. If gap is too large for a proper sealant profile (generally less than 1 inch is desirable), infill gap with wood and paint. (Figure 56)

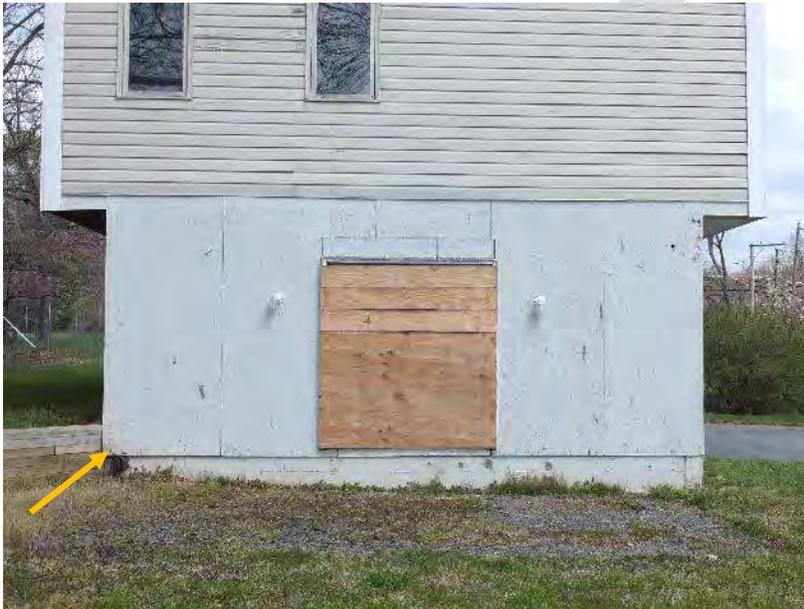
Figure 57. Exterior wood sheathing used for the southern addition to the garage.

- Roof underlayment was placed over the wood at the southwest first floor and has been exposed. This particular underlayment should not be exposed to UV for longer than 6 months.²² Remove and inspect the interior for indication on why this may have been installed. Evaluate installation of new WRB and exterior finish to protect the WRB.
- Re-install lid to cover brick pit.
- Temporarily fill penetrations through the building's first floor walls to reduce water infiltration. Future use of this building will dictate need of re-using these penetrations.
- Re-secure or replace loose non-historic railings on north facade.
- Remove exposed wood sheathing at first floor south facade and replace with permanent siding. (Figure 57)

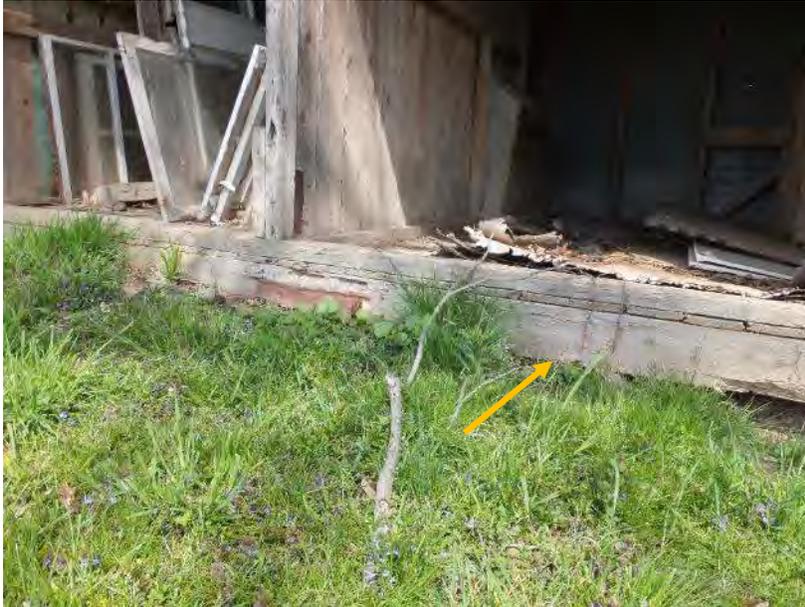
Figure 59. Timber sill bears directly on the ground.

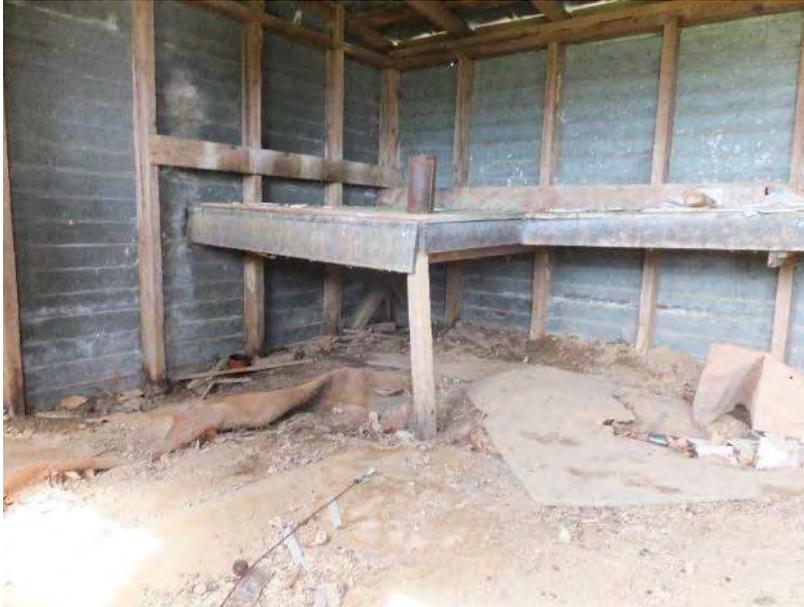
Figure 61. Carpet installed on the floor of the west side of the shed conceals the substrate below.

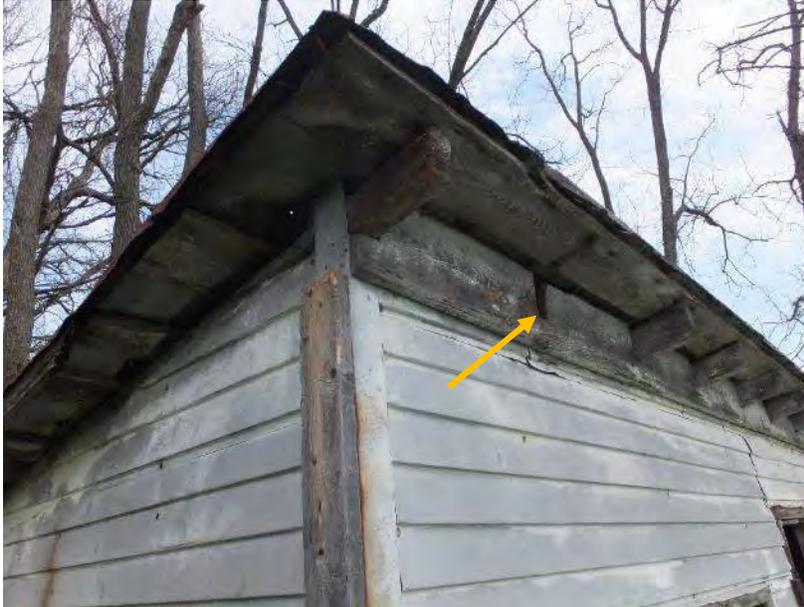
Figure 62. Rafter no longer bears on header.

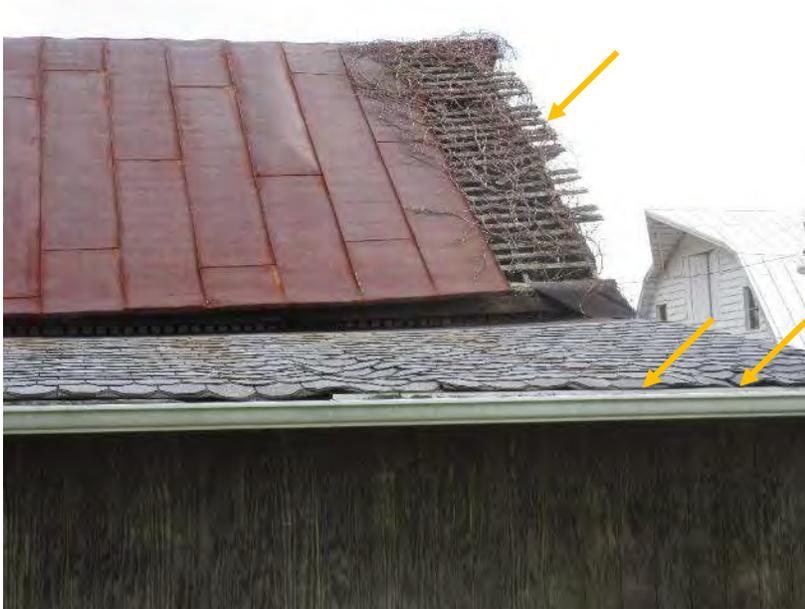
Figure 65. Missing metal roof section along with evidence of heavy vegetation. Note sagging asphalt shingles between rafters on the wing addition.

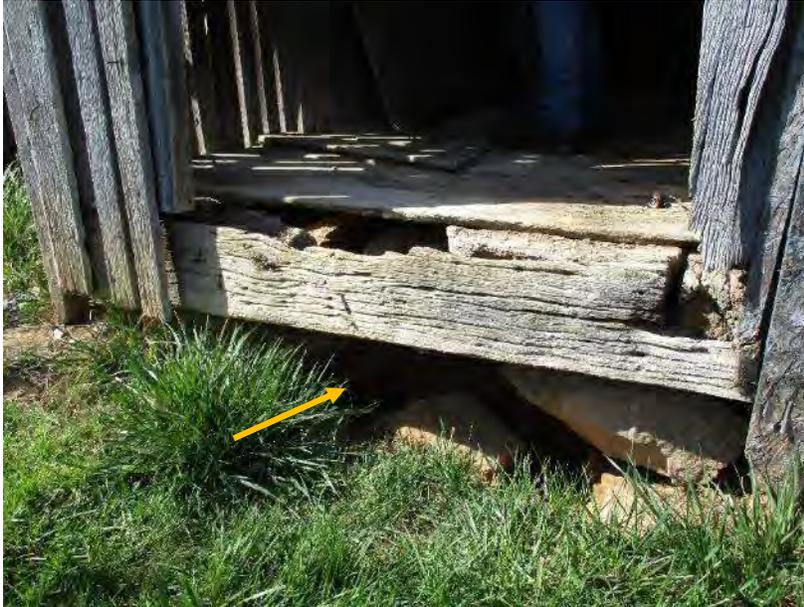
Figure 66. Large gaps are present in the stone foundation.

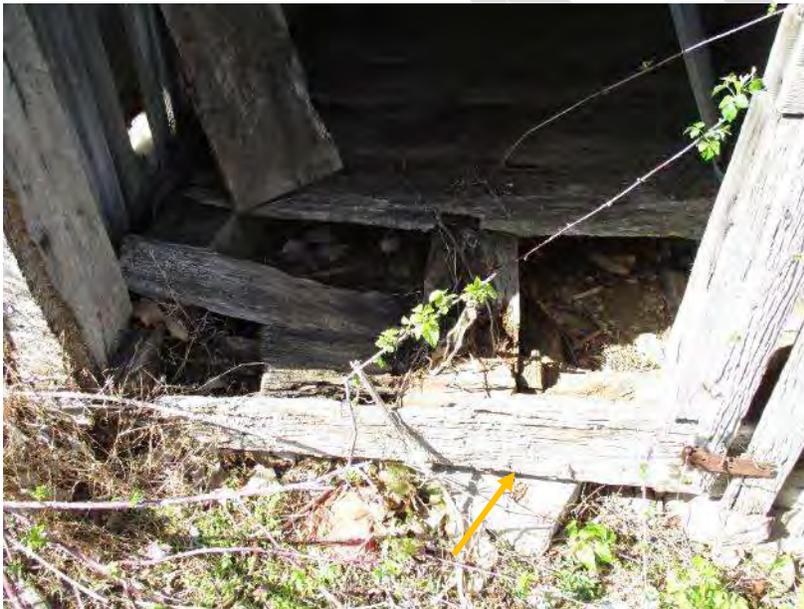
Figure 67. Significantly deteriorated timber sill.

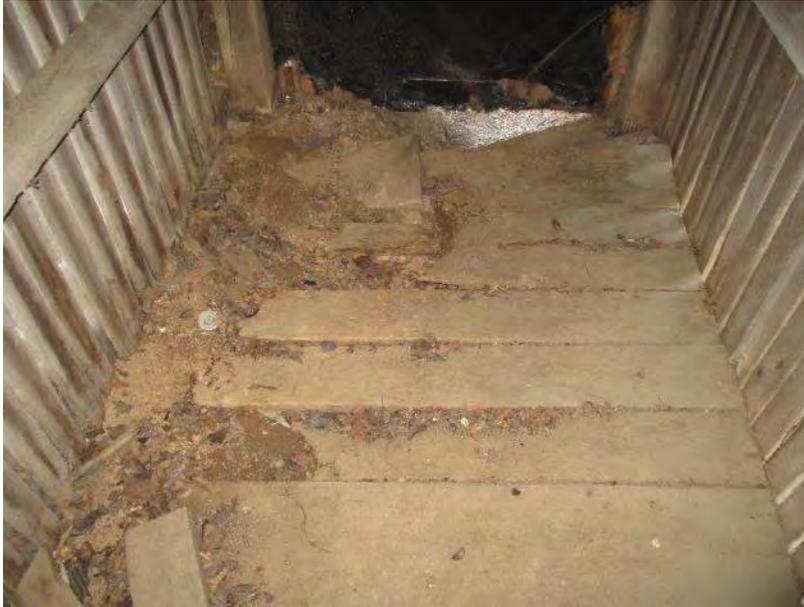
Figure 68. Floor joists and planks are in direct contact with the soil at the west crib.

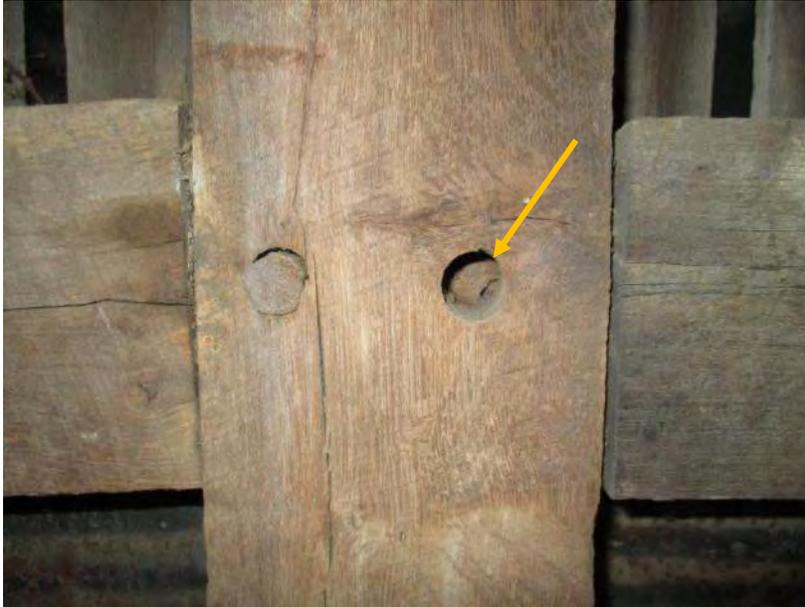
Figure 71. Missing wooden peg at interior connection.
