TURNER FARM
Turner Farm Treatment Report

10609 Georgetown Pike
Great Falls, Virginia 22066

Draft Report
July 8, 2016
WJE No. 2015.3162.2

Prepared for:
Fairfax County Park Authority
12055 Government Center Parkway, Suite 927
Fairfax, Virginia 22035

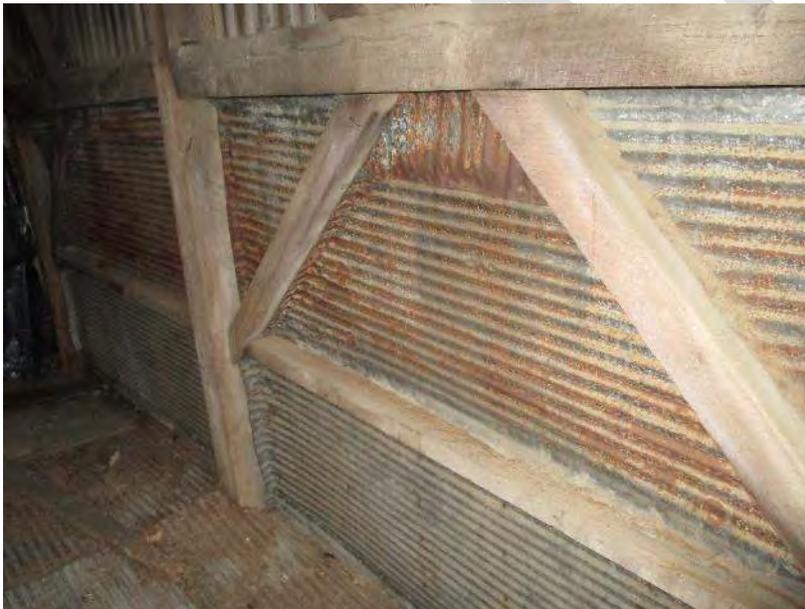
Figure 72. Surface corrosion present on corrugated sheet metal inside of east crib.

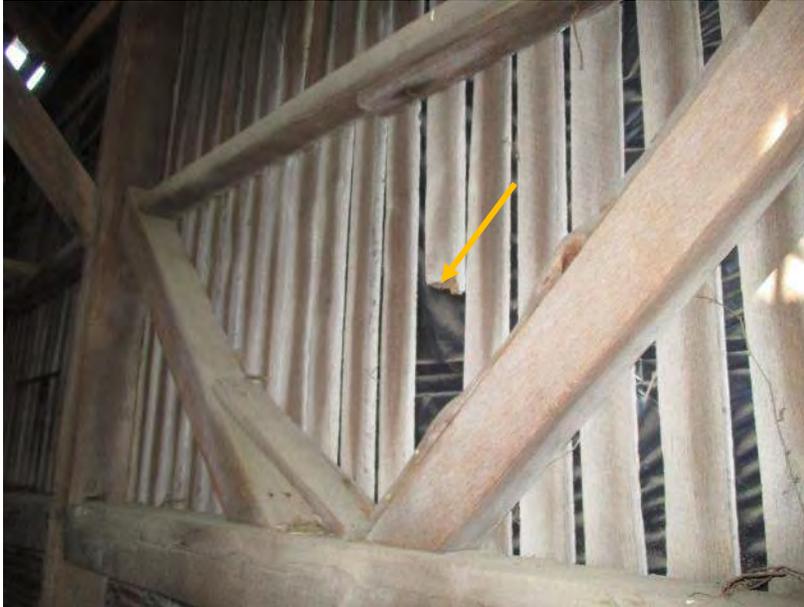
Figure 75. Fractured vertical wood slat.

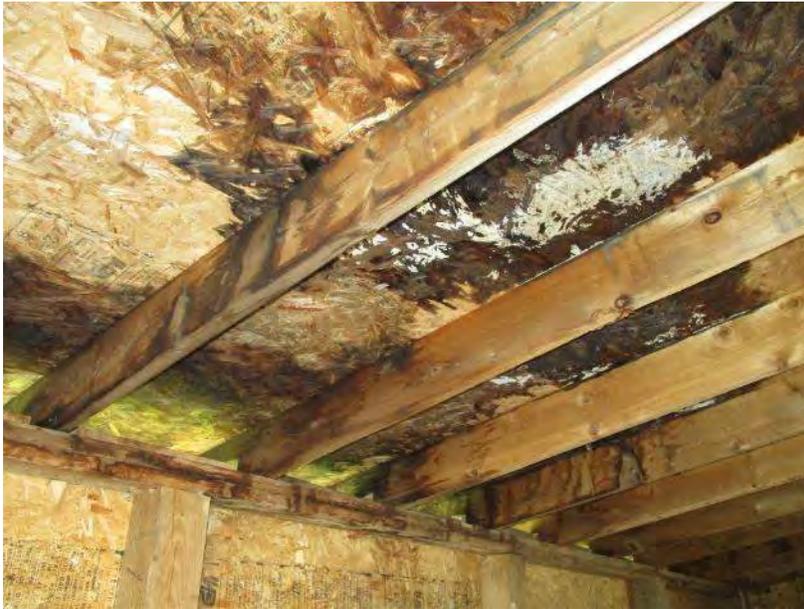
Figure 77. Staining, rot, and biological growth are visible on the underside of the plywood roof sheathing on the west lean-to addition.

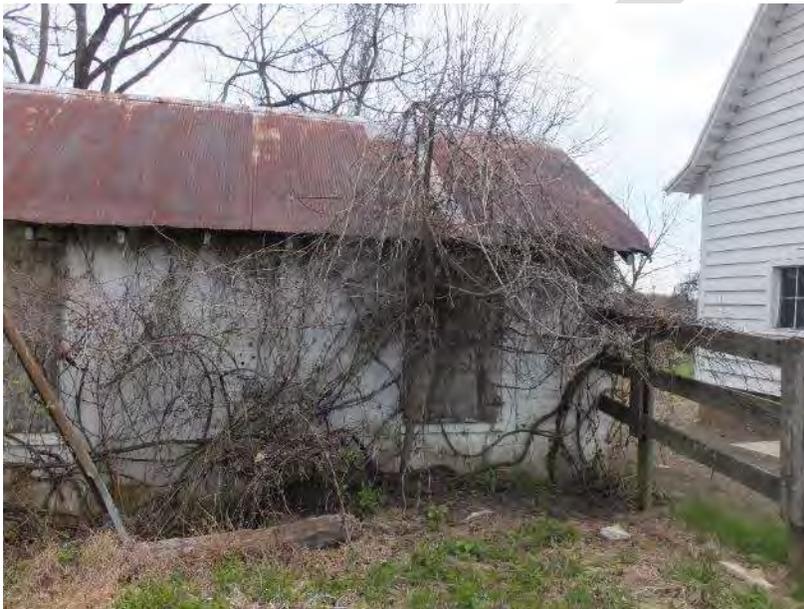
Figure 79. Heavy vegetation at the milk house.

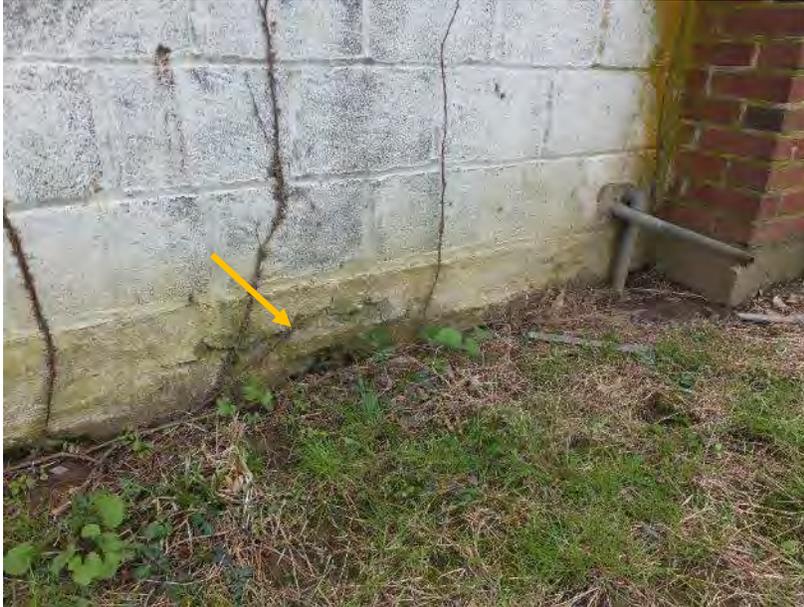
Figure 80. A small spall is present in the concrete foundation wall.

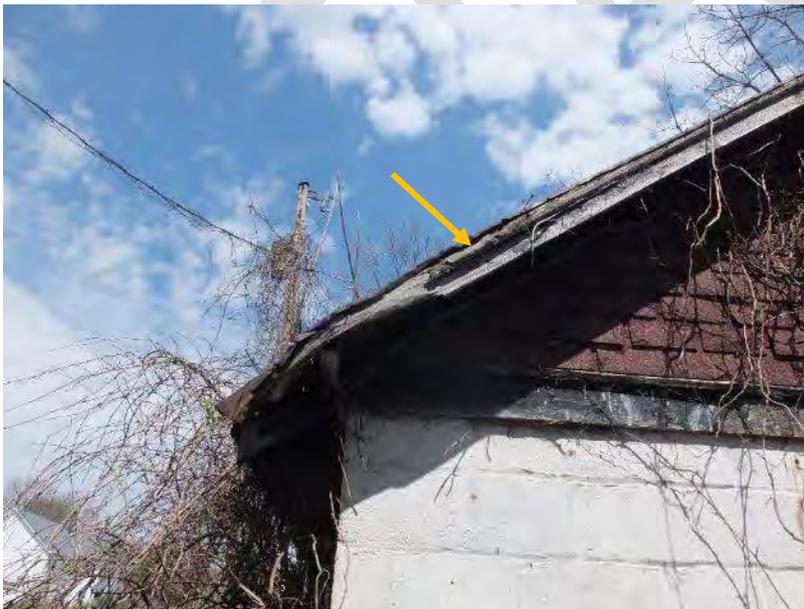
Figure 81. Exposed wood framing is in poor condition.

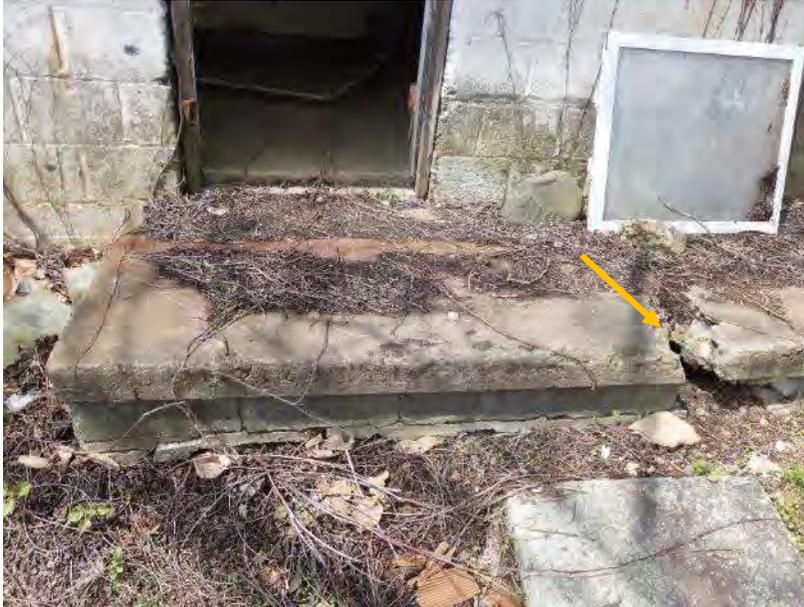
Figure 82. Large crack through concrete landing and deterioration of the supporting CMU.

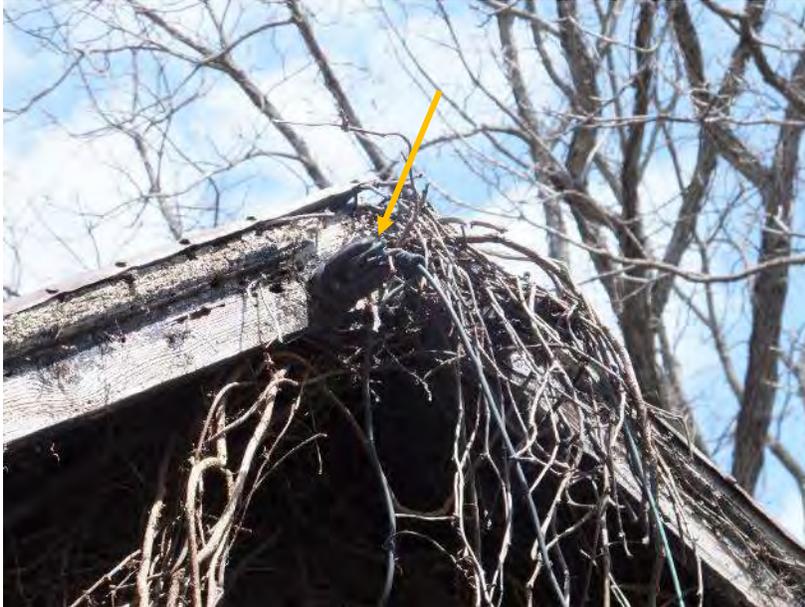
Figure 83. Lightning protection cable extended from the roof. Note heavy vegetation and damage to the fascia board.

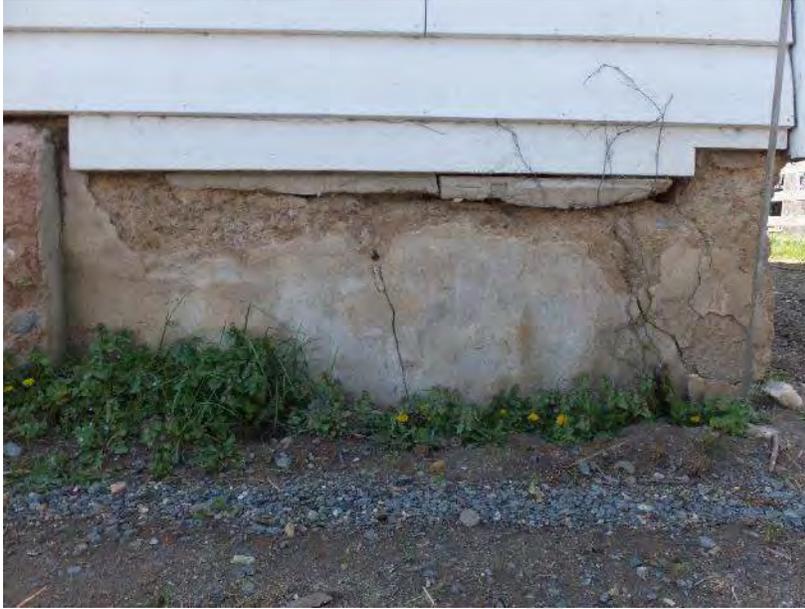
Figure 86. Typical condition of foundation with deteriorated parge coat and concrete spalls.

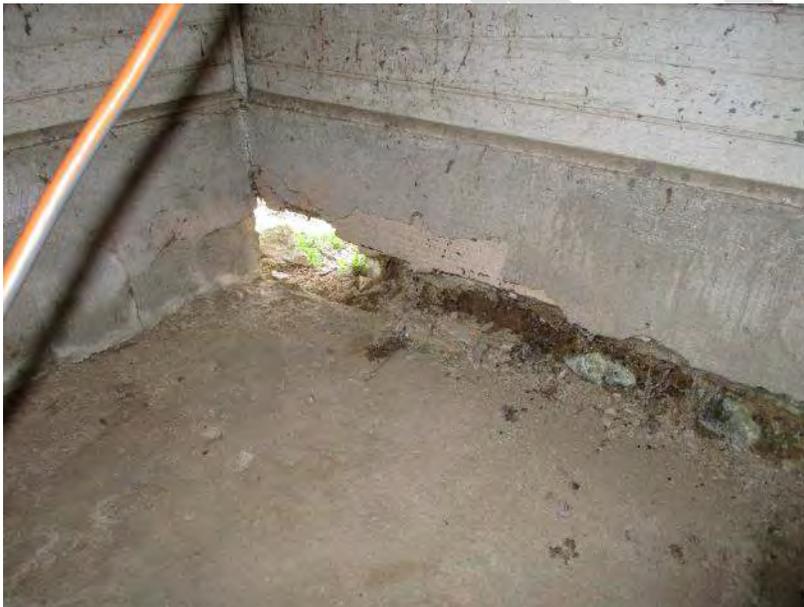
Figure 89. Deteriorated finish at base of interior walls.

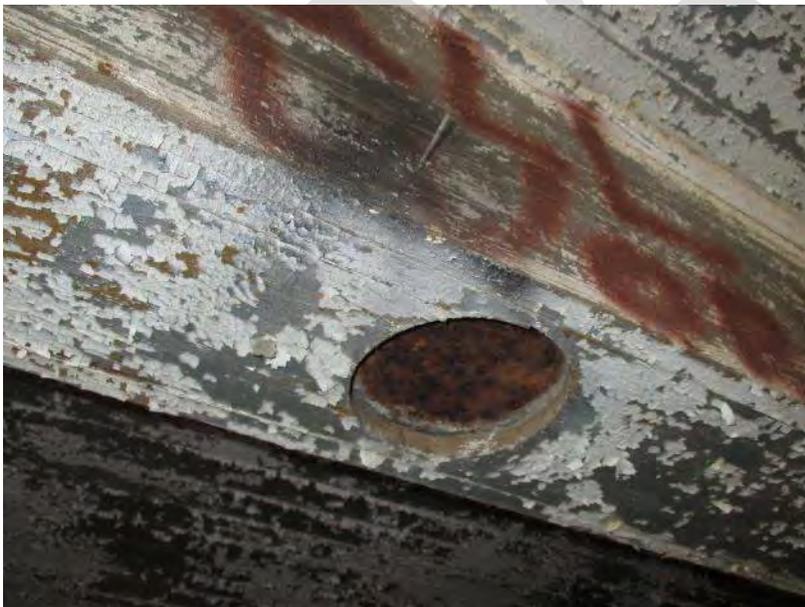
Figure 91. Missing pipe column.

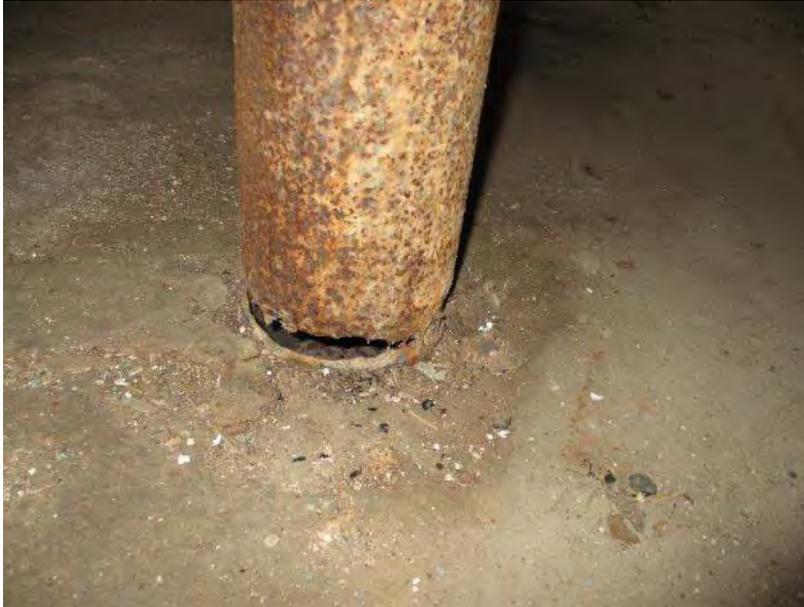
Figure 92. Section loss at base of pipe column.

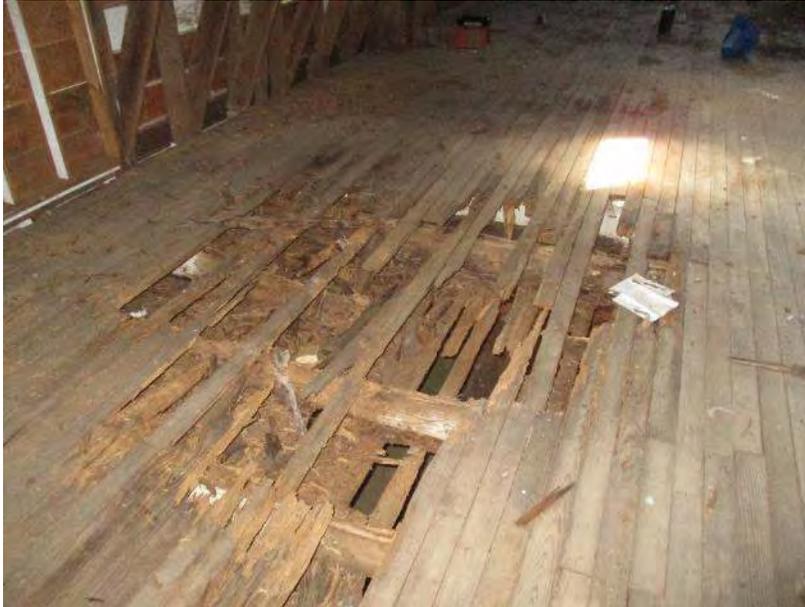
Figure 95. Deterioration of the wood floor boards below the central dormer along the west elevation.

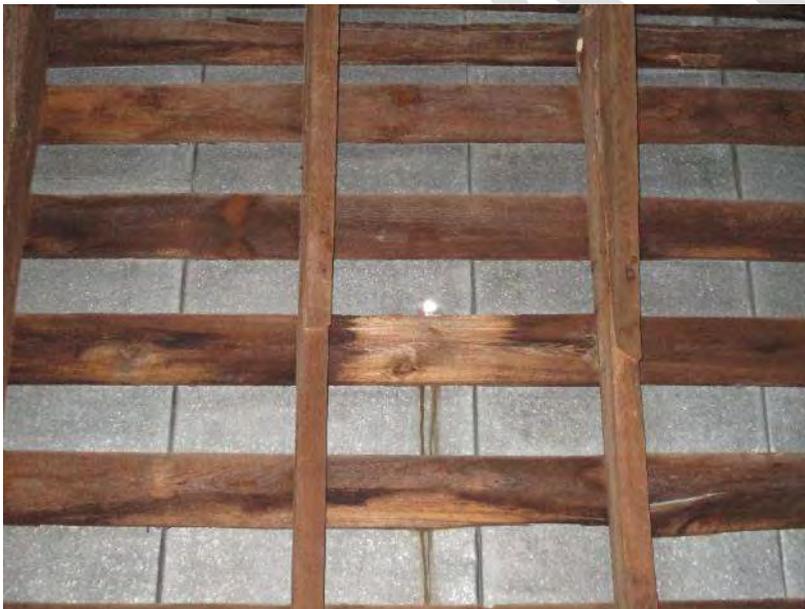
Figure 96. Hole in metal roof with resultant corrosion staining below.

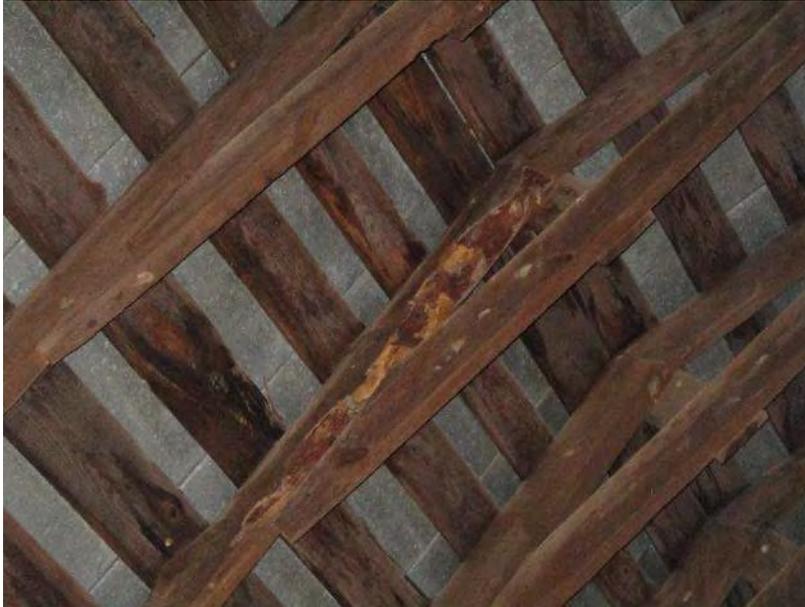
Figure 97. Isolated deterioration at truss framing member.

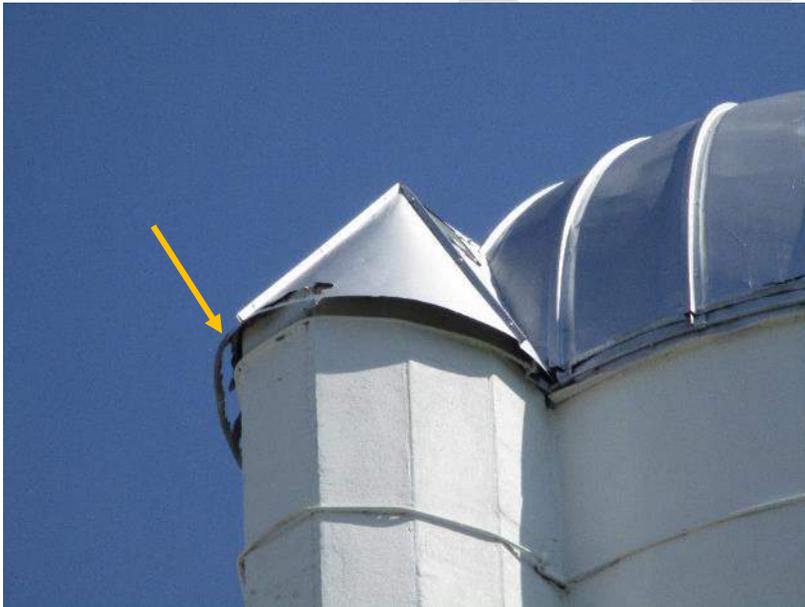
Figure 106. Deteriorated ladder enclosure roof at the silo.
