Massey Building Condition Assessment

Facilities Management Department
March 26, 2010

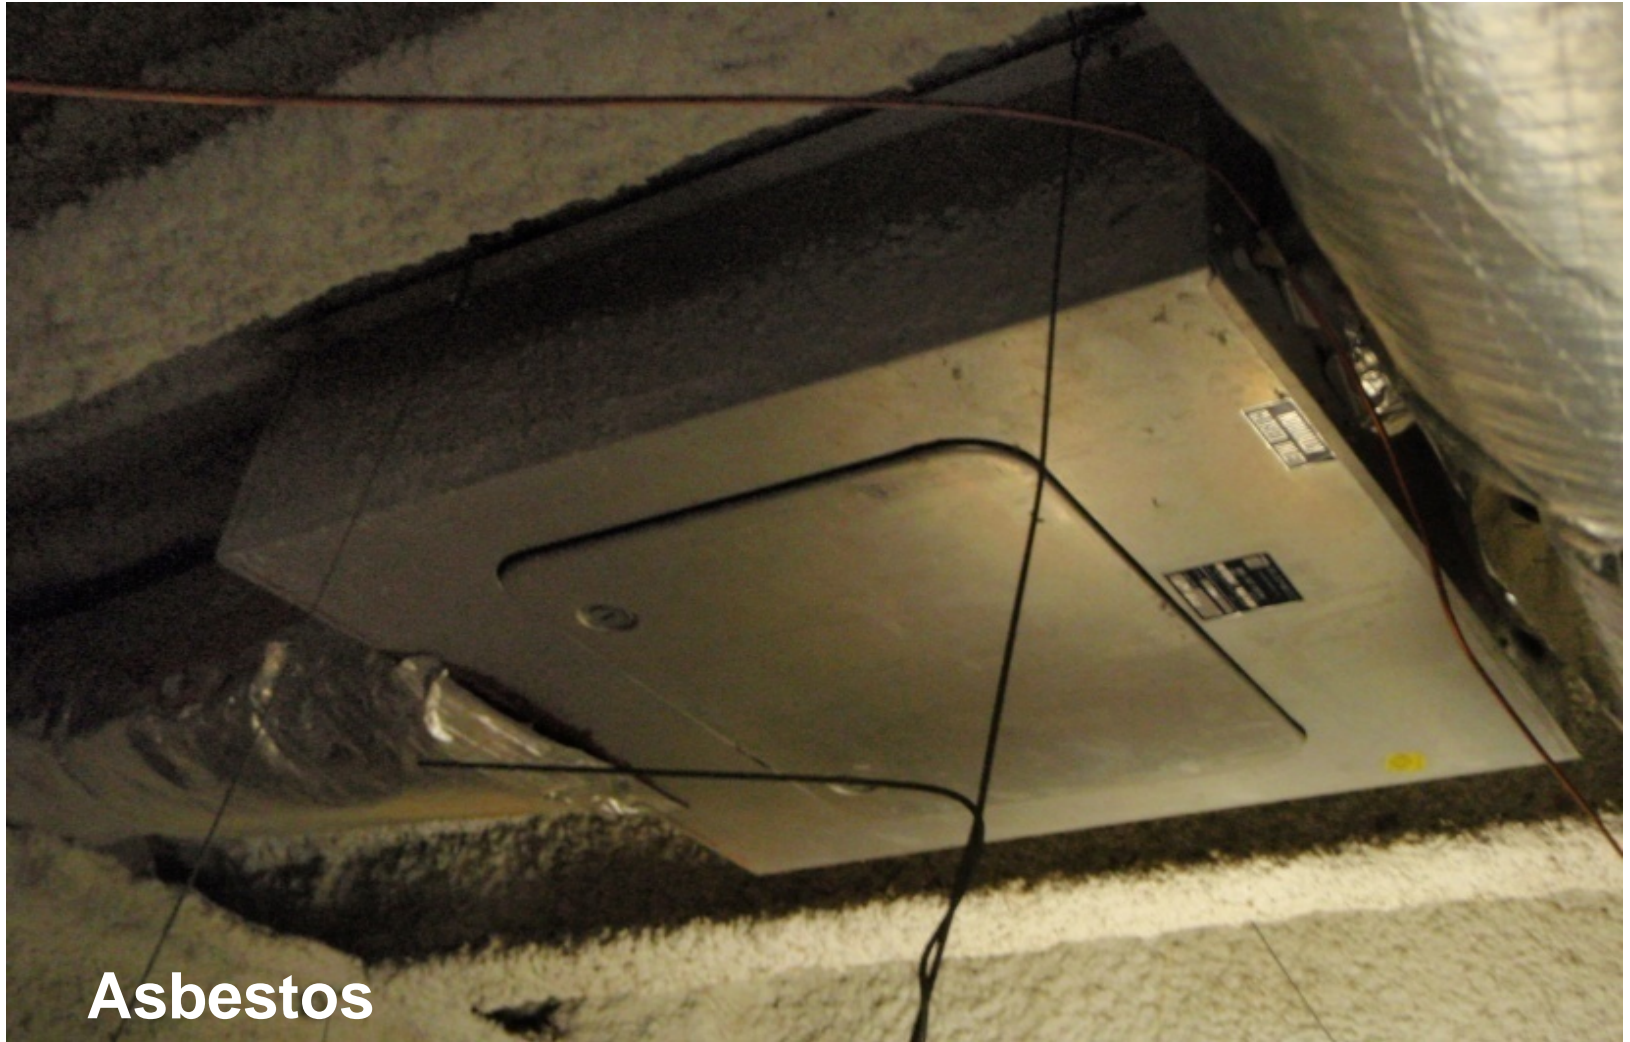
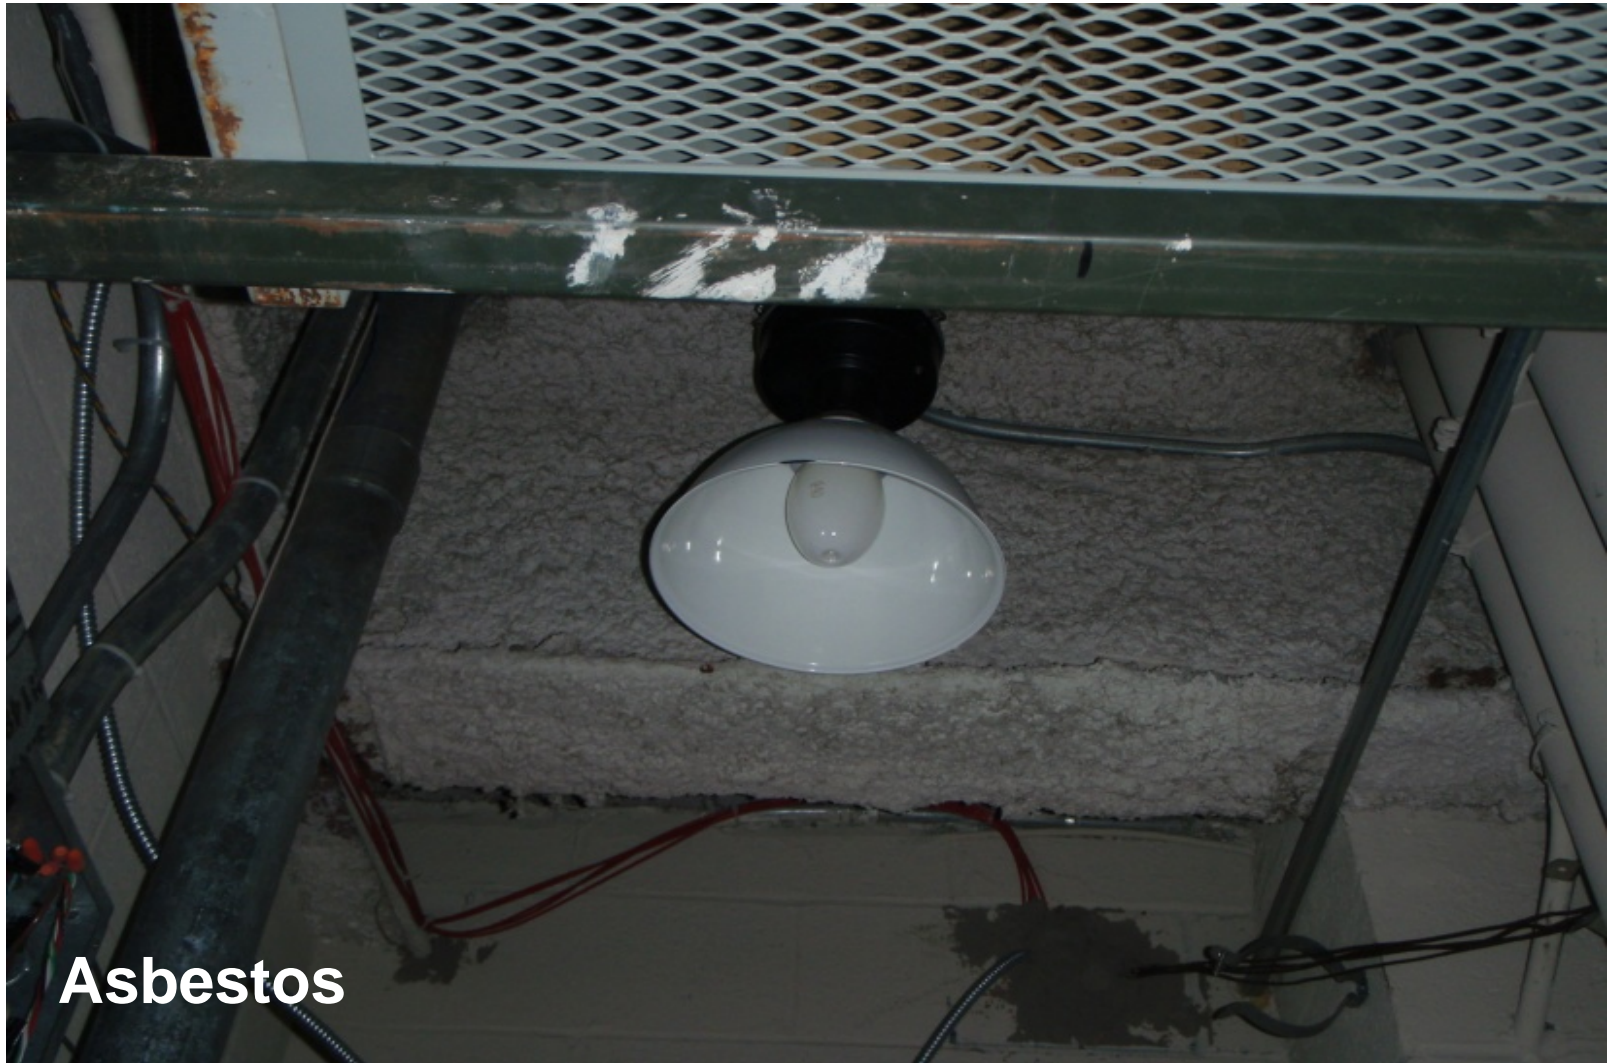
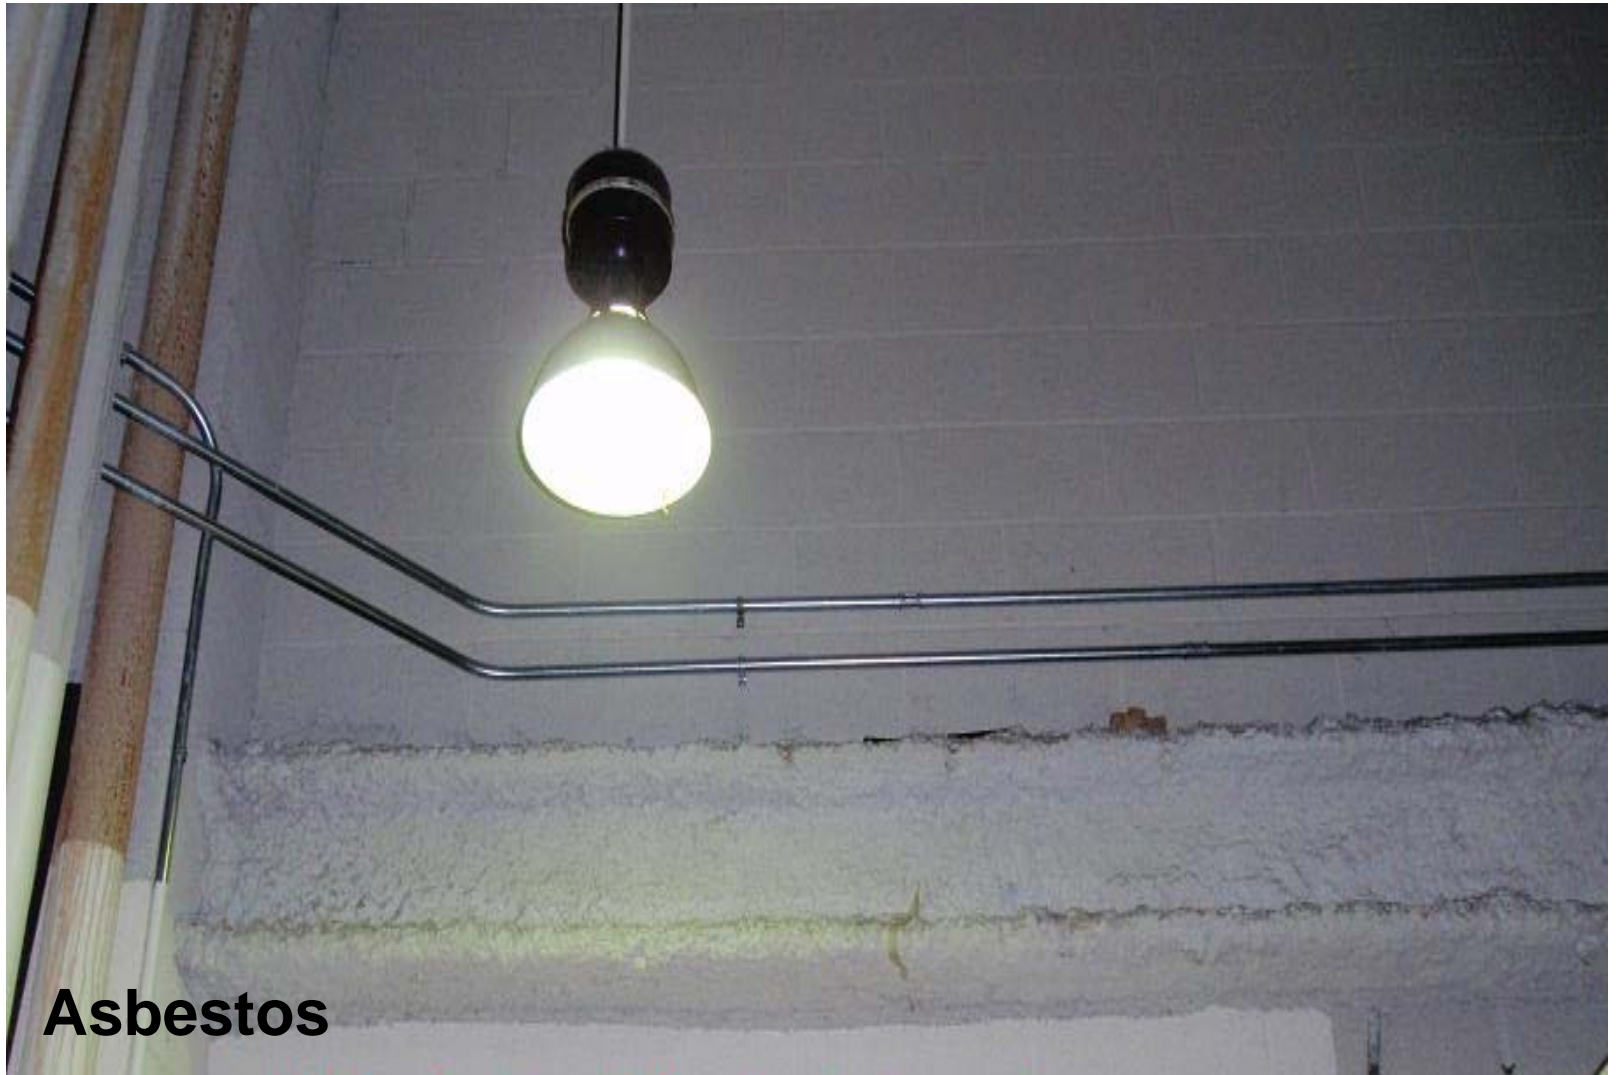
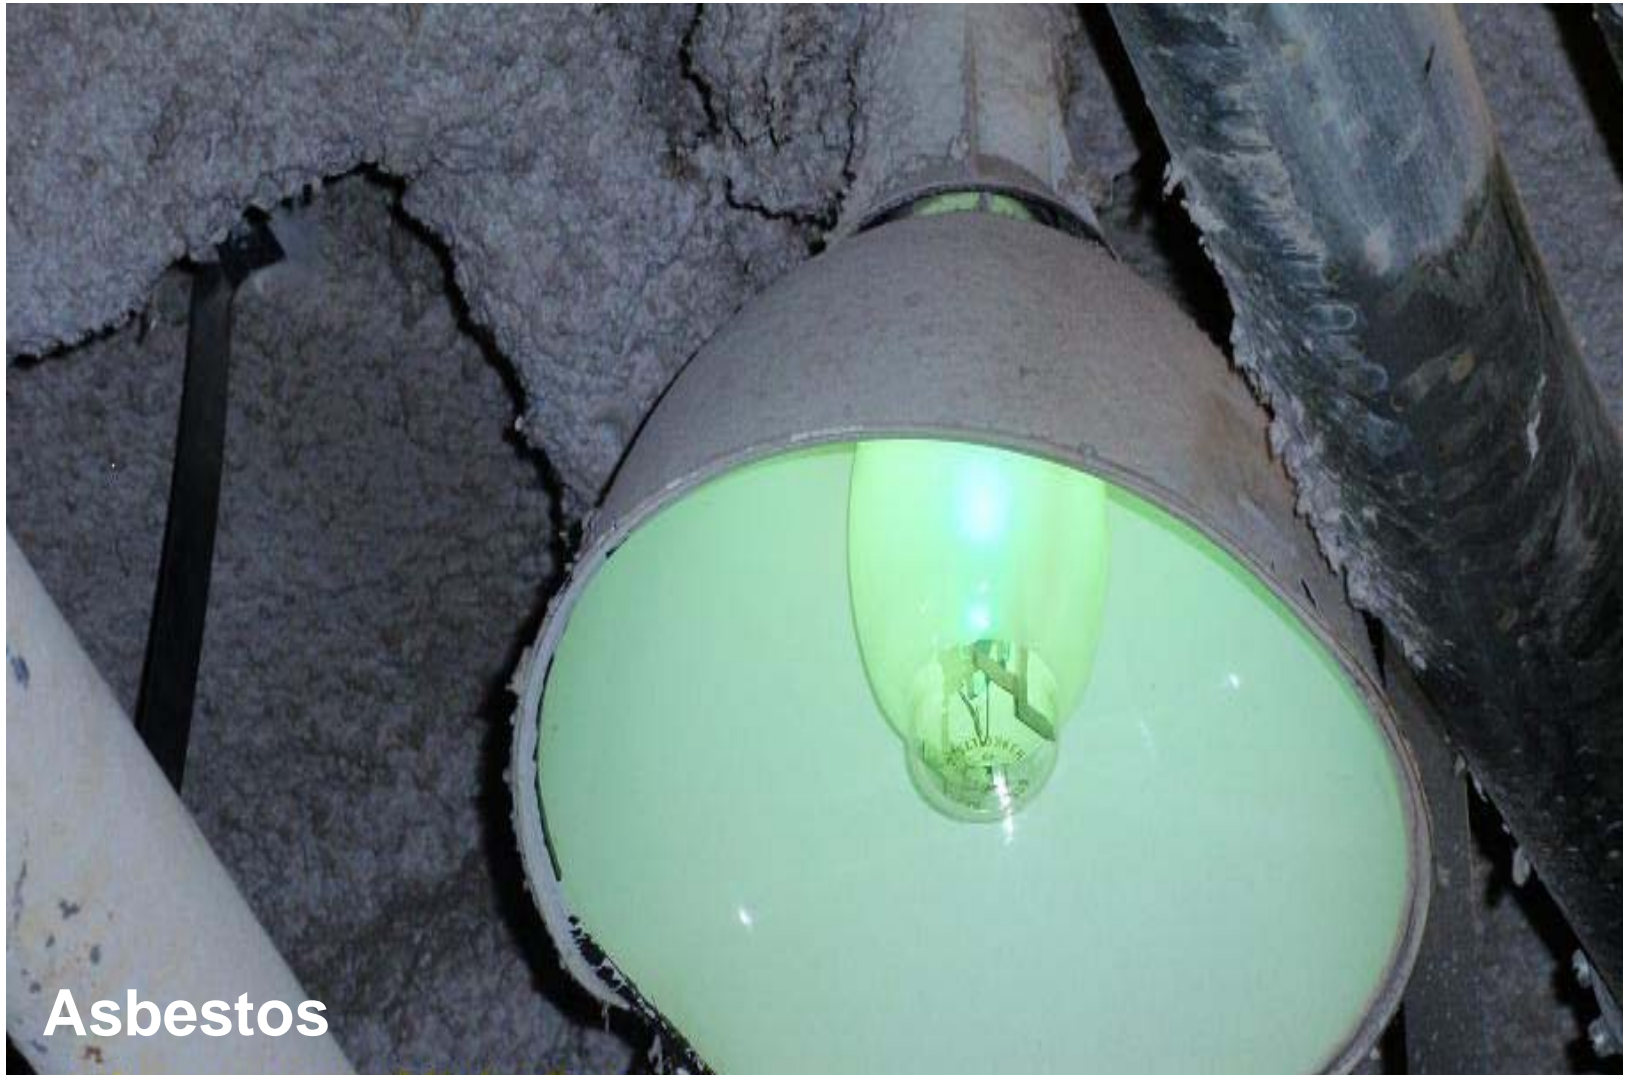
Asbestos

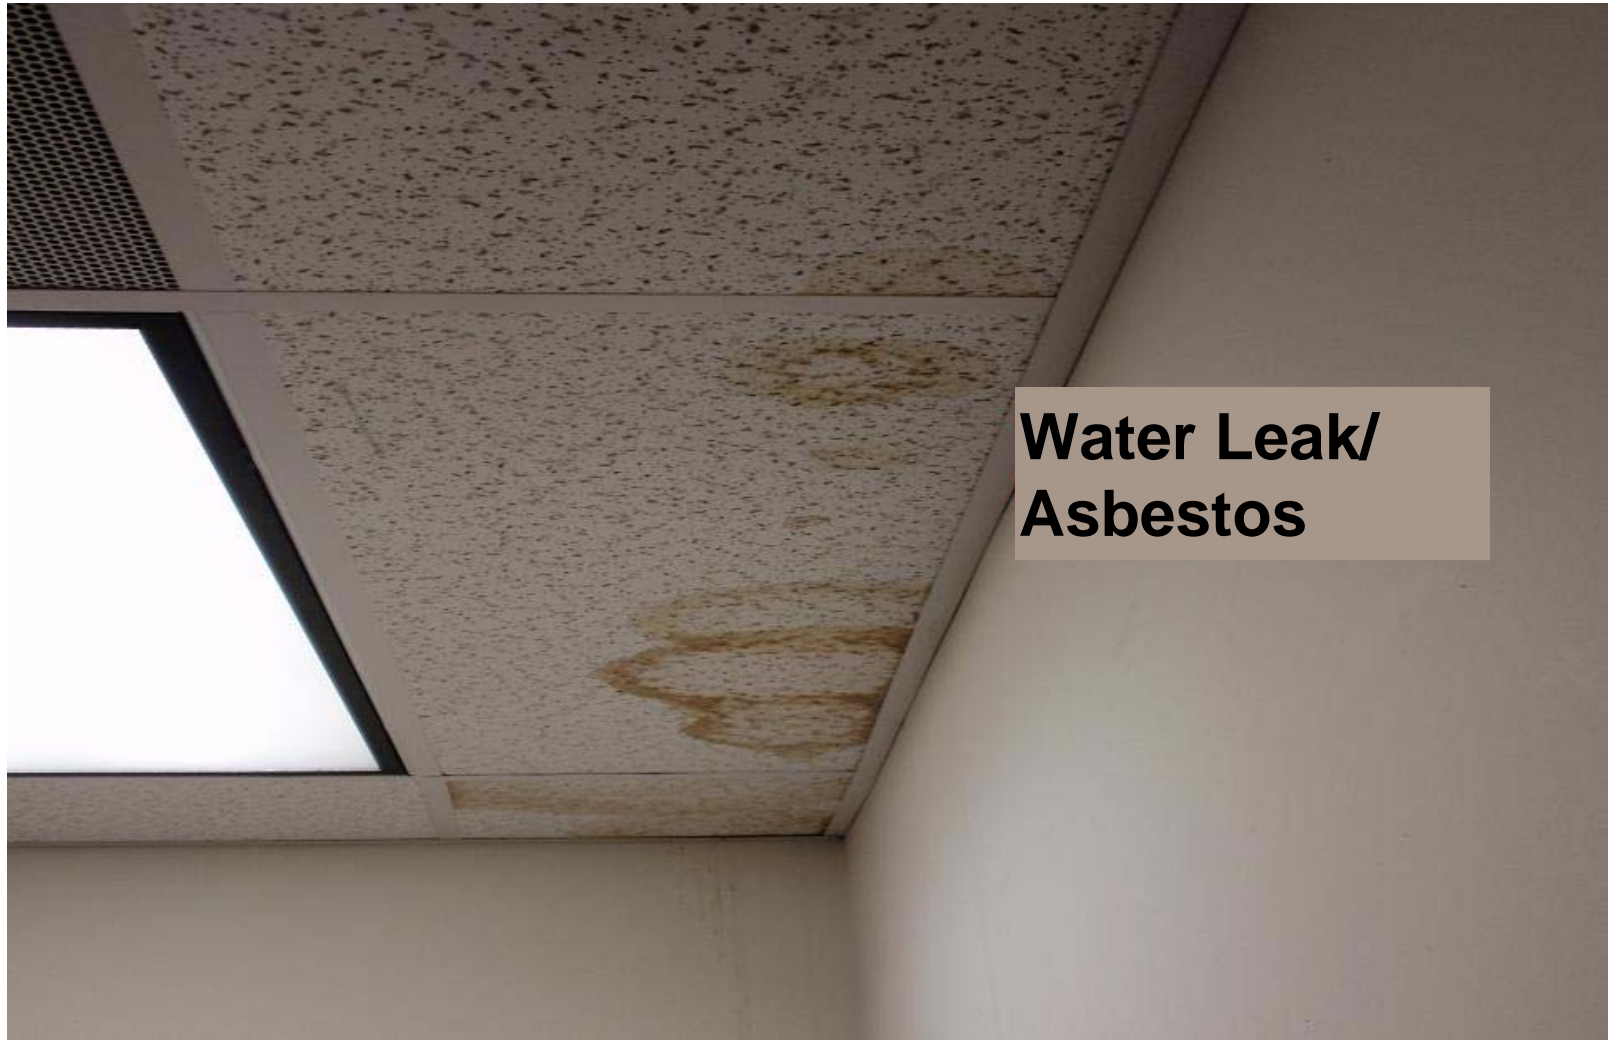
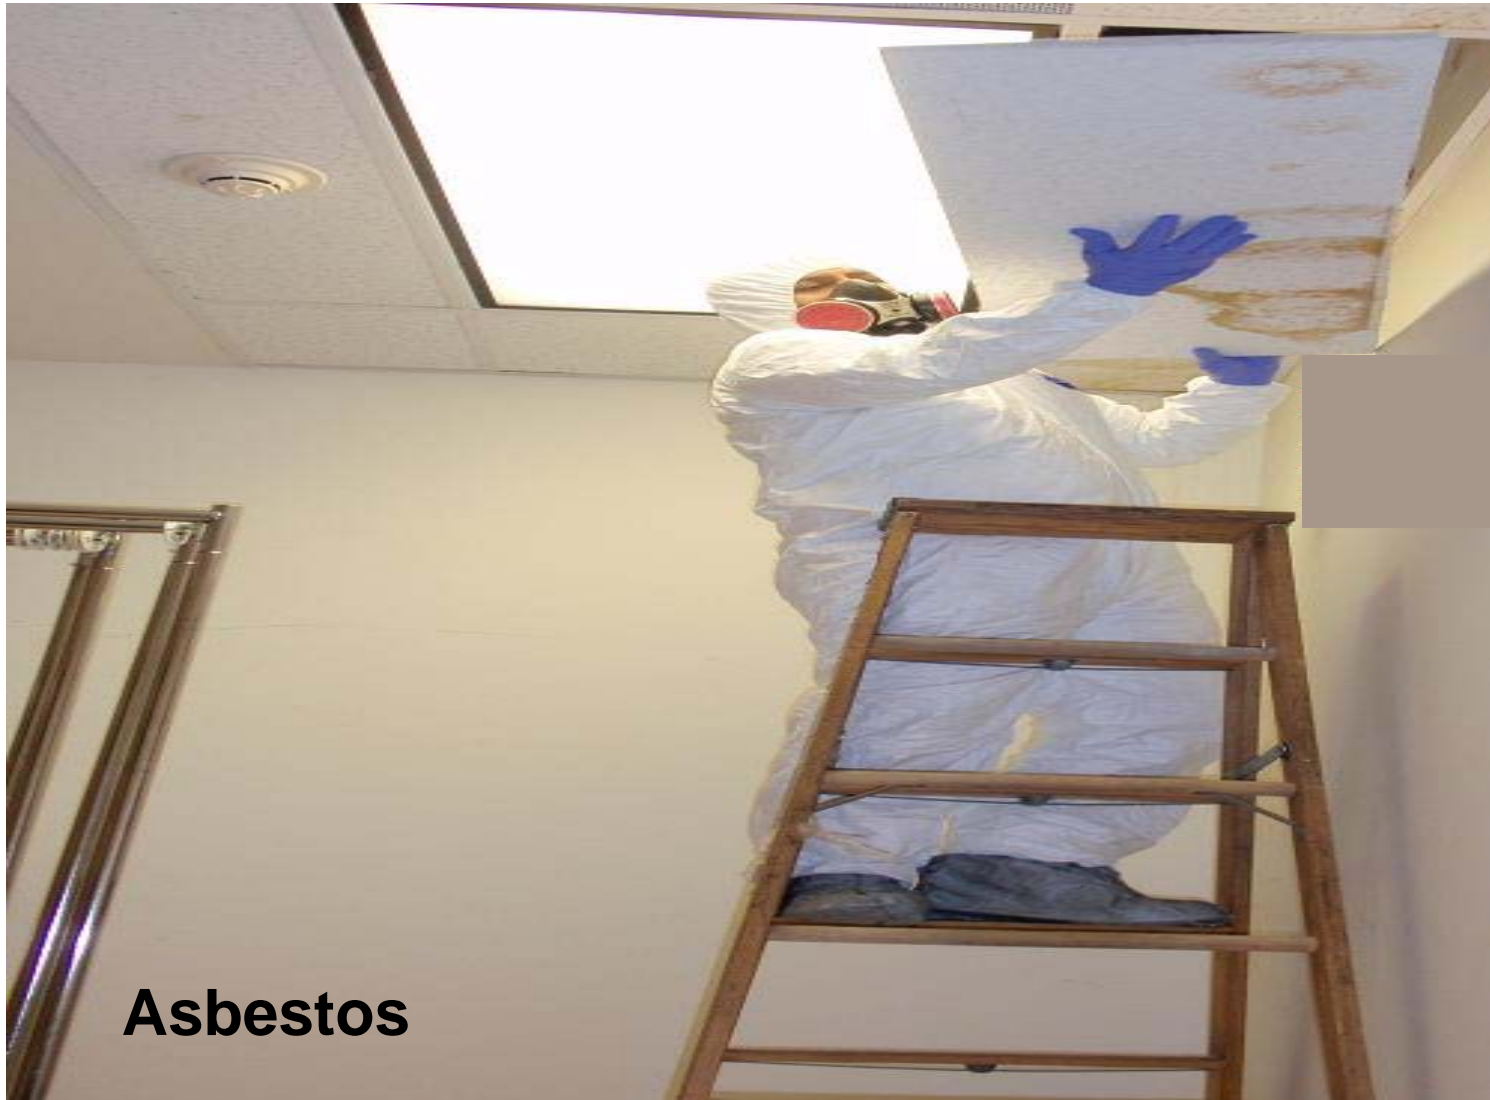
Asbestos

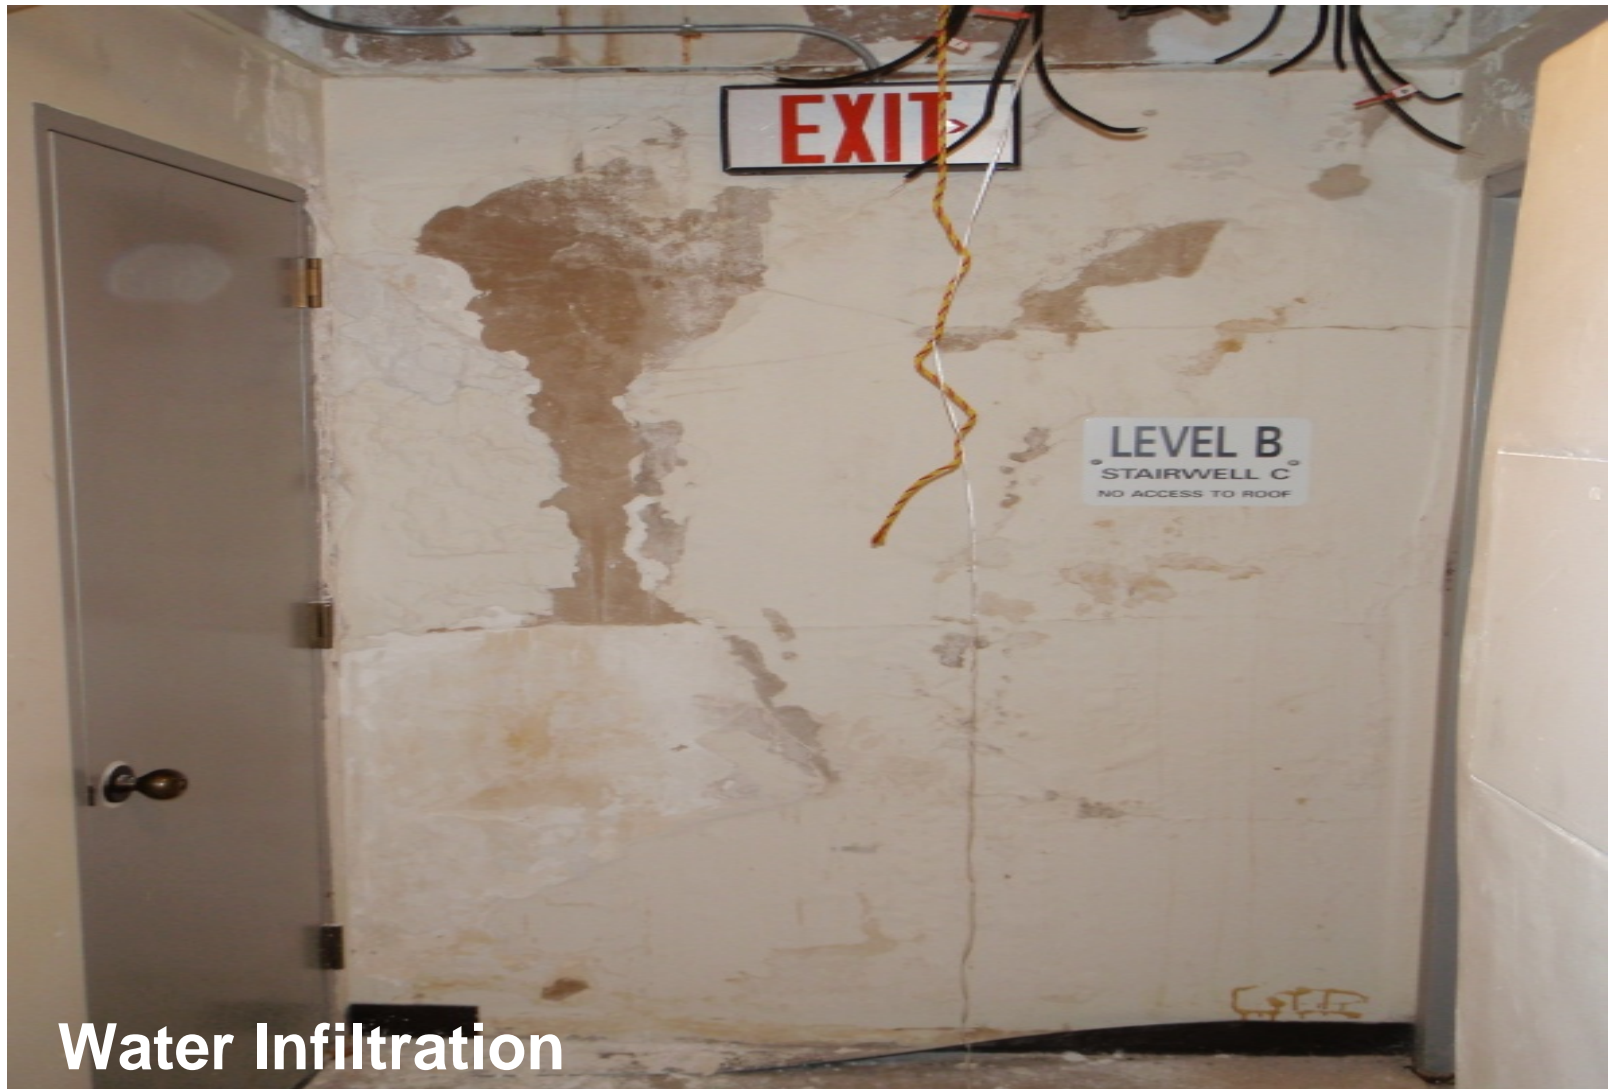
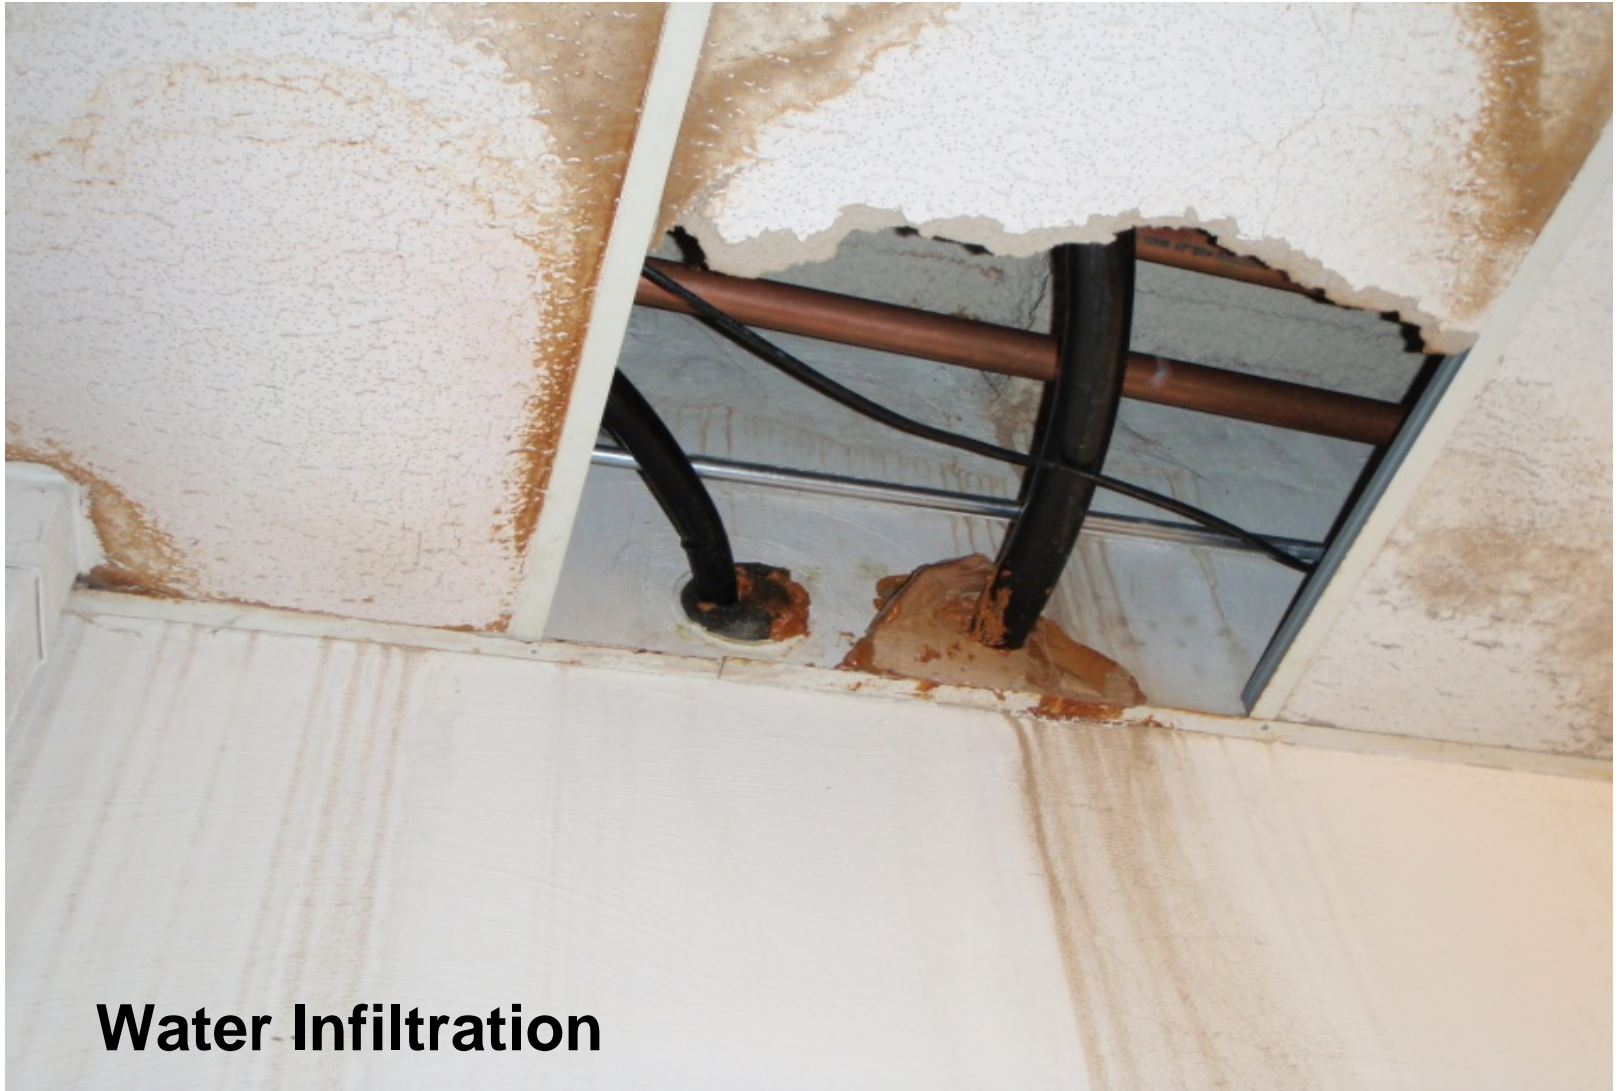
Water Infiltration

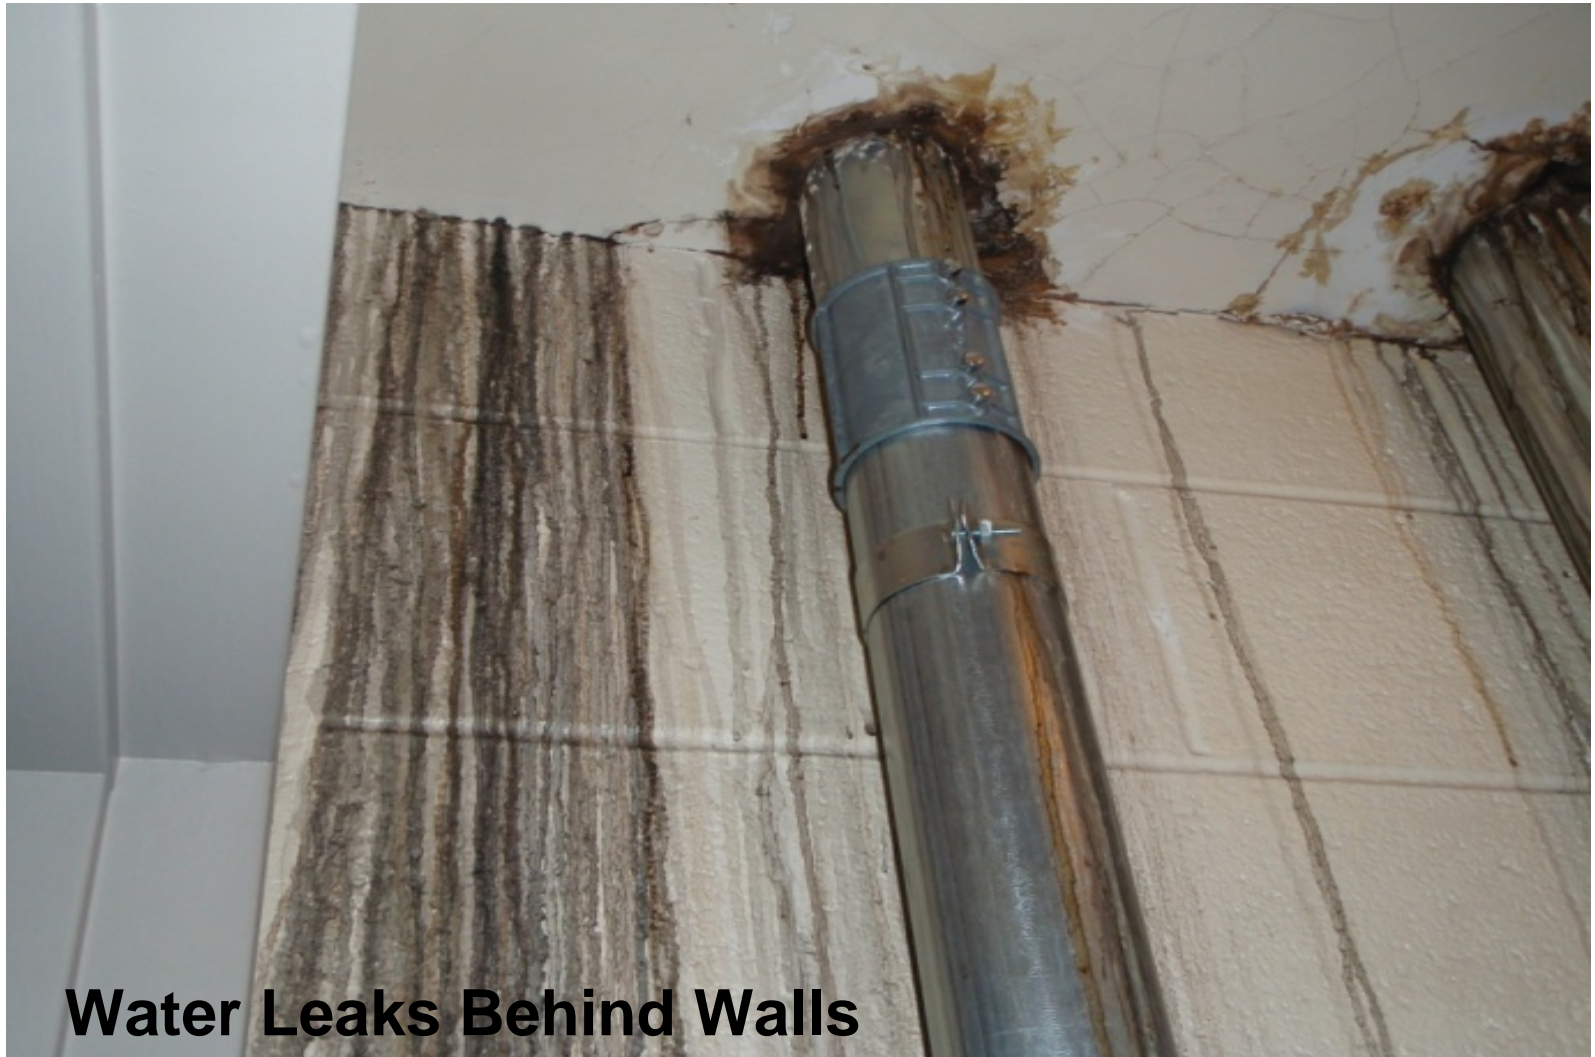
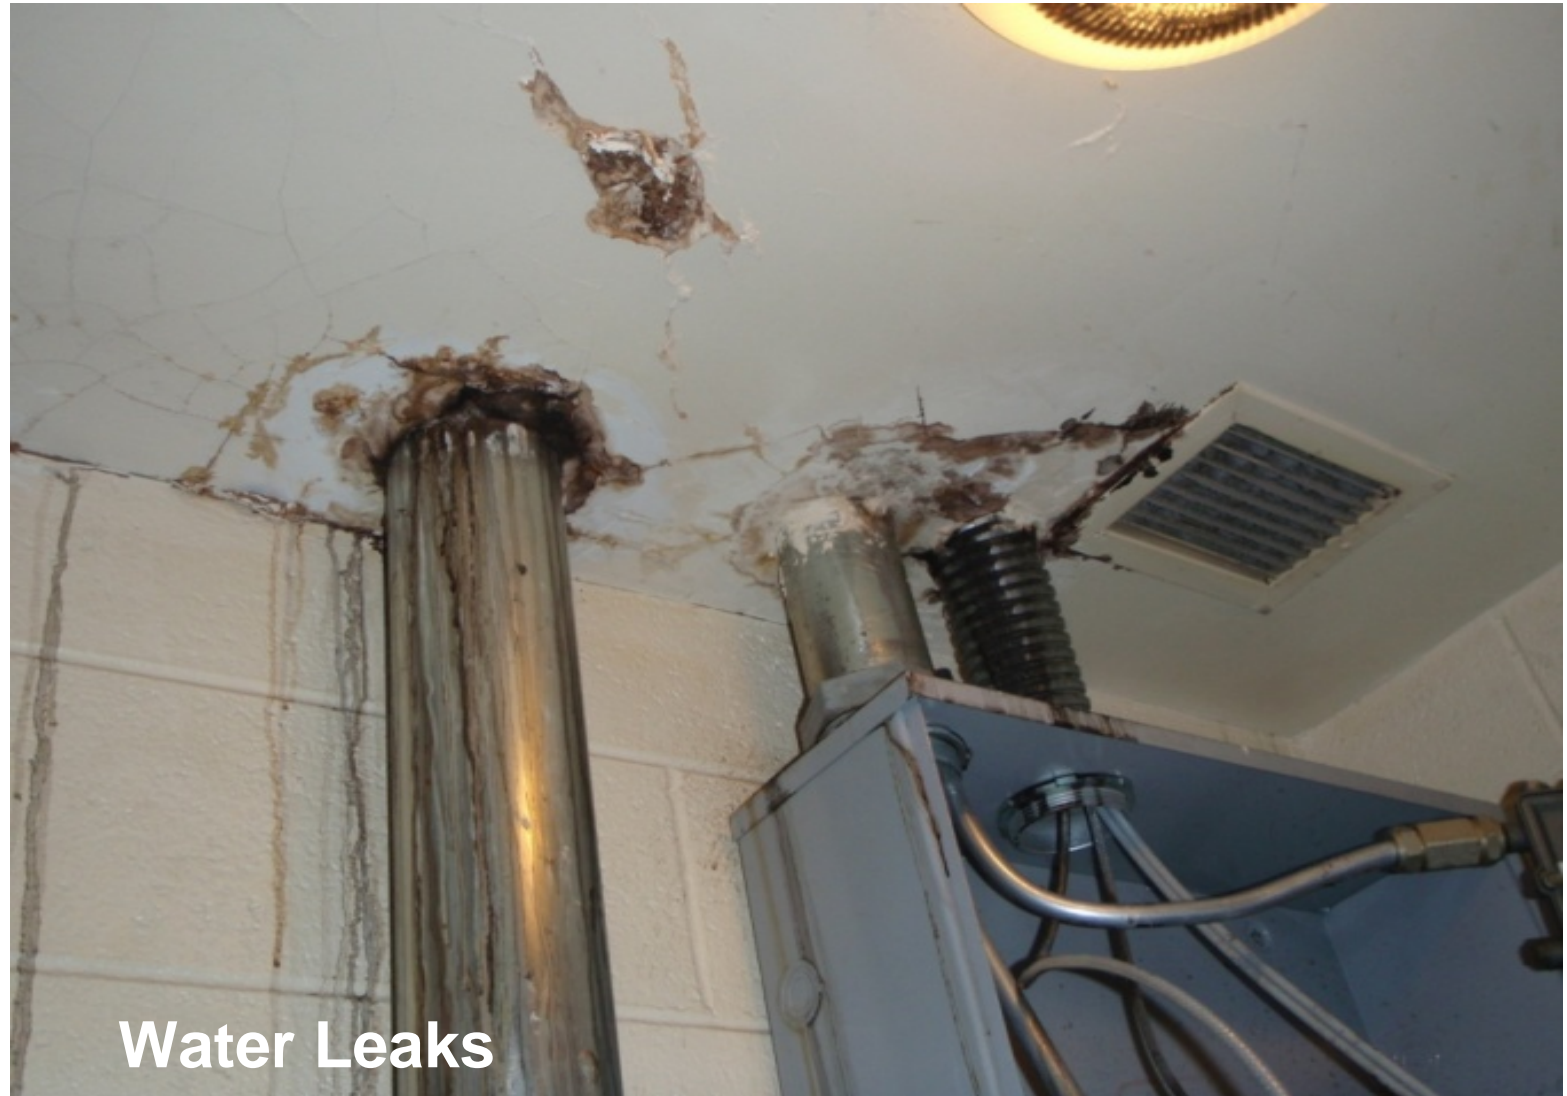
Water Infiltration

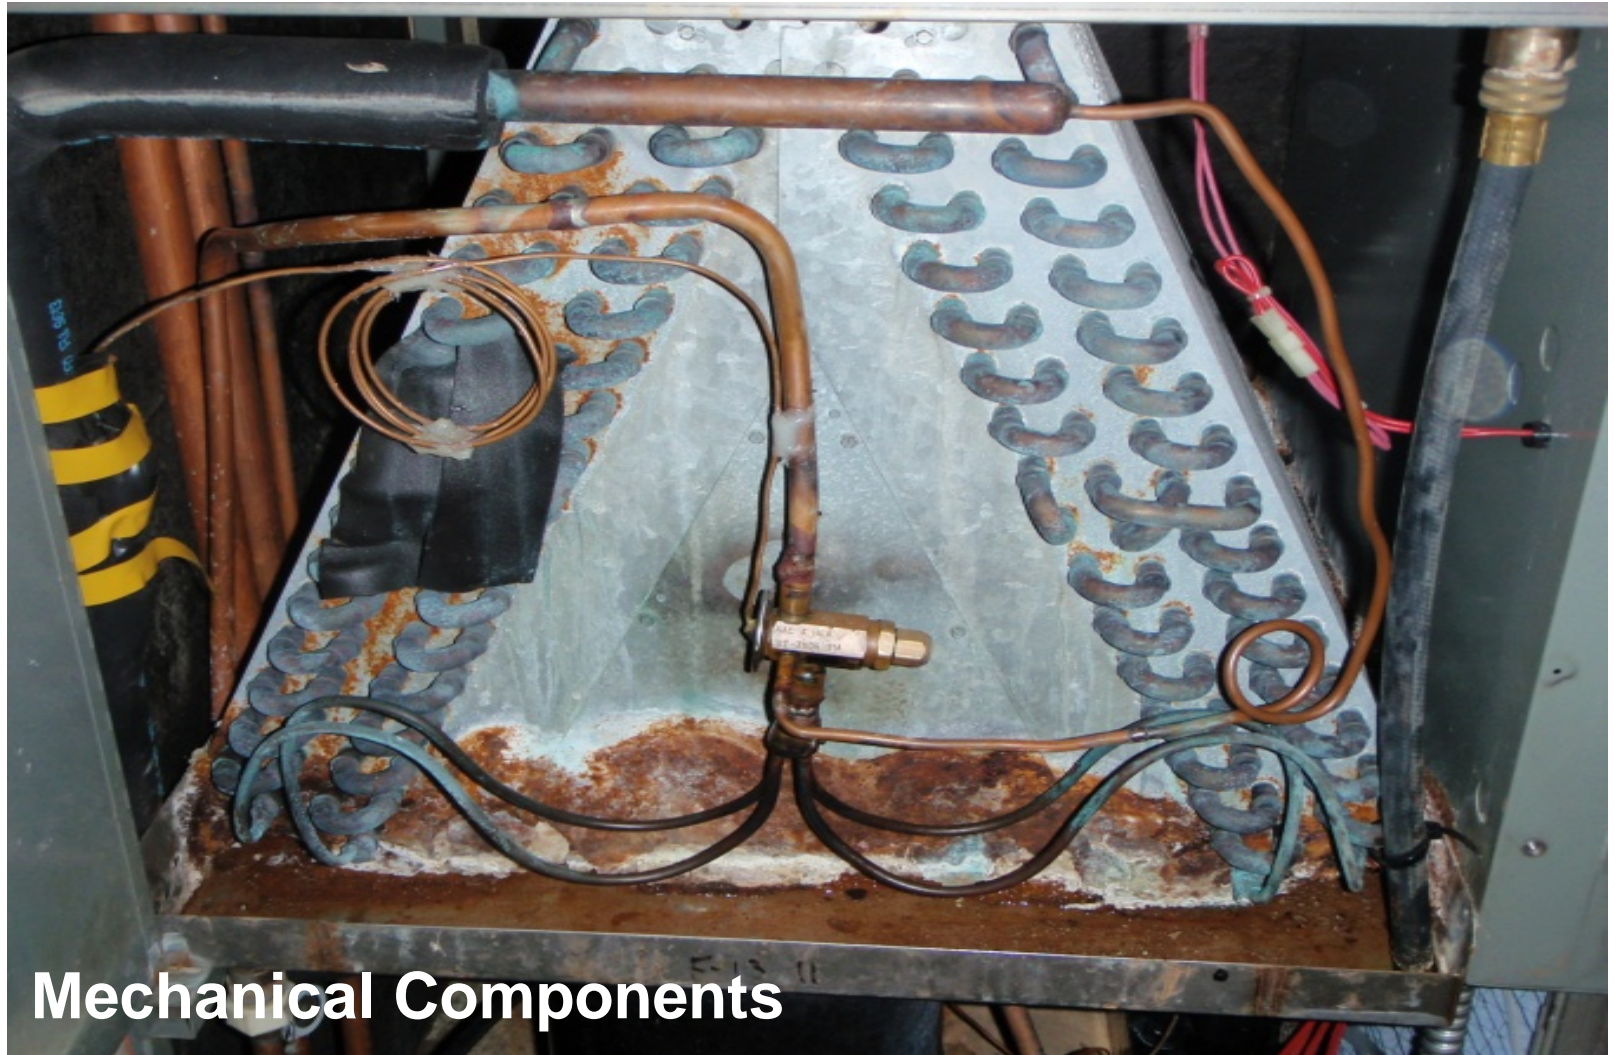
Aging Chiller

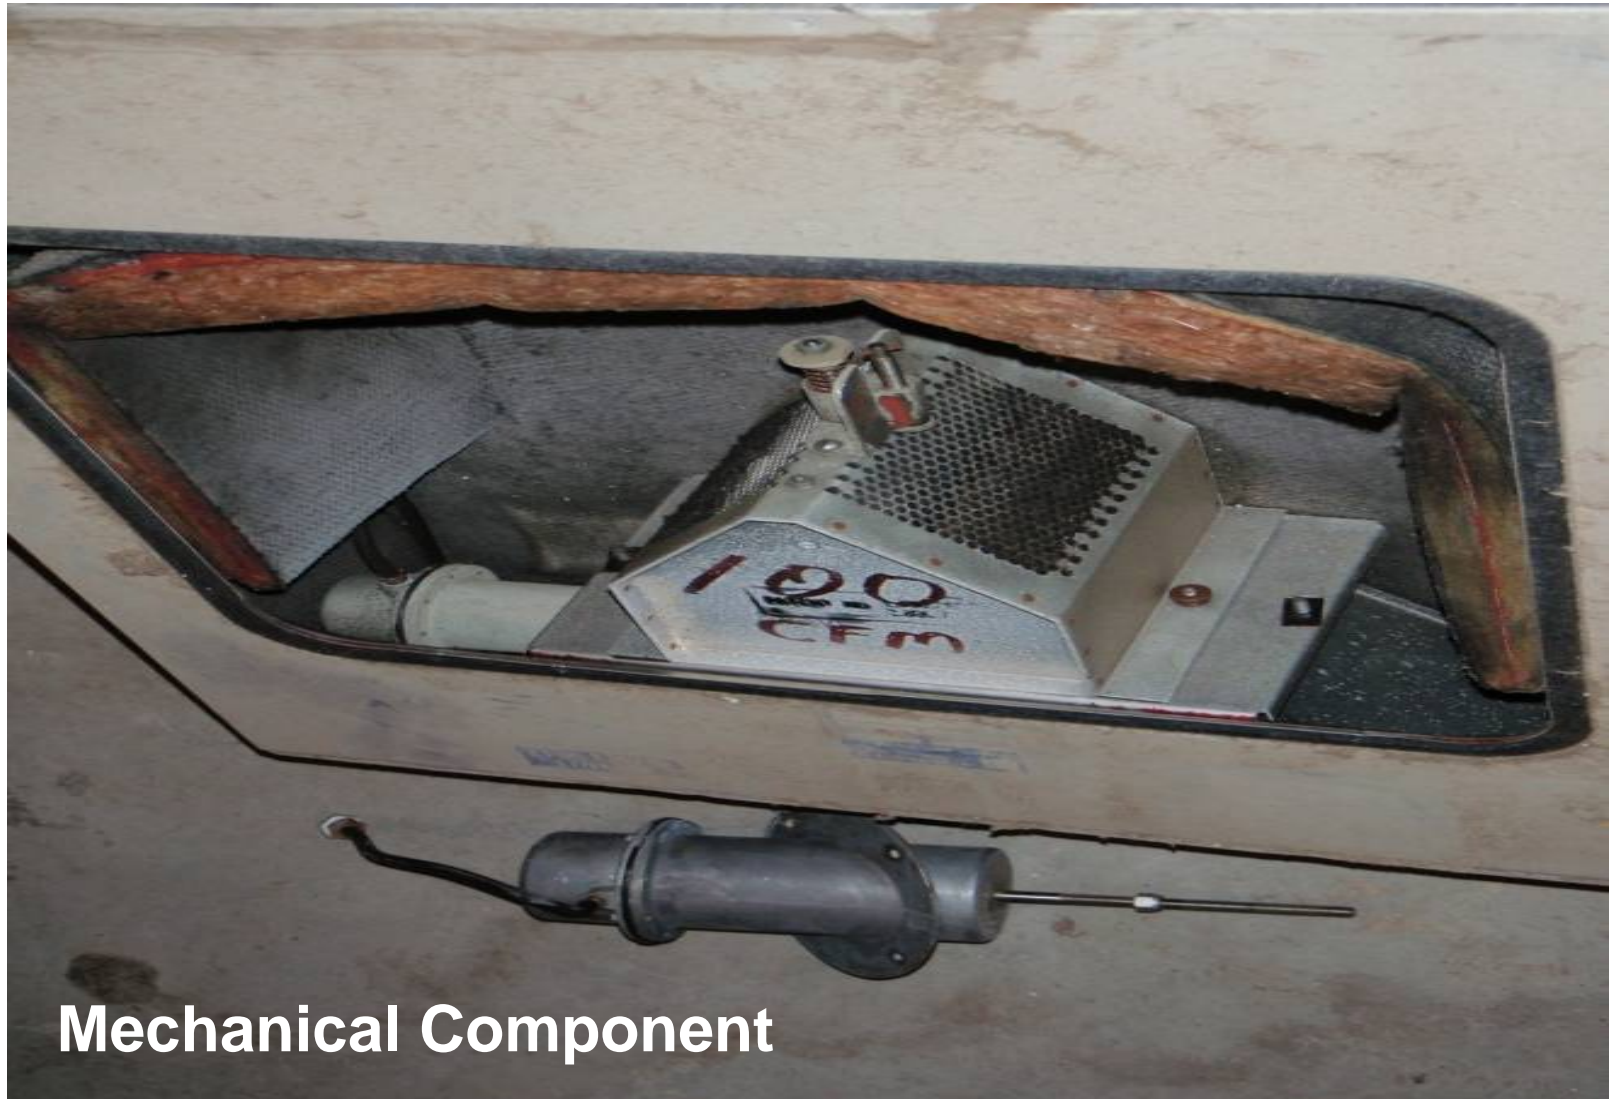
Mechanical Components
