Massey Building Condition Assessment

Facilities Management Department
March 26, 2010

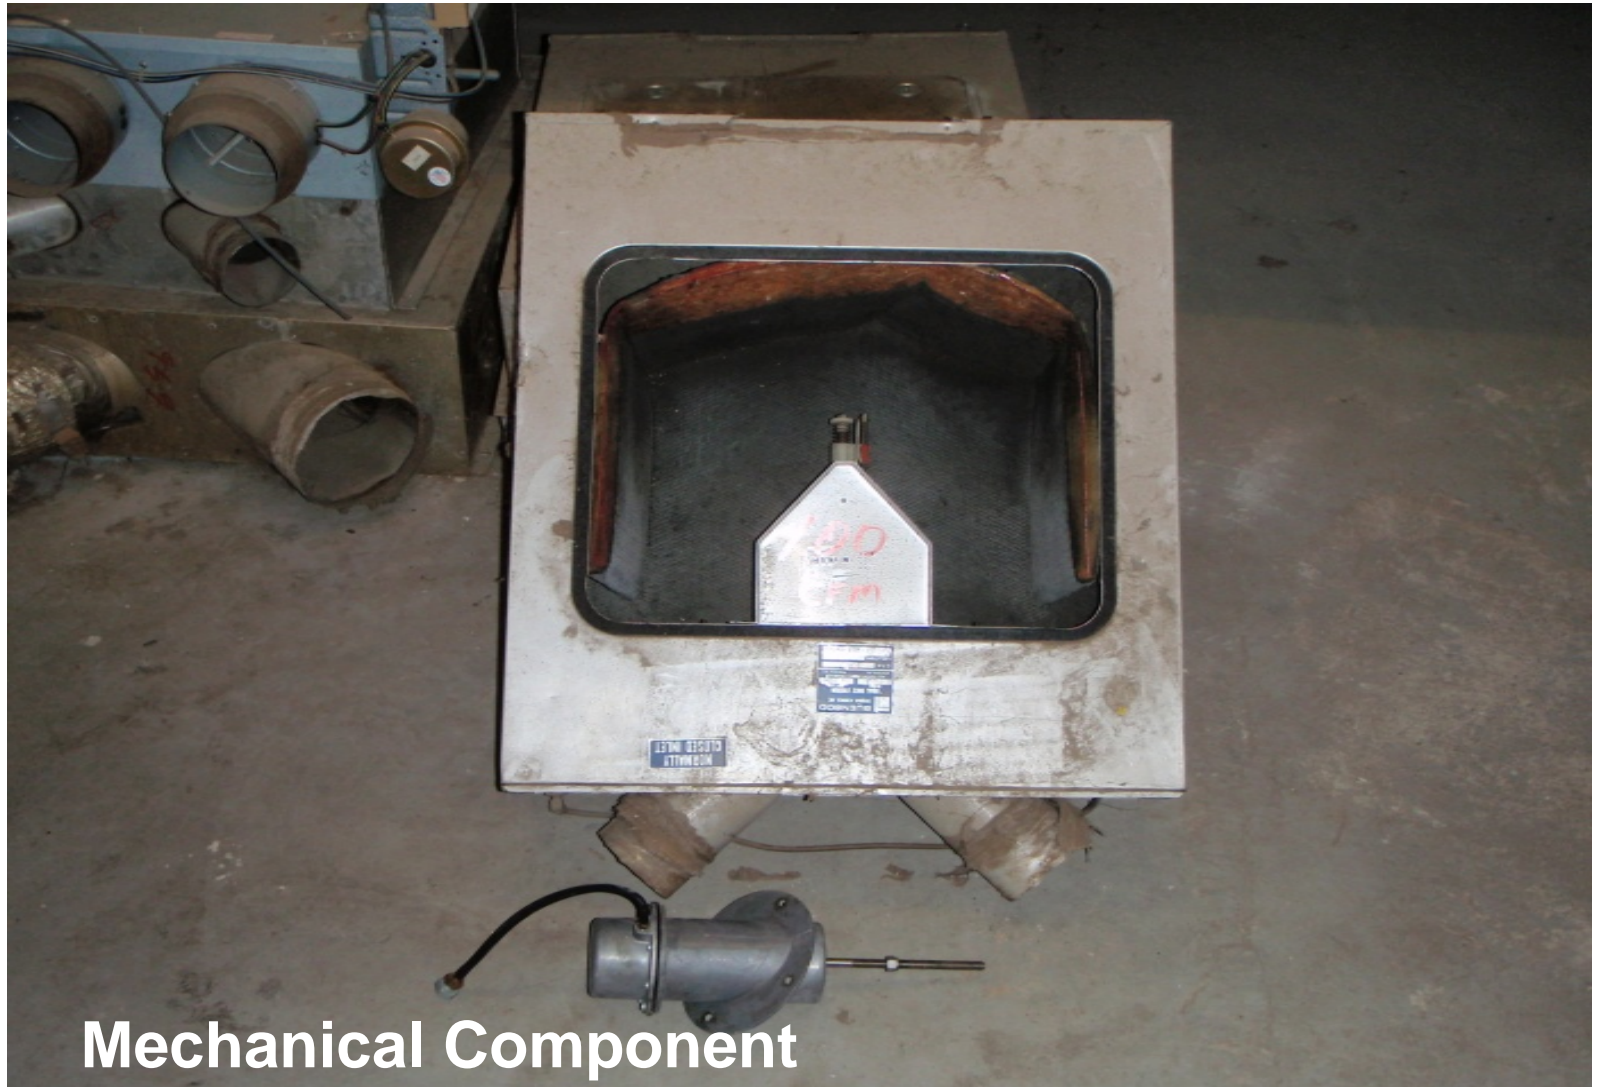
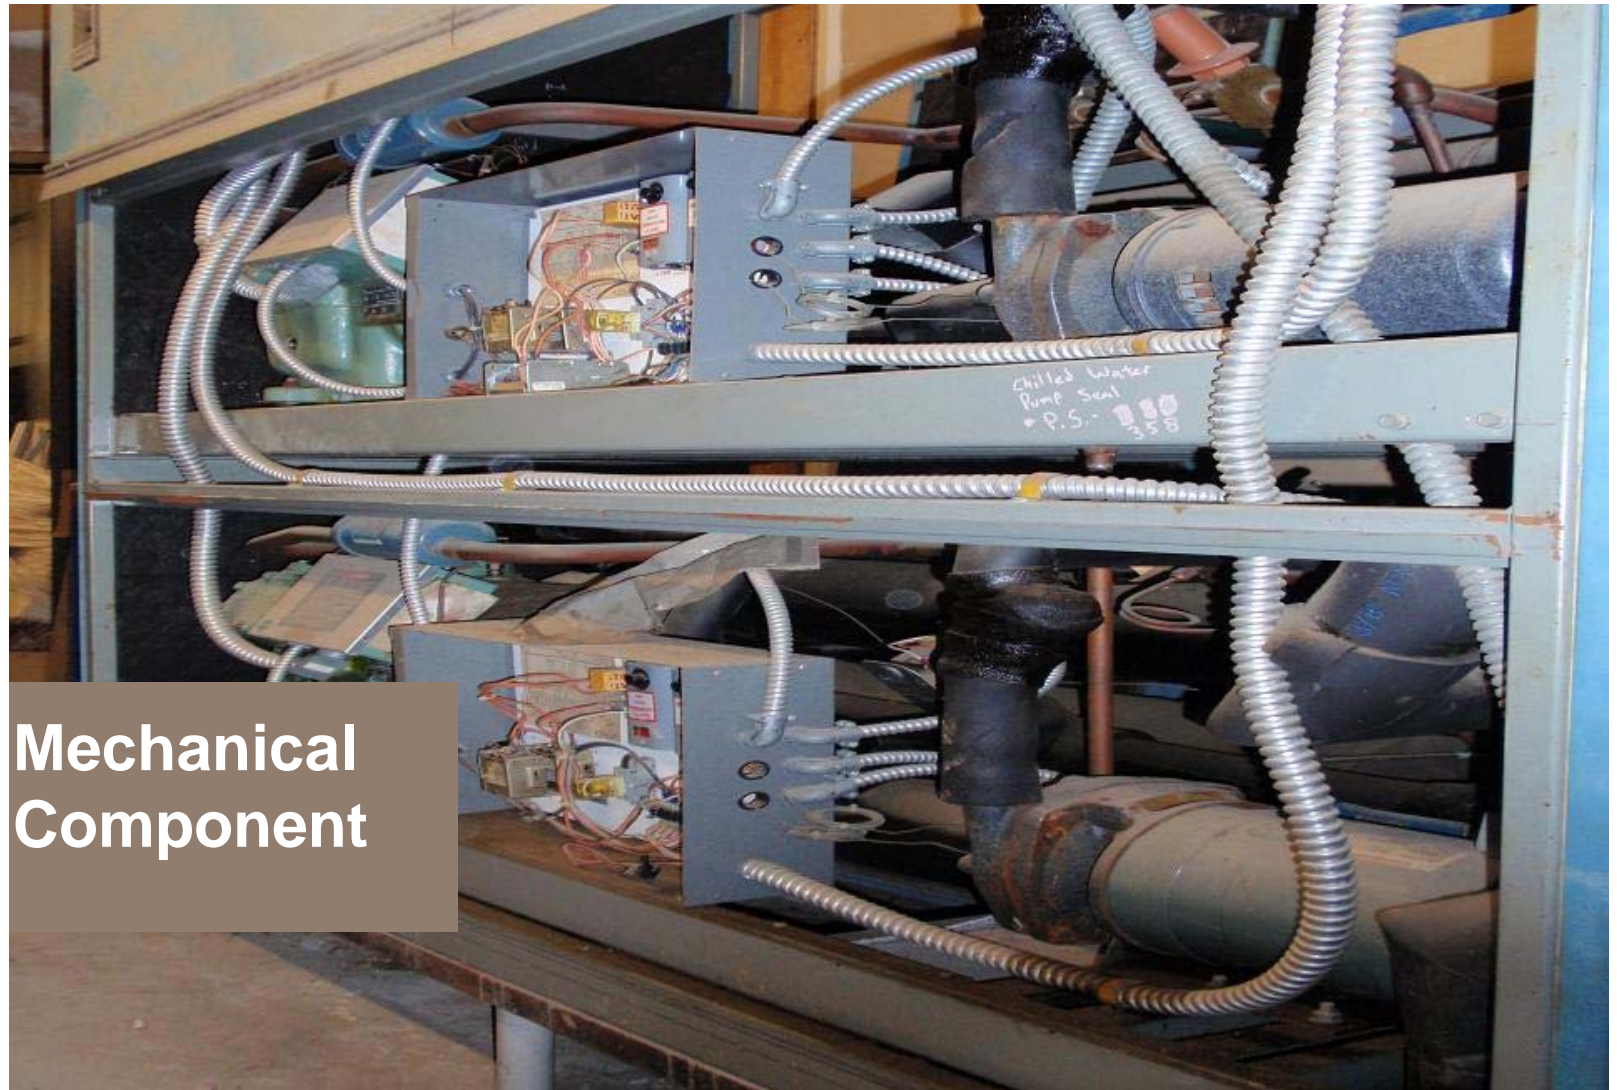
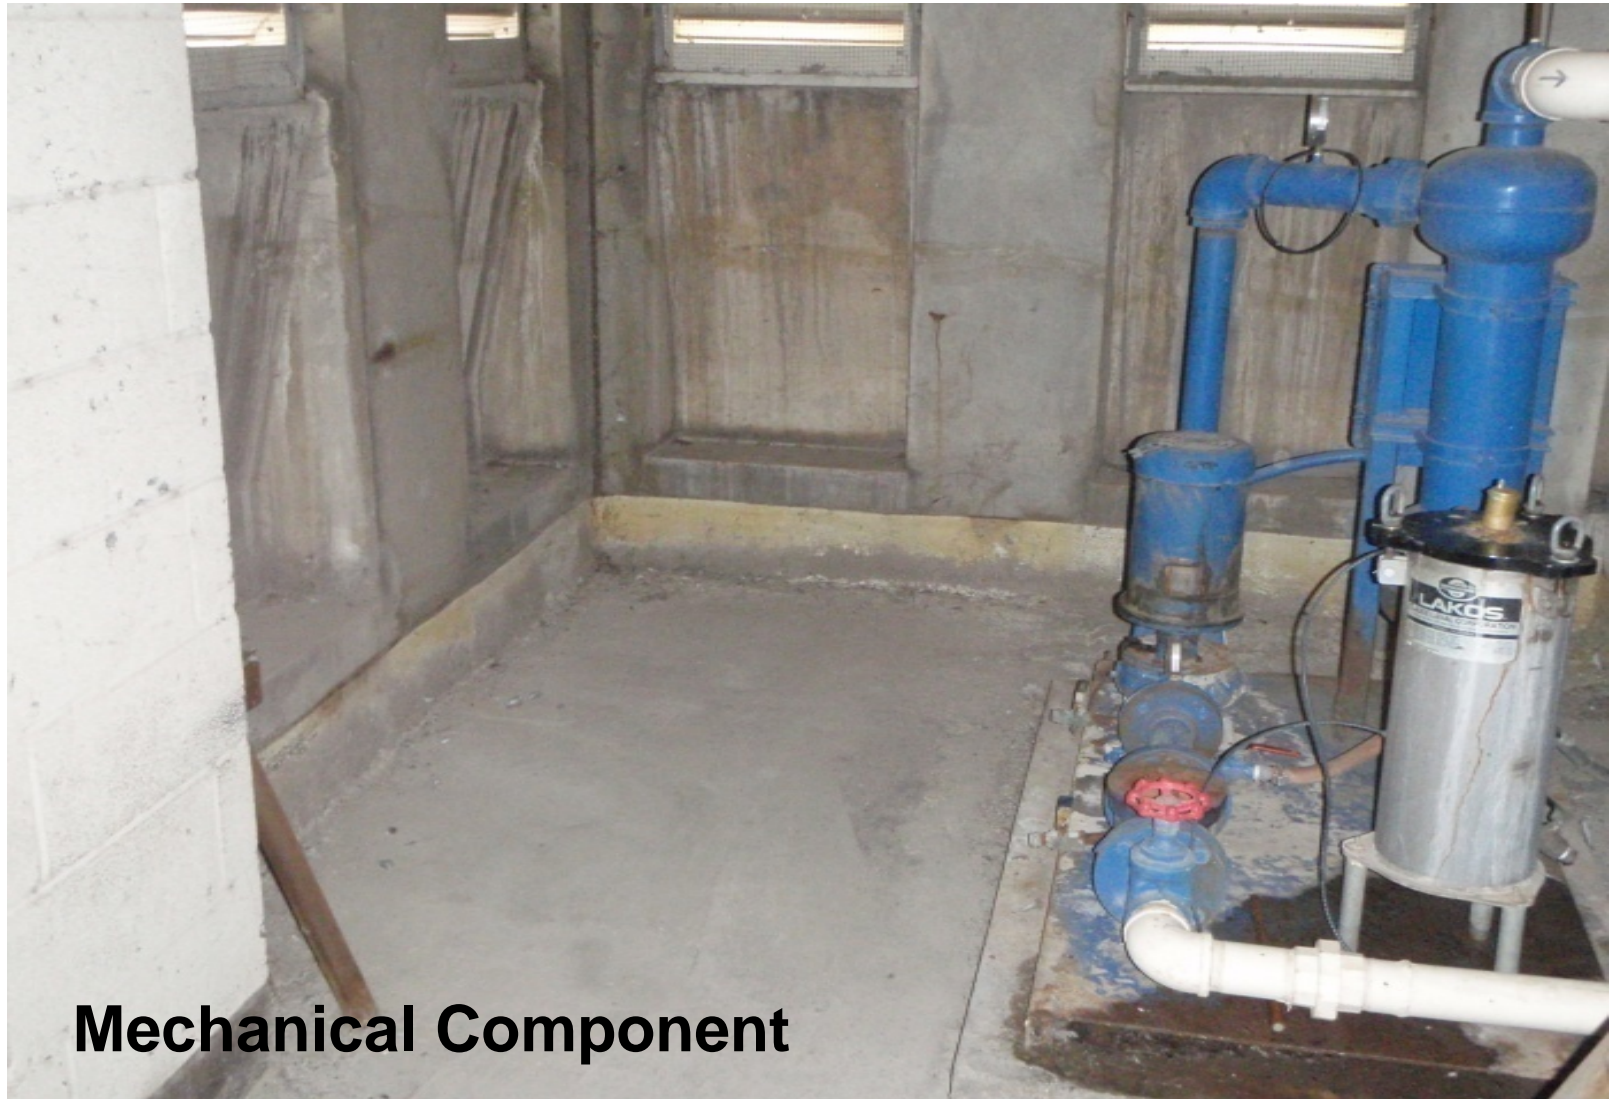
Mechanical Component

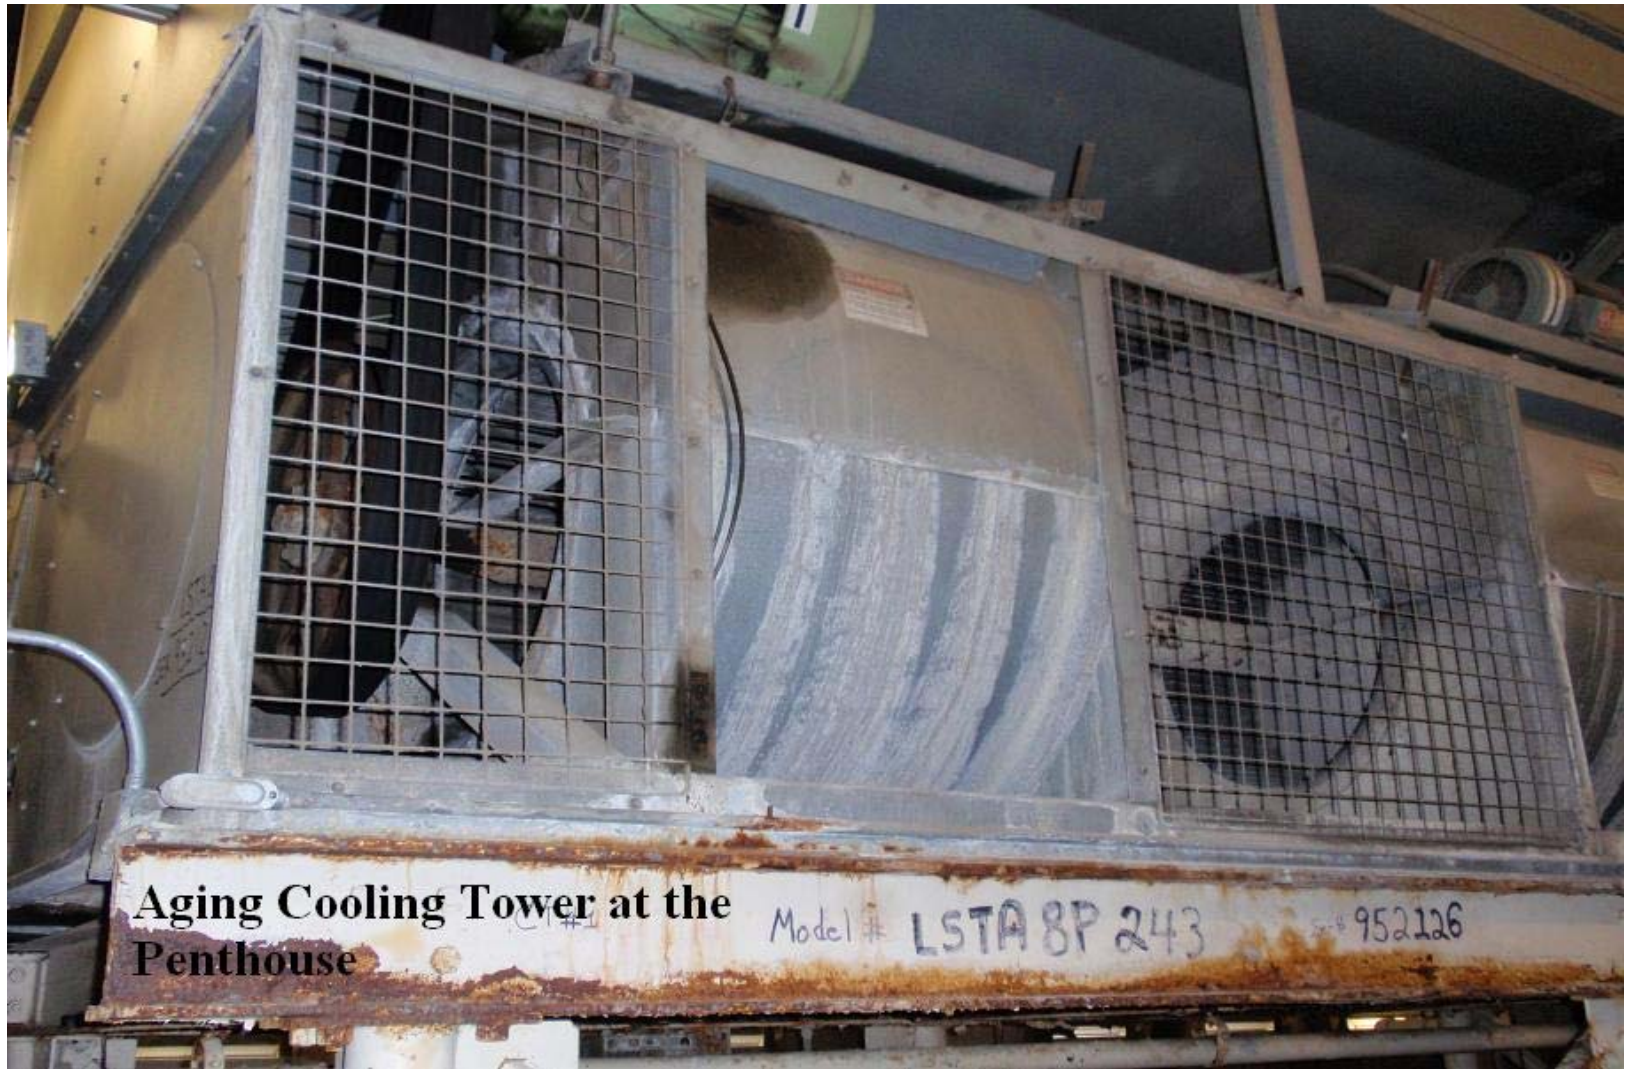
Mechanical Component

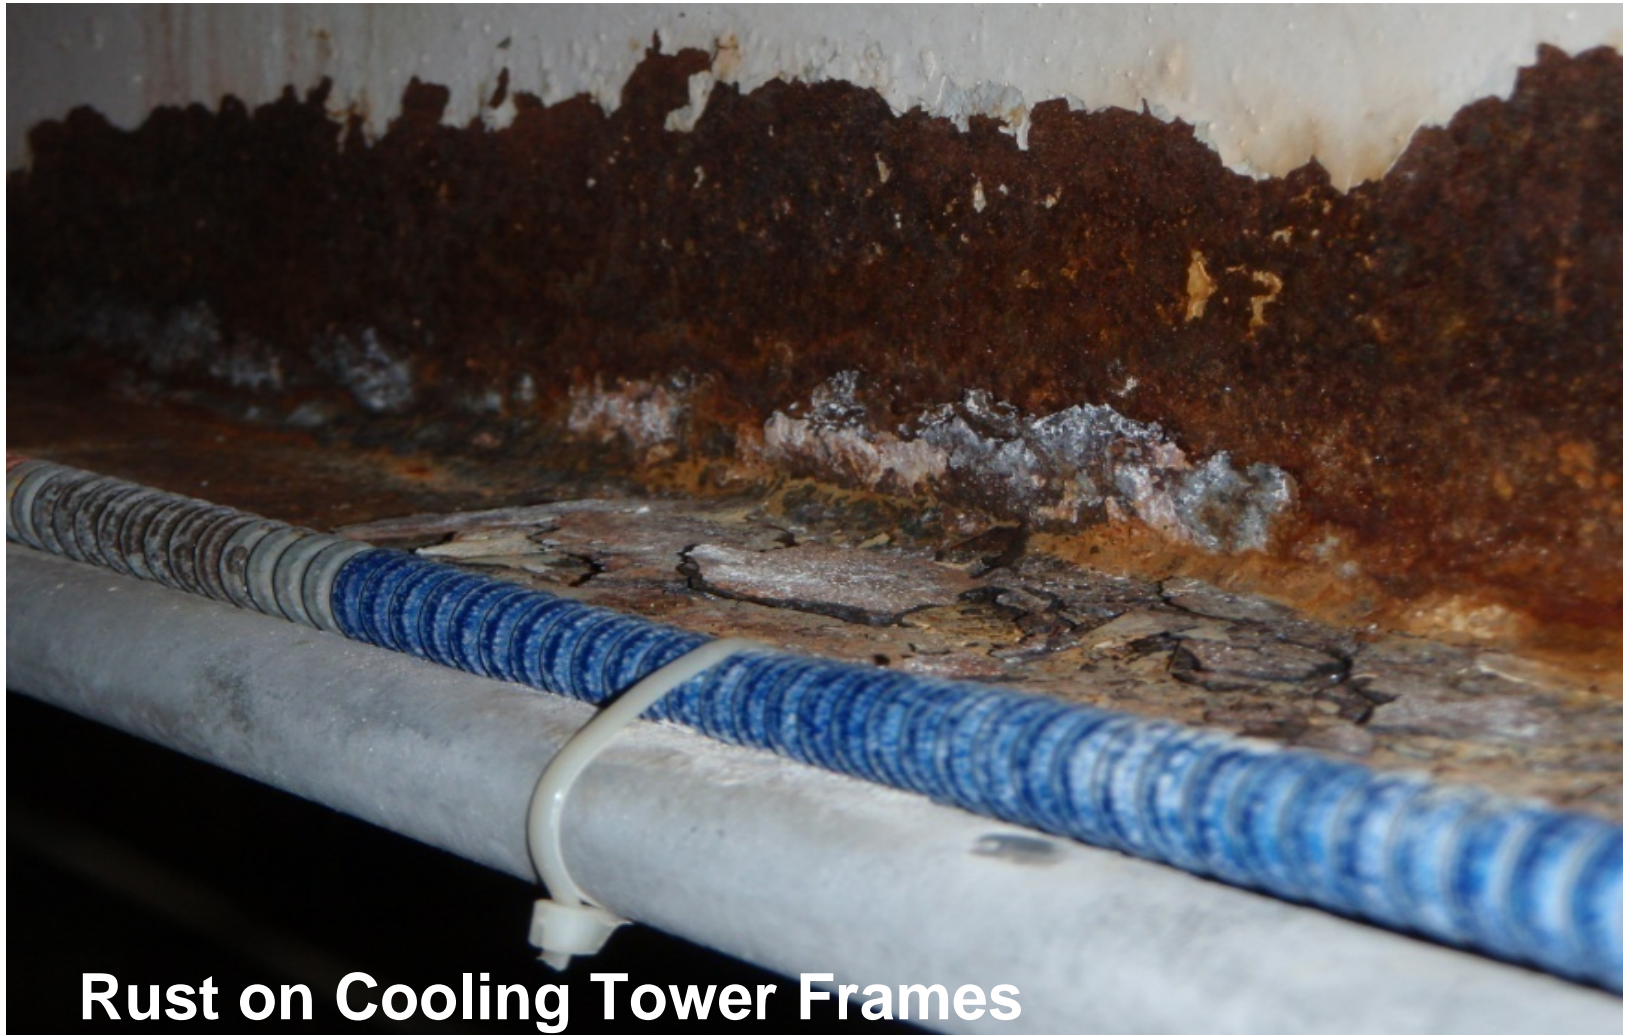
**Aging Cooling Tower at the
Penthouse**

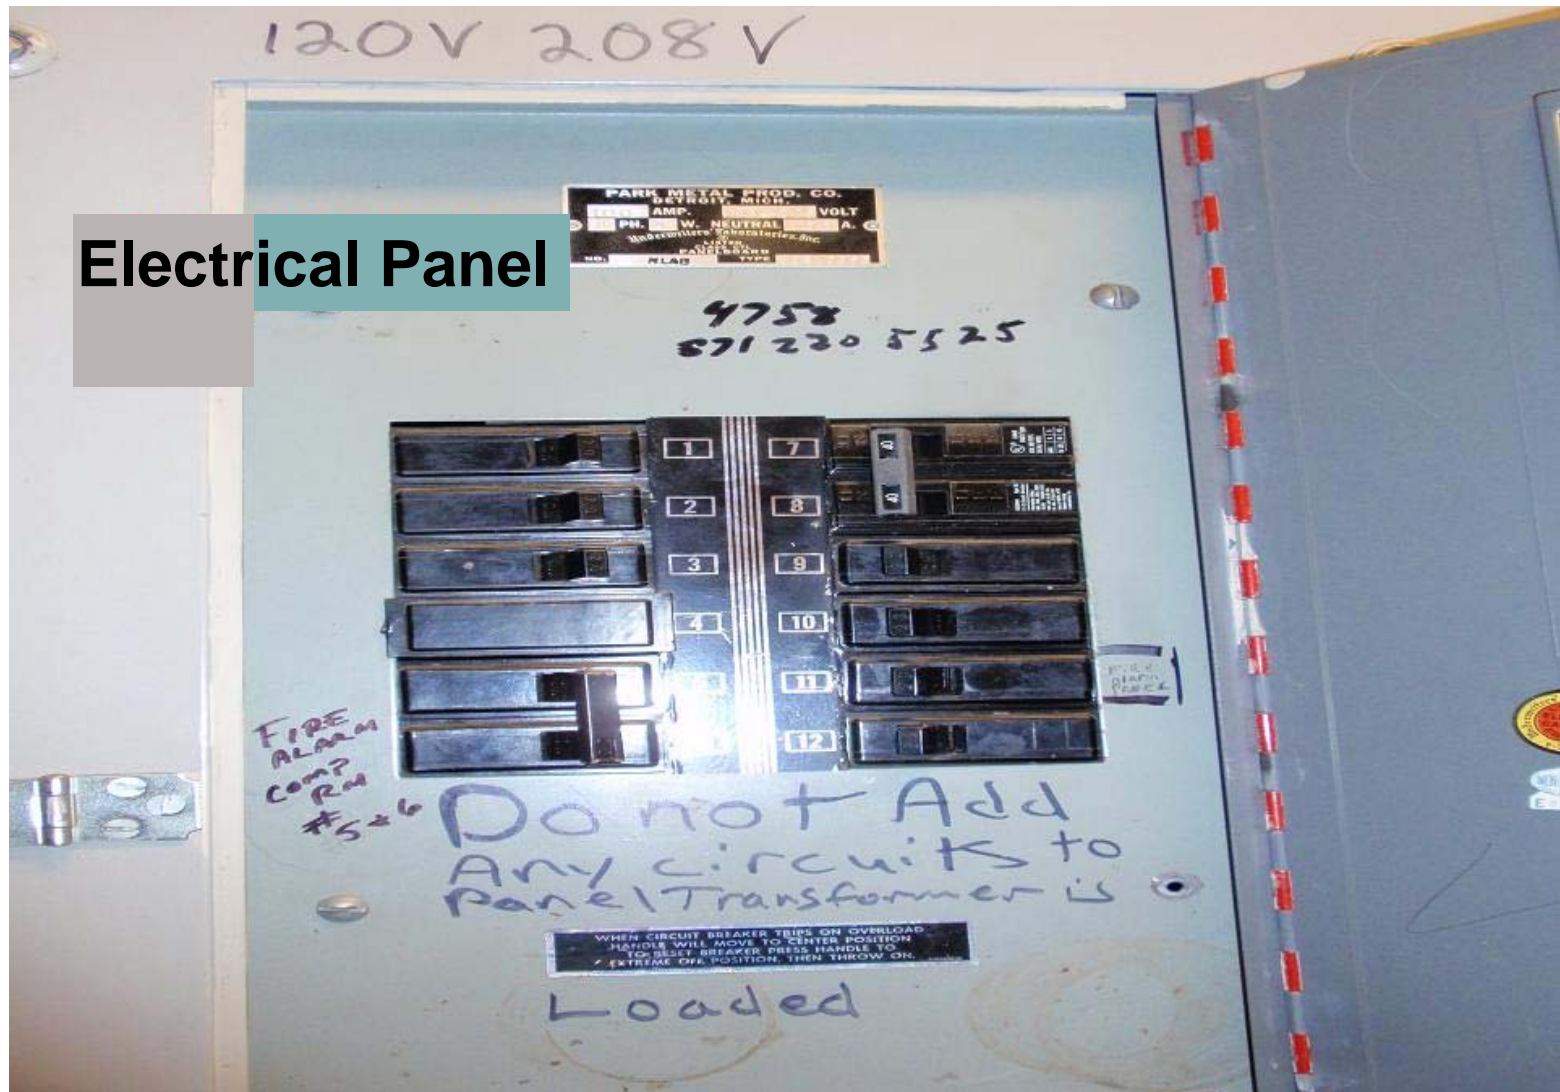
Electrical Panel

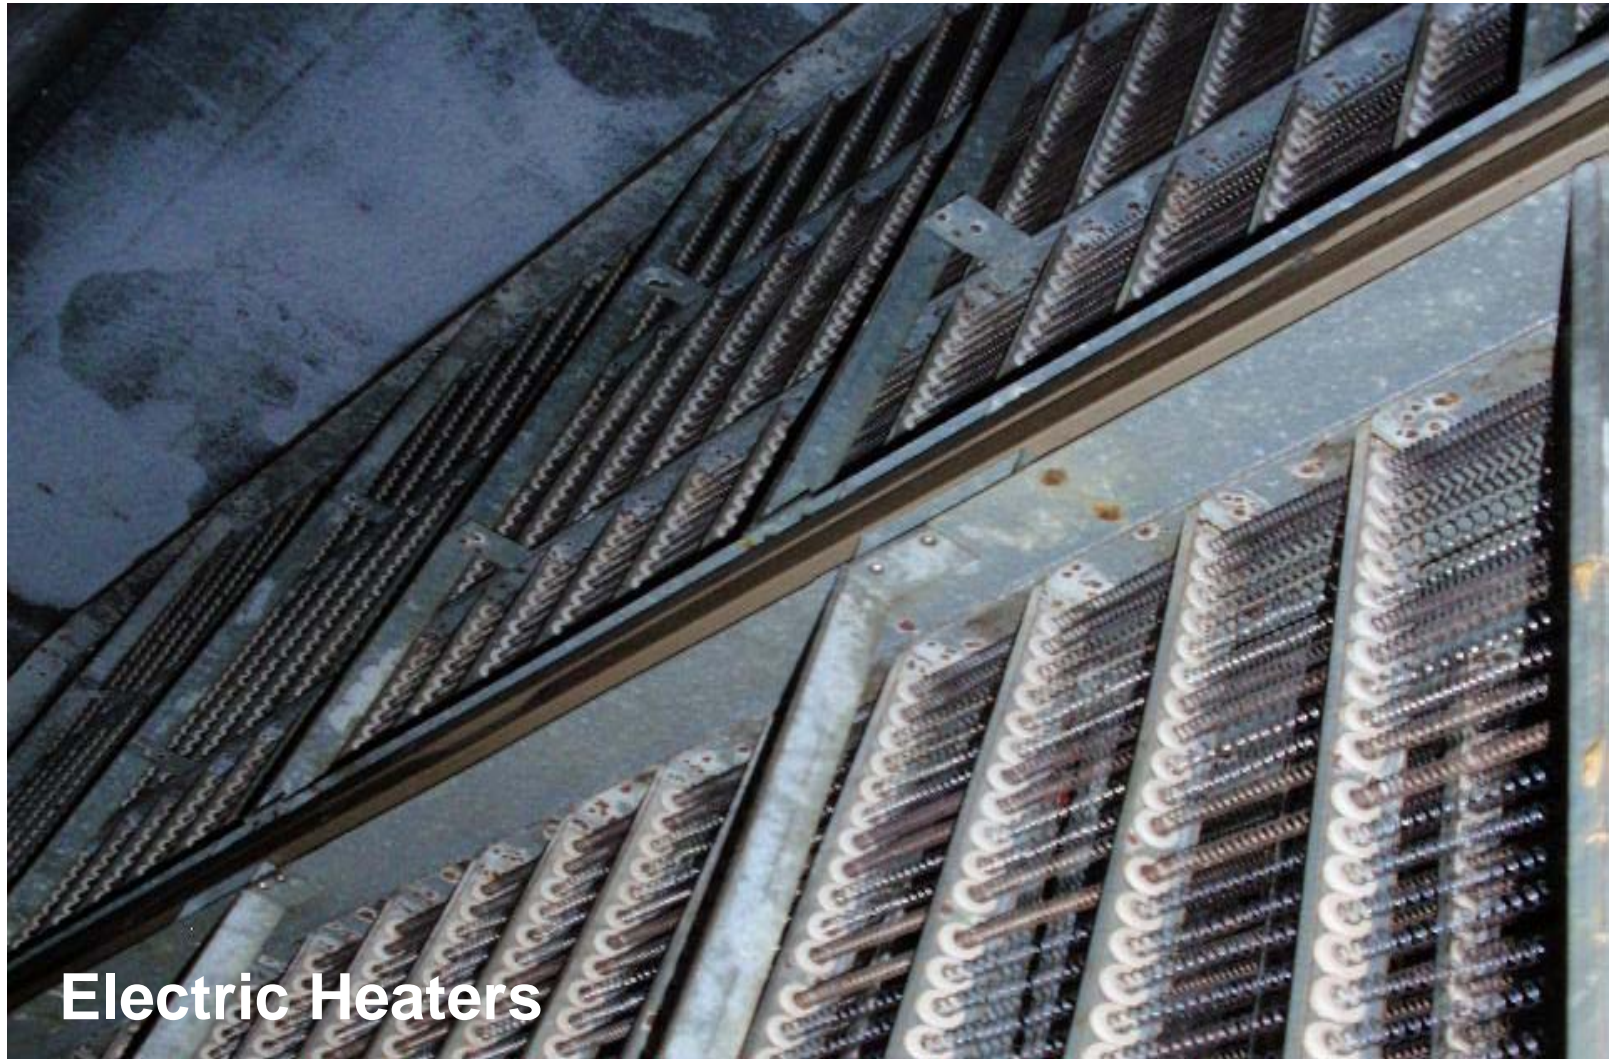
Electric Heaters
