Lake Anne of Reston Condominium Association

CURSORY CONDITIONS ASSESMENT

DRAFT REPORT

September 3, 2021

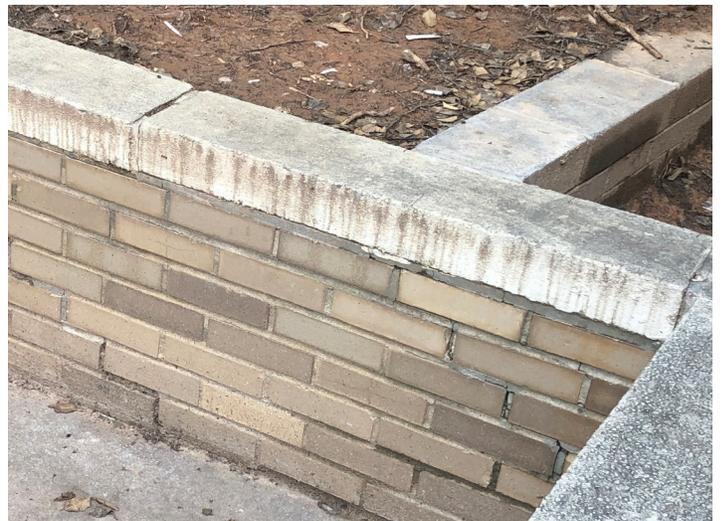
MD-A06 The retaining wall shows significant wear. The wall has dirt and mold present on the brick, mortar, and masonry cap. There are many damaged bricks and some bricks with efflorescence on the surface. The mortar is cracking and damaged throughout the wall. The masonry cap is damaged in many places and the mortar joints are deteriorating. The earth above the wall slopes from the wall up several feet. The earth is present up to the top of the wall. The wall should be cleaned, damaged bricks replaced, and the mortar joints repointed. The masonry wall cap should be replaced and provided with sealant joints instead of mortar. Retaining wall cap should be sloped to prevent standing water. The height of the wall should be reviewed and possibly heightened as soil eroding down the hill is flowing over the top of the wall.

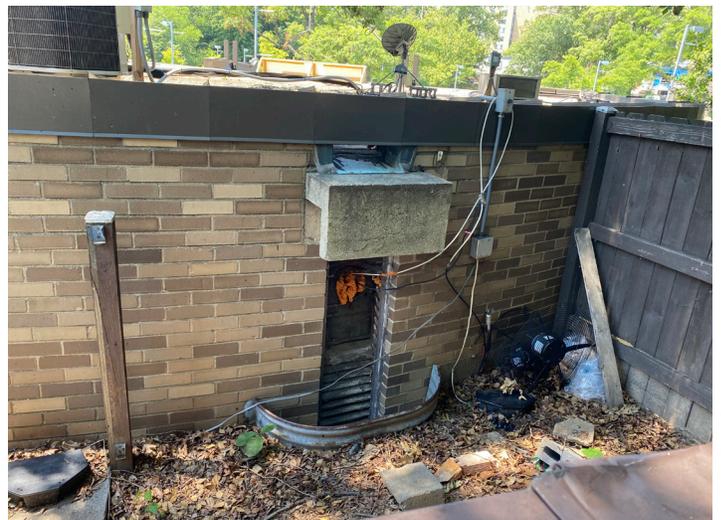
MD-M01 It was observed that the building is currently served by multiple split system air conditioning units. There is also a small kitchen hood exhaust and makeup air system serving the kitchen area. These systems appear to have exceeded their expected service life. Ventilation air did not appear to be provided in sufficient quantities to meet current ventilation codes. It is recommended to provide new HVAC systems to bring the building into compliance with current ventilation codes. See related photo of existing kitchen exhaust system.

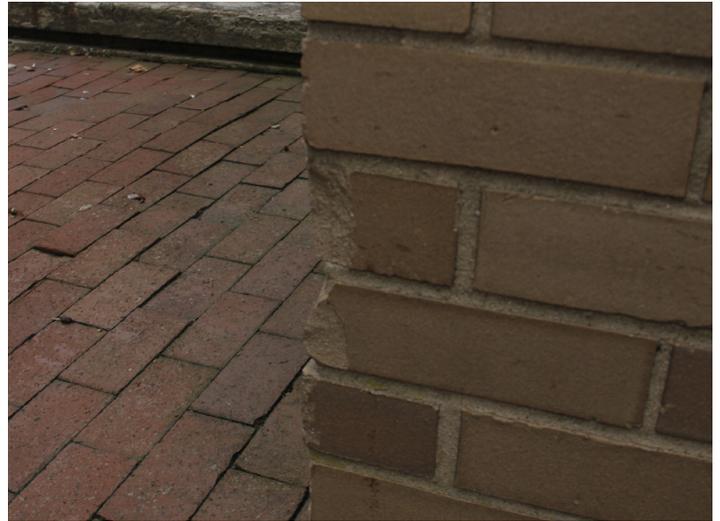
CP-A01

- CP-A01** The brick and mortar throughout the building are dirty with some areas showing signs of mold growth and efflorescence on the brick surface. Concrete lintels and sills have metal staining present on the surface. The exterior of the entire building should be cleaned to remove dirt, mold, staining, and efflorescence present on existing surfaces. Cleaning should be performed prior to any masonry or concrete repairs as further damage may be uncovered with the cleaning.

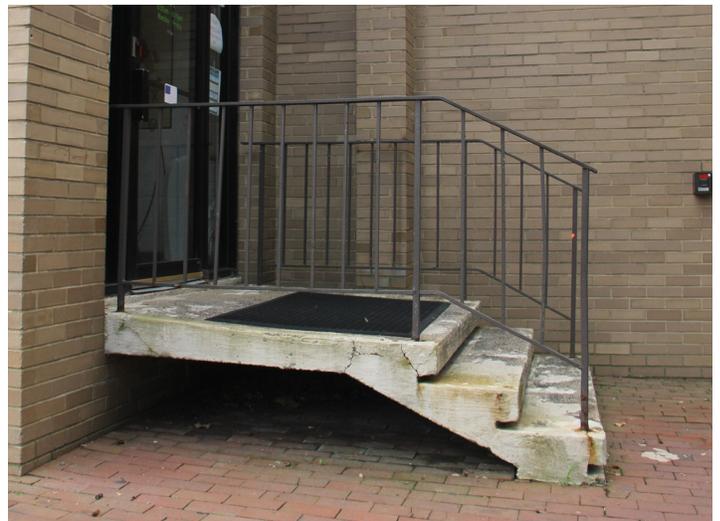
CP-A04

- CP-A04** The balcony railing appears to be rusted and does not meet current building codes. Railings should be replaced with a railing that meets current code requirements.

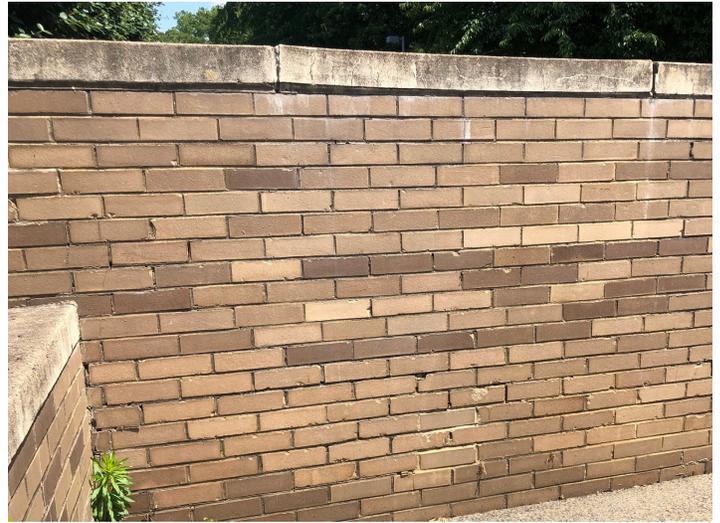
CP-A06

- CP-A06** The retaining walls supporting the enclosed playground and around the rear of the loading dock area are showing signs of damage and stress. There are locations of visible canting/movement in these walls. Some portions of this retaining wall system appear to have been replaced. Canting walls should be repaired or replaced, possibly with a thicker wall to properly support the earth behind.

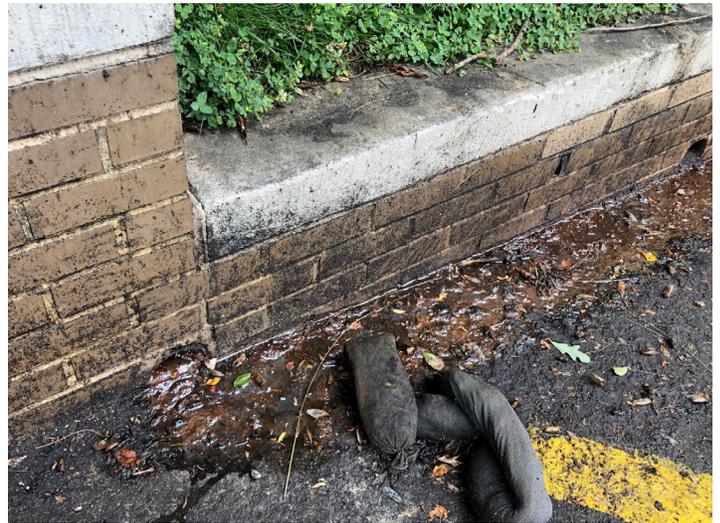
CP-A07

- CP-A07** The retaining walls and planter beds on the upper level of this building around the playground have cracked and spalling brick and mortar as well as efflorescence present. All walls need to be cleaned and have the masonry repaired/replaced and the mortar repointed.

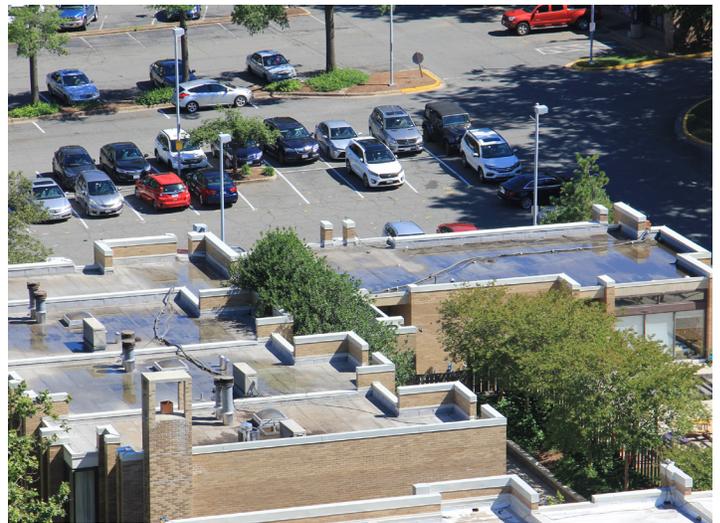
CP-A09

- CP-A09** The loading dock roof membrane is wrinkled, and the flashing is rusted. It is recommended the loading dock roof be replaced with a new membrane roof and flashing. Roof drainage and slope should be reviewed when the roof is replaced to ensure adequate drainage is being provided.

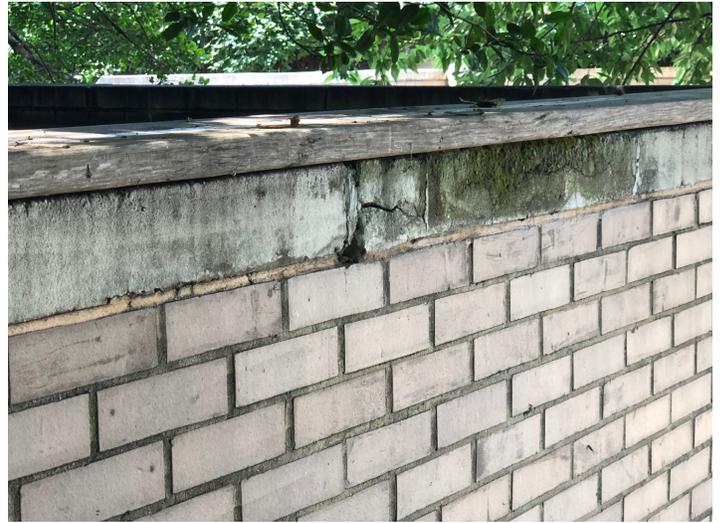
CP-A11

- CP-A11** At the second story floor line, the mortar at the relief angle is being pushed out of the masonry joint, along the entire perimeter of the building. The shifting mortar has potentially allowed water into the wall which has likely deteriorated the steel relief angle. It is recommended that at least three courses of masonry be removed, and the steel angle be replaced with a new galvanized steel relief angle. Flashing with a drip edge and masonry weep holes should be provided over the new steel angle to allow any future moisture in the wall to get out. New masonry and mortar should be patched back into the wall once the relief angle is replaced.

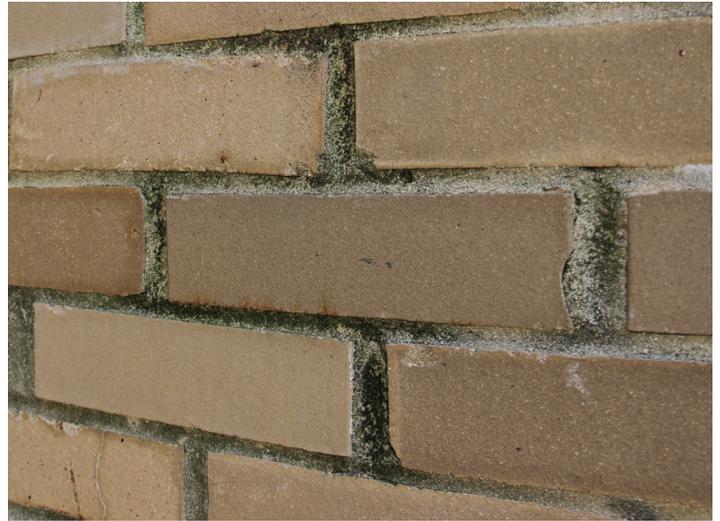
CJ-A01

- CJ-A01** The brick, mortar, and concrete throughout the building are dirty with some areas showing signs of weathering, staining, mold growth and efflorescence on the brick surface. The exterior of the entire building should be cleaned to remove debris, mold, staining, and efflorescence present on existing surfaces. Cleaning should be performed prior to any masonry or concrete repairs as further damage may be uncovered with the cleaning.

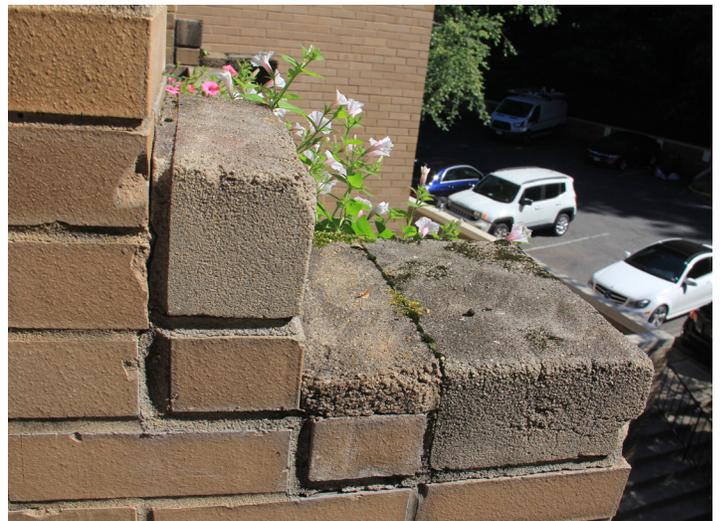
CJ-A05

- CJ-A05** The planter beds and retaining walls around the building all have concrete caps, some which have been damaged. These caps had a mixture of mortar and sealant used to seal the caps. The mortar joints if cracked can allow moisture into the wall. The damaged concrete caps should be repaired or replaced. The mortar joints in the caps should be replaced with sealant. Concrete caps should have a slope at the top to drain water from the caps. If caps are to be replaced sloped caps should be provided.

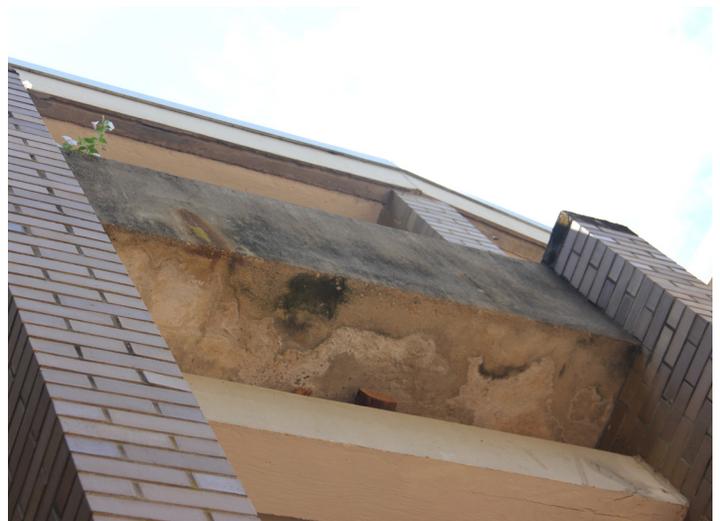
CJ-A10

- CJ-A10** Nearly all windows had stained concrete sills and some damaged, cracking, or spalling due to water ponding on the sills. Sills need to be sloped to prevent water from sitting on the edge of the sill. Window flashing needs to be replaced at all windows and be provided with a sloped sill piece to drain water. A replacement of all windows and flashing is recommended. However, we understand the windows are the tenant's responsibility for replacement and may not be replaced all at once. An alternative option would be to provide a sloped metal sill piece at all windows that is connected to the existing windows frames now. Then in the future as the tenants replace their windows new windows and flashing should be provided. Concrete sills and lintels should be patched and repaired where damaged.

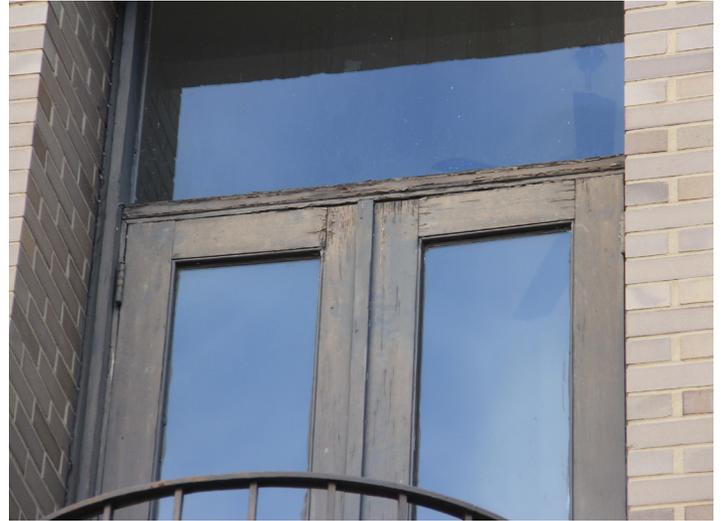
CJ-A12

- CJ-A12** The existing wood window frames are weathering, and the glass is single pane. The wood windows should be replaced with aluminum framed storefront windows with double pane glass. Window flashing should be replaced and a sloped sill pieces should be provided when windows are replaced. It is understood that windows and doors are the tenant's responsibility. However, weathered and deteriorating frames can allow water into the building potentially causing damage to other surfaces.

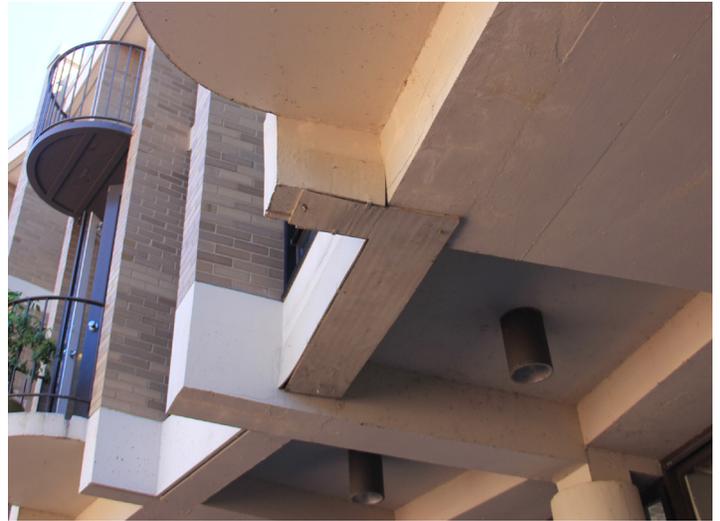
CJ-S01-2

During our visual survey of each balcony from the ground level, we noted that the concrete edge beams at the soffit of the 2nd floor appeared significantly degraded. Plywood boards were nailed to these beams (CJ-S01-2), likely to prevent spalling concrete from falling on pedestrians below. Although these boards obscured the concrete surface in these locations, numerous cracks were observed in the beams and slabs around them (CJ-S02-1); we believe that the concrete that is obscured by the boards has severely deteriorated. We noted that of the two balcony layouts in the building, the edge beams at the outside of the enclosed balconies were in particularly poor condition (CJ-S01-1).
