MARGARET WHITE HOUSE AND BARN Historic Structure Report

Falls Church, Virginia

Final Report

December 20, 2017
WJE No. 2015.3162.6

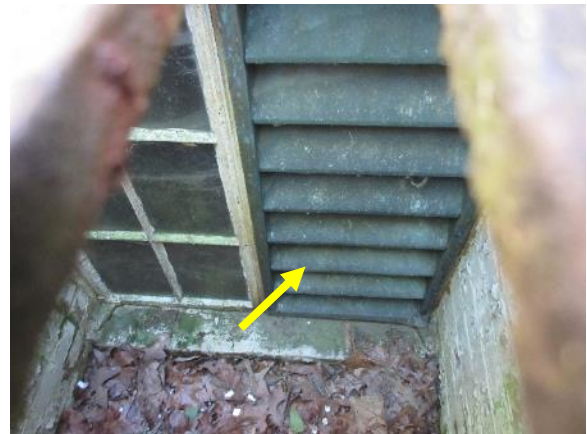
Figure 42. Basement casement window with one sash replaced with a louver.

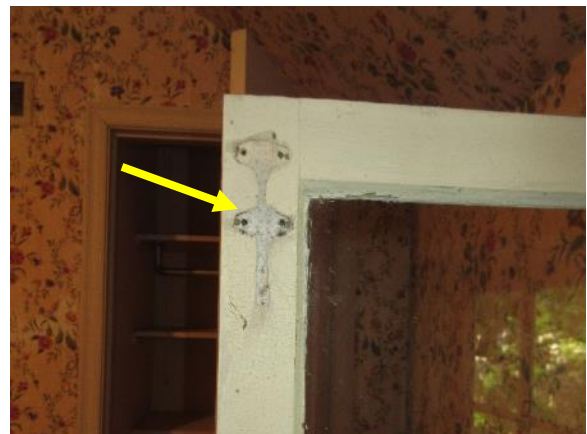
Figure 50. Missing sliding locks on interior storm windows of west window in Bedroom B.

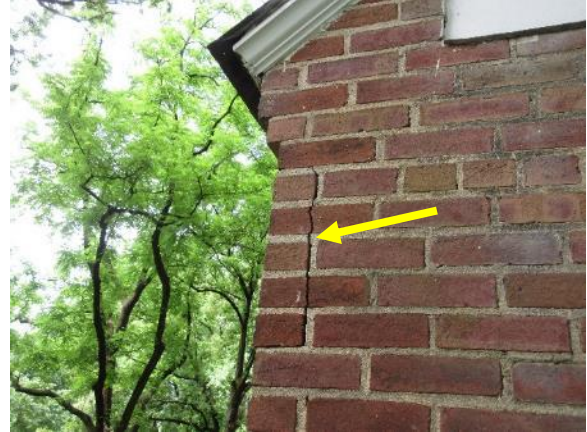
Figure 80. Vertical cracking at south east corner.

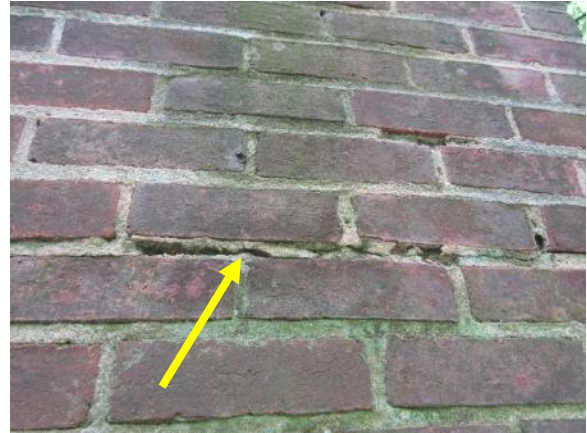
Figure 82. Missing and cracked mortar at chimney on north facade.

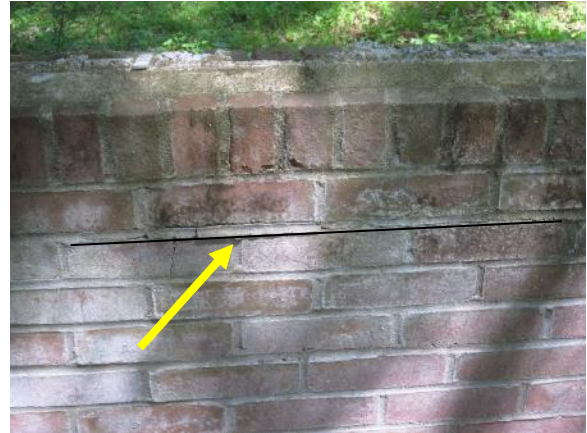
Figure 86. Horizontal crack through mortar on greenhouse wall. Crack traced for clarity.

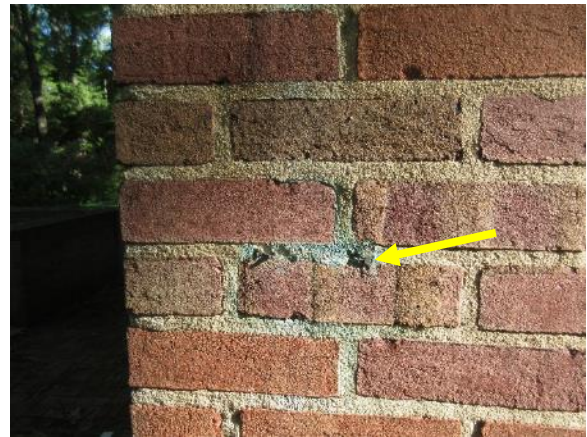
Figure 88. Typical copper staining due to metal fasteners (south facade).

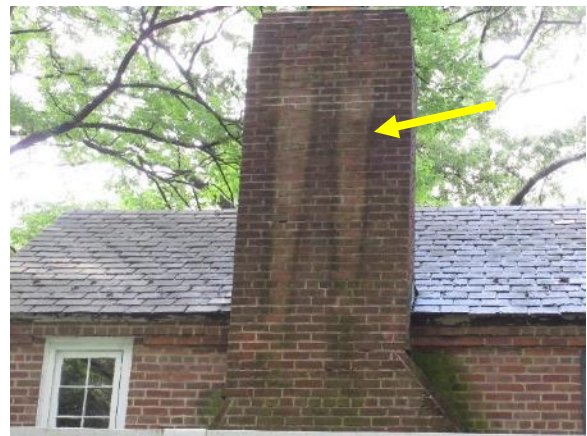
Figure 90. Surface staining of brick due to water runoff from chimney cap.

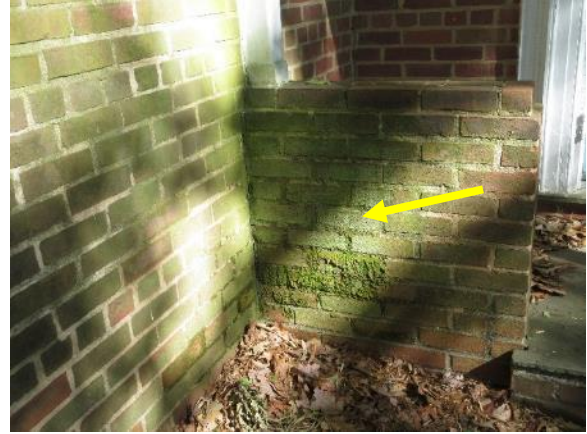
Figure 92. Biological growth and staining of brick at entryway corner.

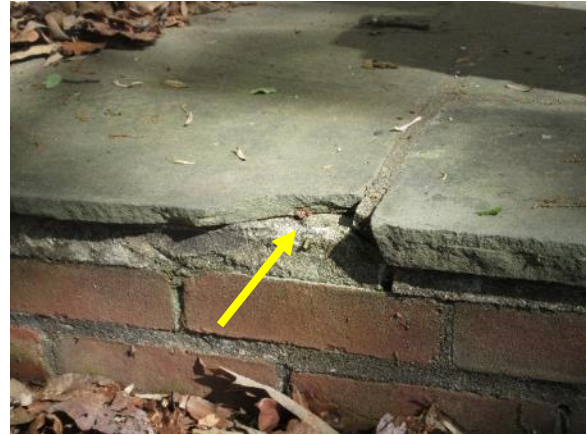
Figure 94. Spalled stone paver on front porch (south projection).

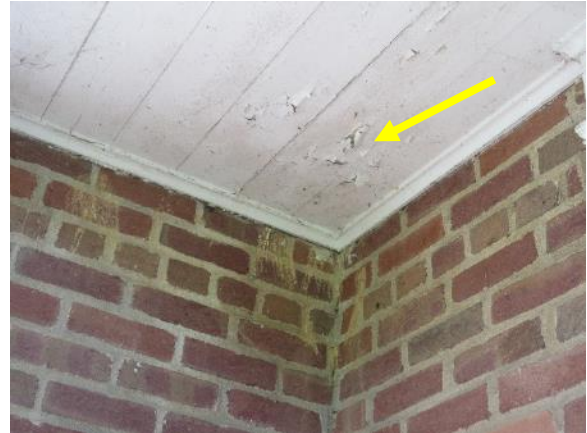
Figure 98. Typical cracked and peeling paint at front porch ceiling.

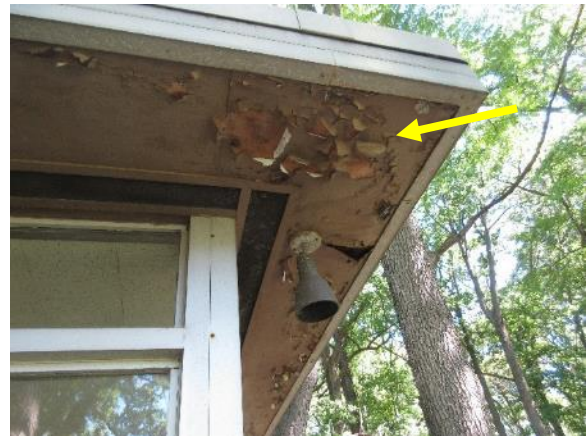
Figure 100. Typical peeling paint on the glass porch soffit.

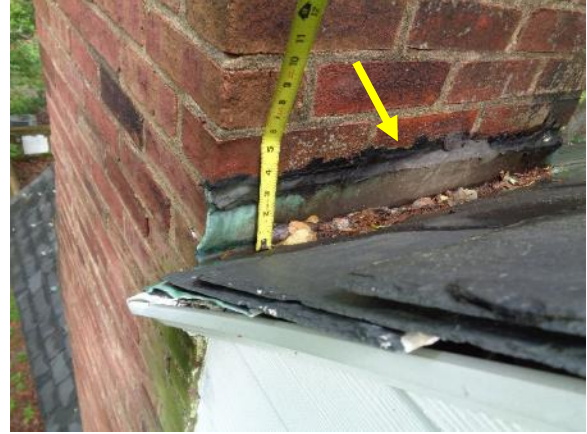
Figure 110. Copper chimney flashing on south chimney with mastic repairs.

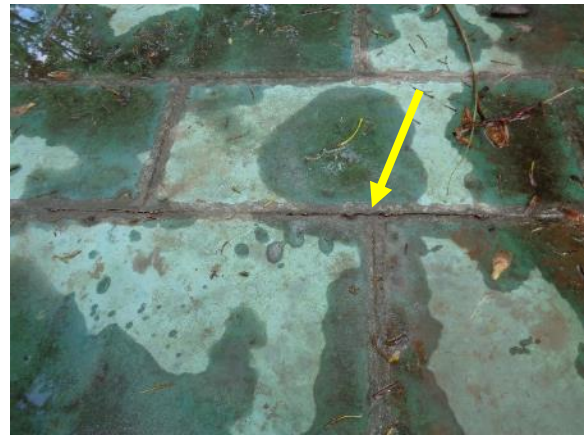
Figure 114. Cracked seams at expansion joint of copper roof over glass porch.

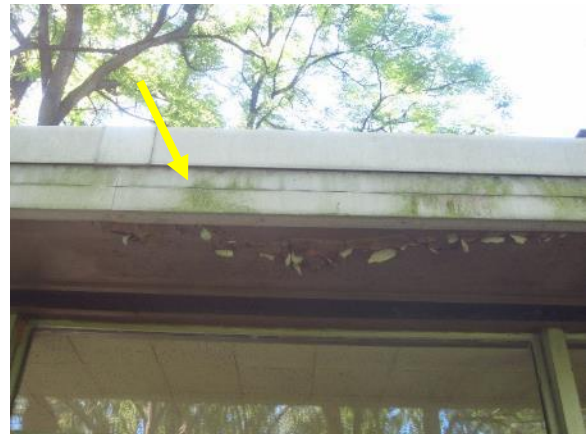
Figure 118. Typical biological growth along gutter of glass porch.

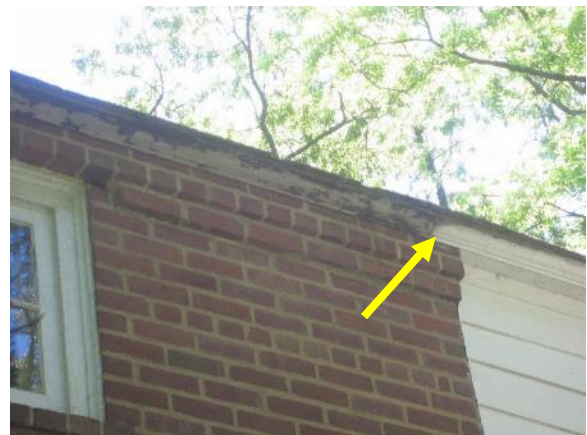
Figure 120. Painted wood trim above siding (west elevation).

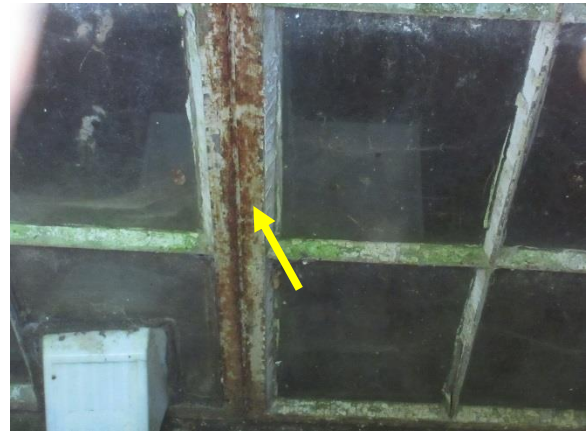
Figure 124. Corroded window casing and sash in basement.

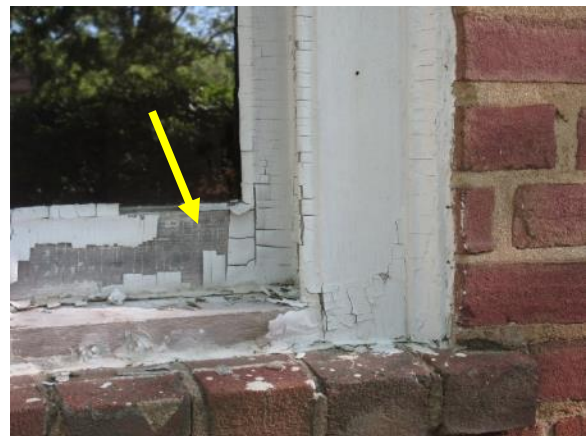
Figure 126. Typical cracked and peeling paint at exterior of window.

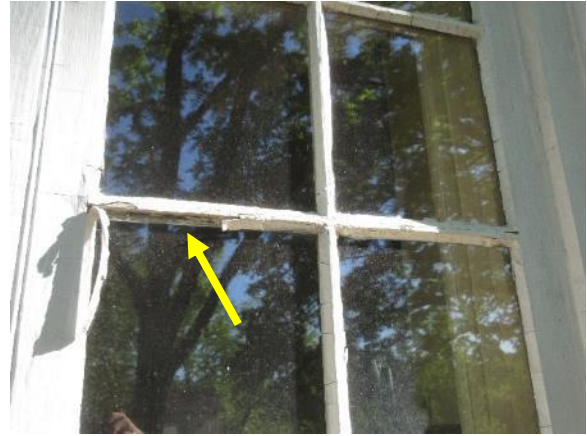
Figure 128. Typical missing glazing putty at exterior windows.

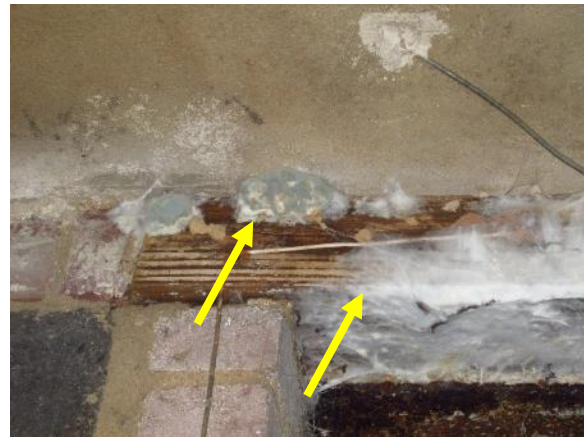
Figure 134. Potential microbial growth and rot on wood lintel in basement.

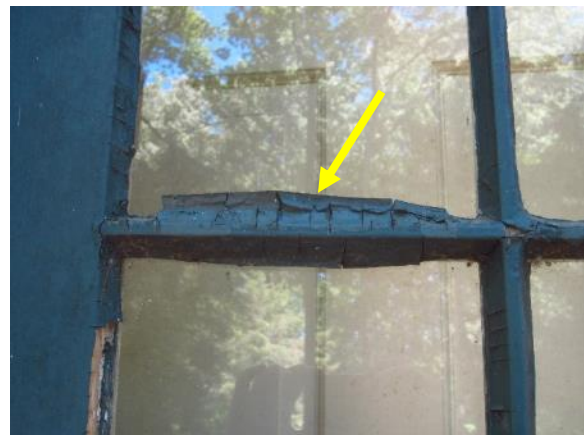
Figure 136. Typical cracked glazing putty at exterior doors.

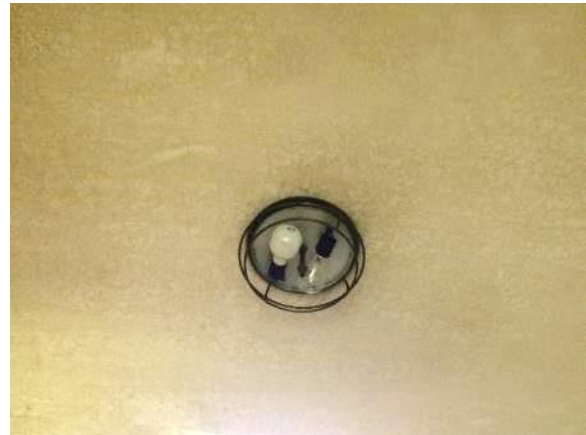
Figure 164. Circular light fixture in foyer with metal base and missing globe.

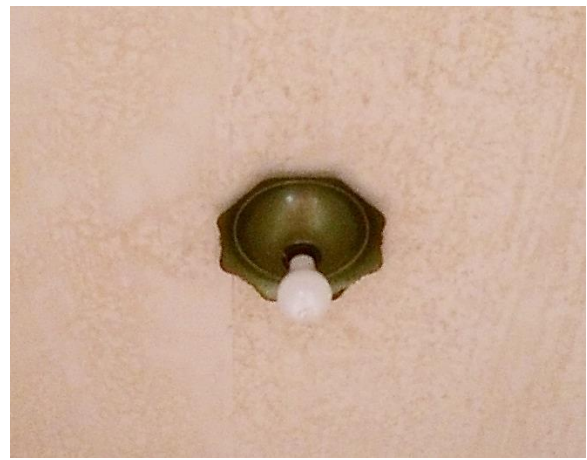
Figure 168. Hallway light fixture with decorative circular metal base and missing globe.

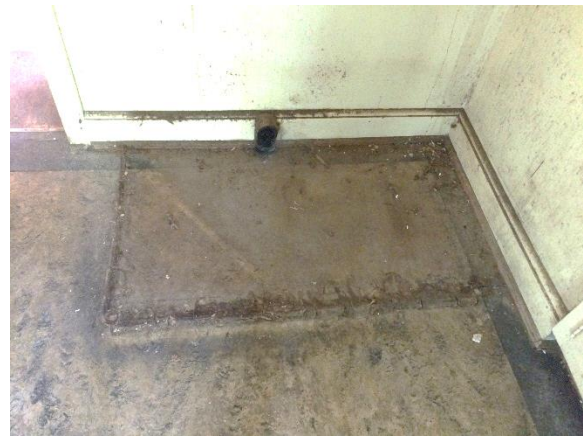
Figure 180. Stained linoleum flooring where kitchen appliance once sat.

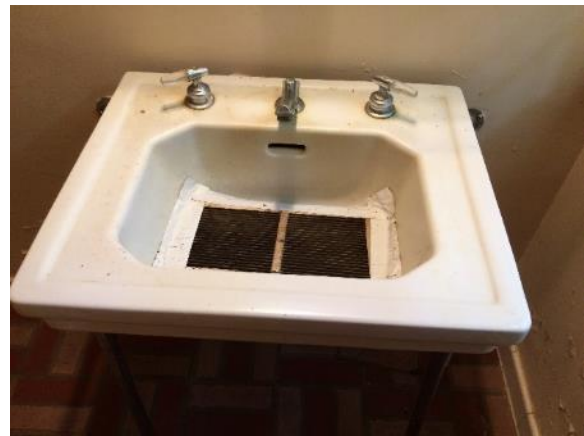
Figure 202. Missing register from Bedroom D located in first floor bathroom sink.

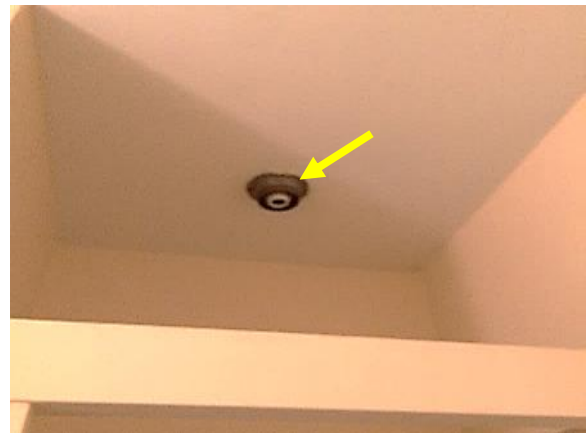
Figure 214. First floor bathroom light fixture above shower missing bulb and glass globe. The fixture is typical for Bathroom B as well.

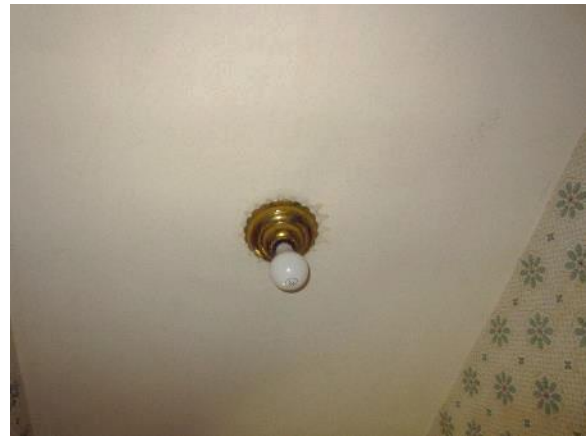
Figure 252. Light fixture with gold base and missing glass globe located in walk through closet to Bedroom A.

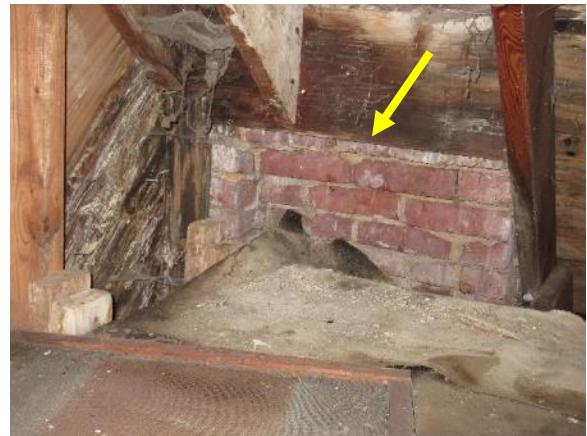
Figure 290. Brick chimney wall at southwest corner of attic above center core. Note moist wood above and adjacent to brick indicating water infiltration.

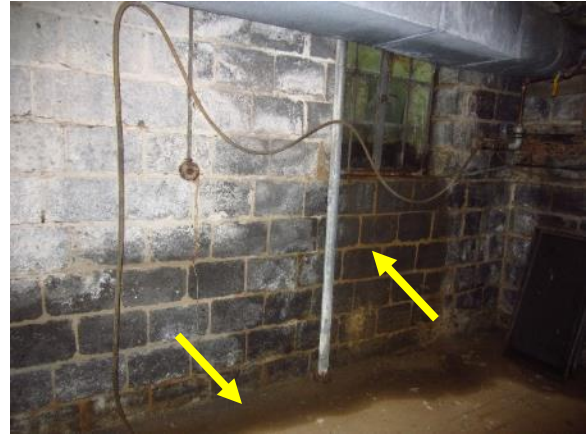
Figure 295. Damp area below window sill and at interface with floor slab several days after a rain event.

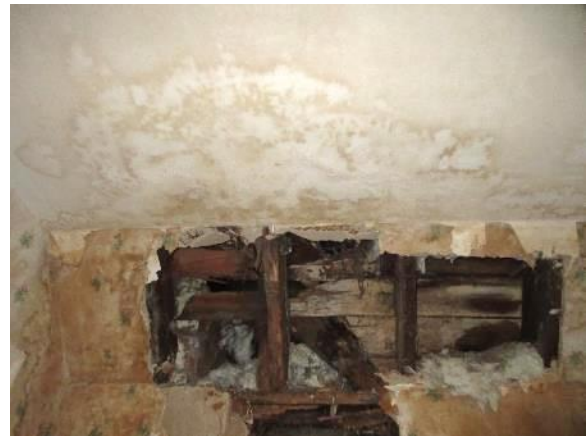
Figure 297. Missing and deteriorated plaster in Bedroom C revealing soft stud framing members.

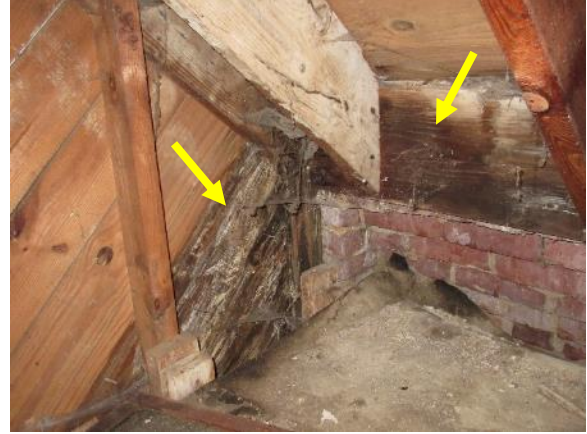
Figure 303. Soft stained wood in attic at southwest corner of house.

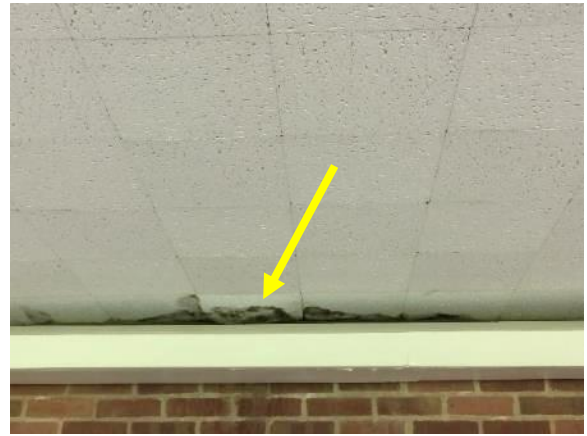
Figure 305. Water staining at acoustic ceiling tiles in glass porch.

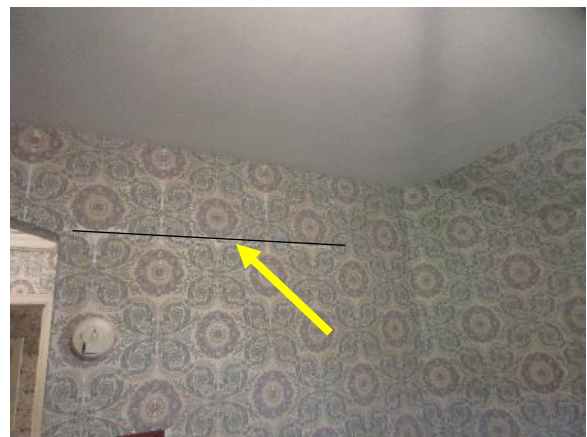
Figure 319. Horizontal crack through plaster in second floor hallway. Crack traced for clarity.

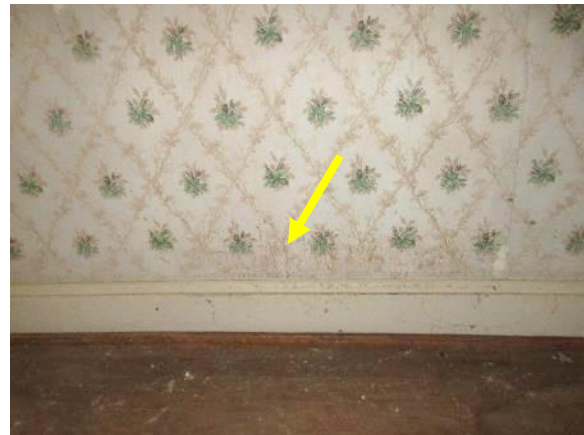
Figure 323. Scraped baseboard and wallpaper in Bedroom C.

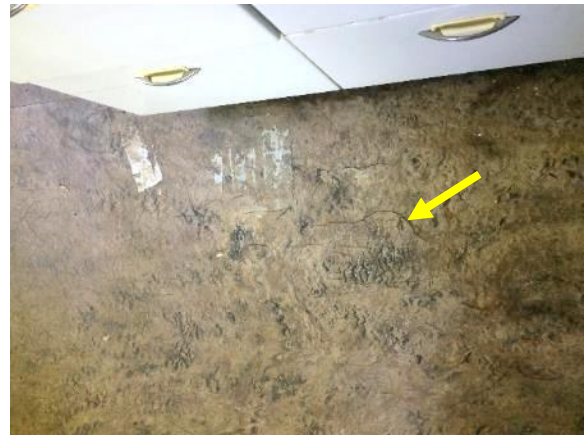
Figure 327. Cracked linoleum in the kitchen.

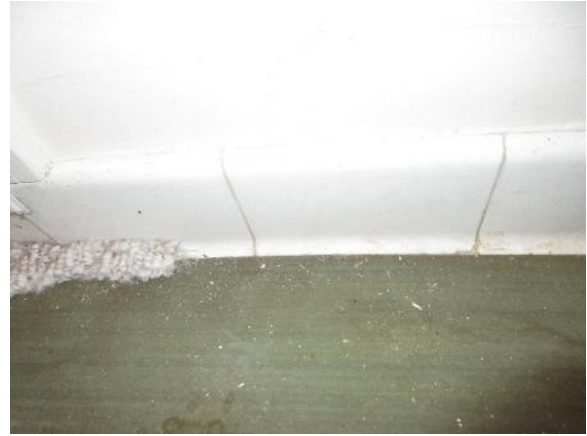
Figure 329. Subflooring under debonded carpet in Bathroom B.

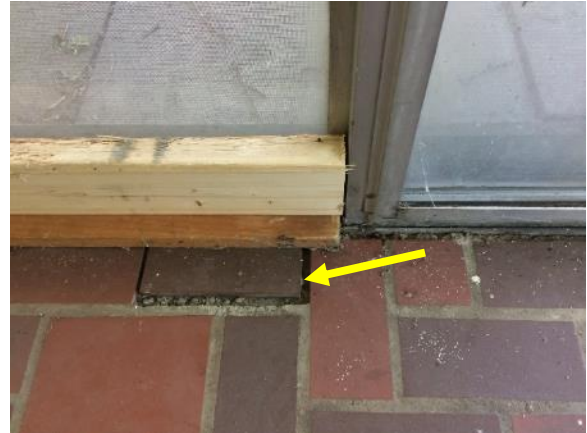
Figure 331. Loose brick paver in glass porch.

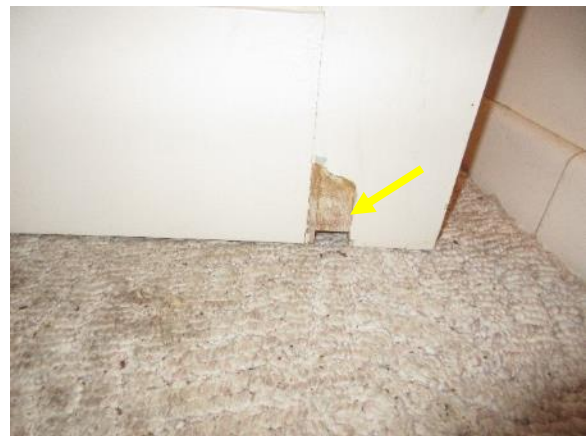
Figure 333. Chip at bottom of door to Bathroom B.

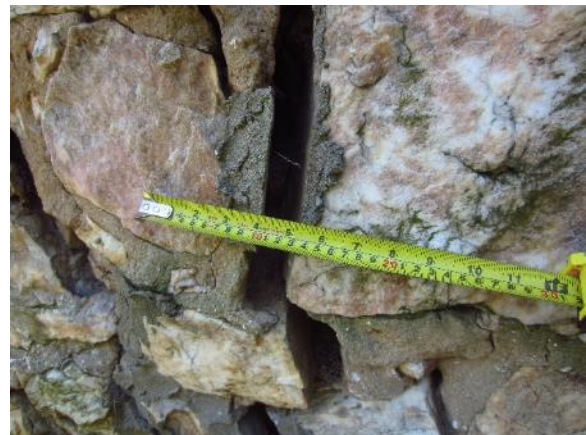
Figure 363. Displaced stone foundation on north side.

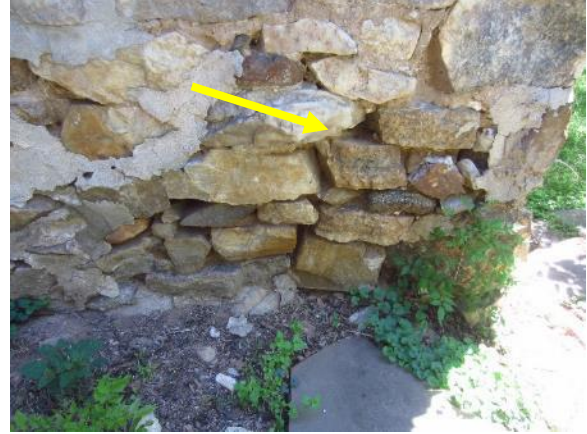
Figure 365. Missing mortar on west end.

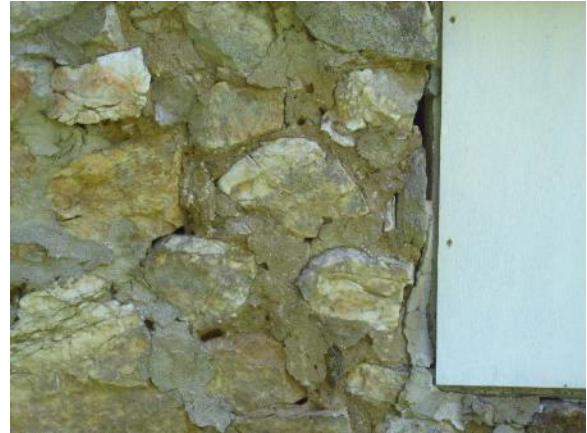
Figure 367. Typical debonded and missing mortar of foundation walls.

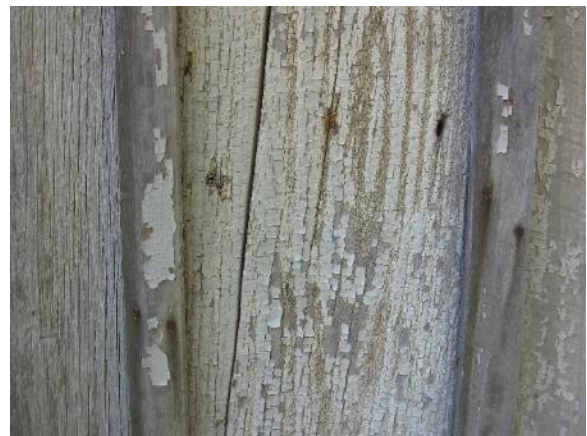
Figure 369. Typical deteriorated coating on exterior of barn.

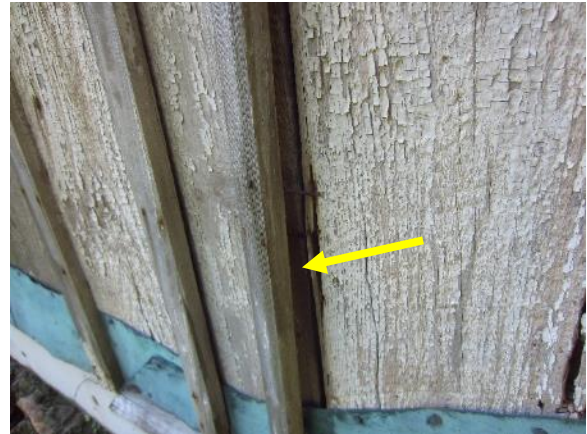
Figure 371. Partially detached batten.

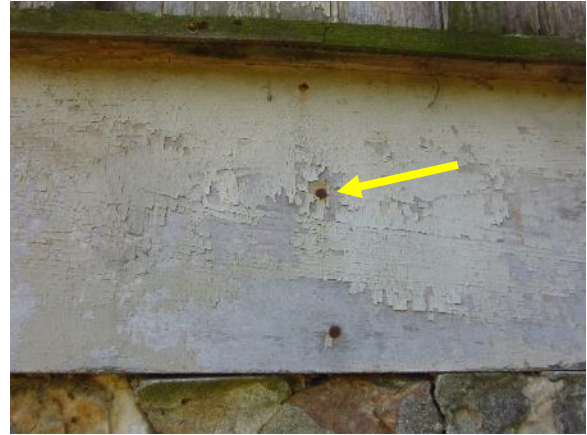
Figure 379. Typical corroding fasteners in wood.

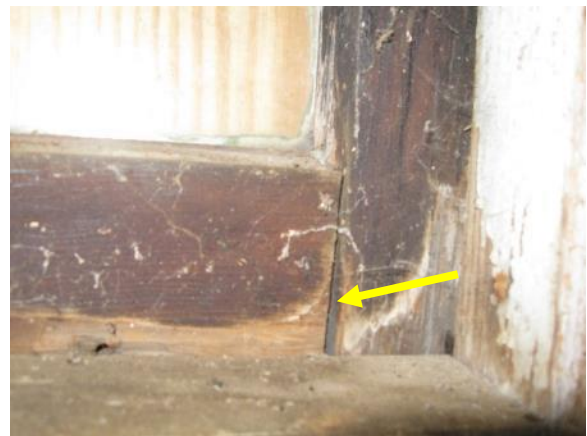
Figure 381. Typical separation between rail and stile at interior window. Note staining.

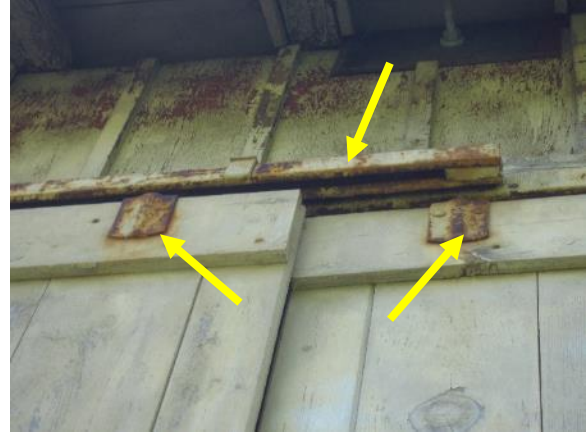
Figure 383. Rusted sliding door tracks and hardware

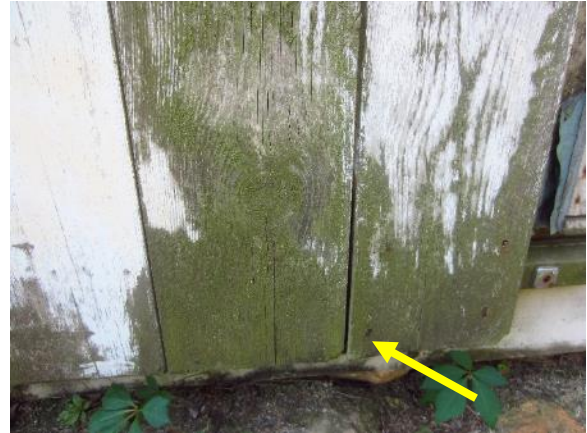
Figure 385. Vegetation growing on bottom of sliding door.

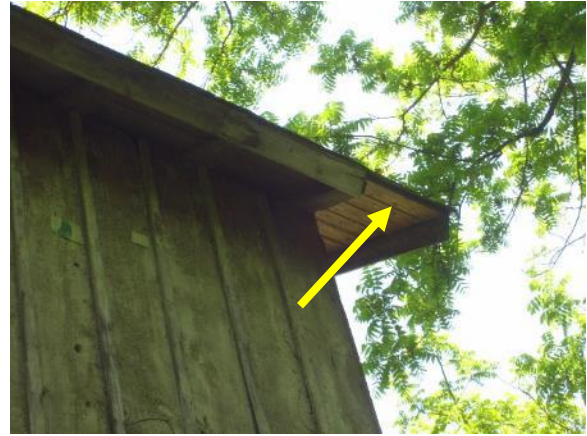
Figure 389. Missing fascia board along south eave.

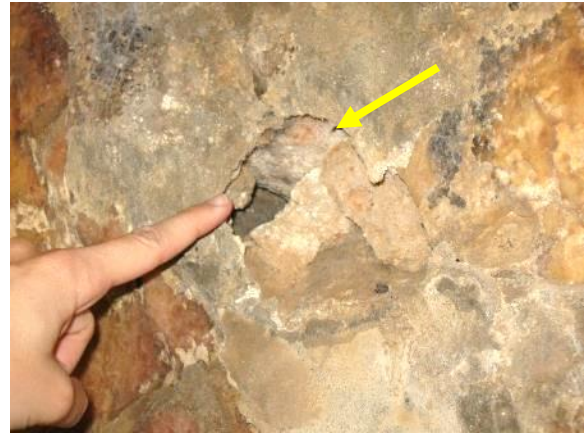
Figure 412. Typical debonded and weak mortar on stone foundation walls in basement.

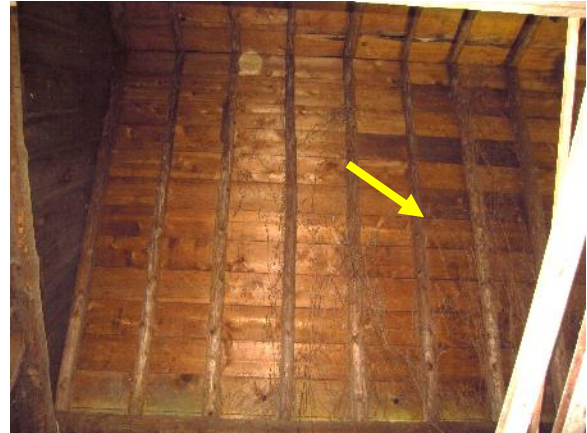
Figure 422. Vegetation on northern roof interior.
