ELLMORE FARMHOUSE Condition and Treatment Report

2739 West Ox Road, Herndon, VA

Final Report

WJE No. 2017.5127

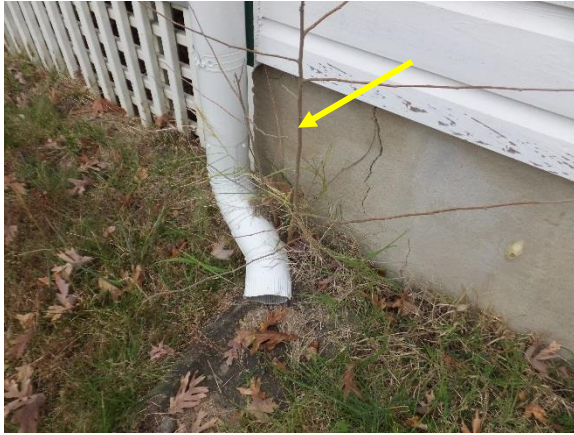
- Some vegetation was observed in close proximity to the house with evidence of growth at the foundation (Figure 11).

Figure 11. Vegetation along foundation at the southeast facade. Note close proximity of downspout to the house without splash pads and crack in foundation parge coat.

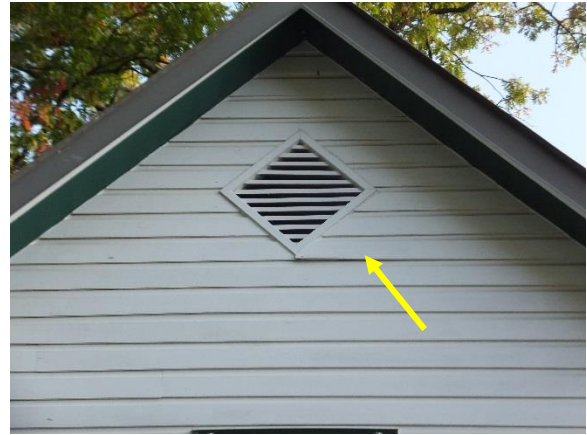
- Displaced wood siding boards were observed at locations throughout the facades, generally around window and vent openings (Figure 12 and Figure 13).
- Several cracks and isolated areas of spalls were observed in wood siding, typically originating from the end of the board or at fasteners. Previous crack repairs were also observed throughout the facade (Figure 14, Figure 15, and Figure 16).
- Minor paint deterioration such as peeling, cracking, and discoloration was observed throughout the exterior of the home with some areas coincidental with wood deterioration as the wood material became exposed with the compromised coating (Figure 17 and Figure 18).

Figure 12. Example of displaced siding at southwest facade.

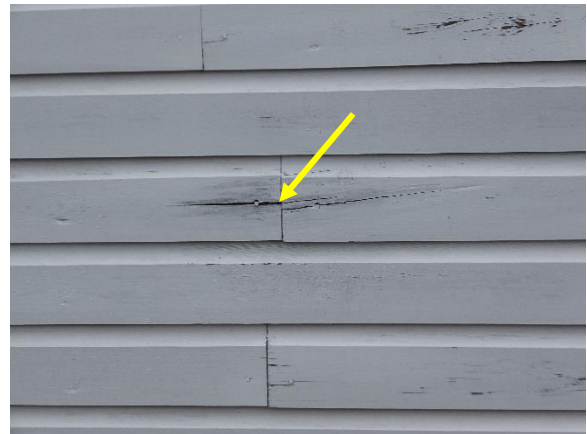
Figure 14. Typical cracking at fastener and end of boards.

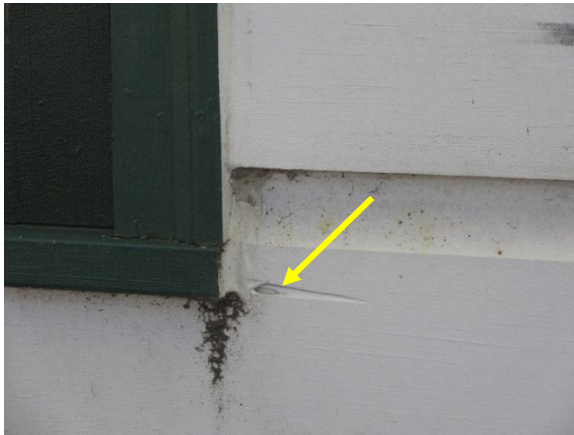
Figure 15. Chip in siding adjacent to a window corner. Typical on northwest facade.

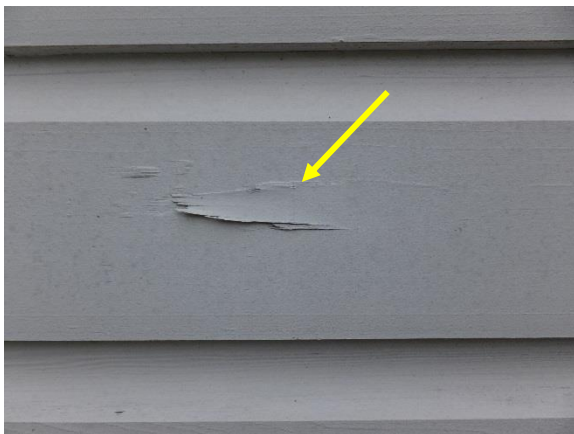
Figure 17. Typical flaked paint, and potentially damaged wood below, on wood siding.

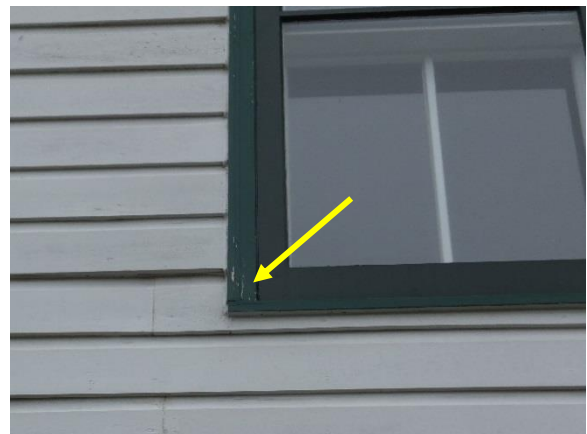
Figure 18. Flaked paint on window frame at southeast facade.

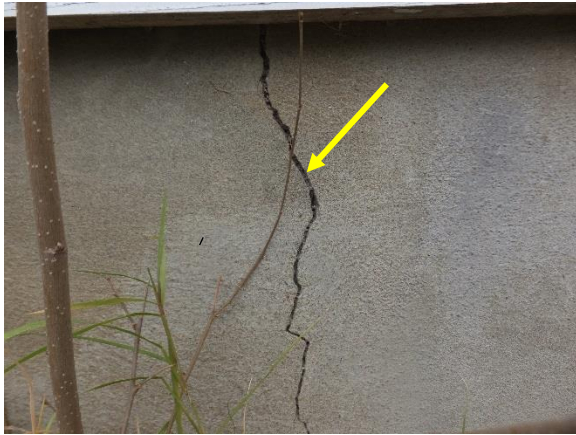
- The field stone foundation at the original portion of the home appears to be in poor to fair condition. Several cracks and isolated spalls were observed in the cementitious parge coat at the areas visible at the exterior of the home (Figure 19, Figure 20, and Figure 21). Moreover, the foundation wall was observed at the interior to be bowing concavely at the northwest façade (Figure 22). There is a large tree in close proximity to this side of the house that may be contributing to the foundation wall condition.

Figure 19. Typical crack and slight delamination in parge coat at original foundation.

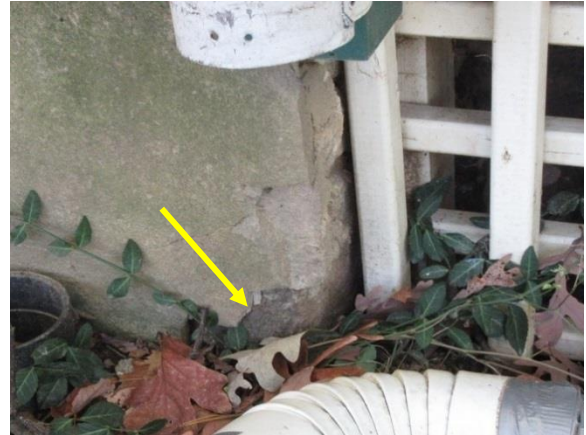
Figure 20. Spall in parge coat at original foundation exposing stone foundation.

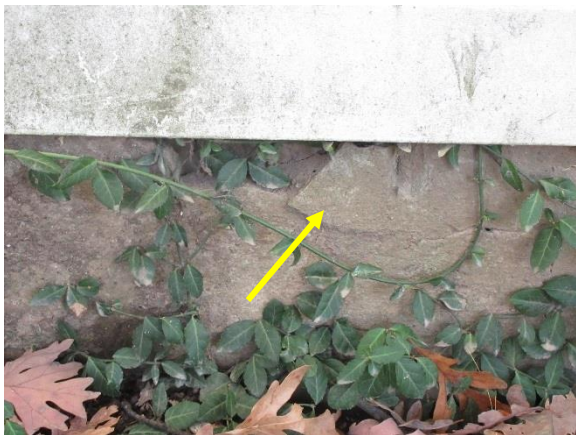
Figure 21. Incipient spall in parge coat at original foundation near window well.

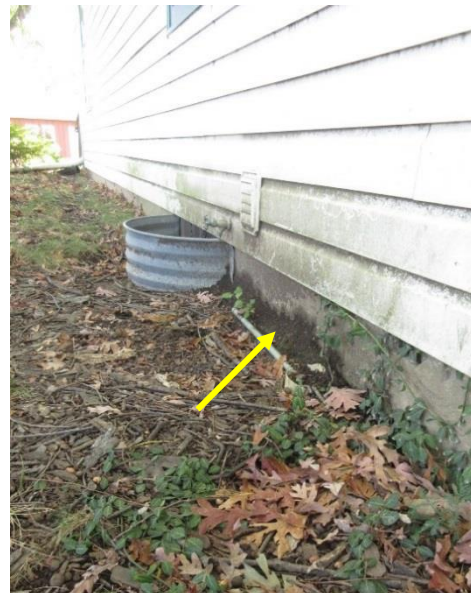
Figure 22. Foundation wall concave at original foundation. Note vegetative growth and staining at parge coat and above siding.

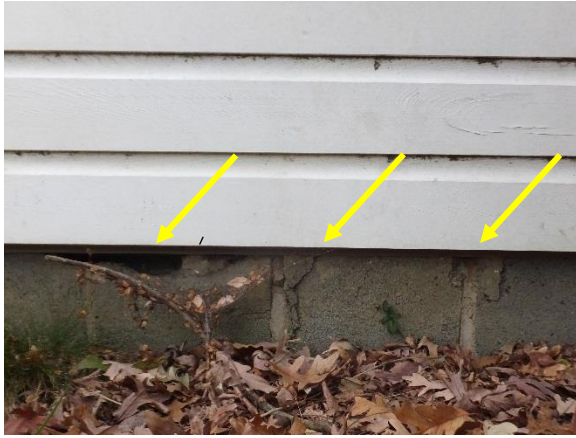
- The foundation at the additions of the home were observed to be in good condition with isolated and very minor cracks and spalls (Figure 23) in the parge coat. At the foundation located on the northwest elevation, isolated areas of spalling and deteriorated mortar joints was observed at the CMU foundation block (Figure 24). In addition, three partially sealed pipe penetrations through the foundation to room 105 (bathroom) are located at the southeast facade to accommodate existing utilities (Figure 25).

Figure 23. Typical spall and cracking in parge coating and CMU foundation at rear of additions.

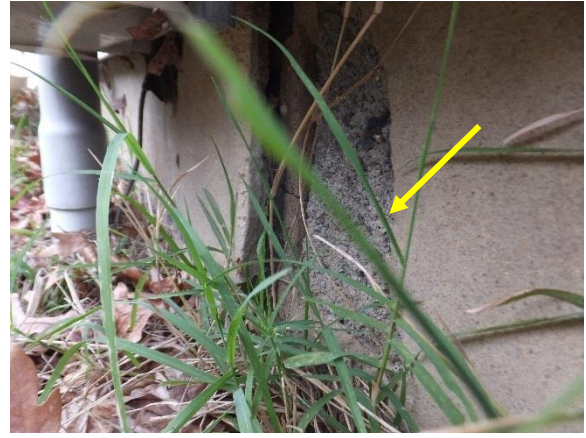
Figure 24. Delamination in parge coat exposing CMU foundation between ca. 1945 and 1984 additions on southeast facade.

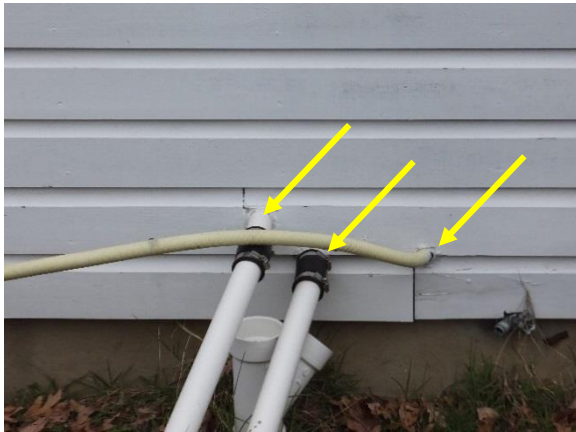
Figure 25. Partially sealed pipe penetrations on southeast facade.

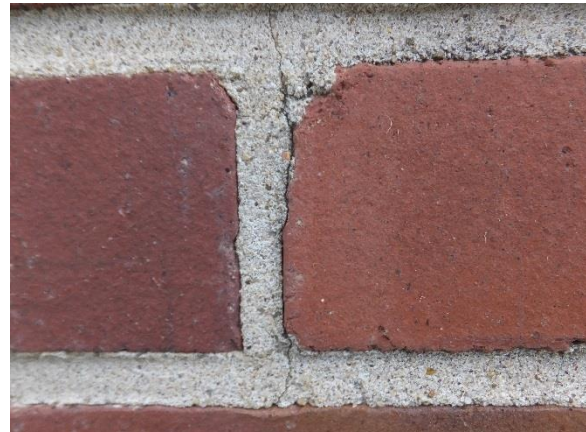
- In general, the chimneys are in good condition. Minor deterioration was observed at the chimney located on the southeast facade including isolated cracks, deteriorated mortar joints and an area of paint staining (Figure 26 and Figure 27).
- Dark staining was observed at the chimney located at the rear of the 1945 addition (Figure 28).

Figure 26. Cracking in mortar joint at chimney on southeast facade.

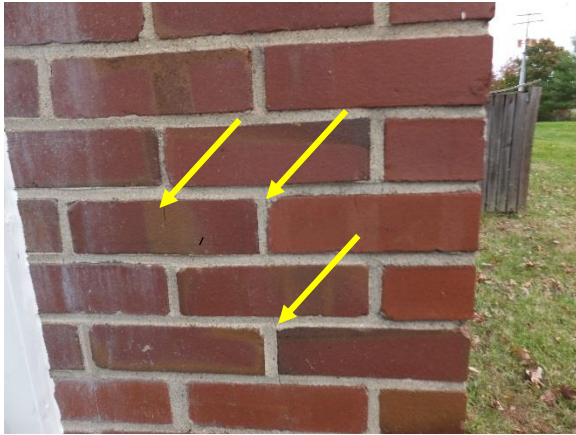
Figure 27. Typical crack in brick and mortar at chimney on southeast facade.

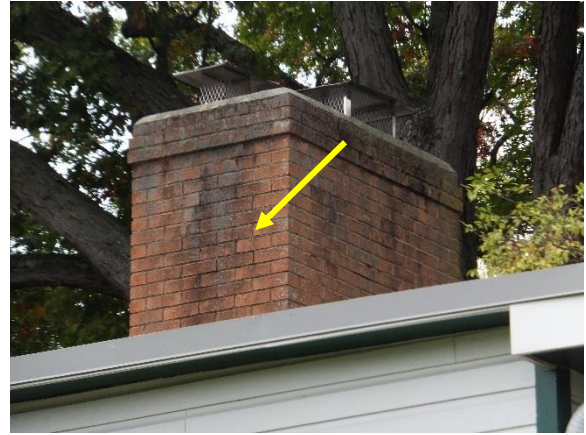
Figure 28. Staining at chimney located at the rear of the 1945 addition.

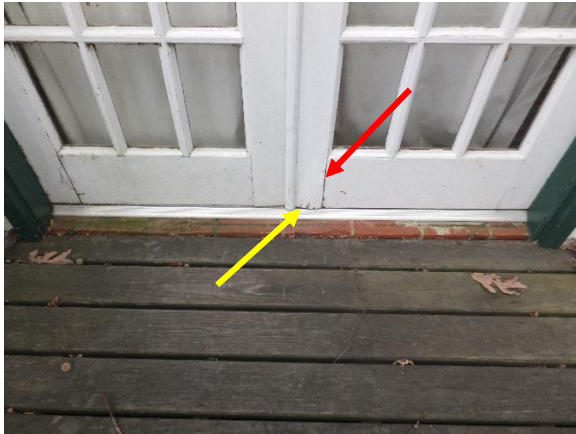
- The exterior doors of the home are in good condition with areas of minor deterioration. Separation between joinery, splintered wood, and missing door hardware was observed at the base of the French doors on the northeast facade (Figure 29 and Figure 30).

Figure 29. Splintered wood at base (yellow arrow) and separation of joinery (red arrow) at French doors.

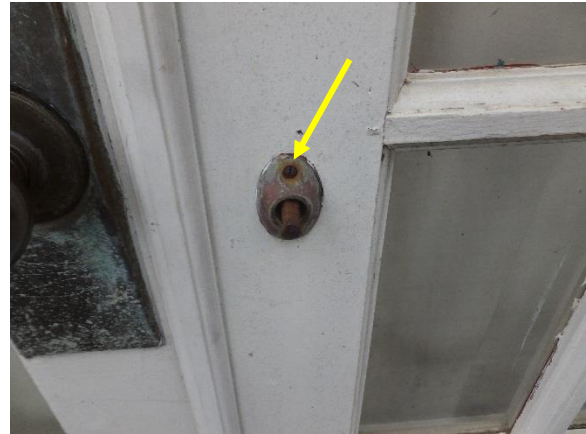
Figure 30. Missing doorknob at French doors on northeast facade.

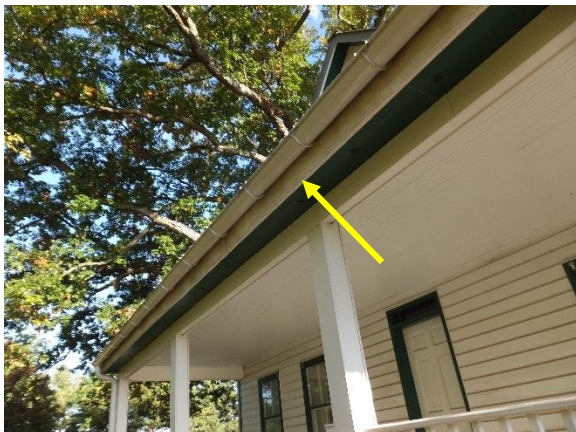
- The metal roofing throughout the home is in good condition with minor areas of soiling such as below gutters (Figure 31).
- A dent and area of displaced metal was observed at the metal coping on the southeast facade (Figure 32 and Figure 33).
- Most downspouts do not have splash pads or extension resulting in the discharged water being deposited close to the foundation (Figure 33 and Figure 34). One downspout was observed to be disconnected at the northwest elevation (Figure 35).

Figure 31. Soiling at fascia board behind gutter.

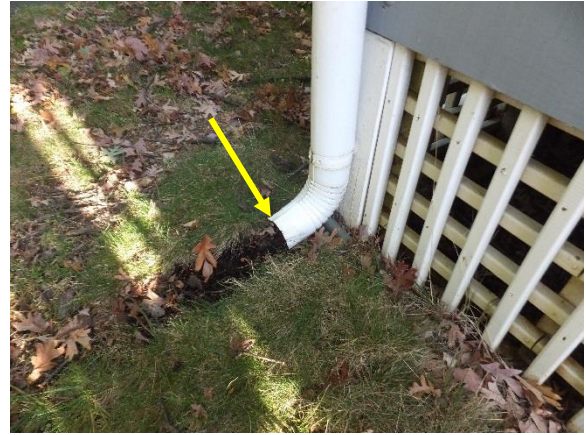
Figure 34. Downspouts terminate near the foundation without splash pads or extensions and have eroded the adjacent soil, typical.

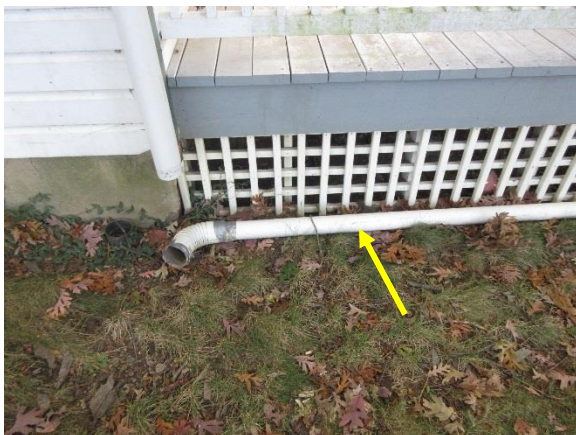
Figure 35. Disconnected downspout at northwest facade.

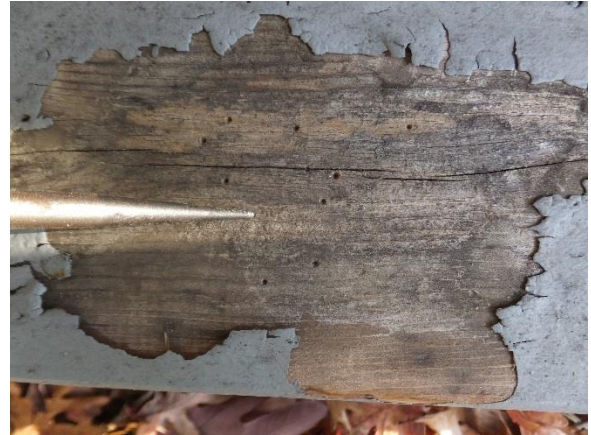
Figure 38. Paint and wood deterioration at porch stairs.

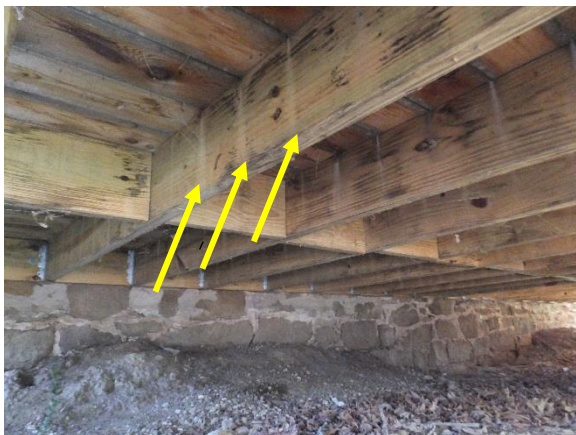
Figure 39. Wood joists under porch exhibiting staining, likely from water.

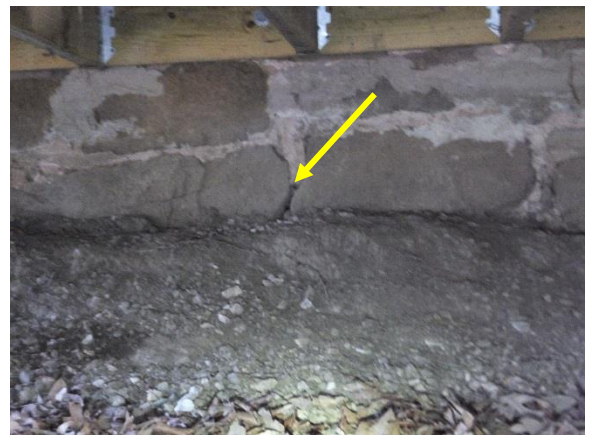
Figure 40. Missing mortar in stone foundation.

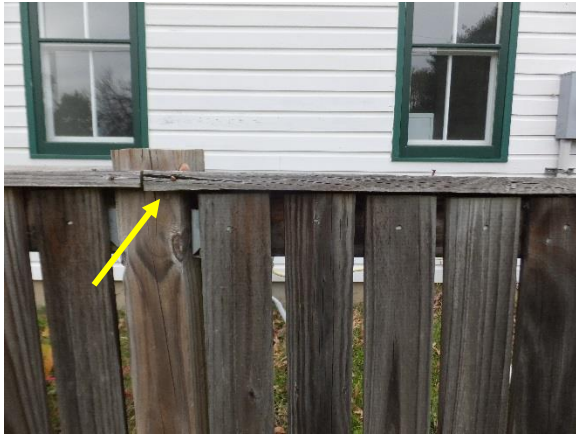
- The wood fence added on the southeast façade is fair condition with areas of multiple cracks, missing areas of wood, and missing rail caps (Figure 41). In addition, as the wood is uncoated, the fence exhibits staining, displacement, and bowing (Figure 42).

Figure 41. Multiple areas of splintered wood on fence at southeast facade.

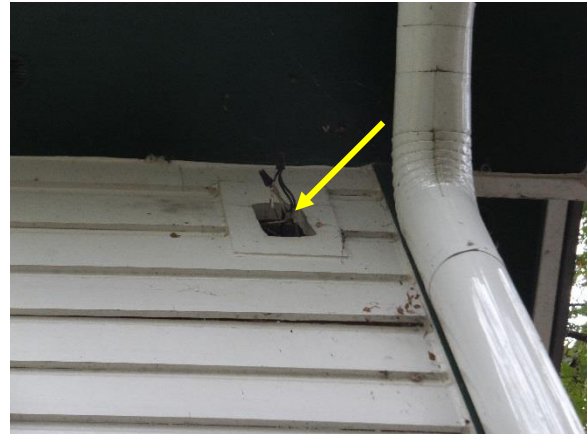
- The exterior lighting fixture located on the northeast facade is in good condition with one fixture missing on the upper corner of the facade (Figure 44).

Figure 44. Missing light fixture at northeast facade.

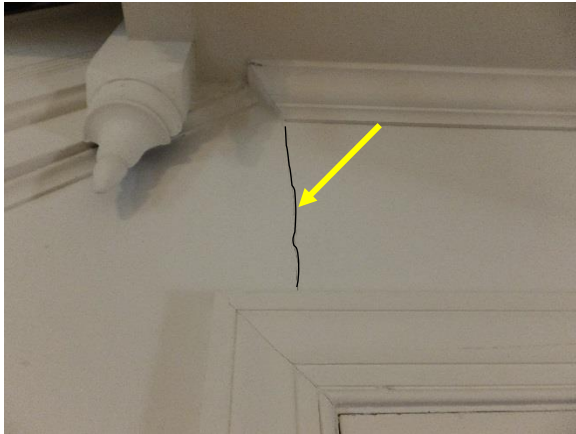
- Interior wall finishes consist of drywall, plaster, and wood paneling. Cracking of plaster and drywall was observed throughout the home generally located near window or doorframes, walls seams, fixtures, ceiling interfaces, and at drywall board seams (Figure 45, Figure 46, and Figure 47). Diagonal cracking was observed on the walls in the stairwell, living room (room 101), and first and second floor bedrooms in the historic portion of the home (Figure 48, Figure 49, Figure 50, and Figure 51). Cracks typically emanated from the ceiling to the wall base with several intermediate cracks following the crack pattern. These cracks were also evident on closet walls in Rooms 201-204 (bedrooms).

Figure 45. Cracked plaster/drywall above 1st floor doorframe, typical. Crack traced for clarity.

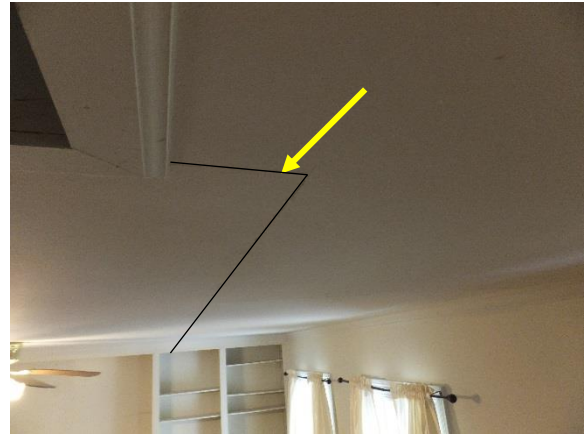
Figure 46. Cracking at ceiling (1st Floor) likely seams between drywall boards. Crack traced for clarity.

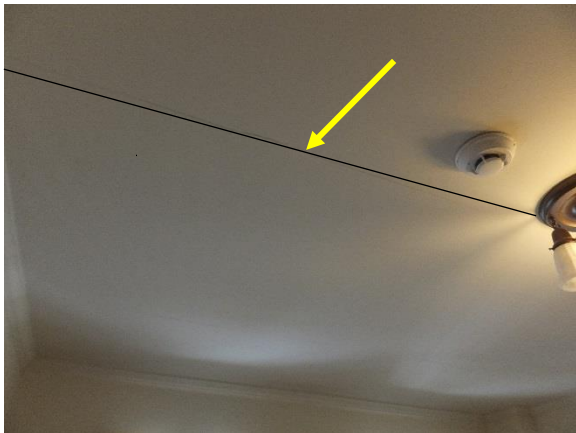
Figure 47. Horizontal cracking at light fixture in room 102 (bedroom/family room) likely between seams of drywall boards. Crack traced for clarity.

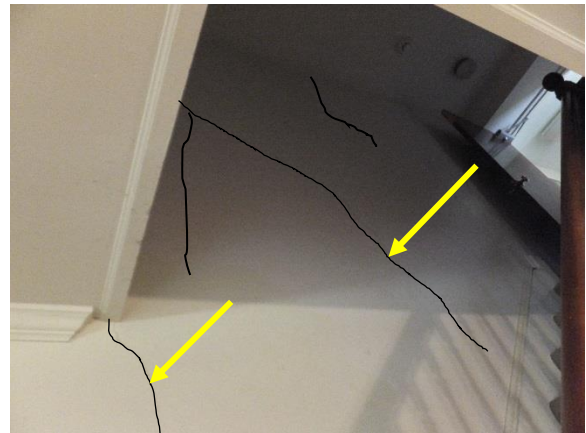
Figure 48. Diagonal cracking at stairwell. Crack traced for clarity.

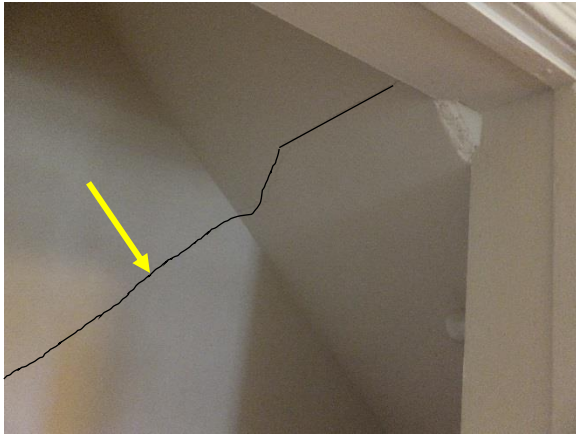
Figure 49. Diagonal cracking underneath stairwell. Crack traced for clarity.

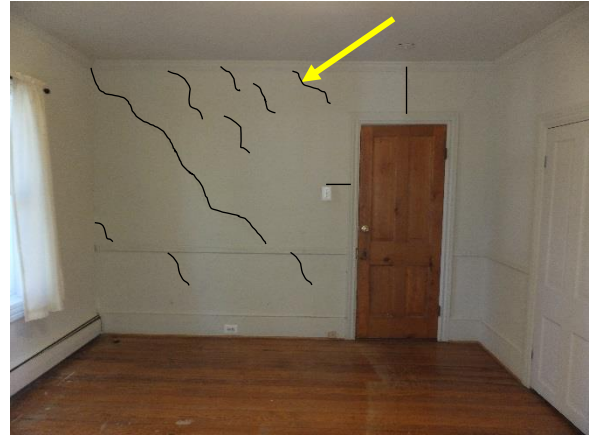
Figure 50. Diagonal and vertical cracking in room 102 (bedroom/family room). Cracks traced for clarity.

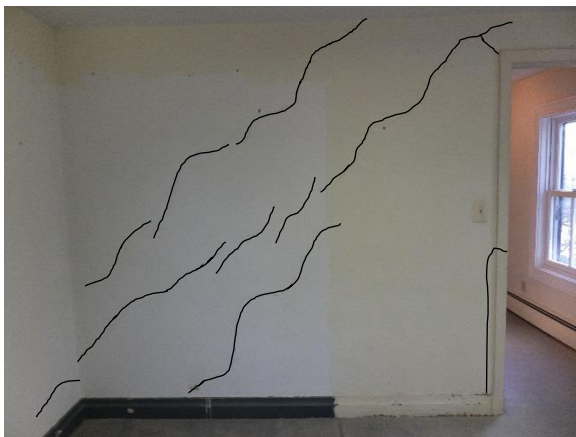
Figure 51. Diagonal cracking in room 202 (bedroom). Crack traced for clarity.

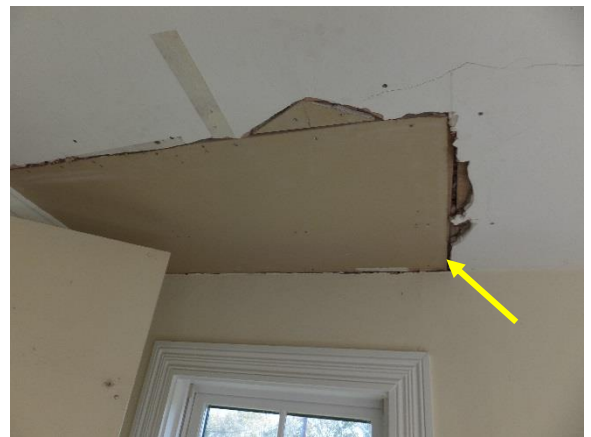
- Isolated areas of damaged plaster and drywall were observed throughout the home including stained and missing finishes likely due to previous water infiltration (Figure 52, Figure 53, Figure 54, Figure 55, Figure 56, Figure 57, and Figure 58). *Note: Although outside the scope of our work, the electrical outlet depicted in Figure 56 is partially exposed and unsecured wire runs through the plaster in Figure 54, which may present substandard electrical work.*

Figure 52. Removed area of plaster with drywall patch in room 201 (bedroom).

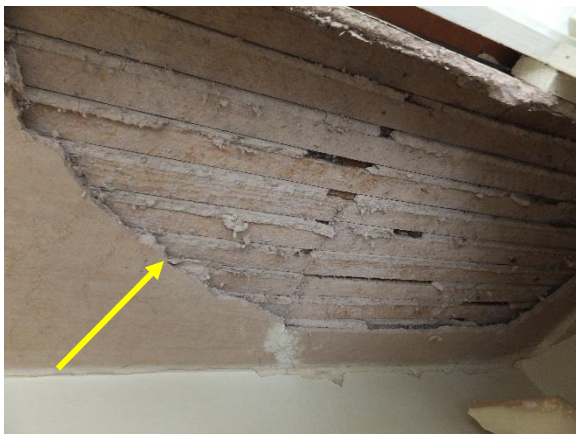
Figure 53. Missing plaster with wood lathe exposed at closet in room 201 (bedroom).

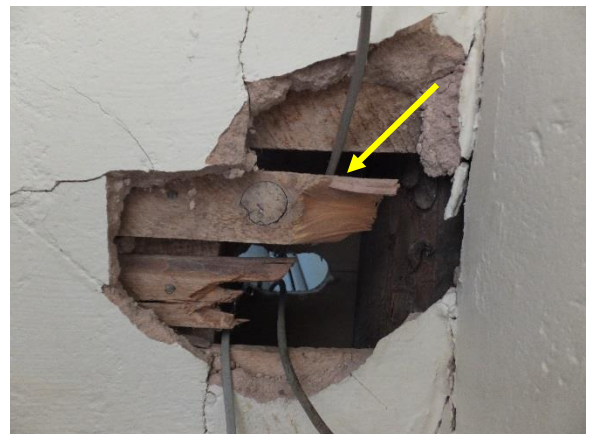
Figure 54. Hole through plaster and lathe for wiring.

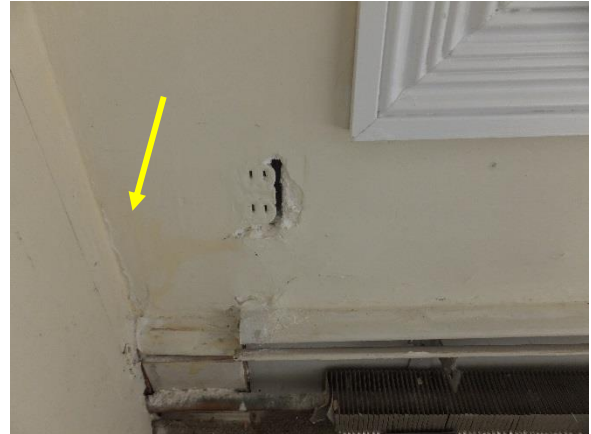
Figure 56. Stained plaster and potential previous repair. Note electrical outlet.

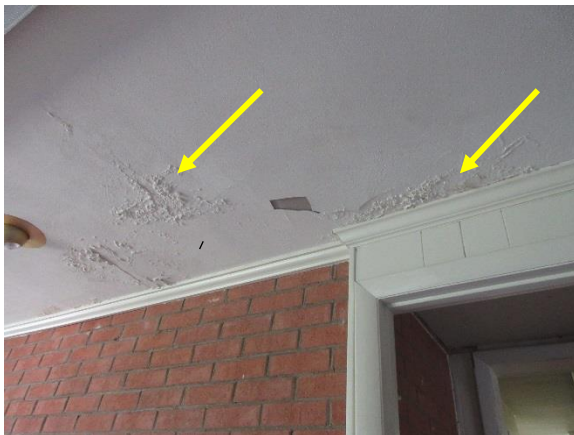
Figure 57. Damaged drywall due to water infiltration

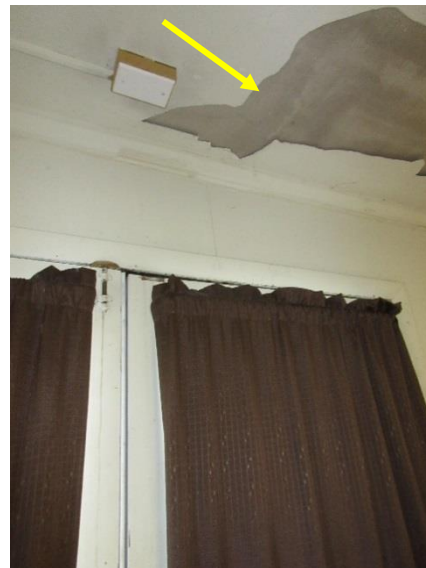
Figure 58. Drywall delamination at rear entryway.

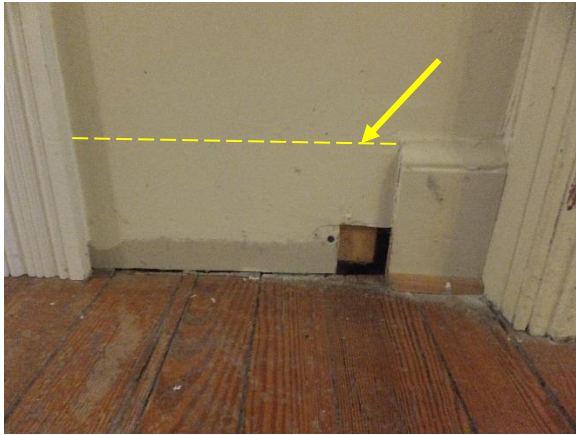
- Missing sections of baseboards associated wood elements were observed in Room 101 (living room) and 210 (office) and around ductwork on the first floor (Figure 59 and Figure 60)

Figure 59. Missing baseboard.

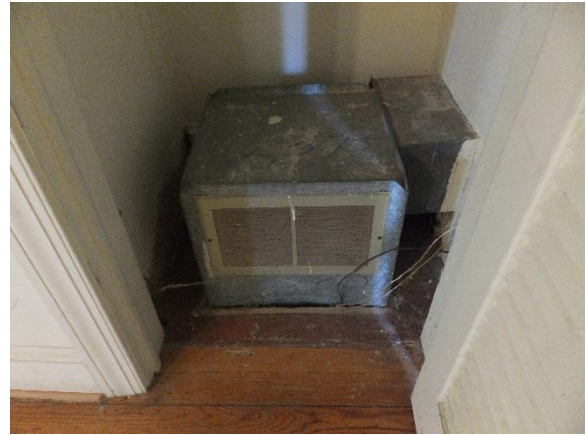
Figure 60. Ductwork installed at closet in stairwell.

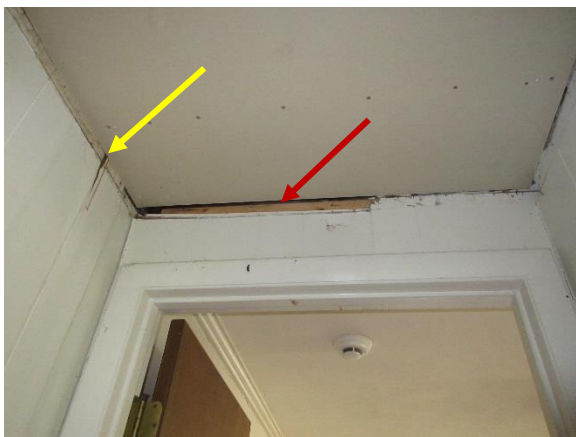
- In room 209 and 210 (offices), observations of the wood paneled siding included separation in joinery, splitting/cracking, tooling damage, and several gaps at crown molding interfaces (Figure 63, Figure 64, Figure 65, and Figure 66). In one isolated area, the siding appeared to bow inward in room 210 (office) (Figure 67).

Figure 63. Cracked wood siding panel and gaps at ceiling (red arrow) at entry of Room 210 (office), typical.

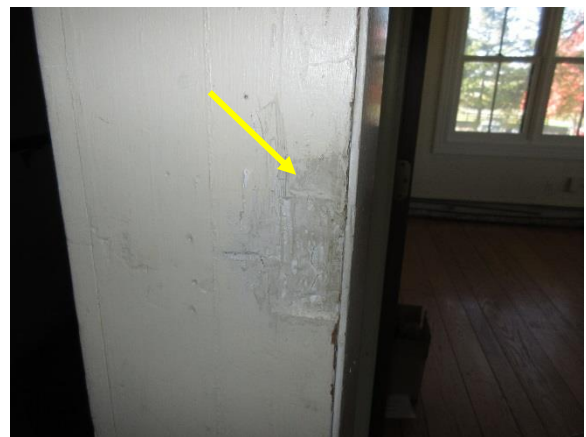
Figure 64 Tooling damage at wood siding panel at entry area adjacent to Room 209 & 210 (offices).

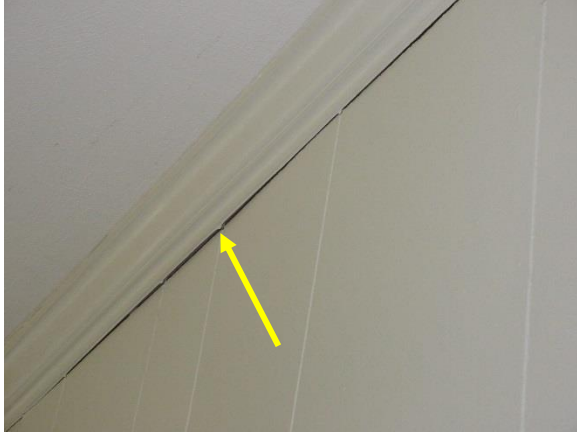
Figure 65. Gap between wood siding panel and crown molding, typical.

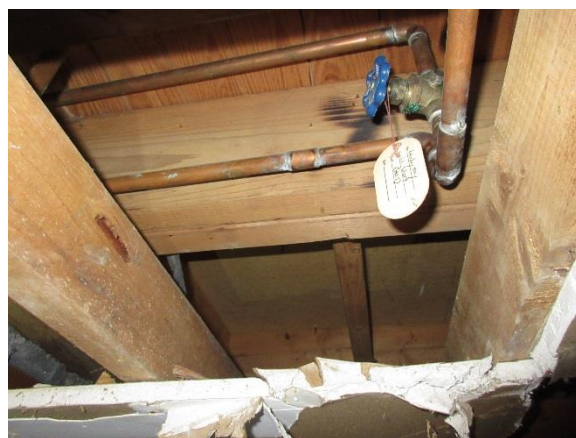
Figure 72. Condition of floor joist at 1945 addition.

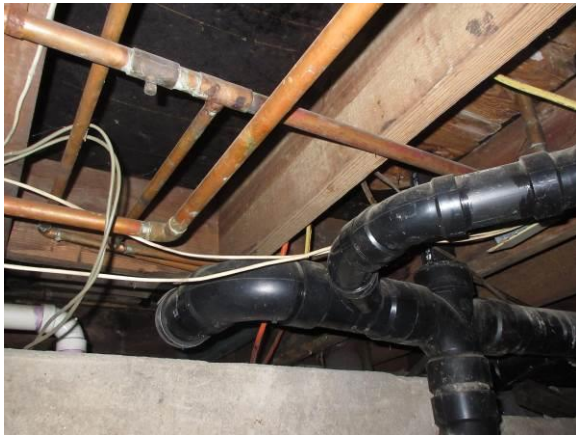
- In the cellar, conditions of the historic floor beams could not be observed due to limited accessibility/visibility. Exposed wood joists at the north corner of area B02 and B03 appeared to be in good condition (Figure 73).
- In the attic, observations included residual staining from water infiltration, rafter supports in place along the southeast, isolated areas of splitting at supports, and a missing piece of wood siding adjacent to vent at the northwest facade (Figure 74). The existing access hatch to the attic is skewed, making it difficult to lower the ladder. The original access, near the southwest wall, has been covered at the ceiling with interior finishes.

Figure 73. Condition of joists visible from cellar.

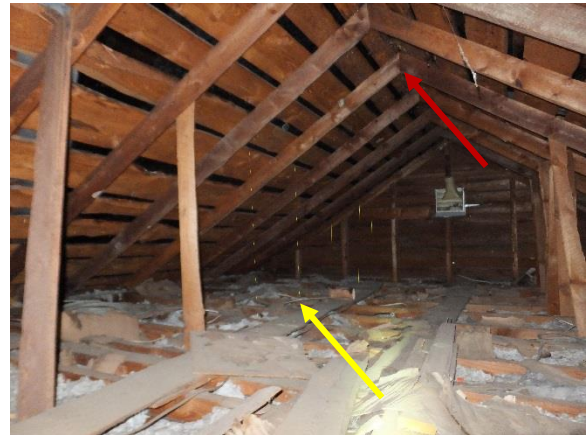
Figure 74. Rafter stud supports not continuous (yellow arrow) in attic and toe-nailed rafters (red arrow).

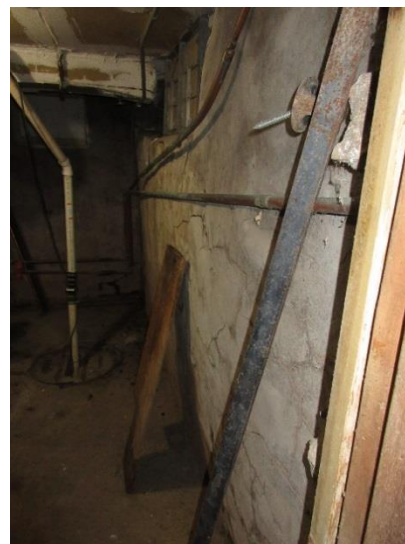
- On the northwest side of the cellar, there are multiple areas of spalling and cracking in the parge coat. The wall also appears to be out of plumb and bowing inward (Figure 76). There is a ventilation opening at this wall that opens due to wind and potentially allowing for possible water infiltration as well as insects and pests.

Figure 76. Northwest wall of cellar bowed out of plane and cracking in parge coat. Typical on northwest side of cellar.

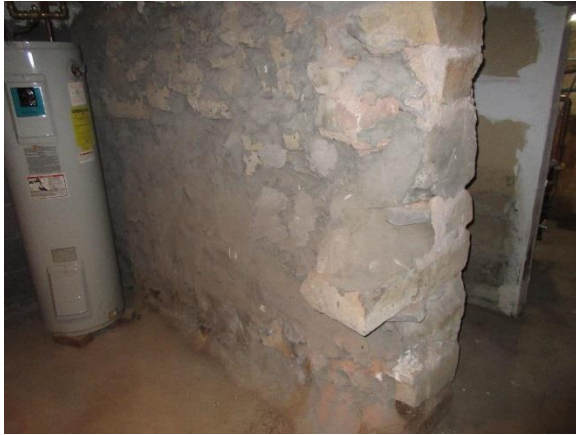
- In areas of exposed fieldstone, deteriorated mortar was observed along with several mortar patch repairs (Figure 77). Isolated areas of cracking in the concrete floor were observed near the entrance of the cellar and Electrical Room, B03 (Figure 78). Minor areas of bondline failure were observed at CMU units on the southeast side of the cellar (Figure 79).

Figure 77. Deteriorated mortar and previous patch repairs at original stone foundation wall in cellar.

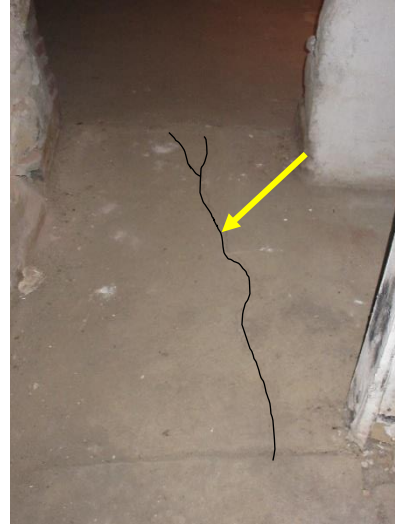
Figure 78. Cracking in concrete floor near the cellar entry. Crack traced for clarity.

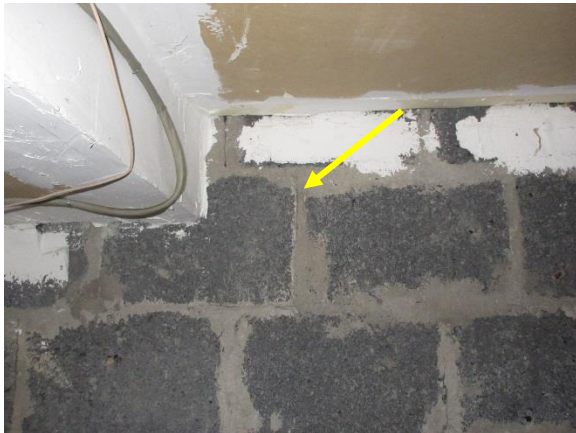
Figure 79. Bondline failure at CMU foundation wall in cellar.

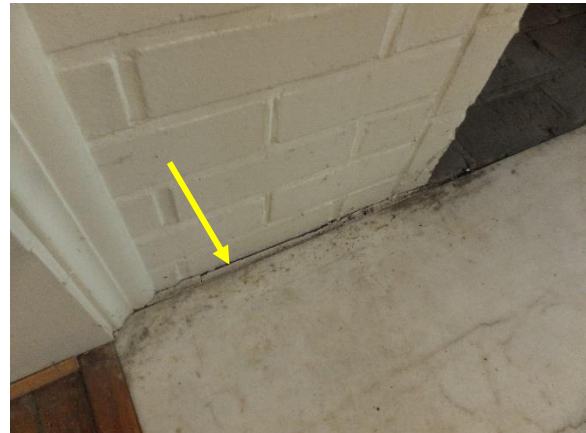
- At stone hearth on first floor, deterioration in mortar joint between the brick wall and apron was observed along with an isolated area of flaked coating (Figure 80).

Figure 80. Deteriorated mortar joint between brick fireplace facing and the stone hearth/apron in living room (room 101).

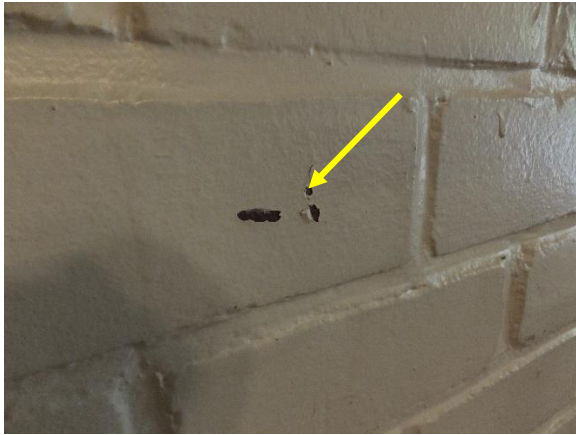
Figure 81. Flaked coating on fireplace brick in living room (room 101).

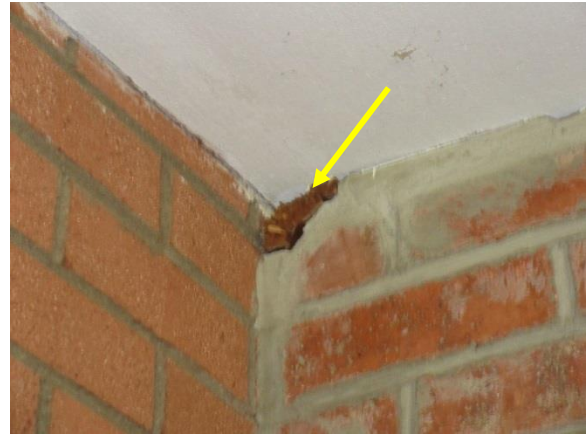
- Spalled brick and separation between brick at rear chimney and adjacent wall was observed (Figure 81 and Figure 82).

Figure 82. Spalled brick infilled with wood piece at Room 107 (bedroom).

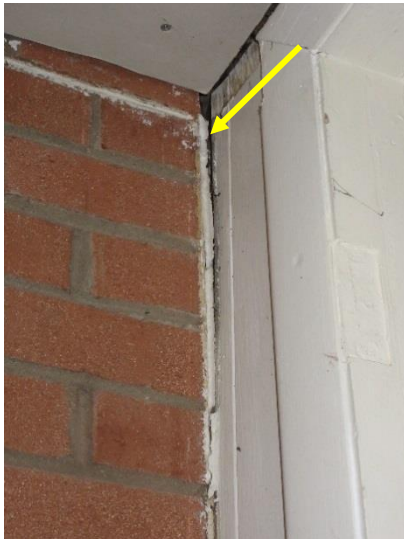
Figure 83. Separation between brick and adjacent wall, typical.

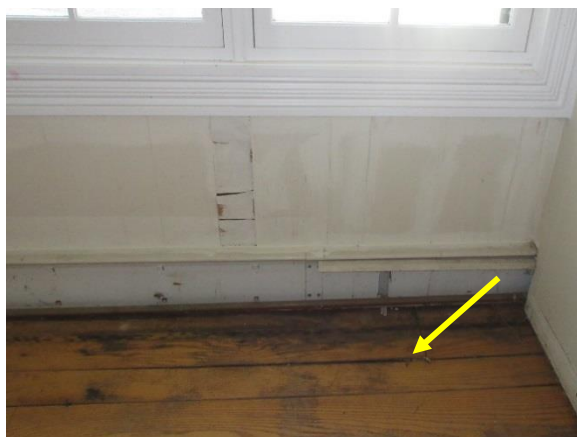
Figure 86. Staining at wood floor in Room 210 (office). Split across flooring visible.

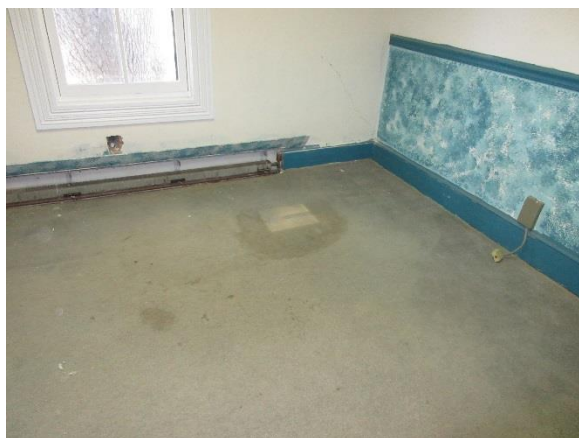
Figure 87. Stained carpet, typical.

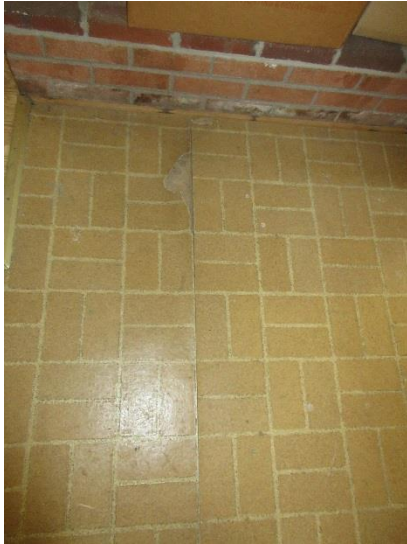
Figure 89. Delaminated and damaged linoleum flooring, typical.

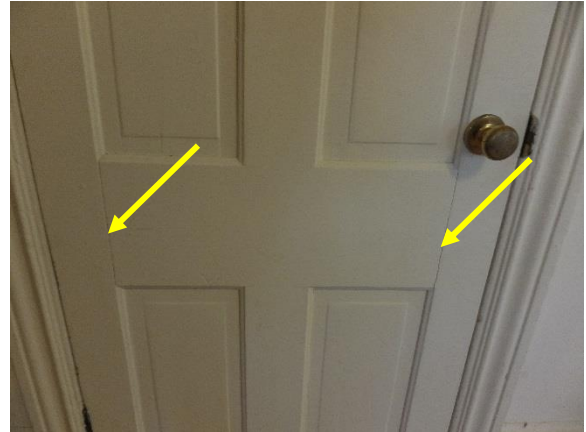
- Typical deterioration/damage observed at historic doors included minor separation at joinery and minor areas of indentations and scratches (Figure 90).

Figure 90. Separation of joinery at original door, typical.

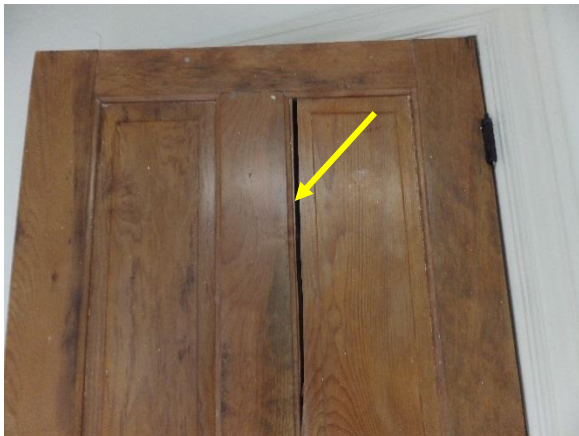
- One isolated area of splitting, creating a void in a raised panel was observed at the second floor, D205 (Figure 91).
- One door at the second floor, D202, did not fully close. At D101, the doorknob is inoperable (Figure 92).

Figure 91. Cracking and missing wood at door panel at D205.

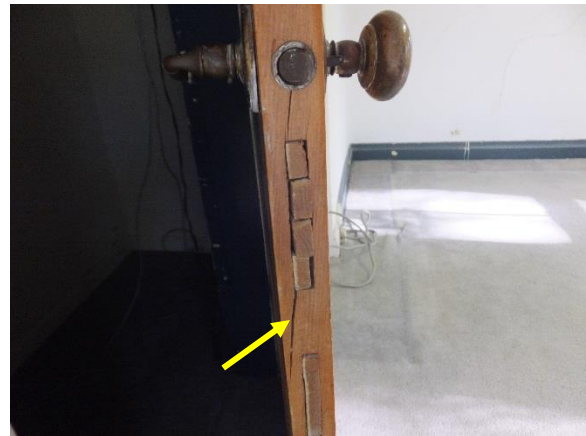
Figure 92. Splitting on stile of door facing latch, at D205.

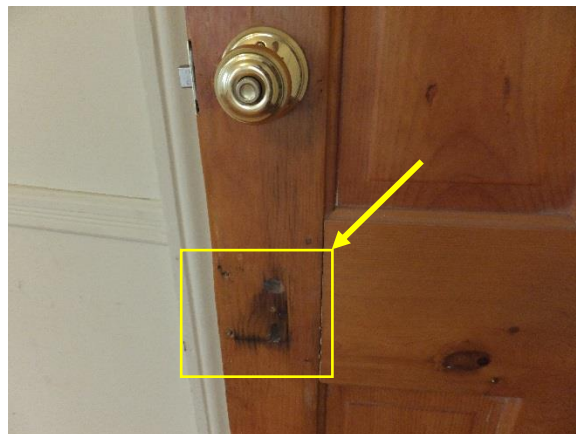
- Several of the historic doors have been replaced with contemporary hardware and thus, original thresholds and rim locks for some doors have been removed (Figure 94). The historic hardware that remains, such as some hinges, were observed to be decorated in various styles, including Queen Anne (Figure 95).

Figure 94. Missing original rimlock at D101

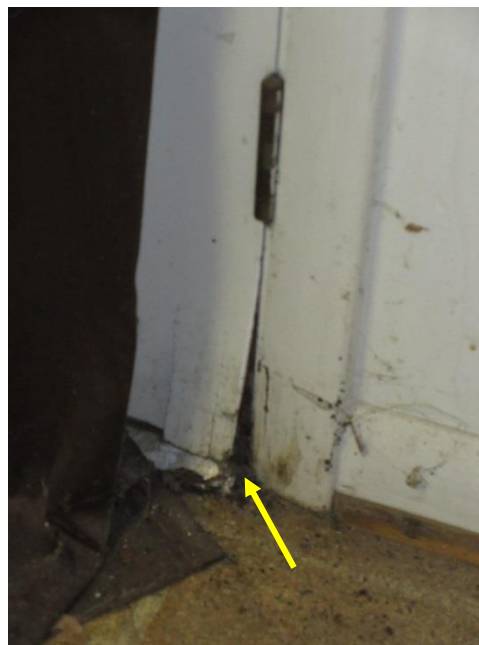
- The doors located at the additions of the home were generally in good condition throughout. Isolated cracking and water damage was observed at the trim of the French doors on the first floor, northeast facade (Figure 96).

Figure 96. Damage at the trim of the French Doors.
