LAHEY HOUSE Historic Structure Report

Vienna, Virginia

Final Report

WJE No. 2018.0216

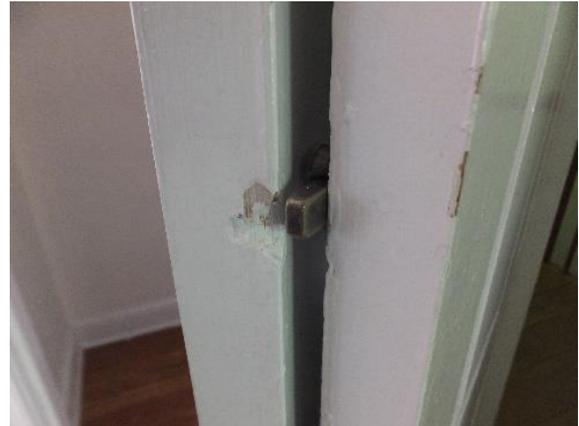
Figure 171. Damage to closet door coincidental with living space door bolt.

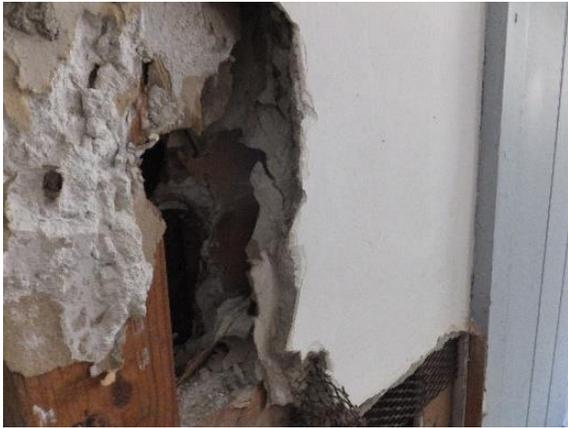
Figure 240. Removed tub with resultant disrupted interior finishes.

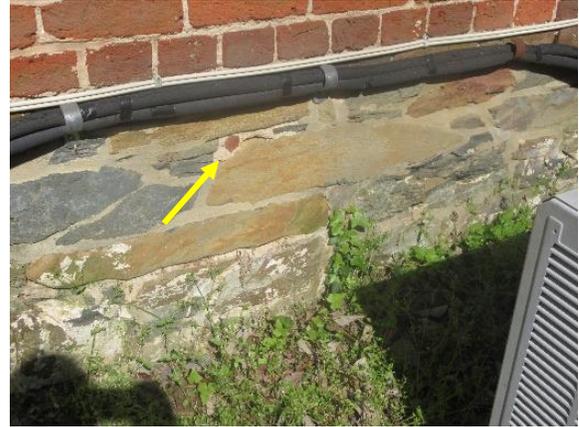
Figure 258. Missing mortar locations at fieldstone foundation.

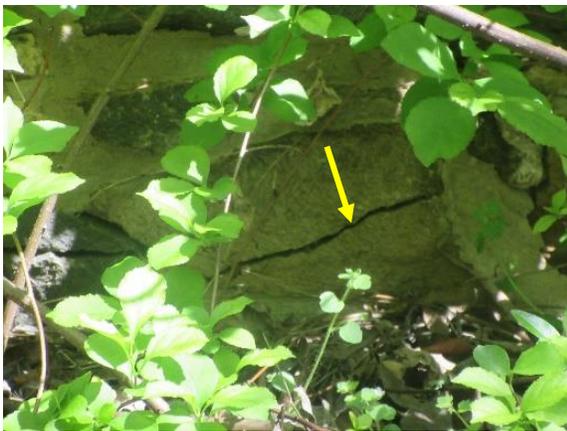
Figure 259. Varying mortar repairs at fieldstone.

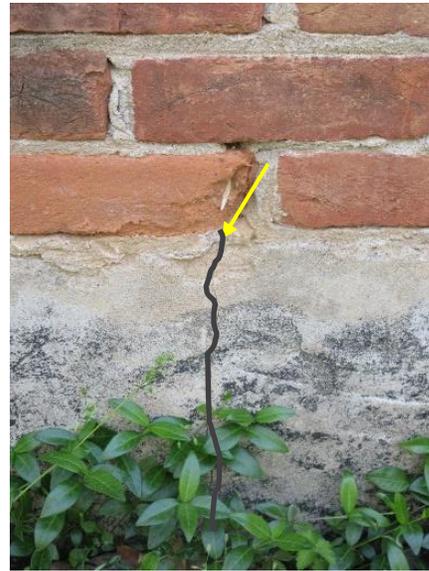
Figure 260. Crack in fieldstone.

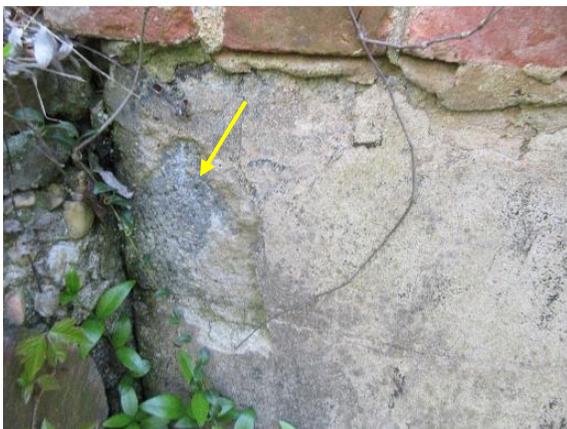
Figure 261. Crack in parge coat.

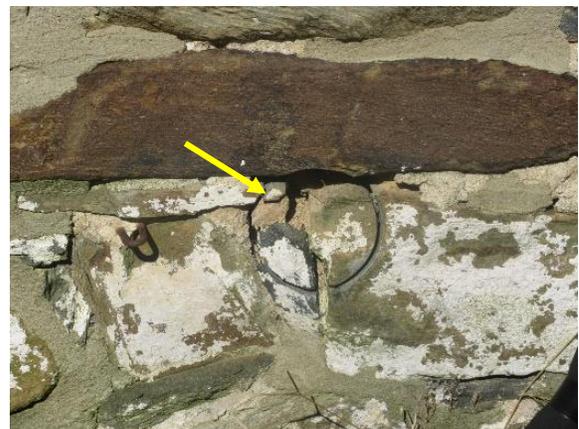
Figure 262. Spall in parge coat.

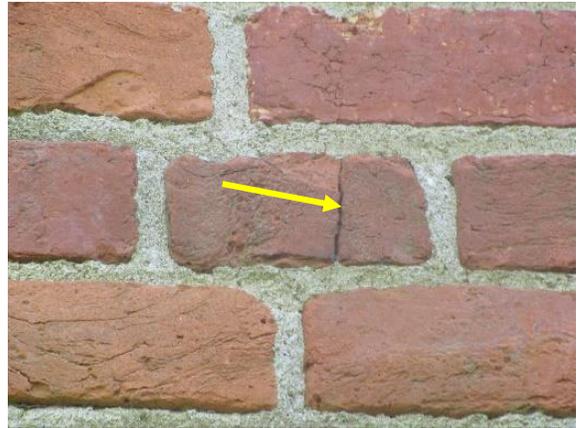
Figure 270. Location of isolated brick face erosion.

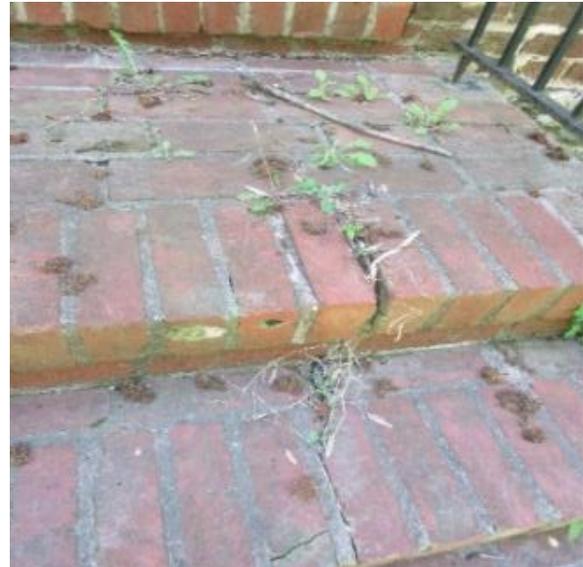
Figure 272. Erosion of brick face material.

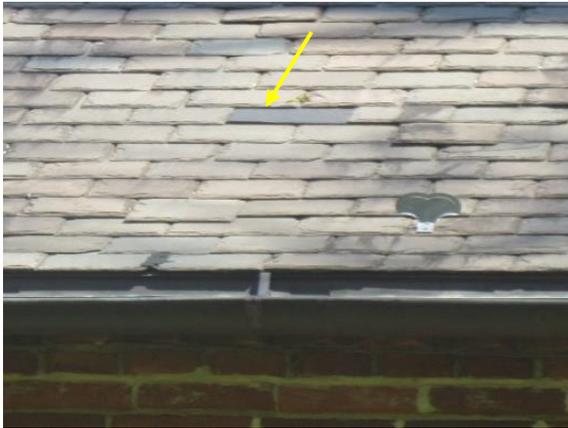
Figure 277 Broken (yellow arrow) and missing slate shingles (orange arrow).

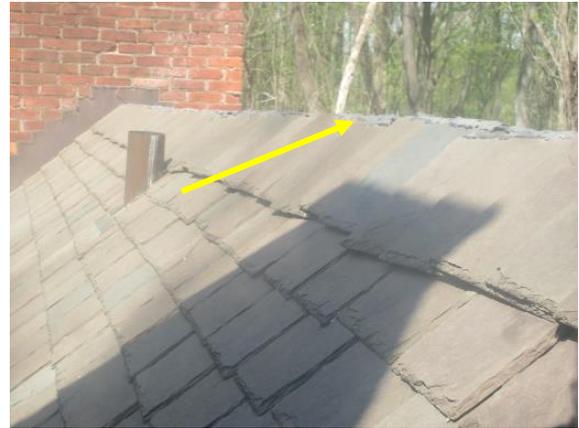
Figure 278. Metal replacement of slate shingle.

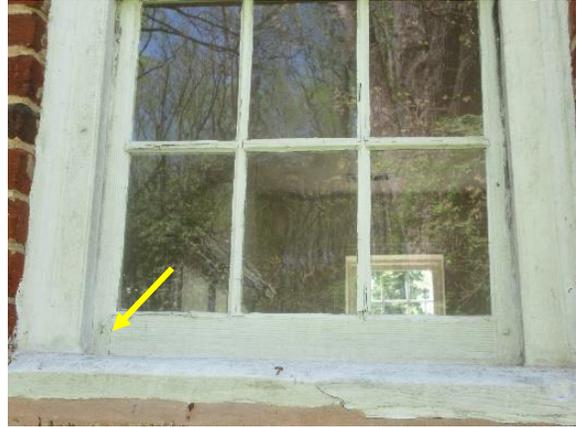
Figure 292. Cracked and peeling paint at window.

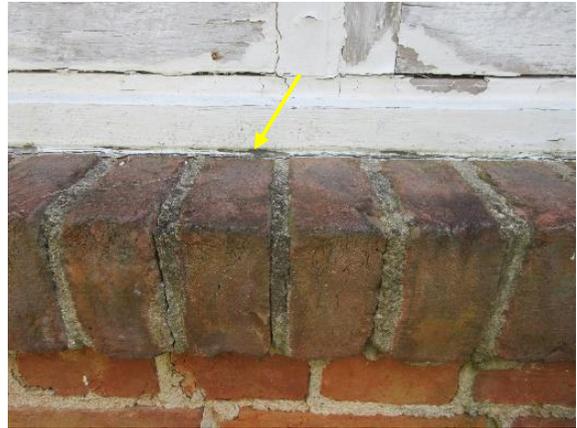
Figure 294. Missing and delaminating glazing putty.

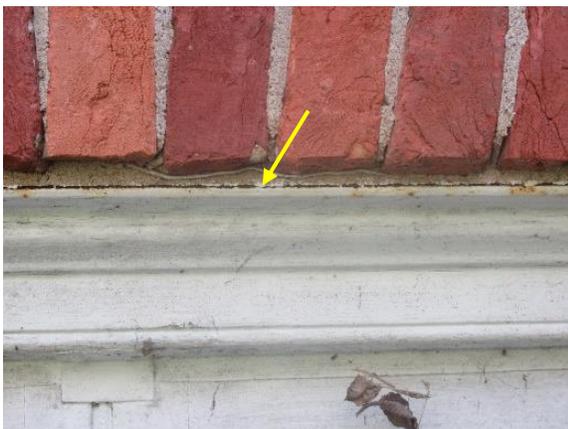
Figure 295. Deteriorated window perimeter sealant.

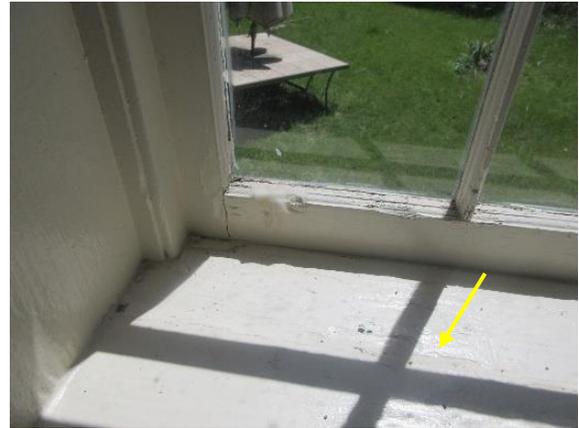
Figure 298. Deteriorated window sill.

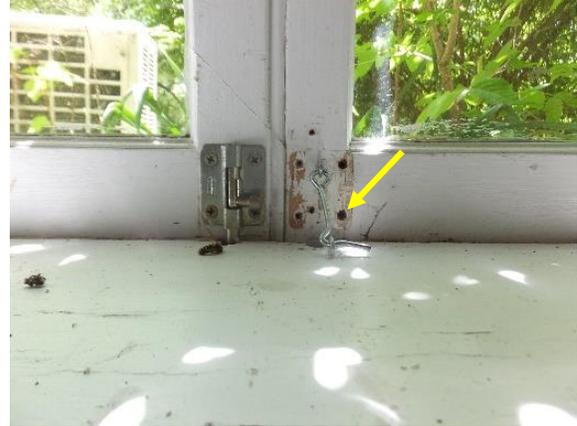
Figure 302. Missing window interior lock (interior).

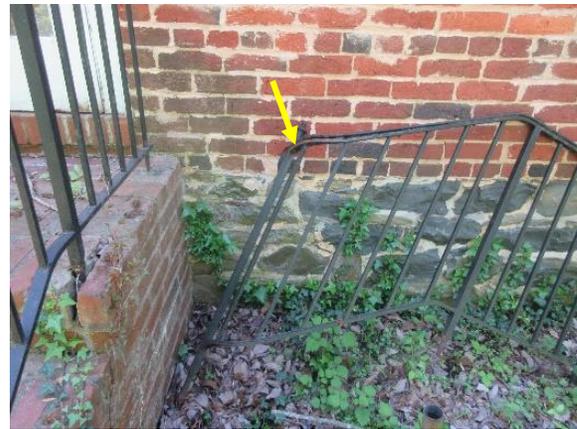
Figure 312. Corrosion and material loss at hand rail.

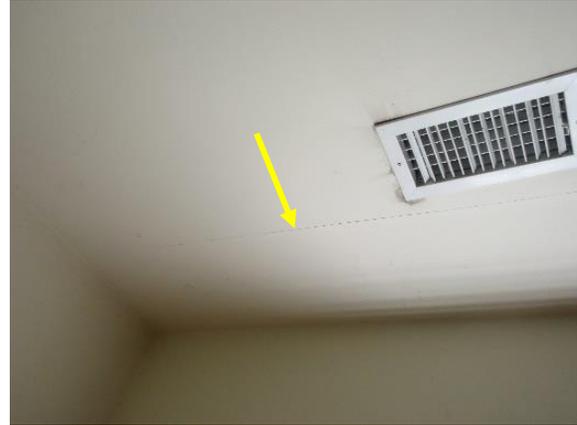
Figure 314. Hairline cracking in plaster adjacent to door frame (crack traced for clarity).

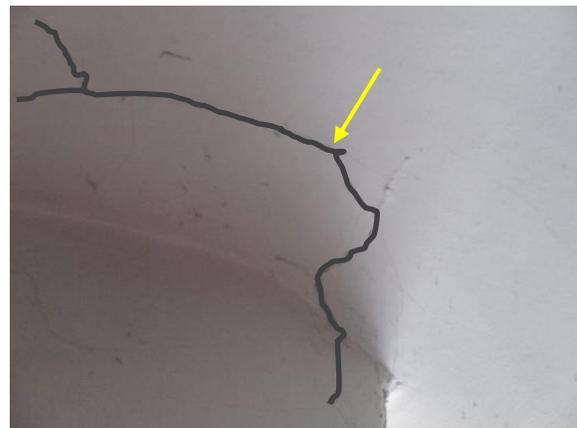
Figure 316 Plaster cracking adjacent paneled door frame in parlor (crack traced for clarity).

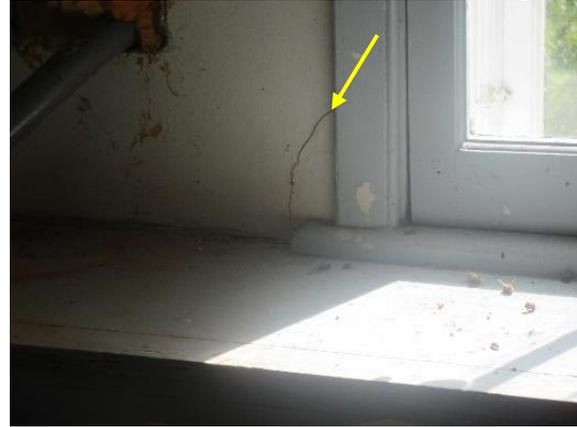
Figure 318. Plaster cracking adjacent to board and batten door frame of east loft (crack traced for clarity).

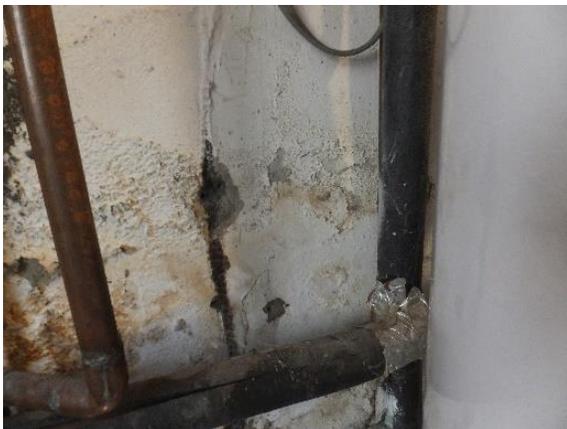
Figure 333. Location of missing parge coating from removed conduit.

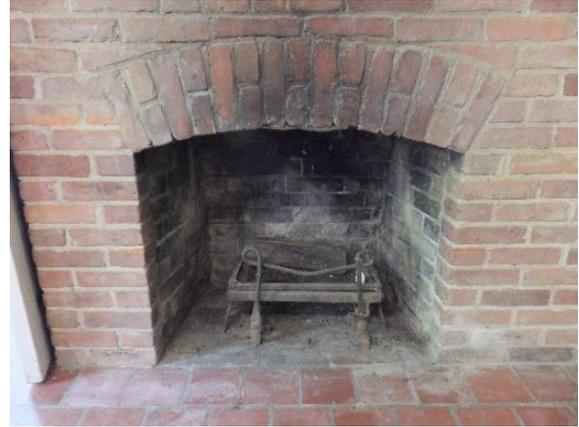
Figure 352. Hanging insulation at the throat of the living space fireplace.

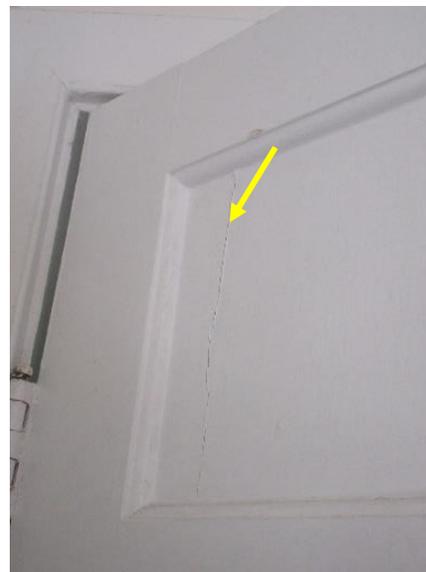
Figure 358. Separation of joinery at interior paneled door.

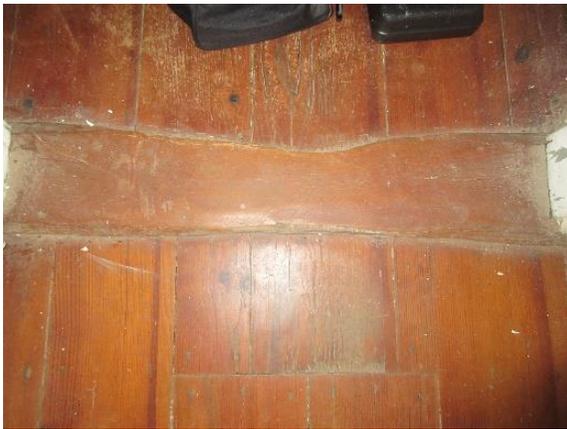
Figure 365. Weather-checking and fading varnish at door threshold.

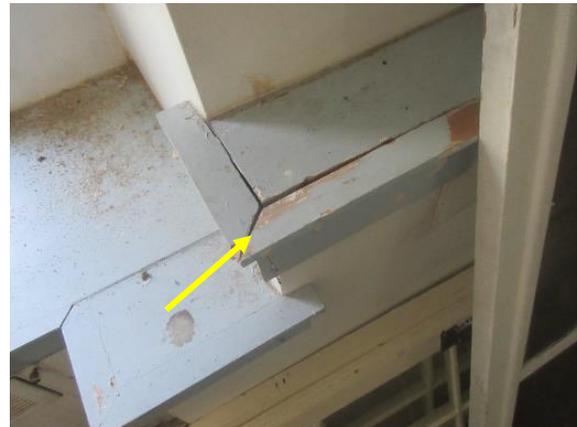
Figure 370. Vertical crack in wood at mantle panel.

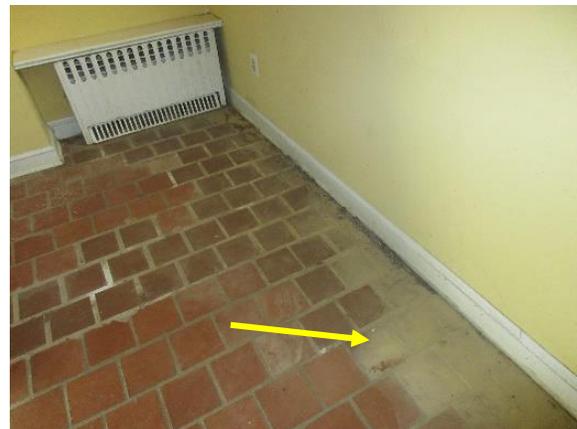
Figure 388. Spall in clay tile flooring at kitchen entry that has been covered with mortar.

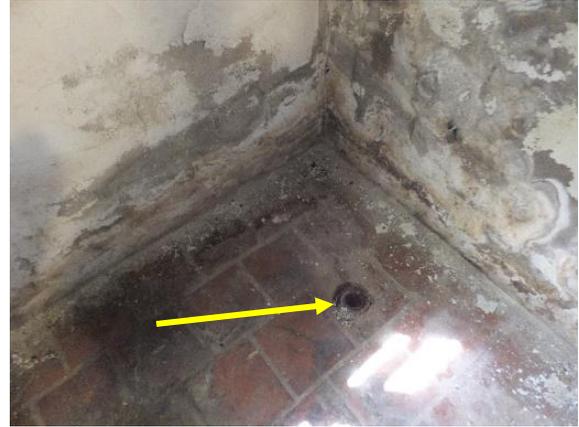
Figure 390. Replacement or staining of clay tile flooring in kitchen.
