ASH GROVE Historic Structure Report

Vienna, Virginia

Final Report

December 04, 2017

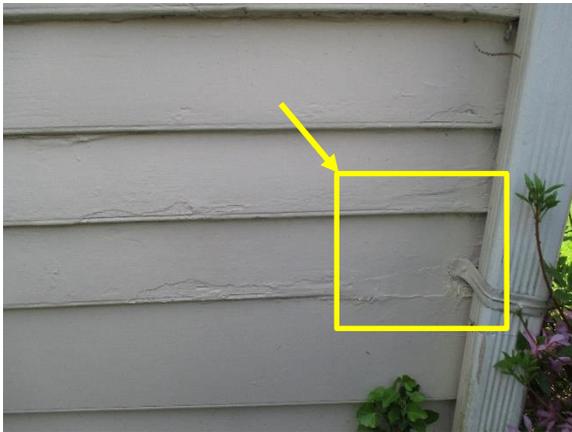
Figure 73. Missing siding that has been painted over, adjacent to a downspout.

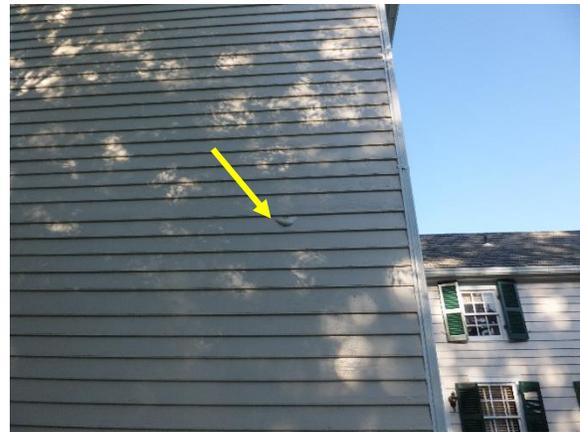
Figure 74. Area of sagging paint holding water on the east facade.

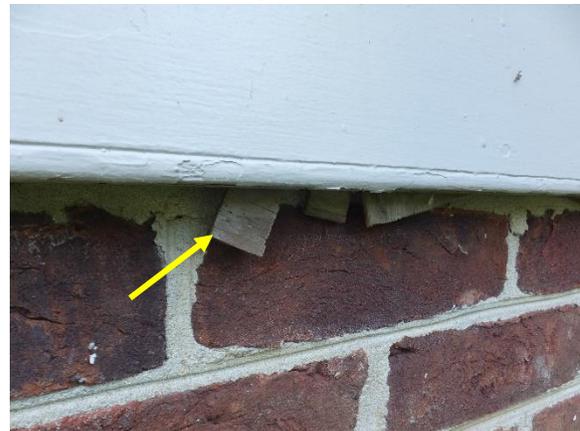
Figure 76. Shims observed between the clapboard siding and brick at the garage.

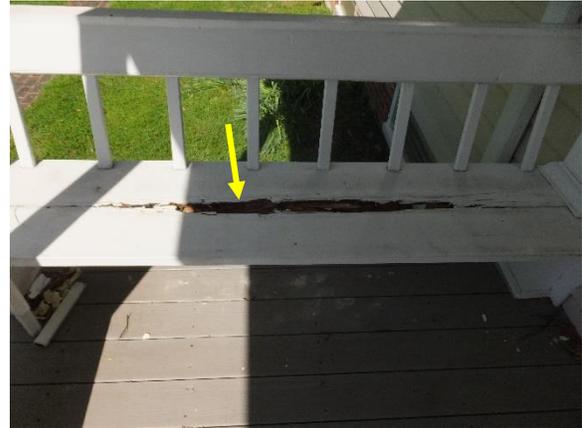
Figure 78. Deteriorated and missing wood at the west bench of the south portico.

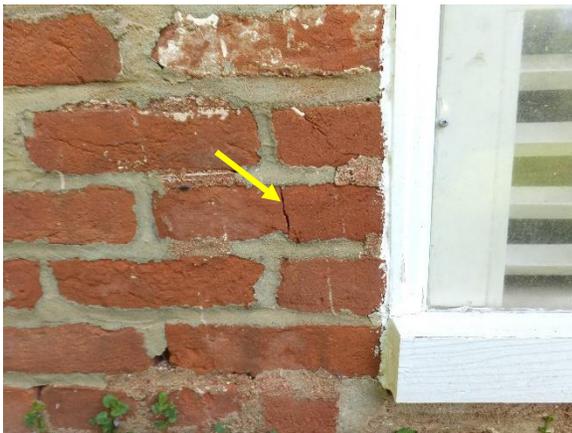
Figure 79. Example of cracking through a brick unit at the brick foundation.

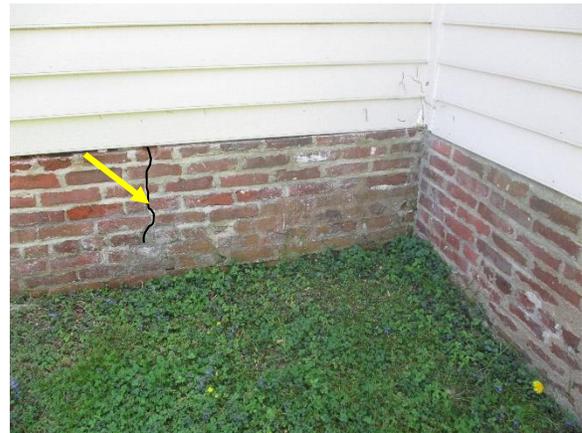
Figure 80. Crack through numerous brick units on the west facade. Crack traced for clarity.

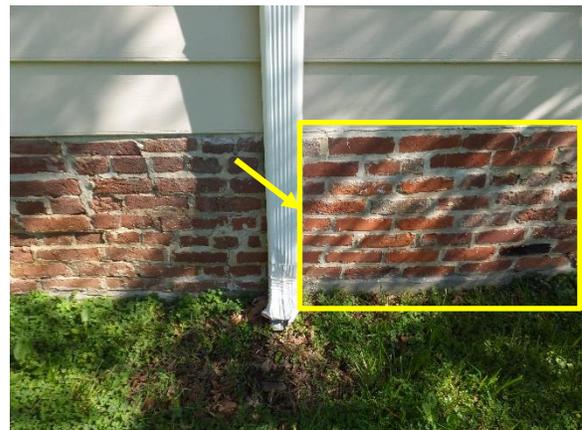
Figure 82. Area of rebuilt brick at the east wing, south facade. Note difference in brick finish and color.

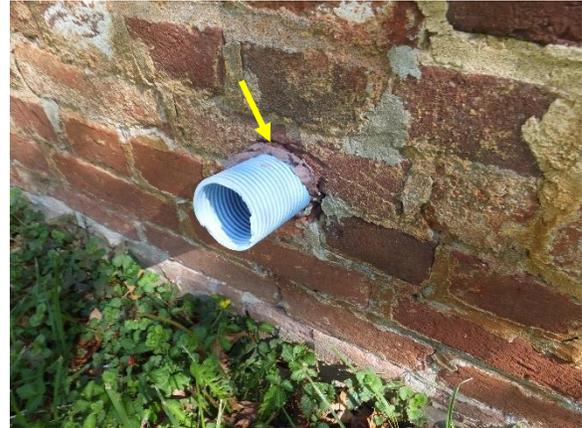
Figure 84. Flexible hose penetration through the brick foundation at the south facade.

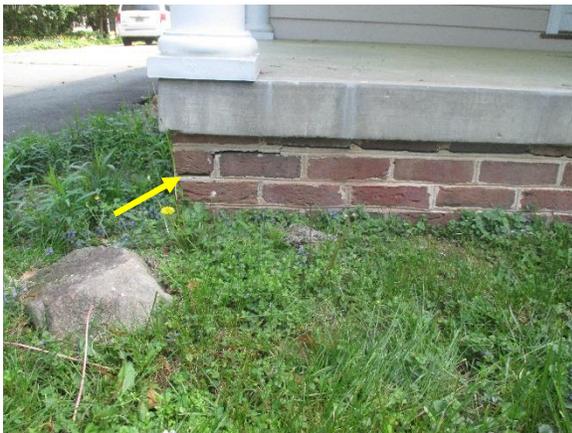
Figure 85. Crack at the upper course of brick at the west patio.

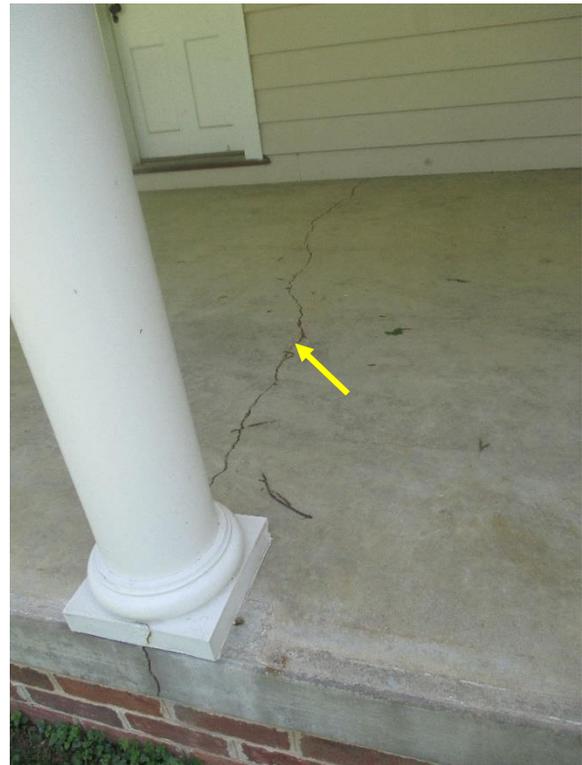
Figure 86. Crack midspan on the west portico.

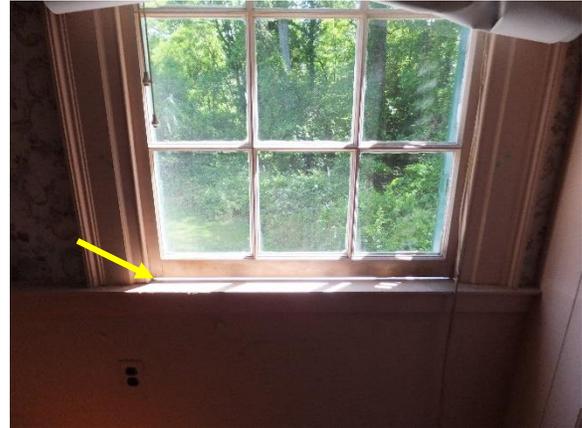
Figure 88. Window at the south facade second floor with 1-inch gap between lower sash and sill.

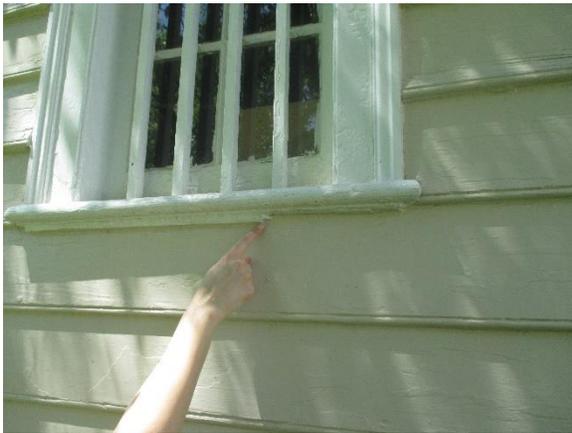
Figure 89. Area of missing trim below sill of east wing window.

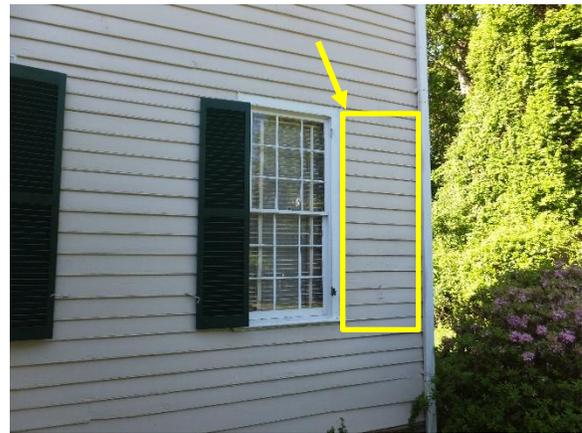
Figure 90. Example of window with missing shutter.

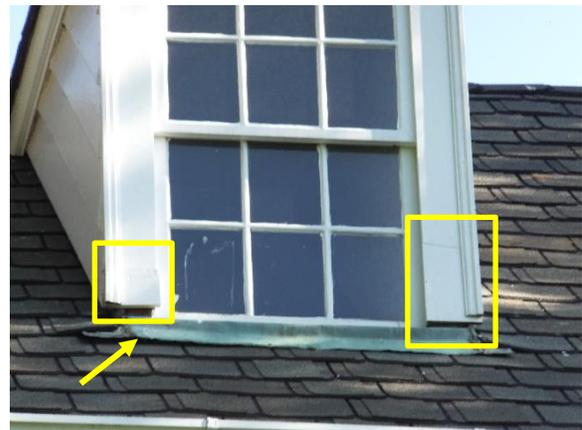
Figure 92. Dutchman repairs were observed at the jambs of dormer windows. Also, note minimal integration of copper flashing at the sill.

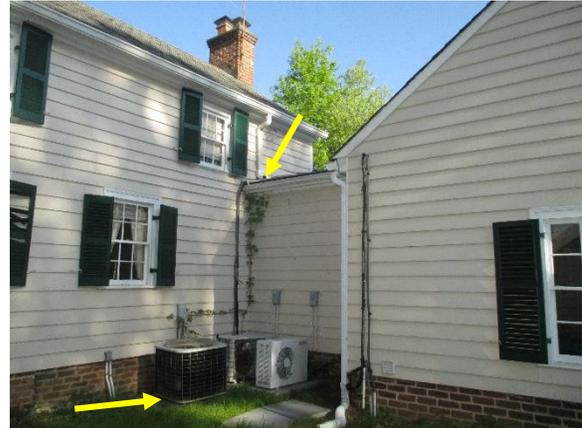
Figure 94. East facade with downspout of central area emptying water on bathroom roof and onto mechanical units. Note vegetation growth in this area.

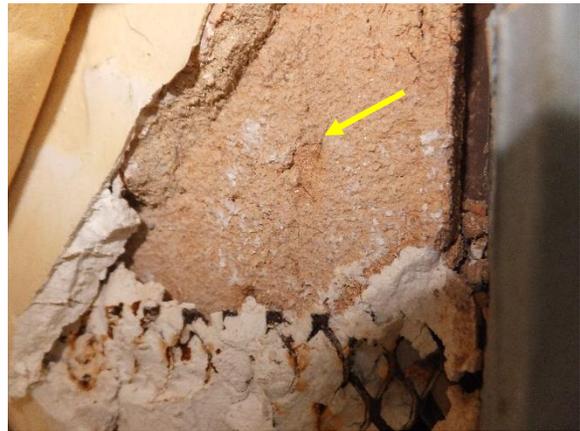
Figure 159. Removal of the damaged wall finish of gypsum board reveals white gypsum material with metal lathe and sandy material with embedded hairs.

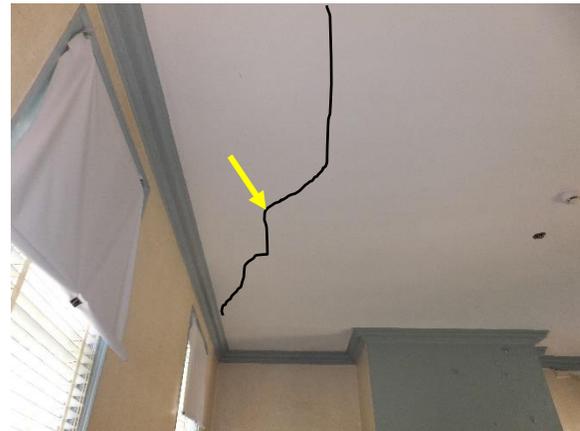
Figure 248. Cracking in plaster ceiling. Crack traced for clarity.

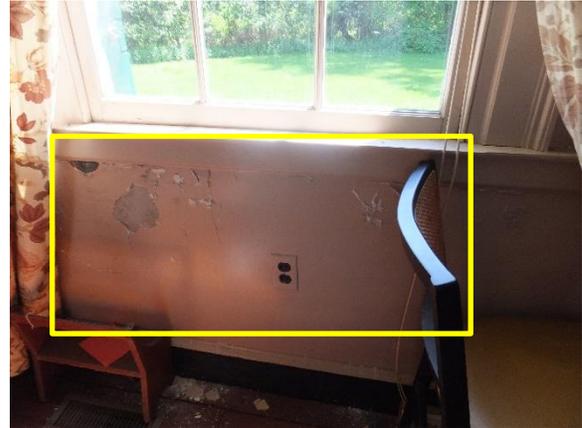
Figure 250. Typical water infiltration damage below windows.

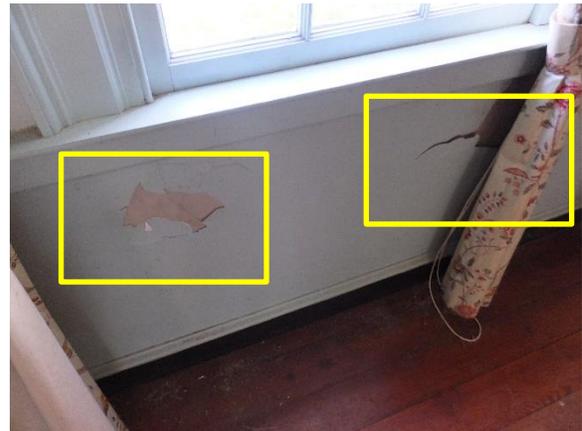
Figure 252. Moisture damage to the east wall of room 105 adjacent to exterior mechanical units.

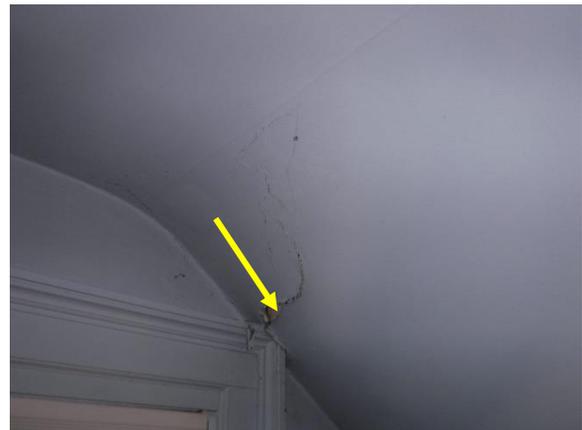
Figure 254. Typical cracking at sloped ceiling to wall interfaces.

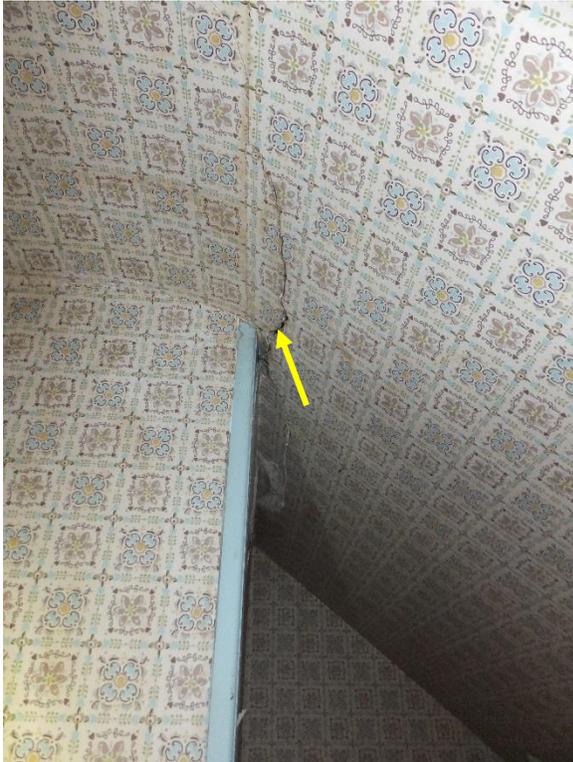
Figure 255. Typical cracking at sloped ceiling to chimney interfaces.

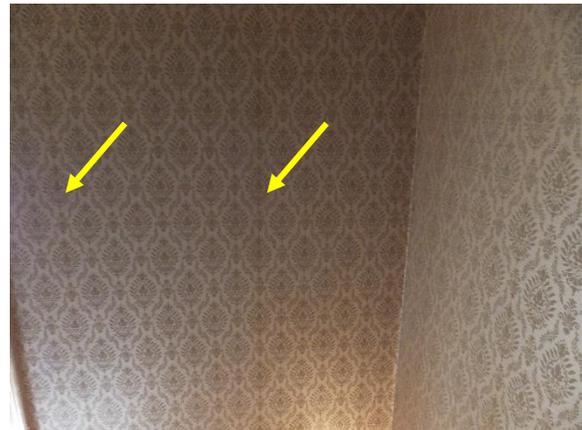
Figure 256. Staining at the seams of the wallpaper.

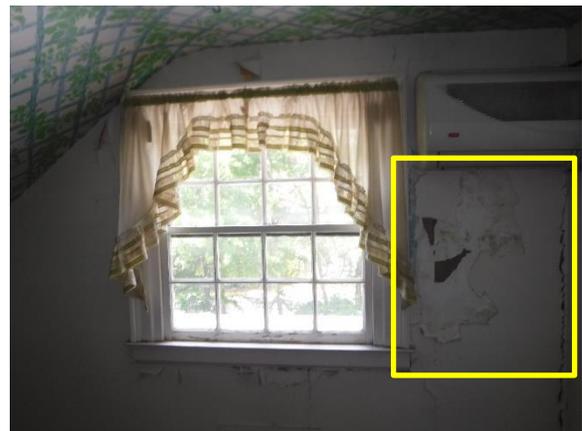
Figure 258. Damage to interior finishes below a mechanical unit.

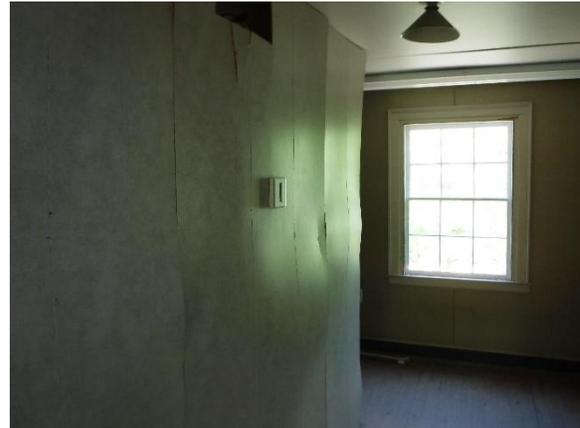
Figure 260. Warped wall paneling in the garage upper space.

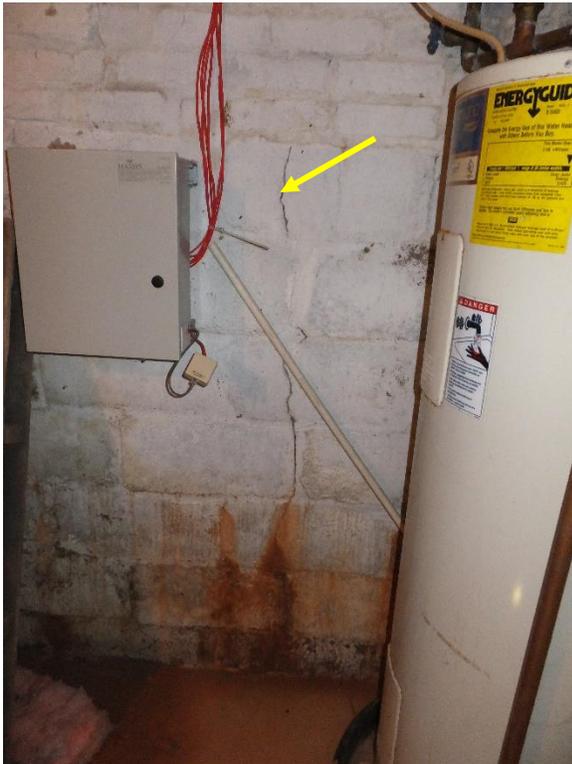
Figure 261. Crack in CMU at central section foundation.

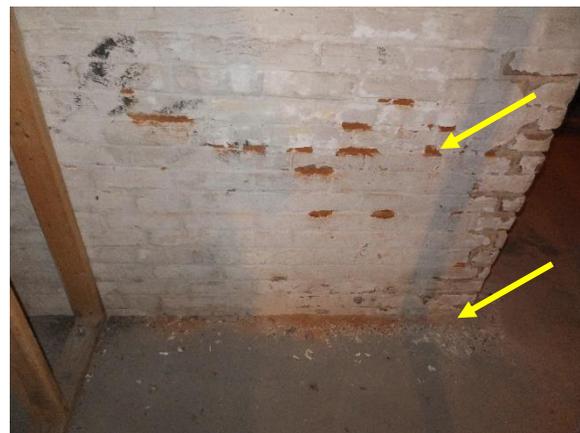
Figure 262. Deterioration of a potentially impermeable coating, likely trapping moisture and contributing to the deterioration of the brick. Note collection of brick debris at the floor.

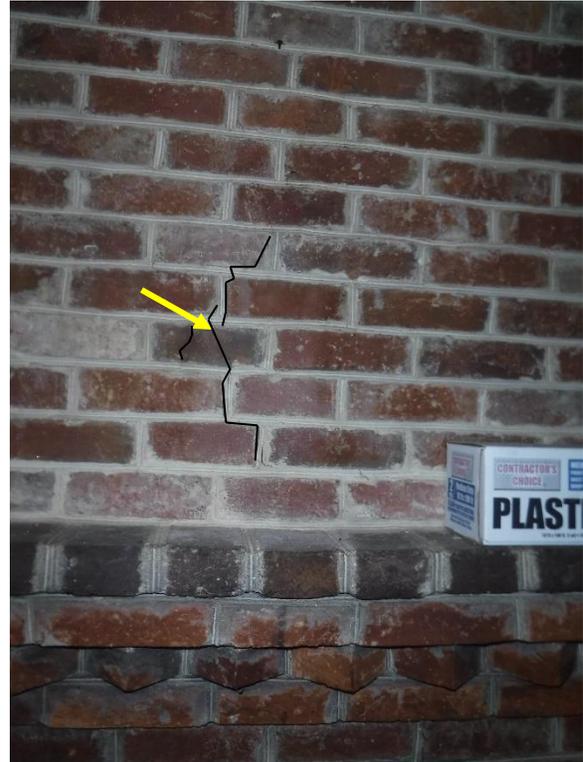
Figure 264. Cracking at fireplace in kitchen. Cracks traced for clarity.

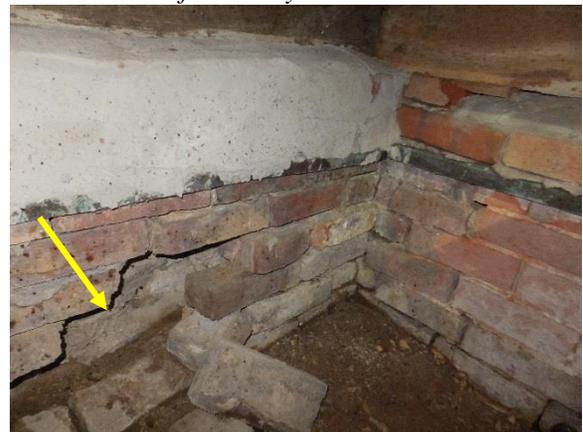
Figure 266. Spalled brick at the foundation under room 102's closet.

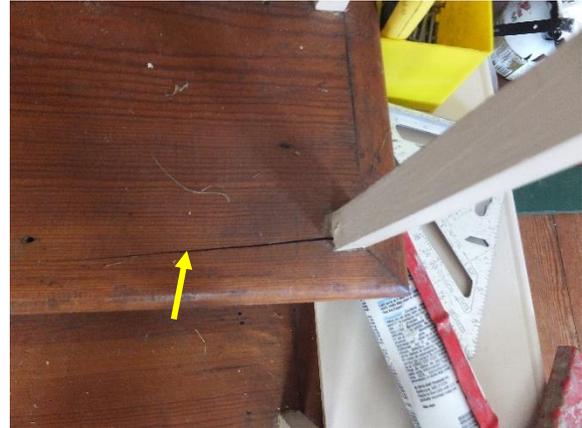
Figure 268. Typical cracking stair treads.

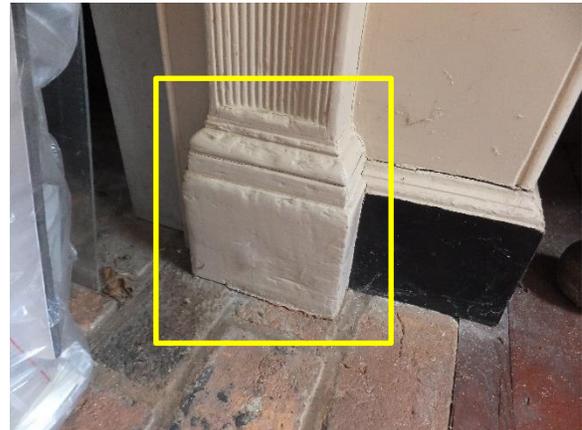
Figure 270. Area of material loss at chimney that has been painted over.

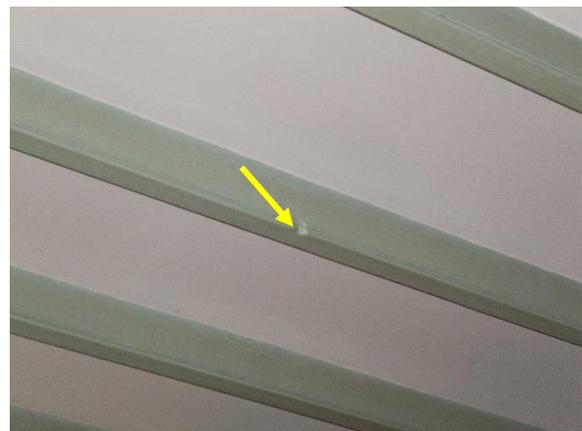
Figure 272. Chip in room 105 joist is likely loss of a knot in the wood.

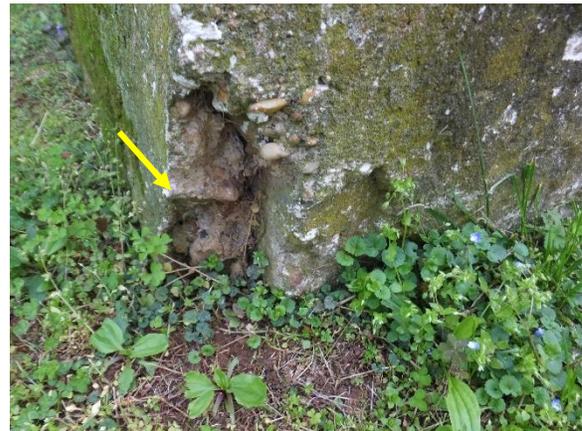
Figure 284. Spall in the concrete "buttress" at the northwest corner.

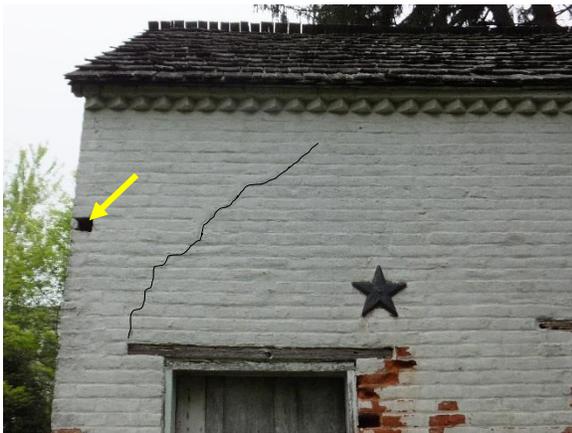
Figure 285. Missing brick at southwest corner. Note adjacent crack to the right emanating from door lintel. Cracked traced for clarity.

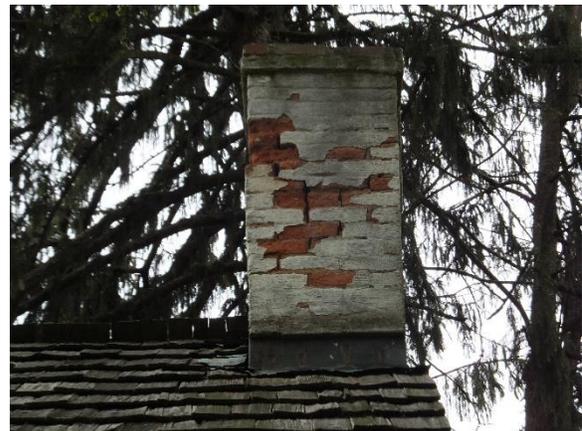
Figure 288. Typical deteriorated condition of the chimney.

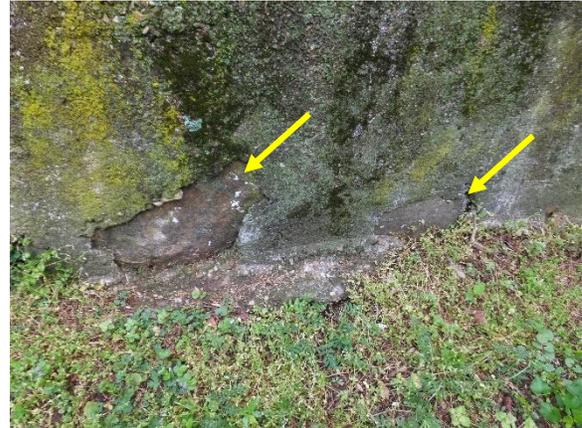
Figure 299. Area of parge coating delamination revealing stone. Note biological staining.

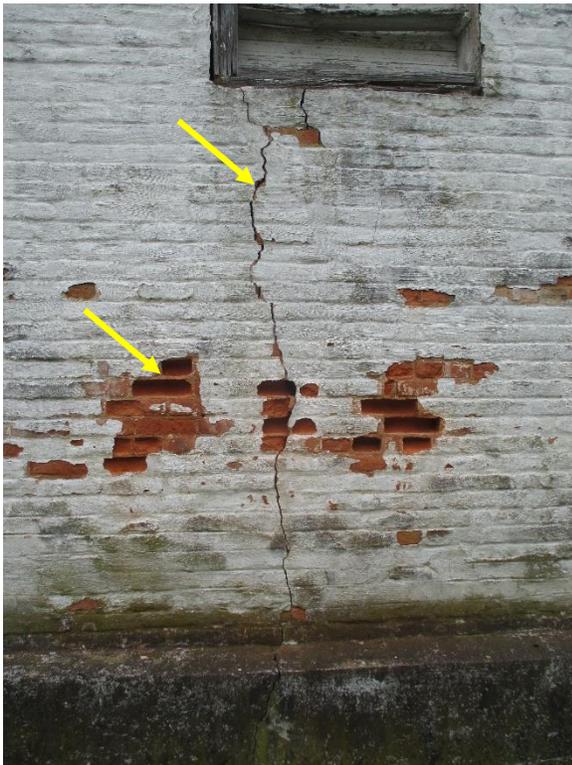
Figure 300. Significant vertical crack, flaked coating, and brick face spalls at the west facade.

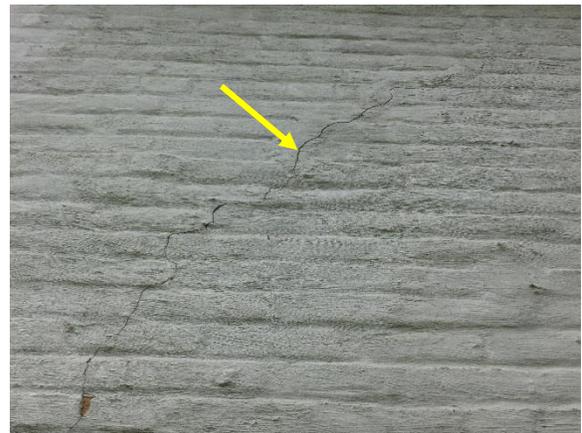
Figure 301. Crack in south facade emanating through the impermeable coating.

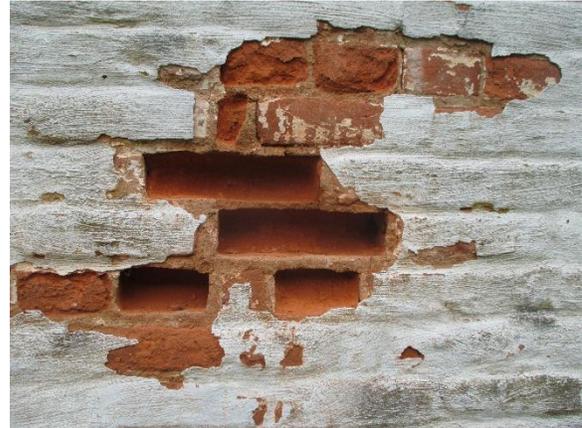
Figure 303. Considerable flaking of impermeable coating with related brick face spalls and deteriorated mortar joints.

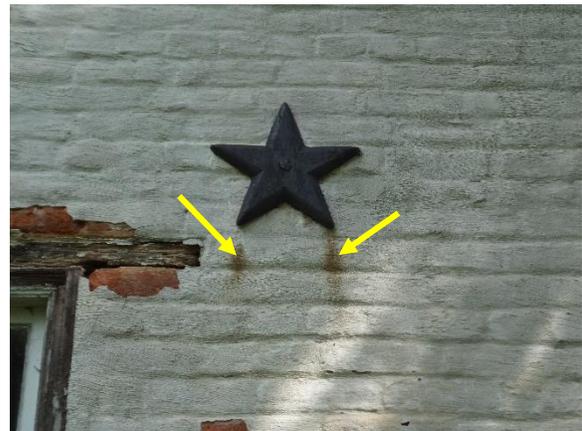
Figure 305. Corrosion staining from the iron star plate.

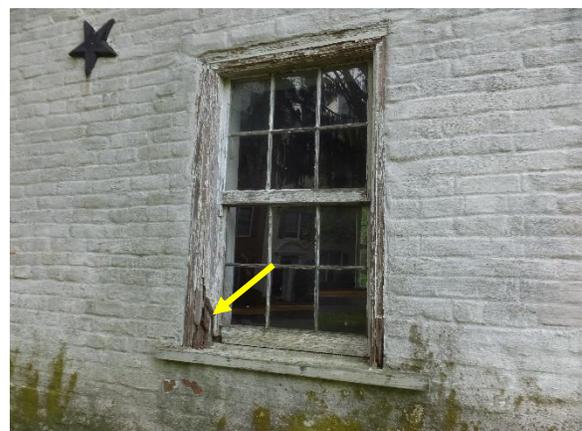
Figure 307. Deteriorated wood with areas of missing material at the jamb.

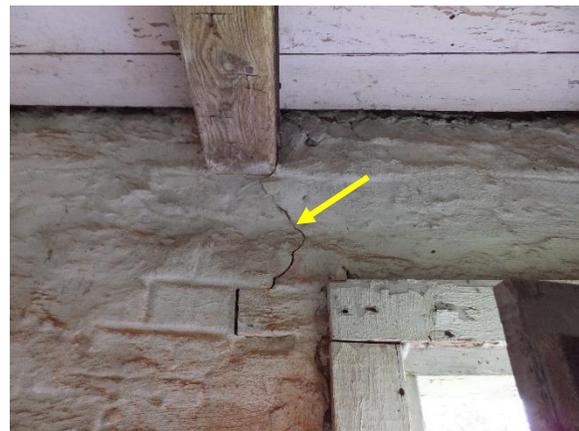
Figure 327. Cracking emanating from floor beam connection.

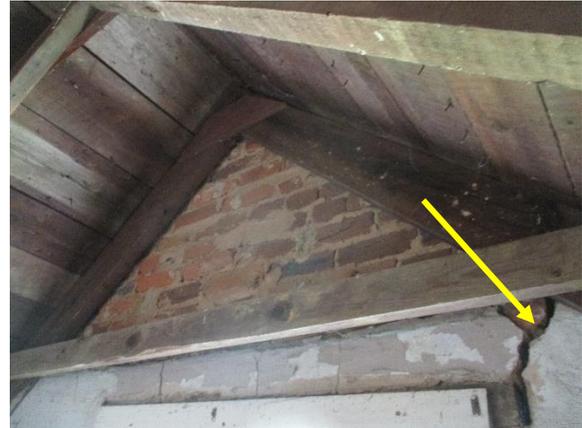
Figure 329. Cracking at the west wall.

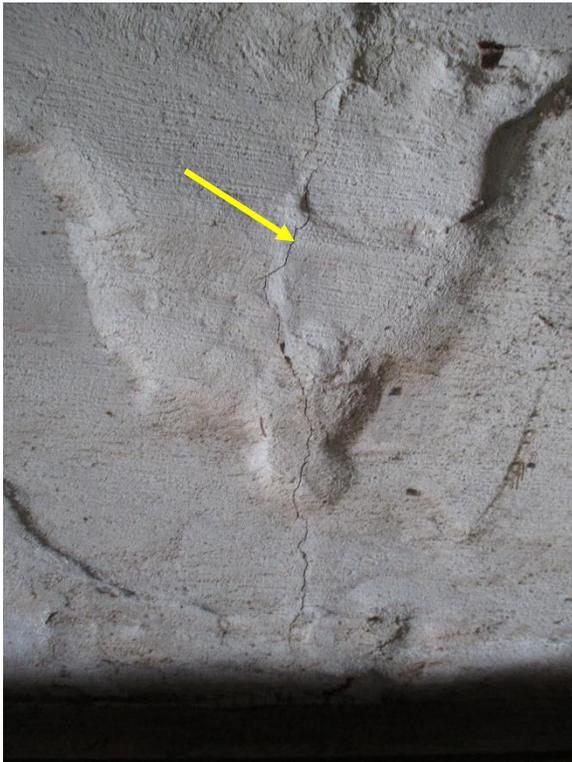
Figure 330. Cracking through the parge coat.

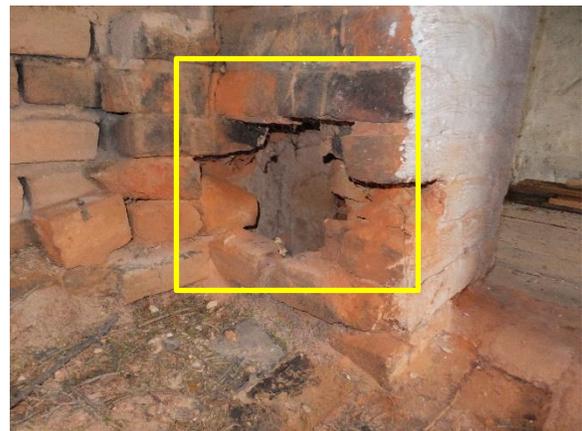
Figure 331. Spalled area of brick in the second floor firebox.

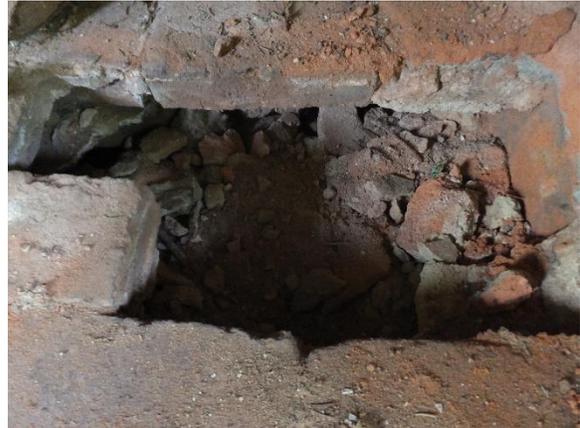
Figure 333. Brick removed to reveal loose gravel below.

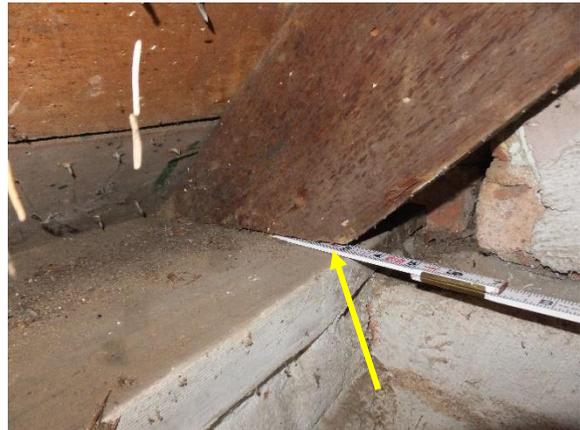
Figure 335. Numerous rafters near the gable ends are not fully bearing on the plate.
