FAIRFAX COUNTY PARK AUTHORITY

Ash Grove

MEP Assessment

Date Prepared:
August 29, 2017

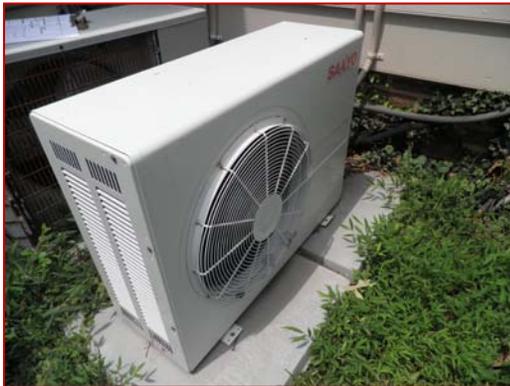
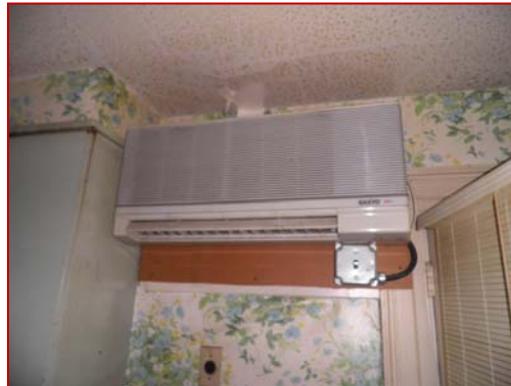
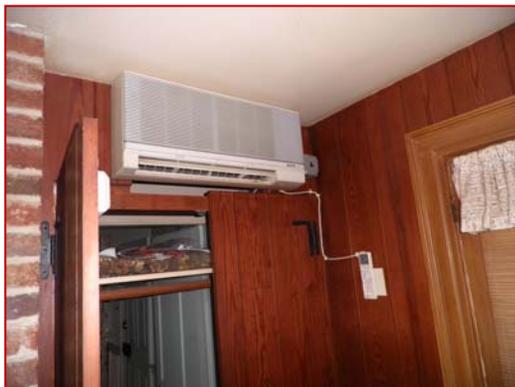
The first system consists of a nominal 18 MBH (1.5 ton) Sanyo ductless mini-split heat pump system that is connected to two nominal 9 MBH (3/4 ton) wall mounted air handling units (AHU). One AHU is located in the first floor kitchen and the other AHU is located in the family room off the kitchen. The fan was operational on the kitchen AHU but the heating or cooling did not work and disabled the fan when selected at the wireless remote control. The outdoor unit did not appear to be operational. The system is dated November 2000 and is past its useful life.

- Remove and replace HVAC system 1 with a new ductless split system to condition the kitchen and family room area.
- Remove and replace HVAC system 2 with a new split system. The dehumidifier can be reused.

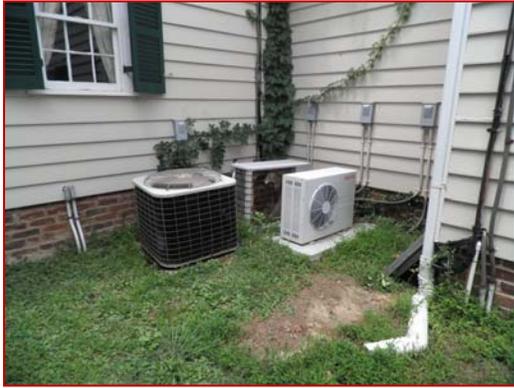
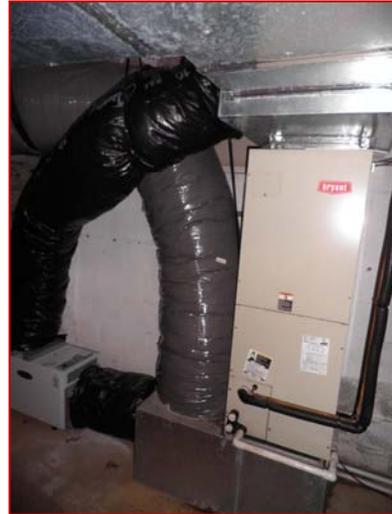
The second system consists of a nominal 30 MBH (2.5 ton) Bryant heat pump split system with a matching vertical AHU located in the basement. An Aprilaire dehumidifier is connected to the return ductwork in a sidestream configuration. The AHU is ducted up to supply registers in the first floor in the dining room, passage area, library, main entry hall, and parlor. The return is ducted to a large floor grille in the passage area. There are also supply registers in the bottom of the ductwork mains in the basement. The ductwork is comprised of galvanized steel mains with flexible duct runouts to the floor diffusers. The outdoor unit and the dehumidifier were operating, however the AHU fan did not appear to be working and the refrigerant piping was frozen which means the coil was also likely frozen. The equipment is believed to be dated March 2001 which puts it at the end of its useful life.

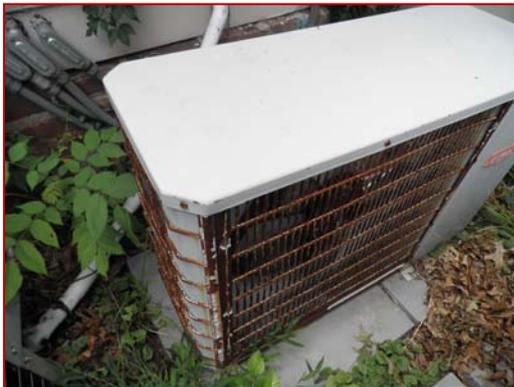
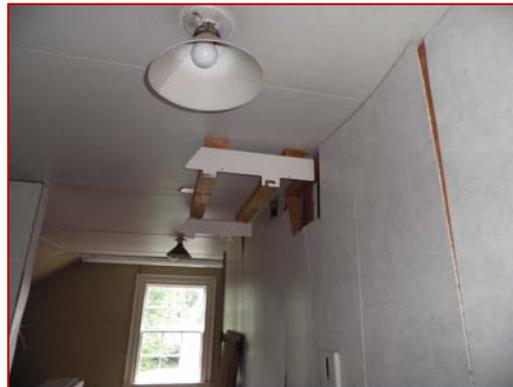
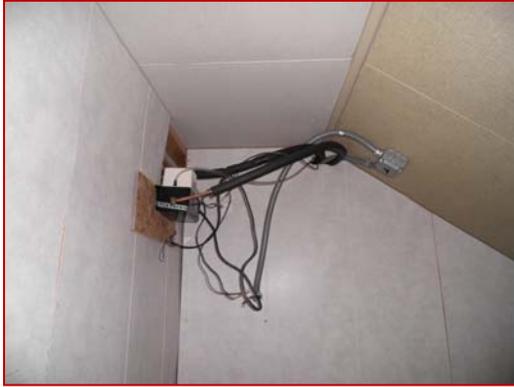
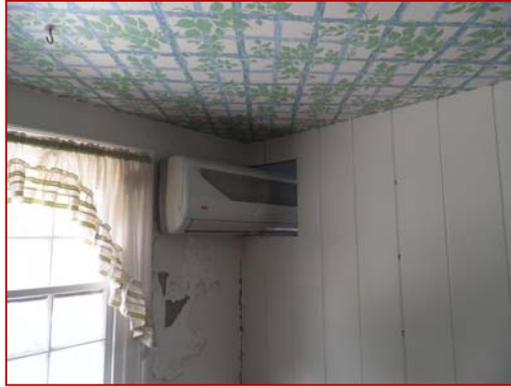
The third system consists of a nominal 18 MBH (1.5 ton) Bryant ductless mini-split heat pump system that is connected to one nominal 9 MBH (3/4 ton) wall mounted AHU. The AHU is located in between the two bedrooms on the second floor. The fan was operational but cooling and heating were not. The outdoor unit appears to be in very poor condition and did not appear to be operational. There is a mounting bracket for a second Bryant indoor ceiling mount AHU in the area above the garage. The AHU has been removed but the refrigerant piping and condensate pump are still installed. The system is believed to be dated April 2001 which puts it at the end of its useful life.

- Remove and replace HVAC system 3 to condition the upstairs bedroom and the area above the garage.
- Inspect and service HVAC system 4 to verify it is operating properly.

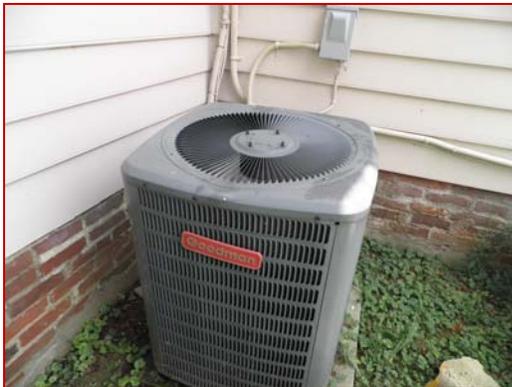
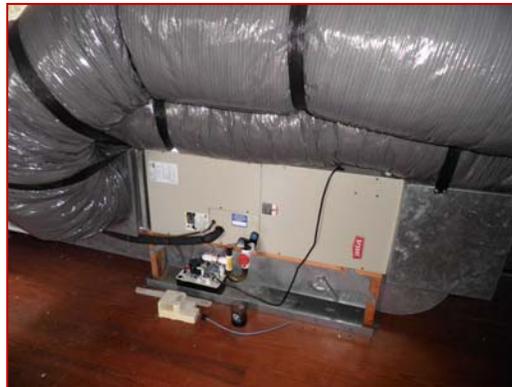
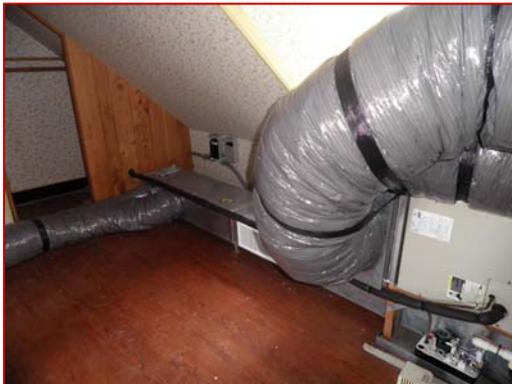
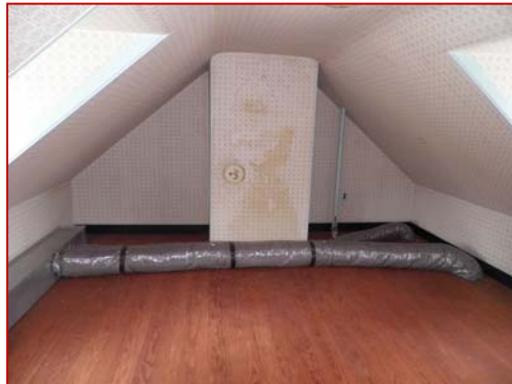
The fourth system consists of a nominal 30 MBH (2.5 ton) Goodman heat pump split system with a matching horizontal AHU located on the third floor. The AHU is ducted along the floor of the third floor to supply grilles located in the ceiling of the second floor in the main hallway, the two public use chambers, and the two toilet rooms off the public use chambers. The return is ducted to a grille in the ceiling of one of the public use chambers. There are also sidewall diffusers serving the third floor. The ductwork is comprised of galvanized steel mains with flexible duct runouts to the ceiling diffusers. The system was operating however it wasn't very comfortable. This could be due to the fact that the other HVAC systems were not operational, the high ambient outdoor temperature, it could be inadequately sized, or it may have been turned on right before we arrived. The equipment is believed to be dated November 2006 and appeared to be in decent condition. It should have another 4 or 5 years of useful life.

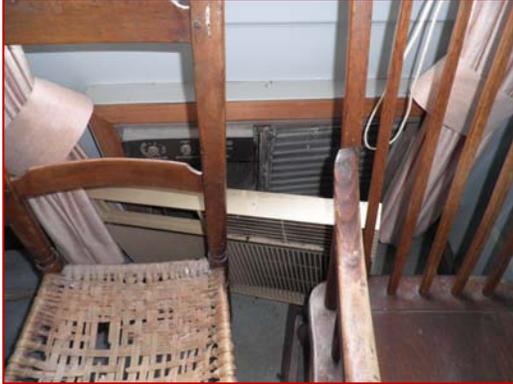
The fifth system is a thru-the-wall unit located in one of the public use chambers. It appears to be in poor condition, past its useful life, and not operational.

- Clean the existing ductwork.
- Remove the thru-wall HVAC unit (system 5) on the second floor. Seal and insulate the penetration.
- Provide an exhaust fan for the first floor toilet room and duct to a louver/hood on the exterior wall.

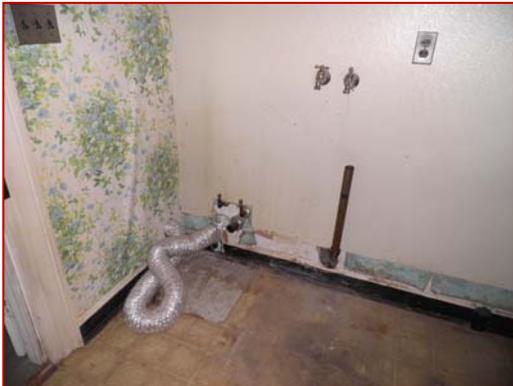
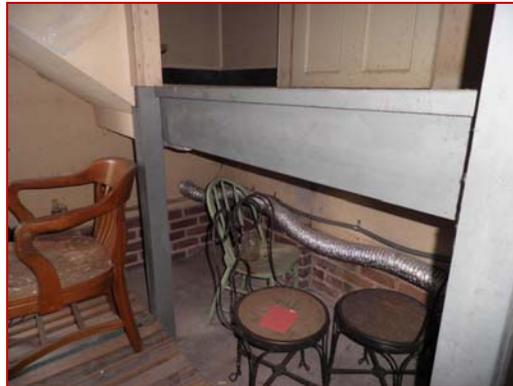
The laundry area is in the kitchen with domestic water and drain stubouts for a utility sink. There is also a drain standpipe and hot/cold water valves for a clothes washer. The dryer exhaust is a flexible duct that is routed through the garage to a vent on the exterior wall.

- Add a range hood for the new cooking appliance and connect to existing ductwork.
- Replace the flexible clothes dryer exhaust duct with rigid duct.
- Verify electric wall heaters operate properly.

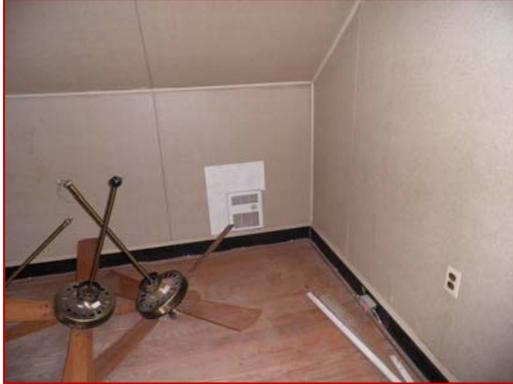
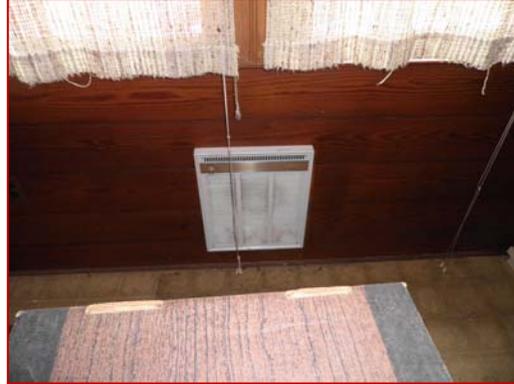
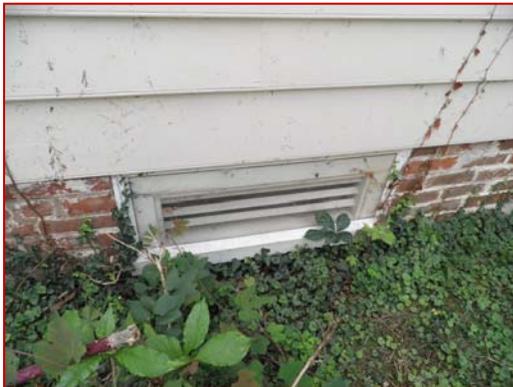
There are two electric wall heaters located in the area above the garage, one in the family room off the kitchen, and one in the second floor bathroom. The heaters were not tested to see if they are operational.

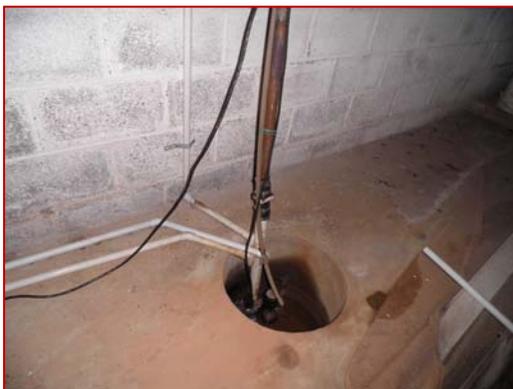
The crawl spaces are open to the basement and the original crawl space ventilation openings have been covered with plexiglass. The basement does have supply registers as described in the second HVAC system above.

- Provide a separate dehumidifier just for the basement area.
- Provide a gasketed lid on the sump pump.

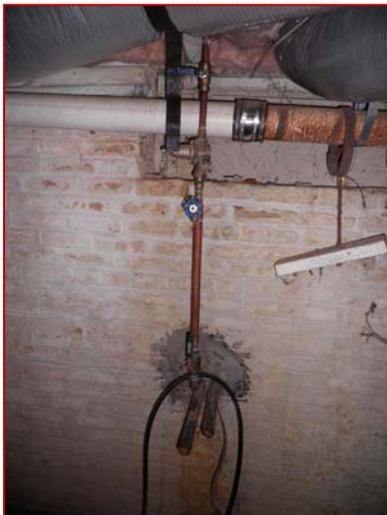
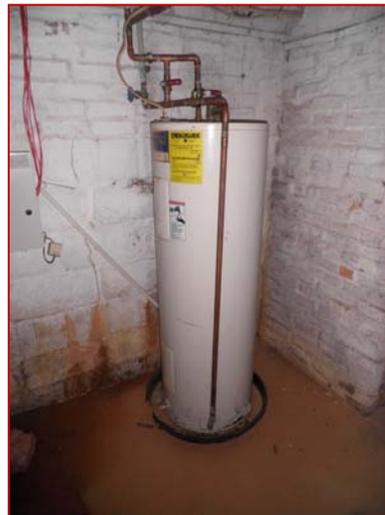
The electric 50 gallon domestic water heater has a 4500 W heating element and was installed sometime before 1994.

- Replace the electric water heater.
- Insulate the domestic hot and cold water piping in the basement.
- Provide new faucet for the kitchen sink.
- Replace the garbage disposer.
- Provide a dishwasher.
- Add a laundry sink (optional, but is currently plumbed for it)
- Provide clothes washer and dryer.
- Replace faucets in all toilet/bath rooms, unless the FCPA wants to retain any for historical purposes. The water service was turned off to the building, so the faucets could not be verified if they are functioning.
- Replace flapper and fill valves in all toilets.
- Clean gutters and downspouts to verify they are clear.
- Provide splash blocks at all downspouts.

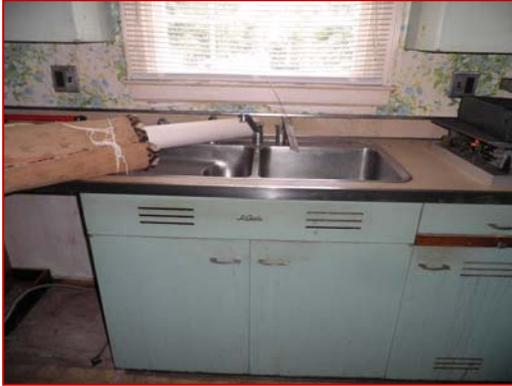
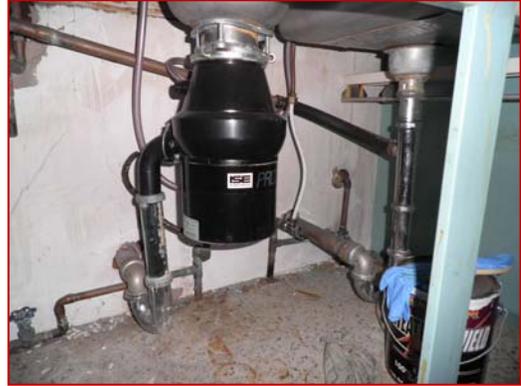
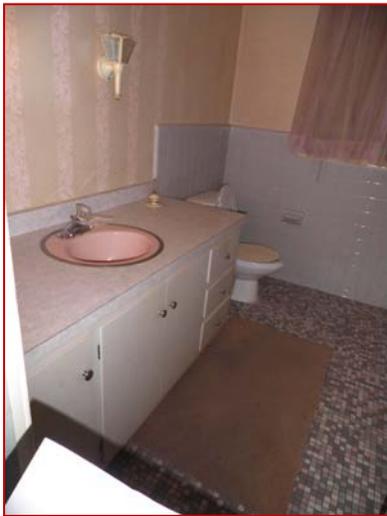
The kitchen has a double compartment sink with faucet and separate pull out sprayer as well as a garbage disposer. There is a space under the counter for a dishwasher that was once plumbed, however the dishwasher has been removed.

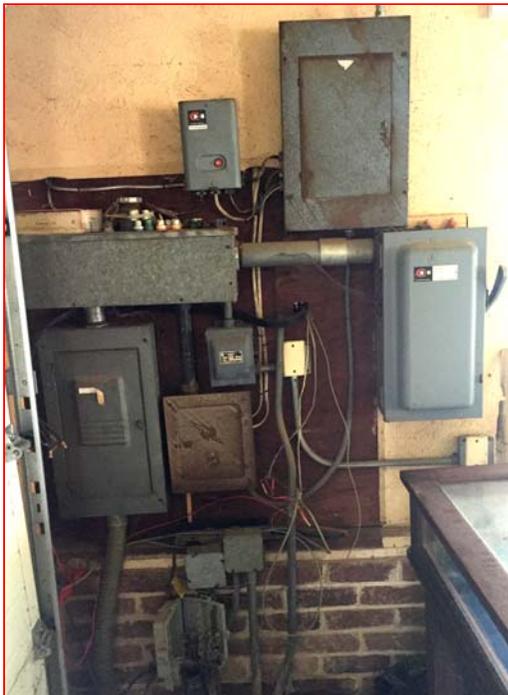
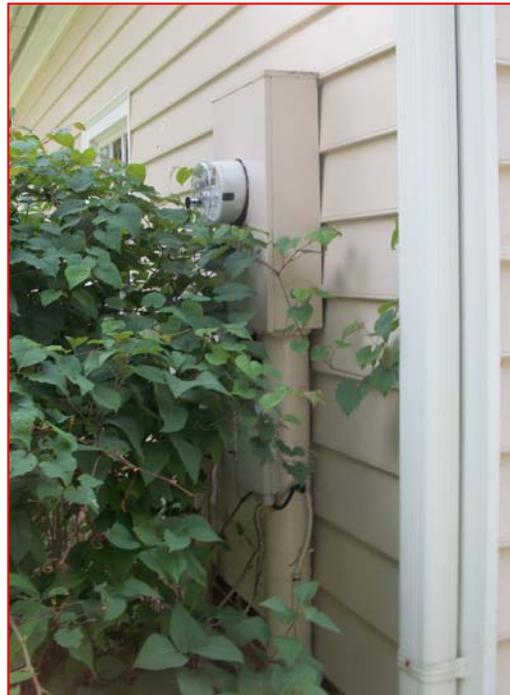
Electrical power is brought to the building by an underground 120/240V, single-phase, three-wire service connecting to a an electric meter on the outside corner of the garage. From the meter the utility service feeds a wire way where the feeder is tapped to supply several pieces of equipment. A bare ground wire is also connected to the wire way. The wire way was not opened to confirm, but it appears to supply four pieces of equipment:

- 200A Removable Fuse Holder
- 200A Disconnect Switch
- 60A Fuse Box
- 30A Disconnect Switch.

- Replace garage service entrance equipment
- Replace (2) 200A (40 pole) panelboards in basement with GFI and AFCI circuit breakers.
- Replace light fixture by sump pump and other non-functioning light fixtures.
- Add receptacles in in toilet rooms off the main bedrooms.
- Replace non-grounded receptacles
- Replace smoke detectors. Recommend networked building powered in lieu of battery powered.
- Feeders to HVAC system 1, 2 and 3 may be reused if sized correctly for the proposed equipment.
- Provide power for proposed exhaust fan in toilet room
- Provide power for proposed dehumidifier in basement

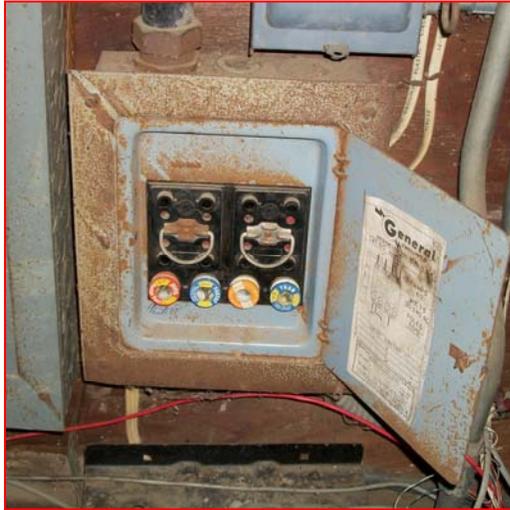
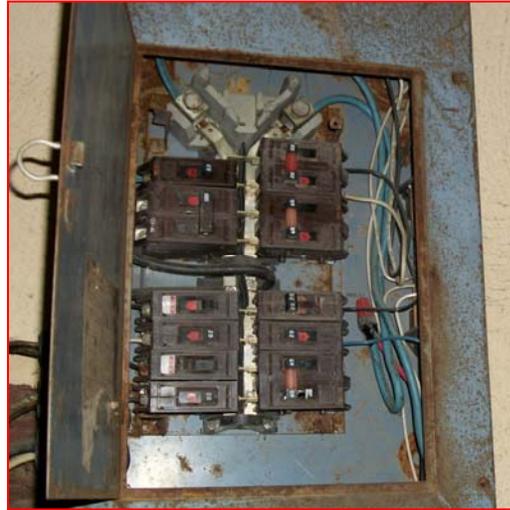
The 60A fuse box and garage panelboard are in poor condition and should be replaced. There are a number of loose low voltage wires which do not appear to be in use.

A telephone company entrance box was also noted in the garage, but did not appear to be functional.

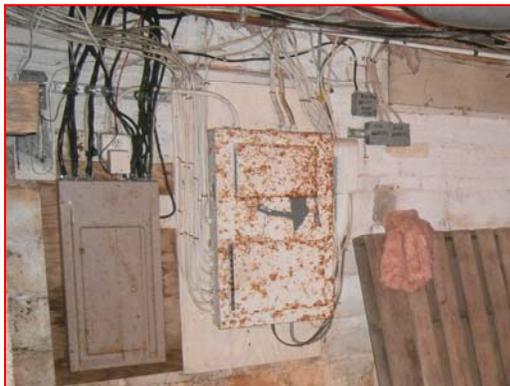
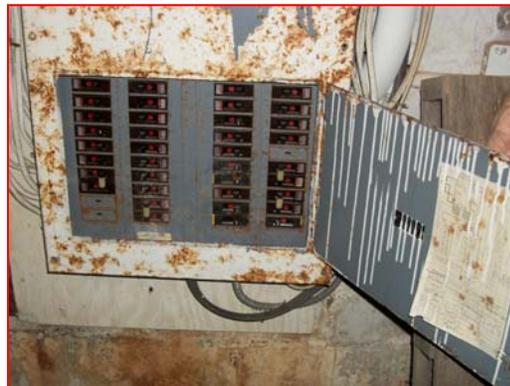
There are two 200A panelboards in the basement. The panelboard on the left feeds HVAC/Furnace loads (two pole loads) and is the newer panel, although neither is dated. The 200A panelboard on the right, which appears to have been installed as part of the 1960s renovation, feeds the kitchen and other building receptacle loads. Both panelboards have extensive exterior rust damage which implies the interior of the circuit breakers are also rusted. The panelboards should be replaced.

The insulation on the cables being supplied by the panelboards does not appear to be damaged and should be able to be reused.

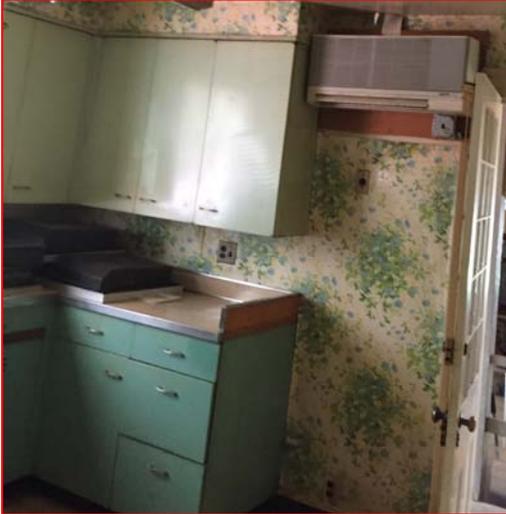
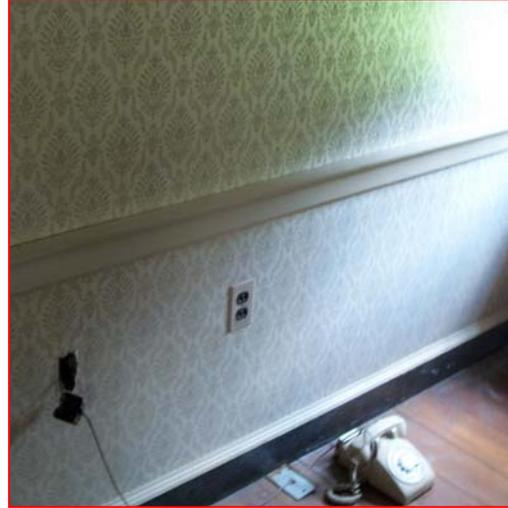
Virginia where the 2014 code is currently in use. The NEC requires Ground Fault Protection (GFI) in Bathrooms, Garages, Outdoors, Kitchens, Basements, and Laundry areas. The NEC also requires Arc-Fault Circuit Interruption Protection (AFCI) in most other areas in a dwelling unit. Protection can be provided by individual receptacles or be provided on the branch circuit breakers supplying the receptacles. While upgrading is not code required, it is recommended to provide GFI and AFCI circuit breakers in the panelboards that have been recommended for replacement.
