Ellmore Farmhouse Historic Structure Report

Prepared by:
Shaffer, Wilson, Sarver & Gray, PC

Prepared for:
Fairfax County Park Authority

May 12, 2011 - Final

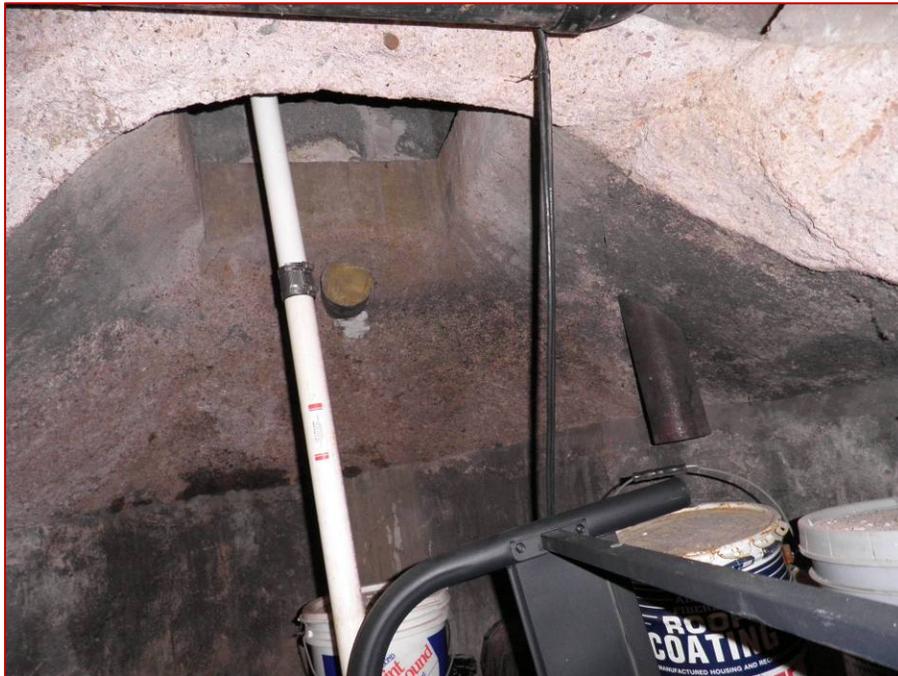
Within the corner of the first major addition of the cellar space is a remnant of an abandoned septic tank. It partially extends beyond the existing CMU foundation wall.

Two iron pipes extend through the concrete septic tank. The vertical pipe was the original sanitary pipe from the fixture to the tank. The horizontal pipe discharged waste to the septic leech field. A square opening at the top of the tank would have had a cover that could be removed to empty the tank. A sump pit, sump pump, and PVC discharge pipe were added more recently.

Image 3.20: Top of Interior of Septic Tank

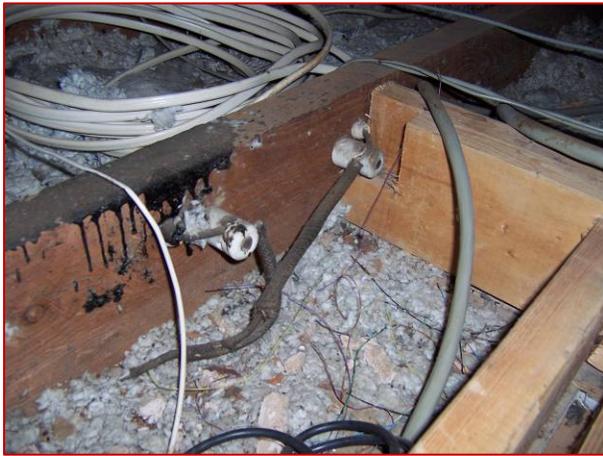
The early tube wiring and ceramic insulators were observed in the attic.

Image 3.56: Early Electrical Wiring

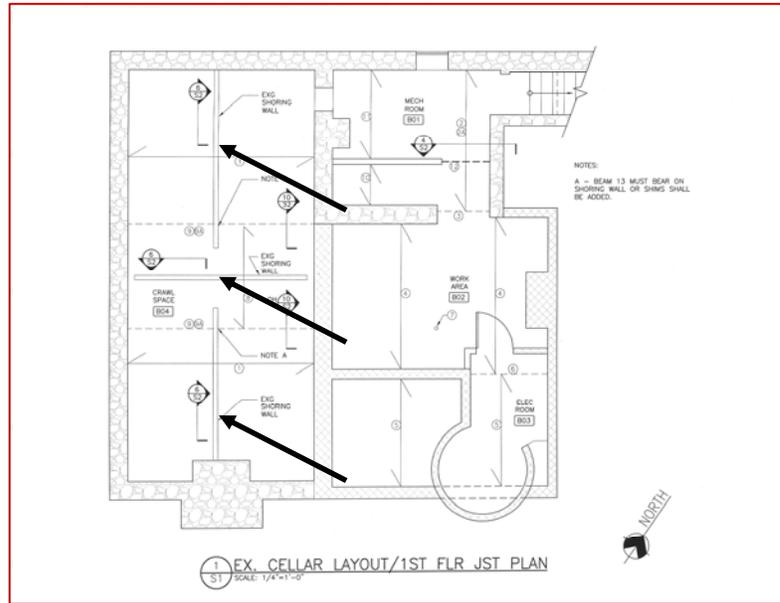
Image 4.1: Crawl Space Shoring Walls

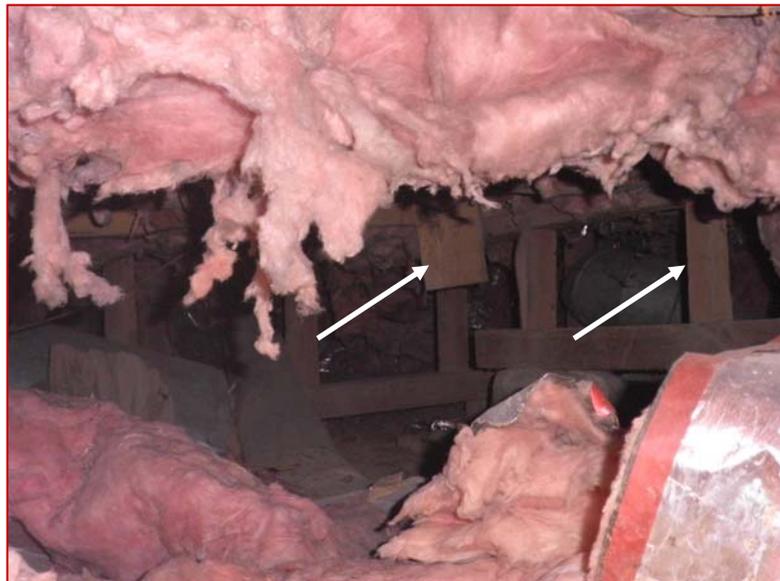
Image 4.2: Crawl Space Shoring Walls

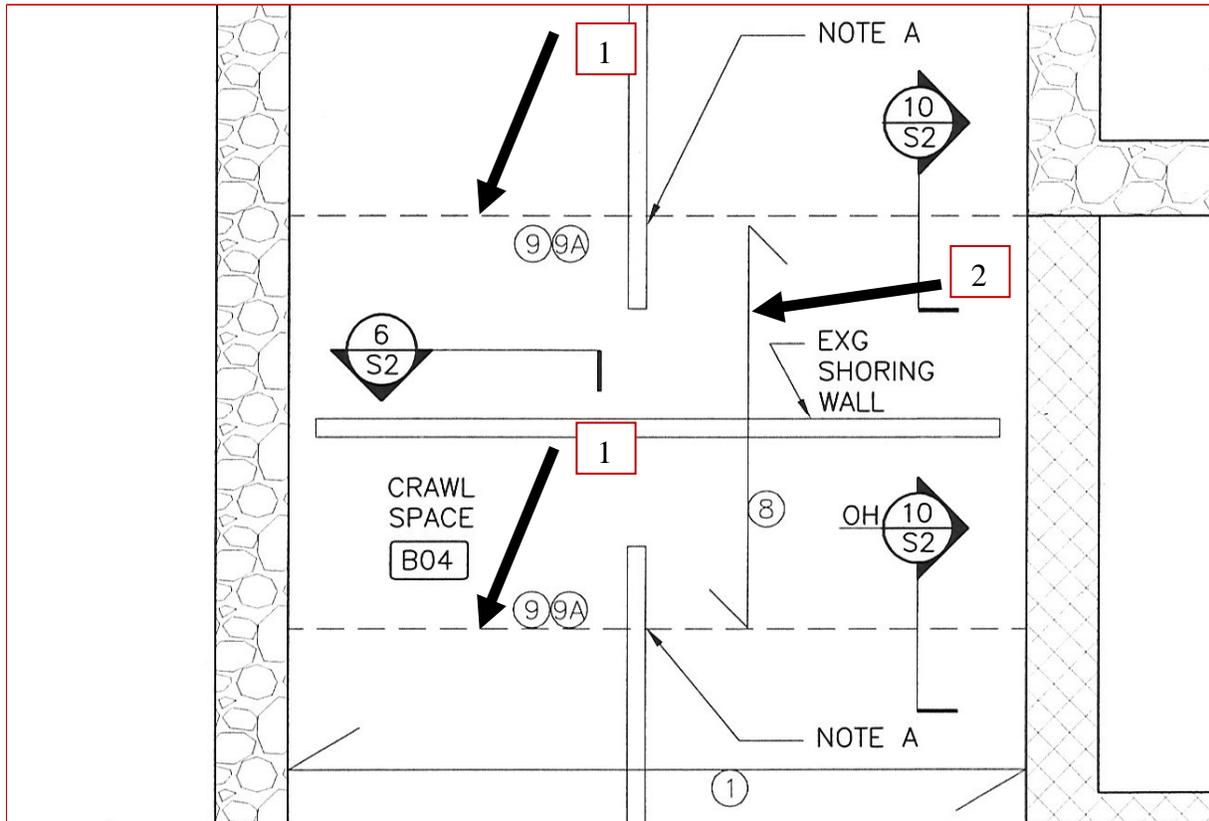
Image 4.3: First Floor Joist Headers

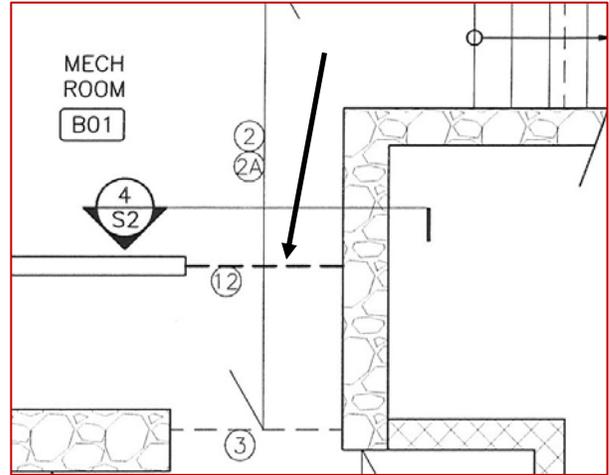
Image 4.5: Rear Joists Below Kitchen

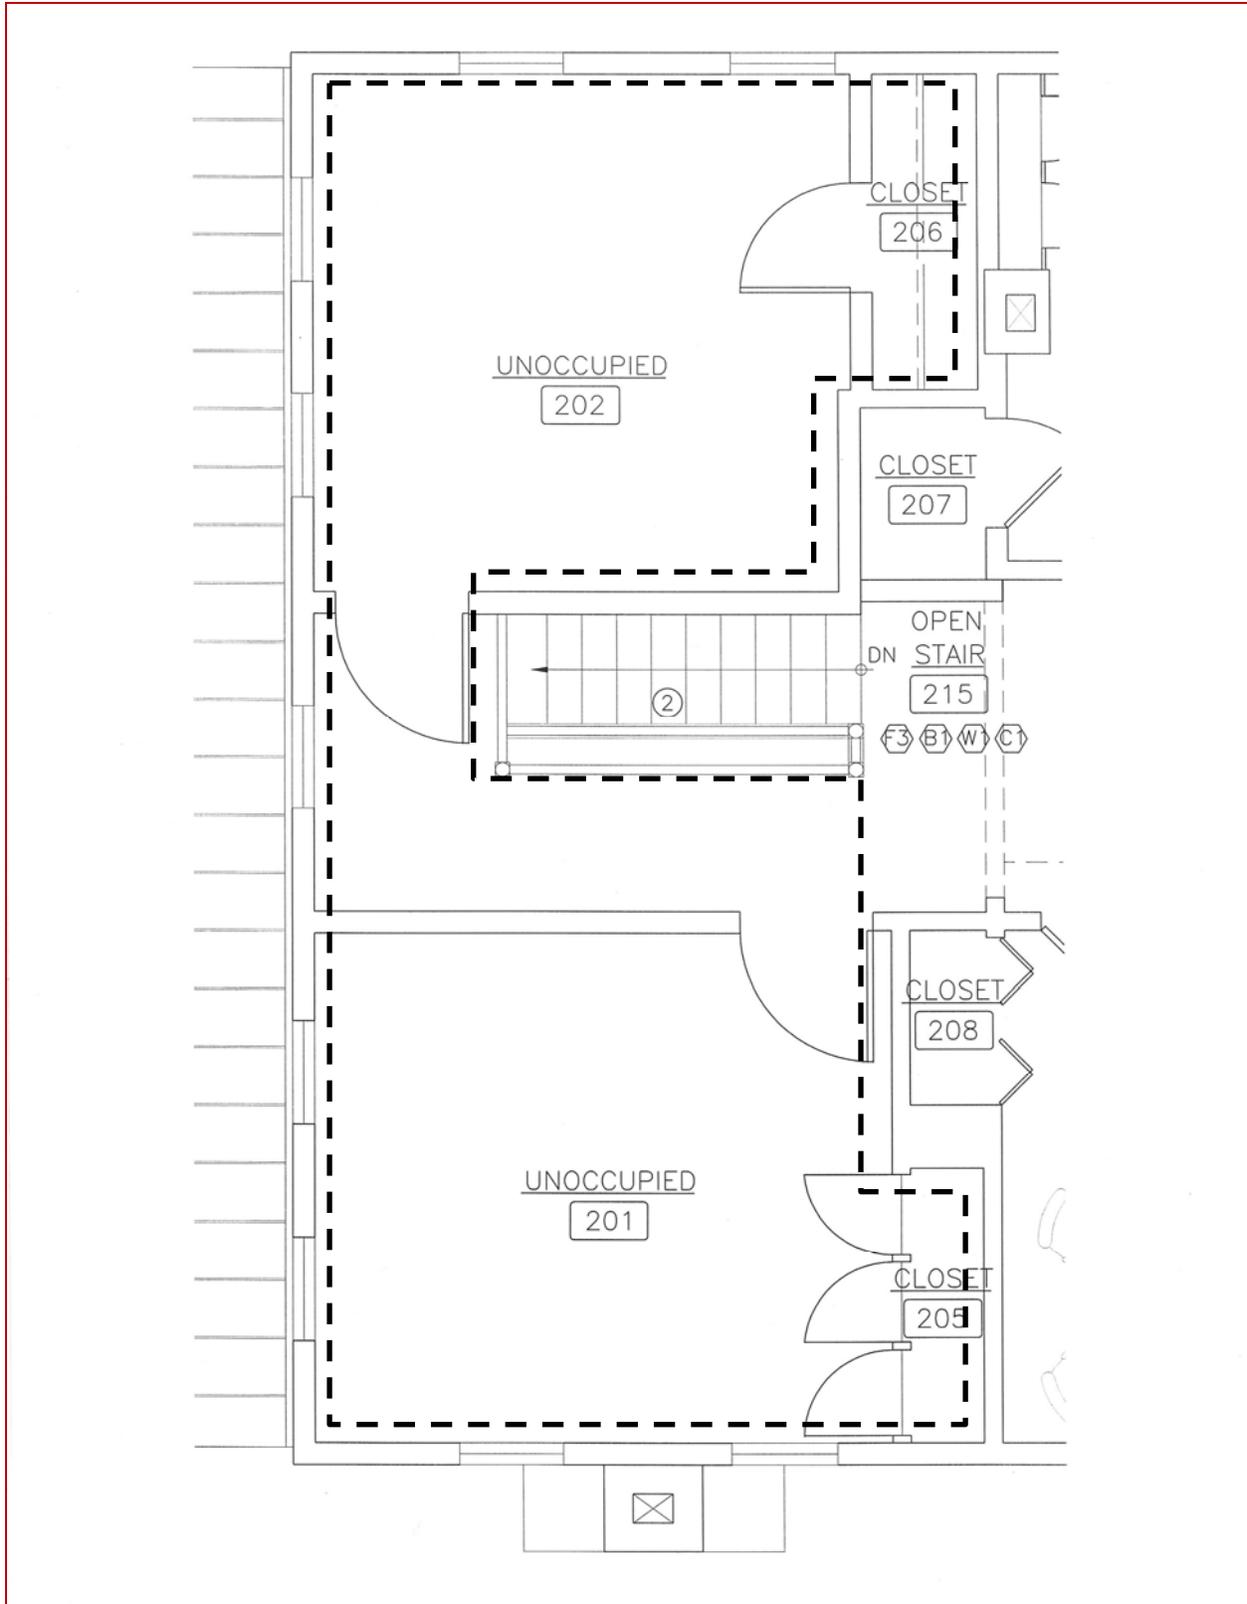
Image 4.6: Second Floor Joists Below Front Bedrooms Are Inadequate

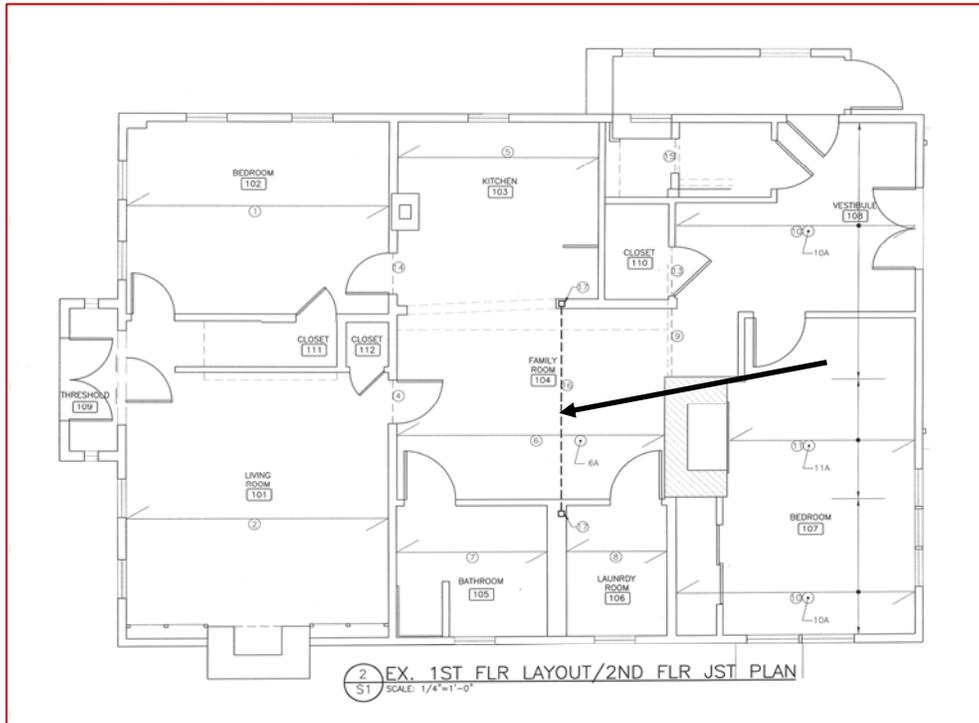
Image 4.7: Second-Floor Joists Below Central Hall

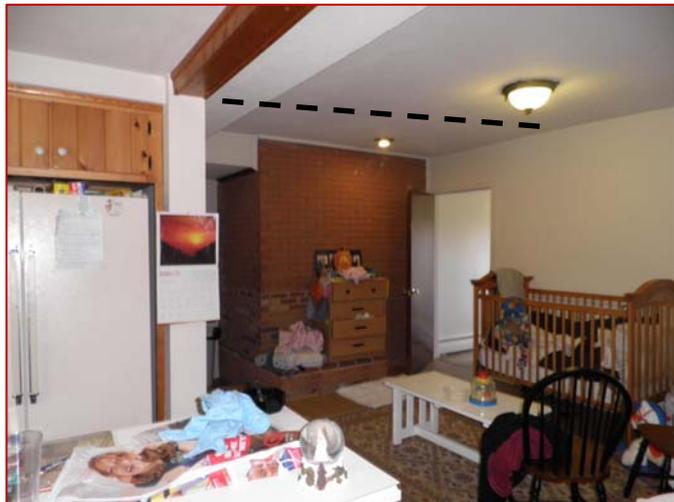
Image 4.8: Second Floor Joists Below Central Hall

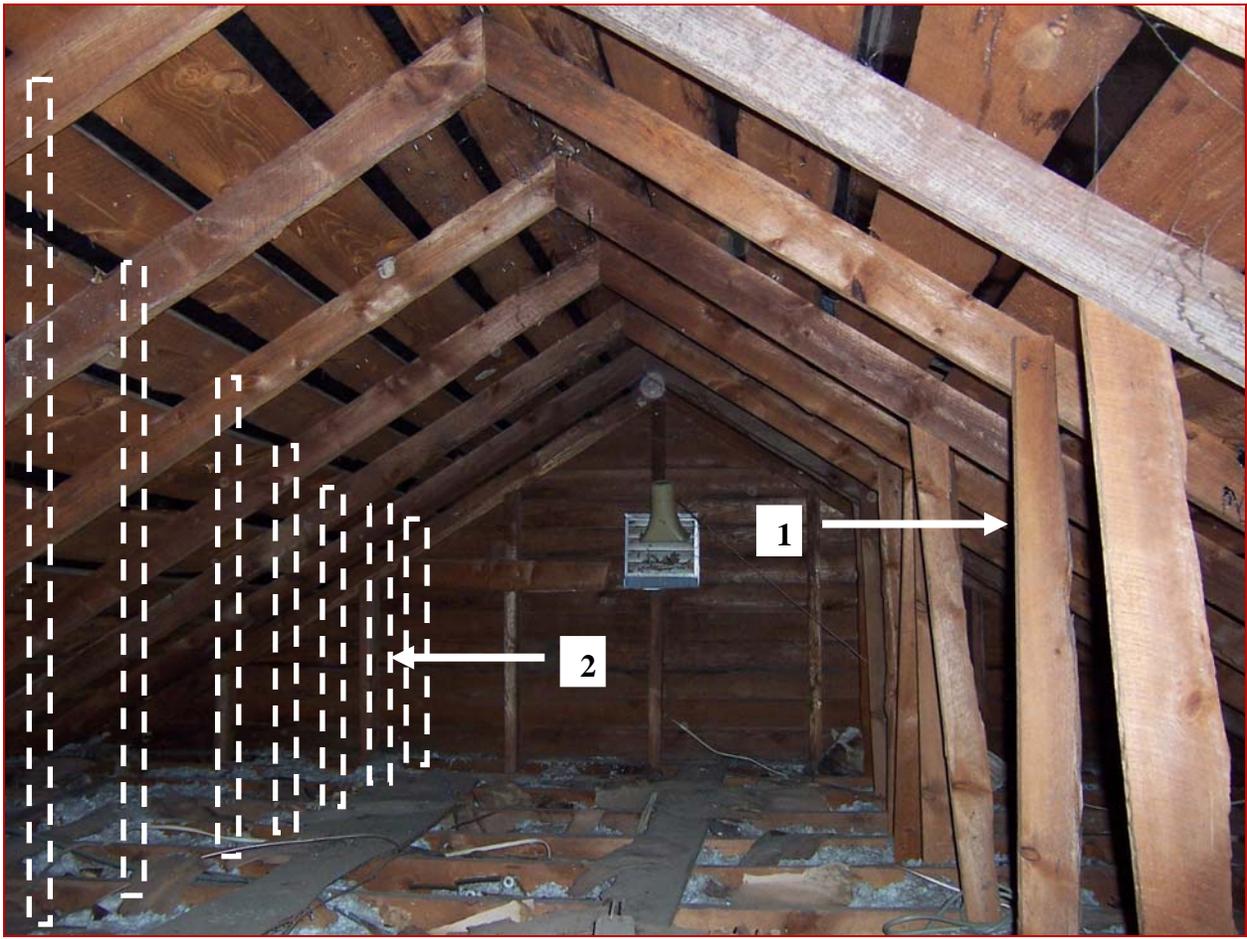
Image 4.9: Roof Rafters Above Bedroom 202

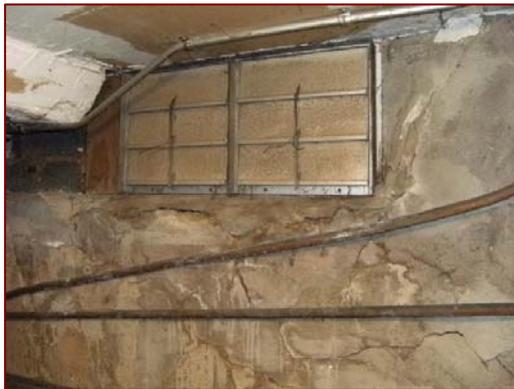
Image 4.10: Uninsulated Copper Piping

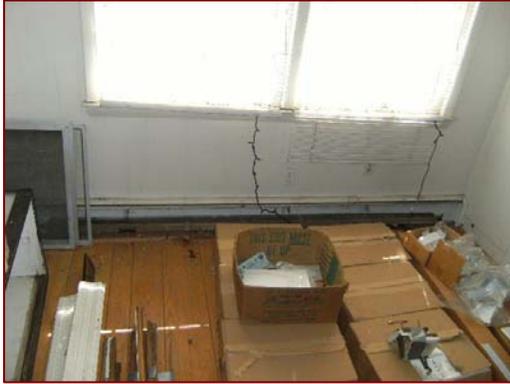
Image 4.12: Typical Damaged Radiator

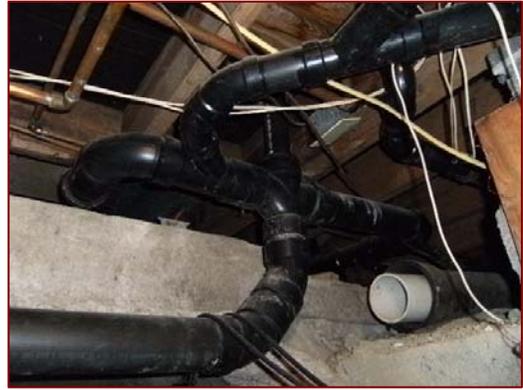
Image 4.17: Sanitary Sewer Piping

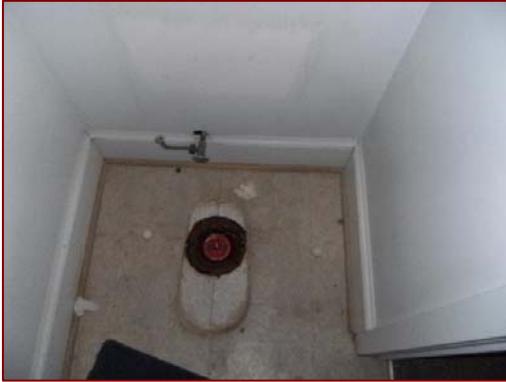
Image 4.20: Capped Sanitary Sewer Line
