## Mount Gilead

### Historic Structure Report

### FINAL REPORT

WJE No. 2019.8373

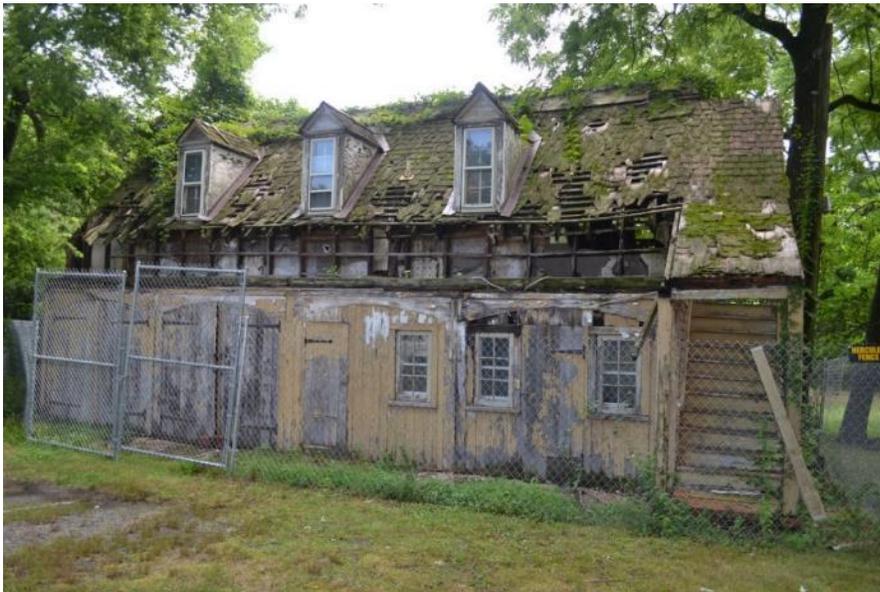
Figure 35. View toward the carriage house/garage built by Alvin Detwiler. The building is in deteriorated condition. Source: Liz Sargent, July 2020.

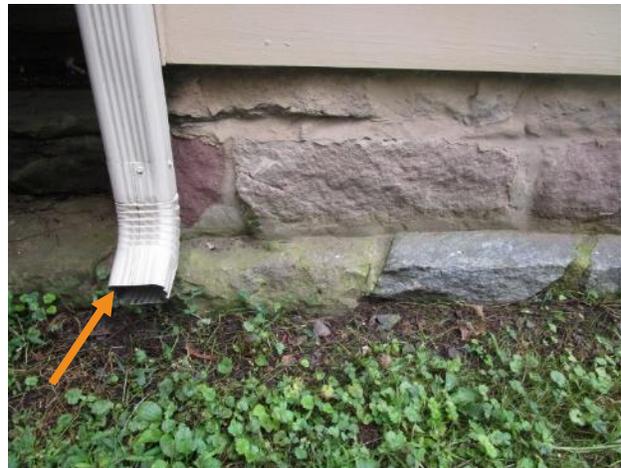
Figure 65. Downspouts deposit water close to foundation.

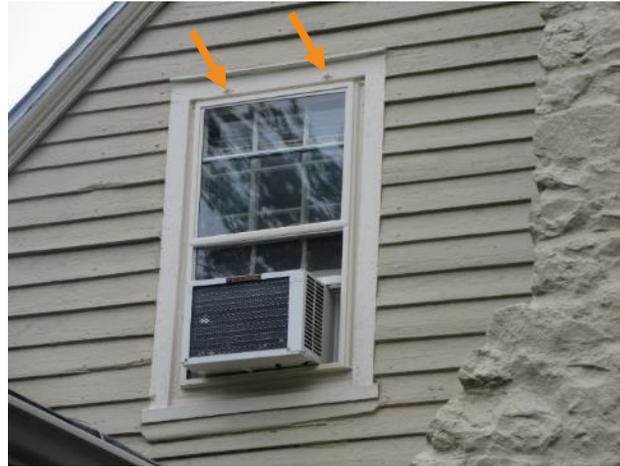
Figure 83. 6/6 gable end window currently holds an air conditioner unit. Note hasps (arrow) over window from previously removed element.

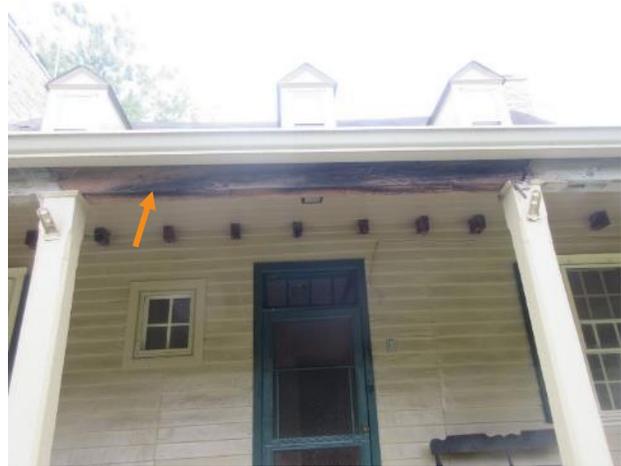
Figure 109. Porch roof rim joist is hand hewn. The center member was previously replaced.

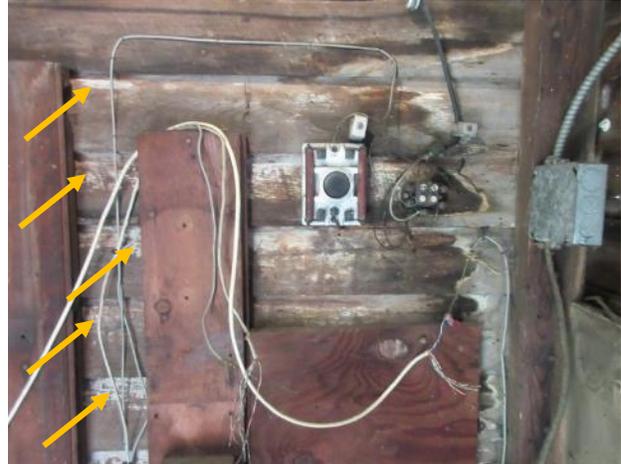
Figure 119. Close-up view of wall that abuts dining room. Notice remnants of deteriorated white coating.

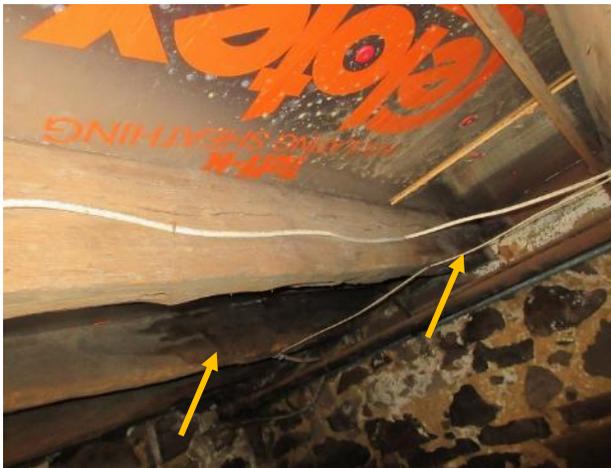
Figure 130. Overhead joists supporting the first floor are hand-adzed. Note water staining at joist ends.

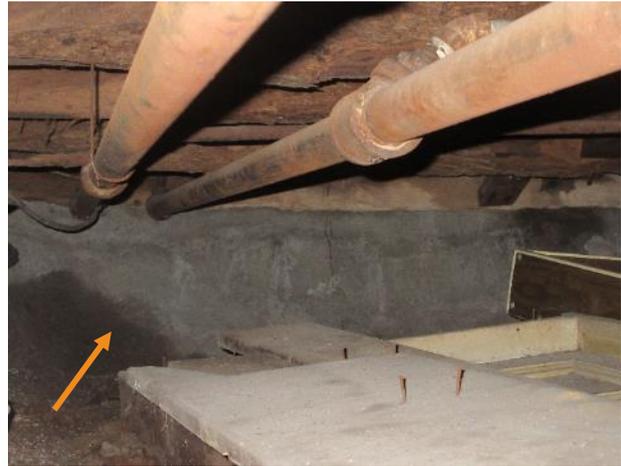
Figure 153. Cementitious coating visible along the west foundation wall at crawl space.

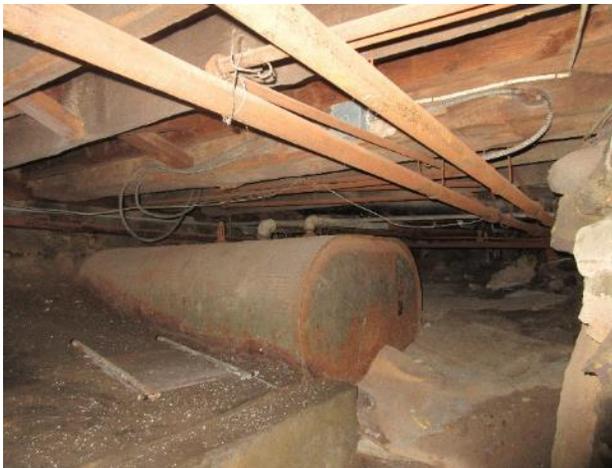
Figure 154. Partially buried oil tank located within the crawl space, which may have supplied radiators in the house.

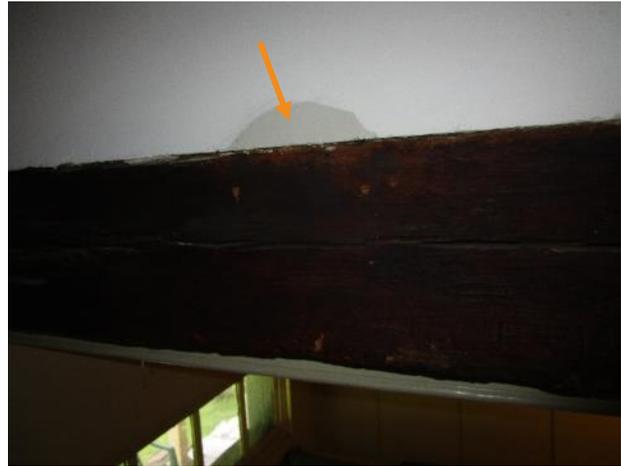
Figure 175. Plaster repair at exposed timber beam along the staircase.

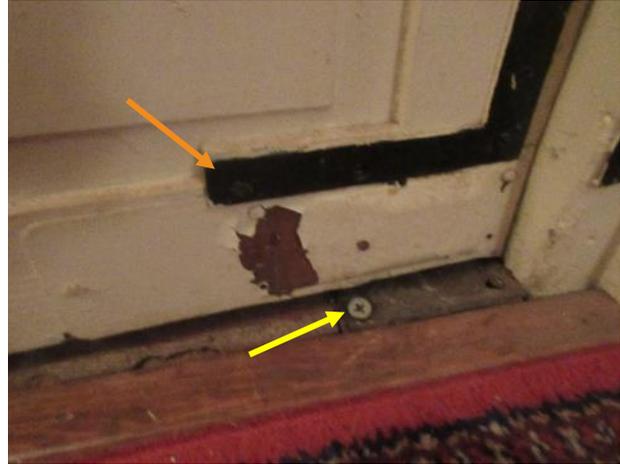
Figure 217. Door hinges below the dining room door have been replaced (orange arrow). Previous pivot hinge was likely for a swinging door (yellow arrow).

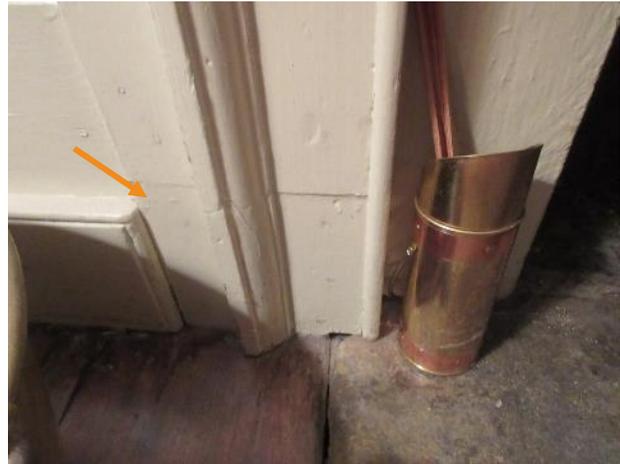
Figure 254. Wood dutchman observed at the base of the fireplace mantel legs.

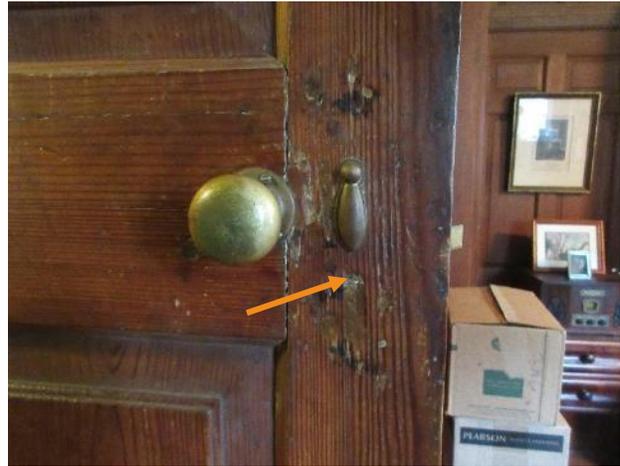
Figure 298. Previous wood putty repair below the key hole on the door between the library and sitting room.

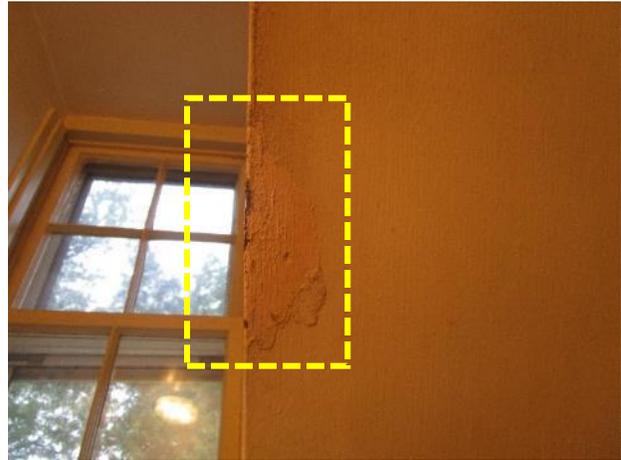
Figure 340. Area of plaster repair at the sloped ceiling.

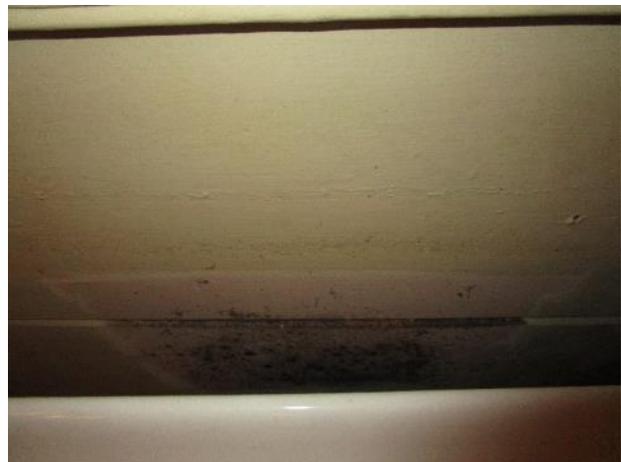
Figure 342. Black staining behind the radiator.

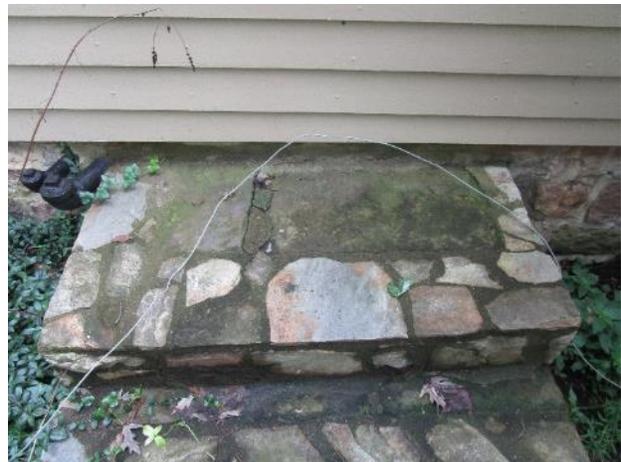
Figure 414. Biological staining at abandoned steps at the south enclosed porch.

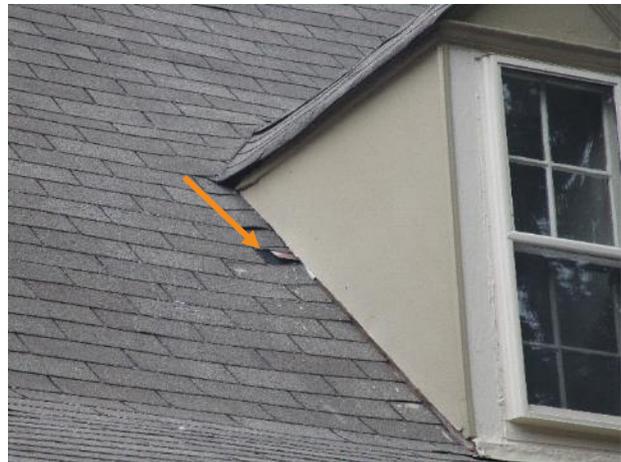
Figure 426. Missing shingle at dormer, view from south.

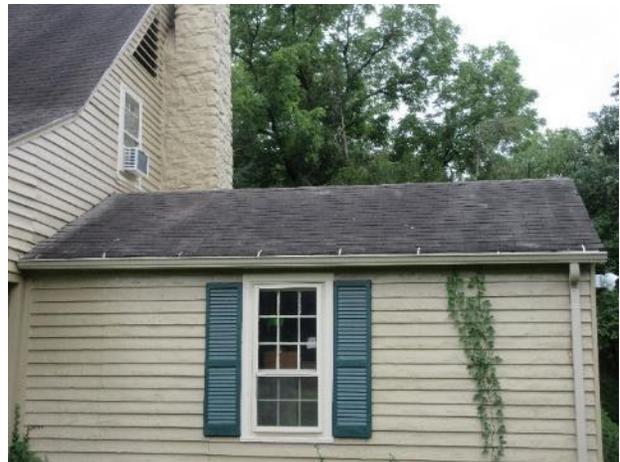
Figure 430. Typical dark staining on the north roof, west addition.

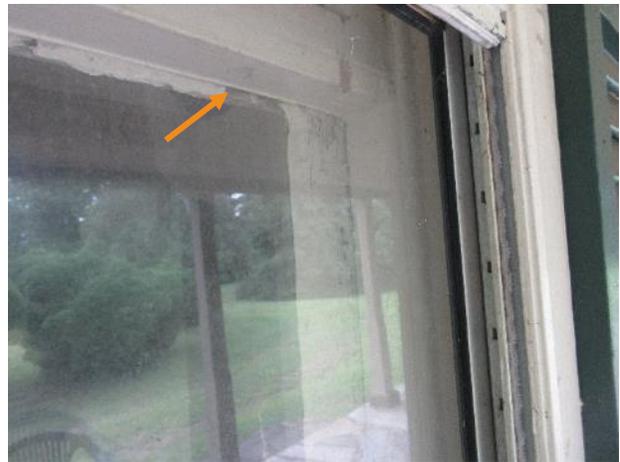
Figure 446. Missing section of glazing putty at a north facade window. Storm windows are in place at this window.

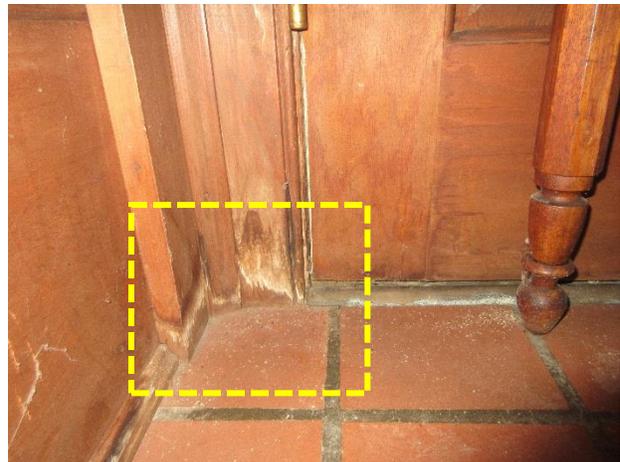
Figure 461. View of the west addition exterior door from the interior, which shows active water infiltration at the base of the door with related staining of the wood.

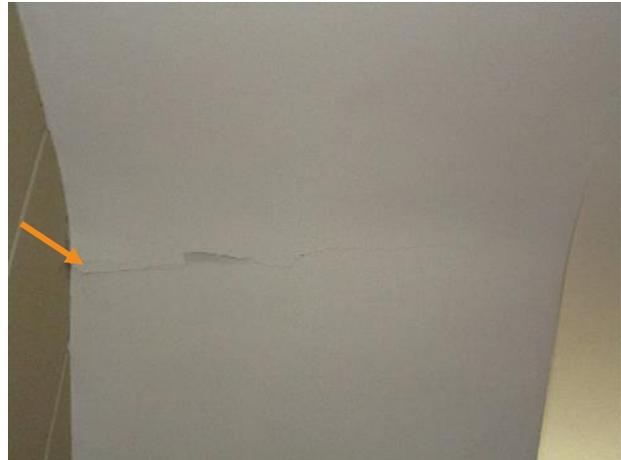
Figure 486. Plaster cracking and small spalls in the sloped ceiling of the master bathroom.

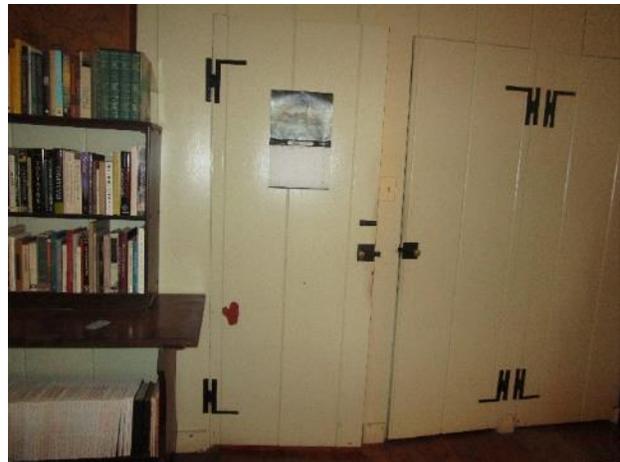
Figure 494. Example of missing paint at the guest bedroom wood door.

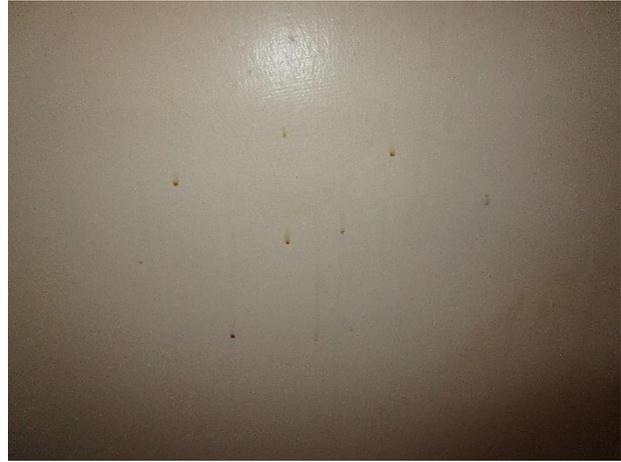
Figure 496. Water staining on the sloped ceilings from condensation, guest bathroom shown.

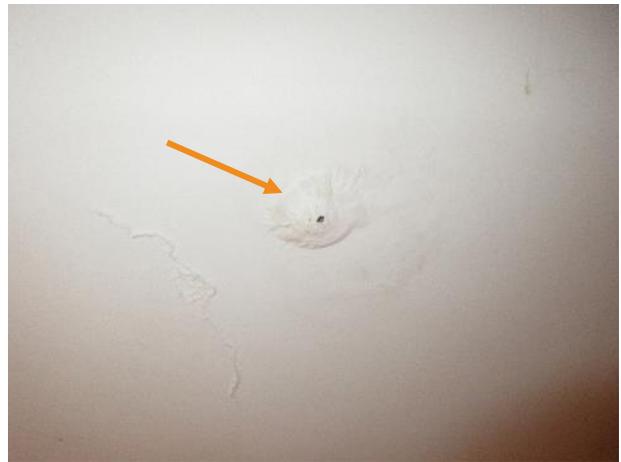
Figure 498. Area of blistered and stained plaster ceiling, living room shown.

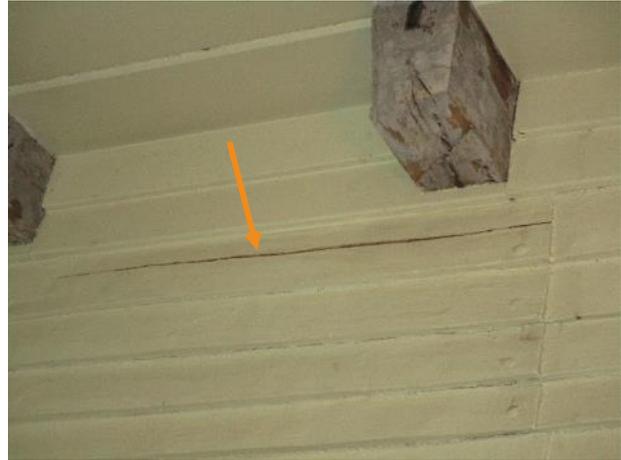
Figure 528. Crack in a clapboard below the exposed joists.

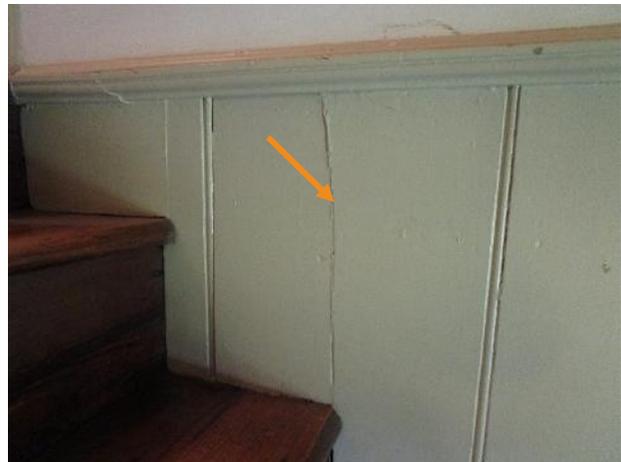
Figure 538. Crack in wood paneling within the stairwell.

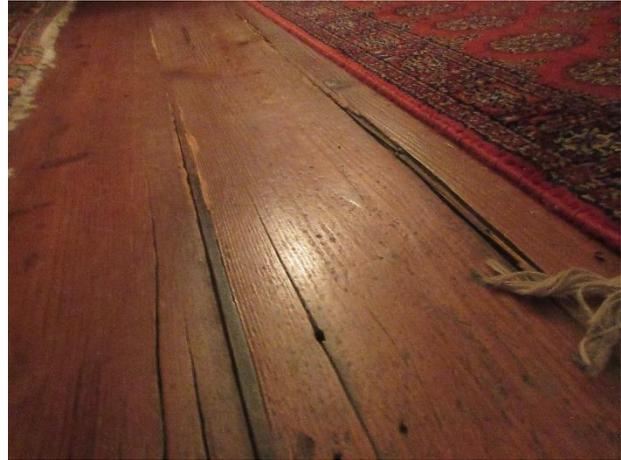
Figure 548. Cracking and checking in the floor boards.

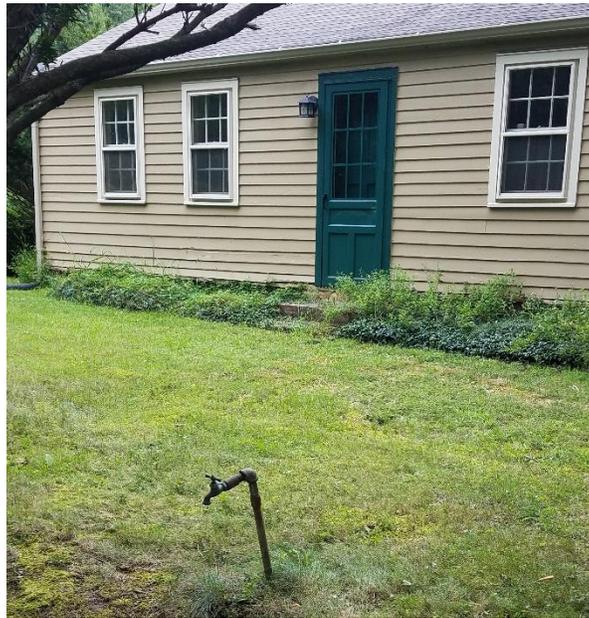
- There is an outdoor spigot at the rear of the house with no water. It may have been abandoned when the house was taken off its well and added to the county's service.

Photo 3: Outdoor spigot without water.

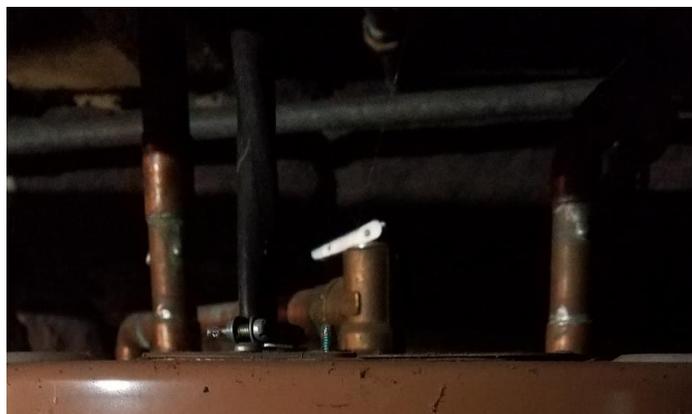
- The hot water heater is over 20 years old and temperature only reached 100 degrees F.
- None of the domestic hot water pipes were insulated. Since the house is used in a residential setting, it is not recommended that the domestic hot water pipes have insulation. Insulating domestic hot water pipes is beneficial in a commercial setting when the system is in constant use to maintain system temperature and reduce energy loss. In a residential setting, the domestic hot water system can be inactive for long periods of time with an overall system temperature drop from inactivity. The amount of energy conserved with the installation of piping insulation would be negligible for the short periods of time that the domestic hot water system is active. It would take decades to earn back the cost of insulation in energy savings.

Photo 4: No pipe insulation.

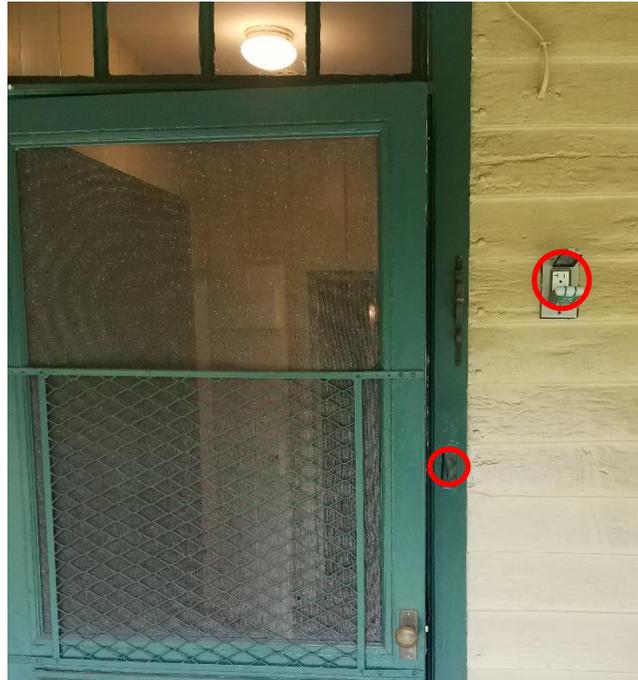
Photo 5: The front doorbell is taped over and the outlet has no power.

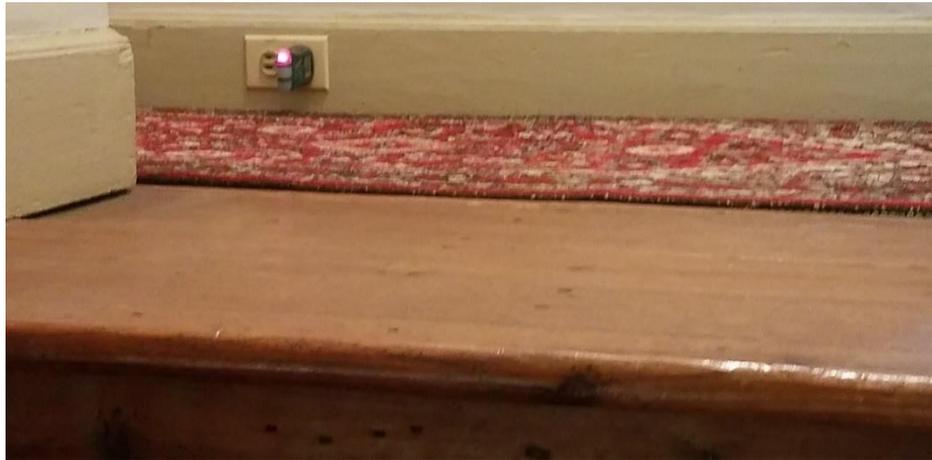
- The electrical receptacle at the top of the stairs, along the baseboard, is not properly grounded. Recommend identifying the problem and correcting so the outlet is fully functional.

Photo 6: The circuit tester is indicating a bad ground.
