TURNER FARM
Turner Farm Treatment Report

10609 Georgetown Pike
Great Falls, Virginia 22066

Final Report

November 10, 2016
WJE No. 2015.3162.2

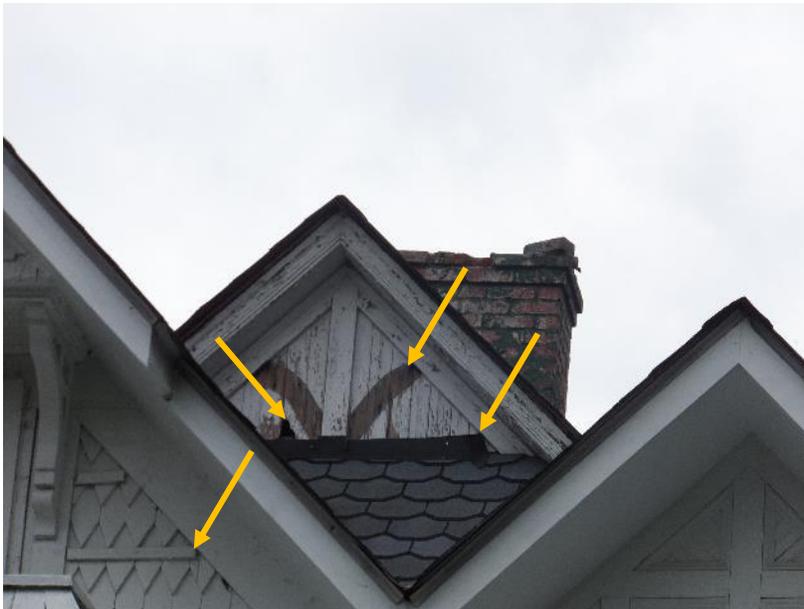
Based upon site observations, it is apparent that some repair work has been completed since the 2011 HSR; mainly to the porch, siding, and roof. At the northeast corner of the 1905 structure roof, a course of six asphalt shingles near the gutter are lifted and out of plane. There are isolated areas of deteriorated flaking paint and exposed wood throughout the exterior, most notably at the secondary gables. The secondary gable to the north of the deteriorated wood has resulted in a hole, as well as general flaking of paint that does not appear to have been addressed in any recent work. The roof termination at this secondary gable also appears to be inadequate with black roof felt attached to the gable and asphalt shingles serving as some sort of seam lap. (Figure 5)

Figure 5. Roof felt at the secondary gable and roof shingles. Note hole in wood and profile from previous decorative trusses as well as miscellaneous horizontal wood boards on forefront gable.

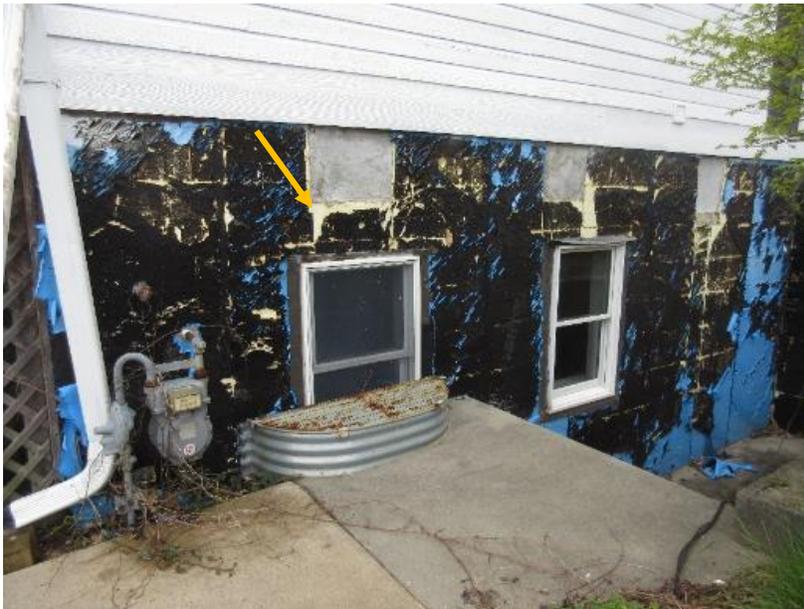
Figure 6. Deteriorated WRB and exposed insulation form where WRB is no longer in place.

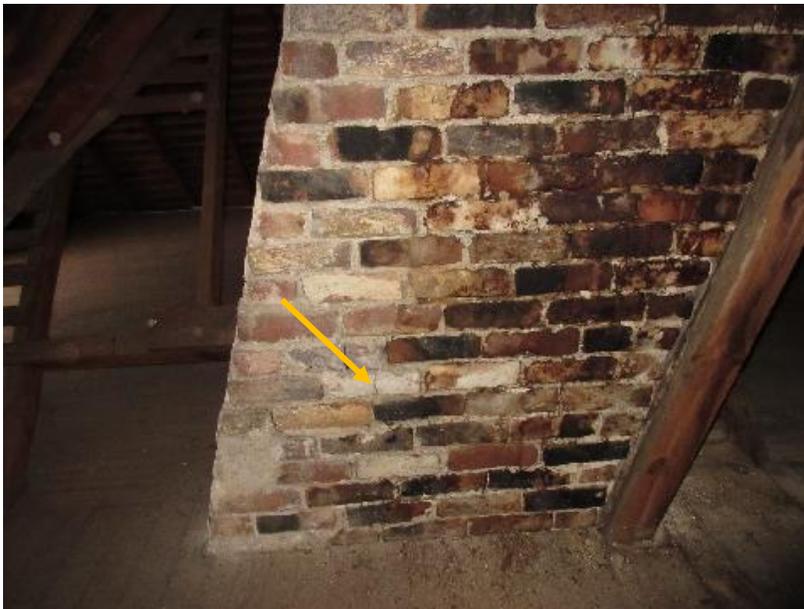
Figure 7. Vertical crack in the north face of the chimney in the attic.

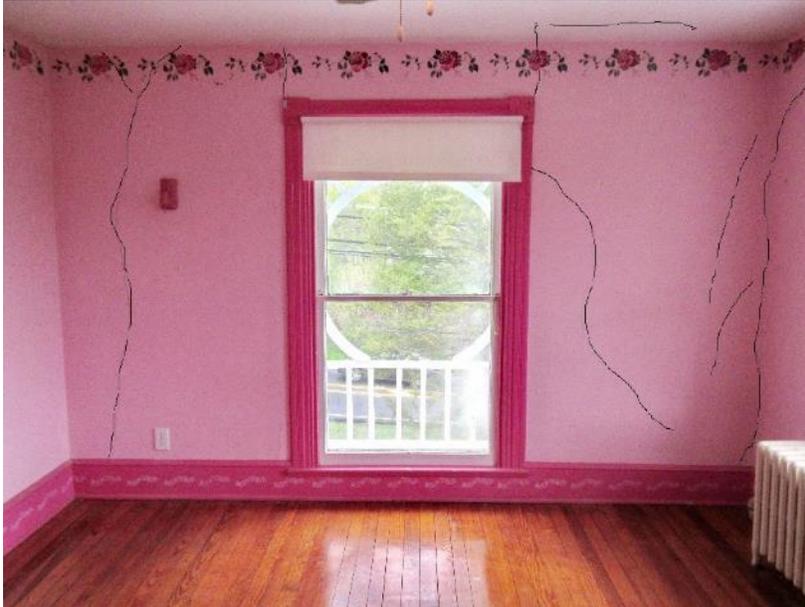
Figure 8. Example cracking in Room 201 at the north wall. Cracks have been traced for clarity.

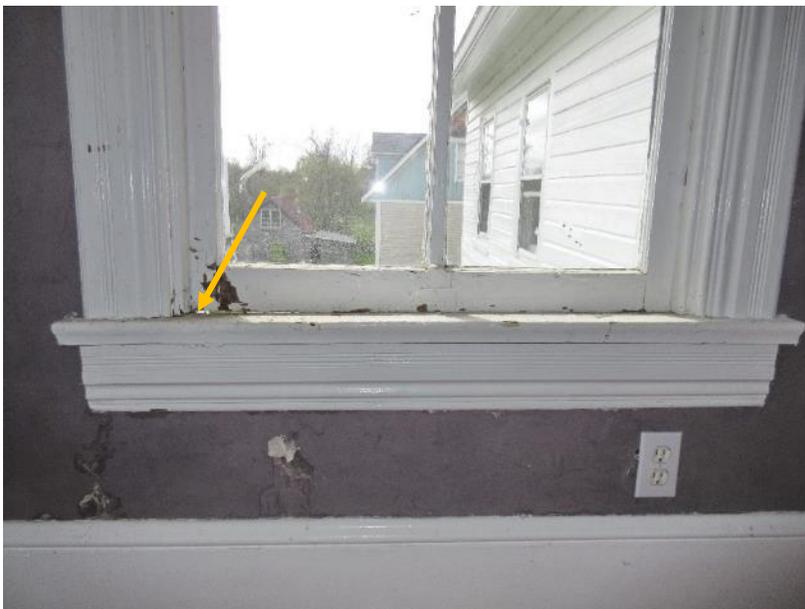
Figure 11. Typical staining and cracking below original window. Note this window is racked with visible daylight below the sash.

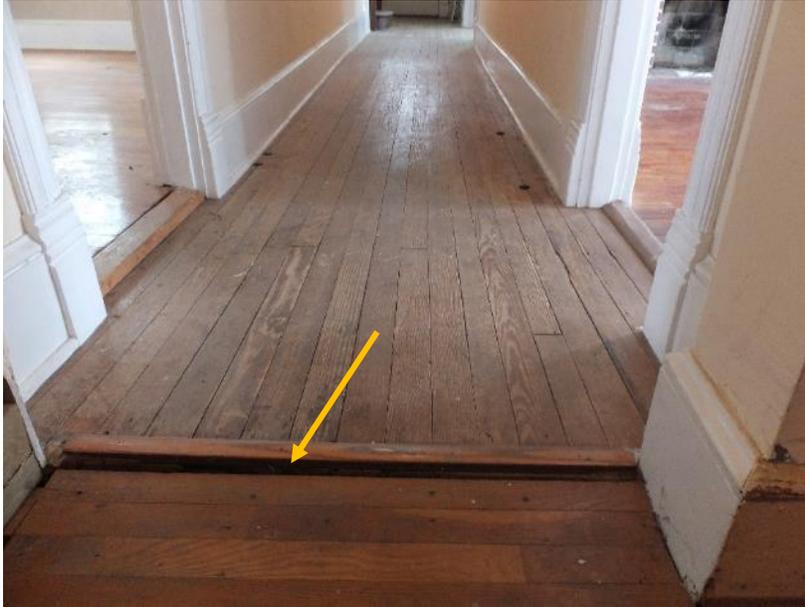
Figure 12. Transitions between Hallway (100) and adjacent rooms. Note gap between the rear hall to the Hallway (100).

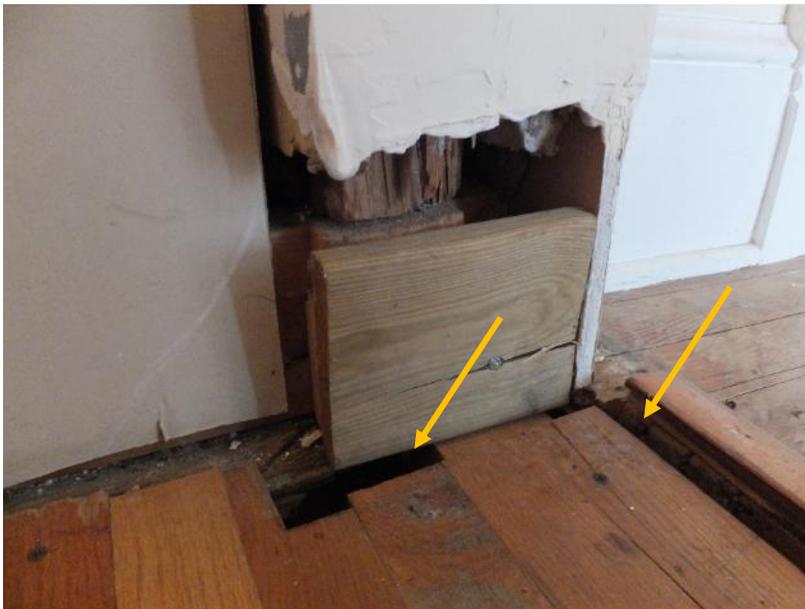
Figure 13. Voids in the floor at the rear hall allowing the below cellar to be visible. Note the missing baseboard and interior finishes at this location.

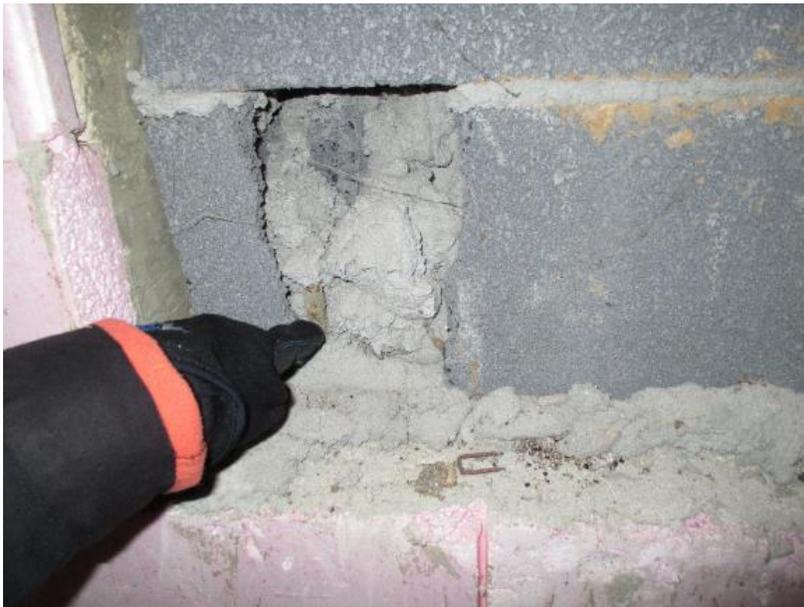
Figure 15. CMU infill at blockout in cellar wall. Note the reinforcing bar present inside the damaged cell.

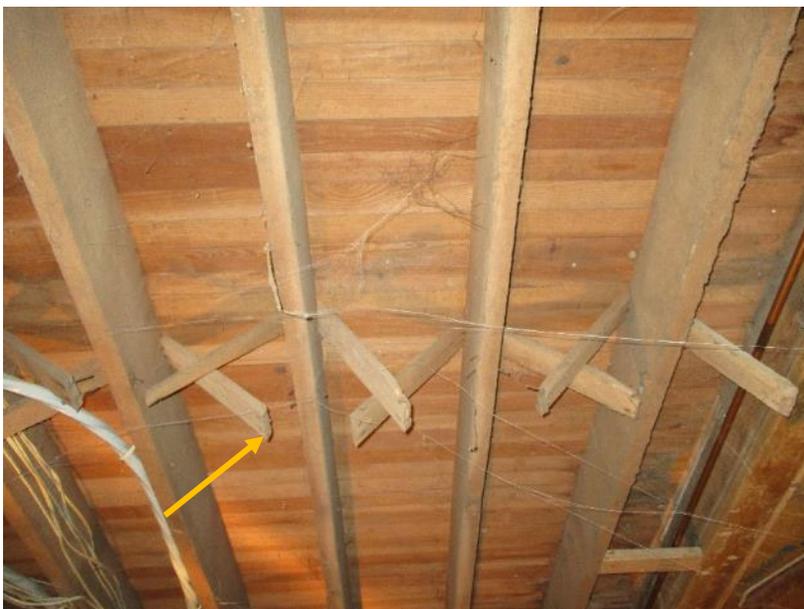
Figure 22. Disengaged and missing wood bridging between first floor joists (typical at original first floor framing).

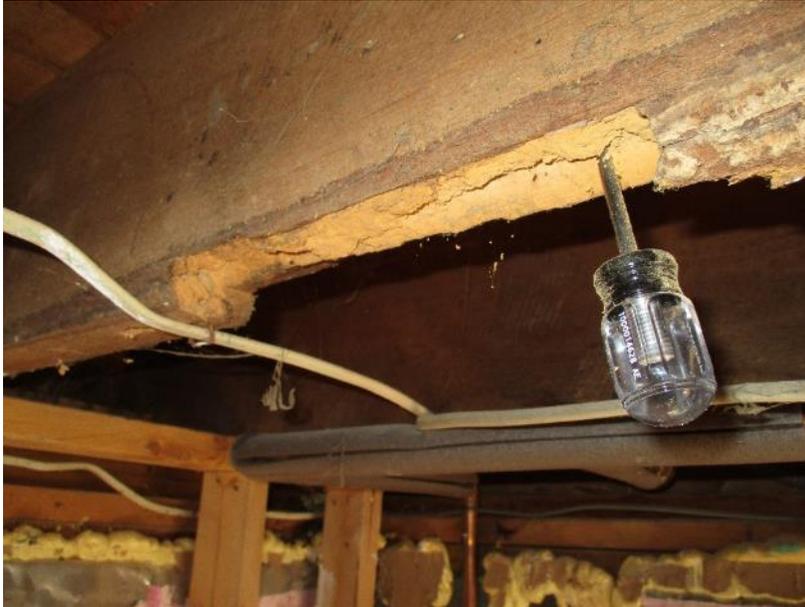
The majority of the first floor wood framing is in fair condition; however, decay is present at isolated locations along several of the original joists (Figure 24 and Figure 25). The extent of the damage observed was limited and does not suggest that the joists are structurally undermined. WJE took limited moisture readings at the original joists using a handheld moisture meter and measured an average moisture content of thirteen percent, which is on the high side for interior wood members not exposed to weather, but less than the twenty percent threshold which is the general value recognized to support the initiation of decay. Since the house has not been occupied for several years, we anticipate that it has not been conditioned, i.e. heated and cooled, like typical interior spaces and that this has contributed increased humidity levels in the below-grade space and higher moisture readings in the wood framing. Water stains and deteriorated floor boards are present at isolated locations along the edge of the original farmhouse (Figure 26).

Figure 24. Deterioration at first floor joist in original farmhouse.

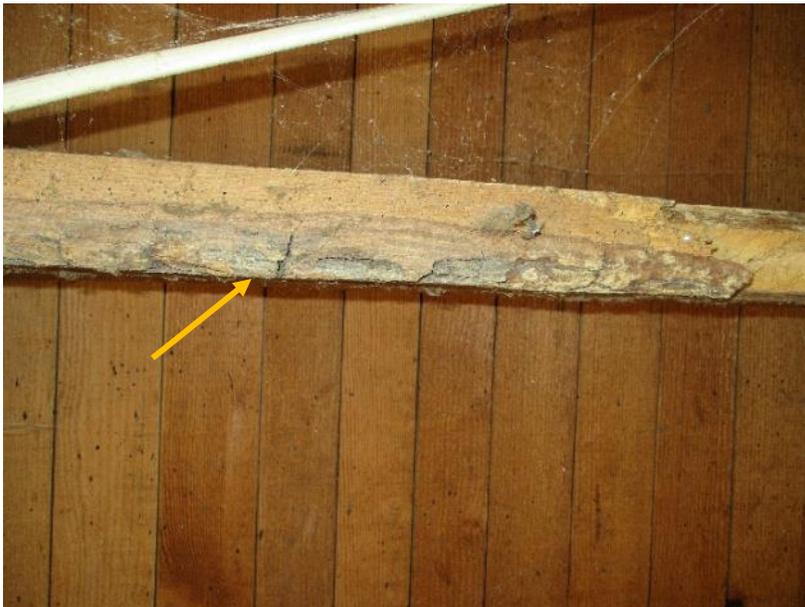
Figure 25. Deterioration at first floor joist in original farmhouse.

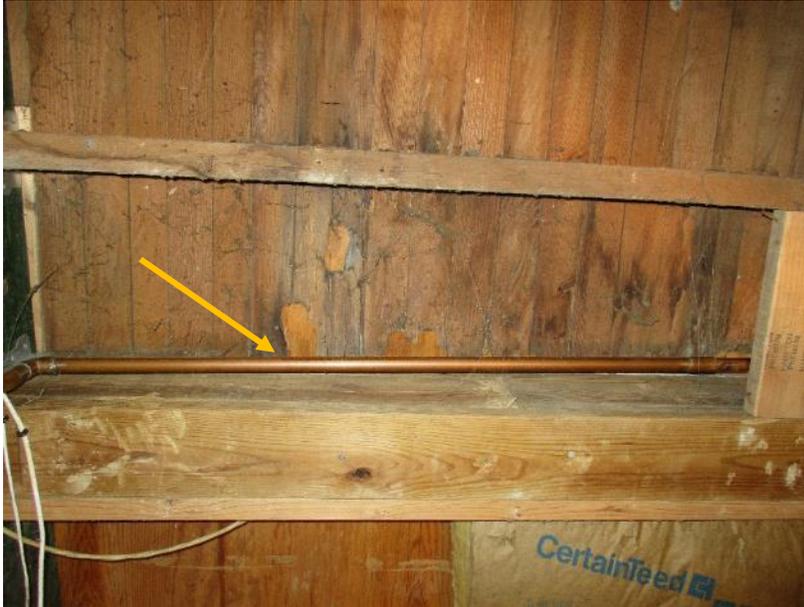
Figure 26. Staining and deterioration at first floor boards at the west edge of original farmhouse footprint

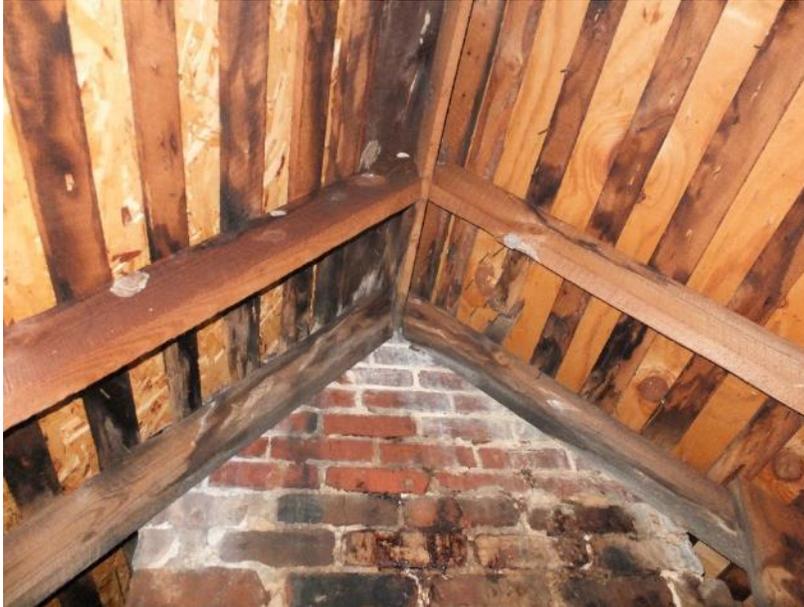
Water stains are present on wood sheathing and roof framing members adjacent to the chimney as well as several other isolated areas of the roof framing (Figure 28). Despite the staining, the roof framing appears to be in fair condition.

Figure 28. Staining in original roof wood framing adjacent to the chimney. Note the two types of brick indicating that the chimney may have been extended at one point.

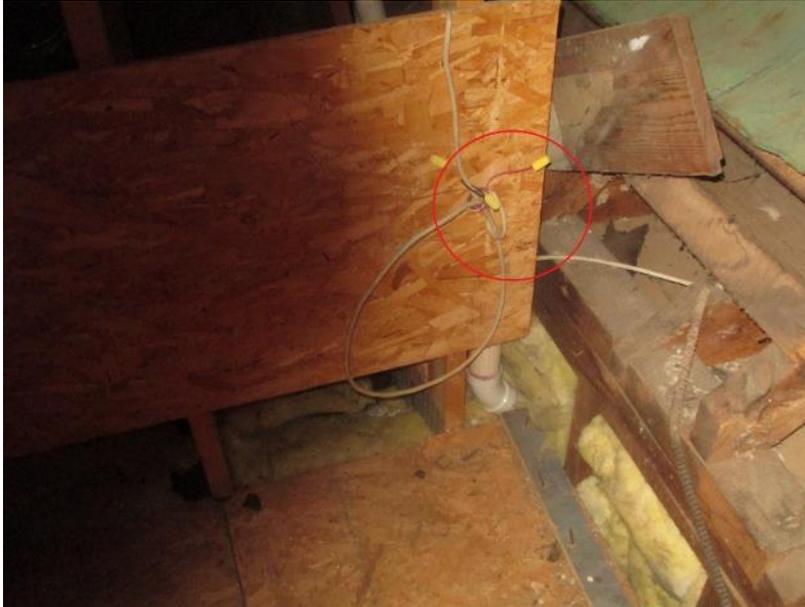
Figure 29. Unsecured wires in the attic. Photo courtesy of MBP.

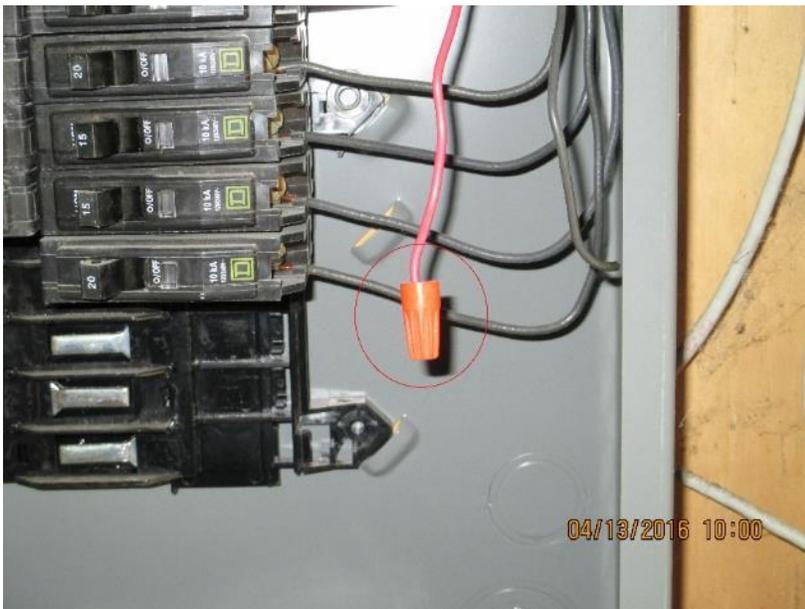
Figure 30. Electrical wire that was improperly terminated. MBP installed the wire nut. Photo courtesy of MBP.

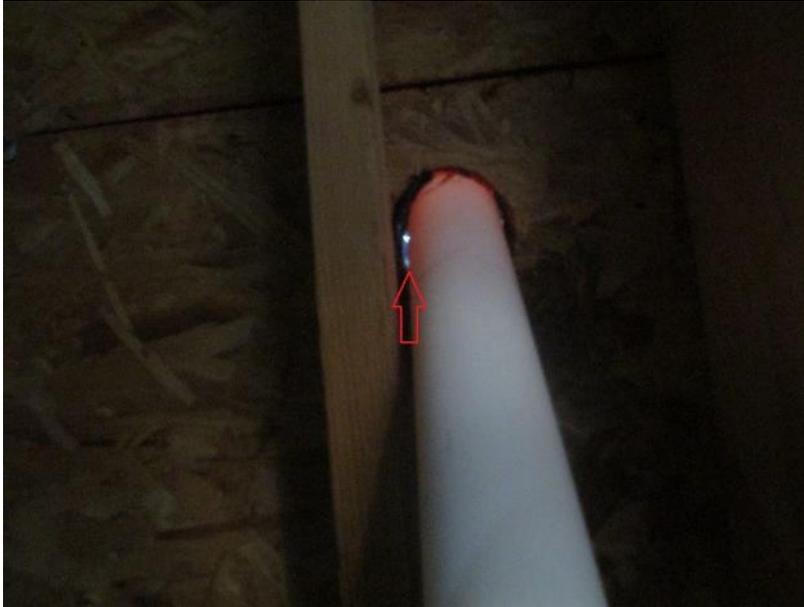
Figure 31. Daylight visible in attic around plumbing vent. Photo courtesy of MBP.

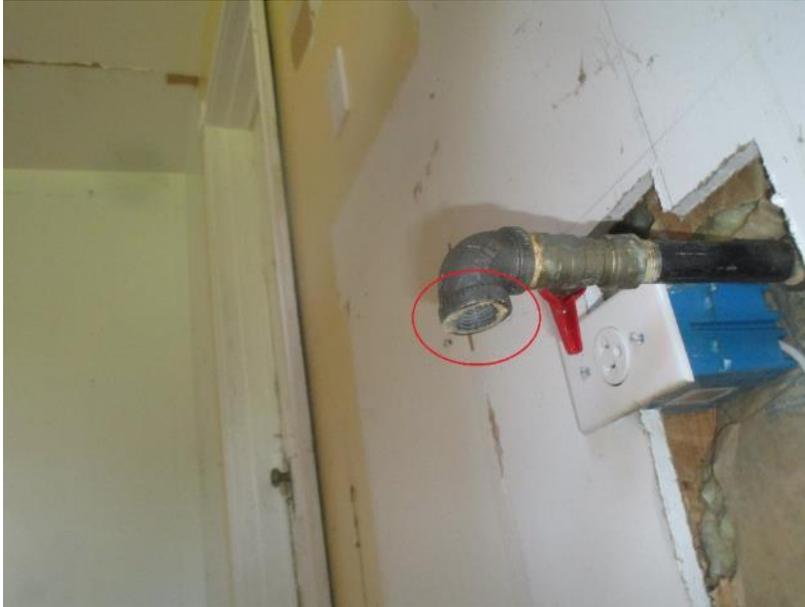
Figure 32. Gas piping improperly terminated in the kitchen. Photo courtesy of MBP.

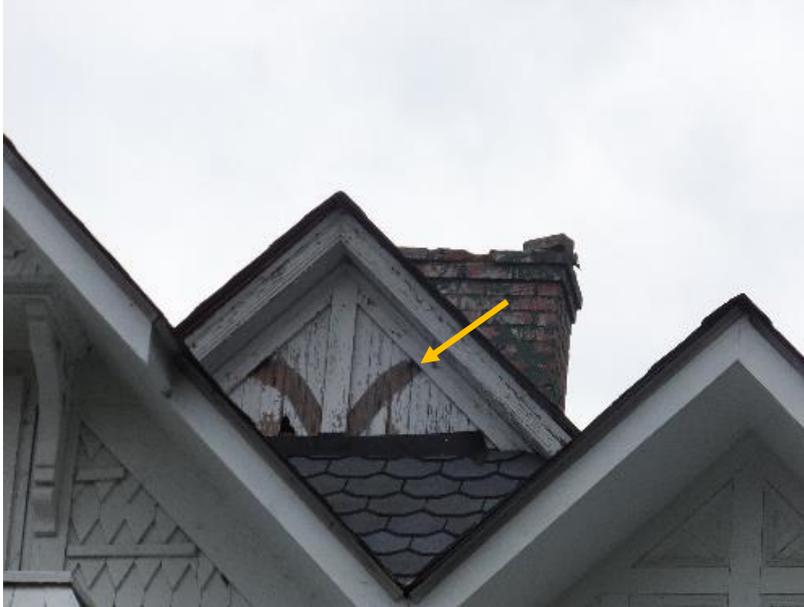
Figure 33. Deteriorated paint with evidence of previous decorative trusses at the secondary gable.

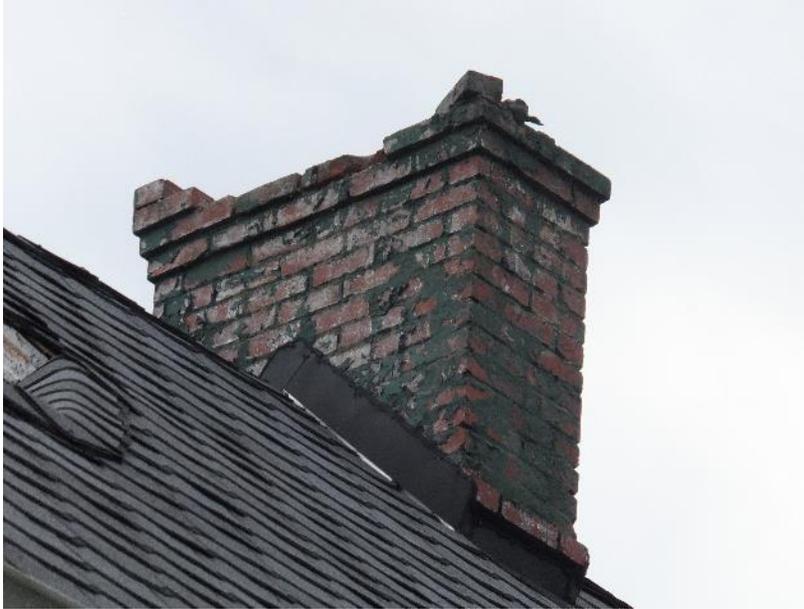
Figure 35. Missing and loose bricks at the chimney.

- Re-secure or replace door handle at the non-historic door of the Kitchen (104) on the west facade.
- Engage a local chimney inspector to inspect the interior of the firebox and chimney. Do not use chimney until inspection and any recommended repairs have been completed. Once chimney repairs have been completed as recommended by the chimney inspector (if any), repoint 100% of the exposed chimney mortar as it is at the end of its life cycle, rebuild and reset the upper courses of the chimney, and install chimney cap. (Figure 35)

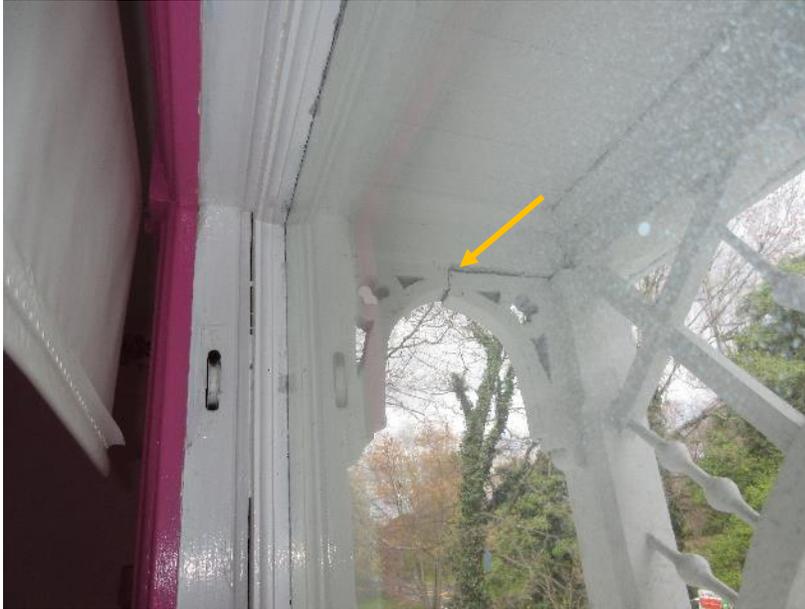
Figure 38. Cracked decorative element at the Juliet balcony.

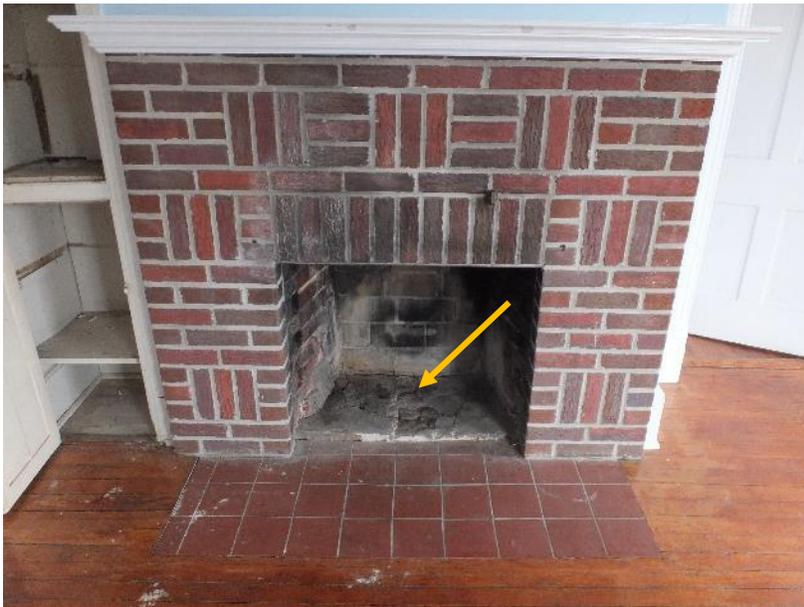
Figure 39. Cracked firebox in the fireplace of Room 102.

- Monitor cracks in concrete floor slab at east wall and near mechanical room. Route and seal if no movement is observed.
- Engage a local chimney inspector to inspect firebox and chimney. Do not use chimney until inspection and any recommended repairs have been completed. (Figure 39)

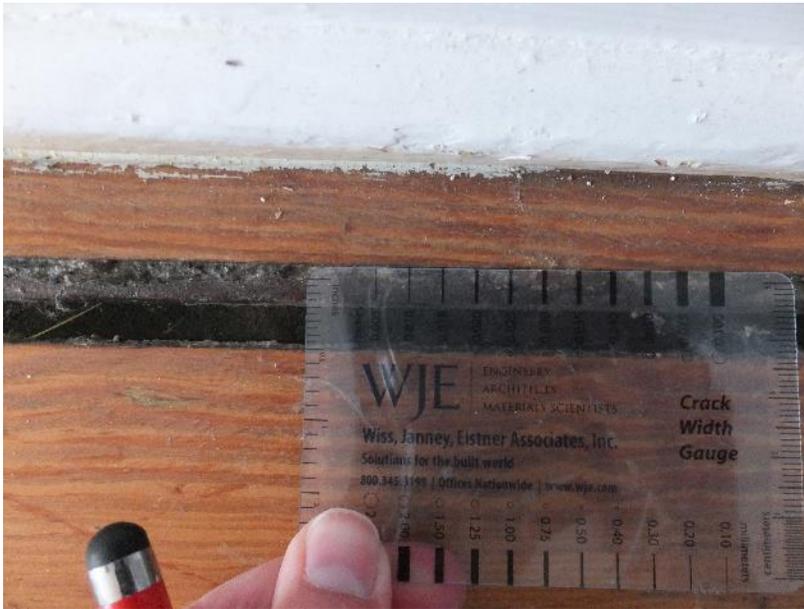
Figure 41. Split in flooring at the south wall of Room 102.

- Repair crack in wood flooring along south wall in the Formal Dining Room (102) with similar wood species and finish. (Figure 41)

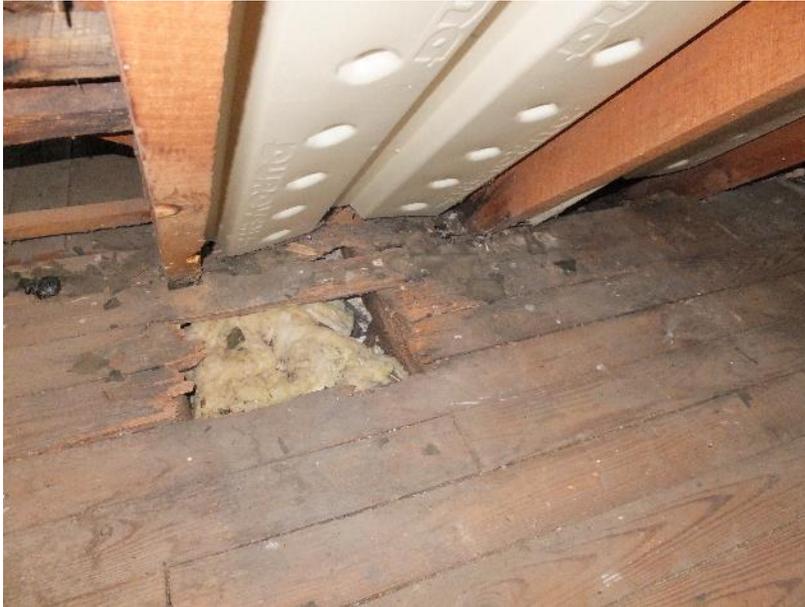
Figure 42. Deteriorated wood flooring in the attic.

- Repair any cracked tiles and tile grout in the Bathroom (105).
- Repair crack in baseboard between stair treads in rear hall stairs.
- Remove soft and damaged wood at the hole in the attic floor and repair. (Figure 42)

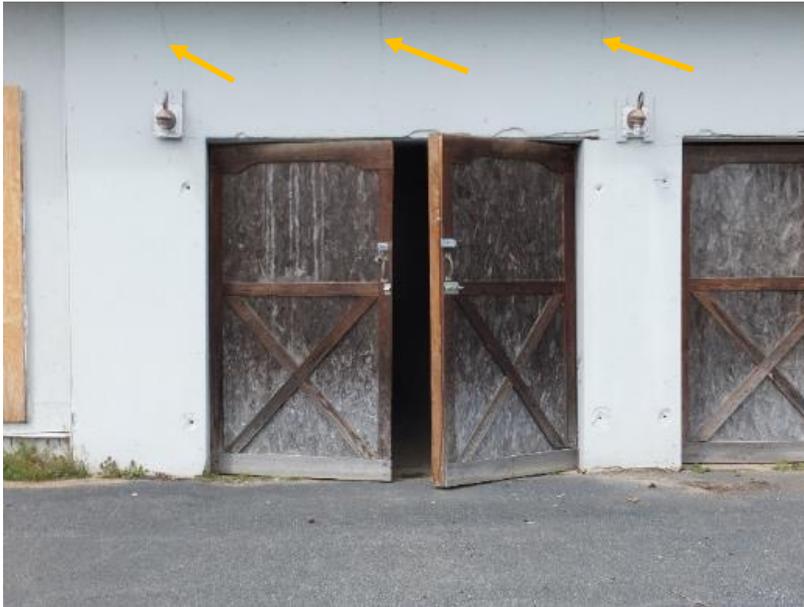
Figure 45. Cracking in the first floor parge coating of the garage.

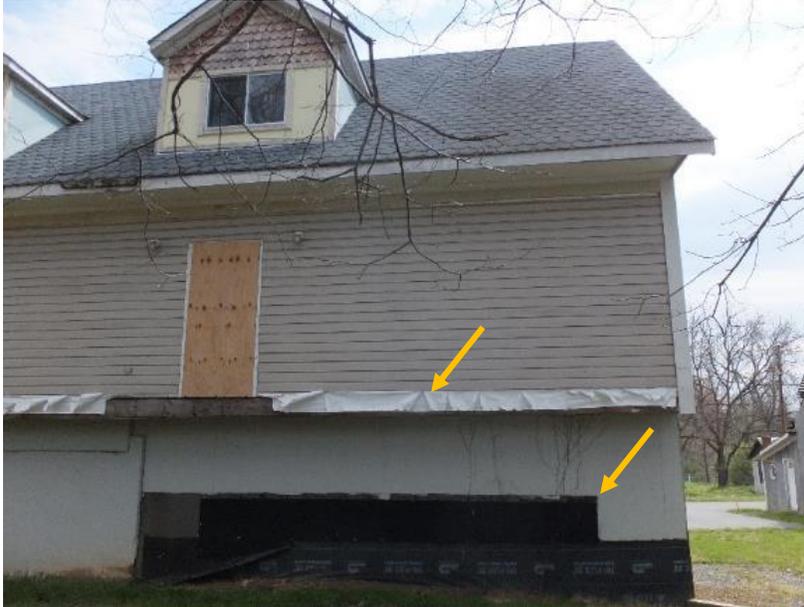
Figure 46. Exposed roof underlayment (black) and building paper (white).

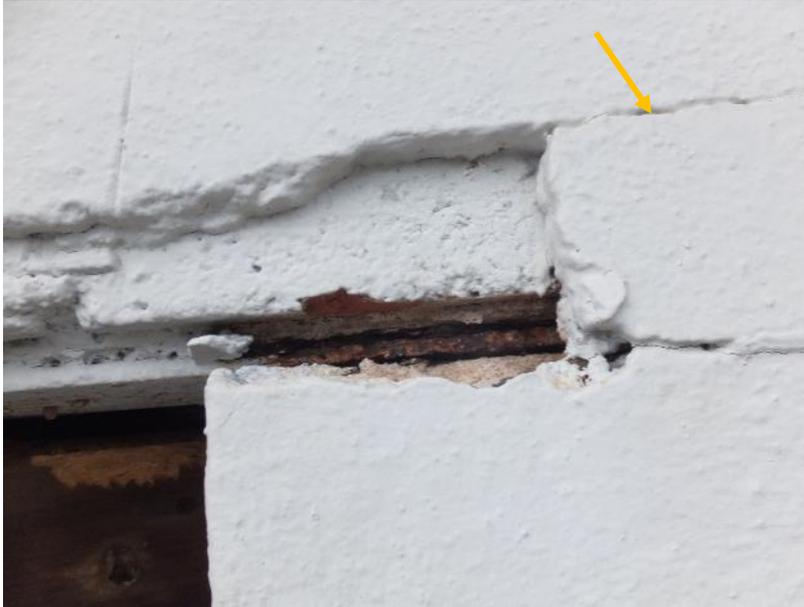
Figure 48. Corroded steel lintel and adjacent cracking in parge coat (orange arrow).

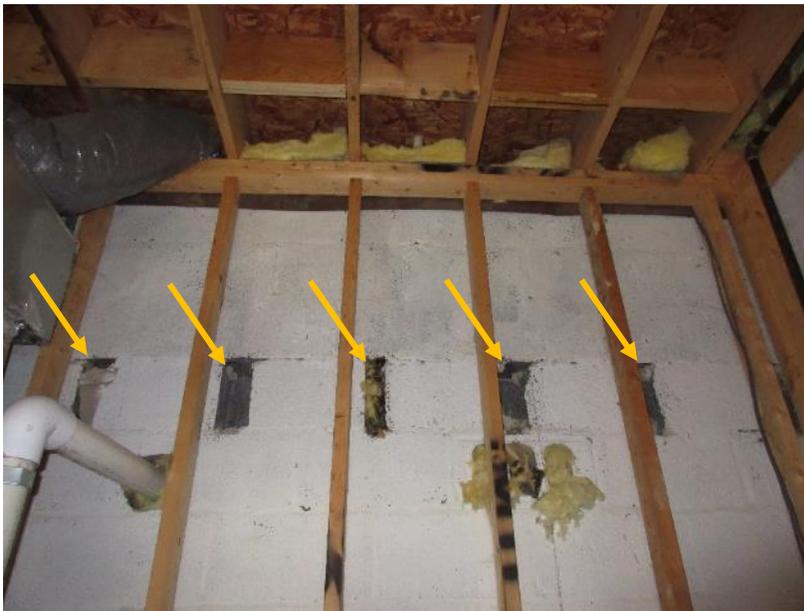
Figure 49. Joists have been removed leaving behind pockets in the CMU walls.

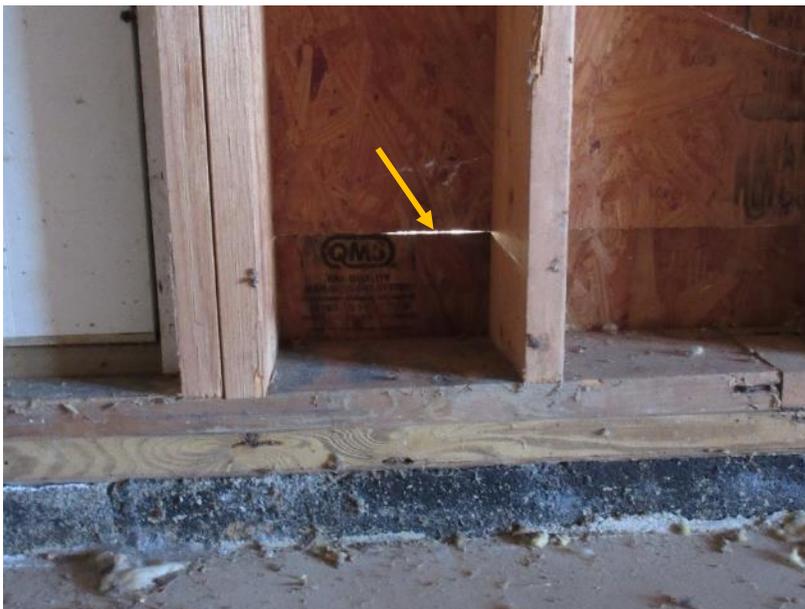
The south portion of the first level features a concrete slab on grade, which is in good condition, and a combination of CMU and modern wood framed walls. Painted plywood is installed on the exterior of the walls. The plywood is deteriorated at isolated locations and daylight can be seen on the interior between the bottom of the plywood and the wall framing. (Figure 51)

Figure 51. Daylight is visible between exterior wall sheathing panels in south portion of the first level.

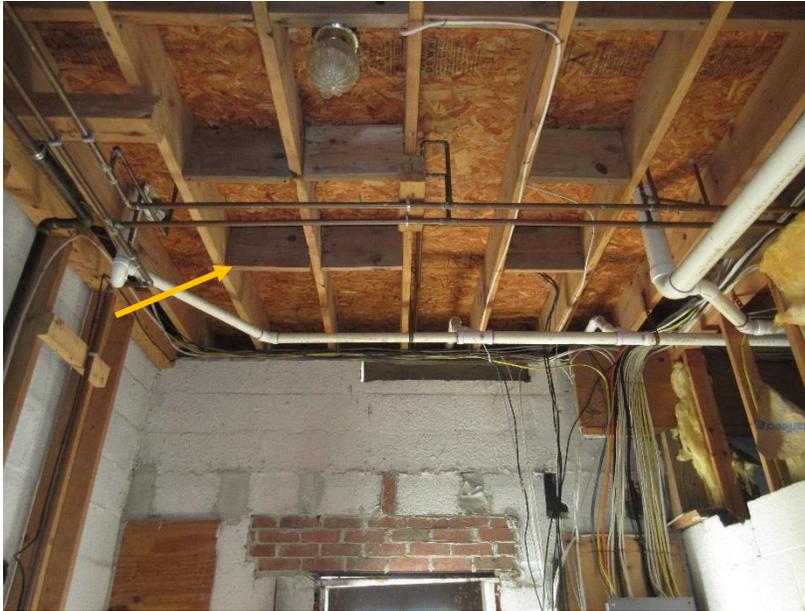
between wood joists (Figure 52) and gaps are present between the ends of the wood bridging and the joists at multiple locations. (Figure 53) Since the interior of the second level was not accessible during our site visits, a review of the interior space should be completed to determine if there is distress resulting from lifting a portion of the house similar to what was observed at the farmhouse. No structural analysis was performed as a part of our evaluation as it is outside of our current scope. In general, the load distribution is difficult to follow as a result of the different additions to the structure. Connections between the first level and second level along with the framing should be further documented and evaluated.

Figure 52. Wood bridging is sporadically installed between joists.

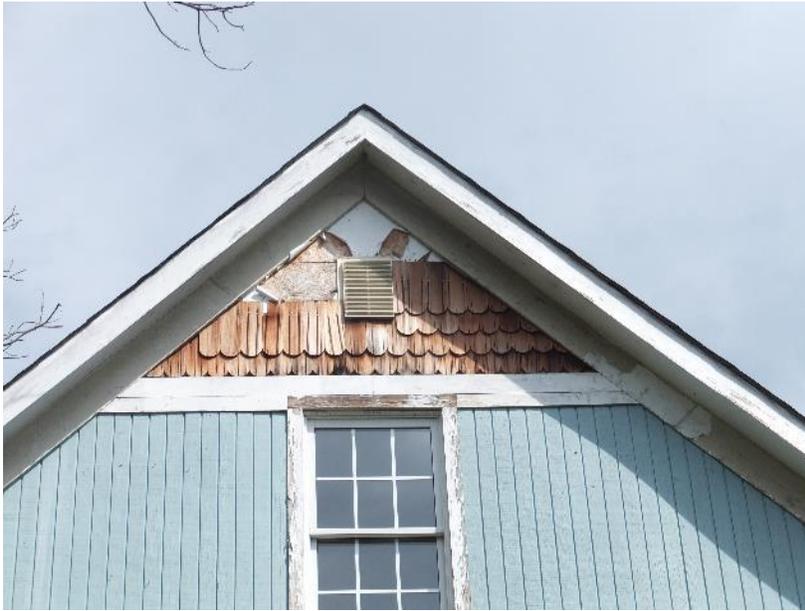
Figure 55. Missing shingles and deteriorated paint.

- Inspect wood shingles at dormer gables for deterioration and repair. Install new patterned wood shingles at south side gable to match existing and half-timbered decorative truss following paint outline (if possible). Paint. (Figure 55)

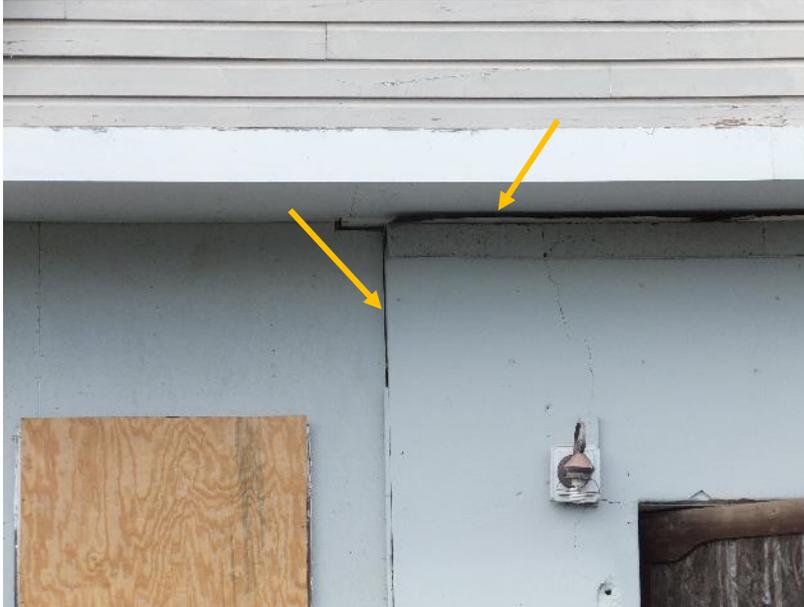
Figure 56. Gaps between the first and second floor and at the south addition.

- Replace broken glass at dormer window.
- Inspect area for any deterioration caused by missing wood under dormer and repair (as appropriate). Install new wood and paint.
- Remove miscellaneous boards and repair/paint underneath wood members unless archival documentation reveals the historic use of these elements.
- Install sealant at gap between the first and second floor and at the east facade of the south addition. If gap is too large for a proper sealant profile (generally less than 1 inch is desirable), infill gap with wood and paint. (Figure 56)

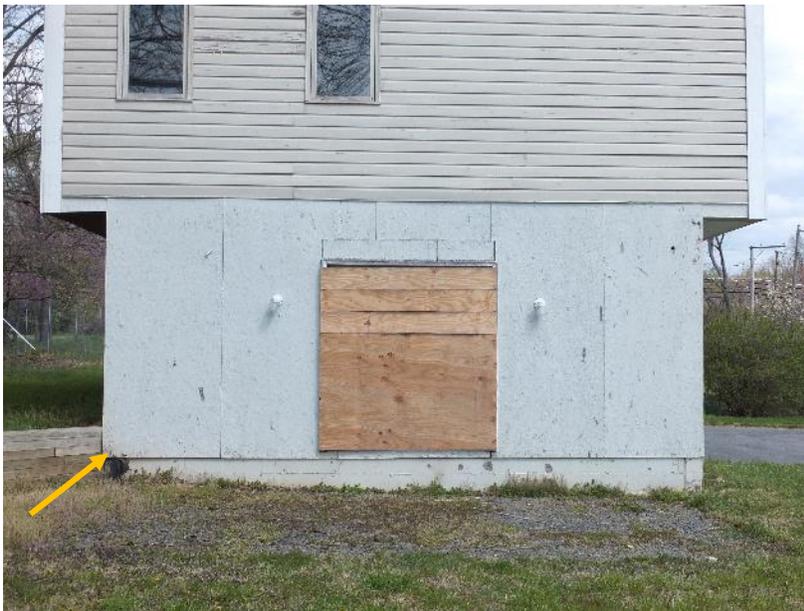
Figure 57. Exterior wood sheathing used for the southern addition to the garage.

- Roof underlayment was placed over the wood at the southwest first floor and has been exposed. This particular underlayment should not be exposed to UV for longer than 6 months.²² Remove and inspect the interior for indication on why this may have been installed. Evaluate installation of new WRB and exterior finish to protect the WRB.
- Re-install lid to cover brick pit.
- Temporarily fill penetrations through the building's first floor walls to reduce water infiltration. Future use of this building will dictate need of re-using these penetrations.
- Re-secure or replace loose non-historic railings on north facade.
- Remove exposed wood sheathing at first floor south facade and replace with permanent siding. (Figure 57)

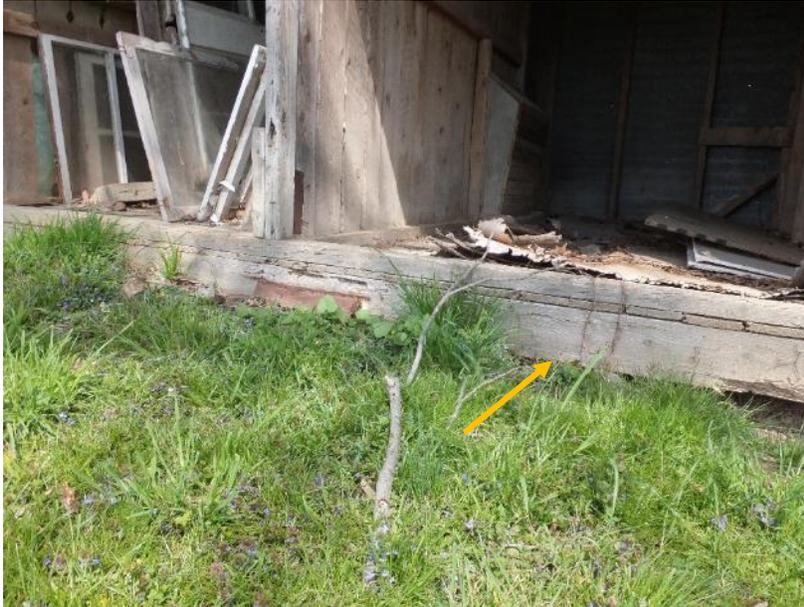
The shed is supported by timber sills, which appear to bear directly on the ground. (Figure 59) No evidence of a foundation was observed. The shed appears to have settled over time as a result of deteriorated wood framing. Tongue and groove floor planks were visible on the east half of the shed. The floor planks are significantly deteriorated towards the north half of the shed. Complete section loss of the plank members along with the presence of an animal habitat, as evidenced by chew marks in a wood plank, are apparent in the east bay. (Figure 60) Carpet is installed on the floor of the west side of the shed and generally conceals the substrate below. At areas that are not concealed by carpet, we observed exposed soil. (Figure 61)

Figure 59. Timber sill bears directly on the ground.

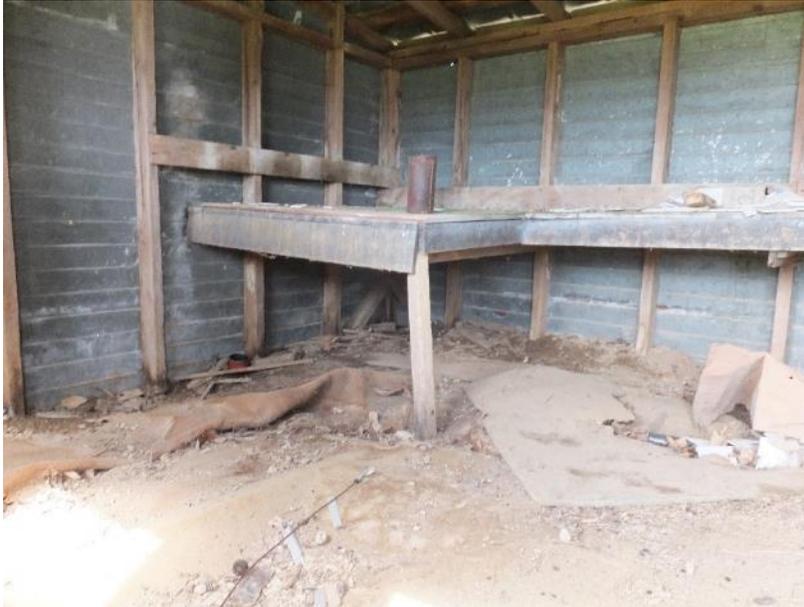
Figure 61. Carpet installed on the floor of the west side of the shed conceals the substrate below.

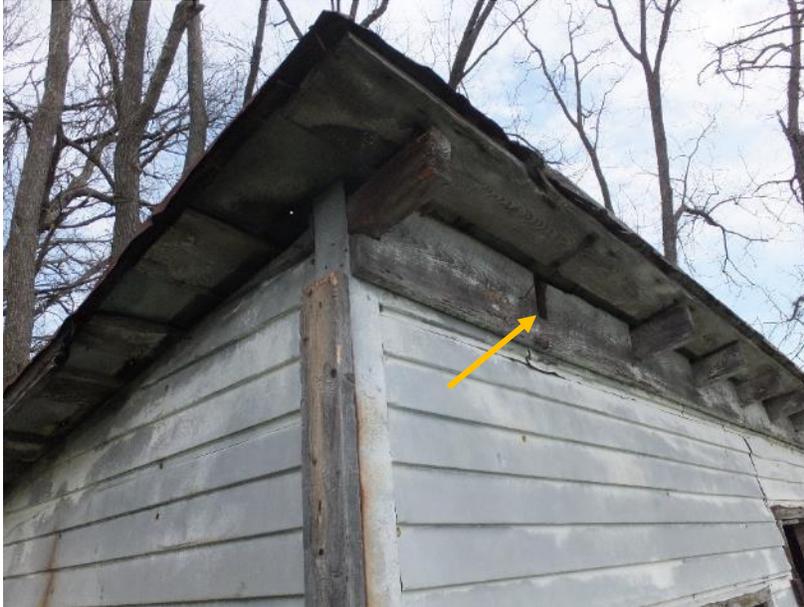
Figure 62. Rafter no longer bears on header.

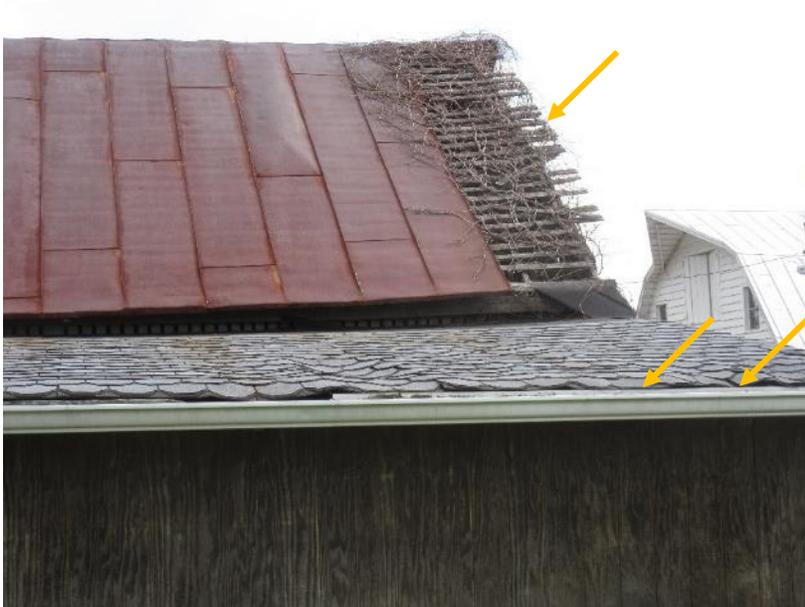
Figure 65. Missing metal roof section along with evidence of heavy vegetation. Note sagging asphalt shingles between rafters on the wing addition.

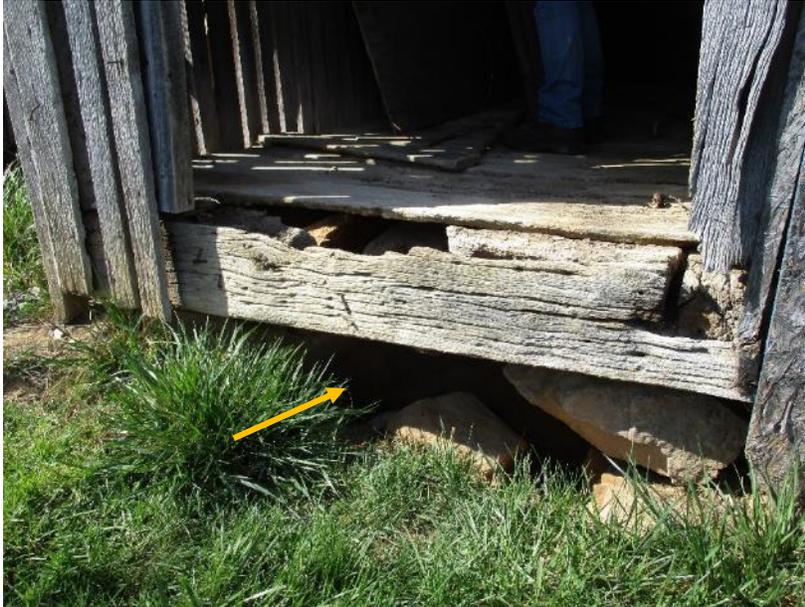
Figure 66. Large gaps are present in the stone foundation.

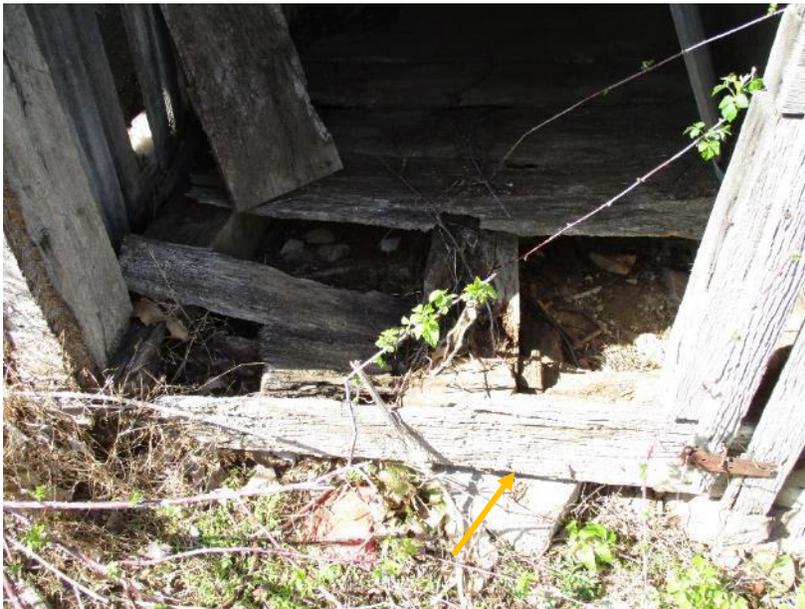
Figure 67. Significantly deteriorated timber sill.

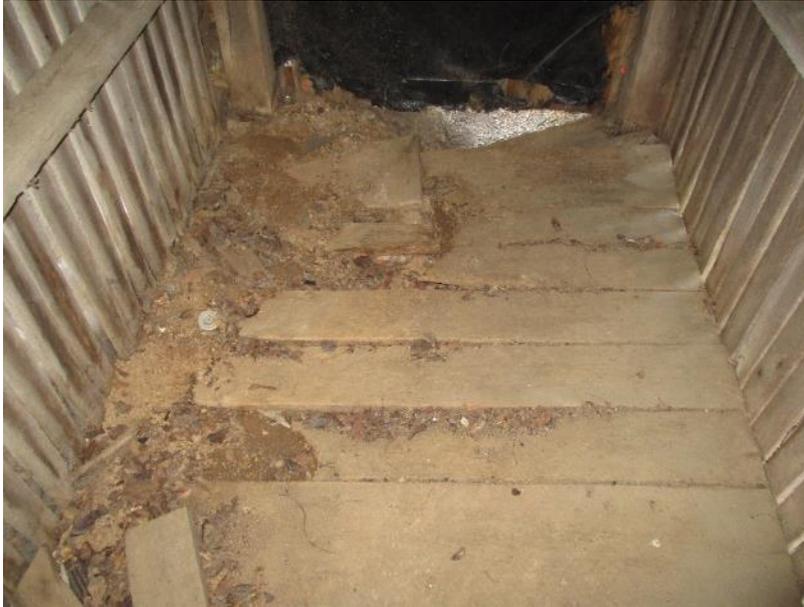
Figure 68. Floor joists and planks are in direct contact with the soil at the west crib.

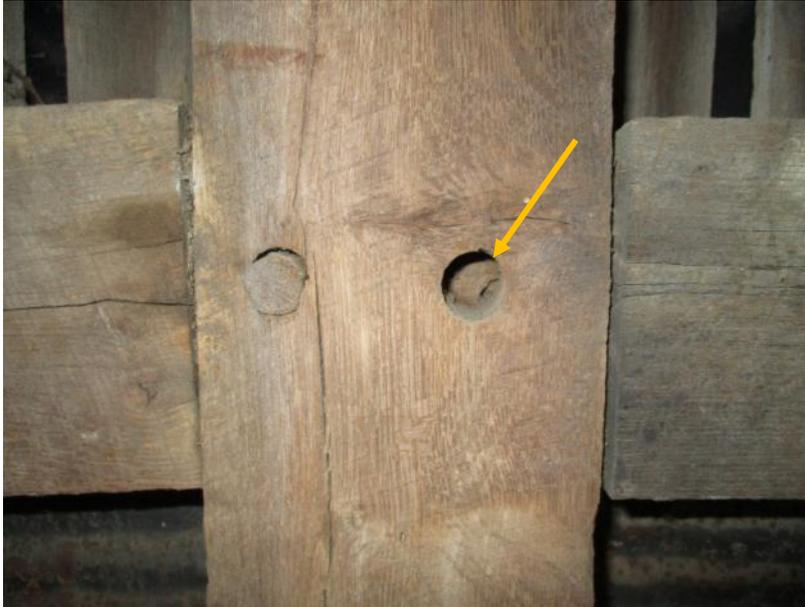
Figure 71. Missing wooden peg at interior connection.

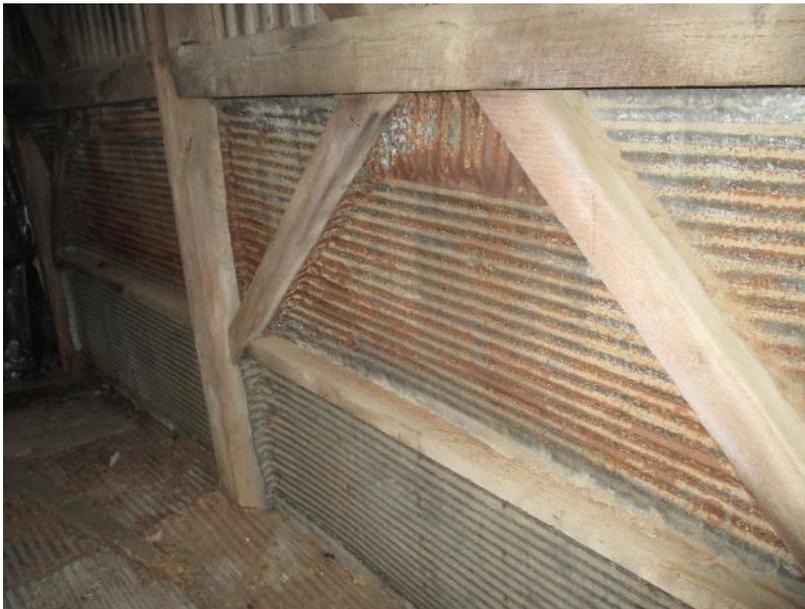
Figure 72. Surface corrosion present on corrugated sheet metal inside of east crib.
