TURNER FARM
Turner Farm Treatment Report

10609 Georgetown Pike
Great Falls, Virginia 22066

Final Report

November 10, 2016
WJE No. 2015.3162.2

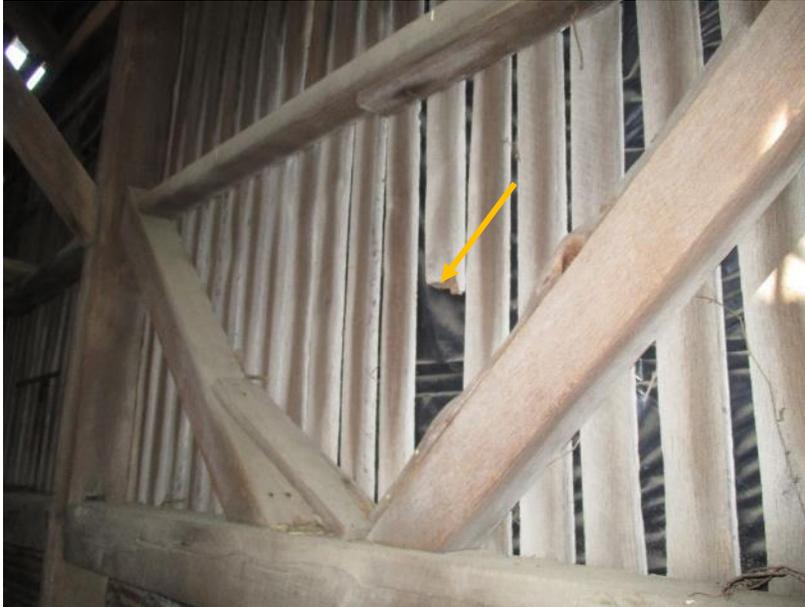
Figure 75. Fractured vertical wood slat.

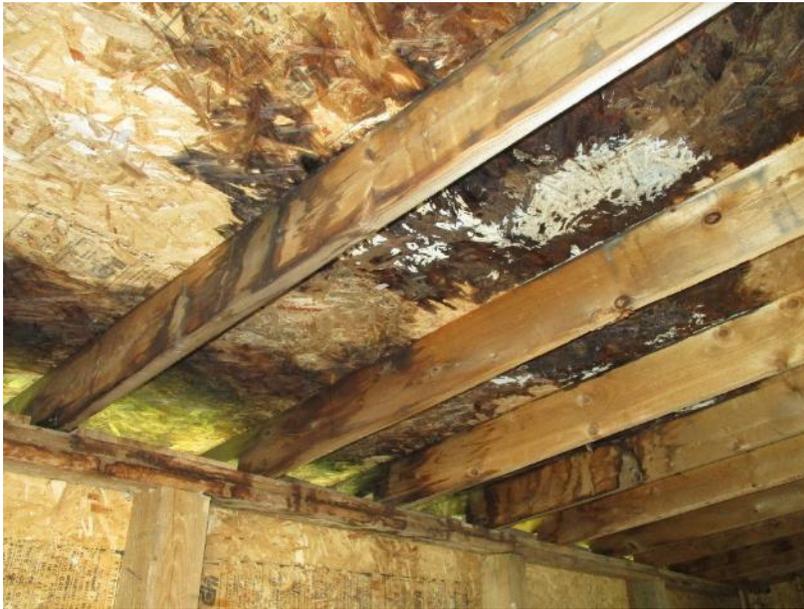
Figure 77. Staining, rot, and biological growth are visible on the underside of the plywood roof sheathing on the west lean-to addition.

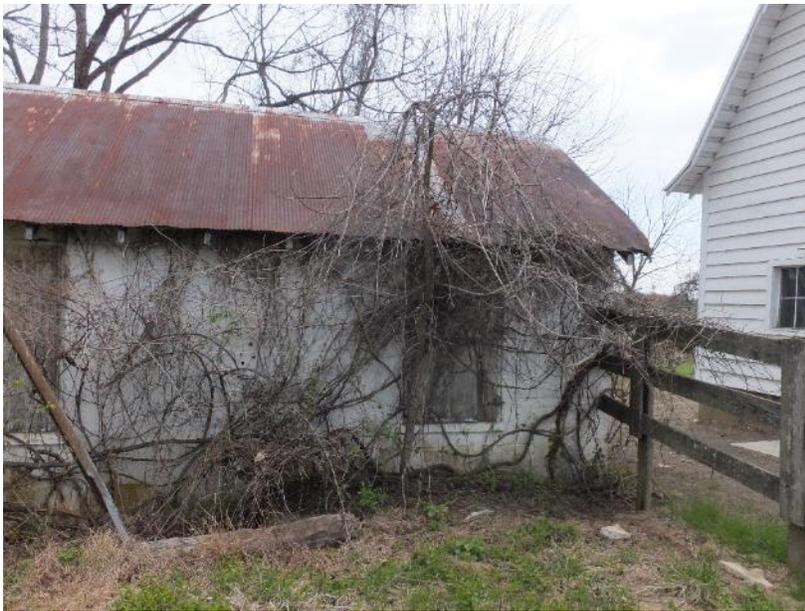
Figure 79. Heavy vegetation at the milk house.

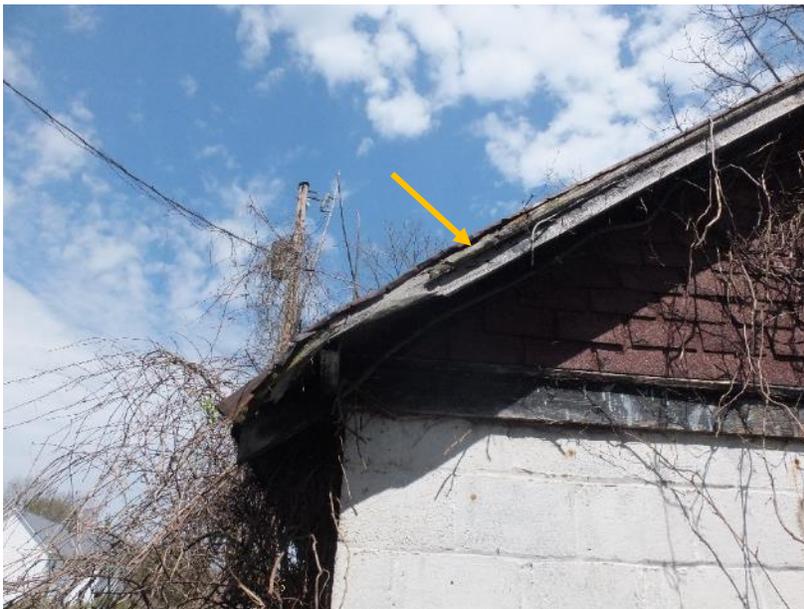
Figure 81. Exposed wood framing is in poor condition.

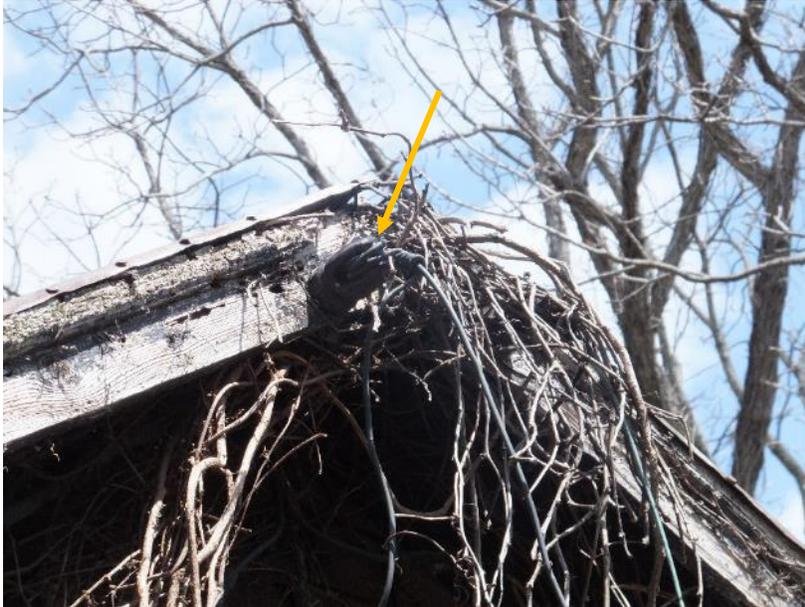
Figure 83. Lightning protection cable extended from the roof. Note heavy vegetation and damage to the fascia board.

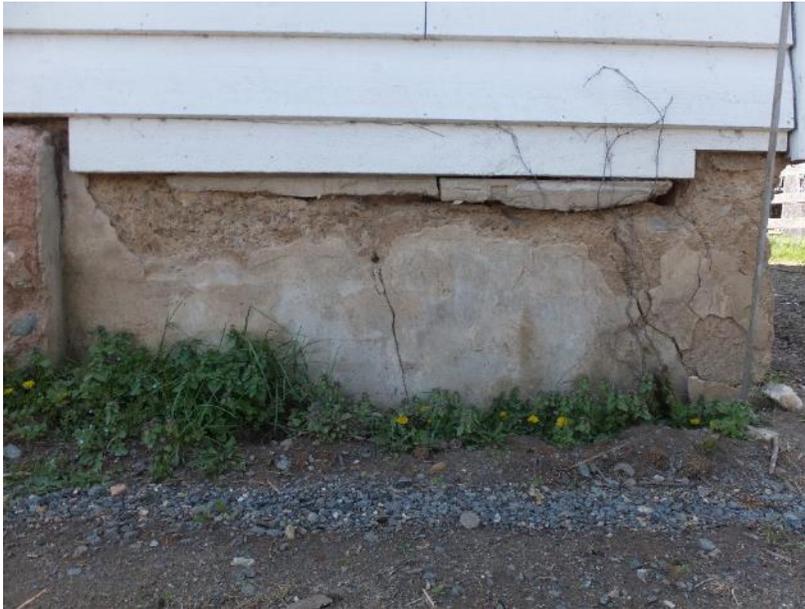
Figure 86. Typical condition of foundation with deteriorated parge coat and concrete spalls.

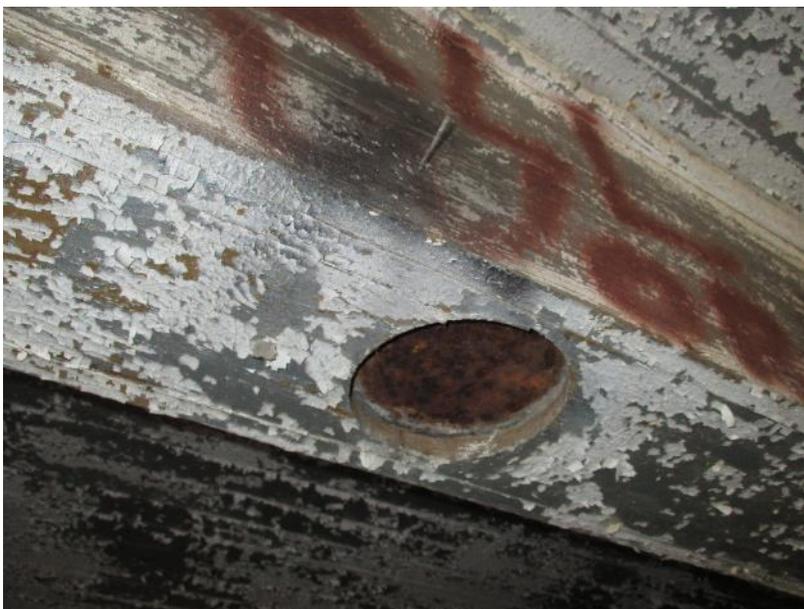
Figure 91. Missing pipe column.

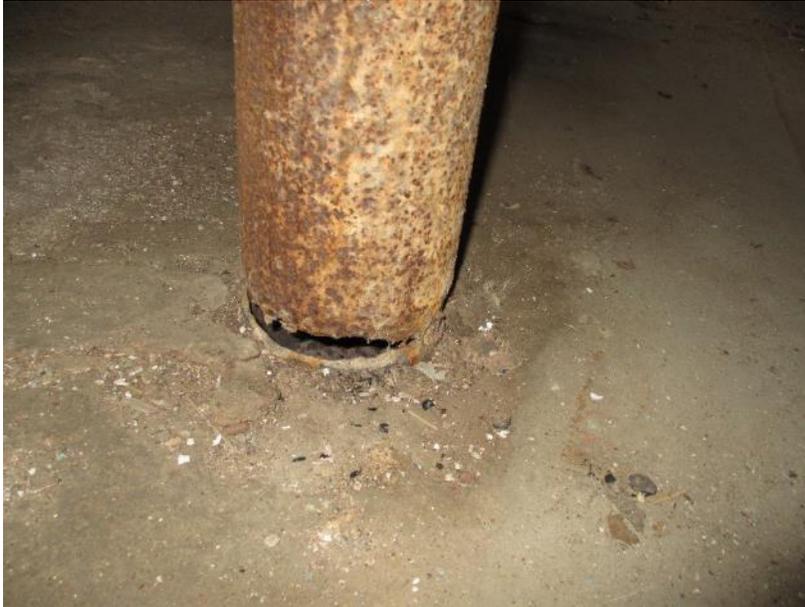
Figure 92. Section loss at base of pipe column.

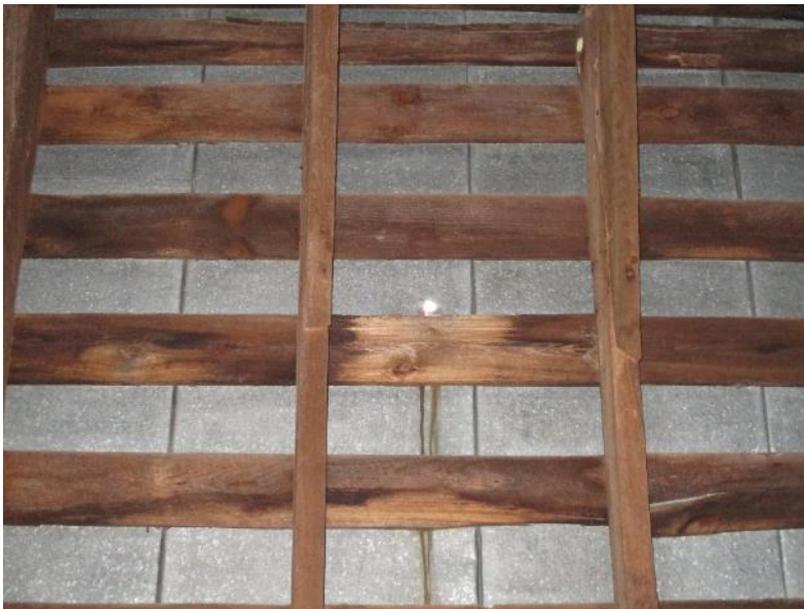
Figure 96. Hole in metal roof with resultant corrosion staining below.

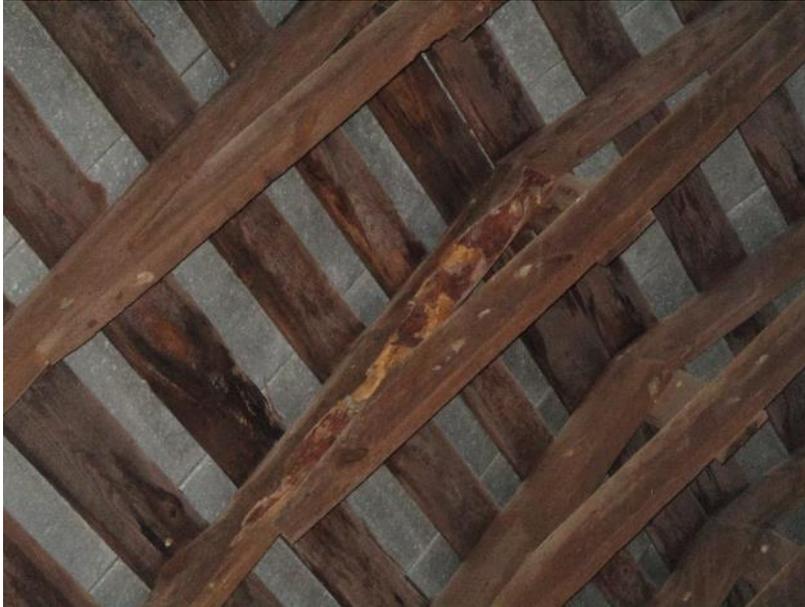
Figure 97. Isolated deterioration at truss framing member.

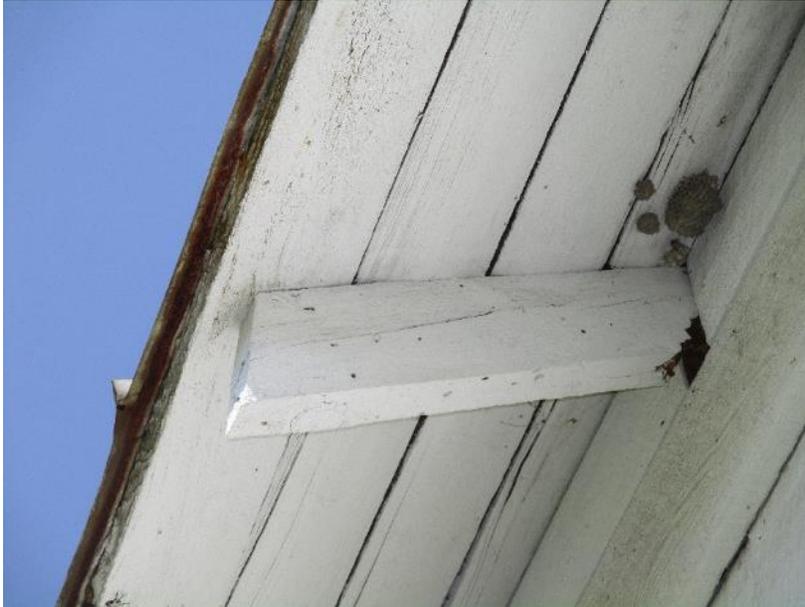
Figure 99. Deterioration at eave rafter.

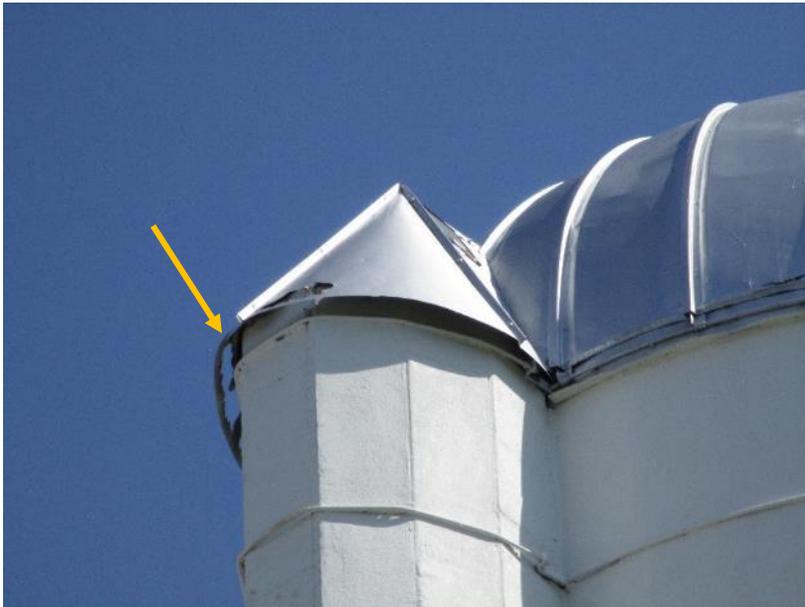
Figure 106. Deteriorated ladder enclosure roof at the silo.

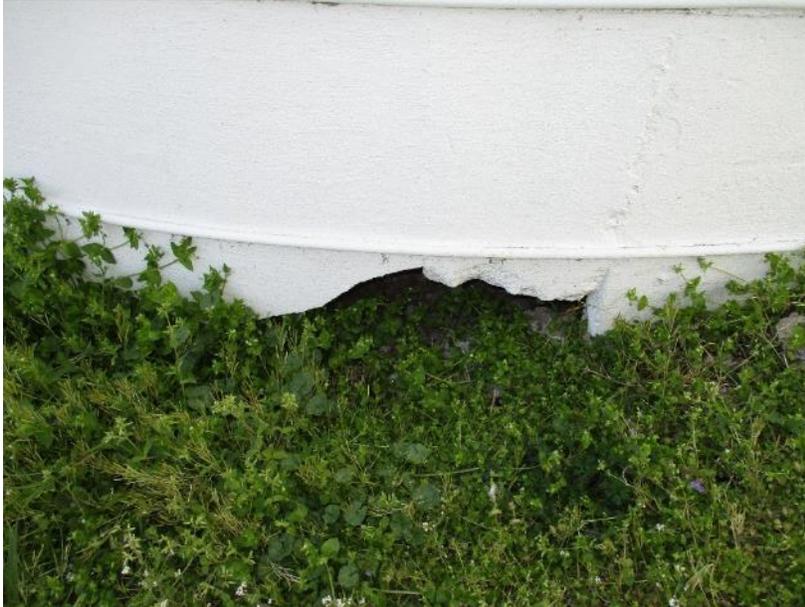
Figure 107. Concrete spall at the base of silo.
