# Lahey Lost Valley

## MEP Assessment

9750 Brookmeadow Drive  
Vienna, VA 22182

Date Prepared:  
January 11, 2019

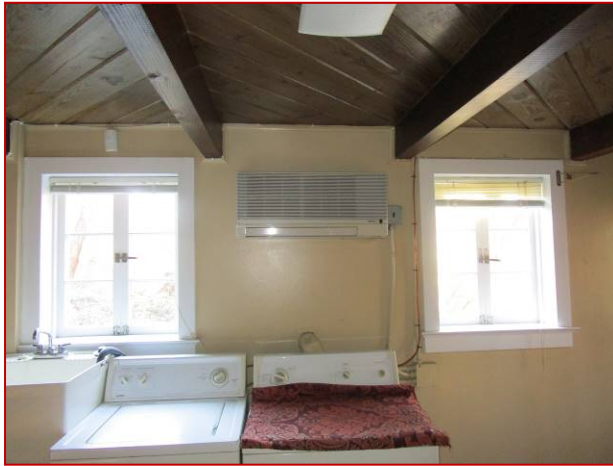
1. The first system consists of a nominal 9 MBH (0.75 ton) Sanyo ductless mini-split heat pump system that serves the kitchen in the cellar level. The system was on stand-by (cooling) mode at the time of survey. The system is not properly working. It is dated January 2001 and is past its useful life.

*Image 1: Indoor Air-Handling Unit for Kitchen*

- Remove and replace HVAC system 1 with a new ductless split system to condition the kitchen area.
- Remove and replace HVAC system 2 with a new ductless split system to condition the cellar.

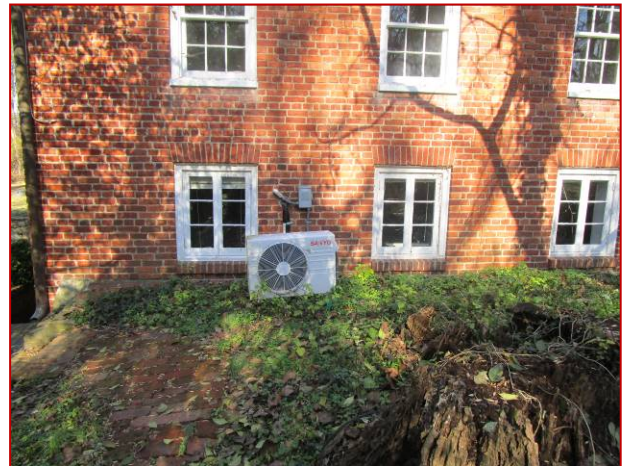
*Image 2: Outdoor Condensing Unit for Kitchen*

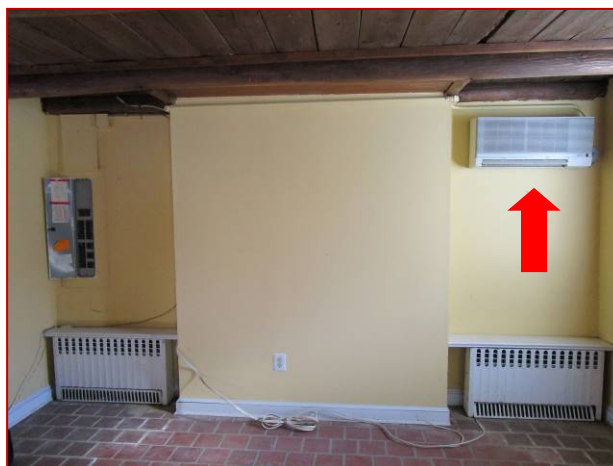
2. The second system consists of a similar nominal 9 MBH (0.75 ton) Sanyo ductless mini-split heat pump system that serves the cellar. The system was on stand-by (cooling) mode at the time of survey. The system is not properly working. It is dated January 2001 and is past its useful life.

*Image 3: Indoor Air-Handling Unit for Cellar*

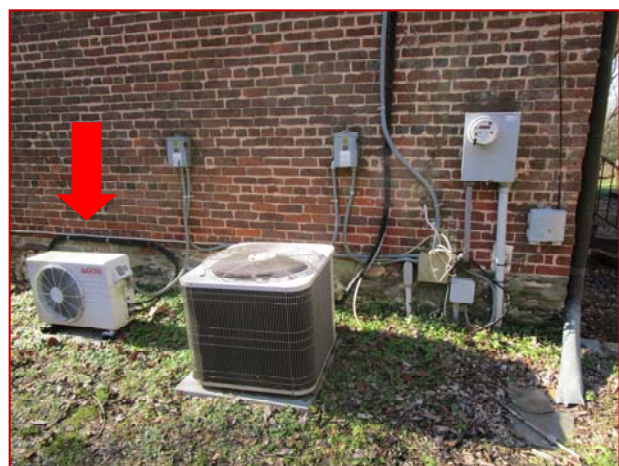
*Image 4: Outdoor Condensing Unit for Cellar*

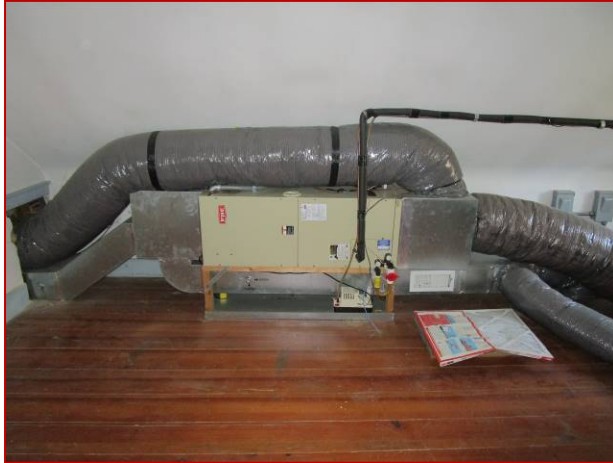
3. The third system consists of a nominal 30 MBH (2.5 ton) Bryant heat pump split system with a horizontal Air-Handling Unit (AHU) located on the second floor in the east loft. The AHU is ducted to supply registers serving the west loft on the second floor and the hall, parlor, living room, and bathroom on the first floor. The return is ducted to two large ceiling grilles in the hall and living rooms of the first floor. The ductwork is comprised of galvanized steel mains with flexible duct runouts to the diffusers. The system did not appear to be working. The condensate is pumped through a condensate pump to the exterior through PEX tubing. The date of manufacture for the outdoor unit is 2001 and the system appears to be at the end of its useful life.

*Image 5: Air-Handling Unit in East Loft*

- Remove and replace HVAC system 3 indoor and outdoor units.
  - There are other modifications to consider if the spaces on the second floor, where the indoor unit and ductwork are installed, are desired to be used as living space.

- The return air grille can be relocated to the northwest corner of the hall and still be far enough away from the supply grilles. This will eliminate the return ductwork that extends across the east loft floor.

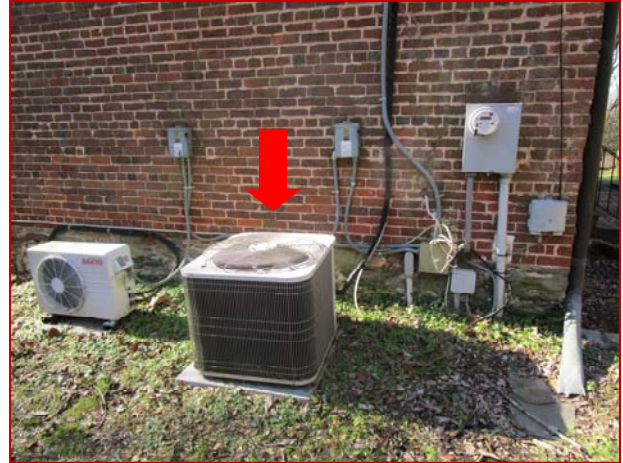
*Image 6: Outdoor Condensing for Main House System*

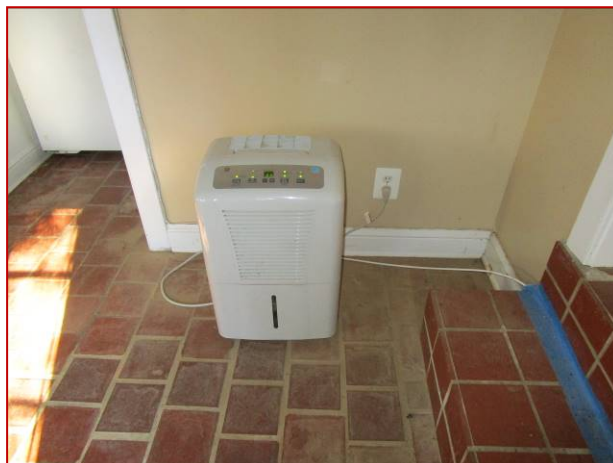
4. The fourth system consists of a free standing floor-mounted dehumidifier placed at the entrance to the kitchen. Its condensate is pumped into the kitchen sink through a PEX tube. It is dated July 2015 and appeared to be in good condition. It appears this unit was installed as a temporary means to help with the humidity in the house since the HVAC systems are not fully functional. Residential dehumidifiers typically only last 3-4 years. This system should most likely not be necessary once the house is occupied and air conditioning systems are operating properly.

*Image 7: Kitchen Dehumidifier*

- Remove the floor-mounted dehumidifier (HVAC system 4) from the kitchen. A new dehumidifier may not be necessary once the HVAC systems are replaced and fully operational.

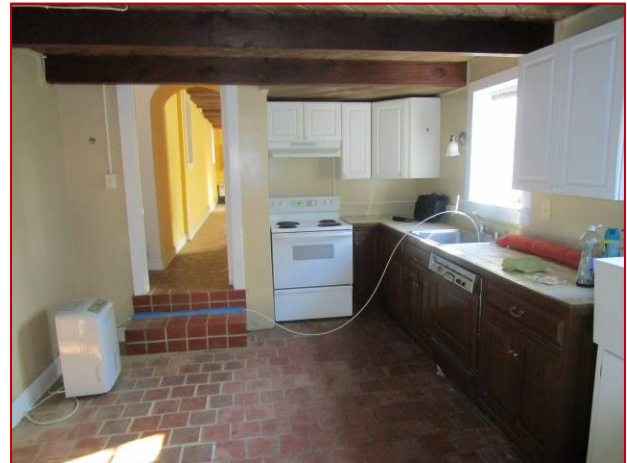
*Image 8: Kitchen Condensate Piping*

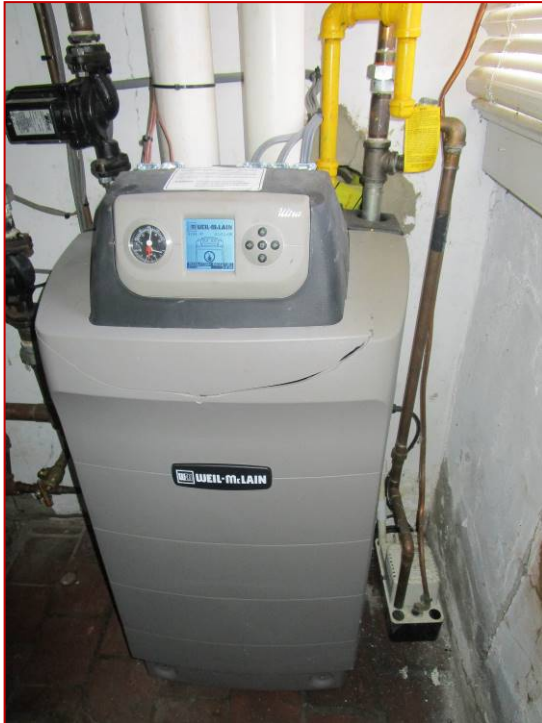
5. The fifth system consists of a Weil McLain hot water boiler system that provides heating to the entire house through two recirculating pumping loops and recessed Sunrad radiators. The boiler uses propane for fuel. It is located in a utility room off the kitchen. There is a 500-gallon underground propane storage tank located between the main house and the cottage. The heating water system has an expansion tank with a make-up water connection. The equipment is working and providing some heat. The date of manufacture for the equipment was unavailable, though the Laheys likely installed the Sunrad radiators in the 1940s.

*Image 9: Boiler*

- The boiler, radiators, and circulating pumps (HVAC system 5) should be serviced. The grill to one of the hall radiators was placed on top of the radiator and should be reinstalled.

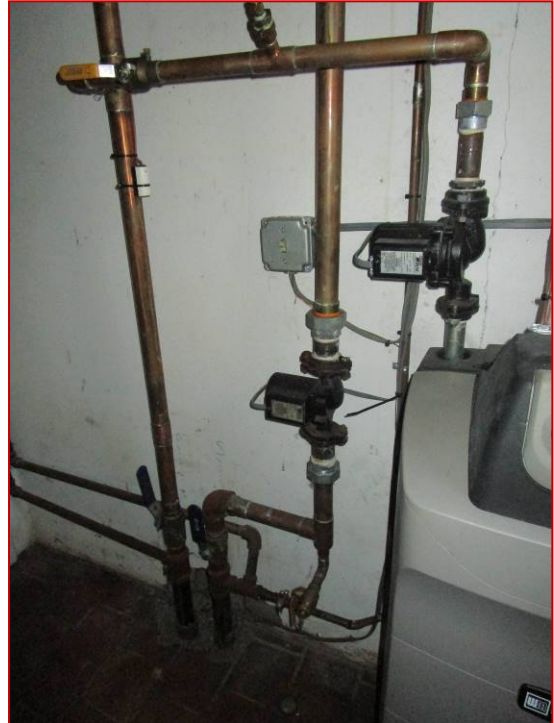
*Image 10: Heating Water Piping*

- Insulate the exposed hydronic heating water piping in the utility room.
- Service the thru-the-wall unit in the cottage and verify proper operation.

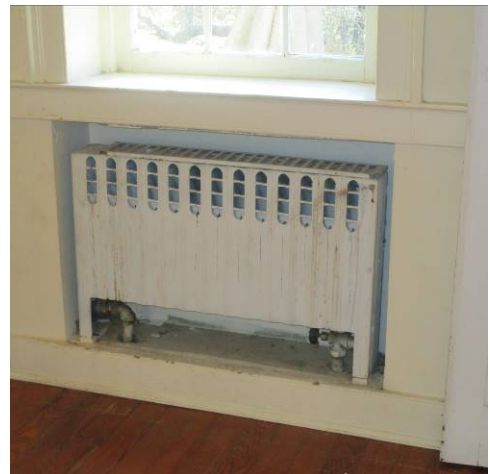
*Image 12: Sunrad Radiator*

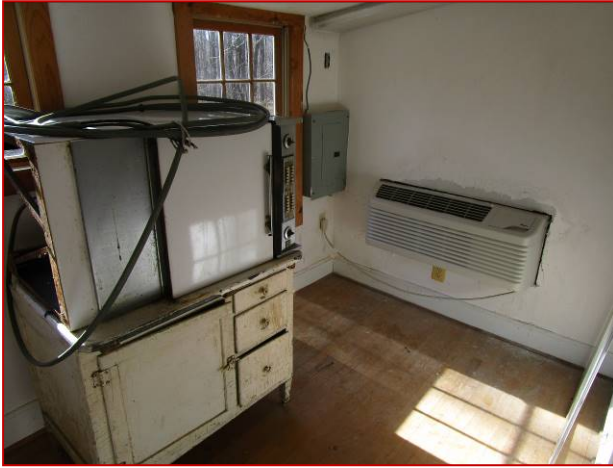
6. The cottage has a thru-the-wall heat pump unit. It appears to be in good condition and is working well. The date of manufacture for the equipment was unavailable.

*Image 13: Thru-the-Wall Heat Pump in Cottage*

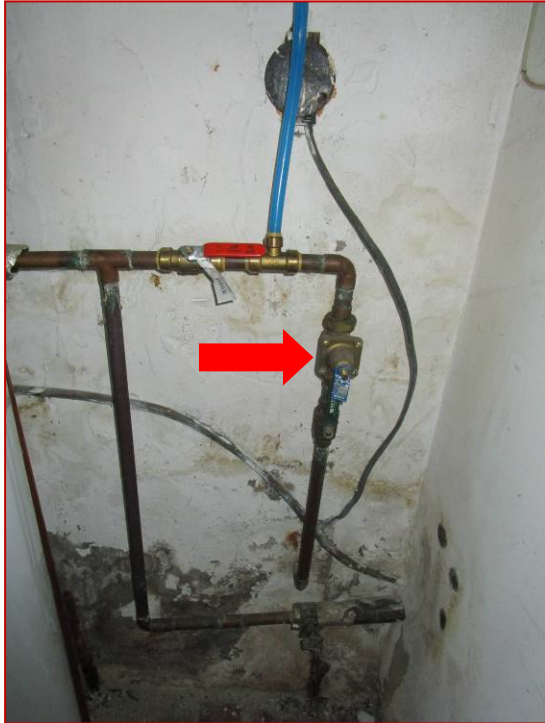
The house has a 3/4" domestic water service that enters the building at the northeast corner of the utility room. There is a pressure reducing valve downstream a the main shutoff valve. There is a new PEX bypass pipe with two new ball valves and tees with push-to-connect type fittings that can be used to bypass the water heater. It is not clear why the water heater would need to be bypassed.

*Image 14: Pressure Reducing Valve*

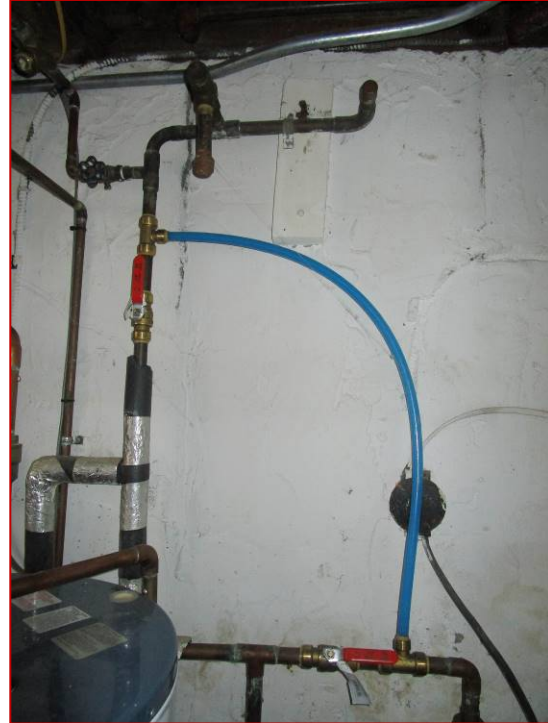
*Image 15: Blue PEX Bypass Pipe*

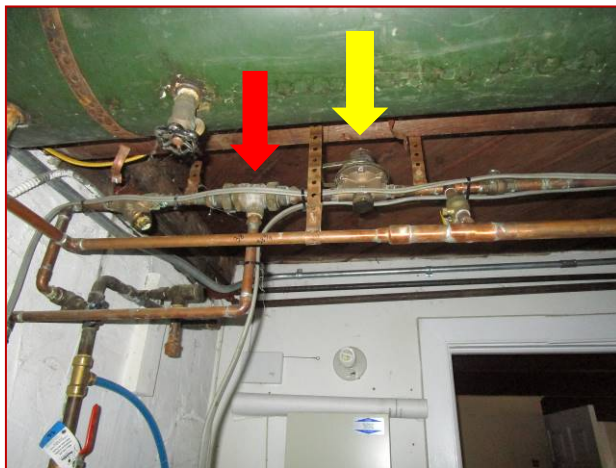
*Image 16: Backflow Preventer (red arrow) and Pressure Regulator (yellow arrow)*

There is a makeup water connection to the boiler consisting of a backflow preventer and pressure regulator.

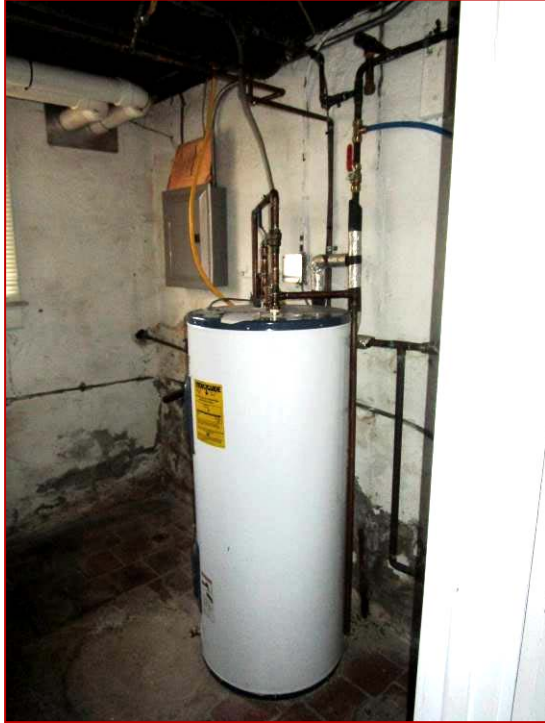
The existing electric domestic water heater has a 40-gallon capacity and 4500W heating element. It has a January 2008 manufacture date, but there is a service ticket noting that it was installed in October 2011. It should typically have approximately 7 years of useful life left. This could be much shorter since it is not currently being used with water flowing through it every day.

Image 17: Water Heater

- Inspect and service the electric water heater to verify it functions properly.
- Insulate the exposed domestic hot and cold water piping in the cellar.
- Remove and replace the garbage disposer.
- Remove and replace the dishwasher.
- Remove and replace clothes washer and clothes dryer.
- Clean gutters and downspouts to verify they are clear. Replace the damaged downspout with a new one matching material and style.
- Provide splash blocks at all downspouts where there isn't a diverter pipe.

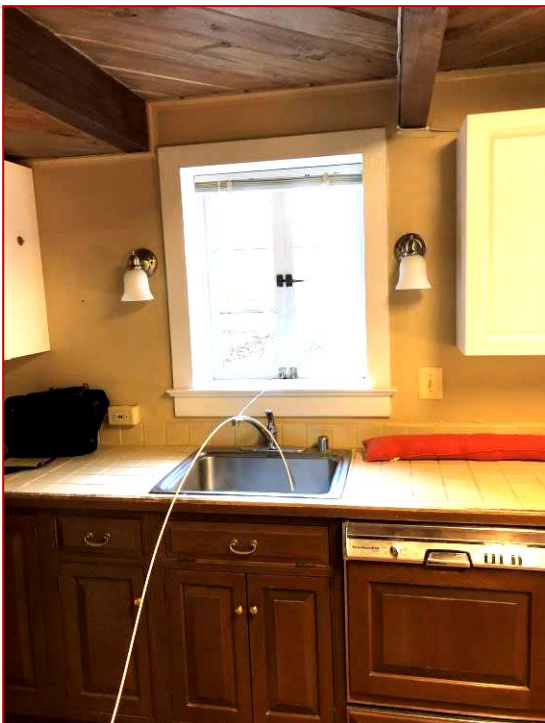
The kitchen sink has a single compartment with a single-lever faucet and an air gap fitting for the dishwasher. There is a garbage disposer, but it was not functional. An under-counter dishwasher beside the sink appears to be very old. It is not known if it is functional.

Image 19: Kitchen Sink and Dishwasher

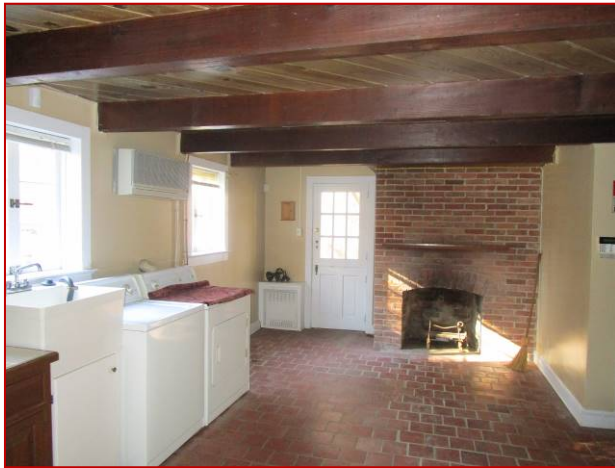
There is a utility/washer sink, washer, and dryer beside the kitchen counter. The utility sink is in good condition, but the washer and dryer have rust in them.

*Image 20: Laundry Equipment in Kitchen*

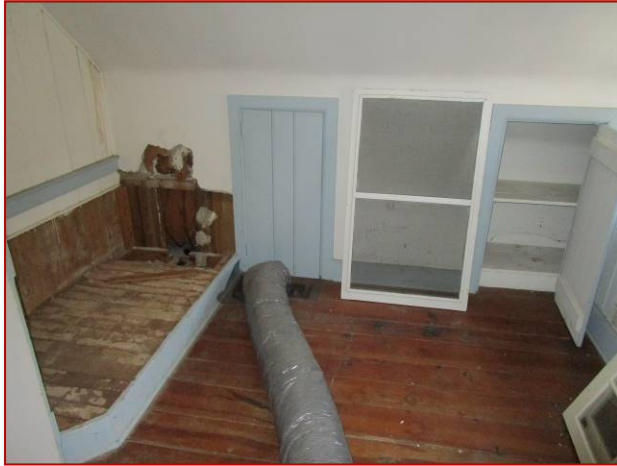
The second floor west loft was converted at one time, possibly in the 1940s, to a bathroom with bathtub, water closet, and lavatory. All plumbing fixtures were removed and all of the piping is capped.

*Image 24: Bathtub Platform*

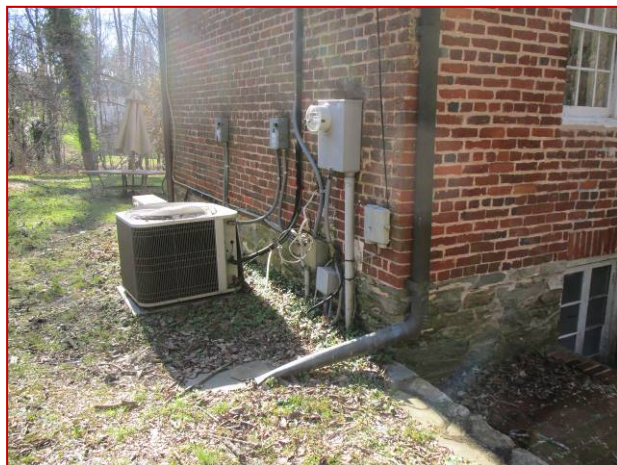
The roof has gutters with downspouts that discharge directly onto grade. There are no splash blocks. One of the downspouts is dented at the end.

*Image 25: Downspout with Damaged Pipe*

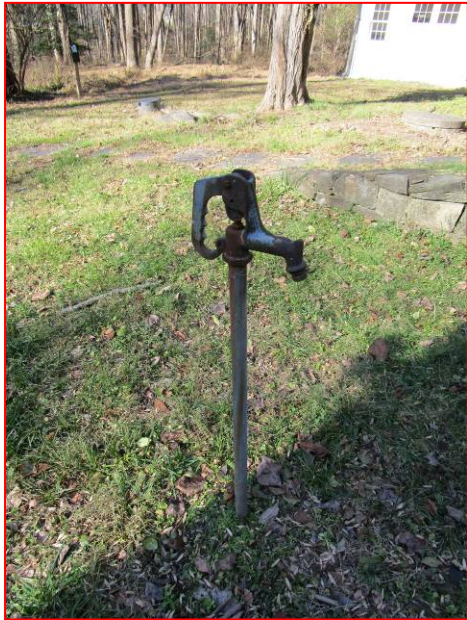
There is an existing well for underground water utilization. This water can be utilized for irrigation purposes, but all the pipes connecting to this system are disconnected. There's a frost free hydrant connected to this system, which is in fair condition.

*Image 26: Yard hydrant*

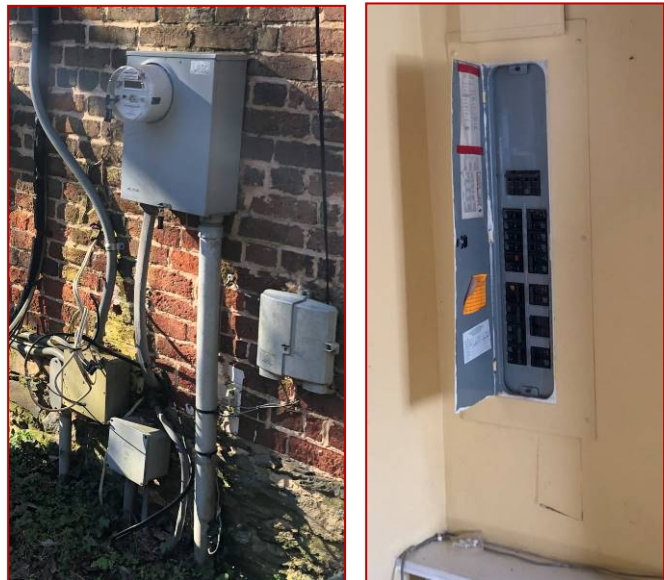
*Image 27, 28: Electric  
Meter and 200A Main  
Electric Distribution Panel*

The useful life of the panels is contingent upon maintenance practices and environmental conditions. Both panelboards have exterior rust damage which implies the interior of the circuit breakers may also be rusted. The panelboards should be replaced. The feeders for the panelboards are assumed to be in good condition. It is also noted that the main distribution panel in the cellar is located above a radiator, which is a code violation; however, this condition does not functionally impact the panelboard.

| <b>Recommendation</b> | <b>Optional but Recommended</b> | <b>Required if in Work Area</b> | <b>Required or Recommended for Safety</b> |
|---|---|---|---|
| Replace (1) 200A (30 pole) panelboard in cellar room with GFCI and AFCI circuit breakers | | | ✓ |

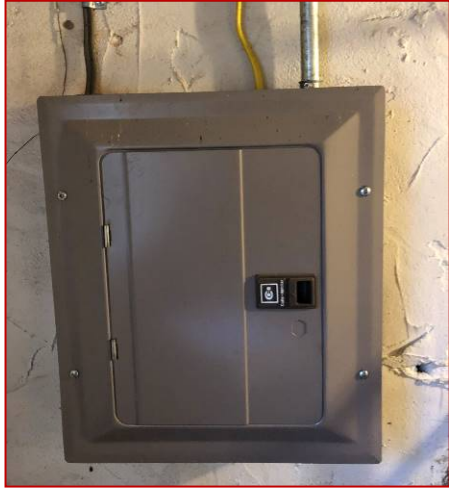
*Image 29: Subpanel*

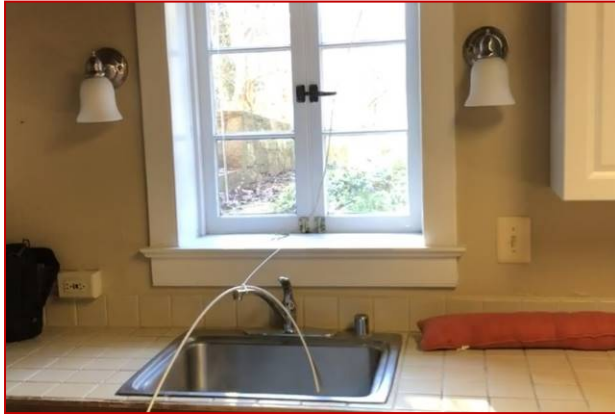
*Image 32: Insufficient Number of GFCI Receptacles at Kitchen Sink*

Dedicated kitchen circuits are now required by the NEC as well a minimum of two dedicated above-counter receptacles. Only one above-counter, surface-mounted GFCI receptacle is in place. Dedicated circuiting for this receptacle is indicated on the panelboard schedule. SWSG recommends providing an additional above-counter kitchen GFCI receptacle with a
