ELLMORE FARMHOUSE Condition and Treatment Report

2739 West Ox Road, Herndon, VA

Final Report

March 28, 2018

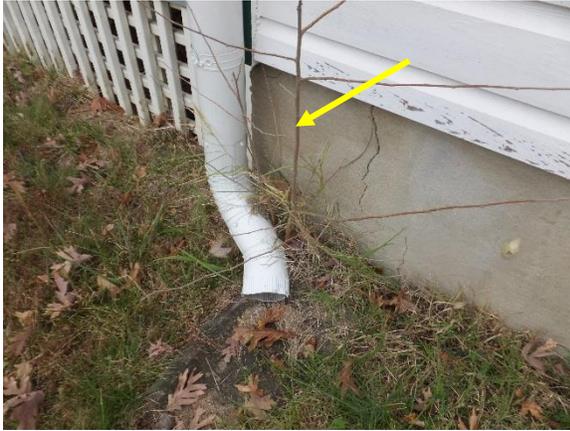
- Some vegetation was observed in close proximity to the house with evidence of growth at the foundation (Figure 11).

Figure 11. Vegetation along foundation at the southeast facade. Note close proximity of downspout to the house without splash pads and crack in foundation parge coat.

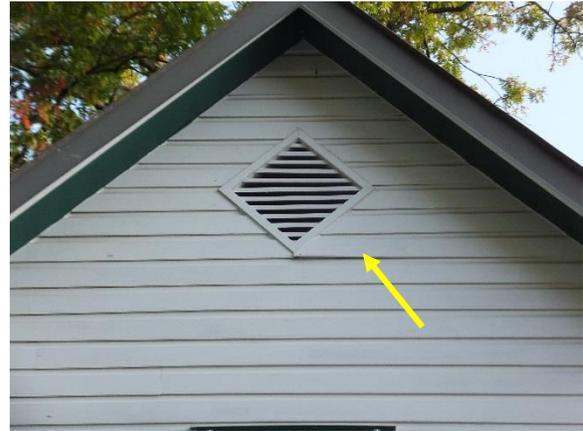
- Displaced wood siding boards were observed at locations throughout the facades, generally around window and vent openings (Figure 12 and Figure 13).
- Several cracks and isolated areas of spalls were observed in wood siding, typically originating from the end of the board or at fasteners. Previous crack repairs were also observed throughout the facade (Figure 14, Figure 15, and Figure 16).
- Minor paint deterioration such as peeling, cracking, and discoloration was observed throughout the exterior of the home with some areas coincidental with wood deterioration as the wood material became exposed with the compromised coating (Figure 17 and Figure 18).

Figure 12. Example of displaced siding at southwest facade.

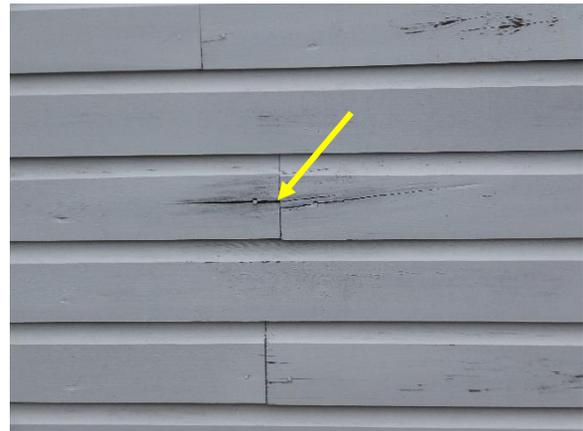
Figure 14. Typical cracking at fastener and end of boards.

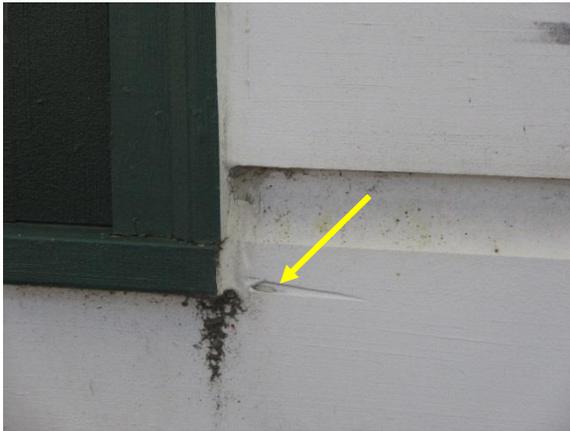
Figure 15. Chip in siding adjacent to a window corner. Typical on northwest facade.

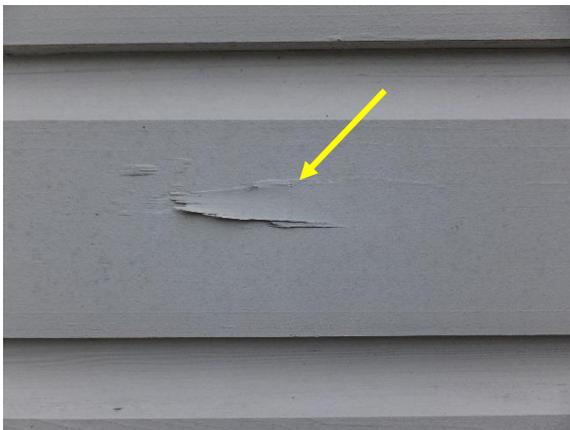
Figure 17. Typical flaked paint, and potentially damaged wood below, on wood siding.

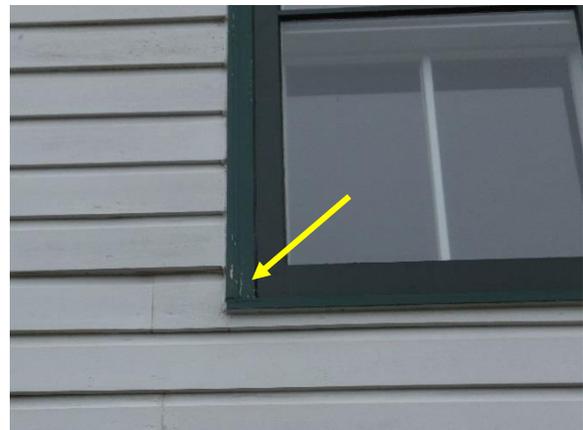
Figure 18. Flaked paint on window frame at southeast facade.

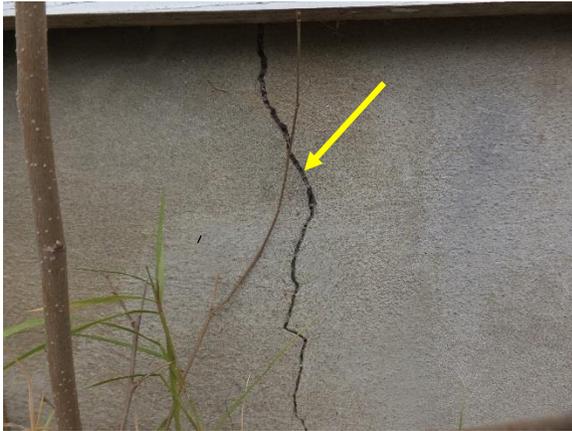
- The field stone foundation at the original portion of the home appears to be in poor to fair condition. Several cracks and isolated spalls were observed in the cementitious parge coat at the areas visible at the exterior of the home (Figure 19, Figure 20, and Figure 21). Moreover, the foundation wall was observed at the interior to be bowing concavely at the northwest façade (Figure 22). There is a large tree in close proximity to this side of the house that may be contributing to the foundation wall condition.

Figure 19. Typical crack and slight delamination in parge coat at original foundation.

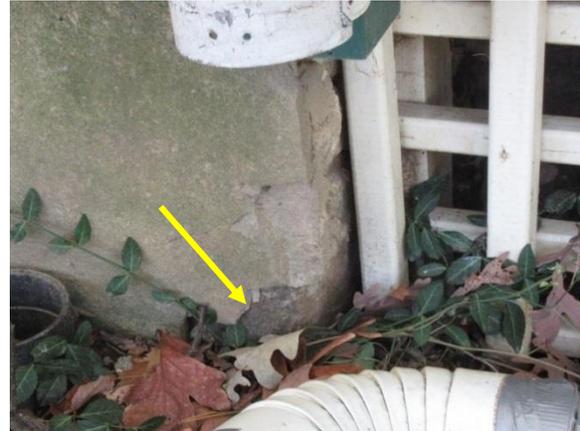
Figure 20. Spall in parge coat at original foundation exposing stone foundation.

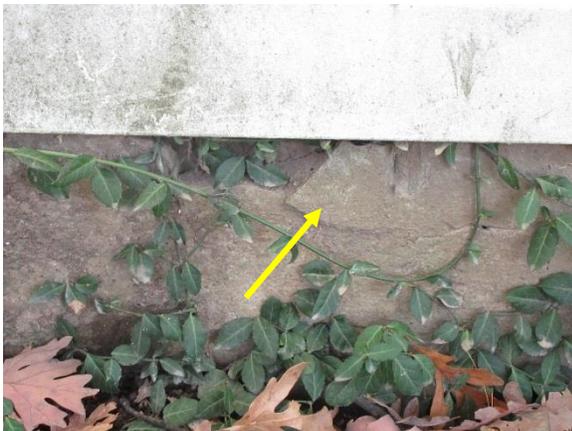
Figure 21. Incipient spall in parge coat at original foundation near window well.

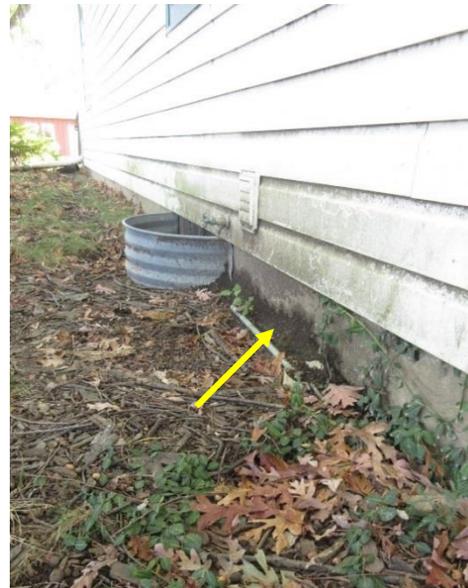
Figure 22. Foundation wall concave at original foundation. Note vegetative growth and staining at parge coat and above siding.

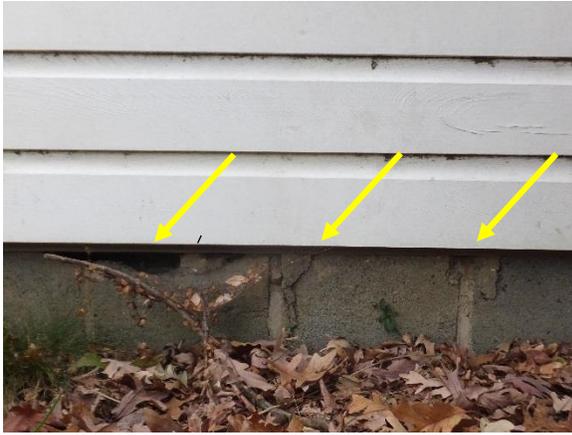
- The foundation at the additions of the home were observed to be in good condition with isolated and very minor cracks and spalls (Figure 23) in the parge coat. At the foundation located on the northwest elevation, isolated areas of spalling and deteriorated mortar joints was observed at the CMU foundation block (Figure 24). In addition, three partially sealed pipe penetrations through the foundation to room 105 (bathroom) are located at the southeast facade to accommodate existing utilities (Figure 25).

Figure 23. Typical spall and cracking in parge coating and CMU foundation at rear of additions.

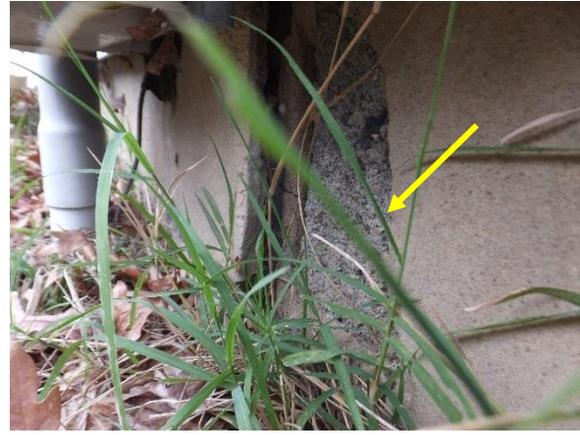
Figure 24. Delamination in parge coat exposing CMU foundation between ca. 1945 and 1984 additions on southeast facade.

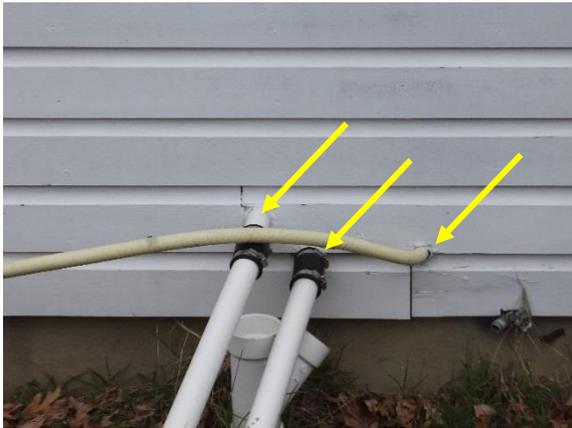
Figure 25. Partially sealed pipe penetrations on southeast facade.

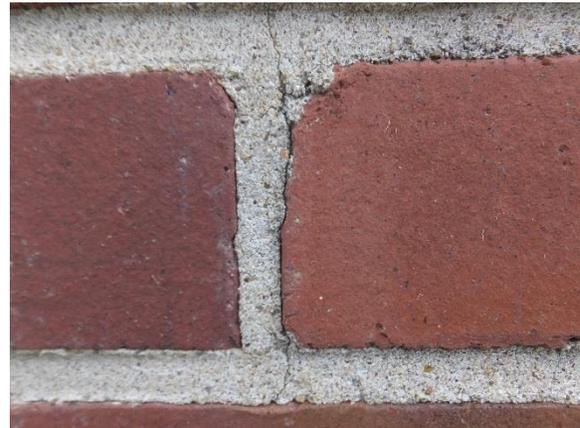
- In general, the chimneys are in good condition. Minor deterioration was observed at the chimney located on the southeast facade including isolated cracks, deteriorated mortar joints and an area of paint staining (Figure 26 and Figure 27).
- Dark staining was observed at the chimney located at the rear of the 1945 addition (Figure 28).

Figure 26. Cracking in mortar joint at chimney on southeast facade.

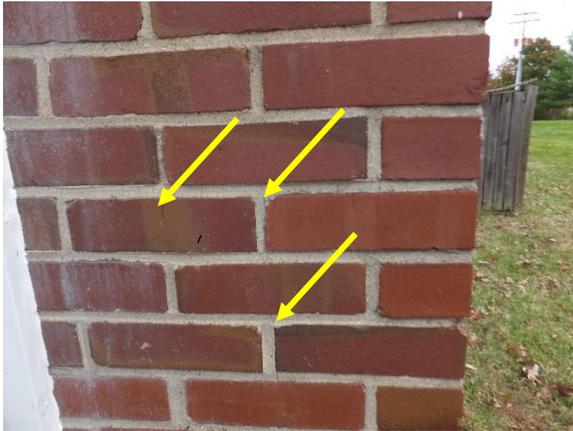
Figure 27. Typical crack in brick and mortar at chimney on southeast facade.

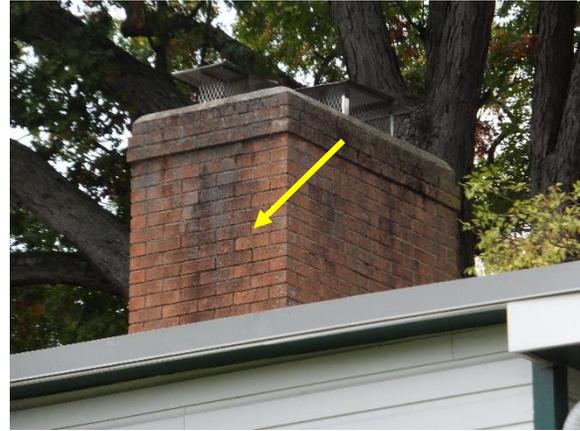
Figure 28. Staining at chimney located at the rear of the 1945 addition.

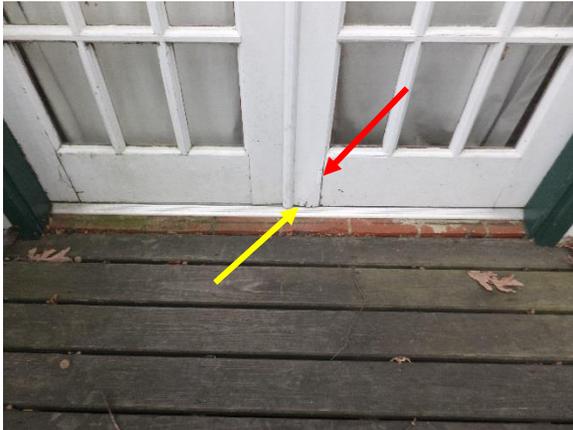
- The exterior doors of the home are in good condition with areas of minor deterioration. Separation between joinery, splintered wood, and missing door hardware was observed at the base of the French doors on the northeast facade (Figure 29 and Figure 30).

Figure 29. Splintered wood at base (yellow arrow) and separation of joinery (red arrow) at French doors.

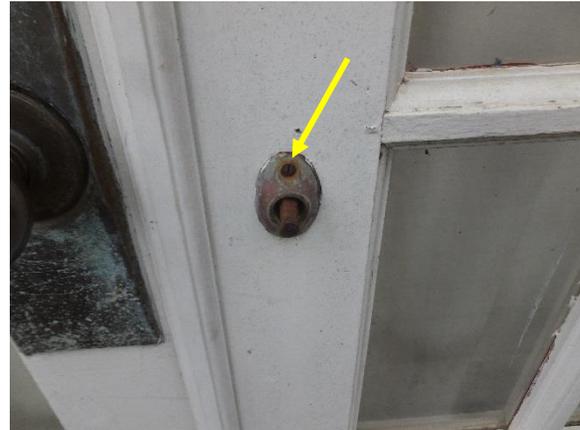
Figure 30. Missing doorknob at French doors on northeast facade.

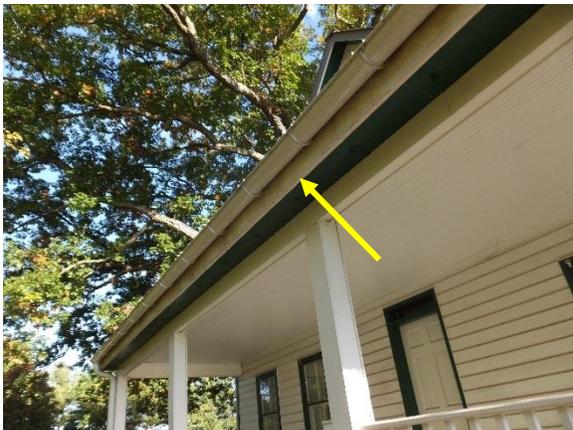
- The metal roofing throughout the home is in good condition with minor areas of soiling such as below gutters (Figure 31).
- A dent and area of displaced metal was observed at the metal coping on the southeast facade (Figure 32 and Figure 33).
- Most downspouts do not have splash pads or extension resulting in the discharged water being deposited close to the foundation (Figure 33 and Figure 34). One downspout was observed to be disconnected at the northwest elevation (Figure 35).

Figure 31. Soiling at fascia board behind gutter.

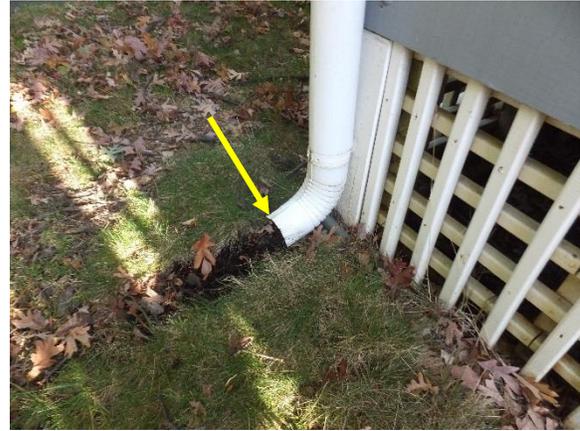
Figure 34. Downspouts terminate near the foundation without splash pads or extensions and have eroded the adjacent soil, typical.

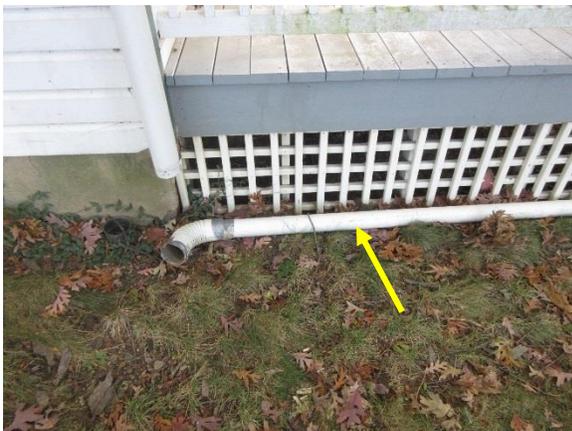
Figure 35. Disconnected downspout at northwest facade.

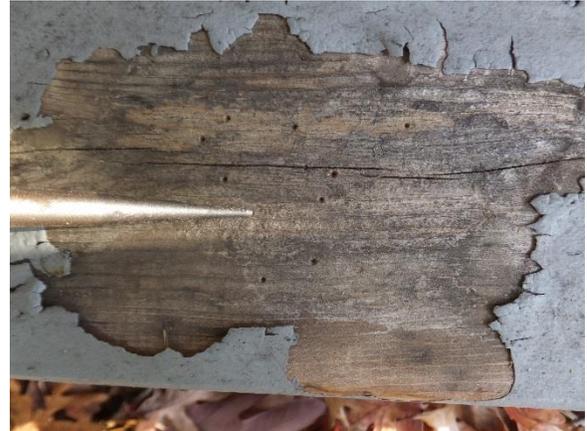
- The porch is generally in good condition with areas of minor deterioration at the door threshold, porch column and porch stairs due to the exposure to the elements. A vertical crack was observed along the base of the southeast porch column (Figure 36). The door threshold was observed to be uncoated (Figure 37) and paint deterioration at the porch stairs resulting in soft wood was exhibited (Figure 38). The decking joists have been replaced in recent years and are in good condition with minor areas of staining (Figure 39).
- The original stone foundation underneath the porch was observed to have deteriorated mortar joints (Figure 40).

Figure 38. Paint and wood deterioration at porch stairs.

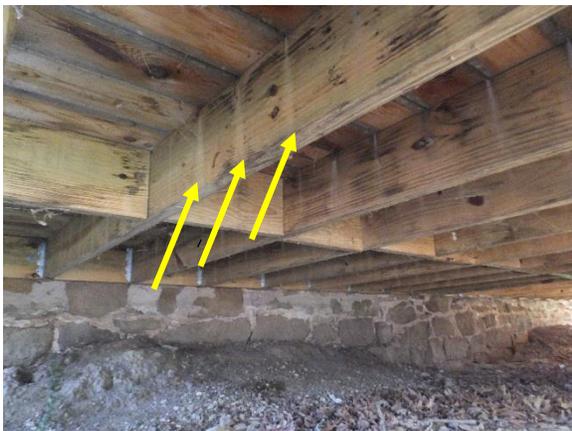
Figure 39. Wood joists under porch exhibiting staining, likely from water.

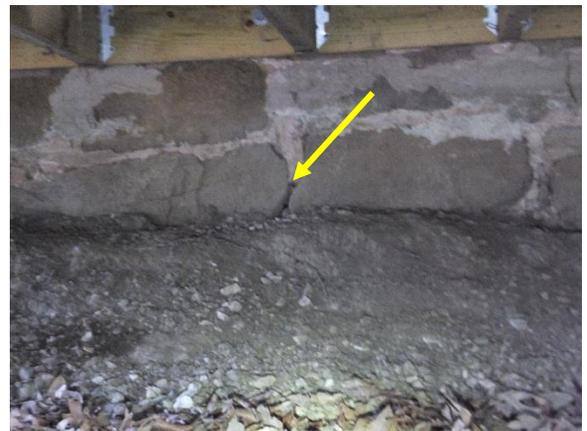
Figure 40. Missing mortar in stone foundation.

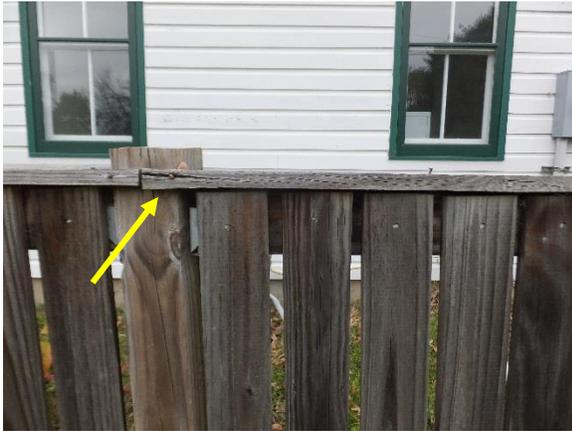
- The wood fence added on the southeast facade is fair condition with areas of multiple cracks, missing areas of wood, and missing rail caps (Figure 41). In addition, as the wood is uncoated, the fence exhibits staining, displacement, and bowing (Figure 42).

Figure 41. Multiple areas of splintered wood on fence at southeast facade.

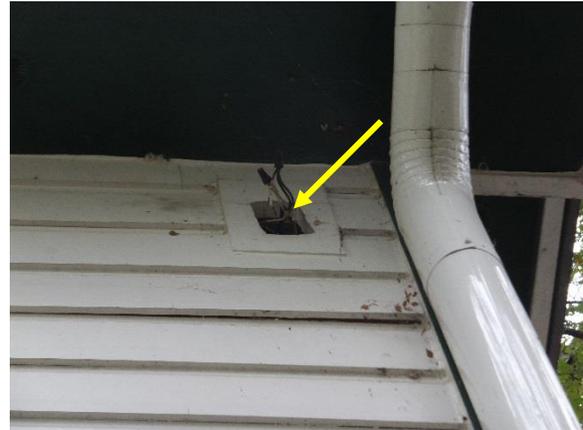
- The exterior lighting fixture located on the northeast facade is in good condition with one fixture missing on the upper corner of the facade (Figure 44).

Figure 44. Missing light fixture at northeast facade.

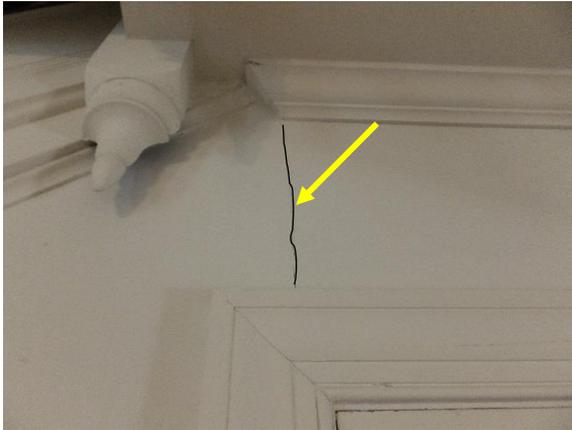
- Interior wall finishes consist of drywall, plaster, and wood paneling. Cracking of plaster and drywall was observed throughout the home generally located near window or doorframes, walls seams, fixtures, ceiling interfaces, and at drywall board seams (Figure 45, Figure 46, and Figure 47). Diagonal cracking was observed on the walls in the stairwell, living room (room 101), and first and second floor bedrooms in the historic portion of the home (Figure 48, Figure 49, Figure 50, and Figure 51). Cracks typically emanated from the ceiling to the wall base with several intermediate cracks following the crack pattern. These cracks were also evident on closet walls in Rooms 201-204 (bedrooms).

Figure 45. Cracked plaster/drywall above 1st floor doorframe, typical. Crack traced for clarity.

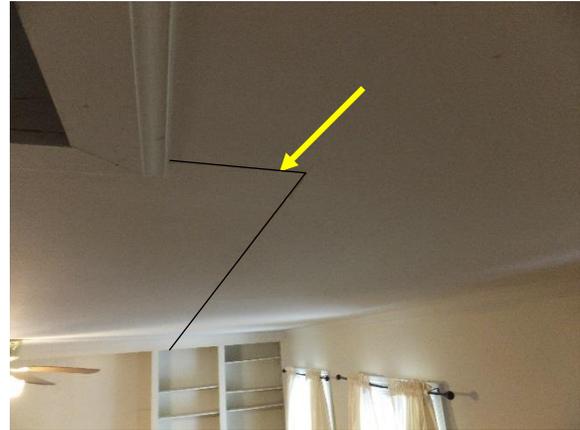
Figure 46. Cracking at ceiling (1st Floor) likely seams between drywall boards. Cracked traced for clarity.

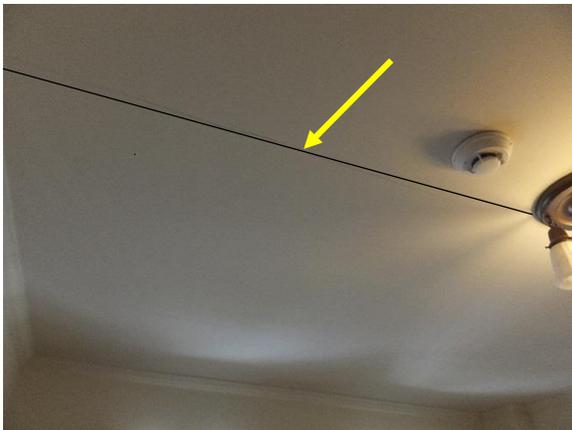
Figure 47. Horizontal cracking at light fixture in room 102 (bedroom/family room) likely between seams of drywall boards. Crack traced for clarity.

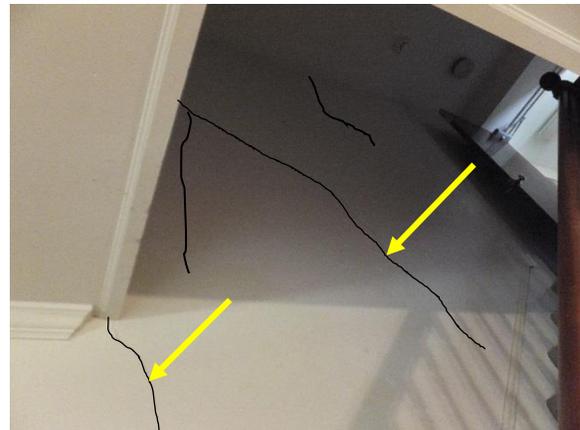
Figure 48. Diagonal cracking at stairwell. Crack traced for clarity.

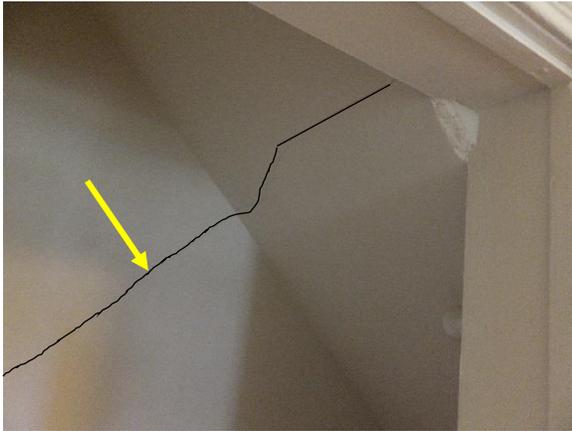
Figure 49. Diagonal cracking underneath stairwell. Crack traced for clarity.

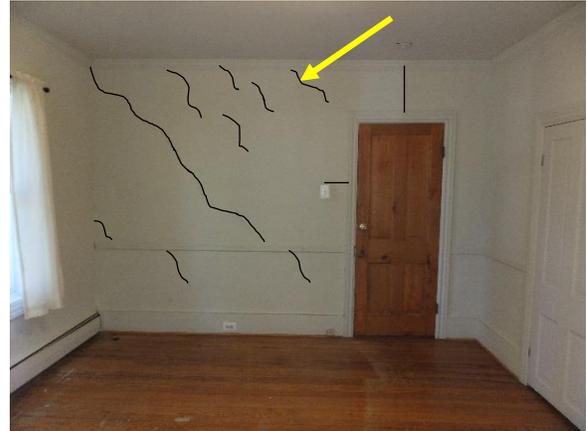
Figure 50. Diagonal and vertical cracking in room 102 (bedroom/family room). Cracks traced for clarity.

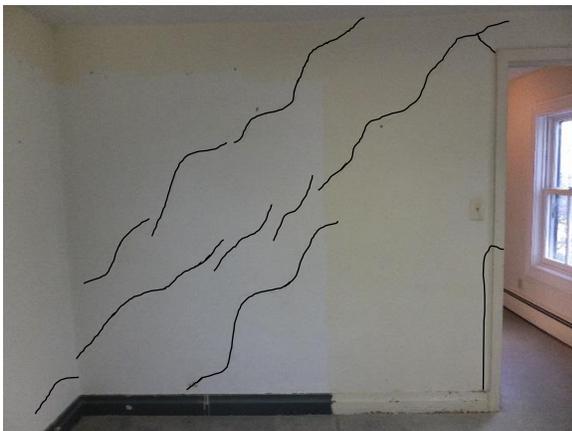
Figure 51. Diagonal cracking in room 202 (bedroom). Crack traced for clarity.

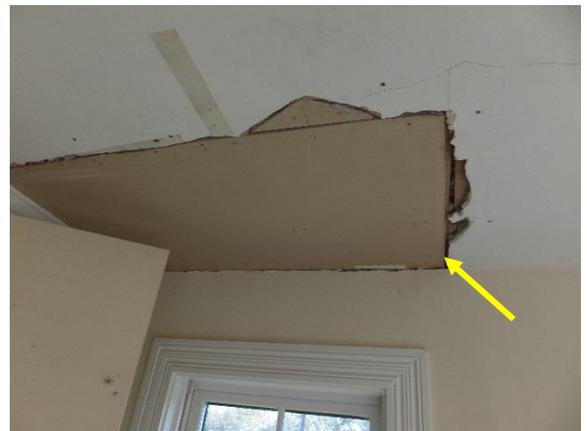
- Isolated areas of damaged plaster and drywall were observed throughout the home including stained and missing finishes likely due to previous water infiltration (Figure 52, Figure 53, Figure 54, Figure 55, Figure 56, Figure 57, and Figure 58). *Note: Although outside the scope of our work, the electrical outlet depicted in Figure 56 is partially exposed and unsecured wire runs through the plaster in Figure 54, which may present substandard electrical work.*

Figure 52. Removed area of plaster with drywall patch in room 201 (bedroom).

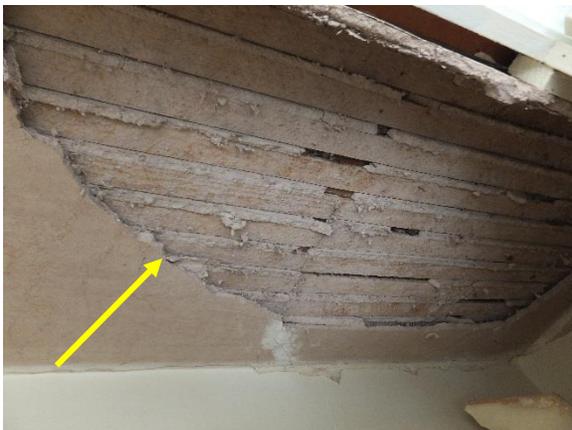
Figure 53. Missing plaster with wood lathe exposed at closet in room 201 (bedroom).

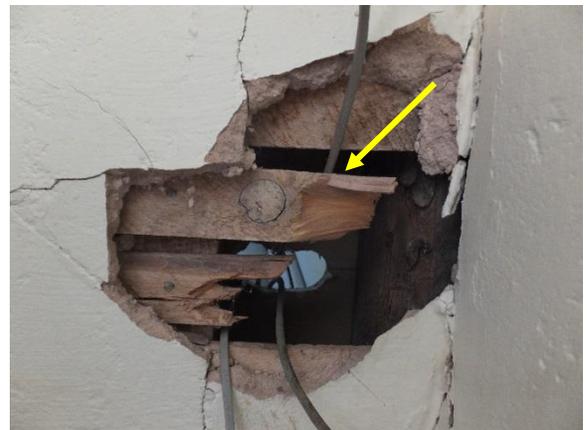
Figure 54. Hole through plaster and lathe for wiring.

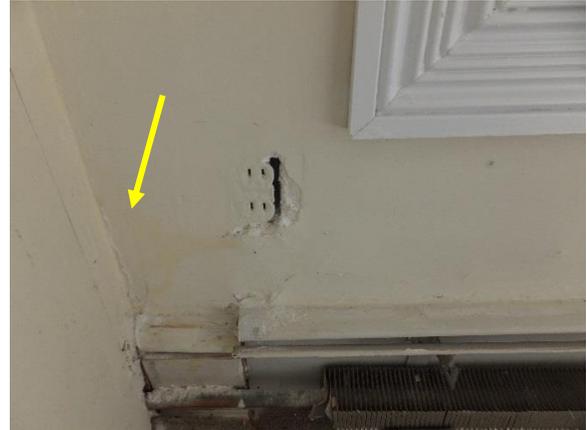
Figure 56. Stained plaster and potential previous repair. Note electrical outlet.

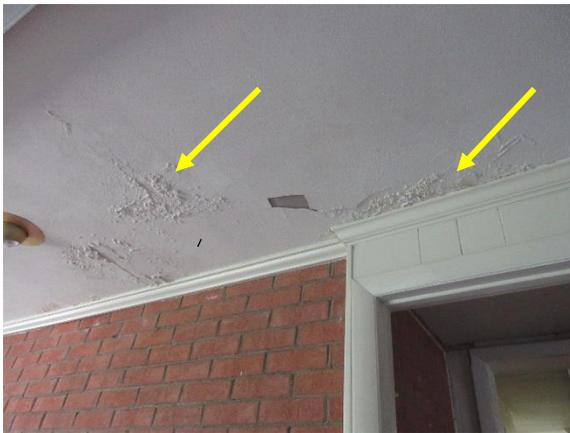
Figure 57. Damaged drywall due to water infiltration

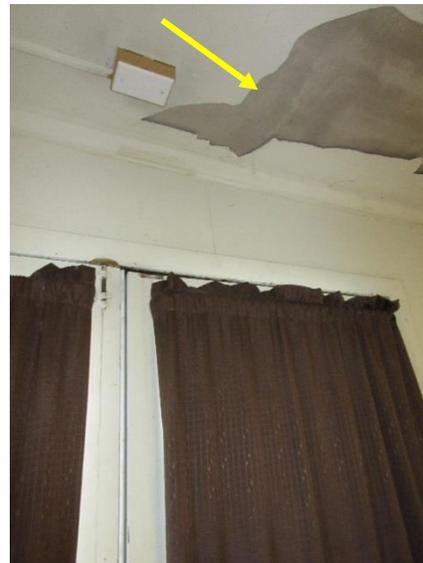
Figure 58. Drywall delamination at rear entryway.

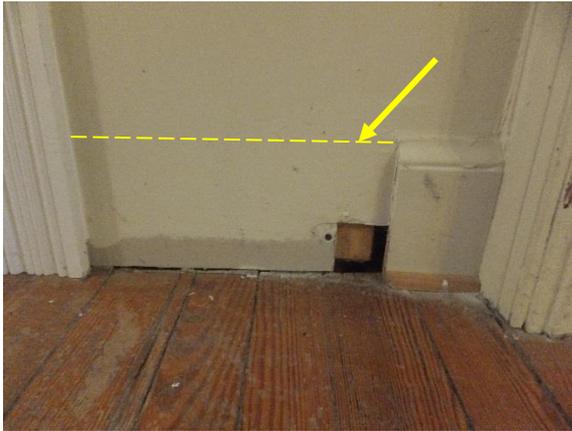
- Missing sections of baseboards associated wood elements were observed in Room 101 (living room) and 210 (office) and around ductwork on the first floor (Figure 59 and Figure 60)

Figure 59. Missing baseboard.

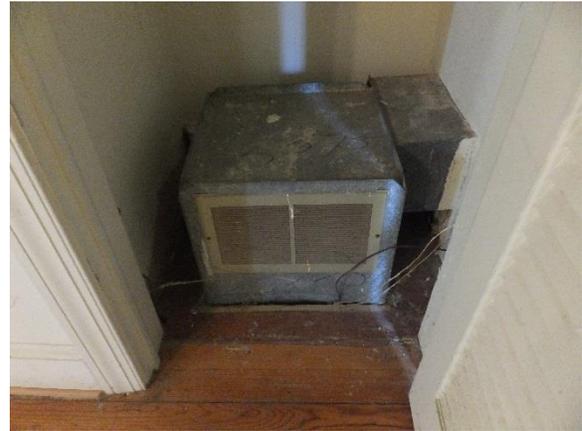
Figure 60. Ductwork installed at closet in stairwell.

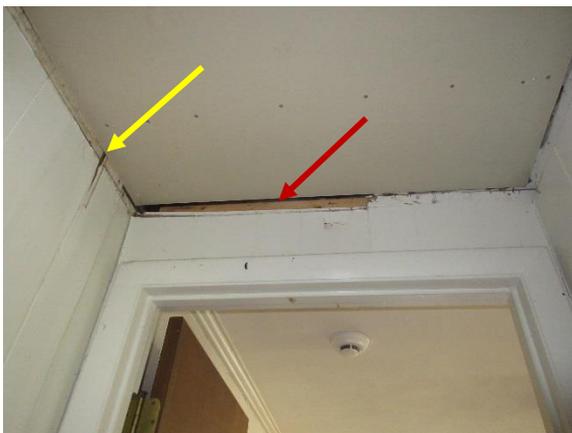
- In room 209 and 210 (offices), observations of the wood paneled siding included separation in joinery, splitting/cracking, tooling damage, and several gaps at crown molding interfaces (Figure 63, Figure 64, Figure 65, and Figure 66). In one isolated area, the siding appeared to bow inward in room 210 (office) (Figure 67).

Figure 63. Cracked wood siding panel and gaps at ceiling (red arrow) at entry of Room 210 (office), typical.

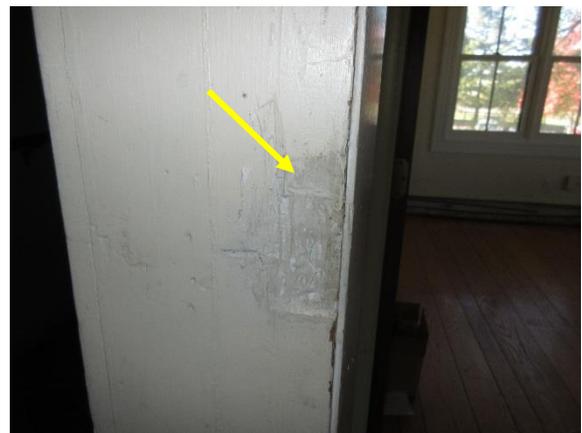
Figure 64 Tooling damage at wood siding panel at entry area adjacent to Room 209 & 210 (offices).

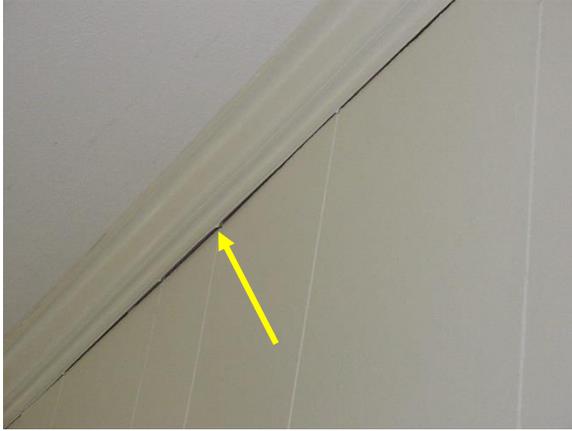
Figure 65. Gap between wood siding panel and crown molding, typical.

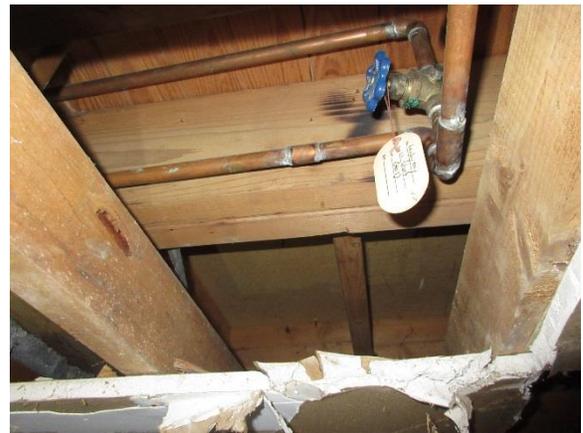
Figure 72. Condition of floor joist at 1945 addition.

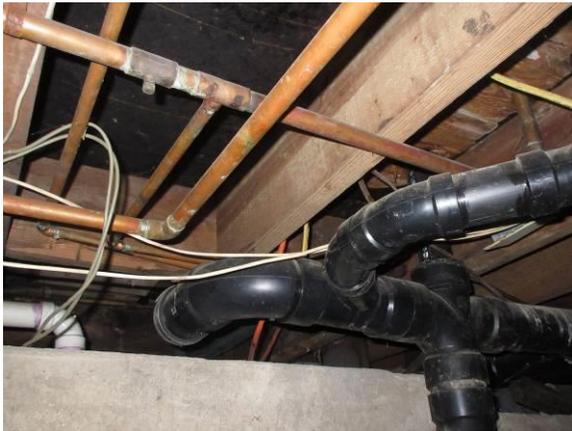
- In the cellar, conditions of the historic floor beams could not be observed due to limited accessibility/visibility. Exposed wood joists at the north corner of area B02 and B03 appeared to be in good condition (Figure 73).
- In the attic, observations included residual staining from water infiltration, rafter supports in place along the southeast, isolated areas of splitting at supports, and a missing piece of wood siding adjacent to vent at the northwest facade (Figure 74). The existing access hatch to the attic is skewed, making it difficult to lower the ladder. The original access, near the southwest wall, has been covered at the ceiling with interior finishes.

Figure 73. Condition of joists visible from cellar.

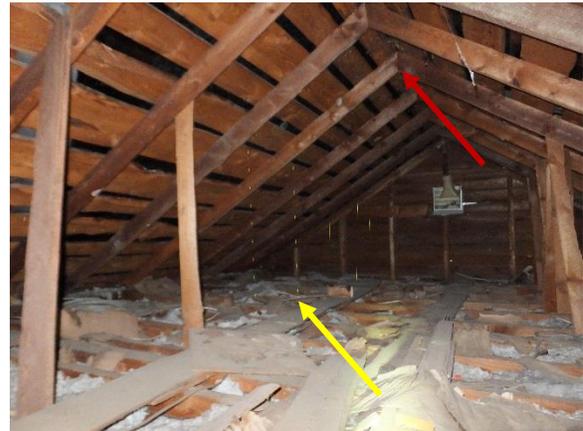
Figure 74. Rafter stud supports not continuous (yellow arrow) in attic and toe-nailed rafters (red arrow).

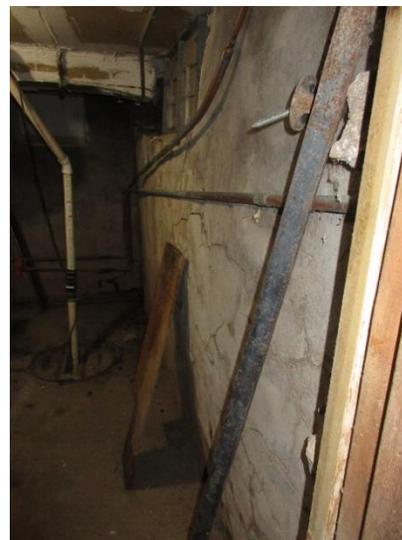
- On the northwest side of the cellar, there are multiple areas of spalling and cracking in the parge coat. The wall also appears to be out of plumb and bowing inward (Figure 76). There is a ventilation opening at this wall that opens due to wind and potentially allowing for possible water infiltration as well as insects and pests.

Figure 76. Northwest wall of cellar bowed out of plane and cracking in parge coat. Typical on northwest side of cellar.

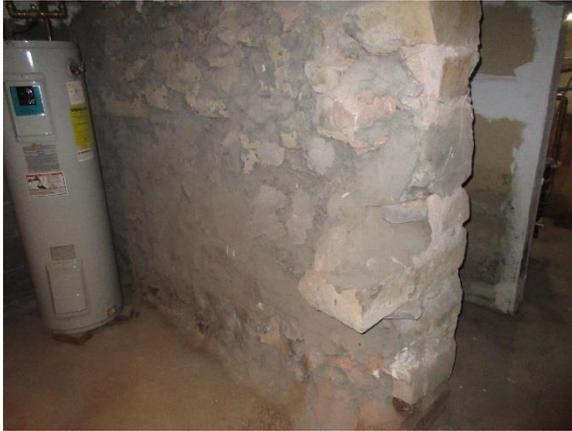
- In areas of exposed fieldstone, deteriorated mortar was observed along with several mortar patch repairs (Figure 77). Isolated areas of cracking in the concrete floor were observed near the entrance of the cellar and Electrical Room, B03 (Figure 78). Minor areas of bondline failure were observed at CMU units on the southeast side of the cellar (Figure 79).

Figure 77. Deteriorated mortar and previous patch repairs at original stone foundation wall in cellar.

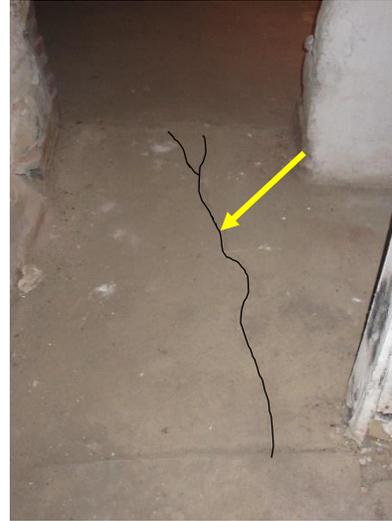
Figure 78. Cracking in concrete floor near the cellar entry. Crack traced for clarity.

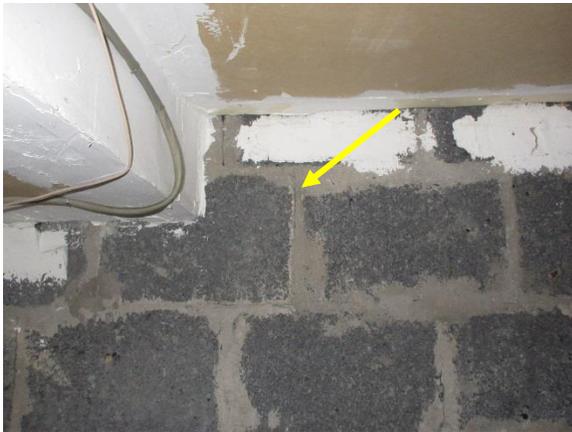
Figure 79. Bondline failure at CMU foundation wall in cellar.

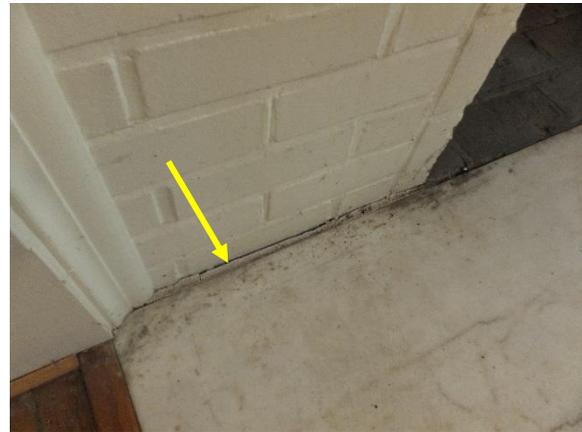
- At stone hearth on first floor, deterioration in mortar joint between the brick wall and apron was observed along with an isolated area of flaked coating (Figure 80).

Figure 80. Deteriorated mortar joint between brick fireplace facing and the stone hearth/apron in living room (room 101).

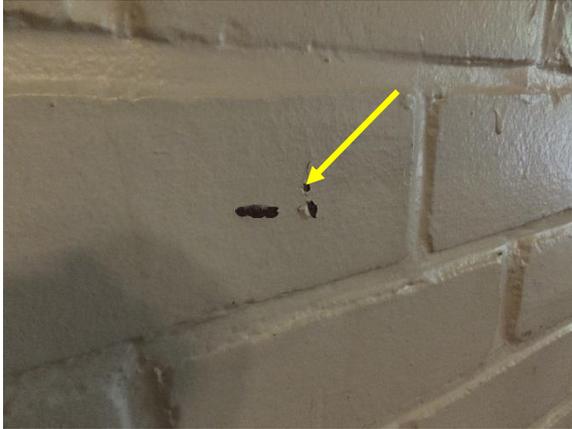
Figure 81. Flaked coating on fireplace brick in living room (room 101).

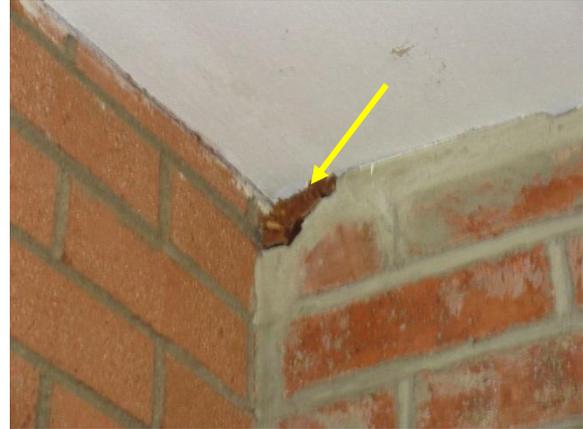
- Spalled brick and separation between brick at rear chimney and adjacent wall was observed (Figure 81 and Figure 82).

Figure 82. Spalled brick infilled with wood piece at Room 107 (bedroom).

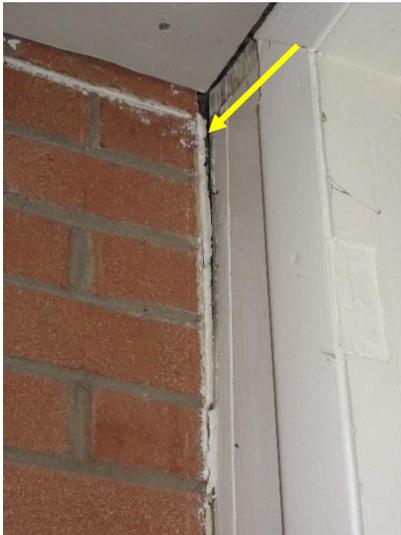
Figure 83. Separation between brick and adjacent wall, typical.

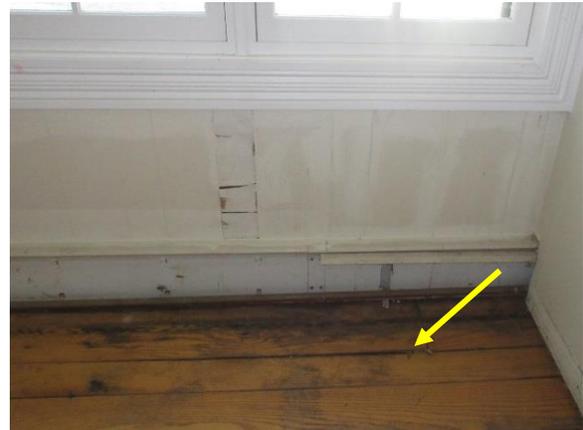
Figure 86. Staining at wood floor in Room 210 (office). Split across flooring visible.

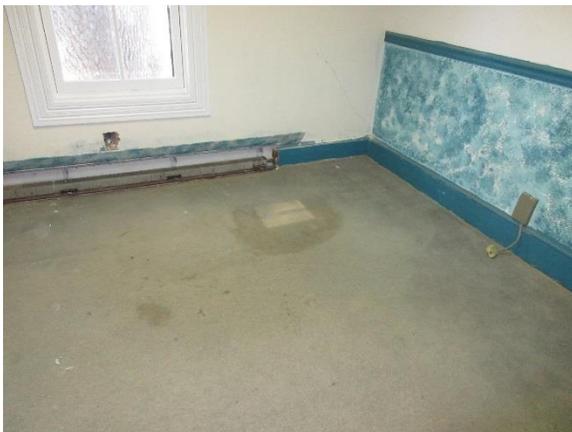
Figure 87. Stained carpet, typical.

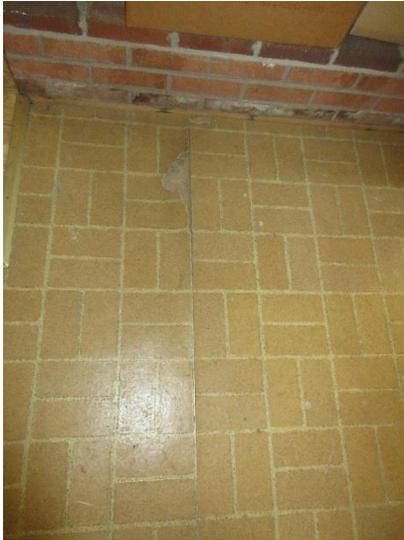
Figure 89. Delaminated and damaged linoleum flooring, typical.

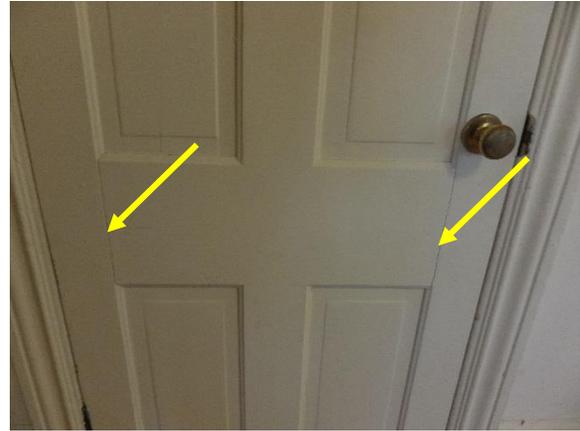
- Typical deterioration/damage observed at historic doors included minor separation at joinery and minor areas of indentations and scratches (Figure 90).

Figure 90. Separation of joinery at original door, typical.

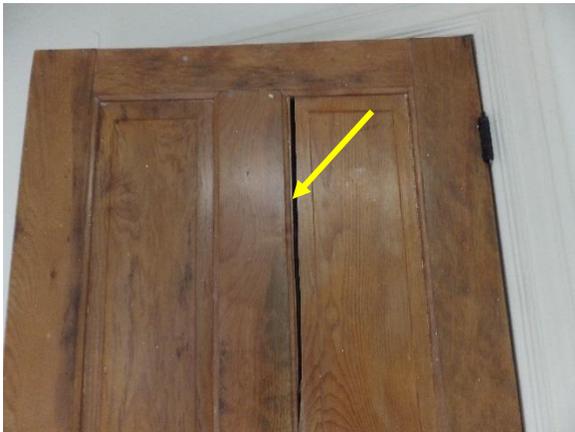
- One isolated area of splitting, creating a void in a raised panel was observed at the second floor, D205 (Figure 91).
- One door at the second floor, D202, did not fully close. At D101, the doorknob is inoperable (Figure 92).

Figure 91. Cracking and missing wood at door panel at D205.

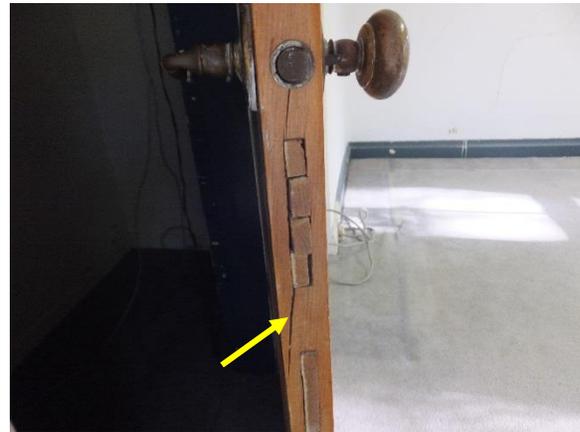
Figure 92. Splitting on stile of door facing latch, at D205.

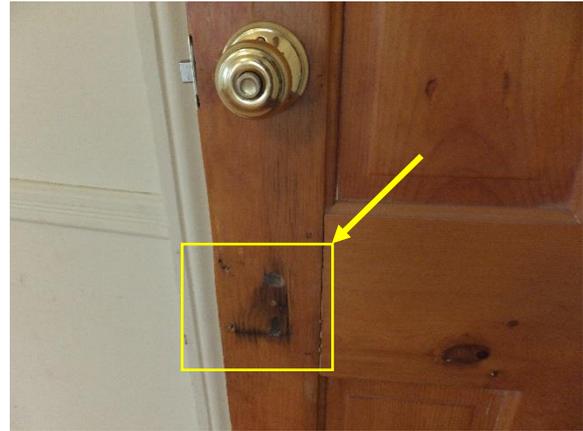
- Several of the historic doors have been replaced with contemporary hardware and thus, original thresholds and rim locks for some doors have been removed (Figure 94). The historic hardware that remains, such as some hinges, were observed to be decorated in various styles, including Queen Anne (Figure 95).

Figure 94. Missing original rimlock at D101

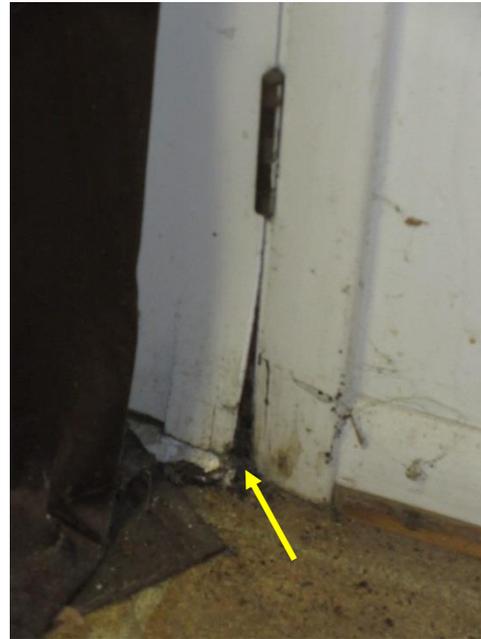
- The doors located at the additions of the home were generally in good condition throughout. Isolated cracking and water damage was observed at the trim of the French doors on the first floor, northeast facade (Figure 96).

Figure 96. Damage at the trim of the French Doors.
