## HANNAH P. CLARK HOUSE Condition and Treatment Report

10605 Furnace Road, Lorton, VA

### **Final Report**

WJE No. 2017.2430

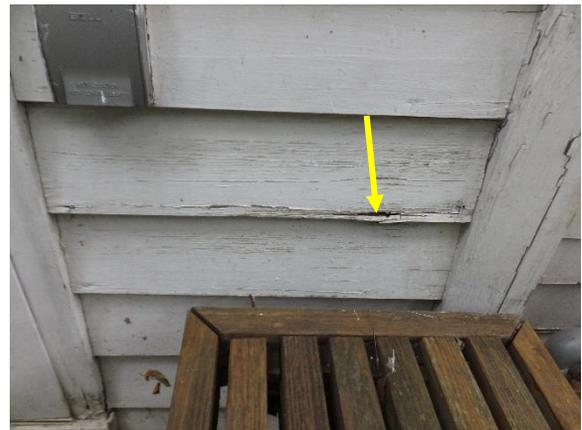
- Deteriorated wood was observed at locations throughout the exterior siding, generally on trim elements at corners and below gutters (Figure 11, Figure 12, and Figure 13). Some of these areas may correspond to damage due to water runoff or overflow. Soft wood areas were particularly found in accessible areas below the southeast corner gutter and adjacent to the wood sided chimney on the east facade (Figure 14 and Figure 15). One section of siding at the chimney was soft enough to allow an awl to pass through the material.

*Figure 12. Deteriorated wood at cornice element on northwest corner behind gutter.*

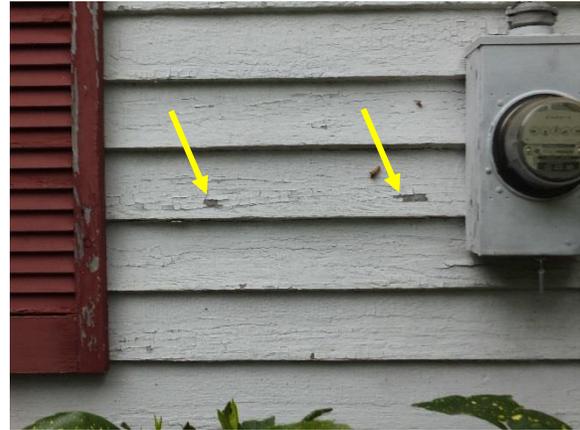
- Paint deterioration such as peeling, cracking, and discoloration was observed throughout the exterior of the home with some areas coincidental with wood deterioration as the wood material became exposed with the compromised coating (Figure 16 and Figure 17).

*Figure 16. Typical paint deterioration on wood siding.*

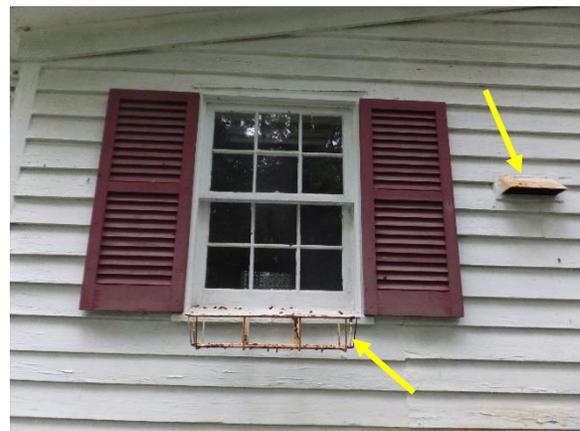
- A large area of ferrous staining was observed on the east facade, adjacent to a water spigot (Figure 18). Other attached metal elements had deteriorated coatings and resultant corrosion (Figure 19). Corrosion was also observed at fasteners in the siding on the south facade (Figure 20).

*Figure 18. Ferrrous staining on east facade adjacent to water spigot.*

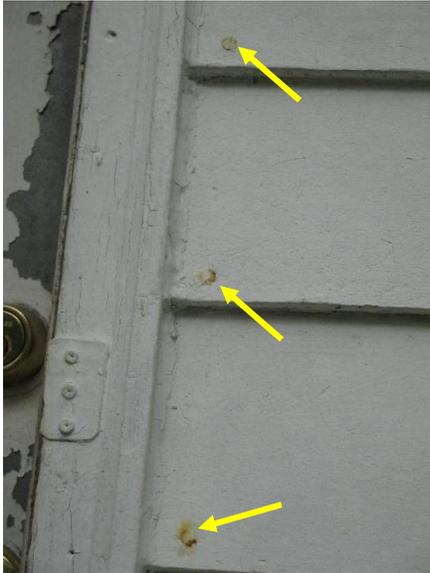
*Figure 19. Corrosion on metal elements attached to facade due to deteriorated coatings.*

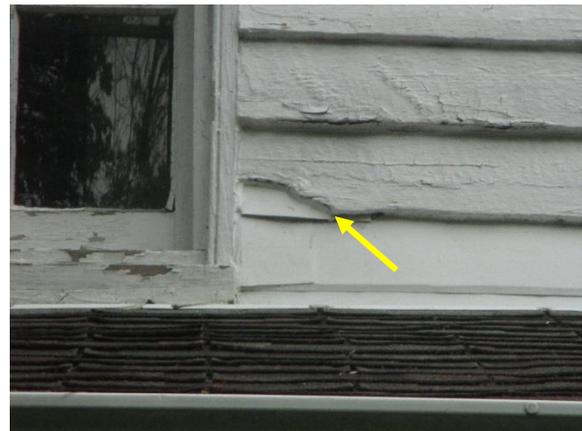
- Isolated cracks and missing areas of wood were observed in wood siding, generally originating from the end of the board or at fasteners (Figure 21, Figure 22, and Figure 23). Separation of some cornice wood members were visible, typically occurring at corners (Figure 24). In addition, one utility line anchor protrudes through the cornice on the east facade through a rough opening that could allow water to enter into the boxed cornice (Figure 25).

*Figure 22. Split in wood originating from southwest corner.*

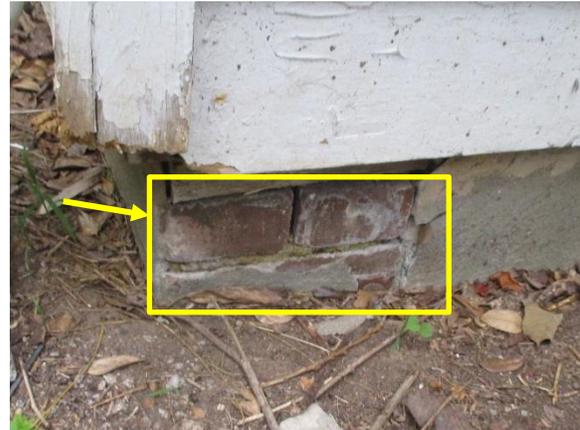
- The foundation appears to be in generally good condition. Isolated cracks and spalls were observed in the concrete parge coat at the areas visible at the exterior of the home allowing brick to become exposed (Figure 26 and Figure 27). Two unsealed pipe penetrations through the foundation to the cellar are located at the north facade to accommodate existing utilities.

*Figure 26. Crack and delamination in parge coat that covers brick foundations.*

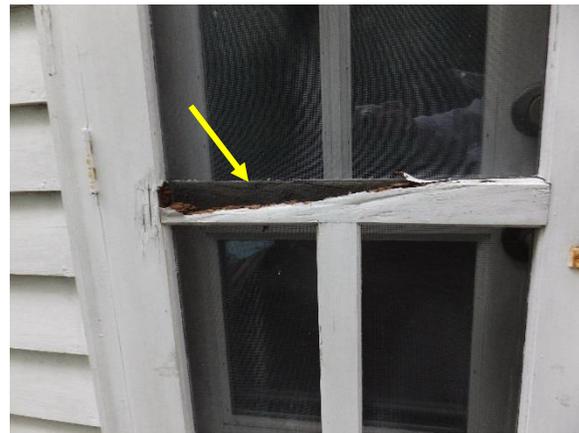
*Figure 30. Typical separation of joinery at doors.*

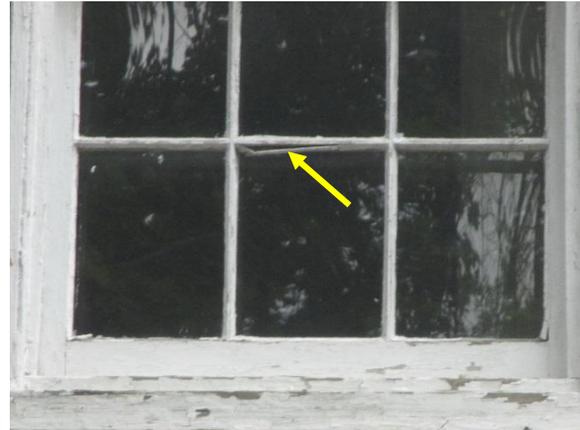
- Typical window conditions included cracked, displaced, or missing glazing putty; flaked and peeling paint; missing and removed interior hardware; flaked and peeling coating at the shutters with isolated areas of broken or missing slats; (Figure 39 through Figure 44). Several of the windows are covered at the exterior or interior with an acrylic glass directly fastened to the frame.

*Figure 39. Typical deterioration of glazing putty at windows.*

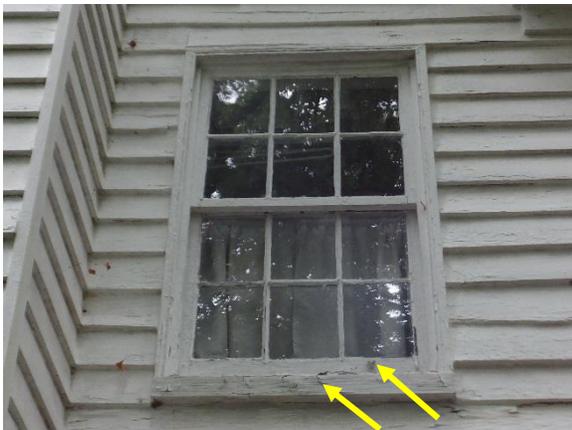
*Figure 40. Typical flaked paint on window elements and frame.*

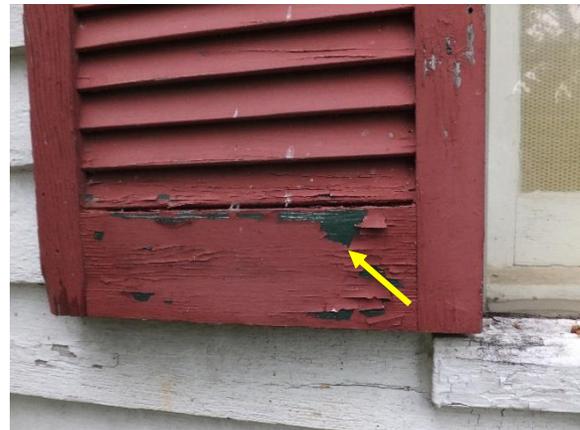
*Figure 41. Typical deterioration of paint on window shutters revealing previous green paint.*

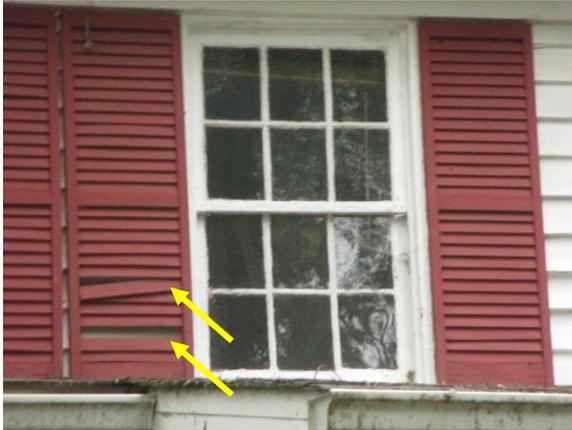
*Figure 42. Broken and missing slat on shutter at south facade.*

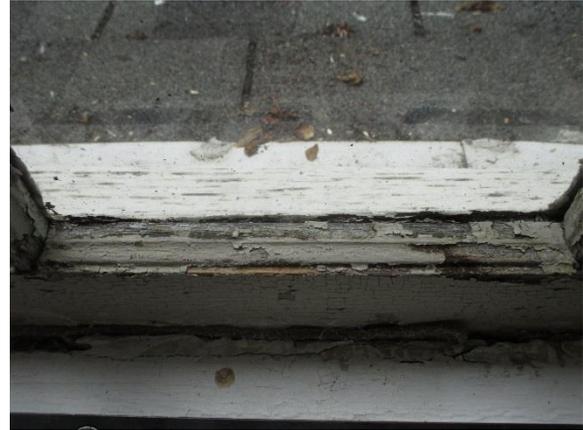
*Figure 43. Typical paint and glazing putty deterioration at windows.*

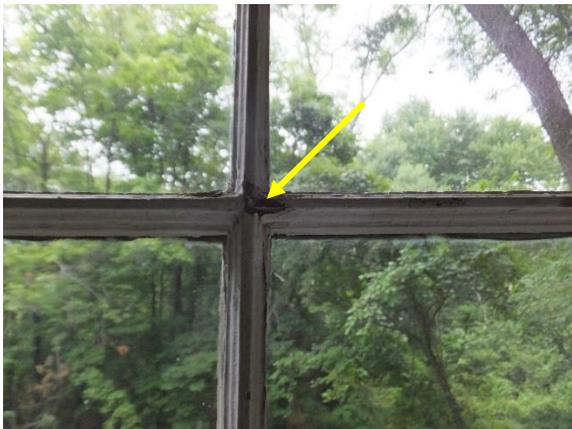
*Figure 44. Typical deterioration of muntins at interior.*

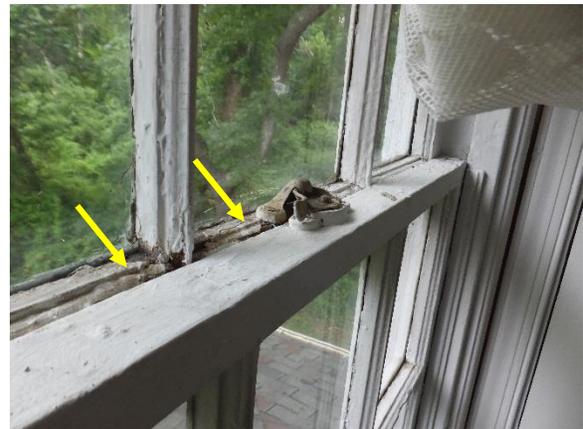
- Isolated conditions observed were cracked glass lites, muntin deterioration typically at the upper sash meeting rail (Figure 45), an area of missing wood from a window sill, an area of missing interior molding, one window with a cracked muntin, and one damaged muntin that reveals the edge of a glass lite (Figure 46 and Figure 47).

*Figure 45. Muntin deterioration at upper sash meeting rail.*

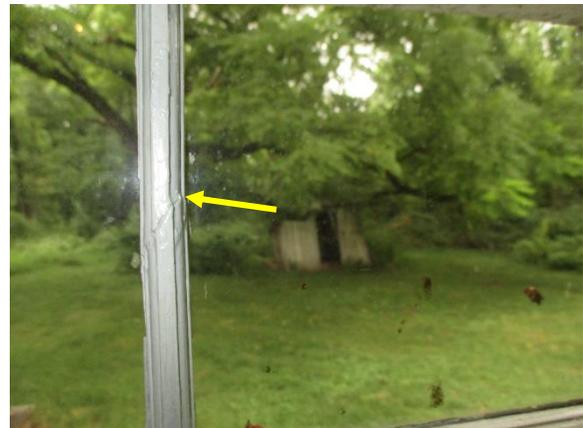
*Figure 47. Cracked muntin in room 109.*

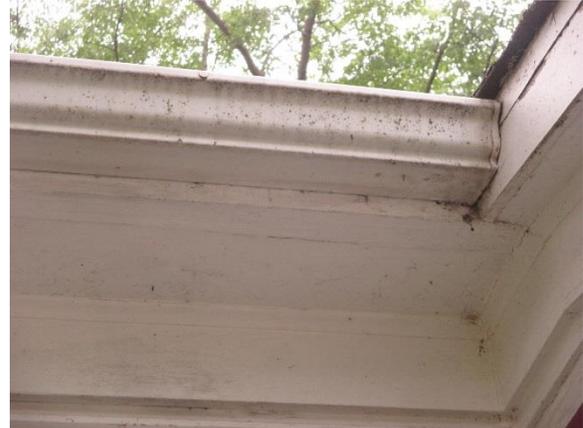
- The asphalt shingles are in fair condition with gutters and downspouts in good condition. Metal flashing appears to have been integrated with the last re-roofing work at the secondary roofs.
- Debris was observed along all gutters, which could be due to build up in the gutters or they could be undersized to accommodate the water flow (Figure 49). Most downspouts do not have splash pads that is resulting in the discharged water being deposited close to the foundation (Figure 50).
- Vegetation was observed growing on the roof and underneath the eaves as well as dark soiling at some areas of shingles (Figure 51 and Figure 52). There were also several shingles missing at the edge of the south gable (Figure 53).

*Figure 49. Debris build-up and staining at gutters providing evidence of overflow.*

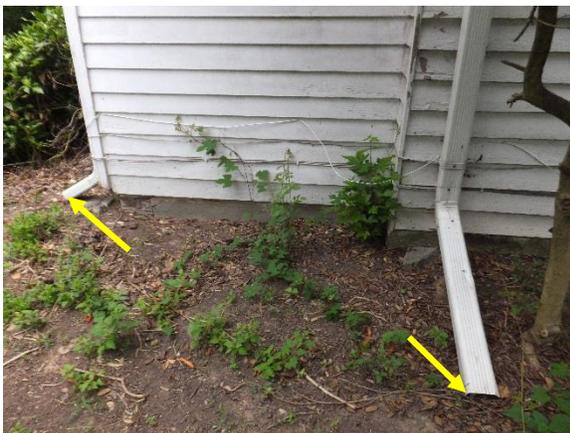
*Figure 50. Downspouts terminate near the foundation without any splash pads.*

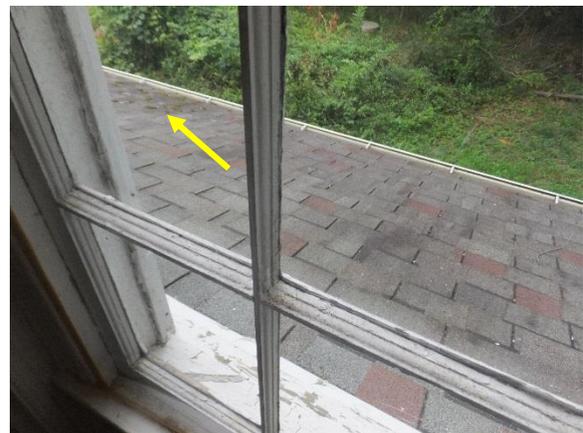
*Figure 51. Vegetation growing on the roof at the second roof on the north.*

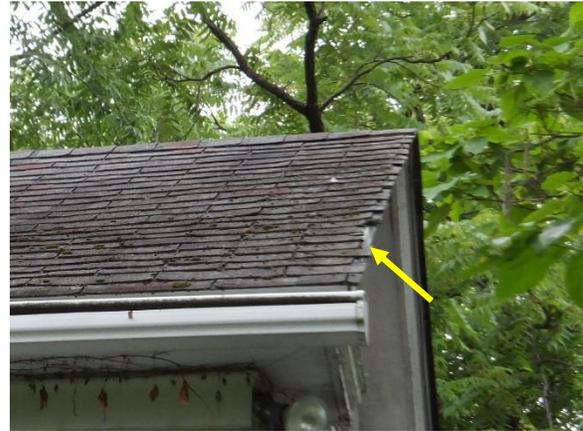
*Figure 53. Missing shingles at the edge of the south gable.*

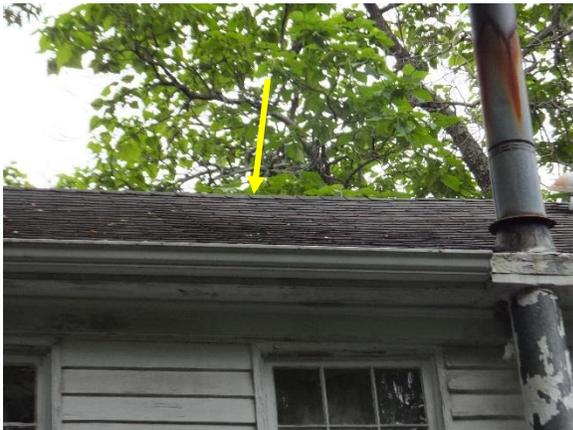
*Figure 54. Low spot on main gabled roof above the Period I section of the home.*

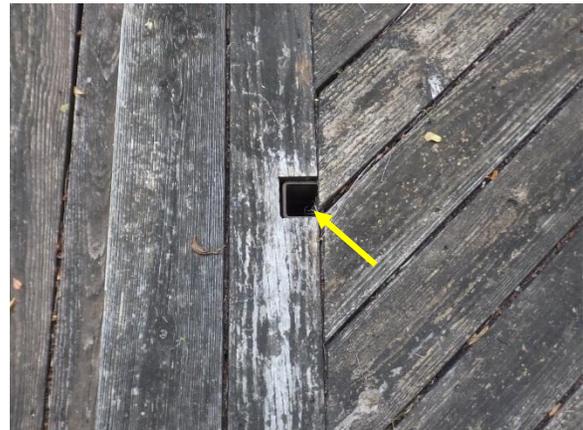
- The wood deck added on the east is generally in good condition with areas of minor deterioration due to exposure to the elements. Handrails have been removed with only the pockets for the posts remaining (Figure 55).

*Figure 55. Removed handrails at the deck on east side of home. Note condition of wood decking.*

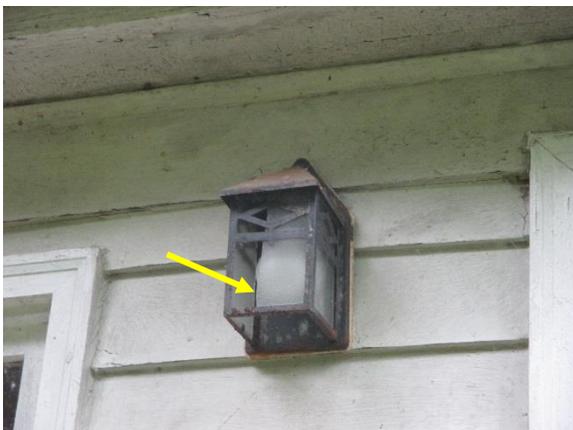
- The exterior lighting fixtures are not original and are in good condition with only one fixture on the north side having a broken pane of glass (Figure 56).

*Figure 56. Lighting fixture on north facade with cracked glass at front.*

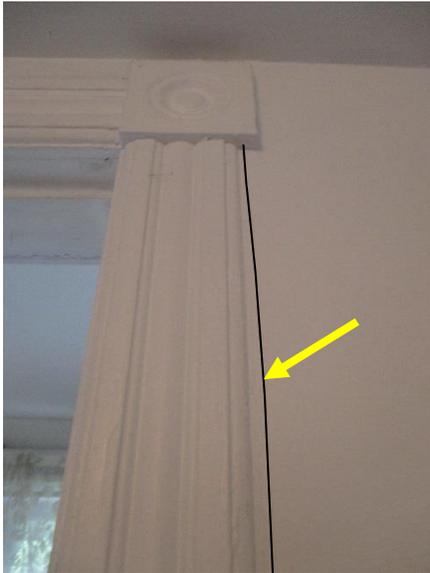
- Interior wall finishes consist of drywall, plaster, and wood paneled siding. Cracking of plaster and drywall was observed throughout the home generally located near window or door frames, fixtures, or wall seams (Figure 57, Figure 58, Figure 59, and Figure 60). There were also areas of flaking and stained paint with isolated areas of damaged plaster and drywall.

*Figure 57. Crack in plaster around door frame on second floor. Crack traced for clarity.*

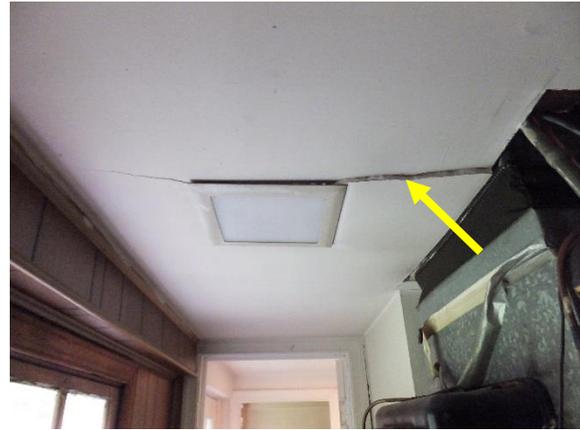
*Figure 58. Crack and vertical displacement in ceiling at lighting fixture in room 104 (enclosed north porch).*

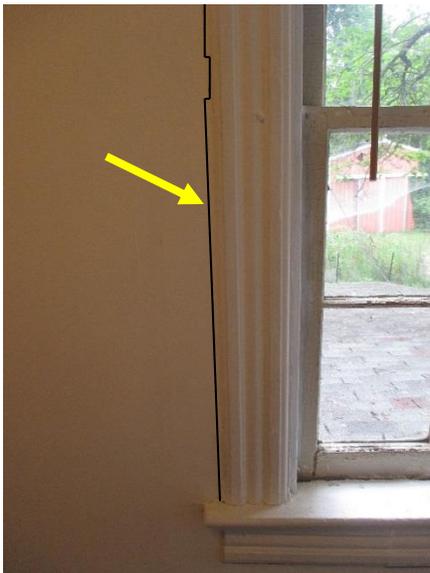
*Figure 59. Crack in plaster wall around window frame on second floor. Crack traced for clarity.*

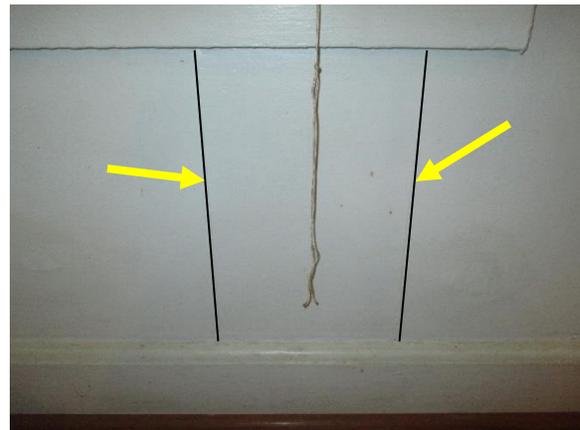
*Figure 60. Cracks in plaster beneath window sill. Cracks traced for clarity.*

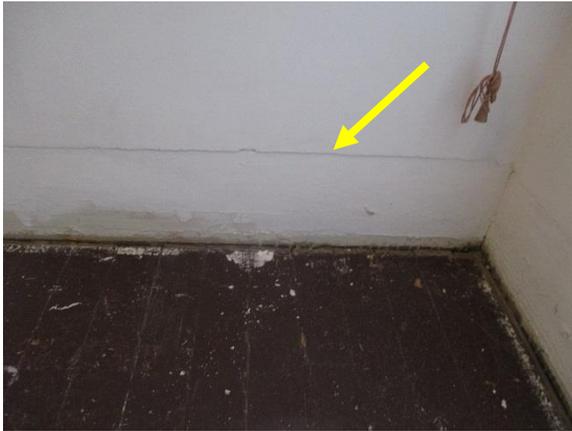
*Figure 61. Typical condition in rooms that are missing baseboards: paint build-up line across wall and scraped paint at bottom of baseboard.*

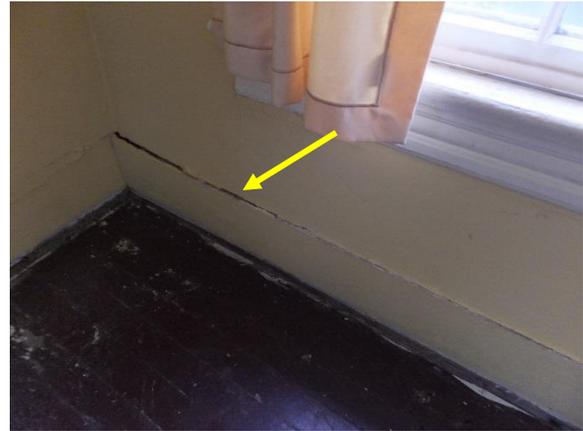
*Figure 62. Horizontal cracking at location of previous baseboard in room 200.*

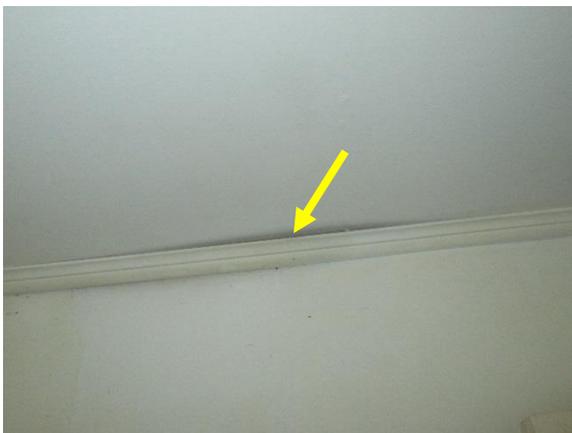
*Figure 63. Separation of crown molding from ceiling and wall.*

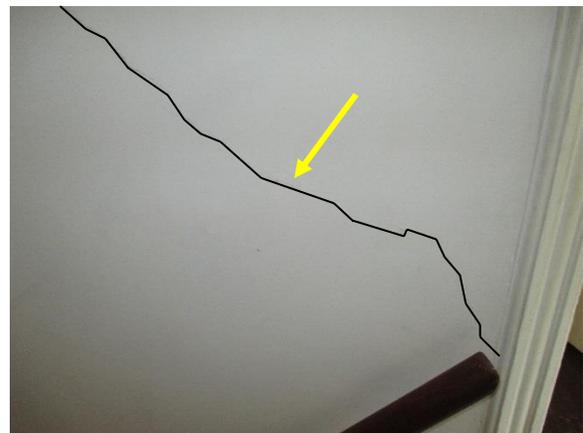
- Diagonal cracking was observed on the wall in the stairwell, originating from a doorframe, traveling to the ceiling with another originating from the handrail travelling to the stringer against the wall (Figure 64 and Figure 65).

*Figure 64. Diagonal cracking in stairwell. Crack traced for clarity.*

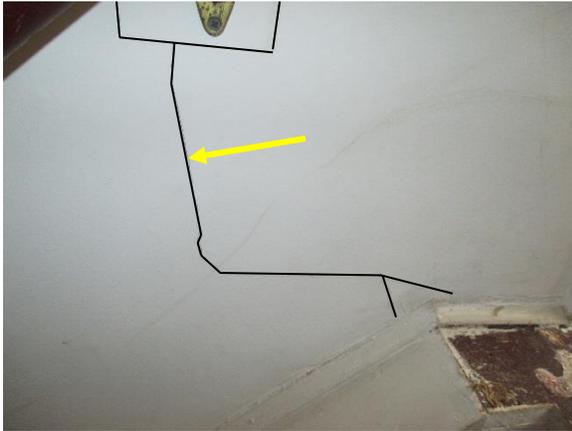
Figure 65. Cracking originating at the handrail connection in stairwell. Crack traced for clarity.

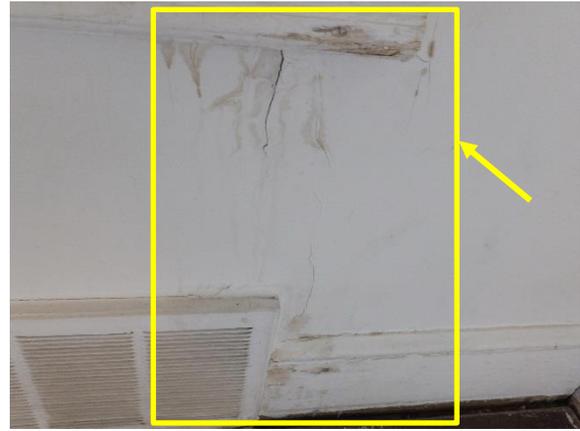
- Evidence of water infiltration was observed below some windows and at the ceiling of the enclosed south porch (Figure 66). Areas of plaster are missing from the sloped ceiling of the closet below the stairwell (room 115) revealing wood lathe (Figure 67). Burn marks on the ceiling in room 100 was observed related to heat damage from the lighting fixture (Figure 68).

Figure 66. Evidence of water infiltration on interior finishes with related cracking on the second floor.

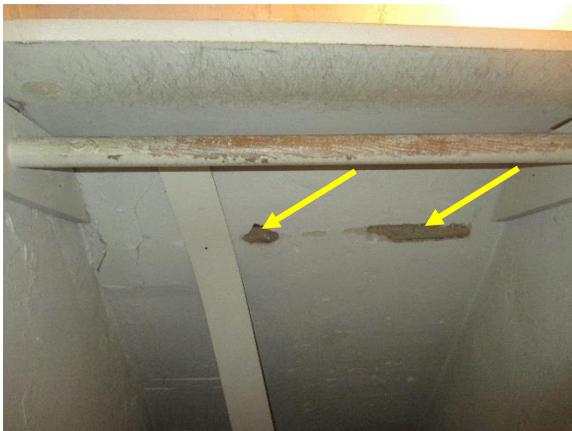
Figure 67. Missing plaster below the stairs revealing the wood lath.

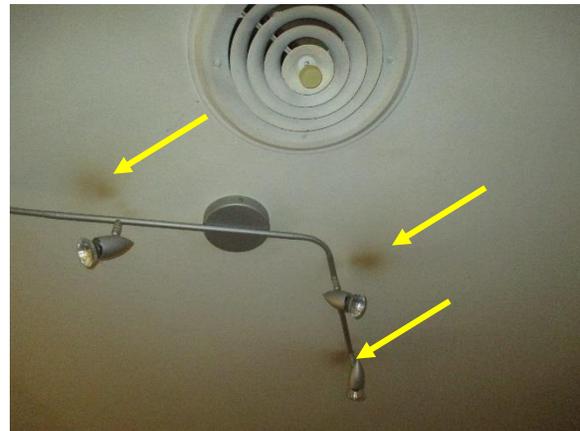
Figure 68. Burn marks on ceiling at room 100 above the light fixture.

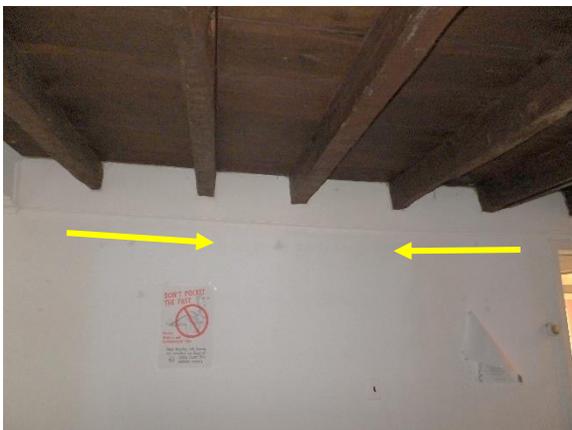
- Walls and ceilings were observed to be sloping on the eastern portion (Period I section) at the first and second floor of the house (Figure 69 and Figure 70).

Figure 69. Sloped ceiling and resultant wall finishes in room 101.

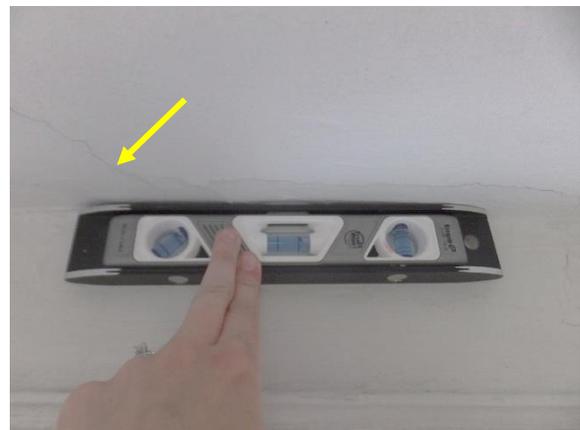
Figure 70. Sloped ceiling in second floor hallway, note cracking in finishes.

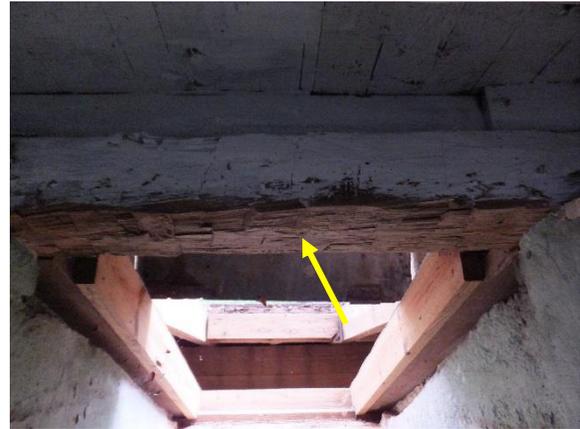
- Deteriorated, soft wood was observed at the underside of the timber sill in front of the hatch door to the cellar (Figure 76). A split was observed through the entire north timber sill in the cellar (Figure 77). Dark staining was observed at the retrofitted beam nearest to the chimney in the cellar (Figure 78).

*Figure 76. Deteriorated wood at underside of timber sill at hatch to cellar.*

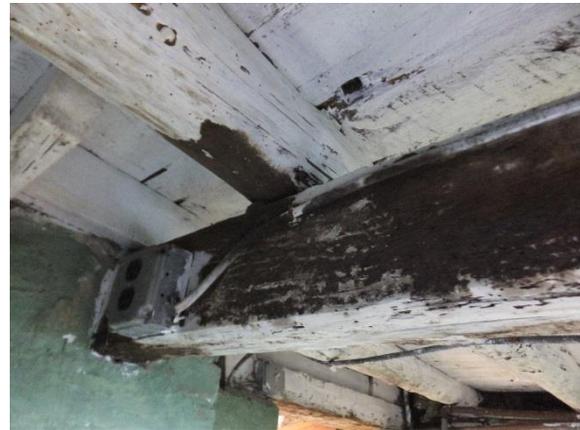
*Figure 78. Dark stain on beam in cellar, adjacent to chimney. Note white coating on original 3/4 round beams and underside of first floor.*

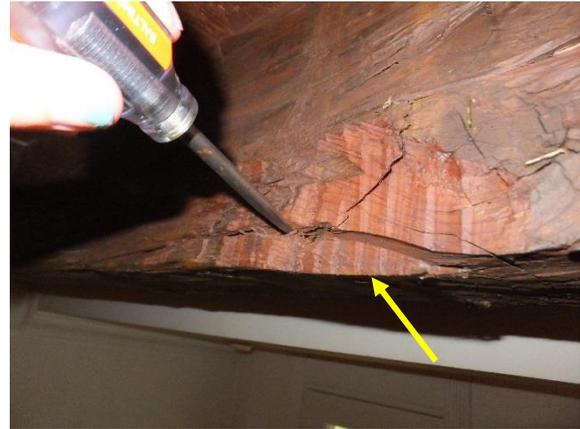
- One of the exposed second floor beams appears to have some pest damage near the north wall while another has a split (Figure 79 and Figure 80).
- In the attic, observations included potential pest damage along the edge of a rafter, a rotated rafter, split and cracking decking, and staining at the west attic flooring (Figure 81 through Figure 85). The wood was dry and may be residual staining from previous water infiltration.

*Figure 80. Split in beam in room 101.*

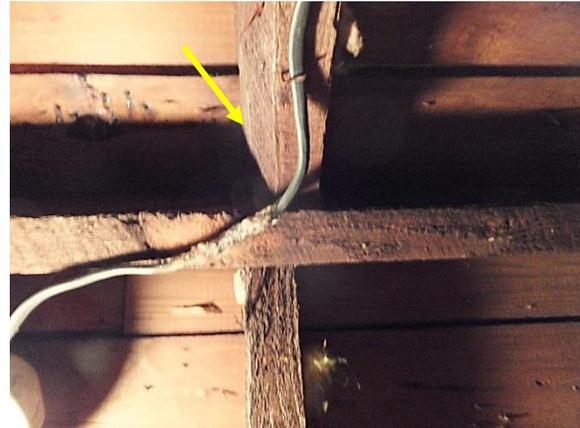
*Figure 82. Rotated rafter in west attic.*

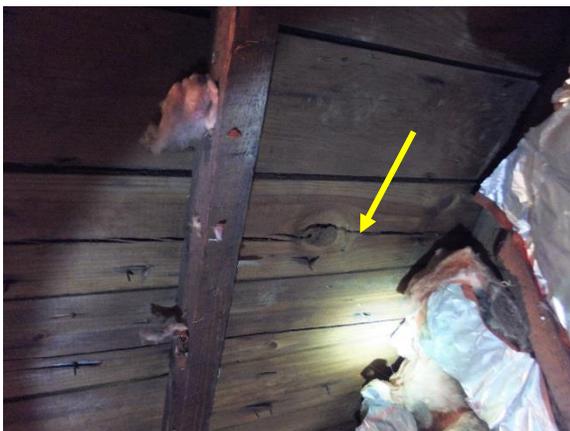
*Figure 83. Cracked decking timber in attic.*

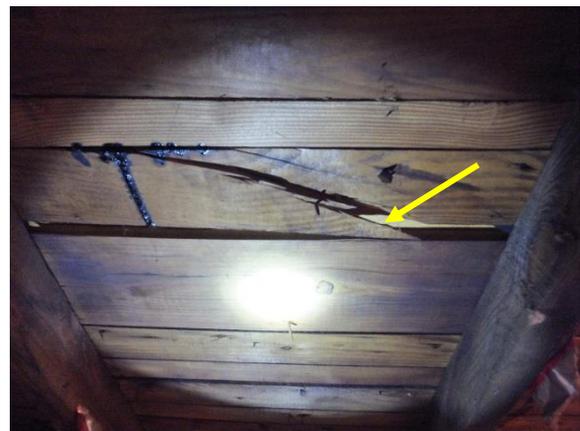
*Figure 84. Split decking timber in attic.*

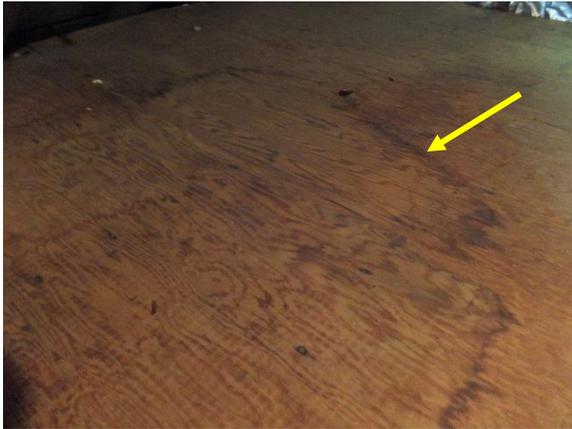
*Figure 85. Stain from previous water infiltration on west attic floor.*

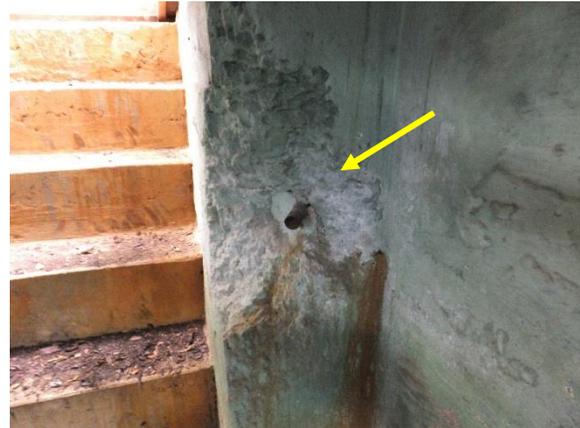
- In the cellar, there is a spall and ferrous staining at a pipe penetration in the cellar near the access hatch and ferrous staining near the mechanical equipment (Figure 88 and Figure 89).
- Ponding of water was observed on the concrete floor in the cellar near the mechanical equipment (Figure 90). The water appears to be originating from a ventilation opening in the north wall that is currently covered with sheet metal (Figure 91).

*Figure 88. Spall at pipe penetration at concrete in cellar.*

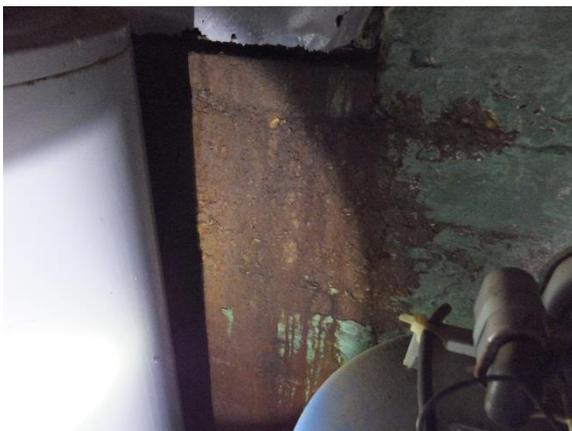
*Figure 89. Rust staining on concrete wall in cellar.*

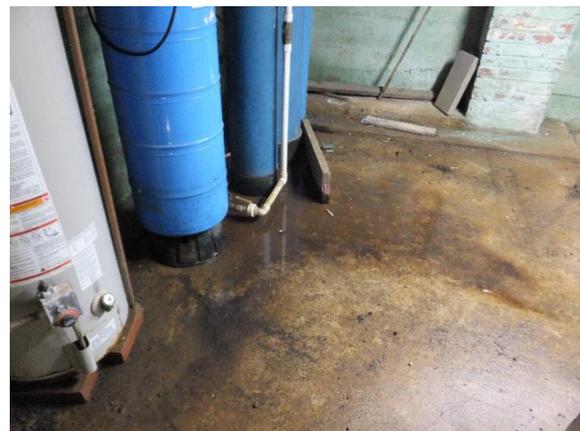
*Figure 90. Water pooling on concrete floor in cellar.*

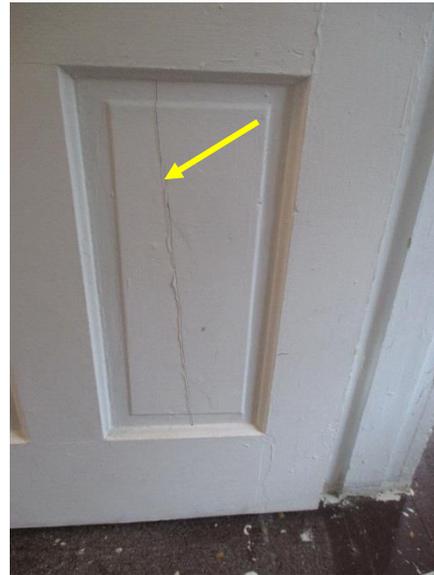
- Several of the doors have been replaced with contemporary doors. Typical damage observed at historic doors was minor cracking in the wood and separation at joinery (Figure 95 and Figure 96).

*Figure 96. Crack through panel of a historic interior door.*

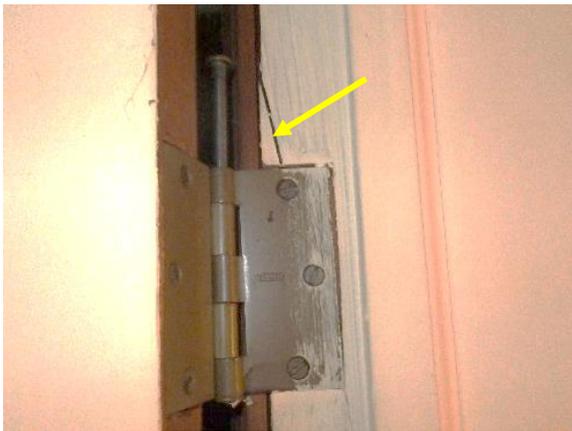
- Isolated deterioration included a crack at a hinge with the pin not fully engaged, impact damage to a door frame and a knob, a partially burned door exposing the interior core, deteriorated weather stripping at a previously exterior door, and water staining at the base of the north exterior door (Figure 97 through Figure 102).

*Figure 97. Crack at hinges of door D113. Hinges also appear to be misaligned with the pin not fully engaged.*

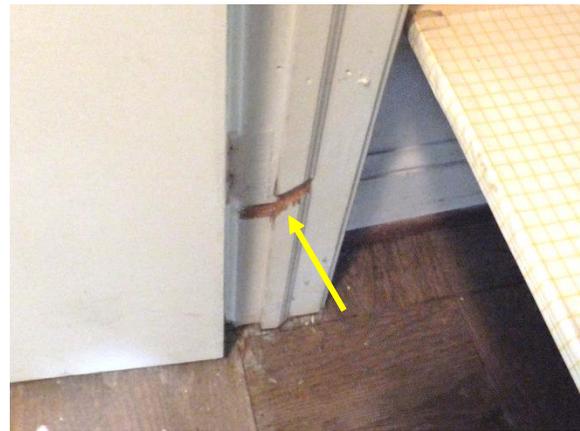
*Figure 98. Gouge in door frame at door D103.*

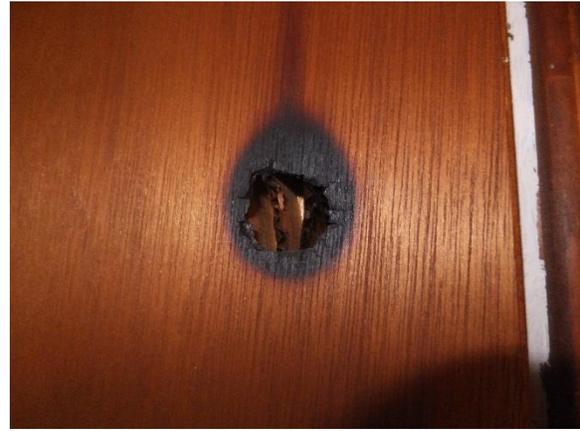
*Figure 100. Burn through door D113.*

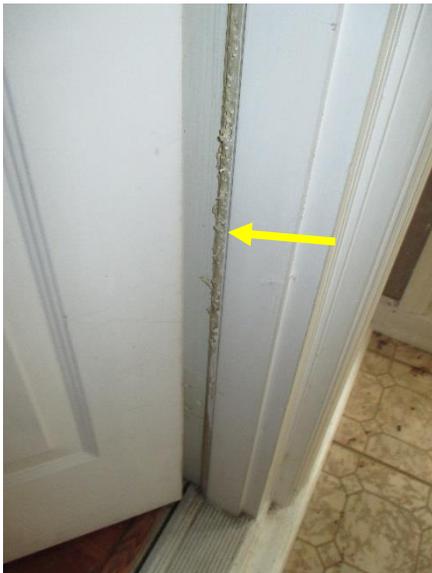
*Figure 101. Deterioration of seal at door D106.*

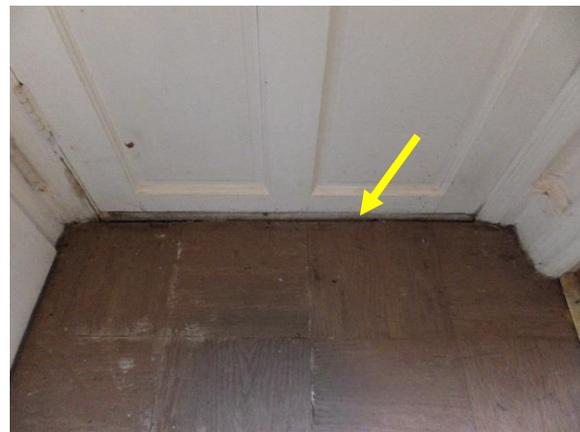
*Figure 102. Water staining at base of exterior door D110.*

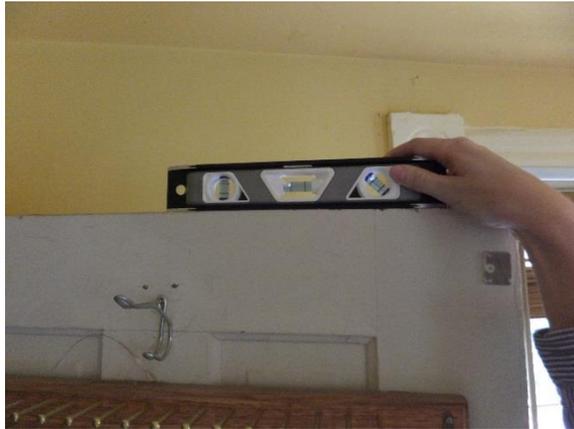
*Figure 103. Door in room 200 on second floor is not plumb.*

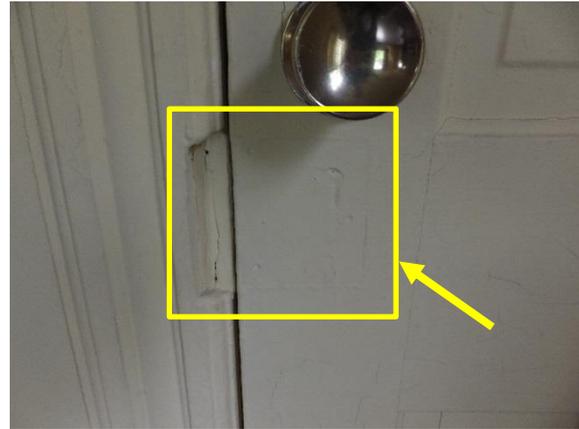
- One door on the second floor is missing with the hinges and latch remaining. Door thresholds and rim locks have been removed from several doors within the home (Figure 104).

*Figure 104. Outline of rim lock that was removed.*
