Mt. Vernon Recreation Center

Facility Condition Assessment and Life Cycle Cost Analysis

Fairfax County Park Authority

Prepared by: Hughes Group Architects
October 24, 2014

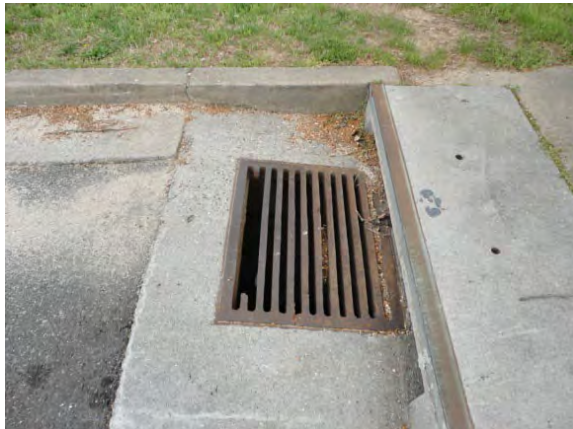
| BUILDING SYSTEMS - SITE | | | | | | | | | | | |
|---|--|---|---|---|---|---|---|---|---|---|---|
| S.2 | Replace damaged storm drain cover | D | 2 | 5 | 1 | EA | 35/15 | - | ✓ | 15 | \$ 996.52 |

| ASSESSMENT REPORT | | | | |
|---|---|---|---|---|
| RECOMMENDATION: Replace damaged storm drain cover with a new cover. | | | | |

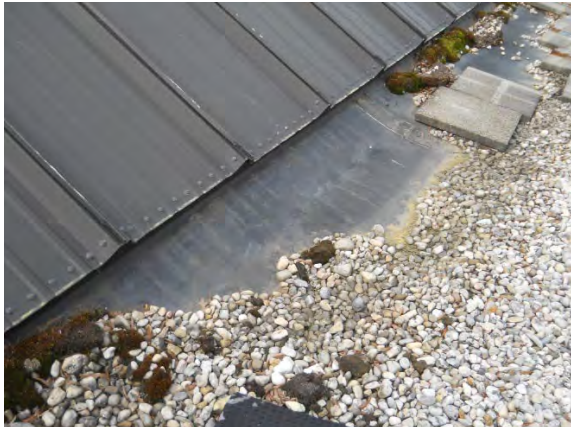
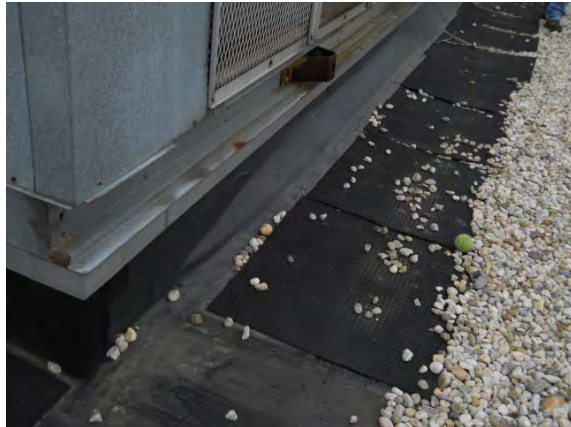
Overall, the existing membrane of the EPDM low sloped roof appears in relatively good condition. However, at several locations, it is visible that the roof membrane is pulling away from its substrate due to membrane shrinkage. Within the next few years, it is recommended that the EPDM membrane be completely removed and replaced with a new single ply membrane roof to include term flashings and terminations.

| BUILDING SYSTEMS – BUILDING ENVELOPE | | | | | | | | | | | |
|---|---|---|---|---|---|---|---|---|---|---|---|
| E.1A | Repair EPDM membrane roof system where shrinking has occurred | F | 1 | 2 | 1 | LS | 17/20 | ✓ | - | 15 | \$ 7,433.28 |

| ASSESSMENT REPORT | | | | |
|---|---|---|---|---|
| RECOMMENDATION: Cut back the EPDM membrane where shrinking has occurred to relax the membrane, adhere new flashing membranes at those locations, and provide new terminations. | | | | |

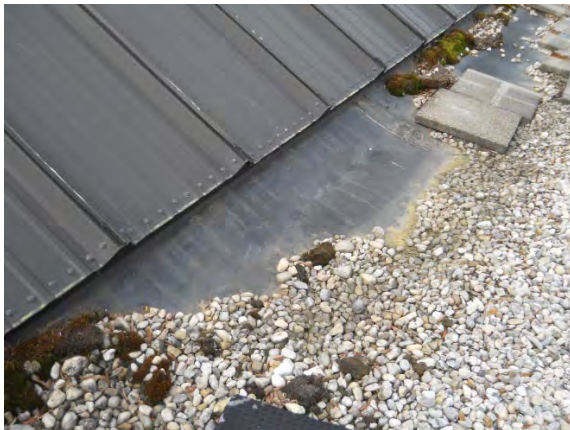
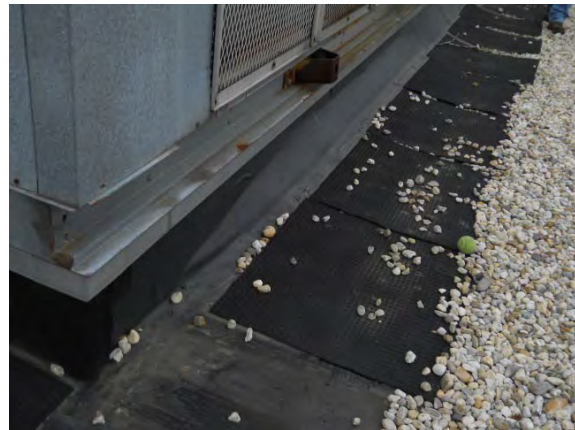
| BUILDING SYSTEMS – BUILDING ENVELOPE | | | | | | | | | | | |
|---|---|---|---|---|---|---|---|---|---|---|---|
| E.1B | Replace EPDM membrane roof system w/ new single ply membrane roof system. | C | 3 | 3 | 1 | LS | 17/20 | - | ✓ | 18 | \$ 137,893.29 |

Completely remove and replace the EPDM membrane and install a new single ply membrane roof. Provide term flashings and terminations.

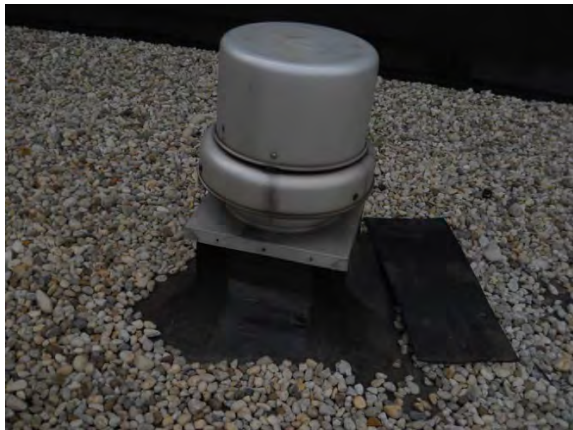
| BUILDING SYSTEMS – BUILDING ENVELOPE (cont'd) | | | | | | | | | | | |
|---|--|---|---|---|---|---|---|---|---|---|---|
| E.1C | Replace roof drains; and replace existing flashing (to include roofing membrane, terminations, and sealants) at existing penetrations. | C | 3 | 3 | 1 | LS | 17/20 | - | ✓ | 18 | \$ 5,825.86 |

| ASSESSMENT REPORT | | | | |
|---|--|---|---|---|
| RECOMMENDATION: During new roofing installation, existing penetrations should be flashed with new roofing membranes, terminations, and sealants. Existing roof drains should be replaced when the EPDM membrane is replaced. | | | | |

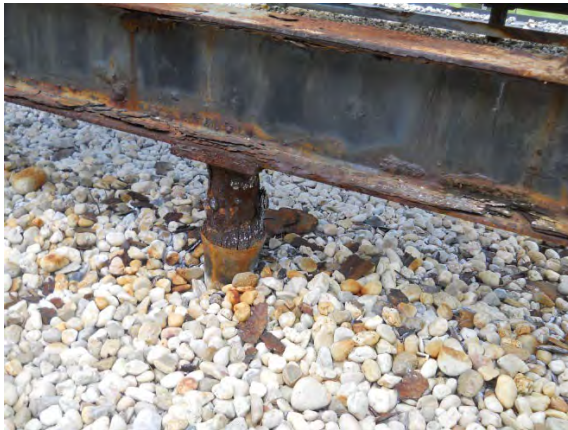
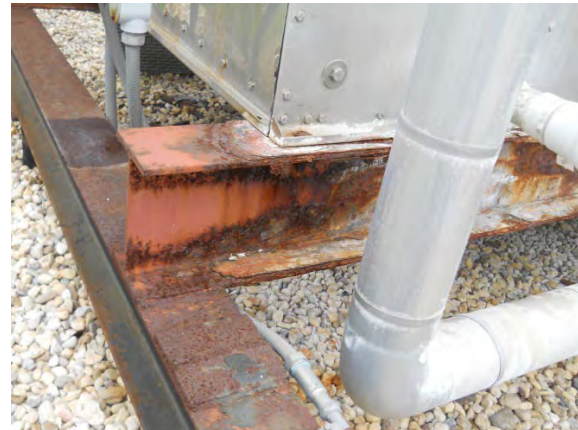
Mechanical equipment and equipment supports are also located on the low sloped roof. A number of the supports are showing significant signs of deterioration and are significantly corroded. Depending on when the mechanical equipment is scheduled to be replaced, a temporary repair may be considered and full replacement deferred until the other work is performed.

| BUILDING SYSTEMS – BUILDING ENVELOPE (cont'd) | | | | | | | | | | | |
|---|--|---|---|---|---|---|---|---|---|---|---|
| E.1E | Repair structural supports for the mechanical units | F | 1 | 5 | 1 | LS | 35/30 | ✓ | - | 15 | \$ 10,020.22 |

Remove existing steel corrosion and repair by welding new steel in place. Paint entire support with corrosion inhibitor paint. At roof penetrations, remove existing EPDM membrane and clean existing supports. Paint support with corrosion inhibitor paints and install new roof flashing and sealants.

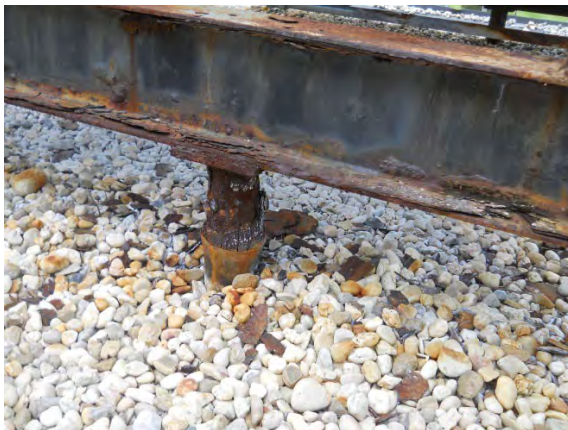
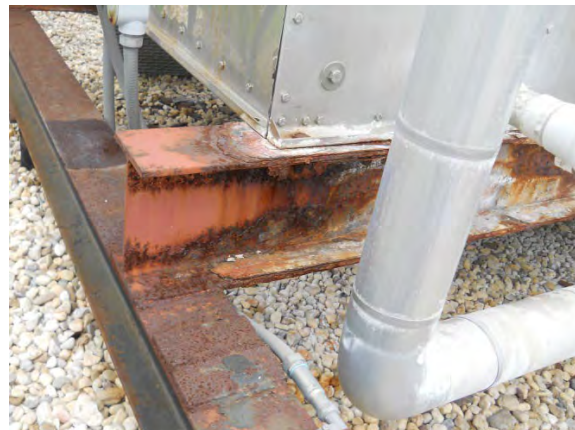
| BUILDING SYSTEMS – BUILDING ENVELOPE (cont'd) | | | | | | | | | | | |
|---|--|---|---|---|---|---|---|---|---|---|---|
| E.1F | Replace structural supports for the mechanical units | F | 1 | 5 | 1 | LS | 35/30 | - | ✓ | 15 | \$ 16,167.38 |

During the proposed roofing membrane replacement or when the existing mechanical equipment is scheduled for replacement, install new structural supports for the mechanical units. The new roof penetrations can be properly flashed and waterproofed. The new structural supports should be painted with a rust inhibiting paint to protect against corrosion.

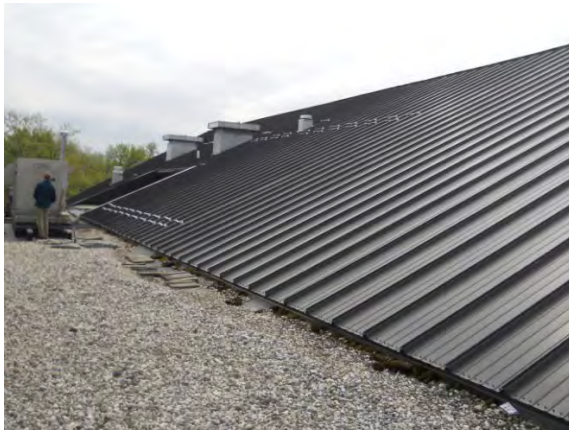
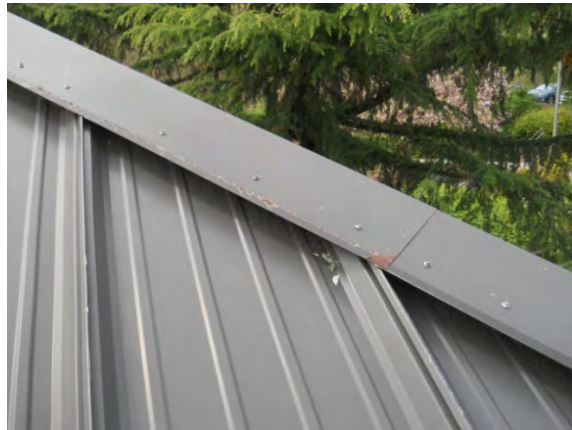
The standing seam metal roof is in good condition. The galvanized metal ridge cover shows minimal deterioration in isolated locations. These areas should be painted to stop the deterioration.

| ASSESSMENT REPORT | | | | |
|--|---|---|---|---|
| RECOMMENDATION: Clean and repair mildly corroded areas (approx. 20% of roof area) and paint to match existing metal roof. | | | | |

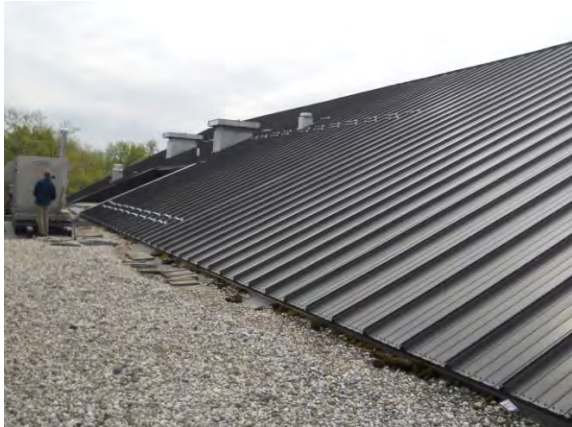
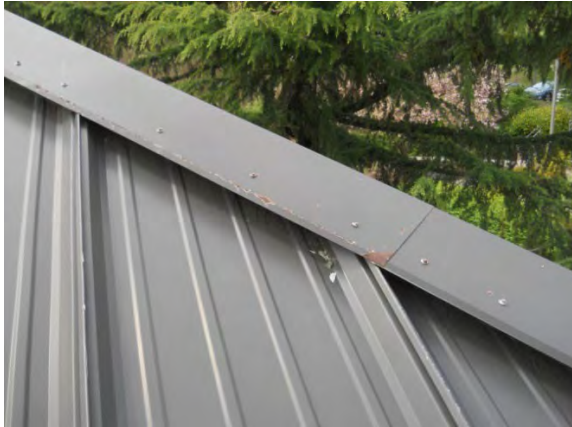
| BUILDING SYSTEMS – BUILDING ENVELOPE (cont'd) | | | | | | | | | | | |
|---|--|---|---|---|---|---|---|---|---|---|---|
| E.1H | Replace metal roof | C | 3 | 3 | 1 | LS | 18/30 | - | ✓ | 27 | \$ 172,817.49 |

| ASSESSMENT REPORT | | | | |
|--|---|---|---|---|
| RECOMMENDATION: Replace metal roof with new metal roof. | | | | |

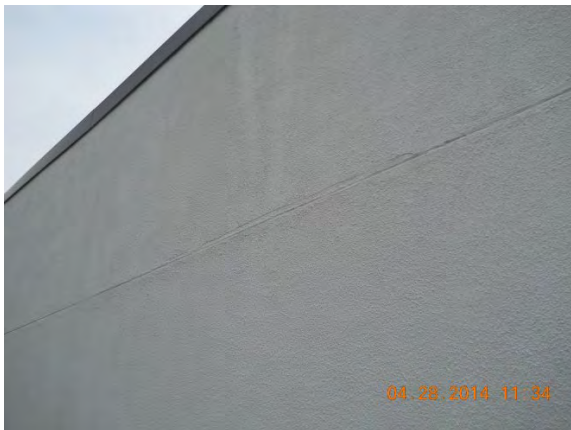
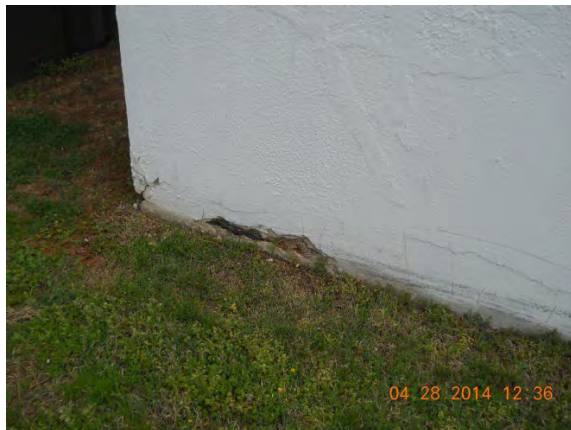
The base of the exterior façade of the Building consists of a CMU wall construction with a painted stucco cladding. Although the stucco cladding is original to the Building and has been in service past its estimated life expectancy, overall it appears in good condition. Surface cracking and delaminated areas were noted. Both vertical and horizontal control joints are visible, but have been painted over and are no longer affective. It is recommended that the painted stucco cladding be replaced with anew to include sealed control joints.

| BUILDING SYSTEMS – BUILDING ENVELOPE (cont'd) | | | | | | | | | | | |
|---|--|---|---|---|---|---|---|---|---|---|---|
| E.2D | Replace painted stucco on exterior of building | C | 3 | 3 | 1 | LS | 35/30 | - | ✓ | 15 | \$ 46,840.61 |

| ASSESSMENT REPORT | | | | |
|---|---|---|---|---|
| RECOMMENDATION: Complete stucco replacement. | | | | |

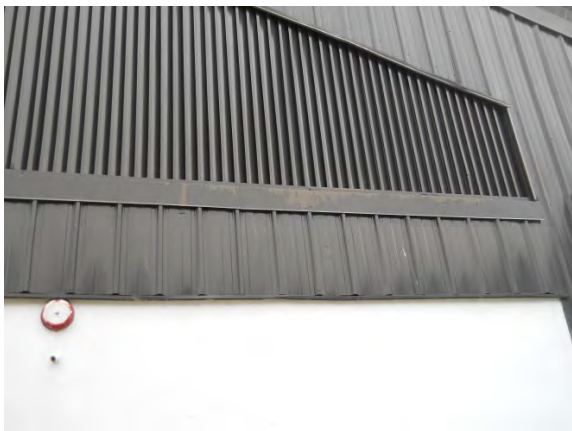
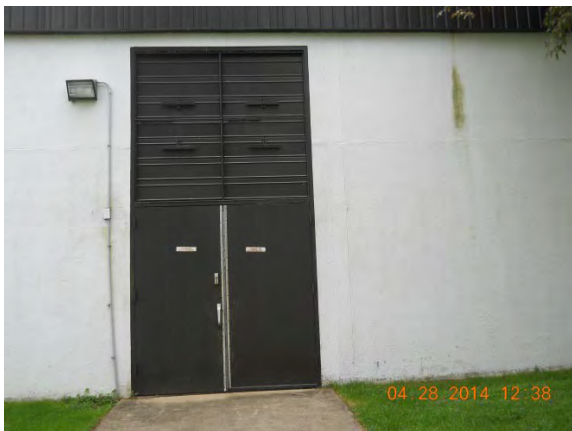
| BUILDING SYSTEMS – BUILDING ENVELOPE (cont'd) | | | | | | | | | | | |
|---|--|---|---|---|---|---|---|---|---|---|---|
| E.2F | Replace outside metal louvers | A | 6 | 3 | 1 | LS | 18/30 | - | ✓ | 27 | \$ 7,508.70 |

| ASSESSMENT REPORT | | | | |
|---|---|---|---|---|
| RECOMMENDATION: Replace metal louvers. | | | | |

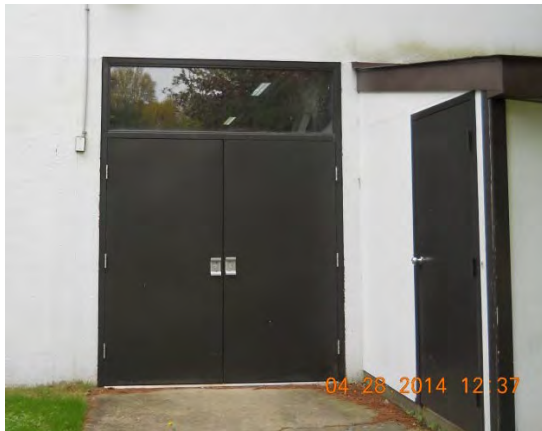
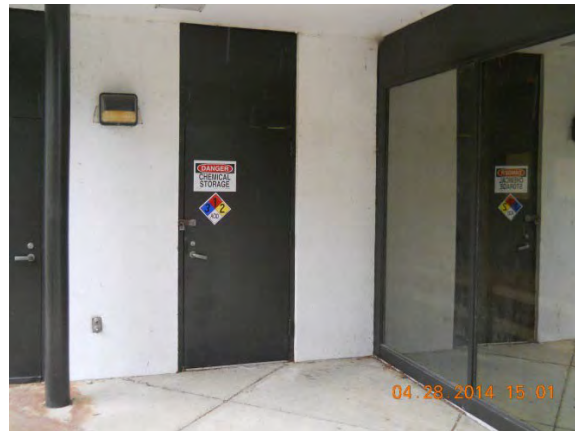
| BUILDING SYSTEMS – BUILDING ENVELOPE (cont'd) | | | | | | | | | | | |
|---|--|---|---|---|---|---|---|---|---|---|---|
| E.2G | Repair and paint damaged exterior doors/frames to include replacement of perimeter sealants. | C | 3 | 1 | 1 | LS | 35/30 | ✓ | - | 15 | \$ 2,051.76 |

Repair all deterioration and paint metal doors and frames. Repairs should include replacement of all perimeter sealants.

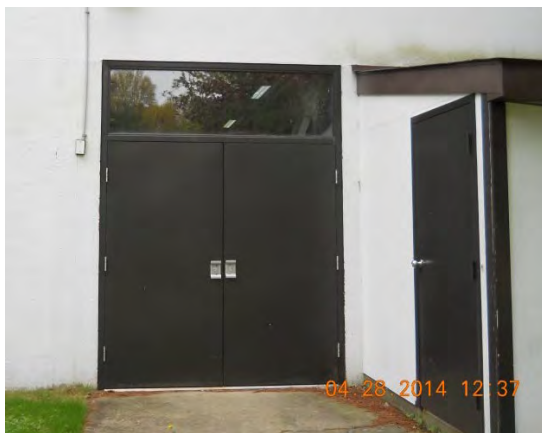
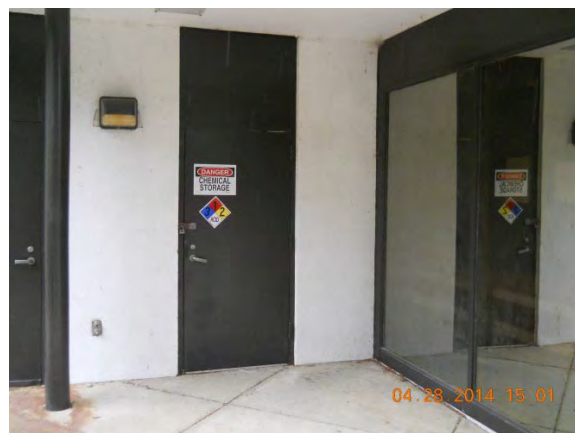
| BUILDING SYSTEMS – BUILDING ENVELOPE (cont'd) | | | | | | | | | | | |
|---|--|---|---|---|---|---|---|---|---|---|---|
| E.2H | Replace exterior doors | C | 3 | 3 | 1 | LS | 35/30 | - | ✓ | 15 | \$ 26,132.63 |

Replace all metal doors and frames (including perimeter sealants).

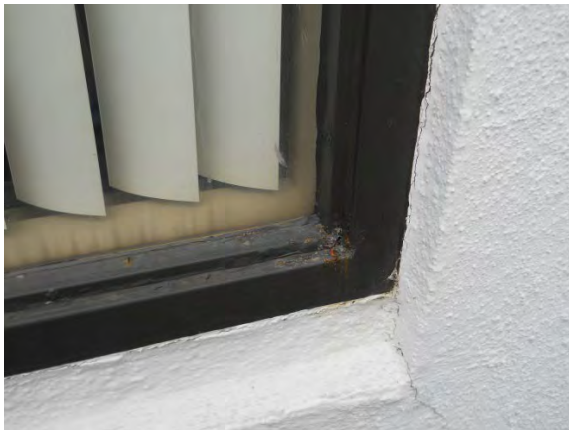
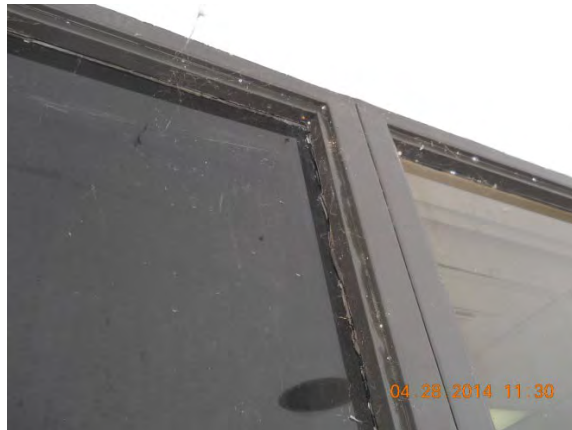
| BUILDING SYSTEMS – BUILDING ENVELOPE (cont'd) | | | | | | | | | | | |
|---|--|---|---|---|---|---|---|---|---|---|---|
| E.2I | Replace exterior storefront windows | C | 3 | 3 | 1 | LS | 35/30 | - | ✓ | 15 | \$ 52,432.50 |

| ASSESSMENT REPORT | | | | |
|---|---|---|---|---|
| RECOMMENDATION: Replace entire window systems with new thermally broken windows to provide better energy efficiency. | | | | |

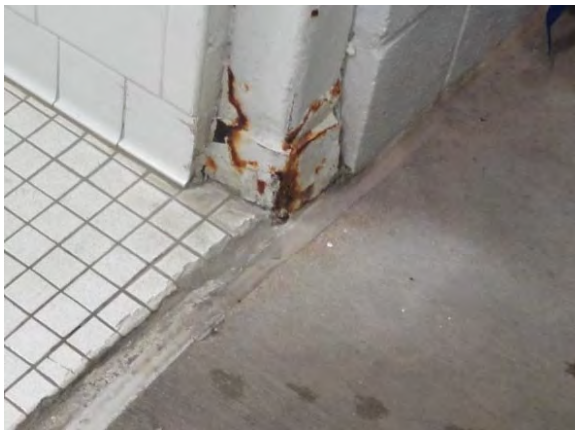
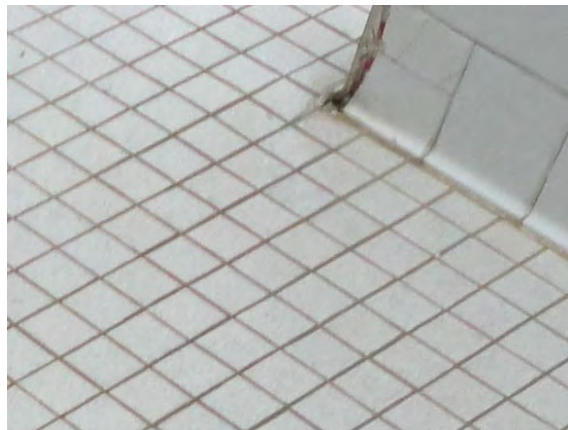
| BUILDING SYSTEMS – INTERIOR FINISHES | | | | | | | | | | | |
|---|---|---|---|---|---|---|---|---|---|---|---|
| F.2 | Replace damaged base and floor tiles in locker room | F | 1 | 5 | 1 | LS | 31/10 | - | ✓ | 15 ² | \$ 480.00 |

| ASSESSMENT REPORT | | | | |
|--|---|---|---|---|
| RECOMMENDATION: Damaged portions of floor and base tiles should be replaced with new tiles immediately to prevent injury to patrons' feet. | | | | |

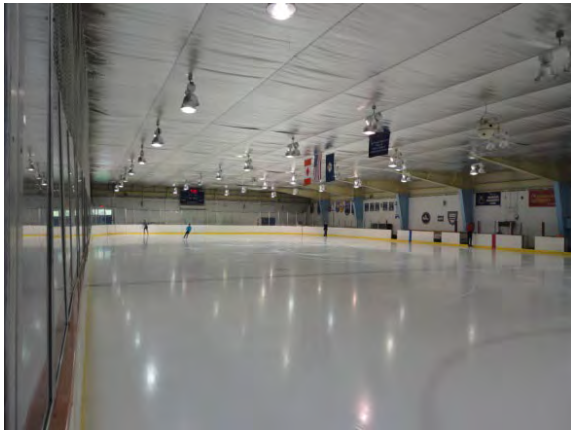
| BUILDING SYSTEMS – INTERIOR FINISHES | | | | | | | | | | | |
|---|---|---|---|---|---|---|---|---|---|---|---|
| F.3A | In Ice Rink area, replace low-E ceiling with a foil & bubble finished low-E ceiling | B | 4 | 4 | 1 | LS | 19/10 | - | ✓ | 15 | \$ 12,655.56 |

| ASSESSMENT REPORT | | | | |
|--|---|---|---|---|
| RECOMMENDATION: Although the low-E ceiling over ice rink is in very good shape with no separation at seams or at connections to the ceiling, we recommend replacing the existing ceiling with a modified low-E ceiling system with foil and bubble finish to improve acoustical quality. | | | | |

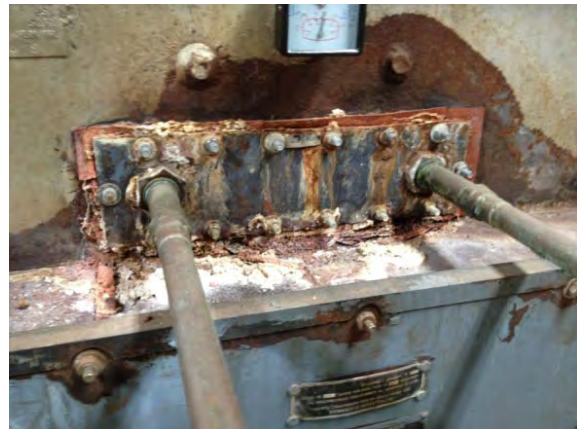
The condition of the pool water heater was surveyed as part of the mechanical systems assessment. The boiler was installed in 1983. Although it is still operational, like the other main mechanical systems, it has reached the end of its expected useful life. It is recommended for the pool heater burner and boiler to be replaced as soon as possible.

| BUILDING SYSTEMS – MECHANICAL | | | | | | | | | | | |
|---|--|---|---|---|---|---|---|---|---|---|---|
| M.1 | Replace Boiler B-1 | F | 1 | 3 | 1 | EA | 35/30 | - | ✓ | 15 | \$ 90,924.76 |

| ASSESSMENT REPORT | | | | |
|---|---|---|---|---|
| RECOMMENDATION: Replace the existing boiler with a new boiler. Replace the piping and pump within the mechanical room, and evaluate the demolished piping to determine if further system demolition is required. | | | | |
