LAUREL HILL HOUSE—CONDITION ASSESSMENT AND TREATMENT OPTIONS

FAIRFAX, VIRGINIA

For:
FAIRFAX COUNTY, VIRGINIA
DEPARTMENT OF
PLANNING AND ZONING

September, 2011

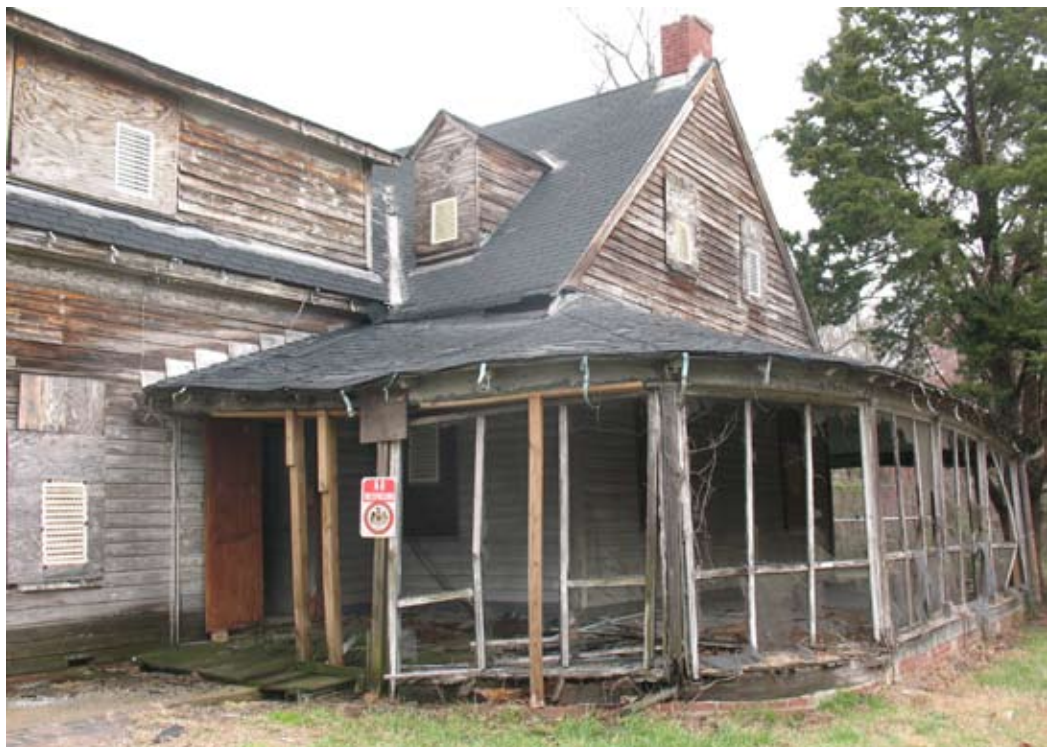
1. The porch that wraps around the south and west sides of the house is severely deteriorated, and there is the possibility that sections of it may collapse. Gaps into the house have opened up where the porch has moved.
2. The bathroom addition on the south side of the house is severely deteriorated after receiving moisture infiltration for many years. The foundation in this area is also in poor condition. The floor in this area is collapsing.
3. The existing asphalt shingle roof is reaching the end of its serviceable life span with moisture being allowed into the building in a number of locations. Deteriorated and missing shingles were noted. Gutters and downspouts are typically missing which increases the exposure of the building to moisture.

Laurel Hill House – April 2011 view from northwest showing deteriorated porch.

2. Demolish the existing porch (#5 on Building Sequence Plan) and deteriorated bathroom addition (#10 on Building Sequence Plan, previous page). Seal resulting openings in the building. Undertake additional photographic documentation during the dismantling as eighteenth-century elements are uncovered.

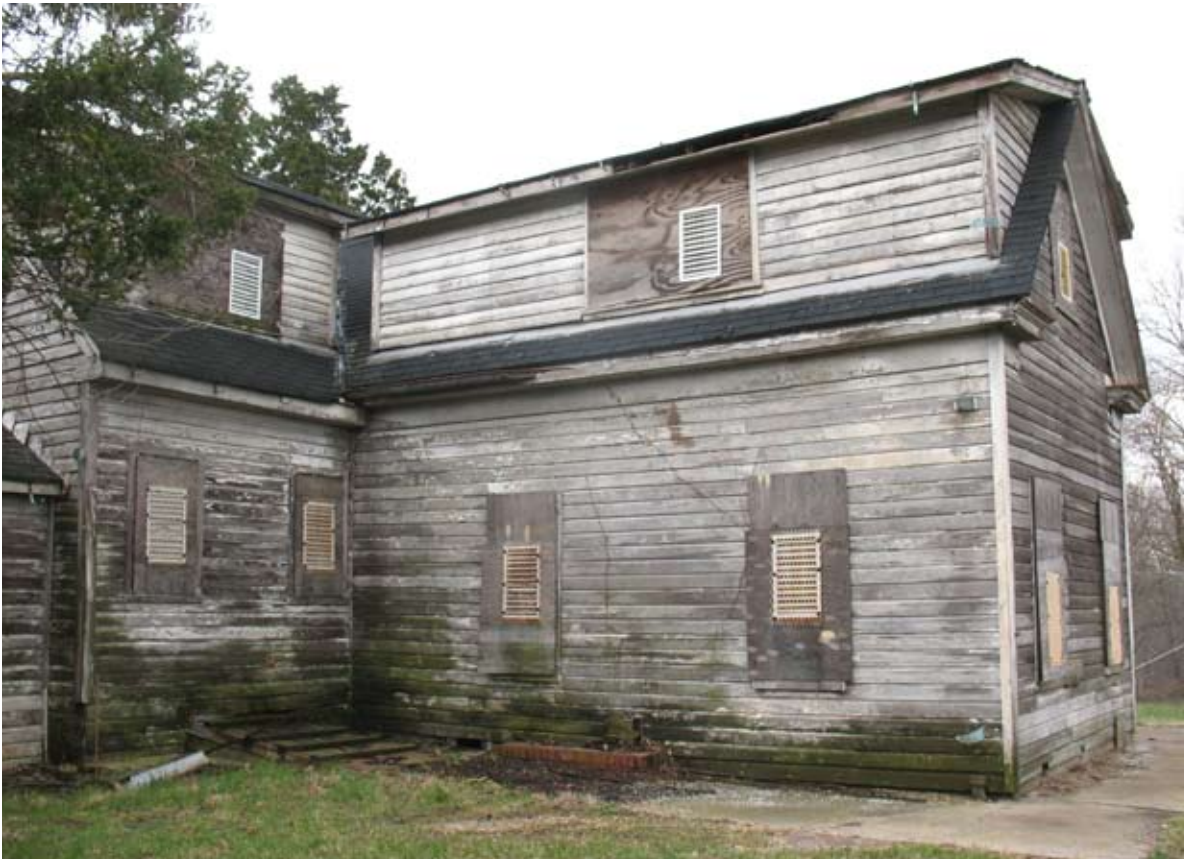
6. Most of the paint has flaked off the existing wood siding and trim. Much of the siding is beginning to deteriorate with the worst sections at grade and at intersections with the roof. In some places, moisture is beginning to enter the house where the siding is deteriorated, broken or missing. Rotten sill plates can be anticipated where moisture saturation is evident near grade.

Laurel Hill House – April 2011 view from northeast. Note moisture saturation of wood siding at base.

6. Remove deteriorated wood siding, and replace it with matching materials. Repair any deteriorated structure exposed in the process. Seal any holes in the building envelope as required to prevent water infiltration. Paint exterior siding.

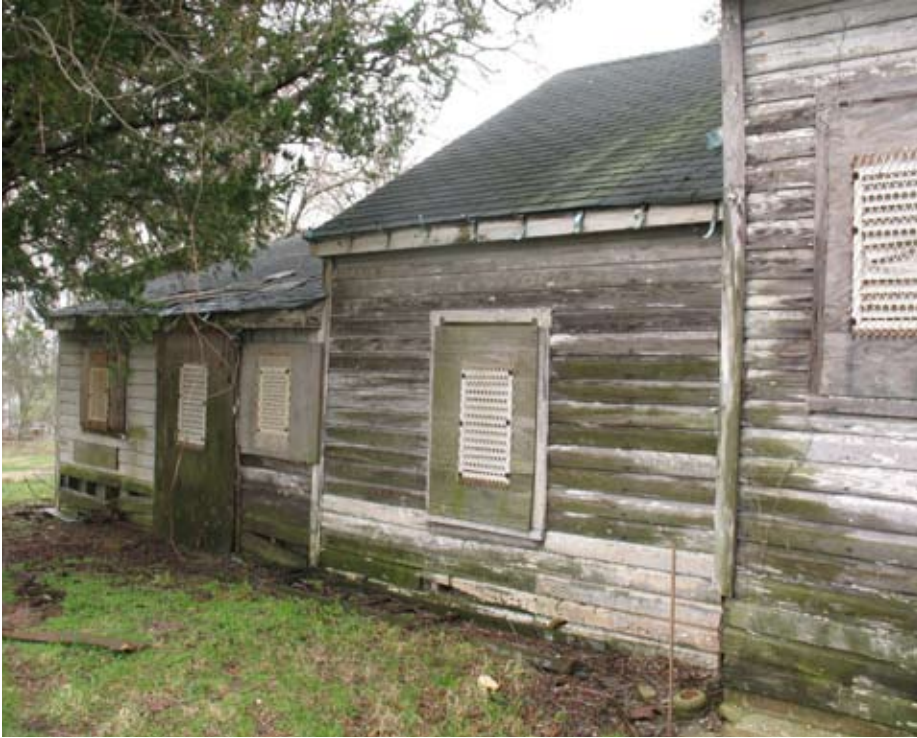
4. Considerable moisture infiltration was noted in the northeast room on the second floor of the original house.
5. The entrance foyer into the north side of the one-story addition is taking on substantial water through the roof. Numerous patches to the roof are evident in this area.

Laurel Hill House – April 2011 view from north side. Note poor condition of roof above entrance.

5. Remove existing roof. Patch deteriorated roof deck and repair deteriorated roof structure. Provide new fiberglass shingle roof and associated flashing. Provide new gutters and downspouts as required to take water away from the building.

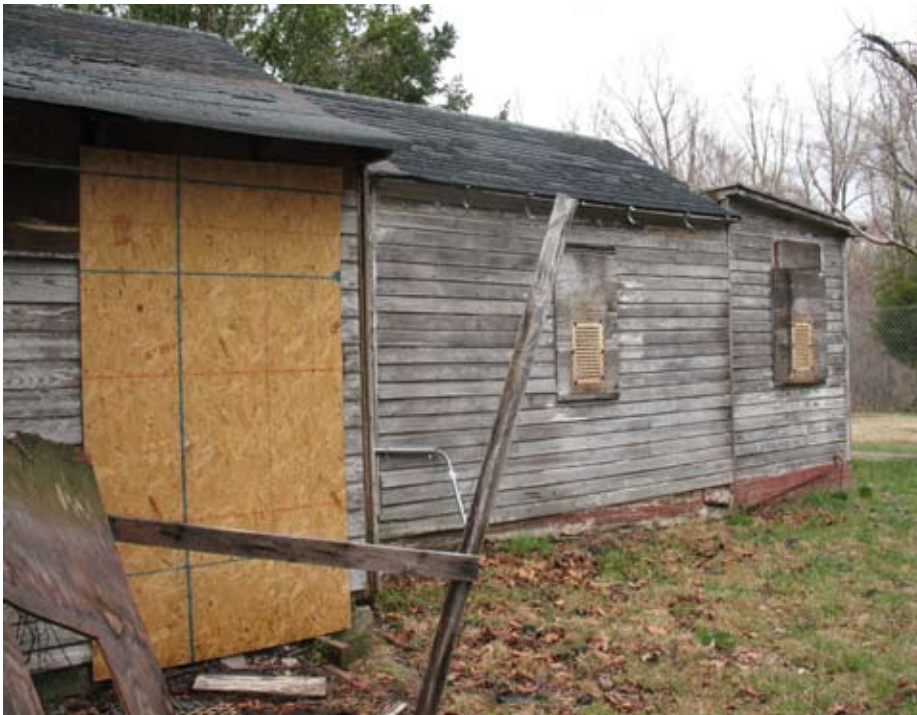
Laurel Hill House – April 2011 view from south with deteriorated bathroom addition in foreground.
