PHYSICIAN'S RESIDENCE

HISTORIC STRUCTURE REPORT

PROPERTY DESCRIPTION, ASSESSMENT, AND RECOMMENDATIONS

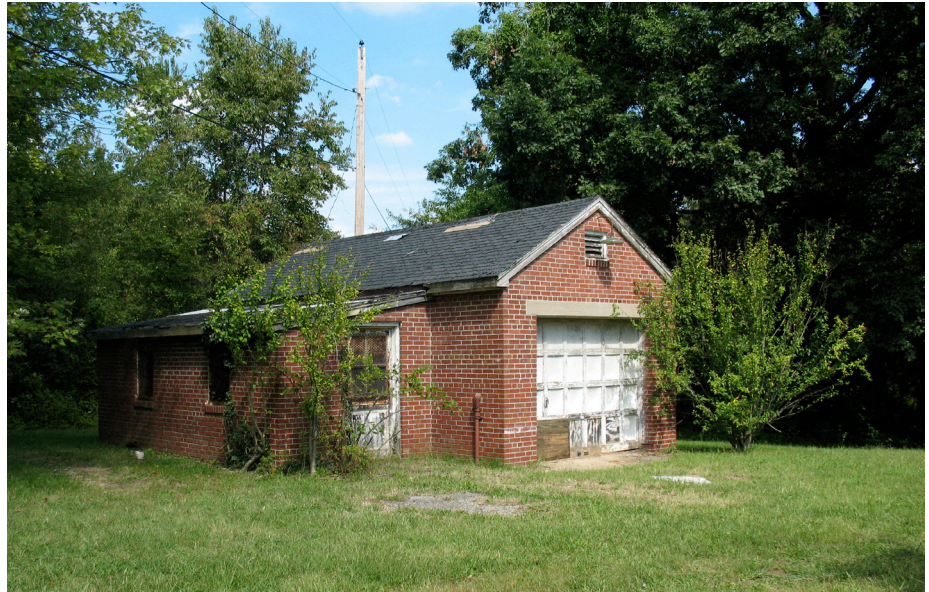
The garage was not accessible and was outside the scope of the study; however, during a general site inspection it was noted that there appears to be failure of the roof allowing moisture infiltration into the building.

Figure 3.3 The garage for the Physician's Residence is located to the north of the house. Note the utility line that enters the property from behind this structure.

Although a non-contributing structure, the garage warrants further inspection to ascertain whether it may be used as a storage building as part of the future program for the site.

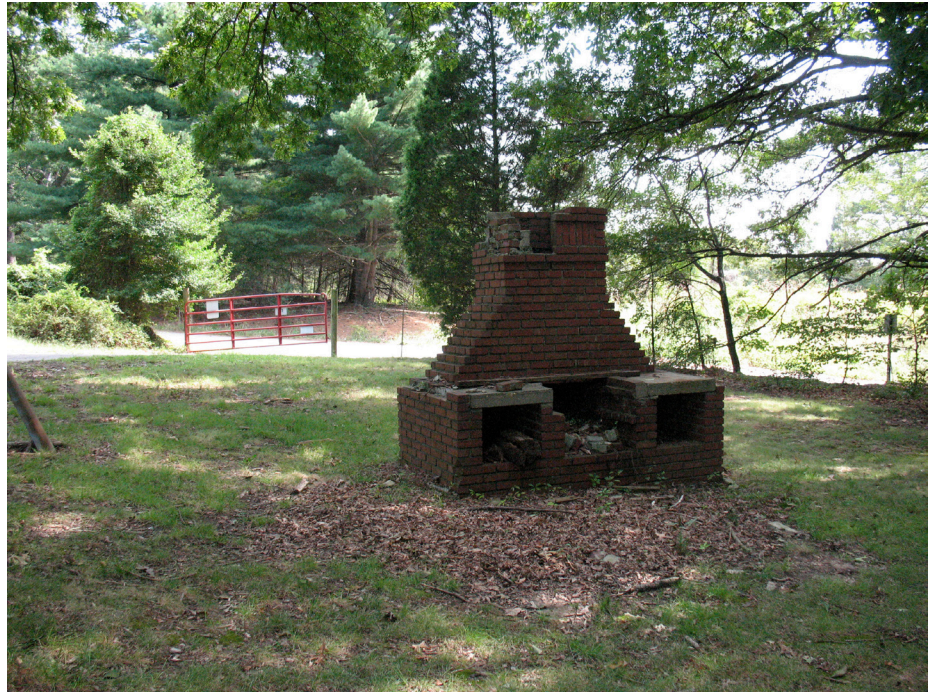
The barbeque pit is starting to disintegrate with the top missing numerous bricks.

Figure 3.14 The brick barbeque pit, constructed of prison-made bricks, is located in the west yard and is in deteriorated condition.

Both of these site features are important to the evolution of the property. The barbeque pit should be repaired and retained. The benchmark should be retained and protected from damage.

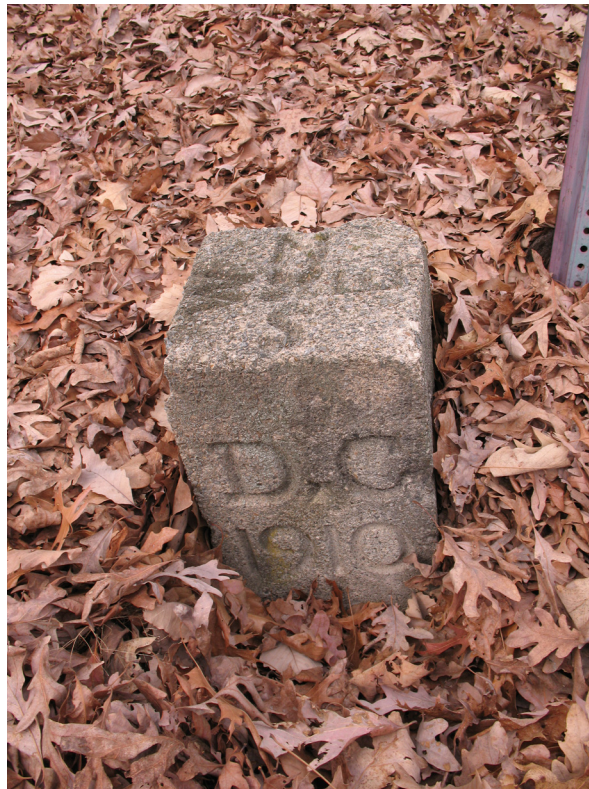
The benchmark shows signs of weathering consistent with its age but is in good overall condition.

Figure 3.15 This concrete benchmark marks the boundary for a portion of the Lorton property.

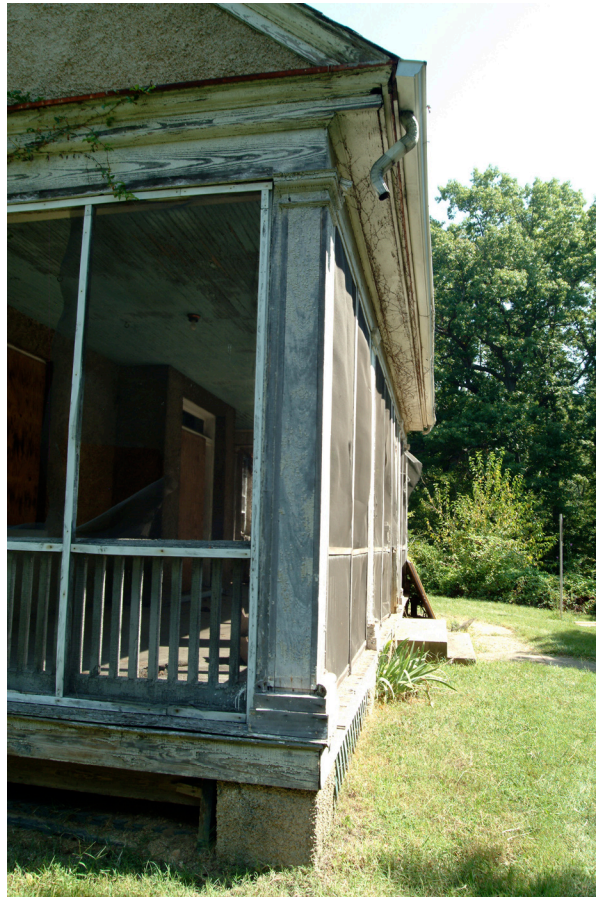
Moisture infiltration into the basement indicates that there is no waterproofing or drain tile below grade next to the foundation.

Figure 3.22 Stucco-covered brick piers provide the foundation for the front porch.

Especially if the basement will be occupied, excavate around the perimeter of the building, and provide new foundation drains set in gravel and surrounded by geotextile fabric. Provide a waterproof membrane on the exterior surface of the foundation along with an insulation/ drainage/ protection board.

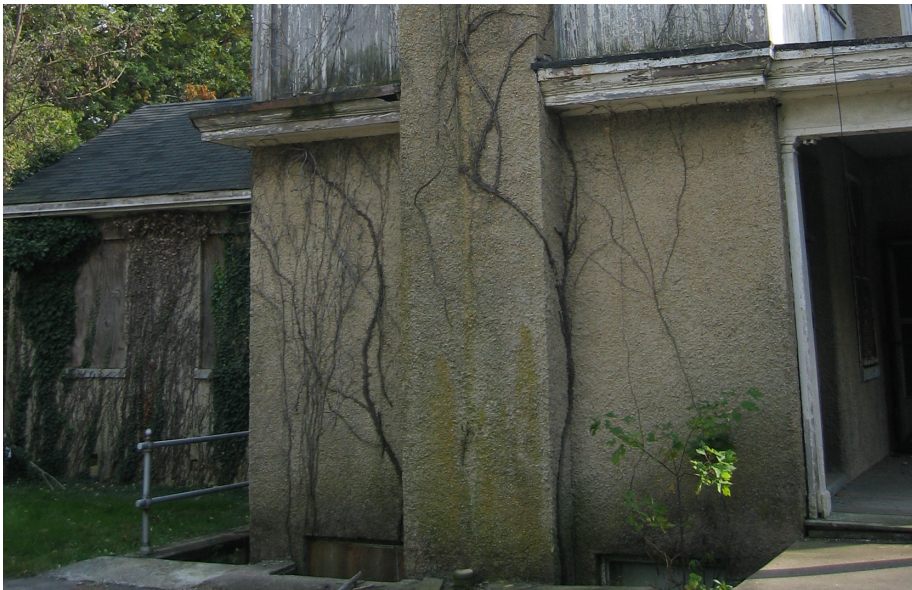
Figure 3.24 Vine growth and moss are evident on the north wall of the kitchen wing.

Remove vine growth (Figure 3.24), clean stucco finish, and repair as needed as part of any exterior rehabilitation.

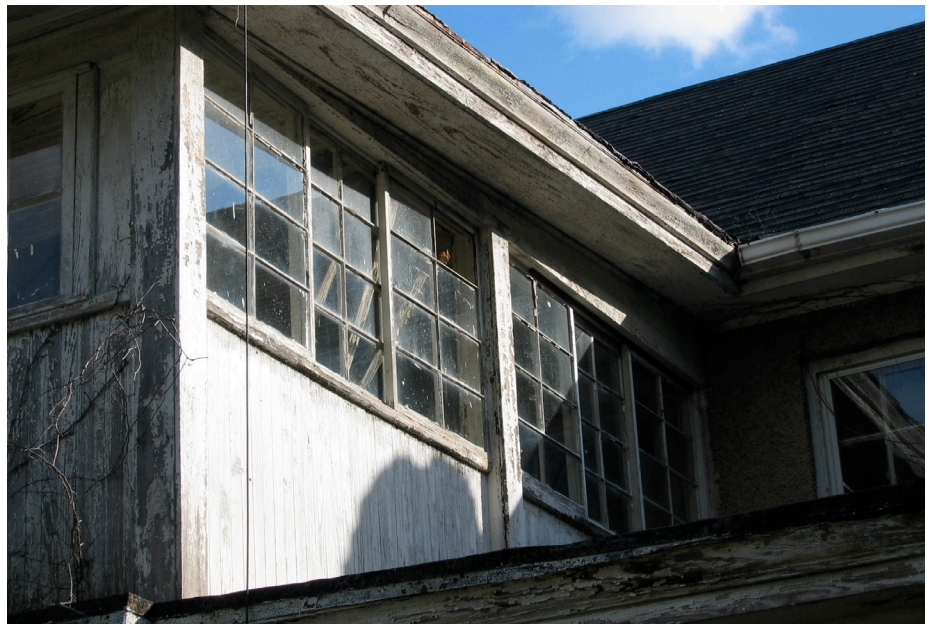
The sunroom addition is in poor condition. The roof of the sunroom has failed, allowing substantial water infiltration into the interior. This has resulted to severe damage to the structure as well as interior finishes. Some of the exterior features such as the windows and wood siding may be partially salvageable.

Figure 3.25 This view of the west elevation of the sunroom addition shows its frame construction.

Due to the poor condition of the sunroom, the low quality of its original construction, and the lack of its clear relationship to the original design, a strong case can be made that the sunroom addition lacks historic significance and does not contribute to the historic character of the Physician's Residence. As a result, options that include removal of the sunroom are included later in this report. If a decision is made to pursue the removal option, the historic significance of the sunroom will need to be reviewed by the preservation review agencies

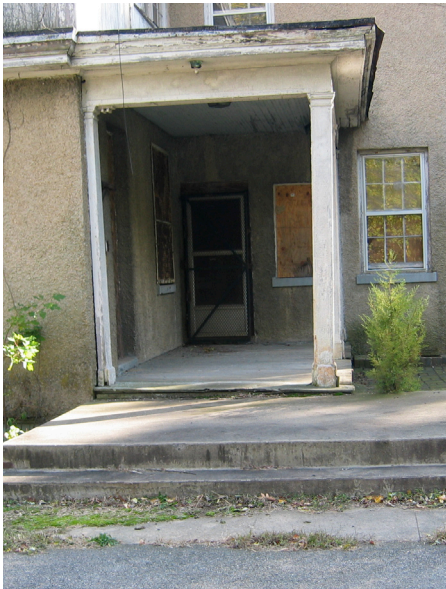
Figure 3.27 The rear porch has been altered over time and is in poor condition.

The railing for the rear porch has been removed. Floorboards are warping and at the north end of the porch have been replaced by a sheet of plywood.

Retain masonry piers and original posts and columns for reuse. Rebuild porches with new floor framing and tongue and groove porch deck.

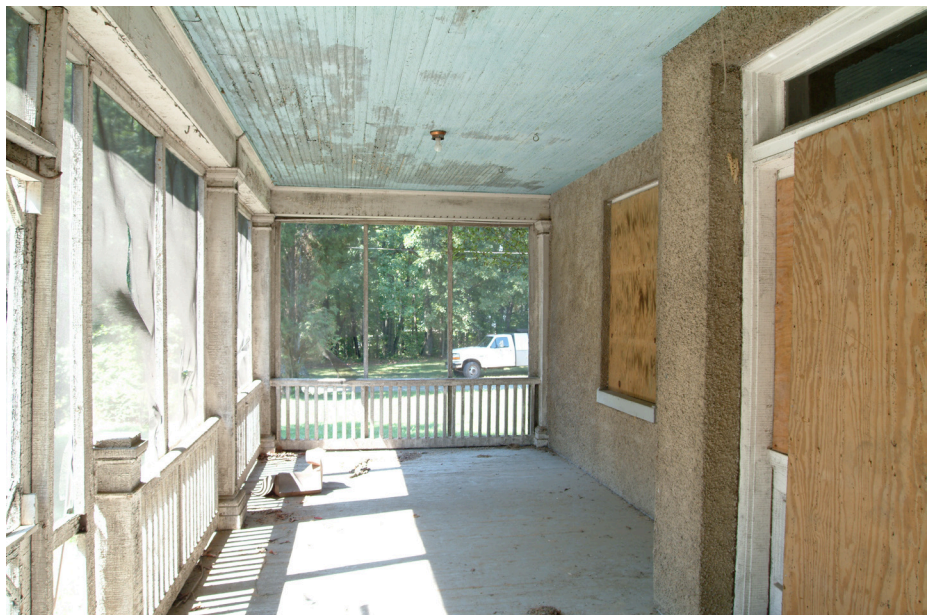
Overall, most wooden elements are in fair-to-poor condition due to exposure to the weather and lack of maintenance. Masonry piers are in good condition. The screening (not original) on the front porch is in deteriorated condition as are a number of the floor and ceiling boards.

Figure 3.28 The screened front porch exhibits deteriorated wood finishes.

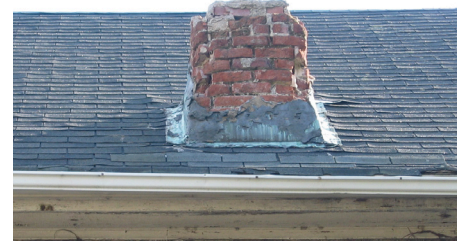
Figure 3.31 The deteriorated condition and reduced height of the living room chimney are clearly visible.

Remove unstable sections of the chimneys. Rebuild the chimneys using, in part, any salvaged chimney brick that is in good condition. The new chimney should use the same detailing as the original. Provide chimney flashing in coordination with roof replacement. For the missing chimney, rebuild as shown on the drawings in this report. Remove extension to chimney at the sunroom if the sunroom is removed. Recoat portions of exposed brick chimneys with stucco to match existing.

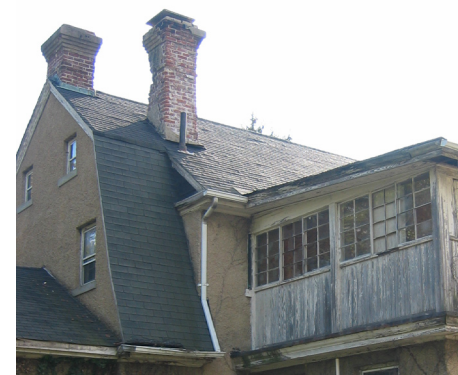
Much of this stucco is deteriorating, as well as the brick underneath (Figure 3.32). The kitchen chimney retains the highest level of stucco finish of the four chimneys.

Figure 3.32 The failure of the stucco coat on the chimneys on the north side of the house is evident.

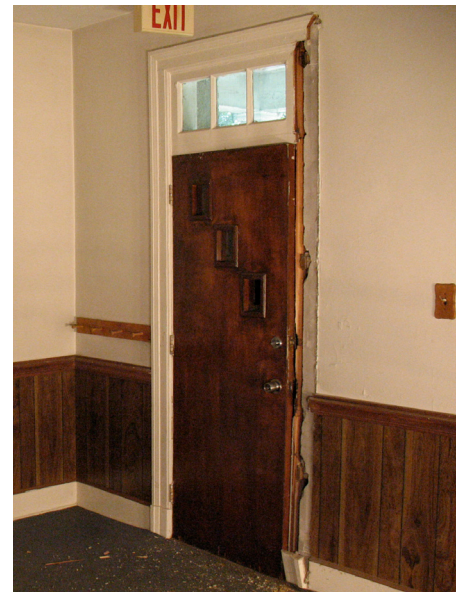
Also located on this elevation is the office door. A partially glazed replacement door of late-twentieth century design has been installed in the original opening. The original three-light glazed transom remains. (Figure 3.34)

Figure 3.34 The office wing entrance has a replacement door and original transom.

Retain existing original doors. Adjust, prepare and paint as required. Replace non-original office door with a six-panel design similar to the main front door. Replace non-original hardware with reproduction Colonial Revival hardware appropriate to the building. Where necessary for handicap accessibility, use hardware that meets ADA requirements.

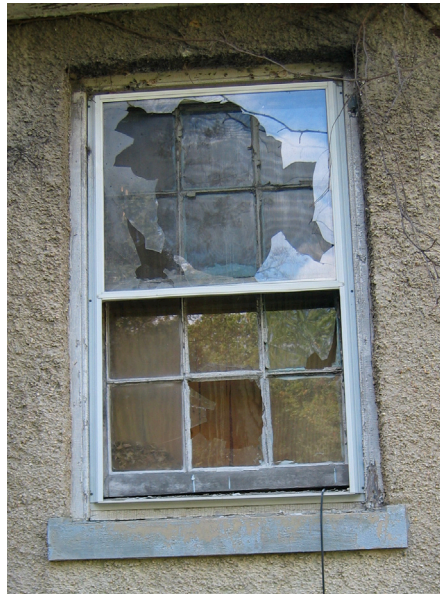
A number of windows and storm windows have broken glass. Overall, the wooden windows are in fair condition; the storm windows are in poor condition. Window wells are in fair-to-poor condition with signs of brick deterioration noted.

Figure 3.37 Broken panes and bare wood are evidence of the deteriorated condition of the house's wooden windows and damage to the existing storm windows.

Retain and refurbish the existing windows. Work should include the reglazing and replacement of sash cords. Replace existing storm windows with new wood or aluminum-coated storm windows that coordinate with the appearance of the windows. Window wells should be rebuilt as necessary. Install foundation drains that include drainage of window wells especially where moisture is infiltrating the basement.

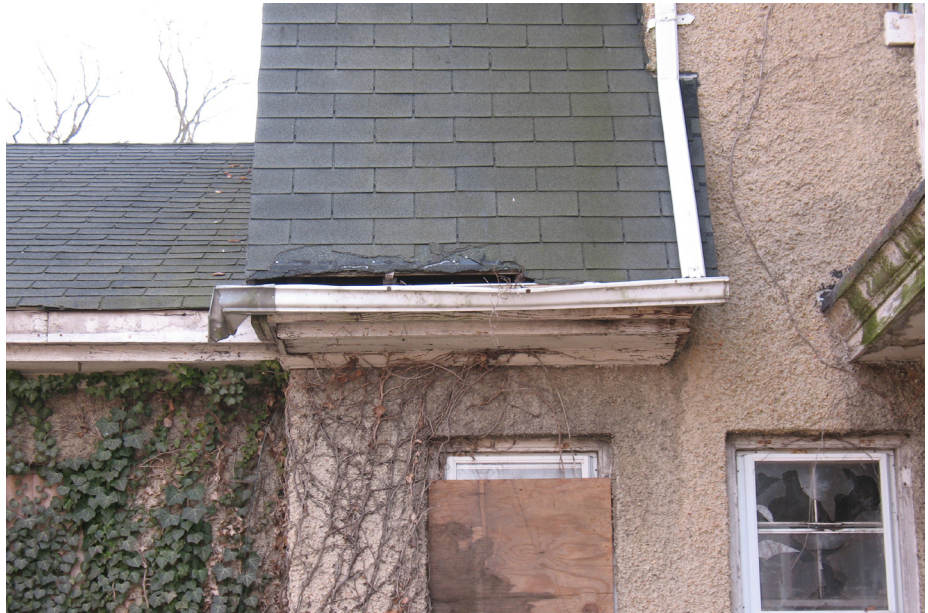
Eaves exhibit significant water damage, missing boards, and holes, especially on the north elevation.

Cornice and eave woodwork is in fair-to-poor condition. The gutters are in poor condition.

Figure 3.42 Water damage has occurred on the eave of the north elevation, east of the sunroom addition.

Prepare and repaint all exterior woodwork. Repair or replace all deteriorated moldings. Replace missing moldings with matching trim.

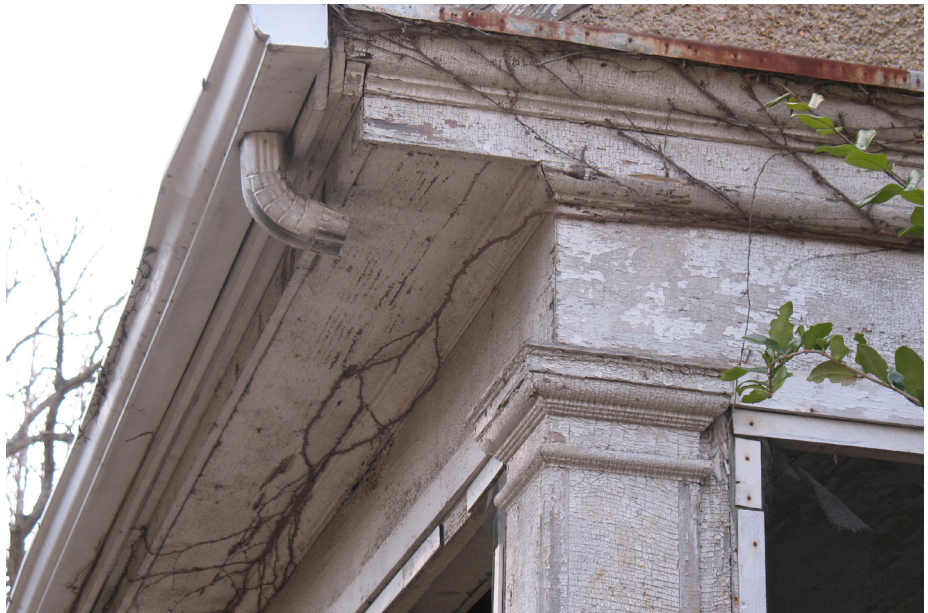
Figure 3.43 The ogee-shaped gutter and missing downspout are shown here on a corner of the front porch.

Replace the current ogee-shaped gutters with pre-painted aluminum half-round gutters and round downspouts more appropriate to the style of the building.

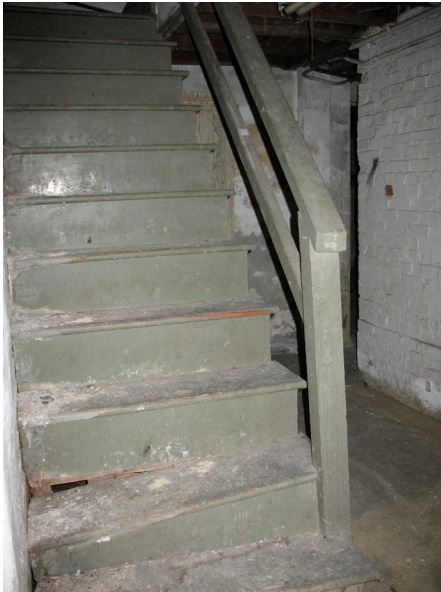
Figure 3.63 The collapsing tread and riser are evidence of the deteriorated condition of the basement stairway.

The basement stair is structurally unsound and should be considered unsafe. Please refer to the Structural Condition Assessment later in this chapter for more information.

The basement stair should be replaced with a new stair.

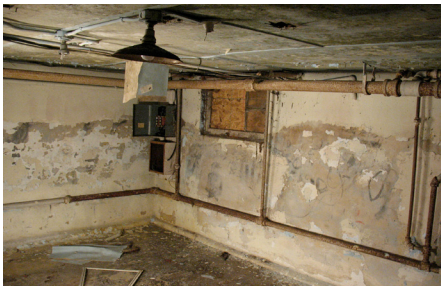
Figure 3.71 Room 001 has parged walls and mold growth on the ceiling.

Finished wall and ceiling surfaces in the basement are in poor condition. Spalling of paint and parging and mold growth is evident due to moisture infiltration and rising damp. The fiberboard ceiling in Room 001 may contain asbestos.

In the basement, repair wall finishes where necessary and repaint. Improve drainage to eliminate moisture infiltration into basement by installing foundation drainage and foundation waterproofing. Remove the ceiling finish in Room 001 (using appropriate methods) and replace with new finish as appropriate to the use of the space. Add finished ceilings in spaces with exposed ceiling that are proposed to be occupied and a more finished wall surface, if desired.

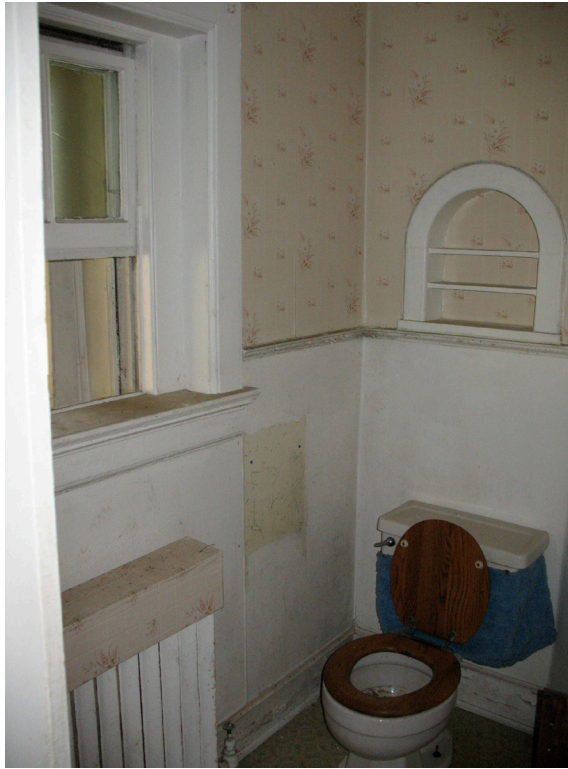
Figure 3.85 The existing toilet in the second floor bathroom is outdated.

Replace or refurbish plumbing and fixtures as part of the overall rehabilitation of the building.
