PHYSICIAN'S RESIDENCE LORTON, VIRGINIA

SUPPLEMENTARY INFORMATION REPORT

September 2010

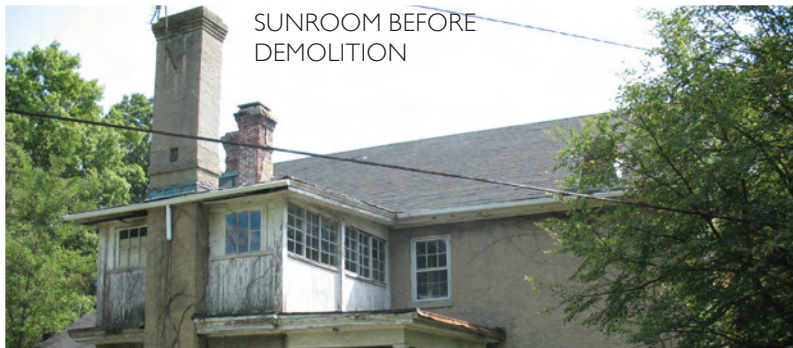
SUNROOM BEFORE
DEMOLITION

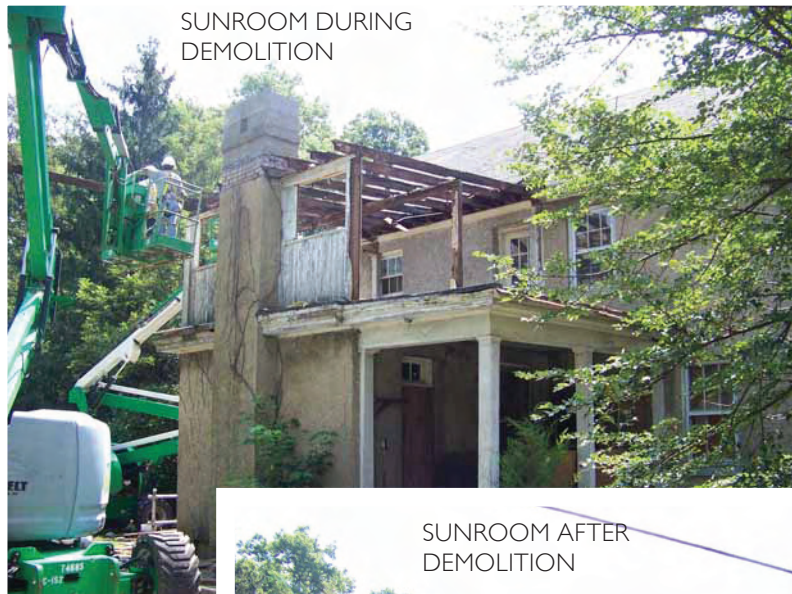
SUNROOM DURING
DEMOLITION

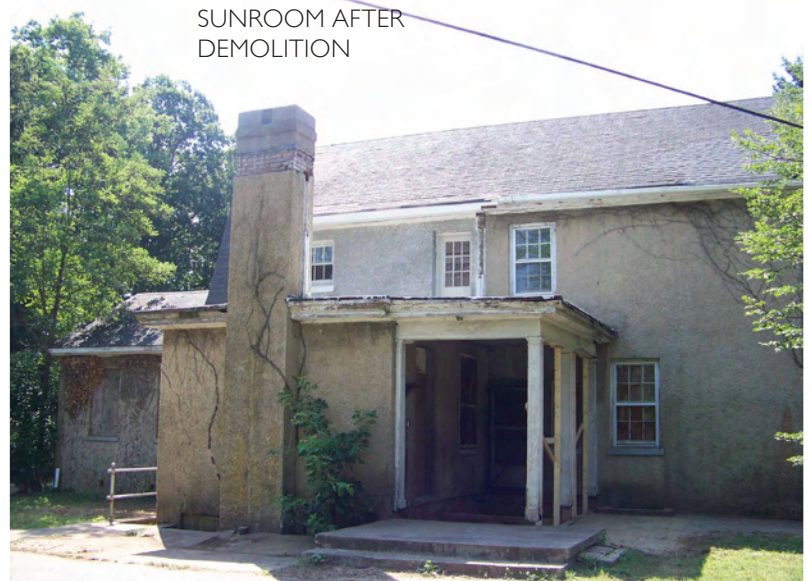
SUNROOM AFTER
DEMOLITION

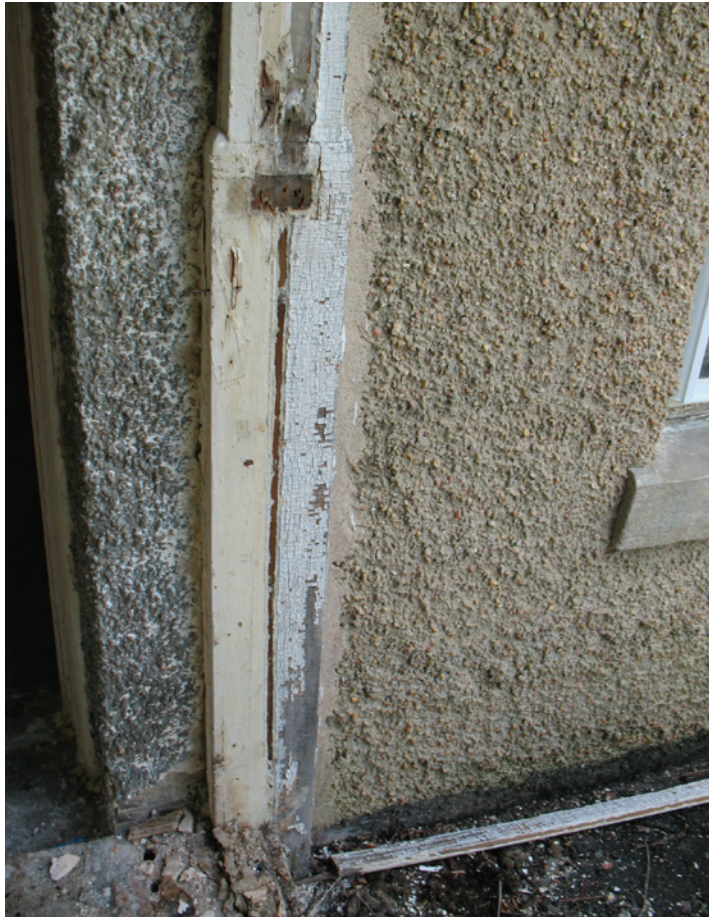
1. End boards (lower) for original railing evident in two-piece construction of vertical porch members next to masonry.

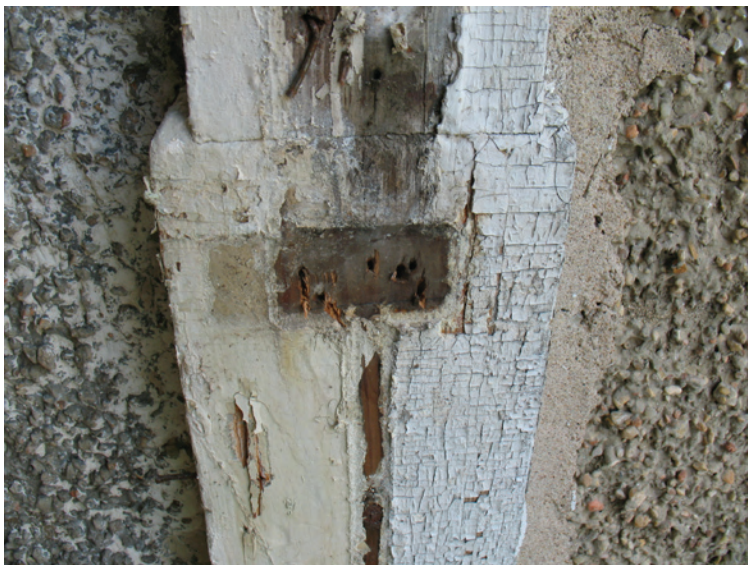
2. Overlapping "ghosts" of railings shown on end boards. Area with no paint is from recently removed paneling.

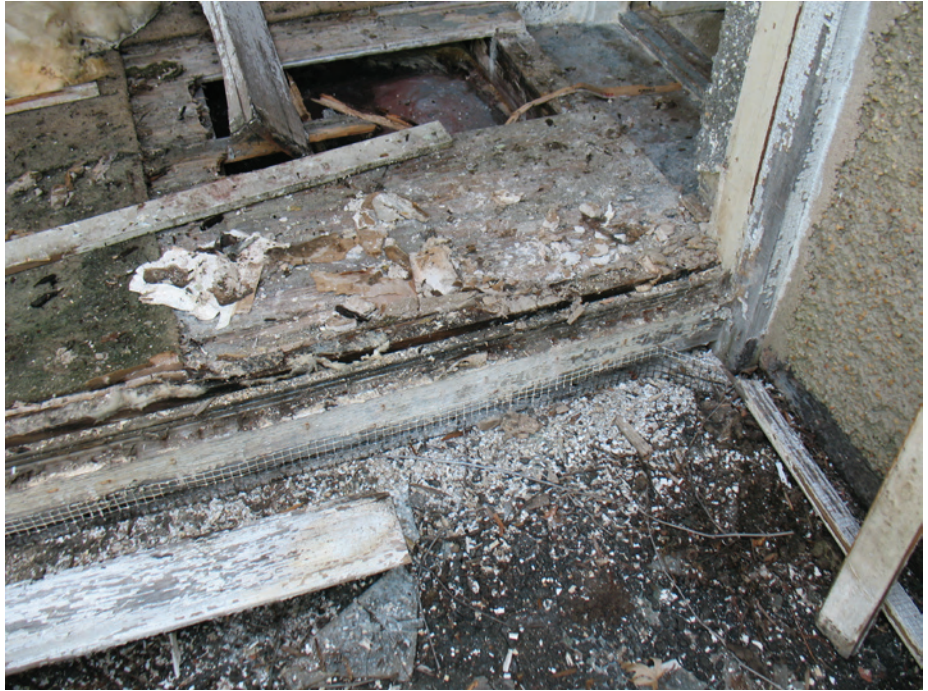
3. Detail of demolition shows screen over drainage plane for metal roof beneath wood floor. This indicates that at one time the interior of the sunroom may have been open to the weather (Phase 2).

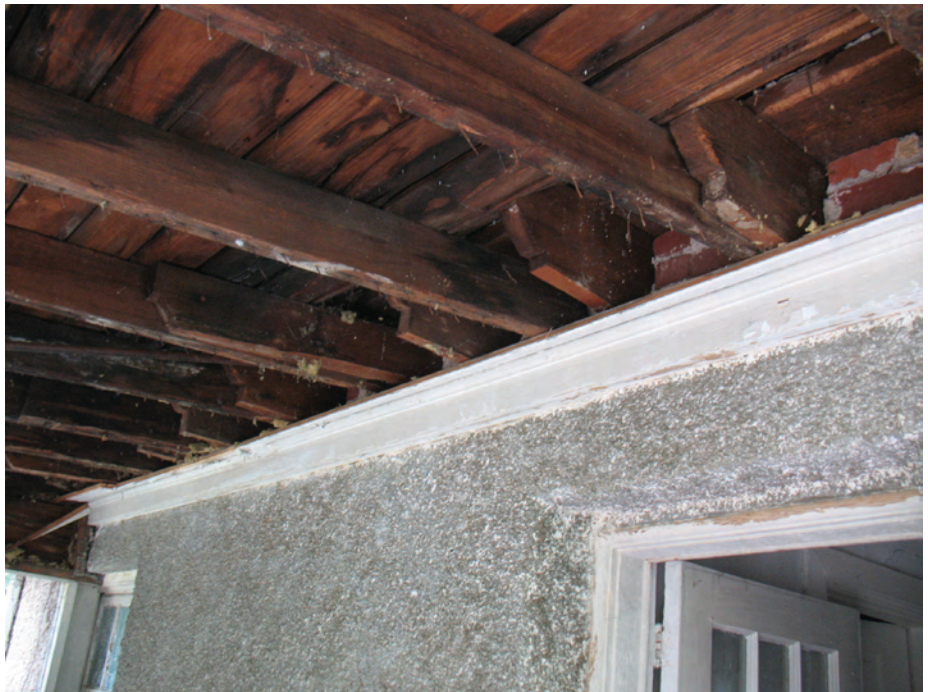
4. Note rafters ends are shaped to receive cornice that was likely removed when the sunroom roof was installed.

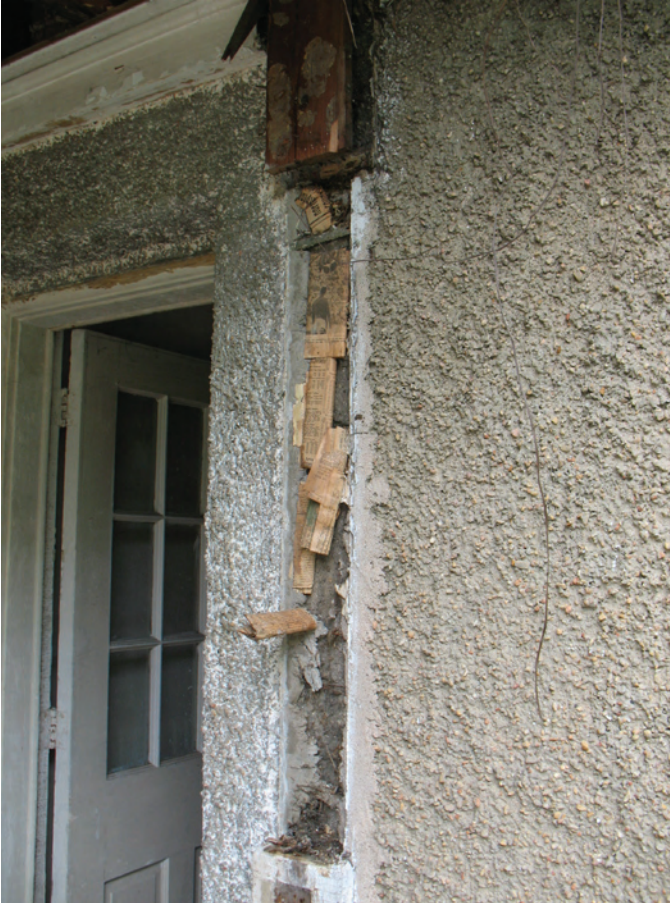
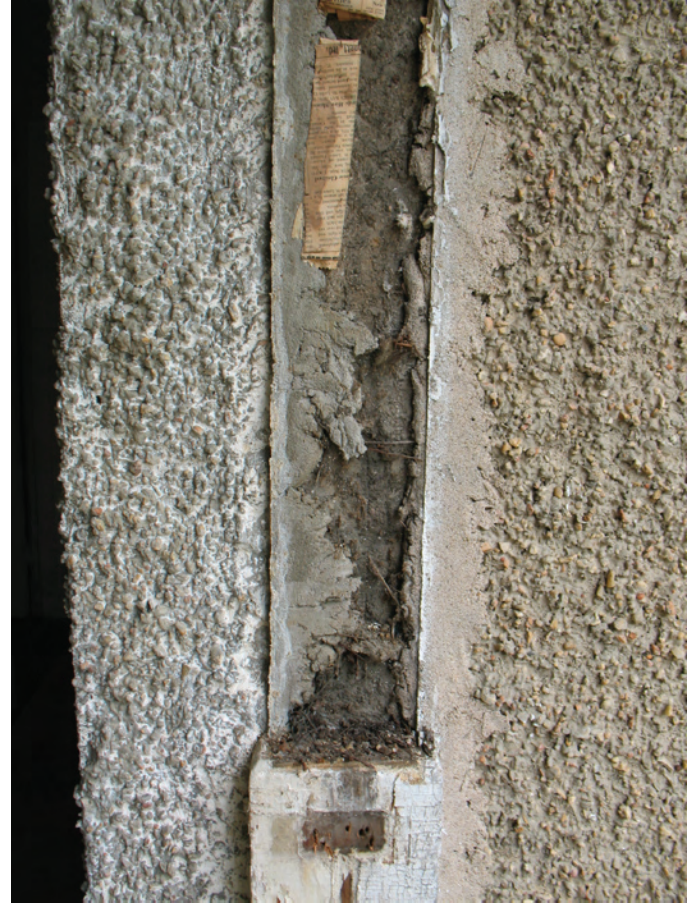
5. Note newspapers (with 1972 date) used as shims behind upper end board. Note also that the pebbled stucco does not extend behind the end board. This gives a good indication of the beginning of Phase 3 including the installation date of the pebbled stucco (and possibly the installation of windows in the top of the sunroom walls). There is a non-pebbled gray stucco behind the board that would have been installed earlier.

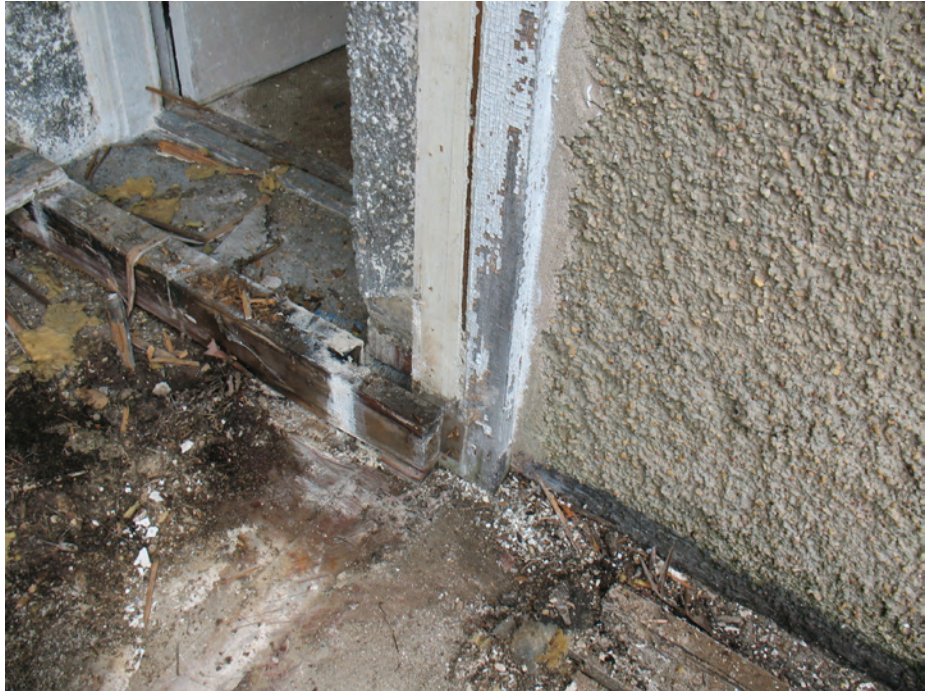
6. Note step up onto porch. The normal relationship is to step down to avoid water infiltration. This points to the wood floor being a later addition (probably after enclosure of the sunroom).

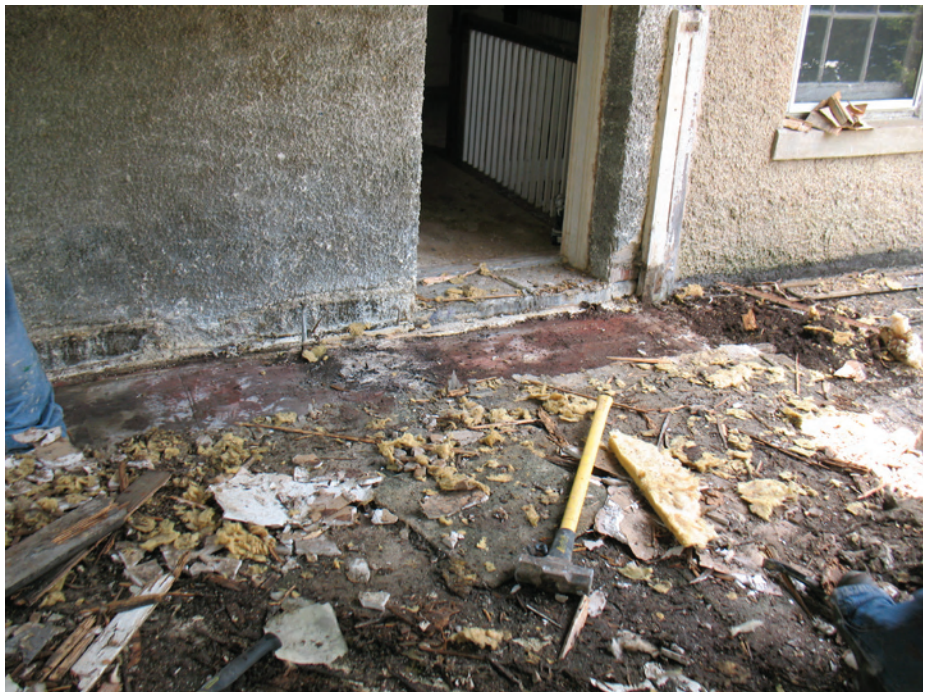
7. With porch floor removed the original step down onto the porch can be seen.

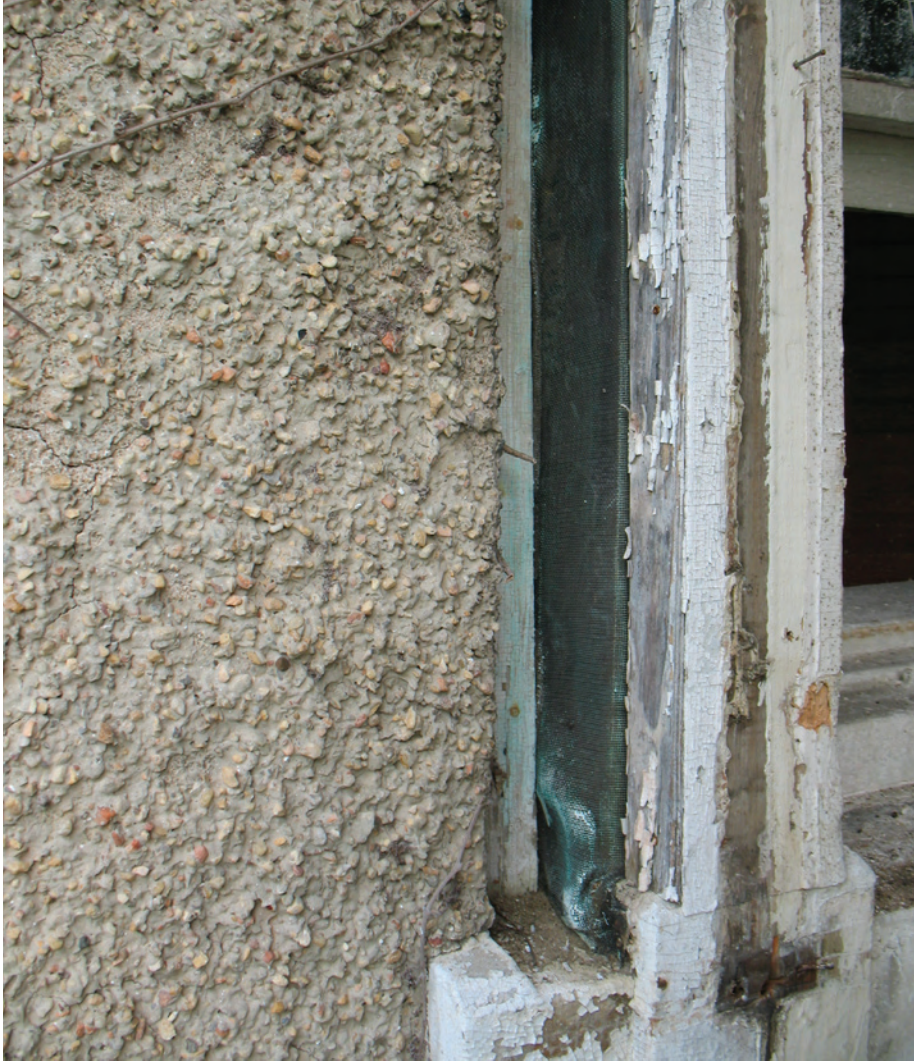
8. View of fixed screen uncovered during demolition. This is evidence of a “sleeping porch” phase that would have been open to the weather but screened (Phase 2).

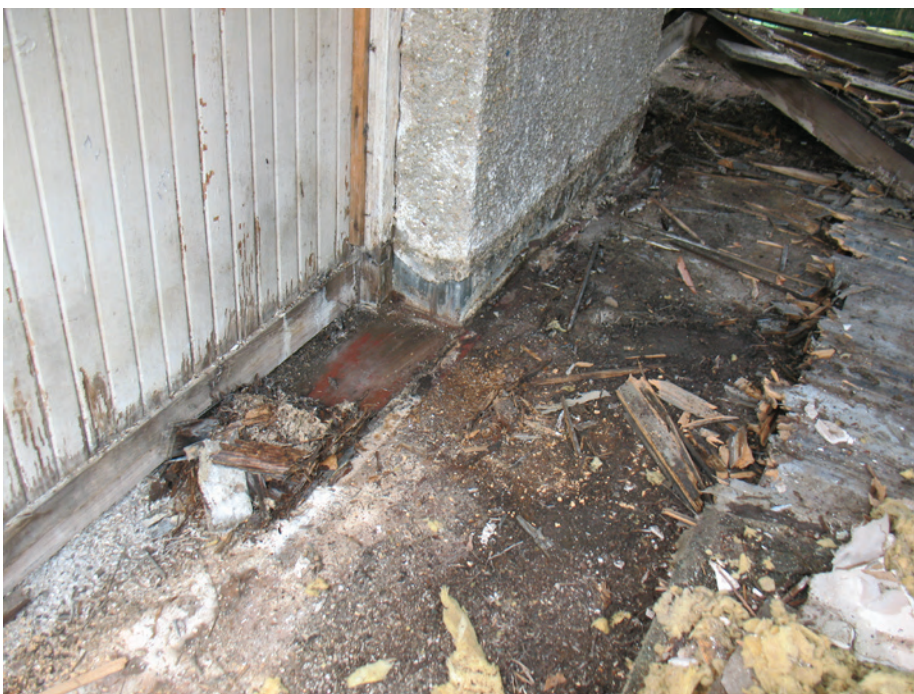
9. View of metal roof material turned up as one piece onto chimney. This indicates that the chimney existed at the time that the roof was installed.

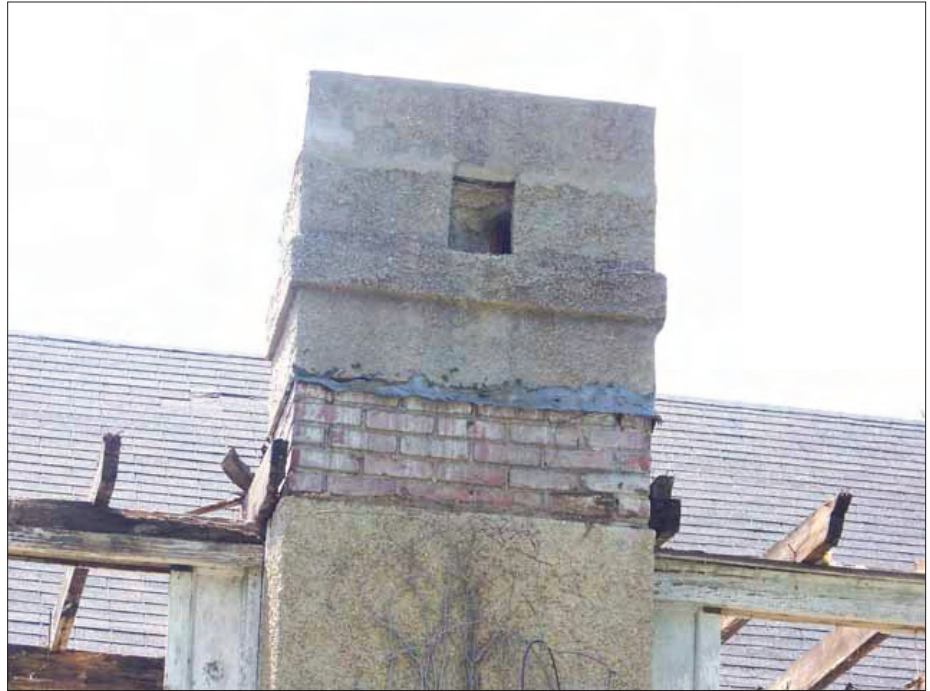
10. View of chimney with roof removed to reveal unstuccoed brick. This indicates that the chimney was built before the installation of any stucco on the brick.

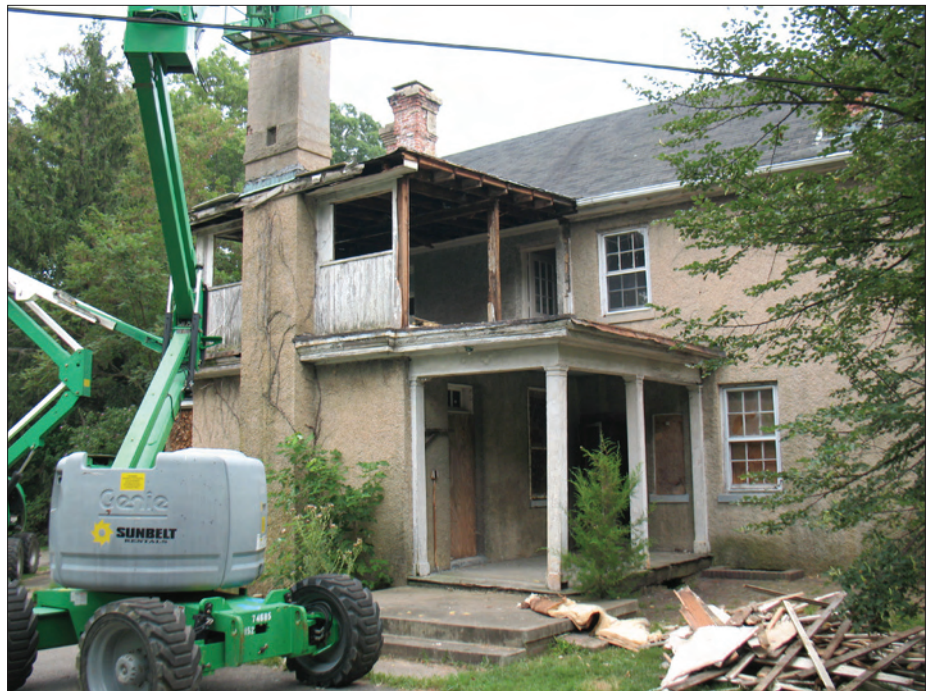
11. It is likely that the original exterior of the house was brick. Note also that upper level of chimney has a different stucco finish than the pebbled finish on the lower section.

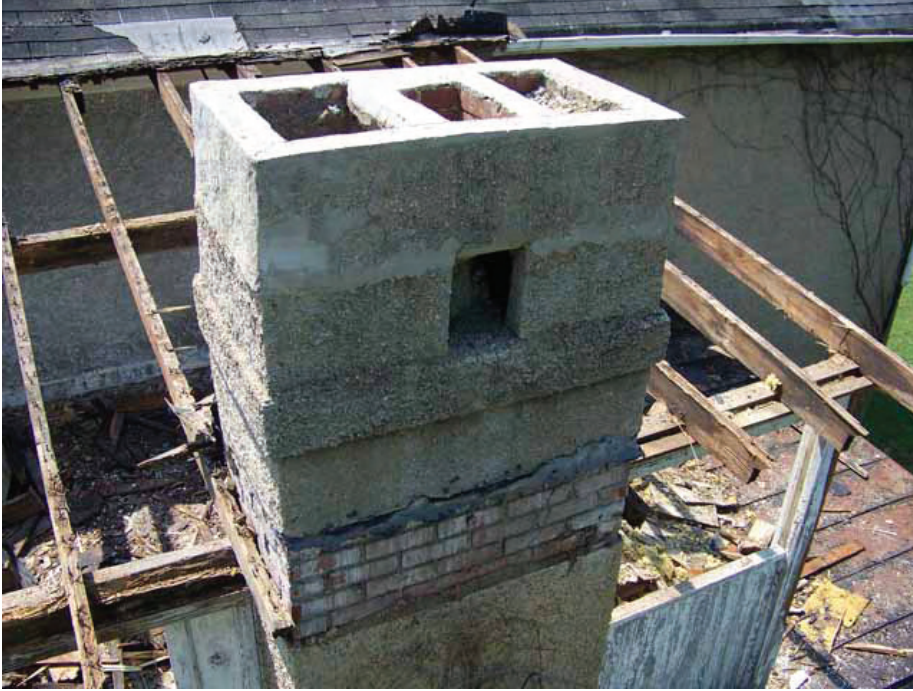
12. View of chimney during demolition.
Note existing roof in background.

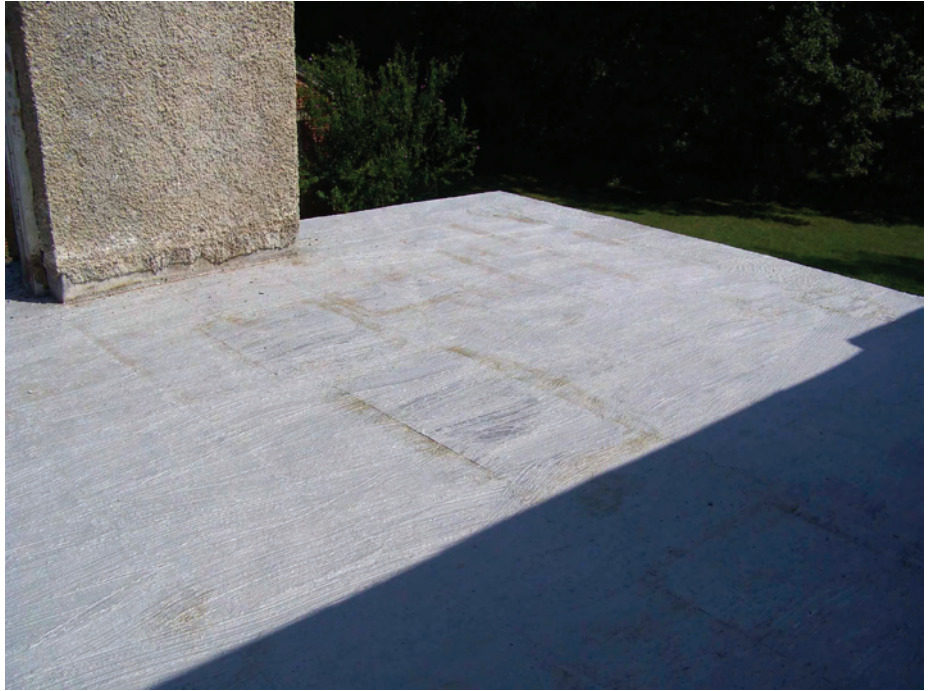
13. View of roof after sealer has been applied.

The demolition contractor, under Fairfax County's direction, made minor repairs to the existing metal roof and coated it with a fiber roofing sealer (mfg. by W. W. Henry Company). Given that the building is not occupied, it may be reasonable for the county to monitor the performance of the roof and forgo the expense of replacement at this time. Any replacement of the roof should consider future uses, appropriate materials, and design review by the Architectural Review Board. Other measures to secure the building should be taken as well to prevent access to the flat roof and avoid the danger of someone falling off the side.

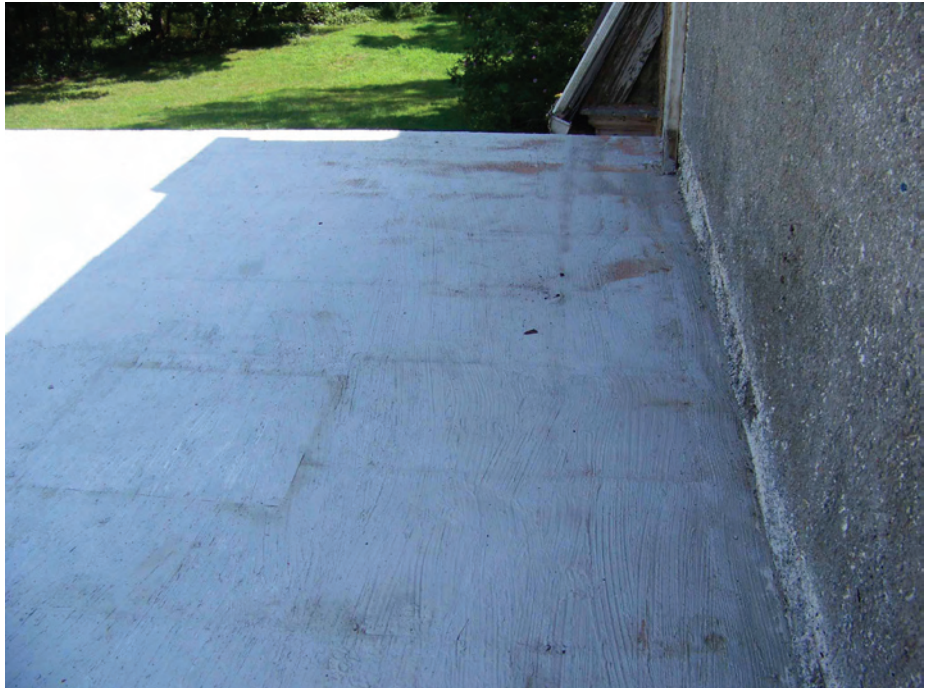
14. View of roof after sealer has been applied.
