LAUREL HILL HOUSE

Historic Structure Report and Treatment Options

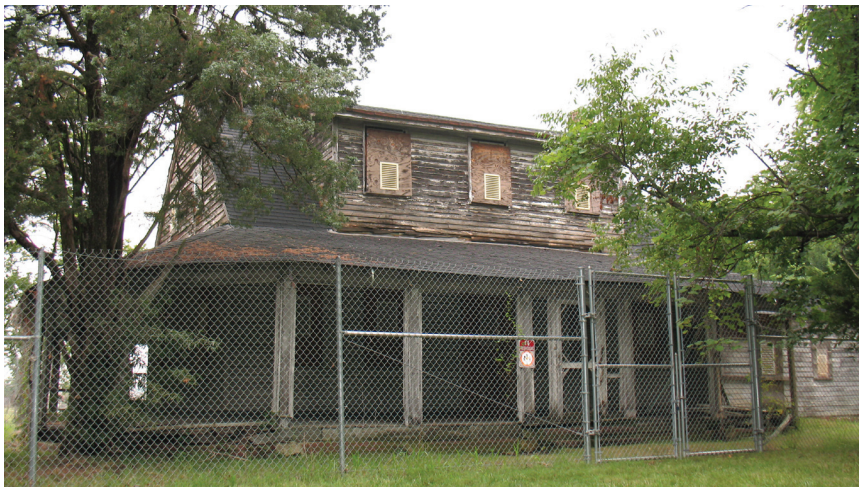
View of front (south) side of building. (X1)

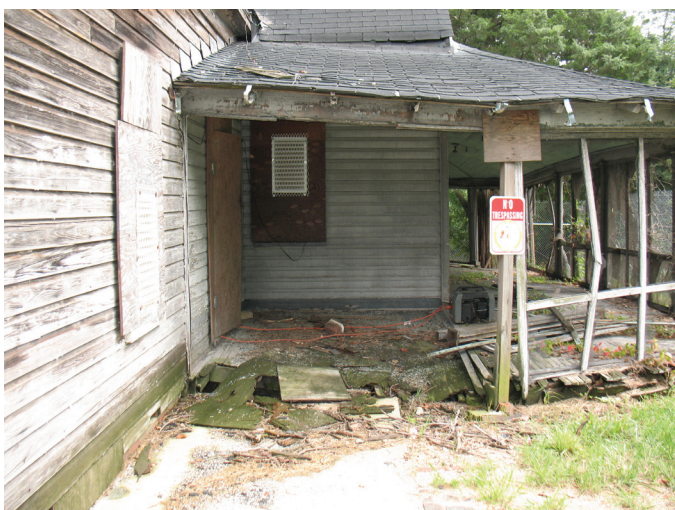
The wraparound porch was added by the time of photos dating to the early-twentieth century. The porch has some interesting details including shaped rafter tails and engaged columns on posts that create a paneled appearance by tracing the porch openings with moldings (Photo X2). The tongue-and-groove floor and its supporting structure are showing severe distress and collapse in some areas (Photos X3, X6 and X15). The beaded tongue-and-groove ceiling boards are similarly in varying states of disrepair (Photo X3). Deflection can be seen in the roof structure above the northwest end of the porch. The entire porch is severely deteriorated, and parts will likely collapse in the near future (Photos X6 and X15).

Detail view of porch on northwest side of the house. (X6)

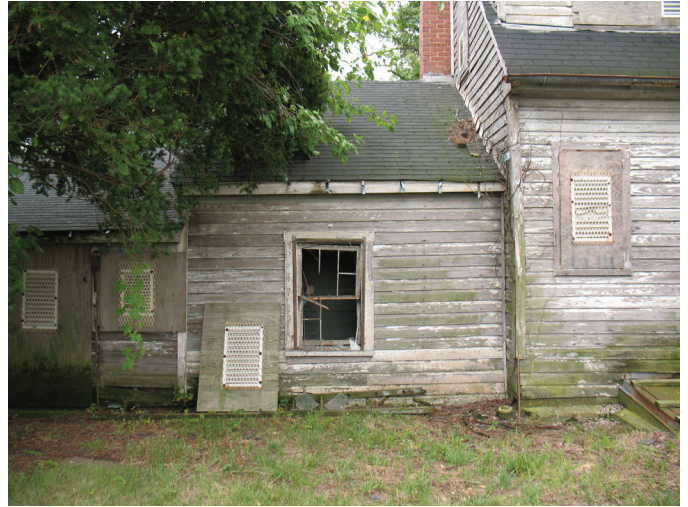
Close-up view of house from north side. (X10)

The windows are typically double-hung wood sash windows with some casements seen in the one-story additions. Few of the original six-over-six sash windows remain. They were replaced with two-over-two windows, possibly at the time the rear addition was added. While the windows are covered with vented plywood, their condition varies from fair to poor (X7, X8, X9, X10 and X12).

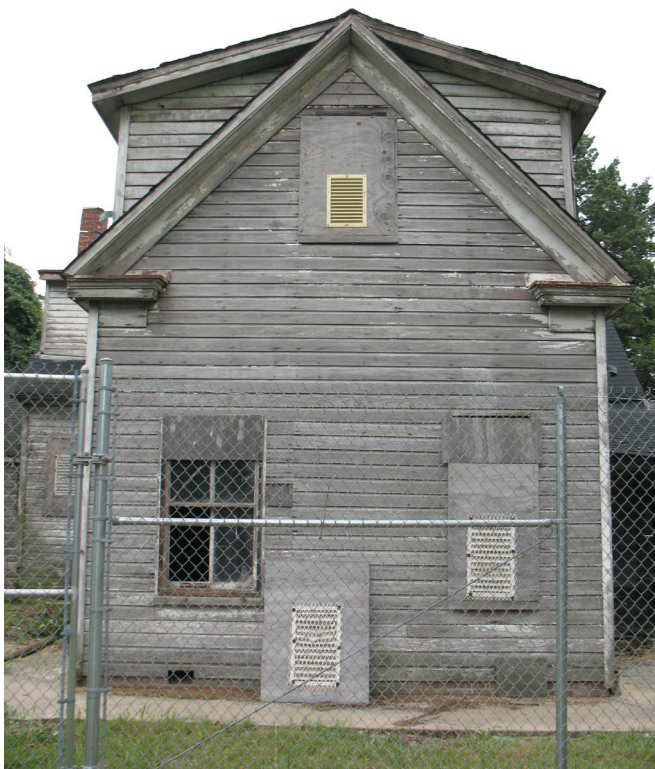
Close-up view of rear addition from north side. Note shed dormers and classical cornice with returns. (X7)

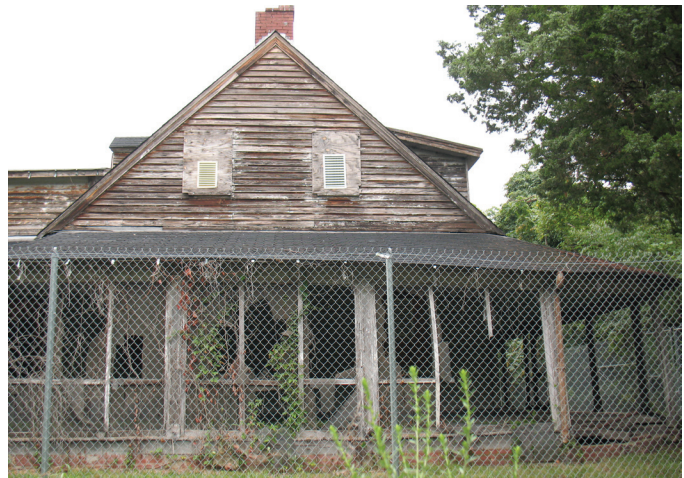
The top of the west chimney has deteriorated. The east chimney is being held together at its top with a metal strap.

View of chimney on the west side of original section of the house. (X4)

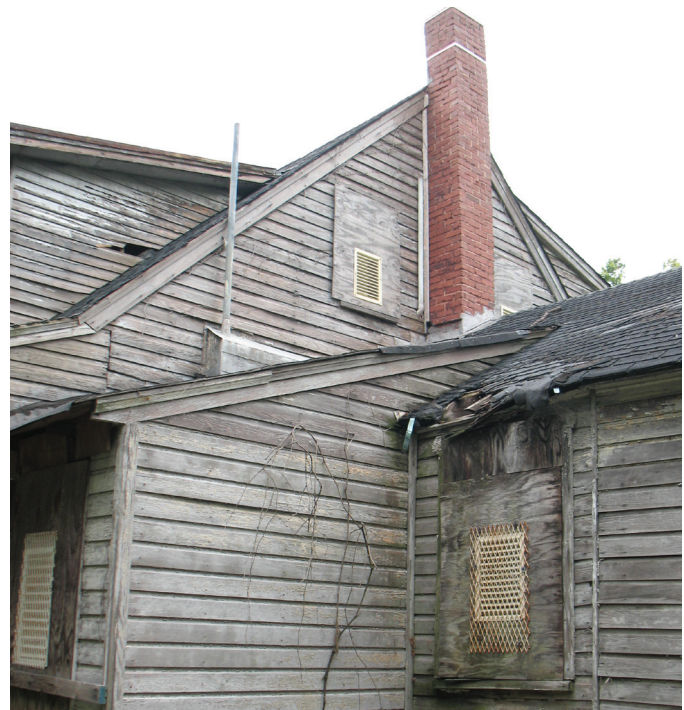
View of chimney on the east side of the original section of the house. (X14)

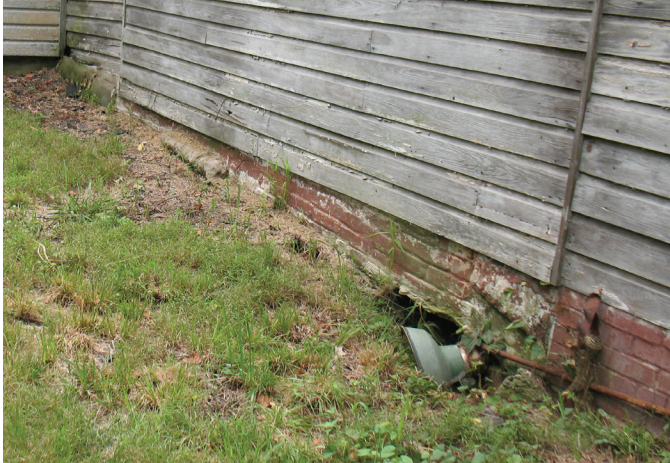
View of hole in foundation on south side of building. (X16)

Several areas of the foundation, along the southeast side of the building, have holes or are partially collapsed (X16).

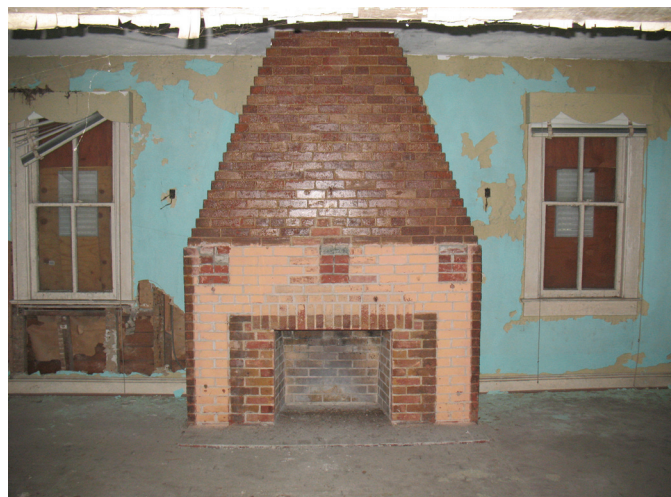
This room was part of the original section of the house and has been heavily altered. Most prominently in this room, the original fireplace has been removed and replaced with a large pyramid-shaped fireplace built of exposed penitentiary-era brick (101-1). A classically designed mantel was reportedly removed from this room and is currently in storage (101-3). A 4" x 4" ceramic tile hearth has replaced the original.

View of fireplace constructed with prison era brick. (101-1)

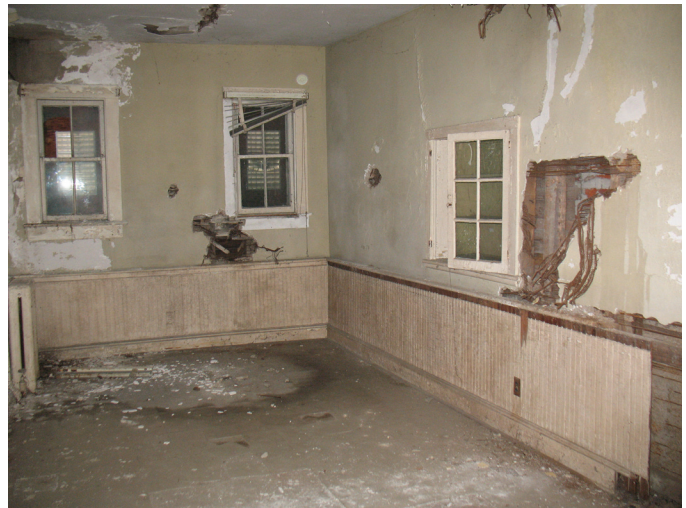
The original window casing has been replaced with painted flat wood casing. The inside of this casing has quarter-round used as window stop. The windows are likely replacements since they have a two-over-two light pattern instead of smaller panes which would have been typical of the original era of construction (104-2).

View of Room 104 in original section of the house. (104-2)

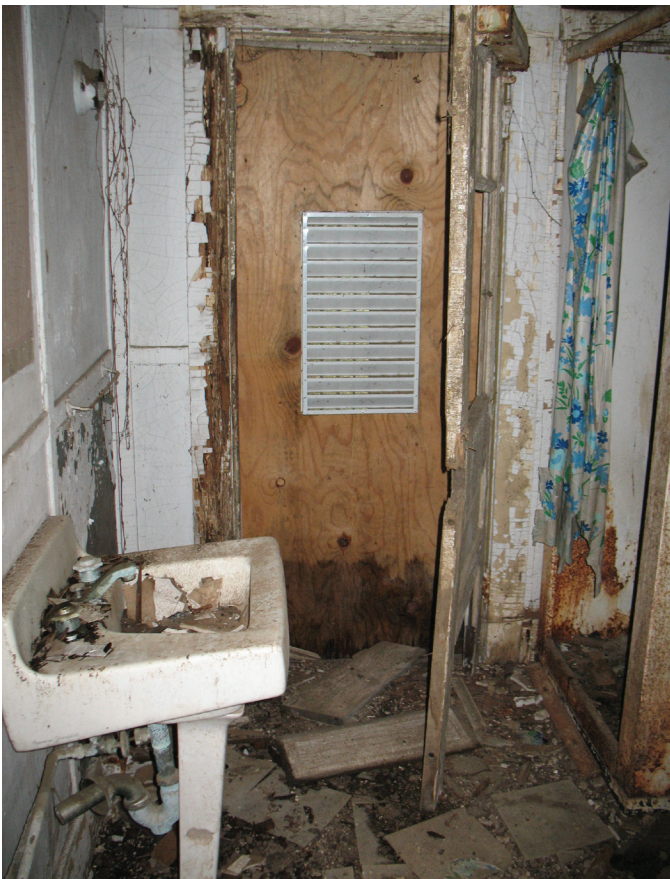
This bathroom is a later addition to the house. It has received considerable damage due to moisture infiltration from the roof and is not safe to enter. The walls are finished with painted hardboard with lattice strips covering the joints. Nothing in the room is capable of being salvaged. Depending on which treatment option is chosen for the building, this room could be considered as a candidate for removal (105-1).

View of Room 105. (105-1)

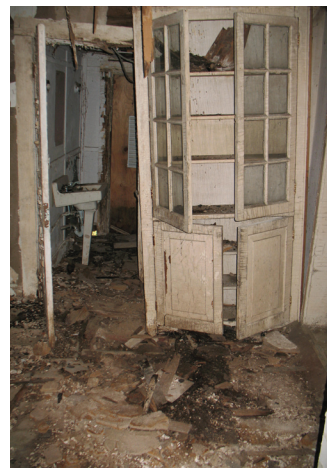
An interesting built-in cabinet in the southwest corner of the room has settled toward the damaged area in the floor (106-1). There is another built-in cabinet, probably dating from the early twentieth century adjacent to the chimney (106-2). This chimney has been boxed in such a way that it is not visible to the room.

View of Room 106 facing bathroom to south. Note water damage to floor and built-in cabinet. (106-1)

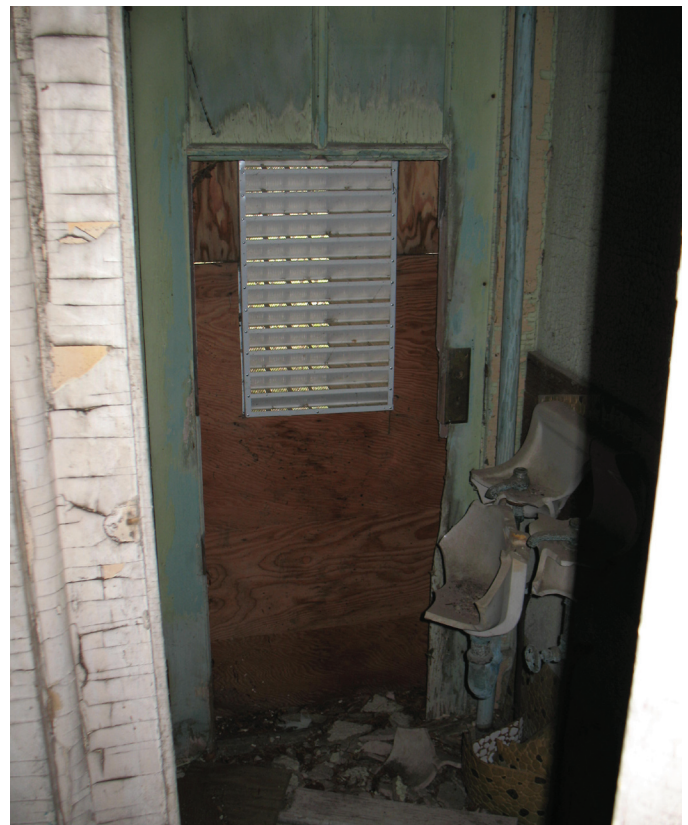
This room and the east end of the kitchen, Room 112, are contained within a shed addition. A fragment of a French door leading to the exterior remains. The plumbing fixtures in this room have been severely damaged and left in place. The windows are six-pane casements with flat casing. The wall finish is painted hardboard with lattice strips covering the joints. The overall condition of the finishes in the room is poor (111-1).

View into room 111 from kitchen. (111-1)
