## Chapter 3: Subwatershed Condition

### 3.1 North Little Hunting Creek Subwatershed

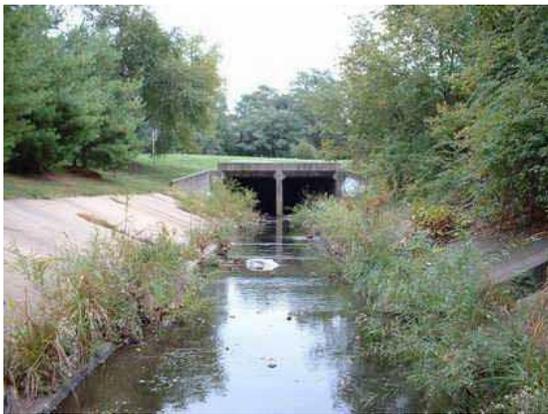
- Fordson Road: Stormwater runoff from neighborhood areas of Mount Vernon Square, Millway Meadows, and Hybla Valley Farms is collected and conveyed through a storm drain pipe system and the outfall, a double eight-foot by eight-foot box culvert, is located under Fordson Road. No impact on the stream was observed due to concrete lined channels on the downstream side as shown in Photo 3.1.

Photo 3.1 Double 8' x 8' outfall box culvert located under Fordson Road

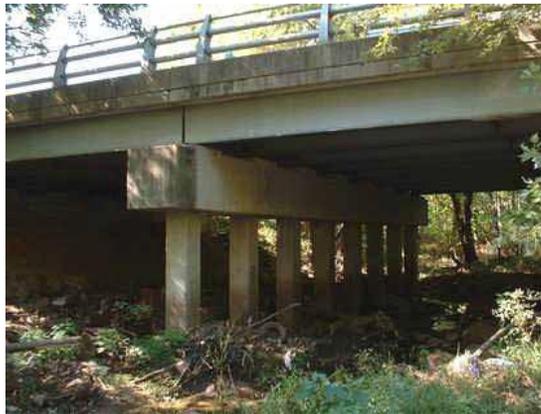
Photo 3.2 Sediment and debris causing a moderate impact downstream of Janna Lee Avenue bridge crossing

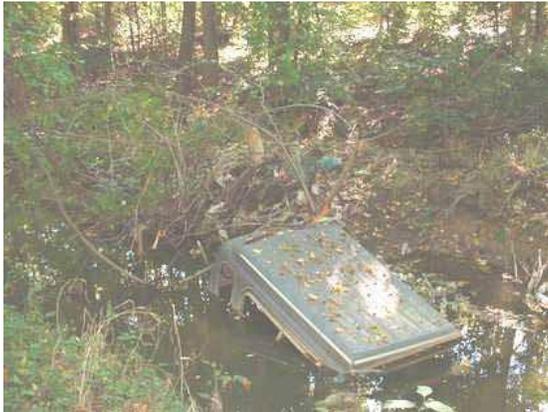
Map 3.3 shows the stream segment CEM type in the subwatershed. Fallen trees and debris obstructing the flow were observed at two locations in the upstream reaches. The impact of this debris on the stream is moderate and can be seen in Photo 3.3. In the downstream stream segment, the stream is littered with shopping carts, trash, and a camper shell. Photos

Photo 3.3 Dump observed in the downstream channel near Richmond Highway

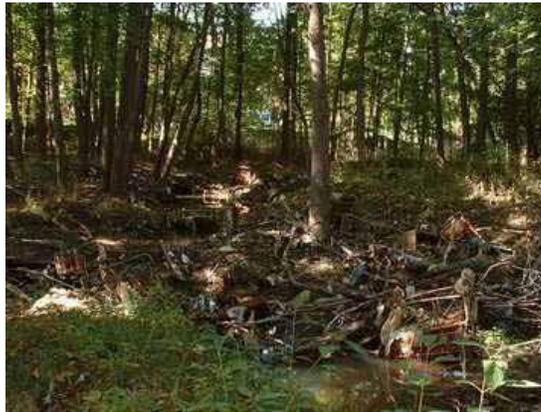
3.4 and 3.5 show dumpsites in the downstream segments. The locations of the dumpsites identified during the stream physical assessment are shown on Map 3.3. Two additional dumpsites have been identified in the area behind the Hybla Valley Shopping Center. A partially buried 12-inch sanitary sewer pipe crosses the stream in the downstream segment and does not cause a significant impact. A raised sanitary sewer manhole is located in the upstream stream segment north of Audubon Avenue and has little impact on the stream as shown in Photo 3.6.

Photo 3.4 Trash dump and littering in the downstream segment near Richmond Highway

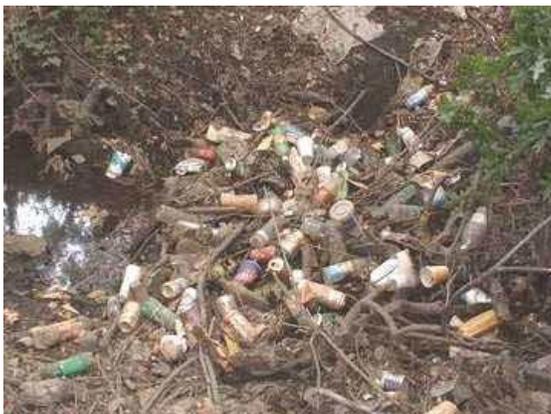
Photo 3.5 Trash located upstream of Fordson Road

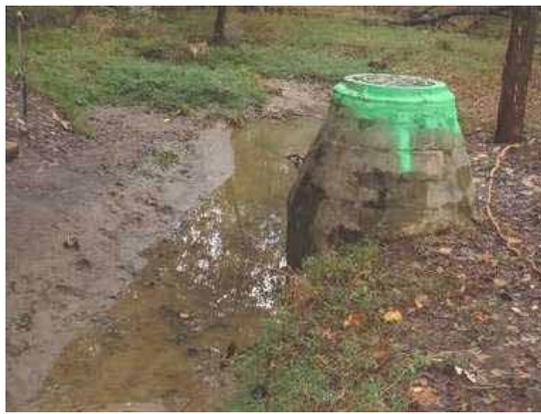
Photo 3.6 Raised manhole obstructing the flow of the tributary located north of Audubon Avenue

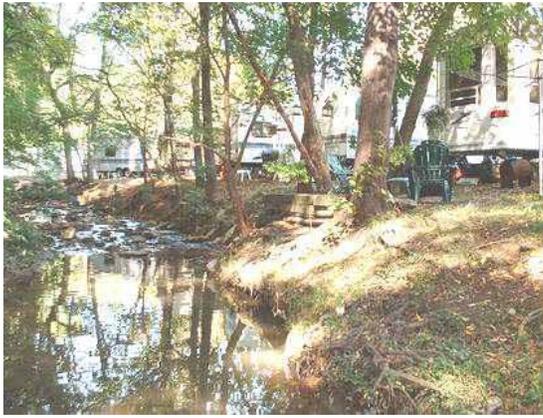
At several locations in the downstream stream segments, there is a severe to extreme impact due to a lack of natural forested buffer as shown in Photo 3.7. At one location in the upstream stream segments, the buffer zone is covered with a parking lot and roadway, causing the severe impact shown in Photo 3.8. Overall, North Little Hunting Creek does not have adequate natural buffer widths of 100 feet. The locations of deficient buffer areas along the stream corridor are shown on Map 3.4.

Photo 3.7 Lack of natural forested buffer upstream of Richmond Highway

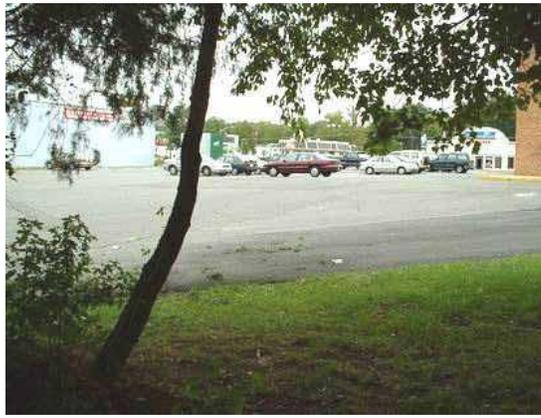
Photo 3.8 Paved surface in the buffer zone upstream of Fordson Road crossing

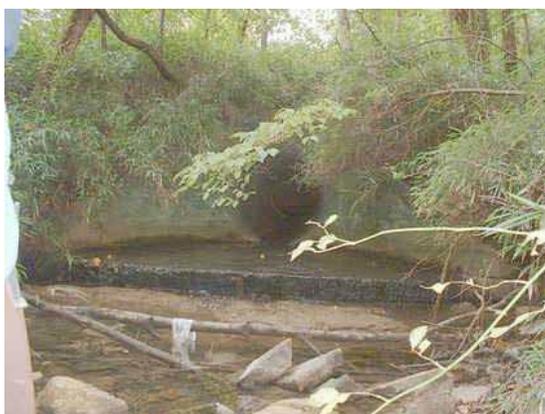
- Brady Street: The five-foot diameter concrete pipe drains to the tributary located on the west side of South Little Hunting Creek as shown in Photo 3.10.
- Linton Lane: Five-foot and three-foot (diameter) concrete pipes drain to South Branch as shown in Photo 3.11.
- Linton Lane: A triple six-foot by three-foot concrete box culvert drains to South Branch.
- East of Linton Lane: Two wooden foot bridges, each 12 feet long with four-foot openings, and four wooden foot bridges, each eight feet long with four-foot openings, are located on South Branch between Linton Lane and Vernon View Drive.

Photo 3.10 5' diameter concrete pipe located under Brady Street

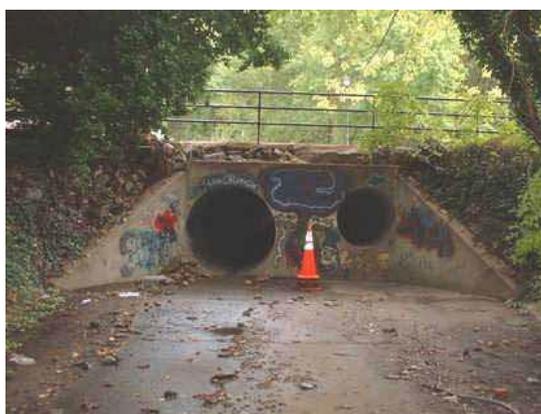
Photo 3.11 5' and 3' diameter pipes located under Linton Lane

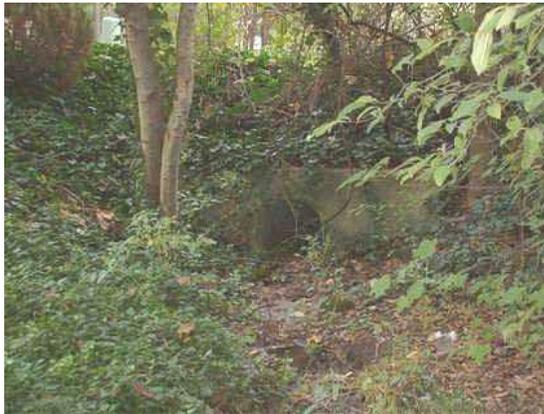
Photo 3.12 2' (diameter) concrete pipe located under Wessynton Way

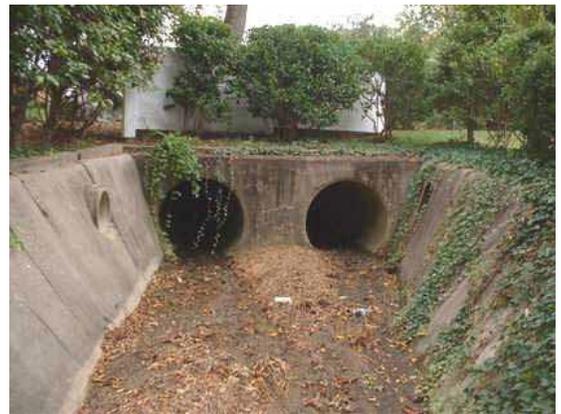
Photo 3.13 Double 3' (diameter) concrete pipes located west of Vernon View Drive

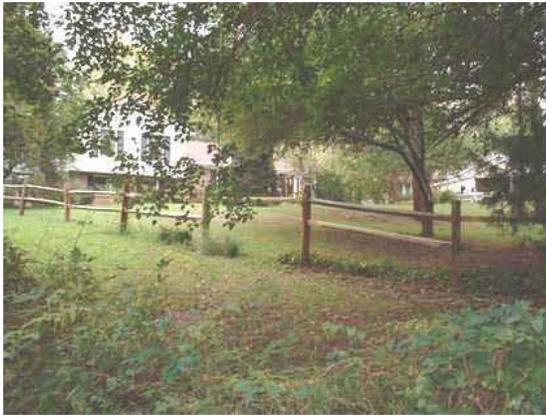
Habitat quality is considered fair for LHLH011 and poor for LHLH012 as shown on Map 3.8. An adequate buffer width does not exist along most of the stream corridors of the tributaries in the South Little Hunting Creek Subwatershed due to residential development in the area. Photo 3.14 shows planted lawns located in the buffer zone along the north branch of South Branch, west of Linton Lane; Photo 3.15 shows deficient buffer along the tributary LHLH012 located on the west side of South Little Hunting Creek. The impact of deficient buffer areas on the streams in this subwatershed is moderate. The stream segments of South Branch and the tributary (LHLH011) located near Brady Street are ideal candidates for stream restoration projects because each individual project would be of adequate stream length, would not involve easement acquisition, and would appear to have good access for construction. No head cuts or erosion of the stream bed and banks were observed as part of the stream physical assessment. An eroded area with large trees along the banks being undercut was identified at a stream tributary on the west side of South Little Hunting Creek near the George Washington Memorial Parkway.

Photo 3.14 Deficient buffer zone with planted lawn grass west of Linton Lane along the north branch of South Branch

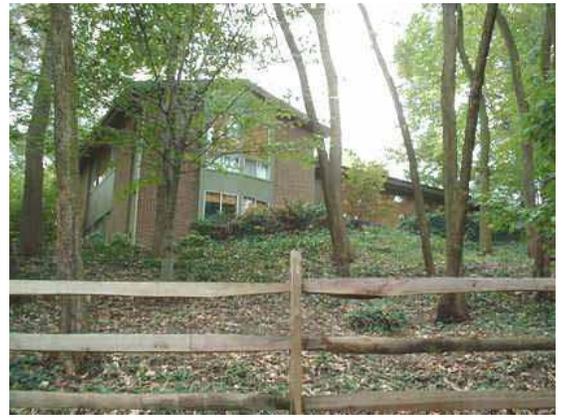
Photo 3.15 Deficient buffer zone along the tributary LHLH012 located on the west side of South Little Hunting Creek

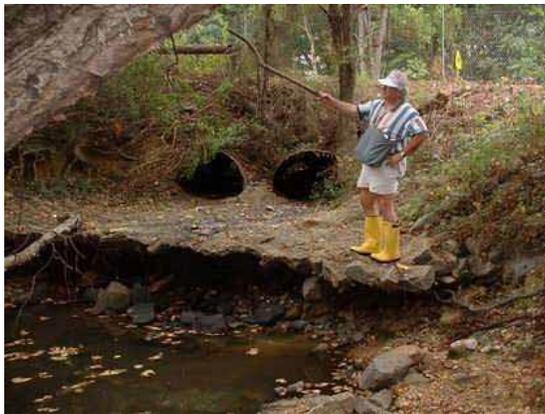
Photo 3.16 Severe erosion downstream of the Mary Baldwin Drive crossing

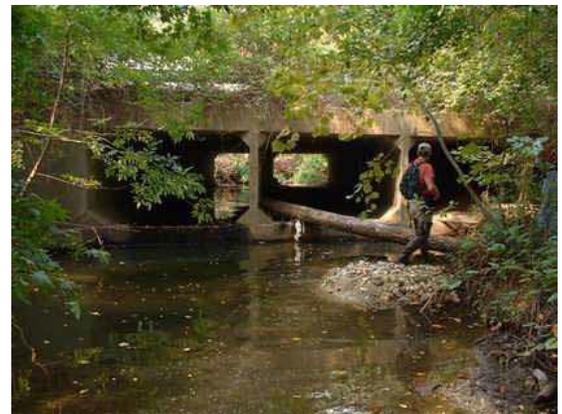
- Sherwood Hall Lane: Four 10-foot by six-foot concrete box culverts, shown in Photo 3.17, with downstream bank erosion of four feet in height, cause a moderate impact on the stream.

Photo 3.17 Four 10'x 6' concrete box culverts located under Sherwood Hall Lane

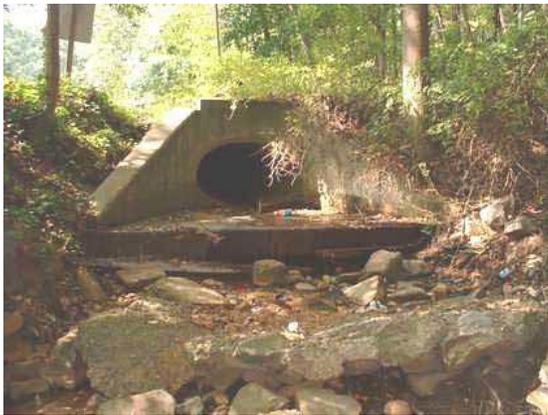
Discharges from four pipe outfalls have caused moderate erosion to the stream, and discharges from the remaining eight outfall pipes have caused minor erosion. The sites of severe to extreme erosion are of significant concern and will need immediate attention. The four ditches that discharge to Paul Spring Branch have caused minor to moderate erosion of the stream, and as an example, the ditch outfall located near the intersection of Paul Spring Road and Pickwick Lane is shown in Photo 3.21.

Photo 3.18 Discharge from 53"x 34" elliptical pipe outfall north of Devonshire Road caused moderate erosion on the downstream side

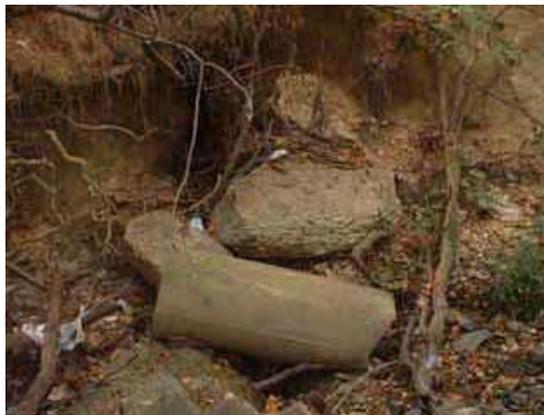
Photo 3.19 Severe erosion caused by discharge from an 18" pipe outfall west of the Mary Baldwin Drive crossing

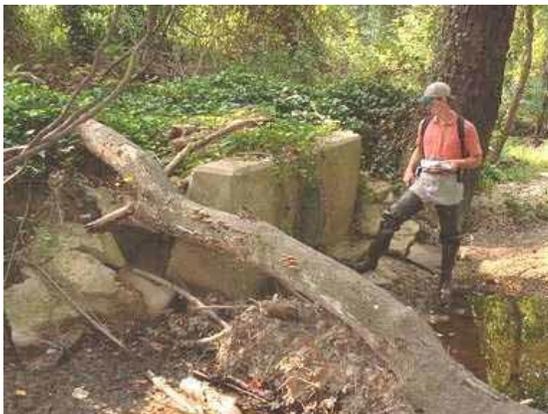
Photo 3.20 Severe erosion caused by discharge from 24" pipe outfall located north of Wellington Road

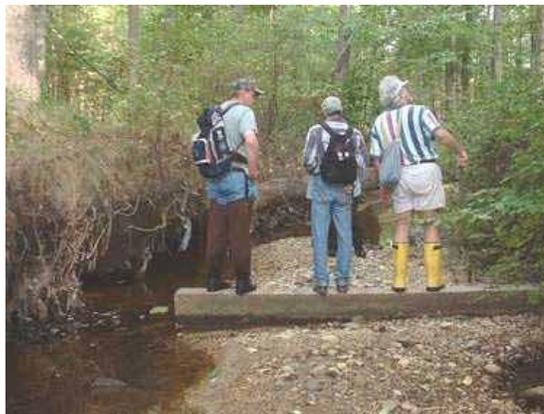
Photo 3.21 Minor erosion of the right bank at the ditch outfall north of the intersection of Paul Spring Road and Pickwick Lane

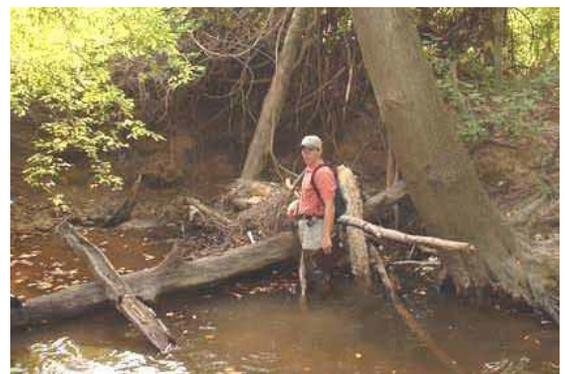
Photo 3.22 Fallen trees and eroding banks causing severe impact to Paul Spring Branch north of Fairfax Road

Fallen trees, dumps, and debris obstructing the flow were observed at many locations in Paul Spring Branch as shown in Photo 3.22. The stream corridor is also littered with lawn waste and

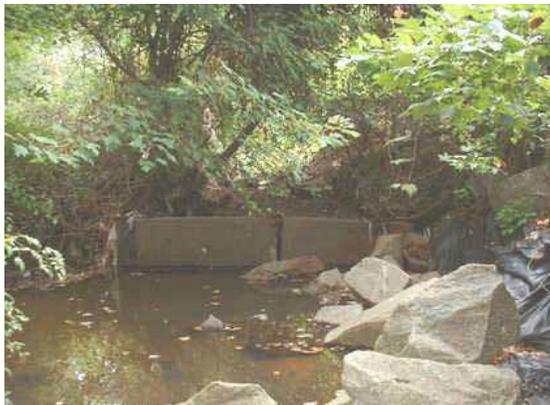
Photo 3.23 Concrete blocks obstructing the flow south of the intersection of Rollins Drive and Radcliff Drive

trash as shown in Photo 3.23. At three locations, partially buried utility lines crossing the stream bed have caused a minor impact to the stream as shown in Photo 3.24. The locations of obstructions, dumpsites, and utility lines crossing the stream are shown on Map 3.11.

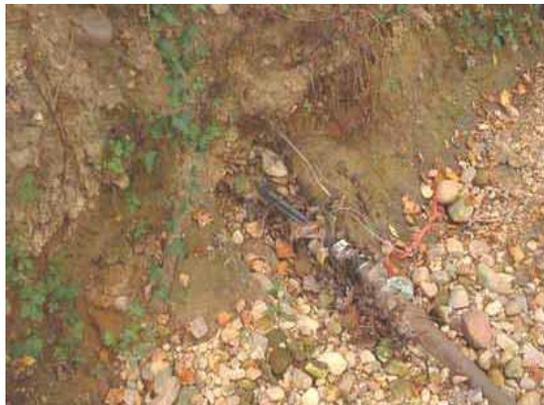
Photo 3.24 Partially buried telephone line south of the intersection of Rollins Drive and Radcliff Drive

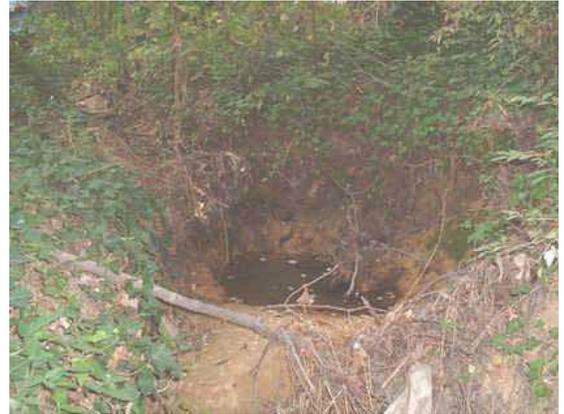
Photo 3.25 Head cutting of 2' of stream bed on the tributary to Paul Spring Branch west of Lyndale Drive

Branch, two feet of head cutting of the stream bed was observed causing minor impacts to stream as shown in Photo 3.25.

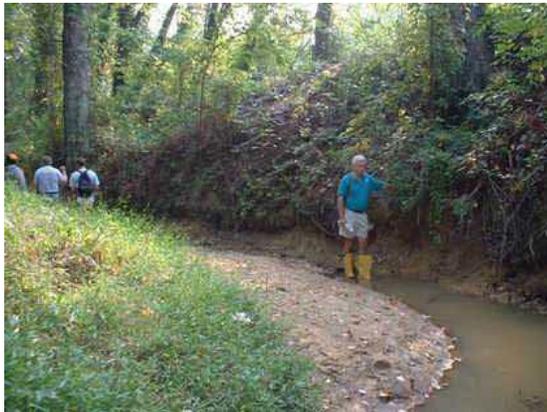
Approximately 1,500 feet upstream of its confluence with North Branch, there is severe erosion of the left bank (six feet high) as shown in Photo 3.26. Downstream of Mason Hill Drive and upstream of the tributary flowing into Paul Spring Branch, moderate to severe erosion with four- to six-foot height of bank erosion was observed at three locations (as shown at one location in Photo 3.27). Downstream of Mary Baldwin Drive, severe erosion of the right bank with eight-foot height of erosion was observed. This erosion problem will require immediate attention.

Photo 3.26 Severe erosion of 6' height was observed west of Admiral Drive

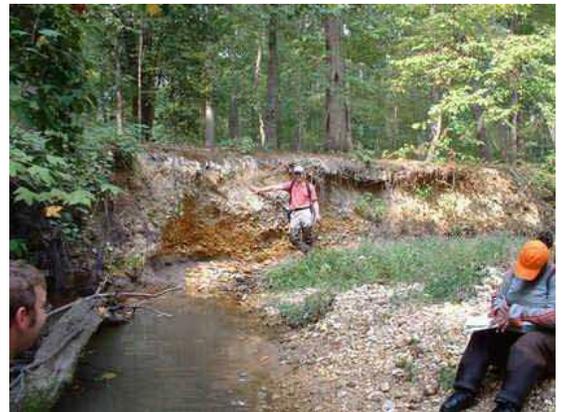
Photo 3.27 Severe erosion of 6' height observed upstream of confluence with North Branch

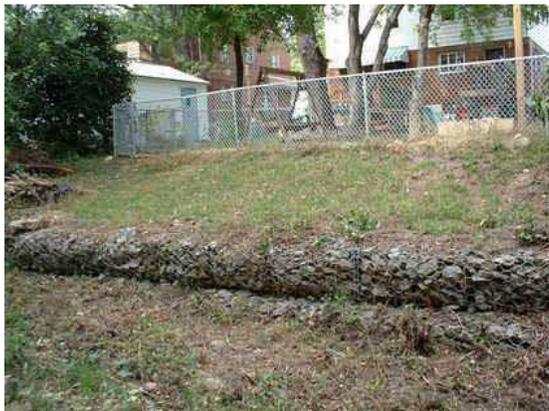
Photo 3.28 Deficient buffer area at the upstream segment of Paul Spring Branch west of Kenyon Drive

moderate and the locations of deficient buffer areas are shown on Map 3.12. Typical deficient buffer areas in the upstream and farthest downstream segments of Paul Spring Branch are shown in Photos 3.28 and 3.29.

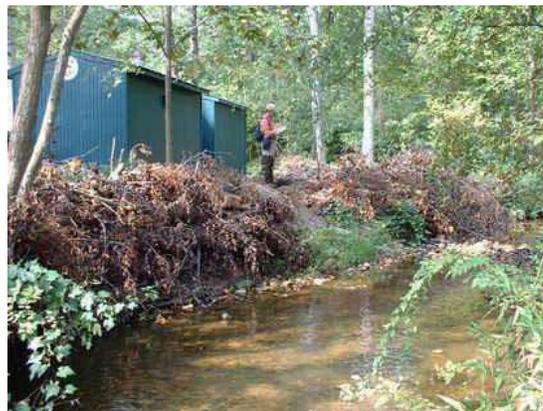
Photo 3.29 Deficient buffer area along the downstream segment of Paul Spring Branch north of Sherwood Hall Lane

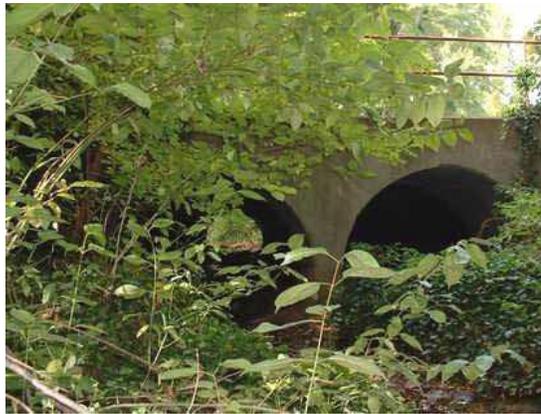
- Sherwood Hall Lane: Two 72-inch (diameter) corrugated metal pipe culverts have no impact on the stream as shown in Photo 3.31.
- Collingwood Road: Five 12-foot by eight-foot box culverts, shown in Photo 3.32, cause minor stream bed erosion upstream of the crossing.
- Collingwood Road: Four 10-foot by 15-foot concrete box culverts, shown in Photo 3.33, with sedimentation upstream of the crossing, are causing a moderate impact on the stream.
- Stacey Road: Four elliptical, five-foot by three-foot corrugated metal pipe culverts are causing minor downstream bed erosion.

Photo 3.31 Double 72" corrugated metal pipe culverts located under Sherwood Hall Lane

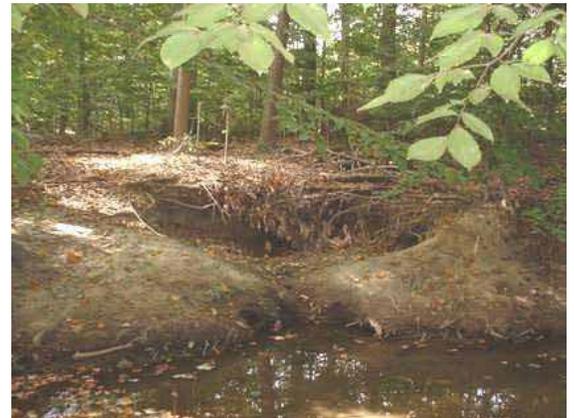
Fifteen concrete pipe outfalls discharge to North Branch and its tributaries. They range in size from 12 to 72 inches in diameter. Photo 3.34 shows a 60-inch concrete pipe outfall located at the headwaters of the tributary LHN001 to North Branch. Discharges from the majority of pipe outfalls are causing only minor erosion and their locations are shown on Map 3.14. Downstream of the confluence with Paul Spring Branch, a small ditch with an 18-inch width discharges into the stream and causes moderate erosion (shown in Photo 3.35).

Photo 3.35 A small ditch, 18' wide, discharges to North Branch just south of the confluence with Paul Spring Branch

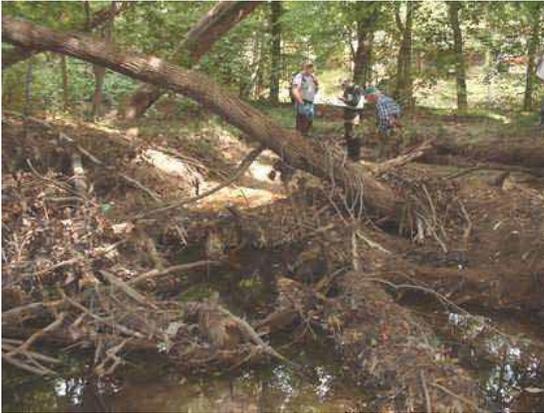
Downstream of the North Branch confluence with Paul Spring Branch, a fallen tree obstructed the fish passage without much of an impact on the stream (shown in Photo 3.36). Tributary LHNB001 has fallen trees obstructing the channel flow at two locations as shown in Photo 3.37. In the upstream segments of North Branch, the channel is littered with lawn waste consisting of grass and leaves. Partially buried or fully encased sanitary sewer pipes cross North Branch at four different locations and cause minor impacts on the stream. The location of all obstructions, dumpsites, and utility crossings impacting the stream are shown on Map 3.15.

Photo 3.36 Flow obstruction downstream of the North Branch/Paul Spring Branch confluence

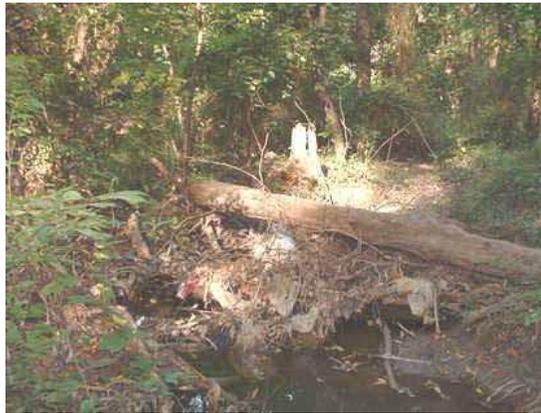
Photo 3.37 Flow obstruction in Tributary LHNB001 upstream of North Branch outfall to Little Hunting Creek

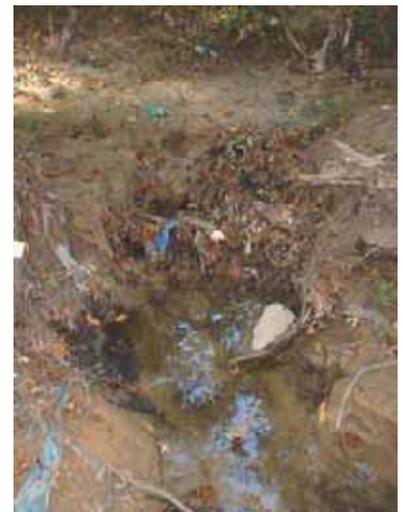
Photo 3.38 Head cutting of the stream bed on Tributary LHNB001

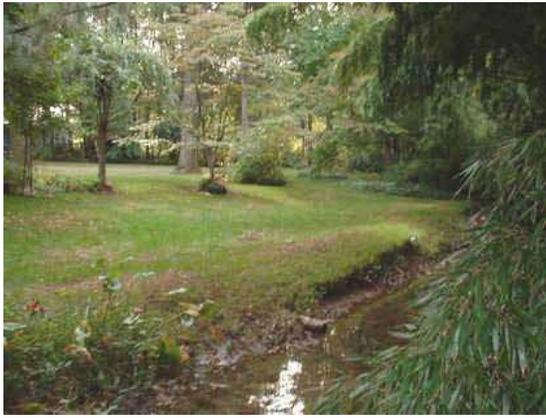
In the North Branch stream segments located immediately upstream and downstream of the North Branch/Paul Spring Branch confluence, the buffer area is covered with lawn causing a severe to extreme impact as shown in Photo 3.39. The downstream segments of Tributary LHNB001 have inadequate buffers adjoining pavement, causing a severe impact on the stream as shown in Photo 3.40. Overall, the North Branch stream segments do not have adequate natural buffer widths of 100 feet. The locations of deficient buffer areas along the stream corridor are shown on Map 3.16.

Photo 3.39 Lawn in the buffer zone downstream of Paul Spring Branch confluence

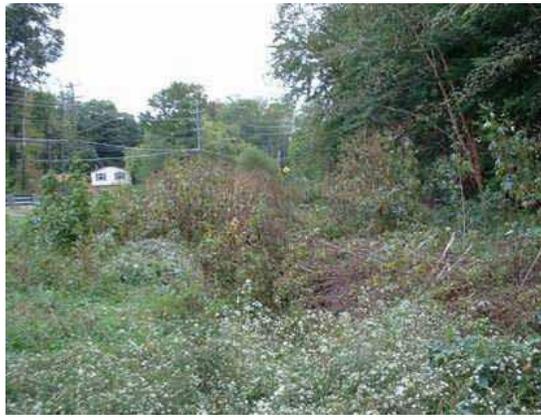
Photo 3.40 Buffer zone next to Collingwood Road on the eastern tributary to North Branch

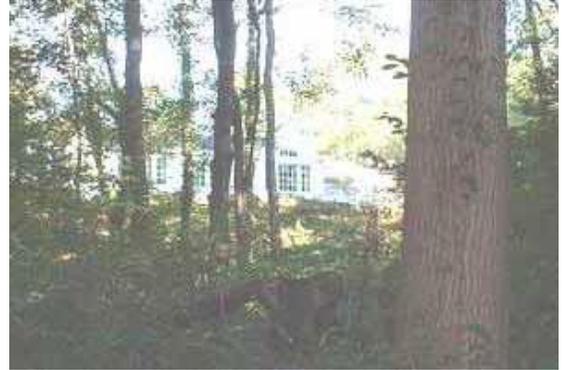
The natural buffer zone has been altered with planted lawns causing minor impacts on the stream as shown in Photo 3.43.

Photo 3.43 Lawn grass in the buffer zone along the stream located south of Eaglebrook Court
