# FAIRFAX COUNTY PARK AUTHORITY

## Final Progress Report

## Fitzhugh Park Ecological Restoration

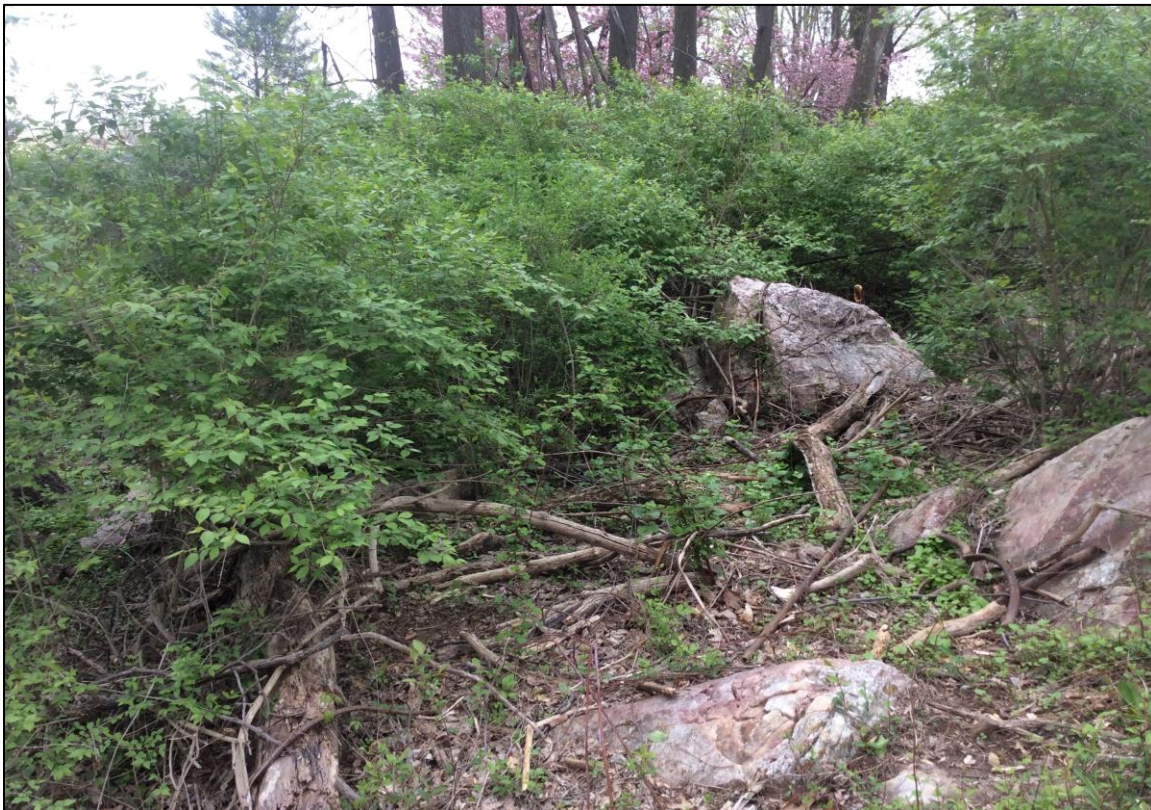
**Heavy invasion of bush honeysuckle (*Lonicera maackii*) in Management Unit 1, with low cover and diversity of native understory plants. Similar conditions existed throughout Units 1, 2, and 3 prior to restoration treatments.**

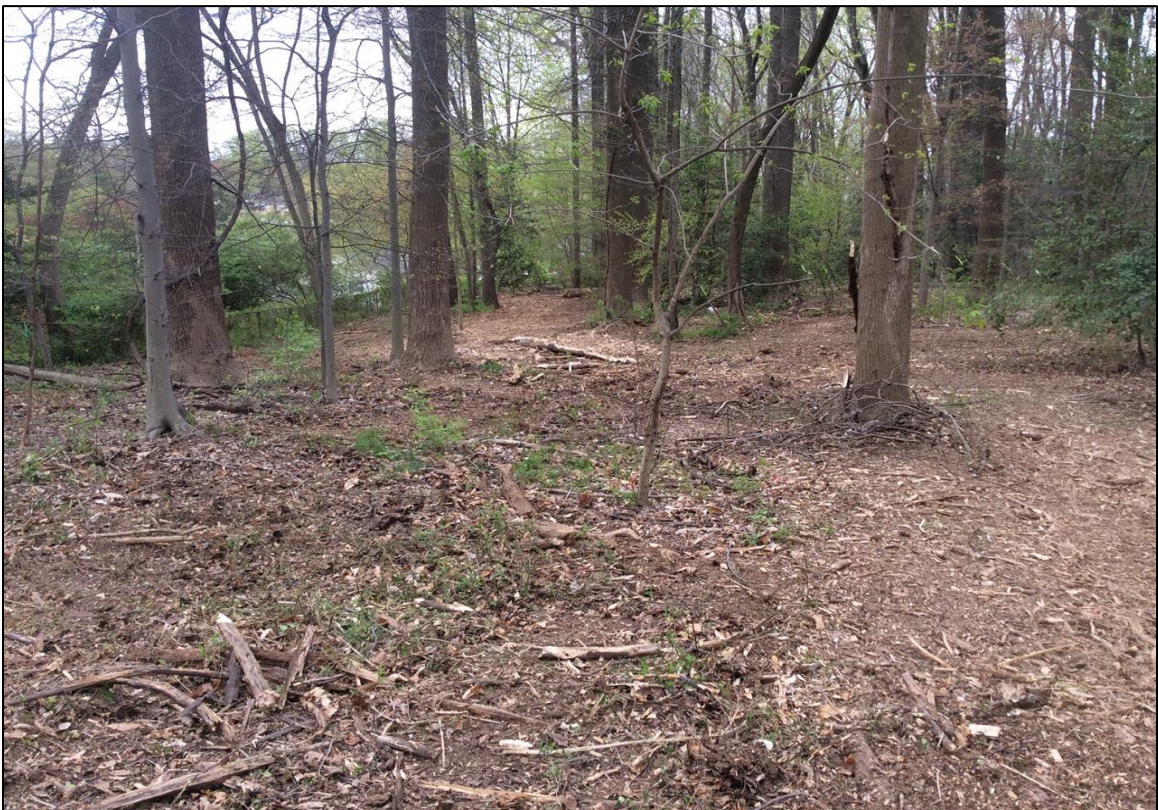
**Unit 1 following removal of invasive thickets with a forestry mulcher. Units 2 and 3 received the same treatment in preparation for planting and seeding natives.**

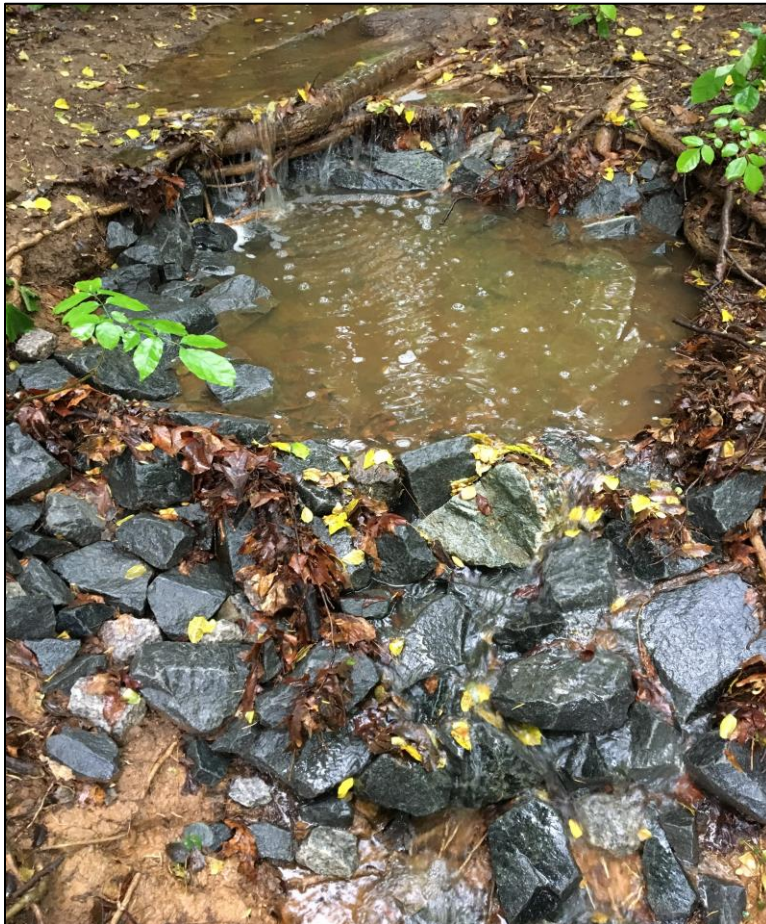
- Zuni bowl – A plunge-pool was built into a large migrating headcut in the forested drainage of Unit 7 using surge stone and class I rip rap (about 10'' in diameter). The purpose of this structure is to dissipate stormwater energy, encourage deposition, and halt migration of the existing headcut. This structure is also discussed in Let the Water do the Work.

**Newly installed Zuni bowl disperses stormwater energy and encourages sediment deposition. This structure was installed in 2017 to stabilize a migrating headcut in Unit 7.**

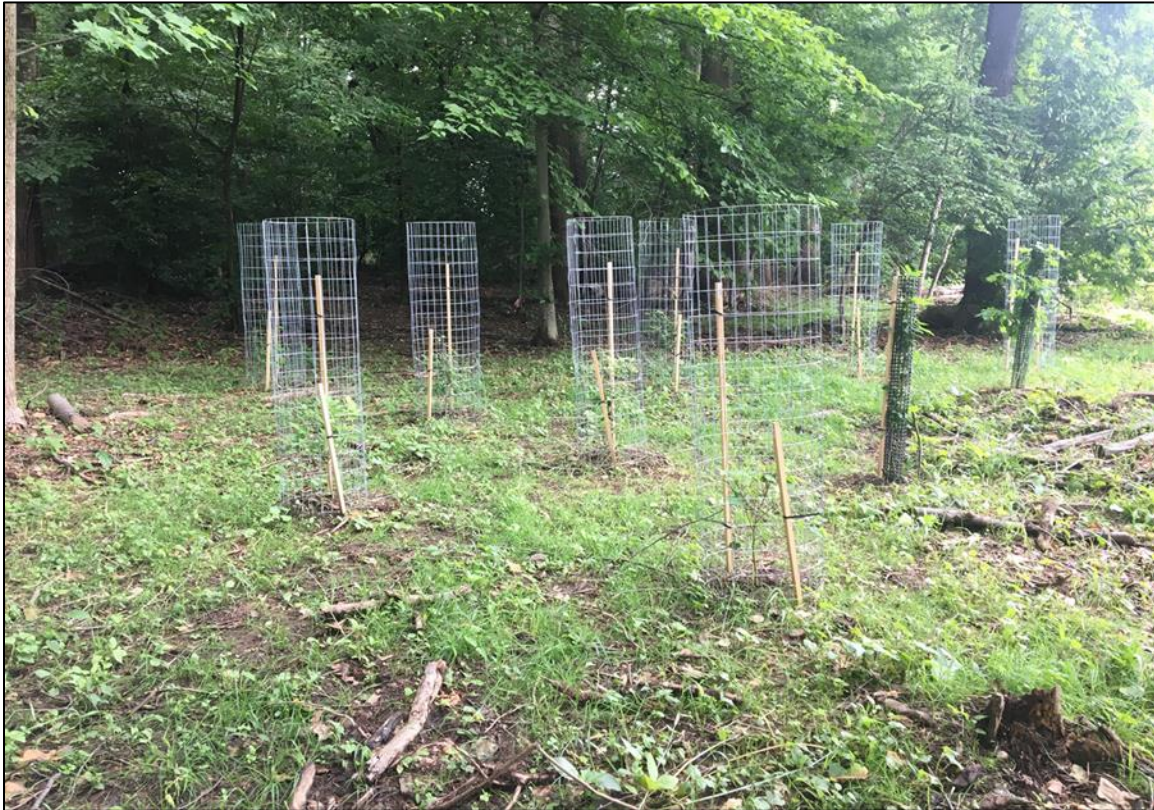
**Welded-wire cages were installed over plantings in Unit 2 in Summer 2019. Cages were mostly effective at preventing deer browse, although growing tips that escaped the cage were browsed.**

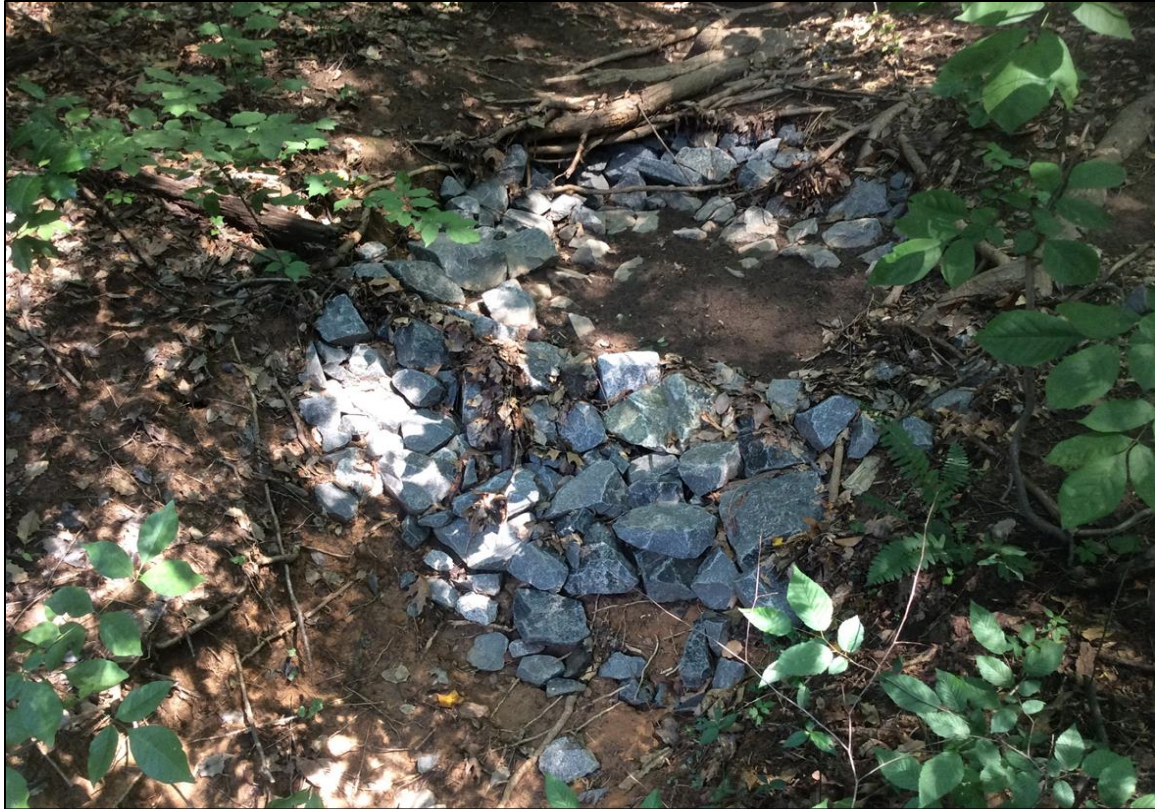
**After several heavy rainstorms, the Zuni Bowl has filled with sediment and presumably stabilized the headcut. Despite being filled with sediment, the structure still functions to disperse stormwater energy and reduce erosion. Ideally, plant roots will begin to colonize stable areas of deposition.**

A Zuni bowl was installed in Fall 2017 at the downstream end of the Unit 7 drainage, where a large headcut was developing. A zuni bowl is essentially a plunge-pool that dissipates energy of flowing water. The goal of the Zuni bowl was to stabilize the headcut, slow stormwater, and encourage sediment deposition. The structure was largely successful and appears to have stabilized the headcut and accumulated several inches of sediment. Further monitoring will be required to assess the long-term effectiveness of this structure.

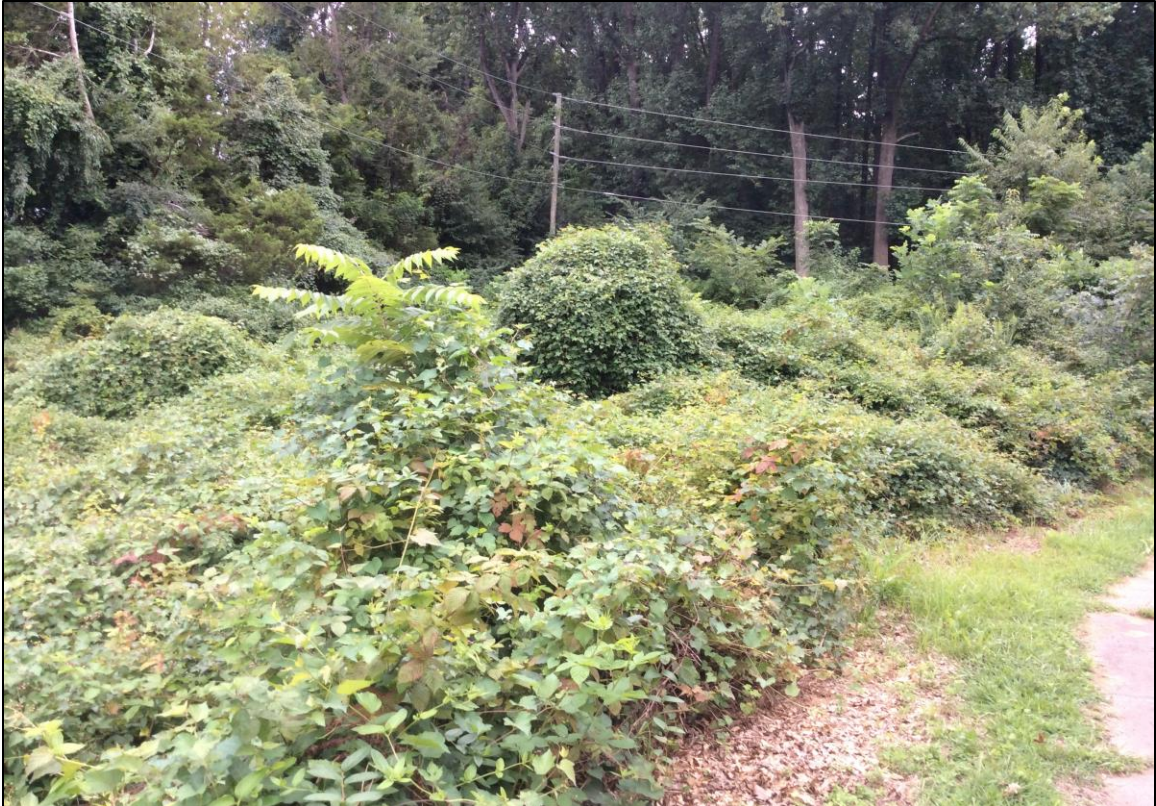
**Heavy invasion of porcelain berry (*Ampelopsis glandulosa*) and low native plant cover and diversity in Unit 4 prior to restoration treatments. Photo taken in 2017.**

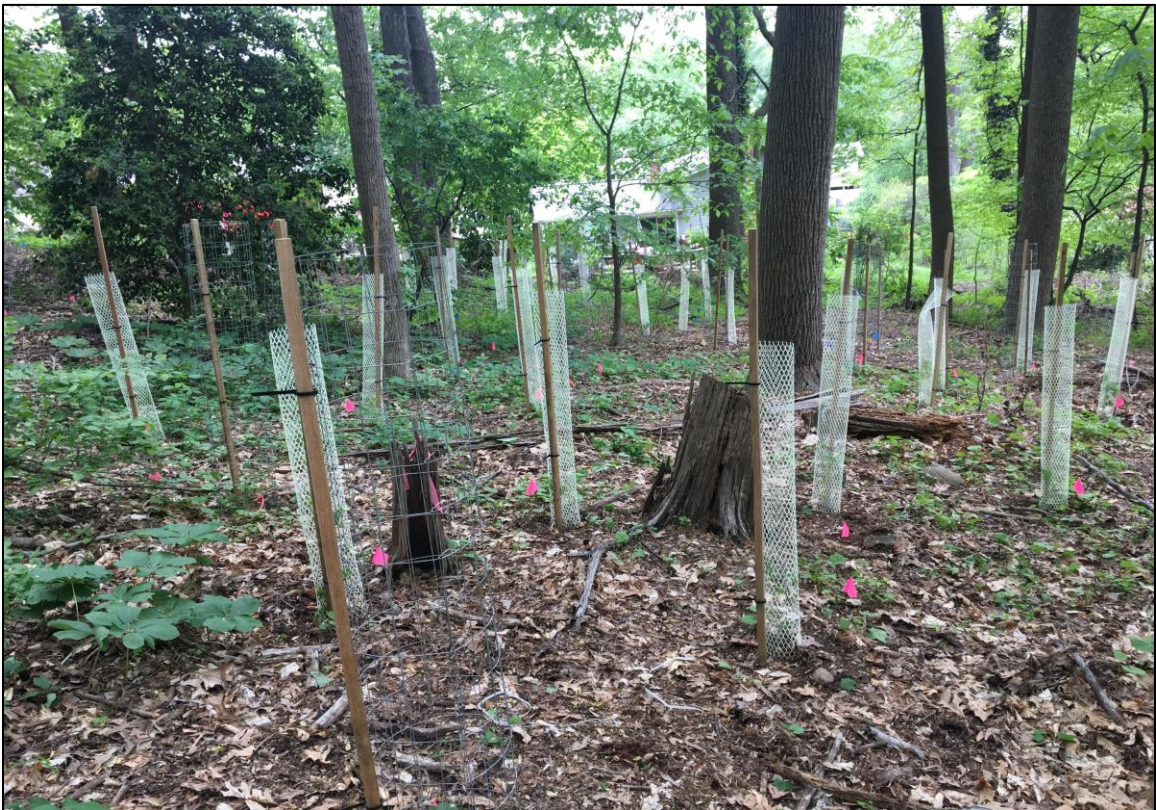
“Rigid Seedling Protector Tubes”, as they are sold on forestry-suppliers.com, are 5’ tall, 5” diameter flexible plastic mesh tubes. The advantage of these tubes is that they are very cheap and do not block sunlight or airflow. They were used to protect individual woody understory plantings in Unit 2S. These tubes were very difficult to install, as branches would get stuck in the mesh holes while installing the tube. Because of the small tube diameter and open-mesh design, growing tips would routinely escape the tube and be browsed. Overall, these tubes were not effective and are not recommended for future restoration plantings.

**Mixed planting of containerized understory shrubs typically found in Piedmont Mesic Mixed Hardwood forests in Unit 2S. “Rigid Seedling Protector Tubes” were used and proved mostly ineffective at preventing deer browse. Survival of this planting was low, possibly due to excessive shade or poor-quality planting stock.**

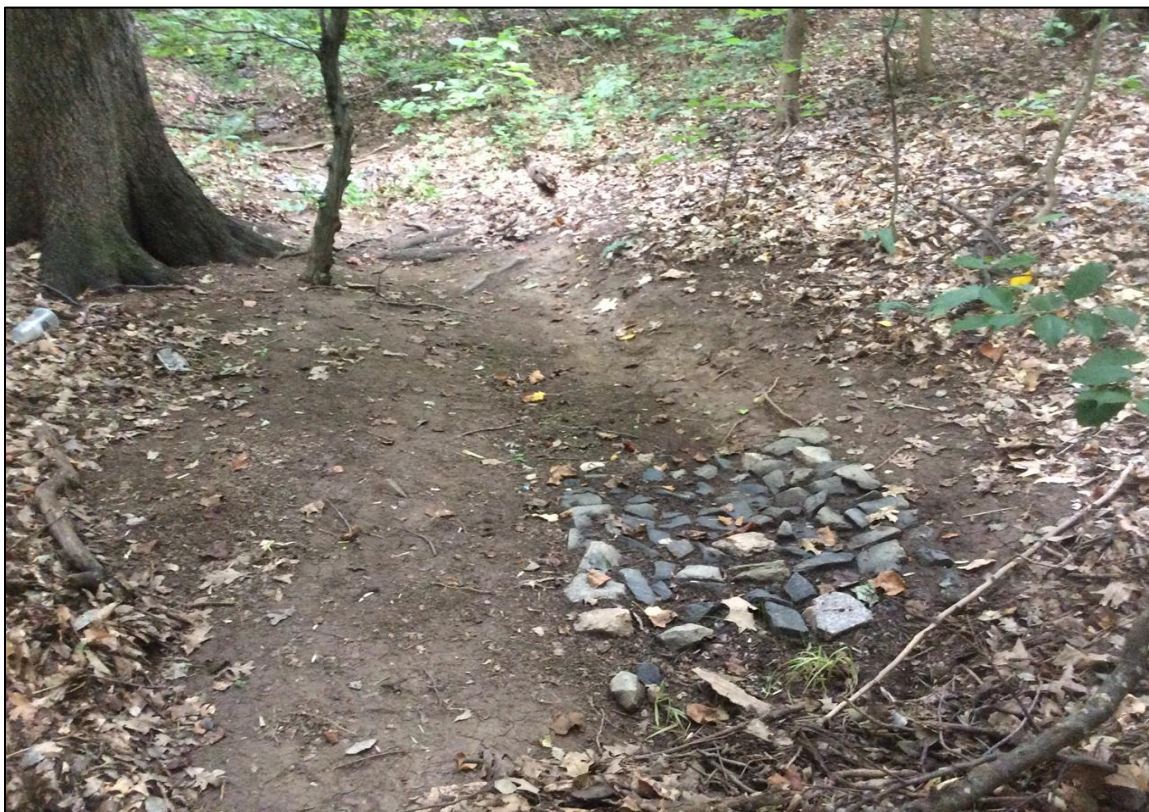
One-rock dams were installed in Fall 2017 at periodic intervals throughout the low-gradient portion of the drainage. These dams are meant to slow stormwater, preventing erosion and encouraging sediment deposition. Over time, spaces between the rocks should fill with sediment and plants may begin to grow into the dam and into the deposition upstream of the structure. The effectiveness of these structures in Unit 7 was mixed. They appear to be slowing water and encouraging sediment deposition upstream, but they also appear to be creating small headcuts directly downstream of each dam. The solution may be to install better rock “footers” downstream of the dams. Sediment has accumulated between the rocks of each dam, but plants have not established likely due to low light levels in the drainage.

Quart-sized herbaceous plantings were installed in Fall 2017 directly downstream of each one-rock dam, with the intention of further slowing stormwater and encouraging sediment deposition. These plantings did not establish well and were almost immediately washed out by heavy rainfall. In retrospect, the plantings may have been effective if placed directly upstream of each dam, where water pools and sediment is deposited.

**After several heavy rainstorms, the one-rock dam has partially filled with sediment and encouraged upstream sediment deposition. It is unclear if these are functioning as intended, since they appear to be scouring soil downstream.**
