### 3.7 Dog Run – Subwatershed Condition

#### 3.7.1 Subwatershed Characteristics

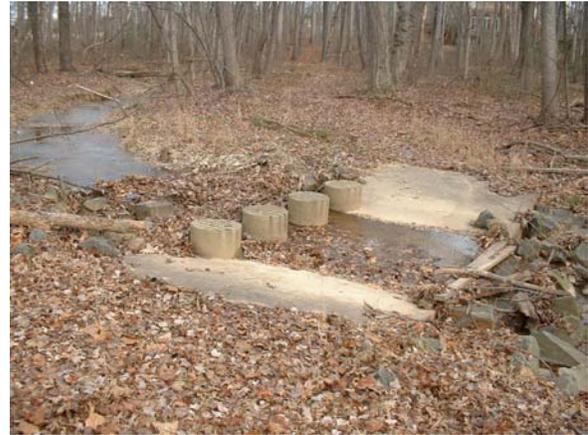
Stream crossings, such as bridges and culverts are often locations of erosion and flooding. The combination of aging structures and frequently high stormwater levels can cause downstream stream stability problems and habitat impairment. Most of the stream crossings in Dog Run were having only very minor impact on the stream condition. One of the crossings is a stream ford, which has deficiencies that should be addressed to enhance stream integrity and future stability of the structure. The impairment is likely due to high levels of upstream debris. The ford, which is a shallow part of a stream that can be crossed by foot or by land vehicle, is shown in Photo 3.8 and is located just upstream of a stream restoration candidate site S78.

*Photo 3.8 Ford located upstream east of Kimberly Place.*

*DF9278 (Stream Restoration)* A pattern, dimension and profile more consistent with a natural stream will be recreated. The stream would be re-connected to the floodplain. A riparian buffer would be established and bed features would be created.

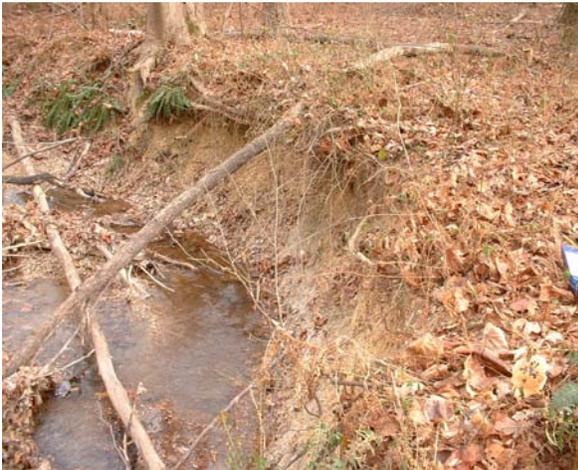
The entire stream length of Dog Run is characterized by moderately unstable banks with high erosion potential during **floods** as in Type II and III channels. Two specific erosion locations were located that are impacting the stream system. The first is located south of Georgetown Pike and east of Kimberly Place, and is 1,800 linear feet on the outer bends (see Photo 3.9). The eroding area is causing instream degradation, may be damaging property and is a stream restoration candidate site S78. The second erosion location (Photo 3.10) is on the most downstream reach near the confluence with Piney Run. It is 50 linear feet in length, has instream degradation, and is also a stream restoration candidate site S02.

*Photo 3.9 Erosion located south of Georgetown Pike, East of Kimberly Place (DFDG001.E002).*

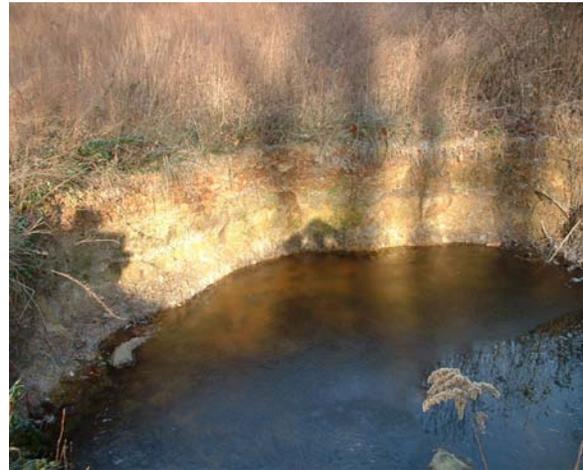
*Photo 3.10 Erosion located near confluence of Dog Run with Piney Run (DFDG001.E001).*

- S02 This reach has active widening, unstable banks, and erosion. It is located in the downstream portion of Dog Run near the confluence with Piney Run (Photo 3.10)
- S78 This eastern reach is in an area with missing buffer and erosion problems combined. This stream has Poor habitat (Photo 3.8 and 3.9).
- S79 This reach has missing buffer on both the left and right banks along with Poor habitat. Channel disturbance in the form of channelization is also an issue on this reach (Photo 3.11).

*DF9202 (Stream Restoration)* A more natural stream would be established with meanders, dimension, and a profile. The stream would be reconnected with the floodplain, the banks would be stabilized, and a stream buffer would be reestablished.

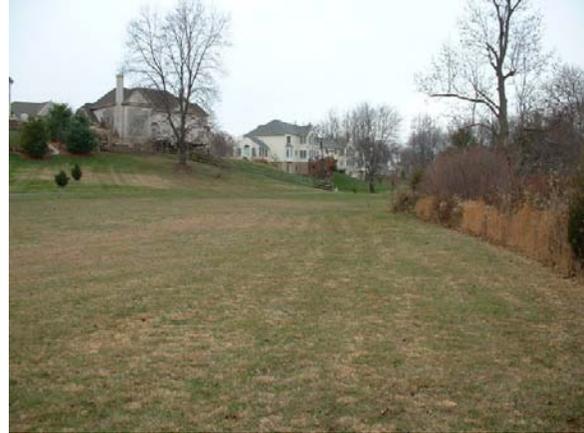
- The entire length of stream in the Dog Run subwatershed has Poor habitat for aquatic insects and fish.
- There is 11,575 linear feet of the stream, or approximately 43 percent of the total, which does not have sufficient **riparian buffer** (the total is for both banks). Of this total, 9,360 feet of the impact is from lawns.
- The western tributary has less than 50 percent of the stream bank surface covered with vegetation such as trees and shrubs.
- Many of the missing riparian buffer areas have good potential for restoration. There is approximately 2,000 feet of deficient buffer located within the Estates at Wyndham Hills between Fieldview Drive and Stones Throw Drive. This area has the potential for stream and buffer restoration, candidate site S79, and is shown in Photo 3.11.

*Photo 3.11 Deficient buffer located in the Estates at Wyndham Hills. (DFDG002.B001).*

*DF9279 (Buffer Restoration)* The buffer at this site has been degraded by development and the clearing of trees up to the streams edge. The riparian zone would be replanted with native trees and shrubs in the non-forested areas.
