3.21 The Glade – Subwatershed Condition

3.21.1 Subwatershed Characteristics

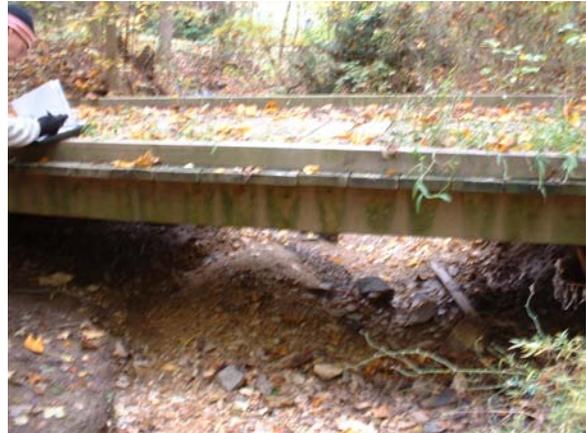
Stream crossings, such as bridges and culverts are often locations of erosion and flooding. The combination of aging structures and frequently high stormwater levels can cause downstream stream stability problems and habitat impairment. Seventeen of the 21 stream crossings in The Glade subwatershed are wooden footbridges. All but two crossings have very little impact on stream character. The two with more significant impact are wooden footbridges where the flow is creating moderate bank erosion. The erosion was not significant enough to warrant further study or restoration. The crossings are shown in Photos 3.64 and 3.65.

Photo 3.64 Wooden bridge where stream flow is causing moderate erosion. Located just off of Bassett Lane (DFGL008.C004).

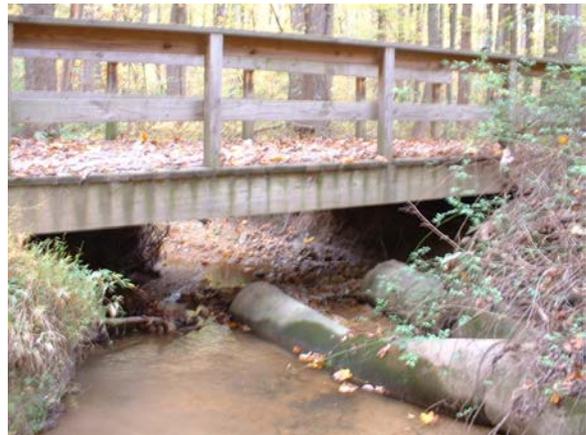
Photo 3.65 Wooden bridge where stream flow is causing moderate erosion. Located just west of Steeplechase Drive (DFGL008.C001).

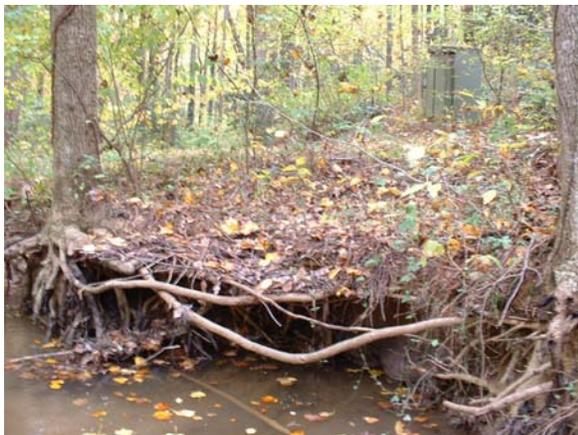
There were only two specific erosion locations noted in the subwatershed. Both were considered to be of moderate impact. These are located just downstream of a candidate stream restoration site S26. An example of the erosion is shown in Photo 3.67.

Photo 3.67 Erosion north of Lawyers Road near Pinoak Lane (DFGL006.E001)

- S26 The Stream Physical Assessment identified a significant portion of the stream, including this reach, which has erosion causing unstable banks (Photo 3.67).
- S104 A utility line was found in the stream along with unstable banks caused by erosion (Photo 3.69).

Site Investigation and Projects: The site investigation showed raw banks and moderate to severe incision. The stream had good pool variability and stable riffle bed features. The stream is largely recovered with some floodplain re-development. Constraints associated with utilities and wetland impacts outweigh the benefits of a bank stabilization project, so no project was identified.

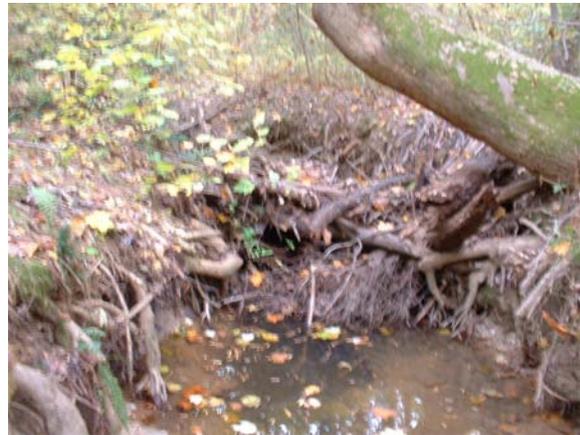
There are ten stream blockages, primarily comprised of downed trees. Eight of these blockages are likely restricting movement of fish within the stream system and can block passage. Only one obstruction is thought to have a severe impact. This obstruction of trees and debris is located on an upstream reach near Stirrup Road, upstream of the candidate stream restoration area S26 (see Photo 3.68).

Photo 3.68 Obstruction of trees and debris near Stirrup Road. (DFGL008.T001)

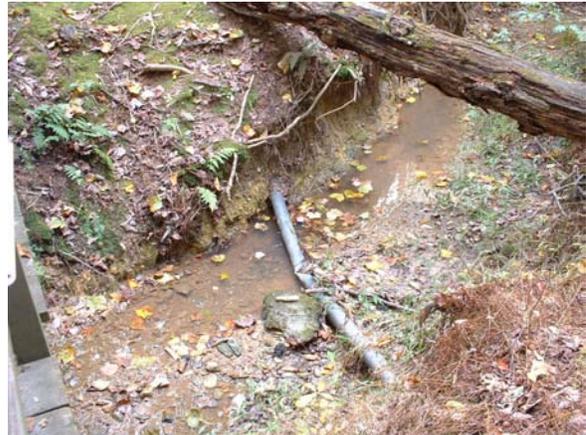
The field crew found a total of five partially exposed utility lines in the subwatershed, which can pose potential problems for both the stream and the utility lines. One utility line of an unknown type was completely exposed. This utility line is located just off of Stirrup Road on an upstream reach of the subwatershed and is a candidate restoration site S104 (Photo 3.69).

Photo 3.69 Utility line located just off of Stirrup Road on an upstream reach of the subwatershed (DFGL009.U001).

Site Investigation and Projects: The site investigation found three pieces of disconnected reinforced concrete stormwater pipe in the stream. The pipes have created an obstruction that has initiated streambank erosion. One project was identified

DF92104 (Streambank Stabilization) The stream would be realigned with a new pattern and profile to be more stable with the existing flow regime. The obstruction would be removed as part of this project. **Portions of this project may be constructed or superseded by Reston Association work in this stream channel.**
