## 2.3 Johnny Moore Creek Watershed (Johnny Moore Creek and Johnny Moore Creek – Bull Run WMAs)

### 2.3.4 Stream Condition

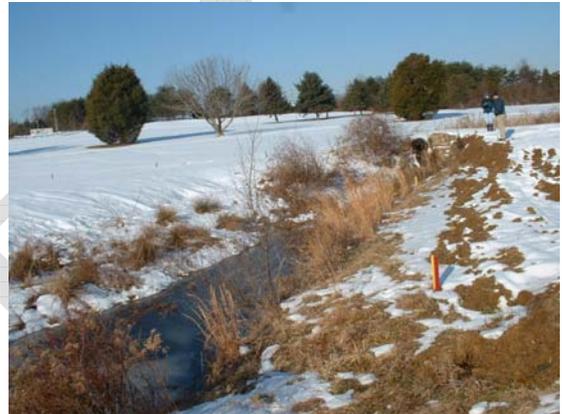
Figure 2-2: Very poor stream habitat segment – Twin Lakes Golf Course

The stream habitat segment classified as very poor in the above list (shown in Figure 2-2) is located within the Twin Lakes Golf Course and is an altered channel with little to no vegetated buffer. Stream segments with sections classified as “poor” for stream habitat are located on various tributaries to Johnny Moore Creek, but none are on the Johnny Moore Creek main stem.

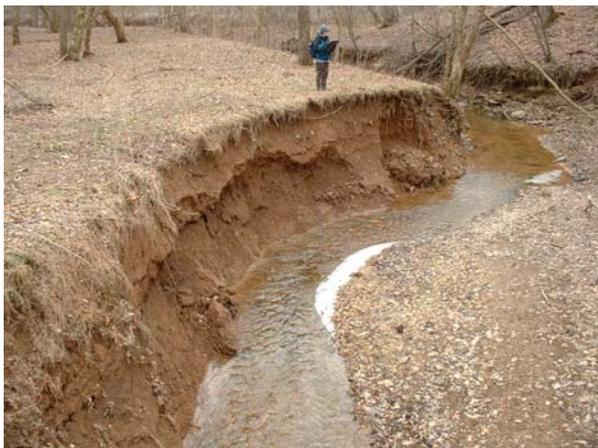
The SPA noted two areas of moderate to extreme erosion on Johnny Moore Creek. One near the confluence with Bull Run and one approximately 800 feet downstream of Balmoral Greens Avenue. Photos of the two areas are shown in Figures 2-3 and 2-4 below.

Figure 2-3: Erosion area near confluence with Bull Run

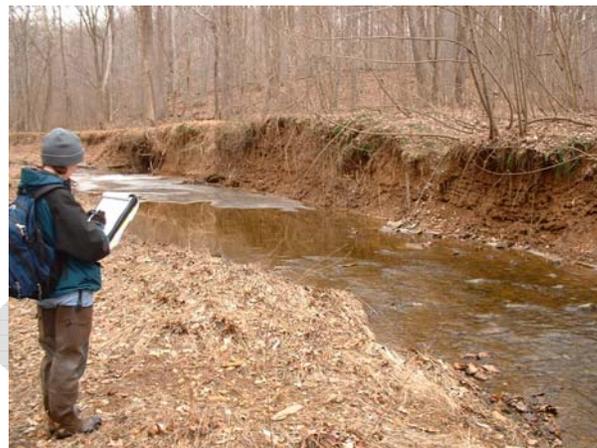
Figure 2-4: Erosion area downstream of Balmoral Greens Avenue

Severe bank erosion was also observed along the main channel of Johnny Moore Creek near the Balmoral Greens neighborhood in the same location as noted in the 2005 SPA. The following pictures show an update of erosion occurring in this area.

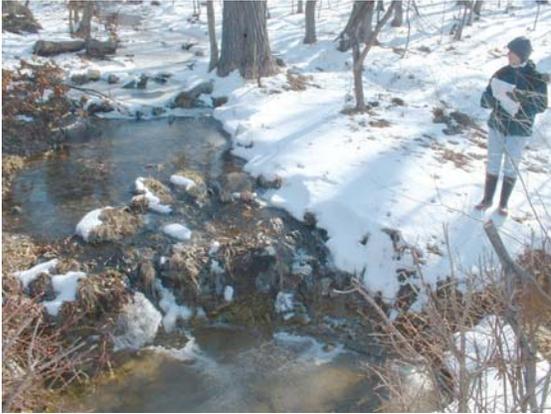
Figure 2-5: Headcut on tributary located on Twin Lakes Golf Course

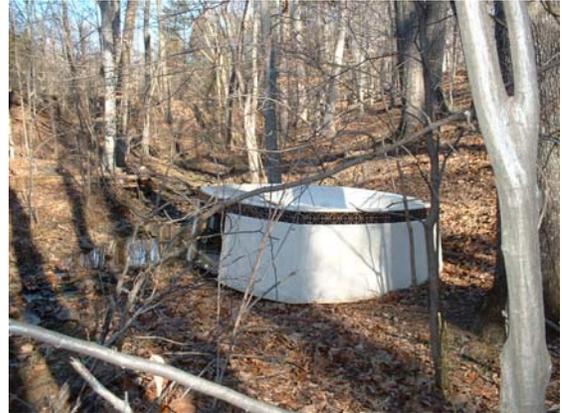
Figure 2-6: Dump Site on tributary along Union Mill Road (no longer there – see below)

existed in 2008. A dump site identified in 2005 on a tributary along Union Mill Road where a hot tub was abandoned is no longer present.

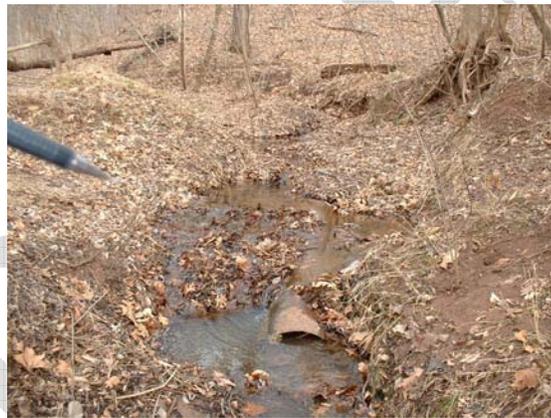
Figure 2-7: Pipe Impact near confluence with Bull Run

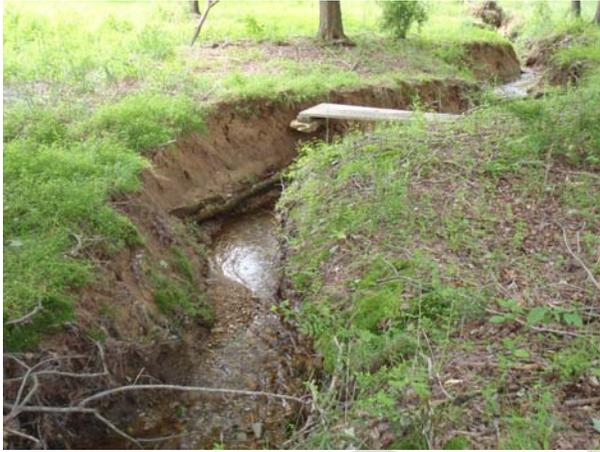
Severe erosion was observed on tributaries as well as the main stem of Johnny Moore Creek. The tributary located near the intersection of Clifton Road and Cedar Ridge Drive is experiencing severe erosion and headcuts. The following pictures show the erosion near the intersection.

Figure 2-8: Bank erosion in excess of 3ft on small tributary near Cedar Ridge Drive

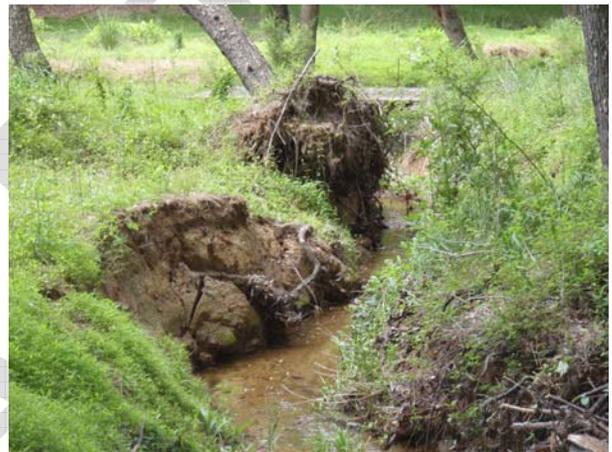
Figure 2-9: Bank erosion in excess of 3ft on small tributary near Cedar Ridge Drive

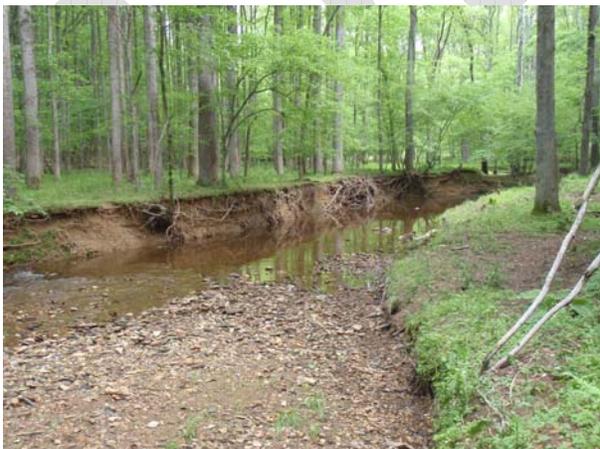
Figure 2-10: Bank erosion in excess of 3ft on Johnny Moore Creek near Balmoral Greens Subdivision

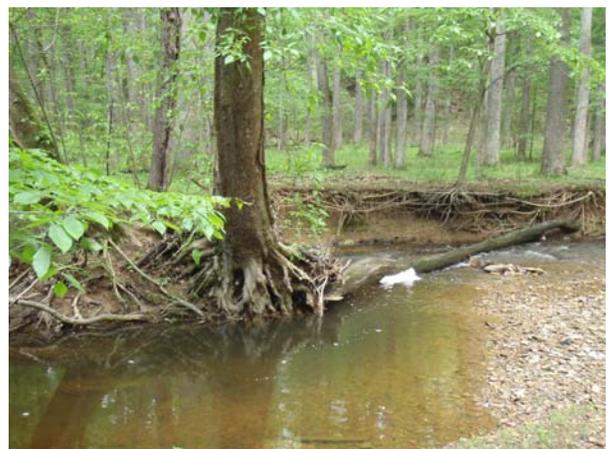
Figure 2-11: Bank erosion in excess of 3ft on Johnny Moore Creek near Balmoral Greens Subdivision
