Chapter 4

State of Cameron Run and its Subwatersheds

4.1 STATE OF CAMERON RUN WATERSHED

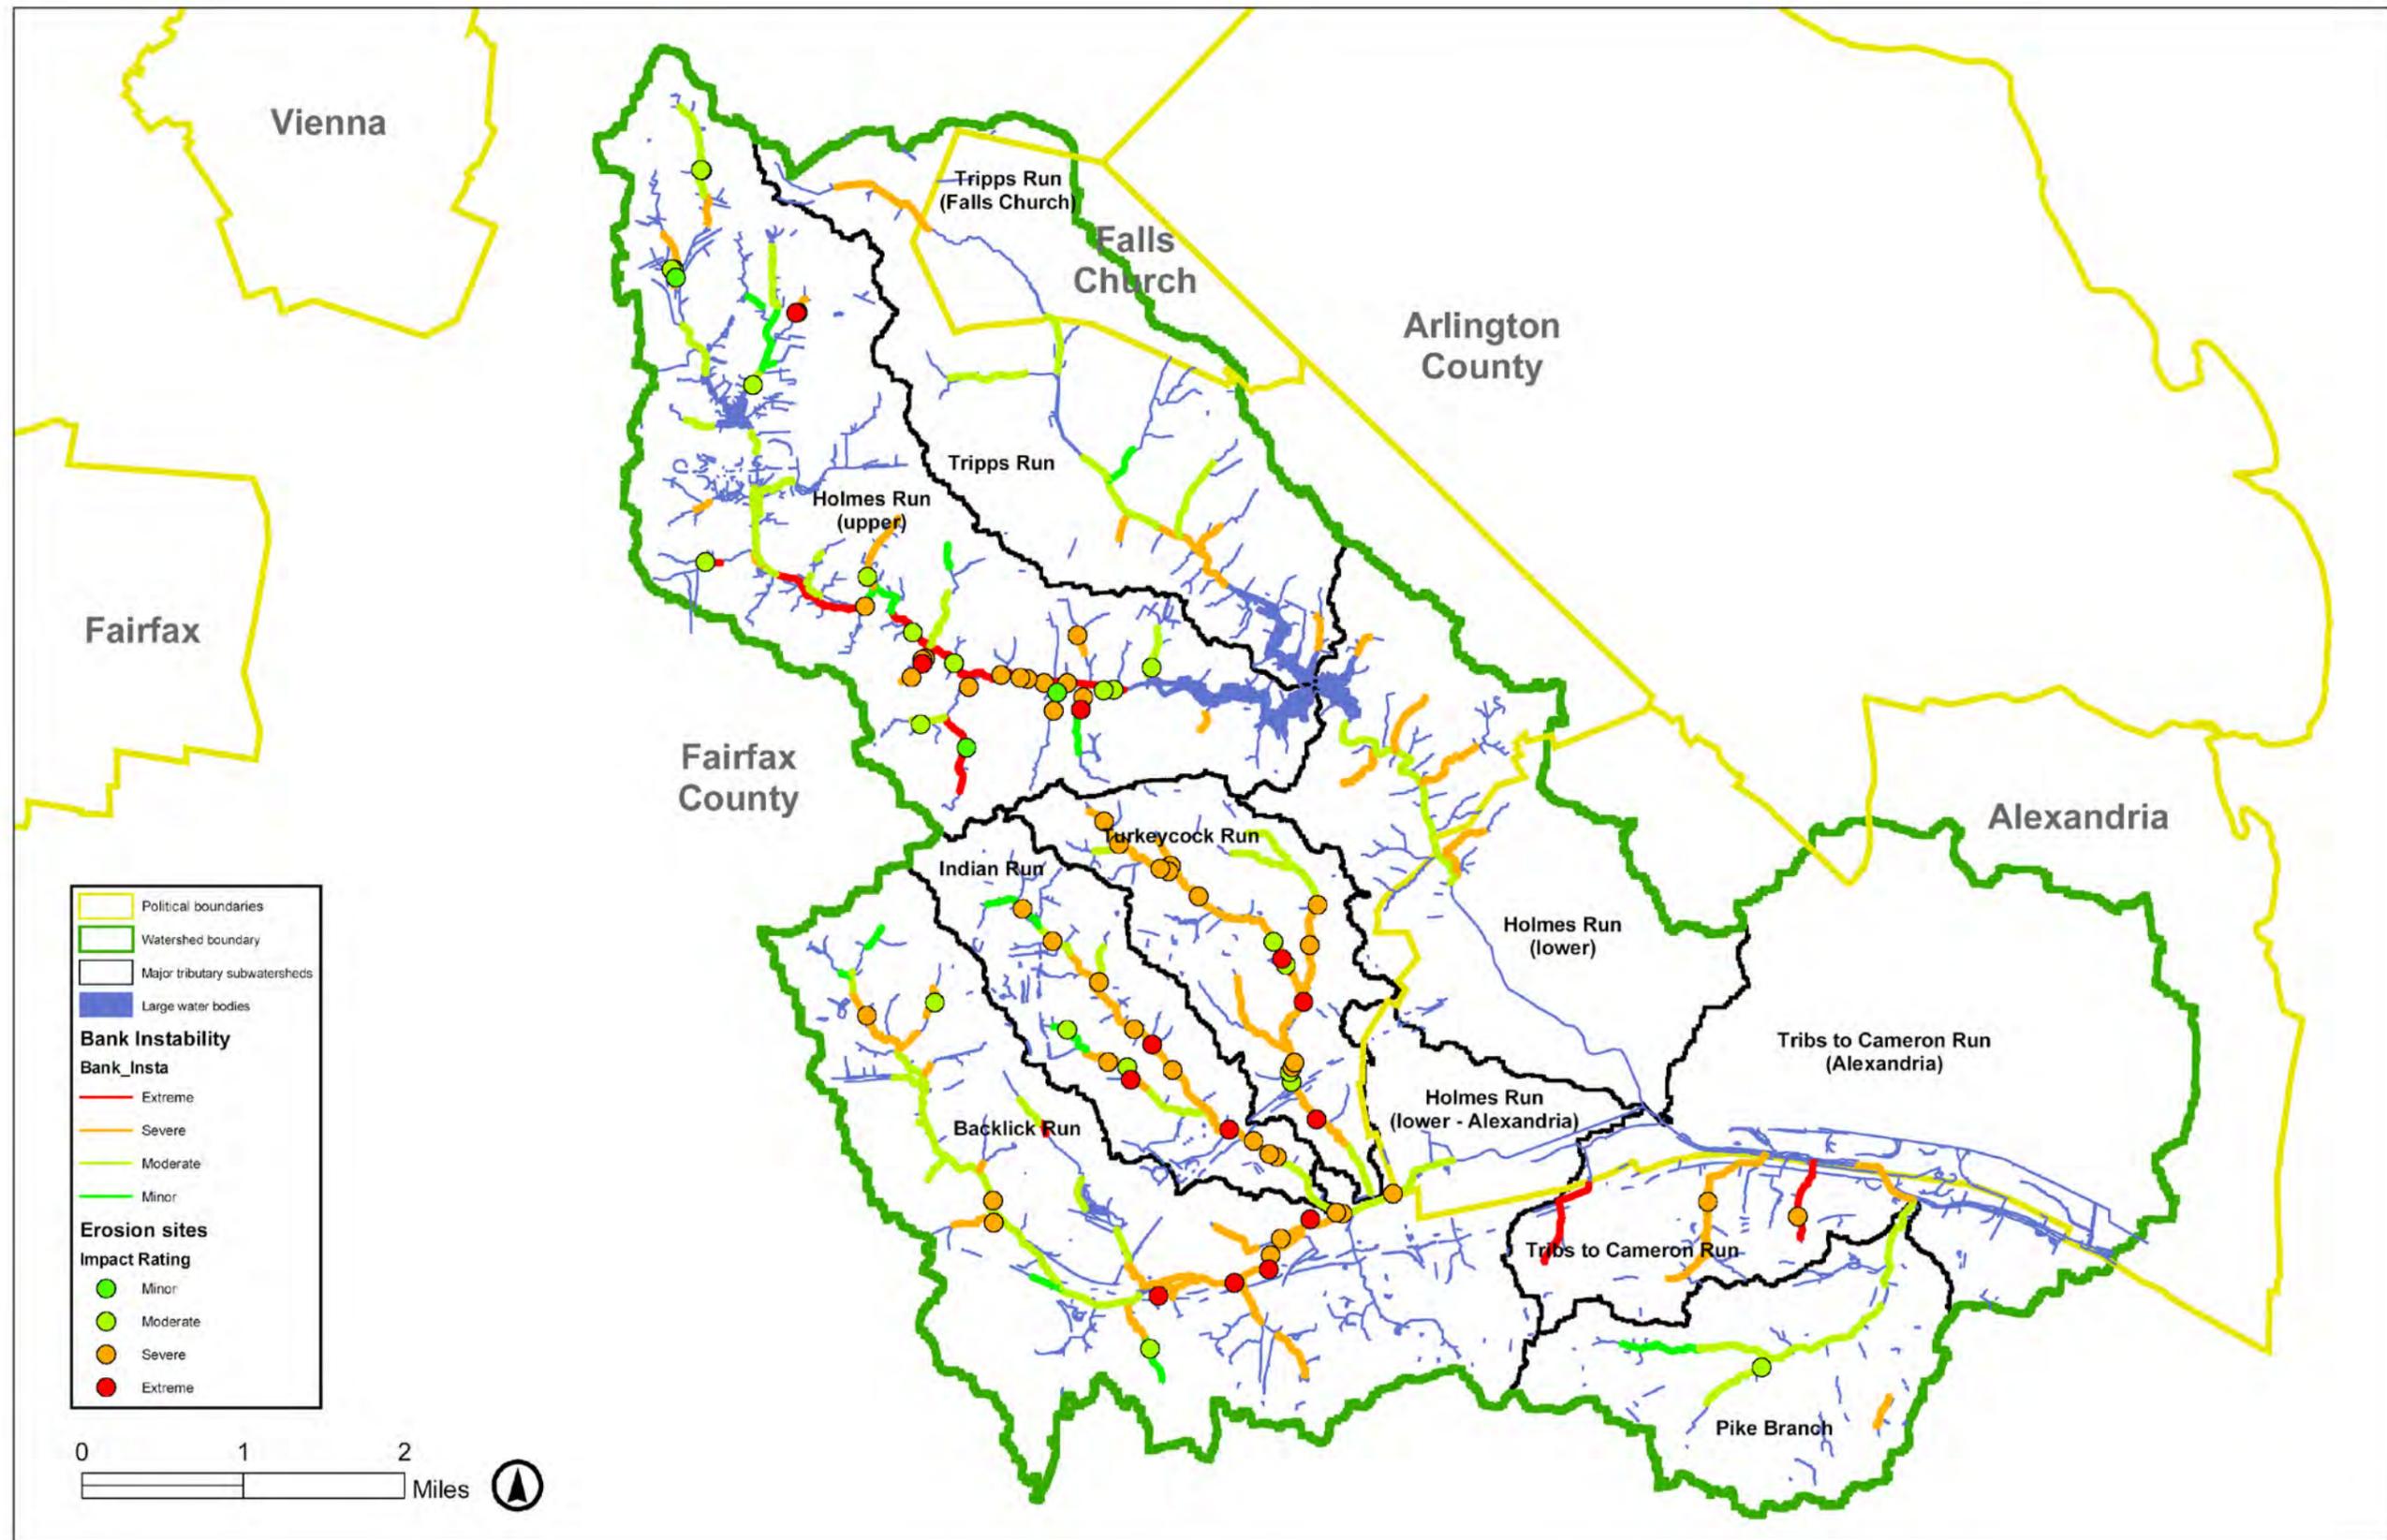
Figure 4-5. Bank instability and erosion sites in Cameron Run watershed

- **Erosion sites** are specific locations along the stream that have been identified as having erosion problems. A severity rating was also recorded to help evaluate the observed erosion problems.

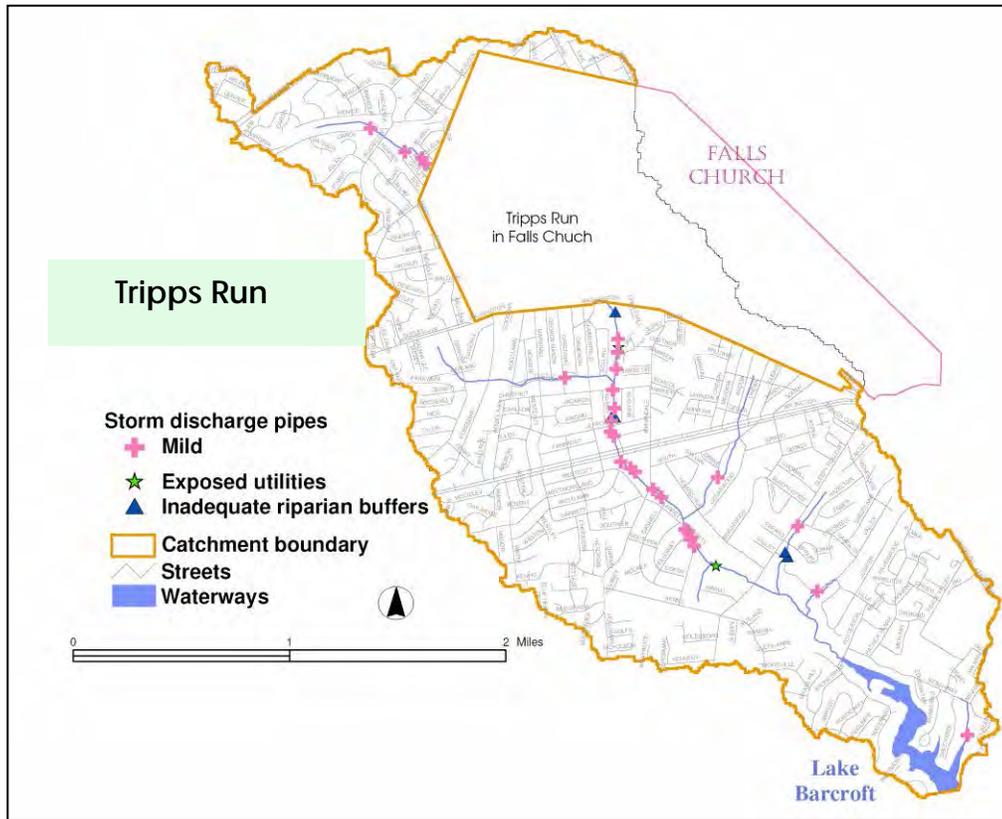
Figure 4-15. Locations of major problems in Tripps Run subwatershed as indicated by SPA data

An analysis of the SPA data indicates that the major problems within the subwatershed are inadequate buffers, numerous stormdrain pipes, and exposed utilities (Figure 4-15).

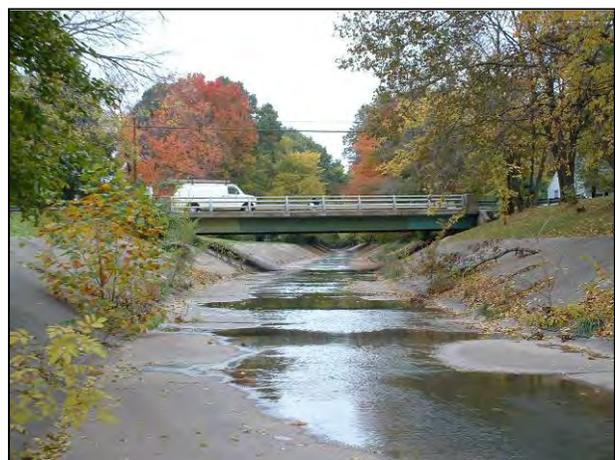
Channelized portion of Tripps Run

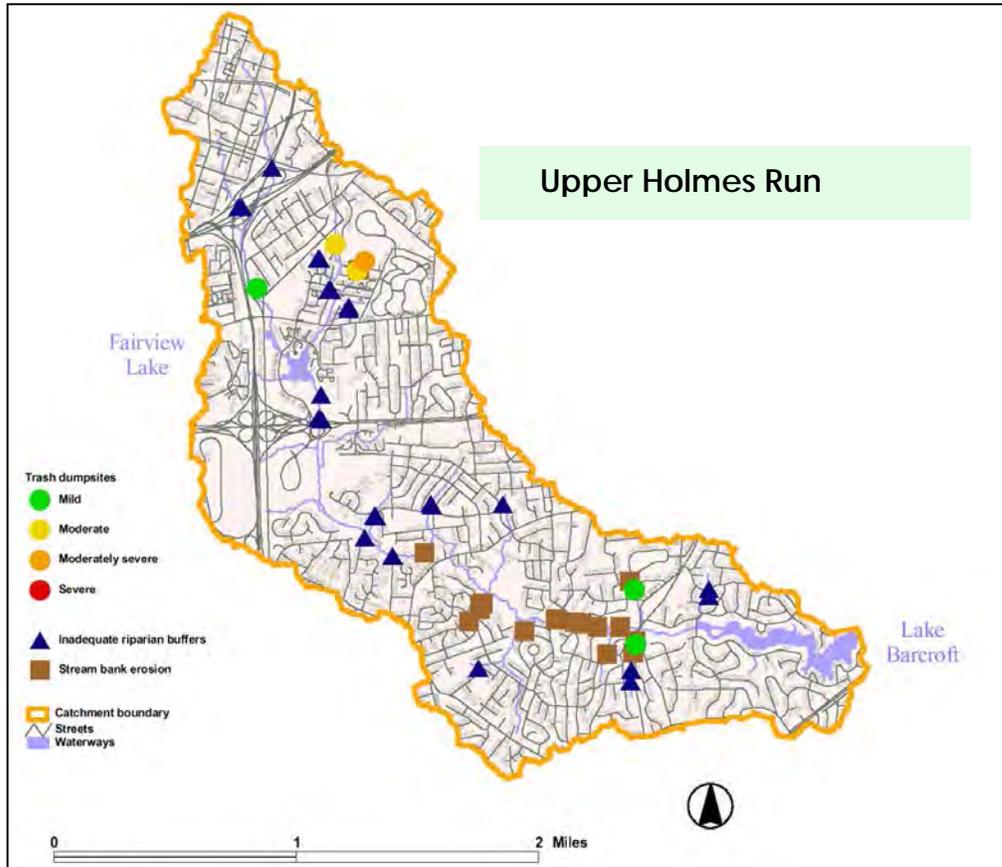
Figure 4-18. Location of major problem areas in Upper Holmes Run subwatershed as indicated by SPA data

An analysis of the SPA data indicates that the major problems within the subwatershed are inadequate buffers, eroded streambanks, and trash dumpsites (Figure 4-18).

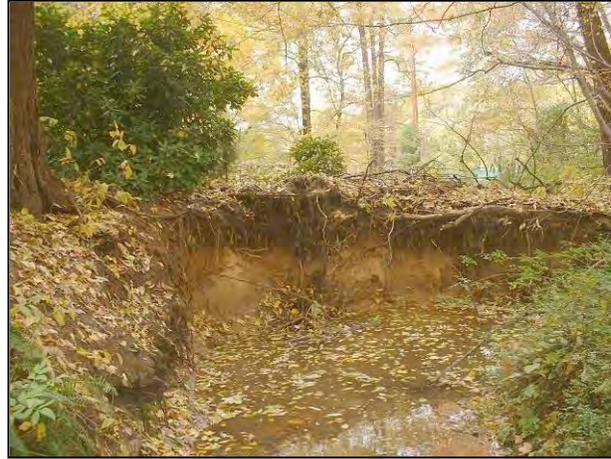
Streambank erosion in Upper Holmes Run

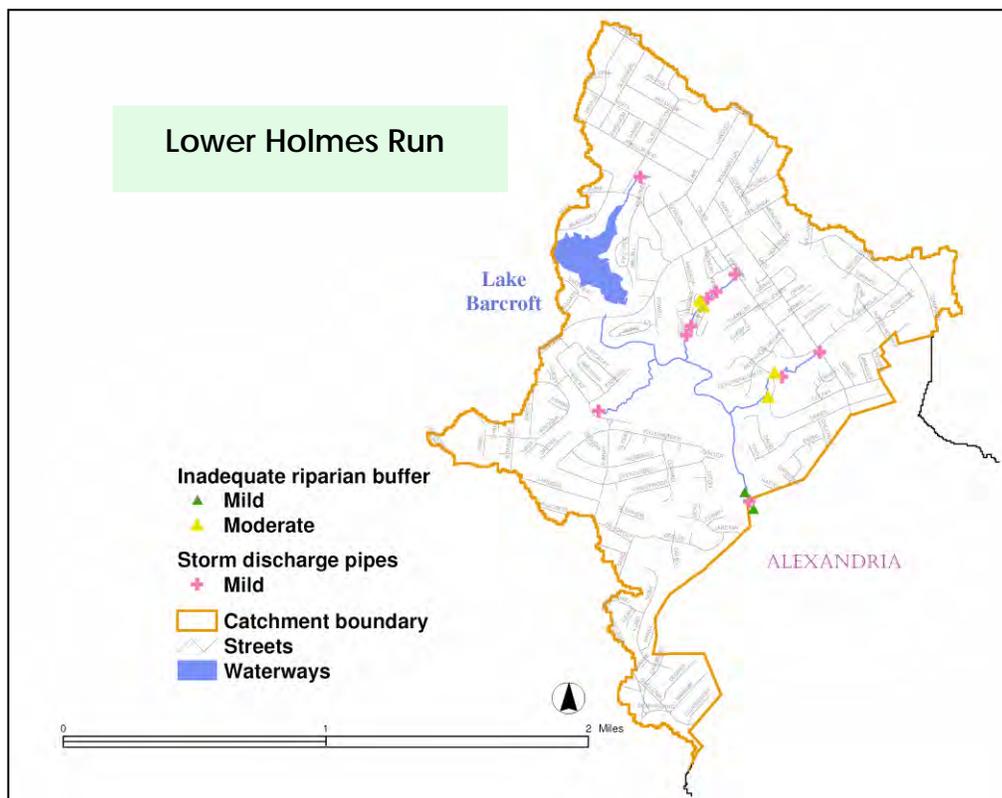
Figure 4-21. Location of problem areas in Lower Holmes Run subwatershed as indicated by SPA data

An analysis of the SPA data indicates that the major problems within the subwatershed are inadequate buffers and numerous stormdrain pipes (Figure 4-21).

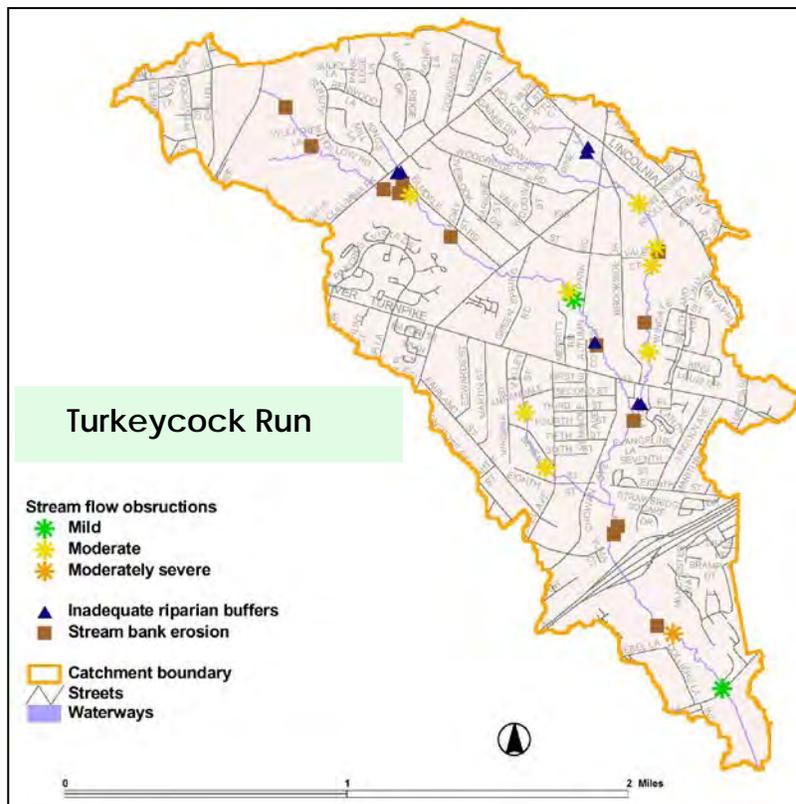
Figure 4-24. Location of major problems in Turkeycock Run subwatershed as indicated by SPA data

An analysis of the SPA data indicates that the major problems within the subwatershed are inadequate buffers, eroded streambanks, and obstructions of stream flow (Figure 4-24).

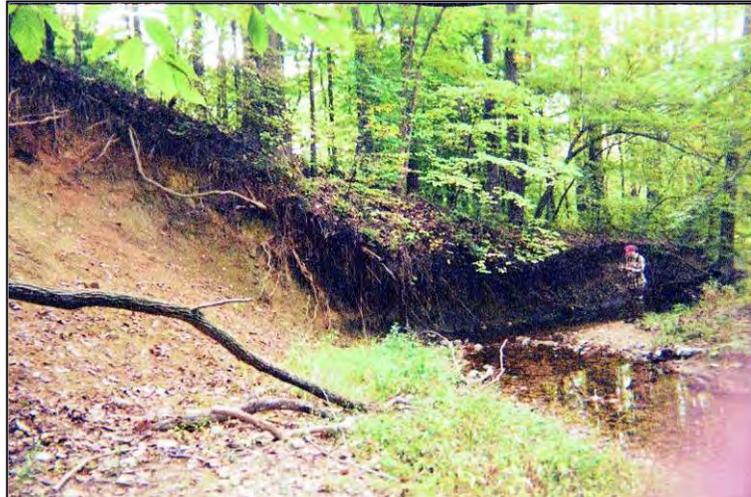
Streambank erosion along Turkeycock Run

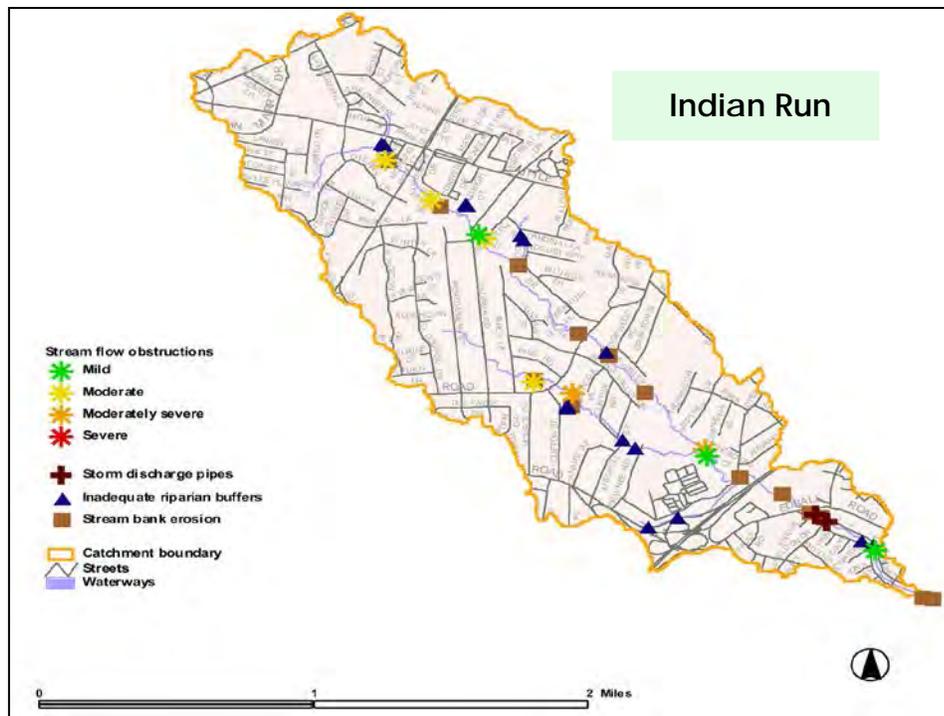
Figure 4-27. Location of the major problem areas in Indian Run subwatershed as indicated by SPA data

An analysis of the SPA data indicates that the major problems within the subwatershed are inadequate buffers, eroded streambanks, storm discharge pipes, and obstructions of stream flow (Figure 4-27).

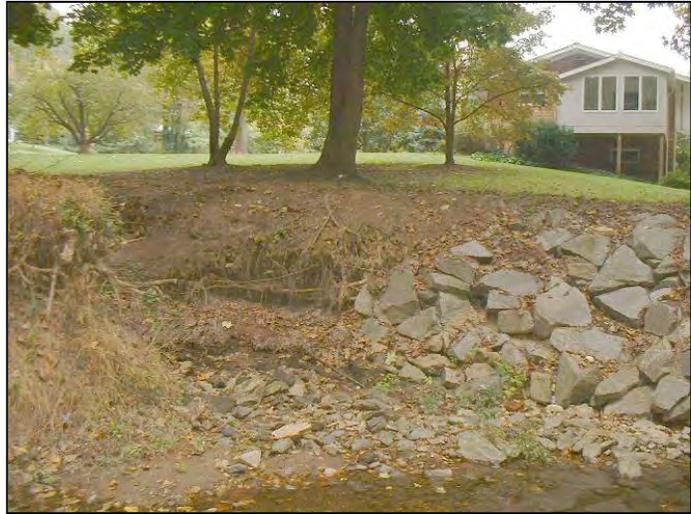
Bank erosion and inadequate buffer along Indian Run

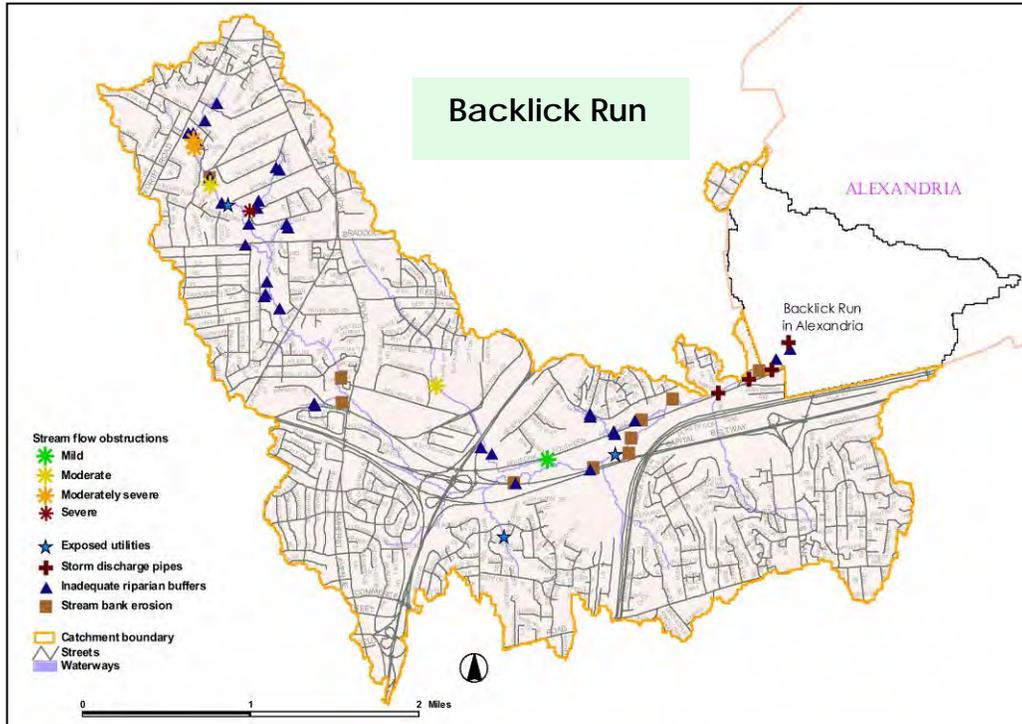
Figure 4-30. Location of major problem areas in Backlick Run subwatershed as indicated by SPA data

An analysis of the SPA data indicates that the major problems within the subwatershed are inadequate buffers, eroded streambanks, exposed utilities, storm discharge pipes, and obstructions of flow (Figure 4-30). Backlick Run was included on EPA's list of impaired waters for fecal coliform contamination.

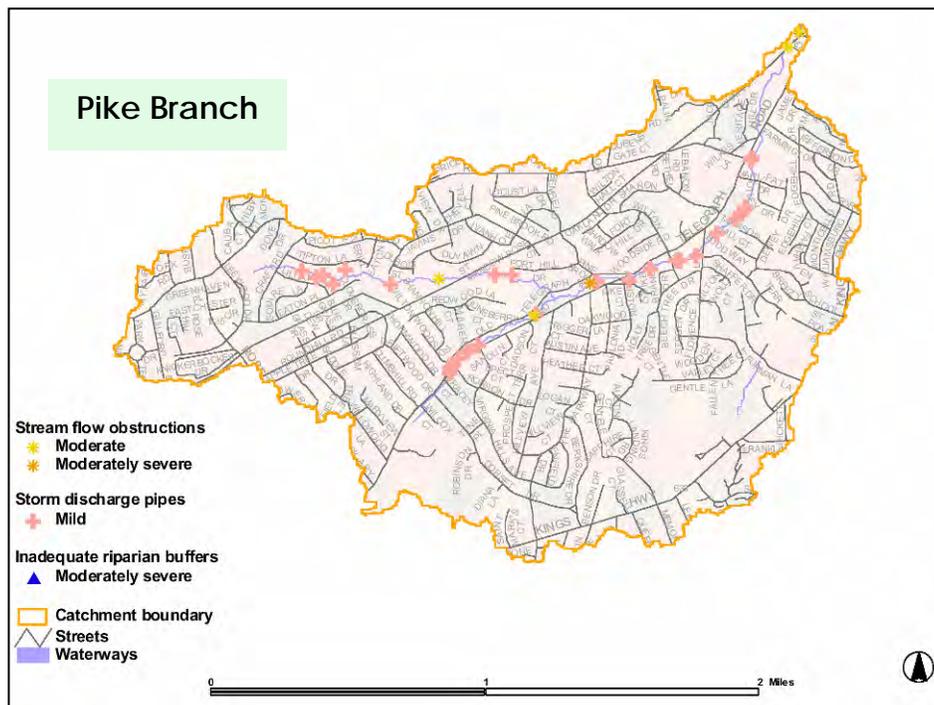
Figure 4-33. Location of major problem areas in Pike Branch subwatershed as indicated by SPA data

An analysis of the SPA data indicates that the major problems within the subwatershed are inadequate buffers, obstructions of stream flow, and stormdrain pipes (Figure 4-33).

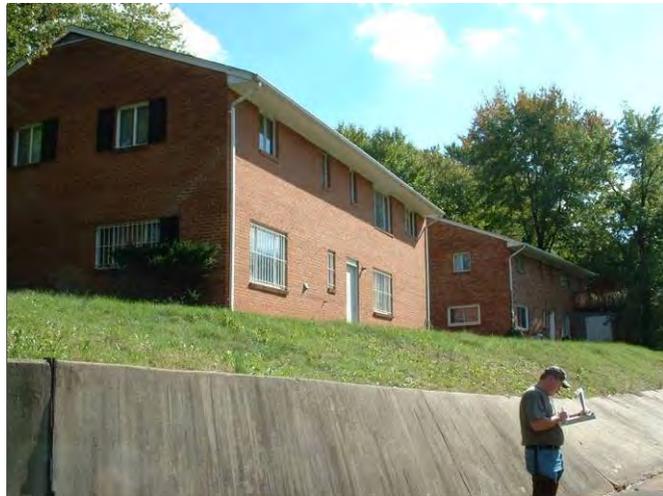
Channelization in Pike Branch

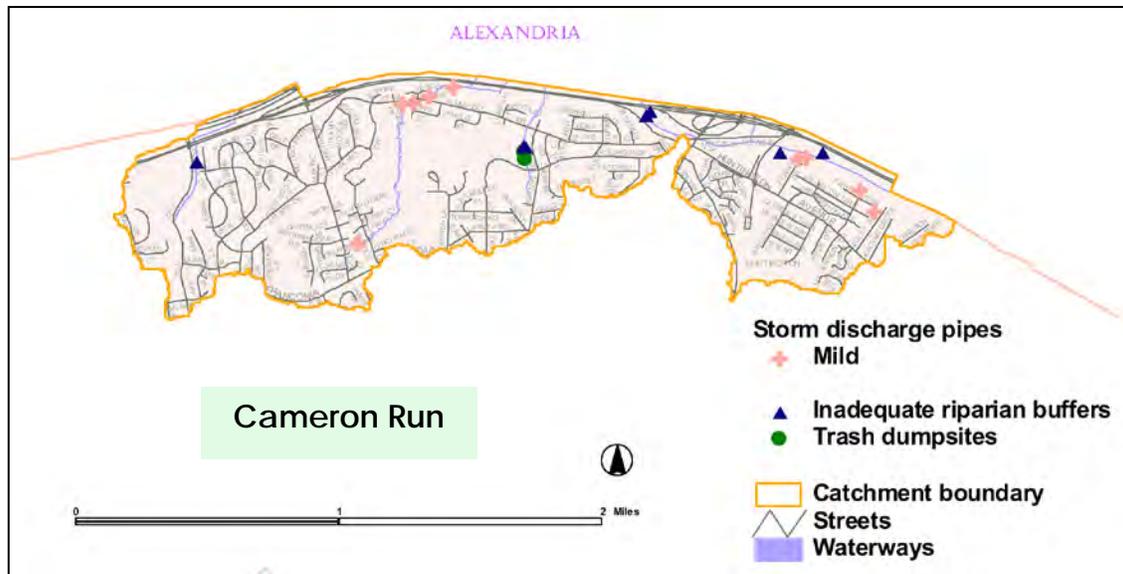
Figure 4-36. Location of major problem areas in Cameron Run subwatershed as indicated by SPA data

An analysis of the SPA data indicates that the major problems within the subwatershed are inadequate buffers, trash dumpsites, and stormdrain pipes (Figure 4-36). These waters are included on EPA's list of impaired waters for acute ammonia and fecal coliform contamination. PCBs were found in fish tissues, which prompted the Virginia Department of Health to issue a health advisory. A 1985 study in Alexandria identified poor groundwater conditions (high sodium chloride, iron, and total dissolved solids), which can influence baseflow water quality.
