3 Subwatershed Condition and Plan Action

3.1 Introduction

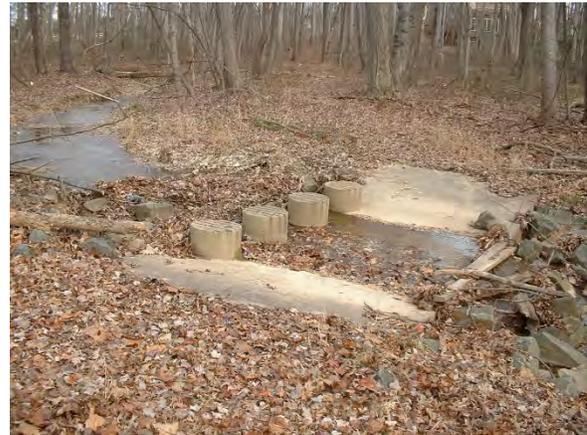
Photo 3.8 Ford located upstream east of Kimberly Place.

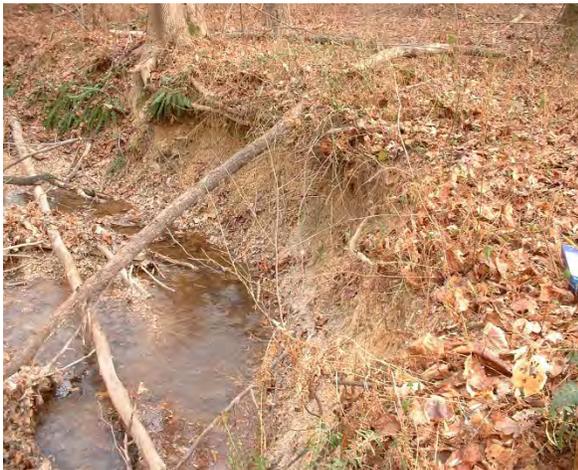
Photo 3.9 Erosion located south of Georgetown Pike, East of Kimberly Place (DFDG001.E002).

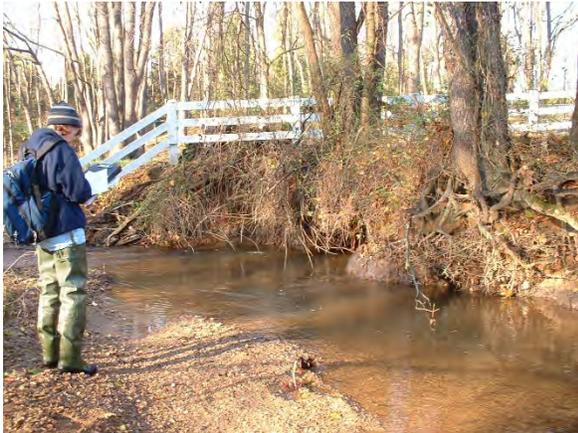
Photo 3.12 Erosion just south of Eisenhower Lane (DFPR005.E001).

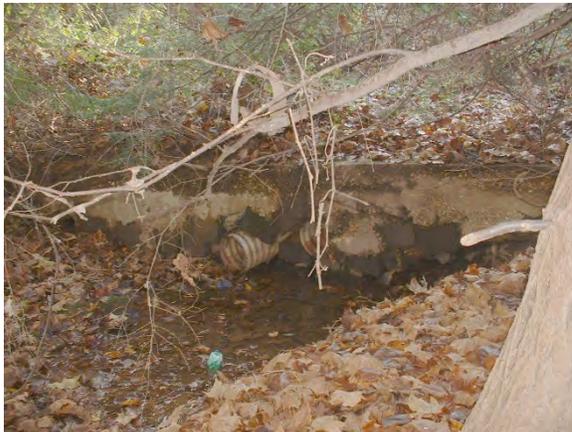
Photo 3.22 Erosion at outfall pipe located near Mill Creek Landing (DFDF003.P001).

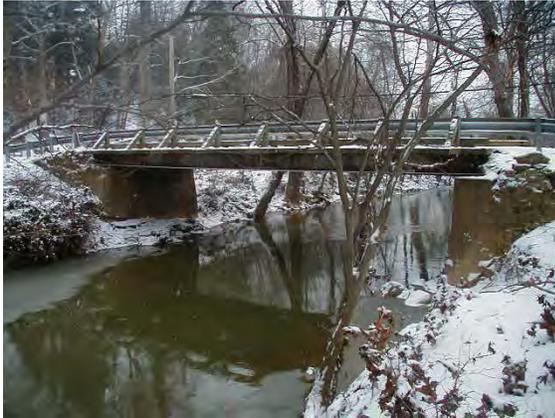
Photo 3.33 Lower Difficult Run Mainstem at **ents**
Leigh Mill Road

Culvert #72 (Photo 3.33) overtopped for all events also. Leigh Mill Road carries through traffic and is thus considered a primary road. Primary roads should pass the 25-year event.

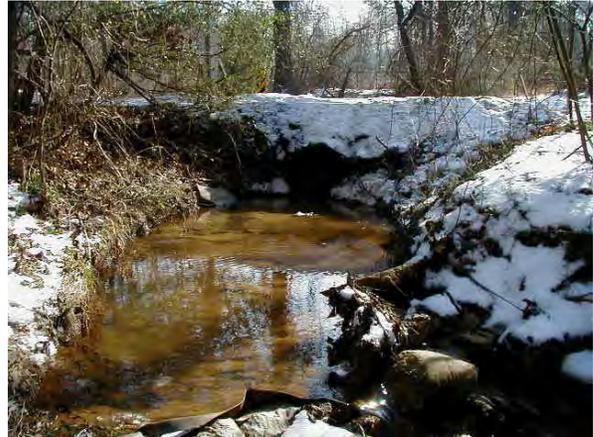
Photo 3.37 Sharpers Run mainstem at Bellview Road.

Culvert #80 (Photo 3.37) overtopped for all events except the one and two-year. Bellview Road carries through traffic, so it is considered a primary road. This means that it must pass the 25-year event.

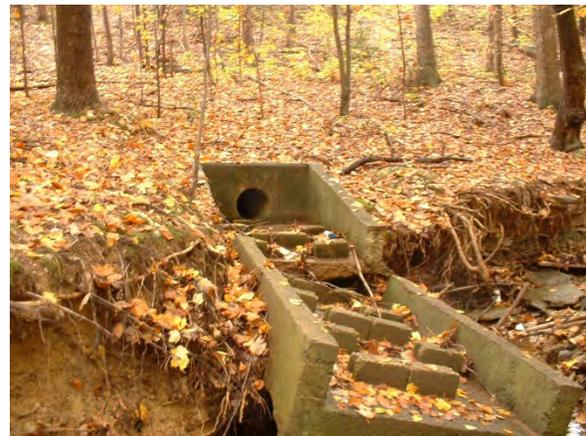
Photo 3.45 Erosion at a 12-inch outfall located just south of North Shore Drive (DFCR013.P003).

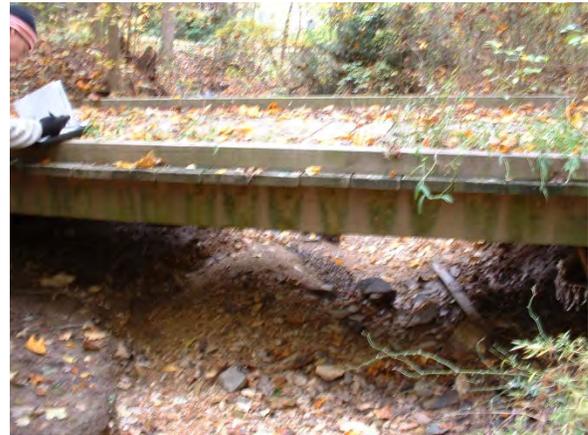
Photo 3.64 Wooden bridge where stream flow is causing moderate erosion. Located just off of Bassett Lane (DFGL008.C004).

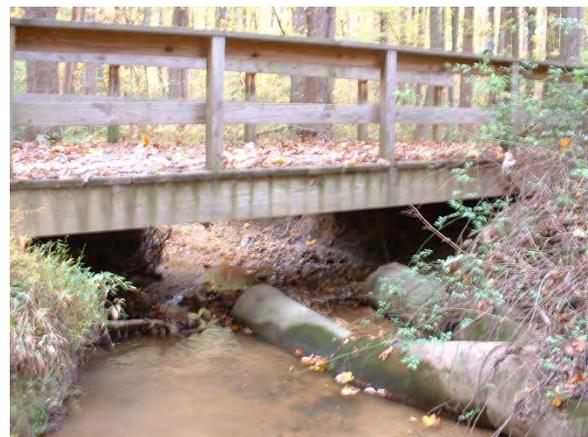
Photo 3.65 Wooden bridge where stream flow is causing moderate erosion. Located just west of Steeplechase Drive (DFGL008.C001).

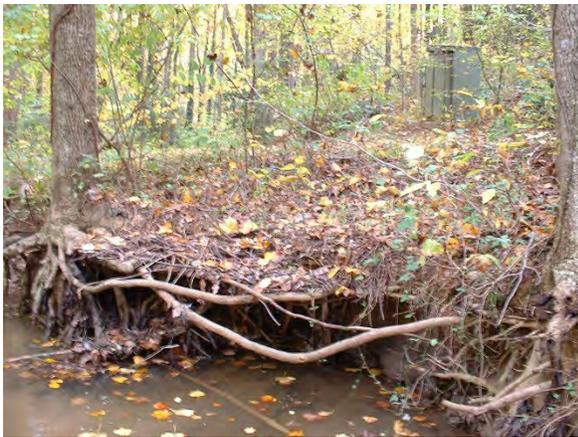
Photo 3.67 Erosion north of Lawyers Road near Pinoak Lane (DFGL006.E001)

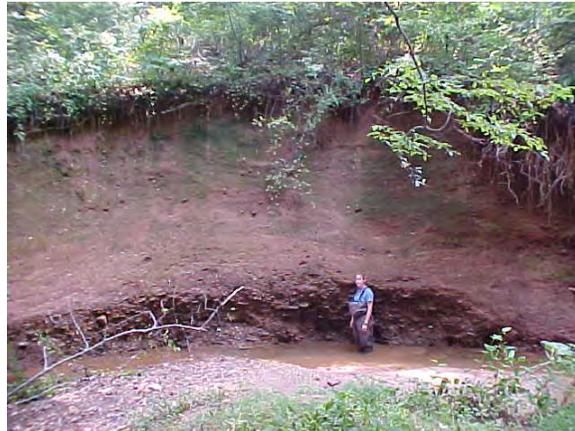
Photo 3.110 Severe erosion located just west of Whippoorwill Road (DFAB001.E001)

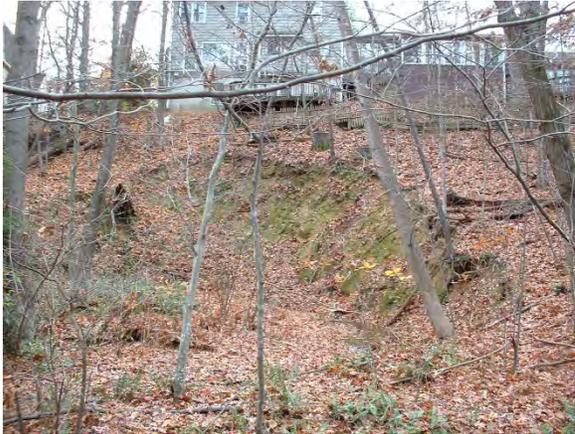
Photo 3.118 Eroding bank located in the southern edge of the Difficult Run Stream Valley Park in the Clarke's Landing subdivision directly north of the terminus of Timberline Court (DFSF002.E001).

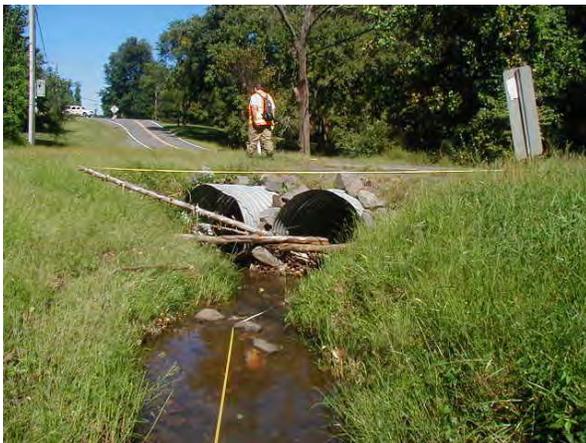
Culvert #17 (Photo 3.132) overtopped for events less frequent than the 5-year storm. This can be classified as a local road, which means the culvert should be able to pass the 10-year event.

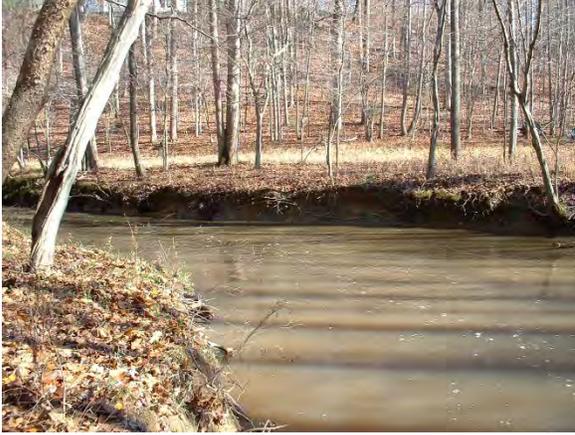
Photo 3.134 Erosion noted by field crews just east of Hunters Crest Way (DFDF009.E001).

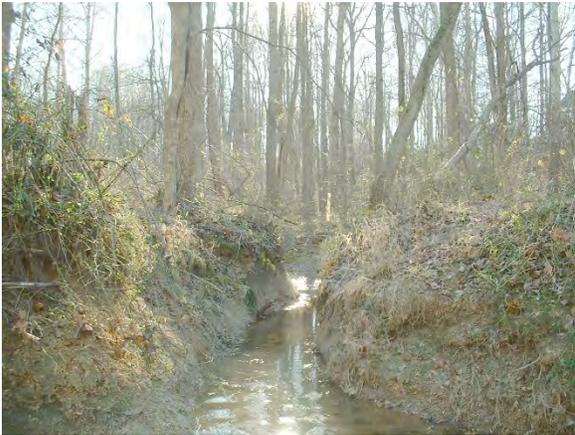
Photo 3.136 Area of extreme erosion with moderate restoration potential. This area is located near the end of Blenheim Drive (DFDF029.E001).
