Difficult Run Watershed Management Plan

**Volume 1: Watershed Plan
February 2007**

*Fairfax County Department of
Public Works and
Environmental Services*

Prepared By:
KCI Technologies Inc.

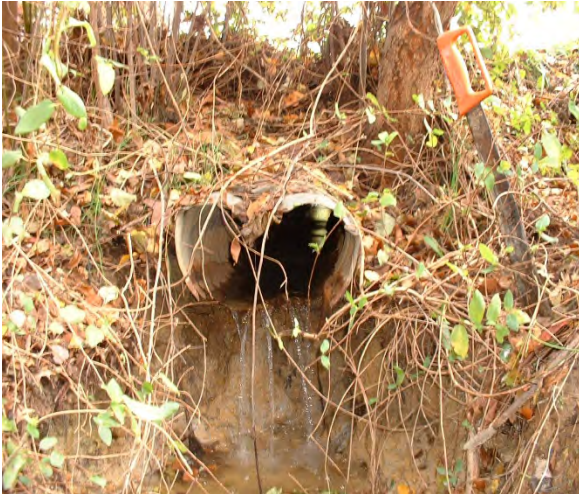
Photo 3.1 Erosion at the end of stormwater pipe located off of Collin Farm Land (DFCH021.P003).

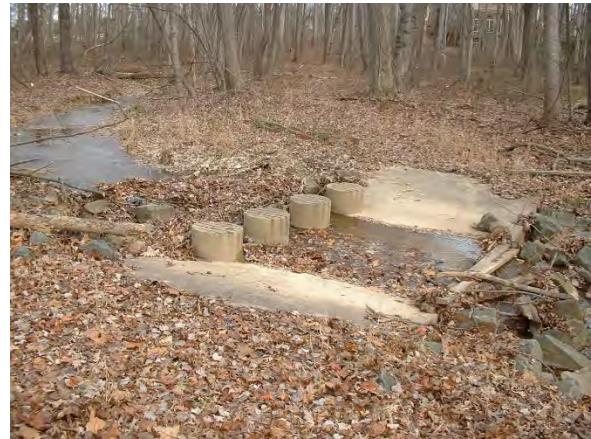
Photo 3.8 Ford located upstream east of Kimberly Place.

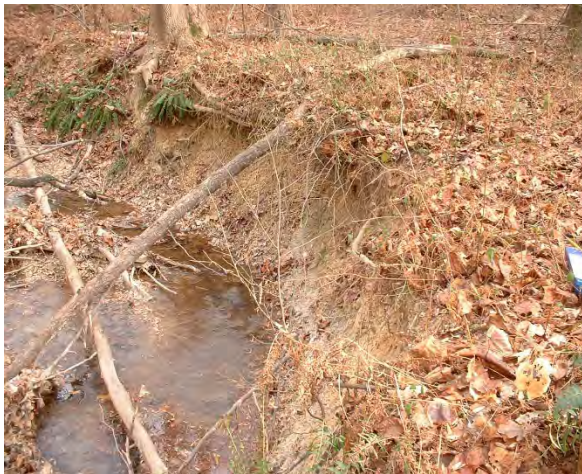
Photo 3.9 Erosion located south of Georgetown Pike, East of Kimberly Place (DFDG001.E002).

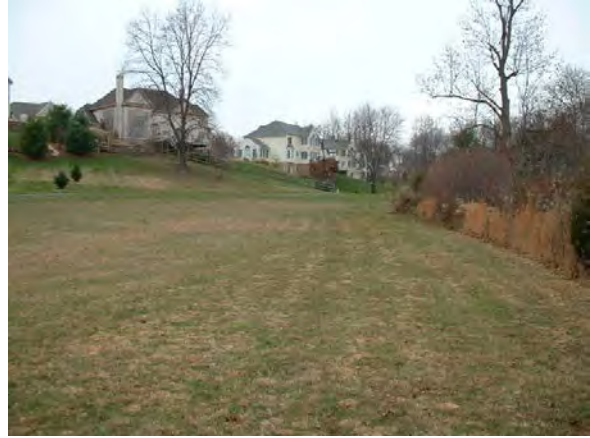
Photo 3.11 Deficient buffer located in the Estates at Wyndham Hills. (DFDG002.B001).

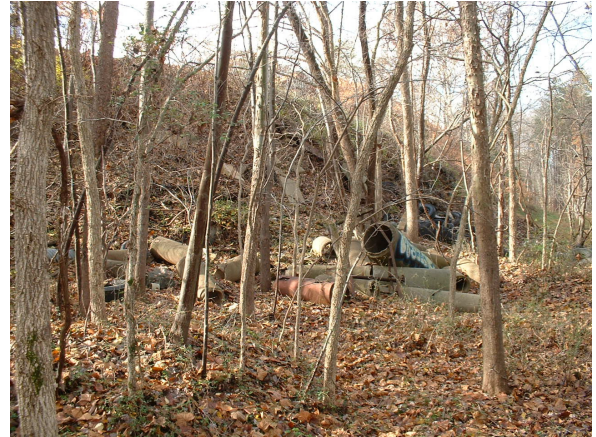
Photo 3.15 Dump site located just north of Springvale Court (DFPR005.M001).

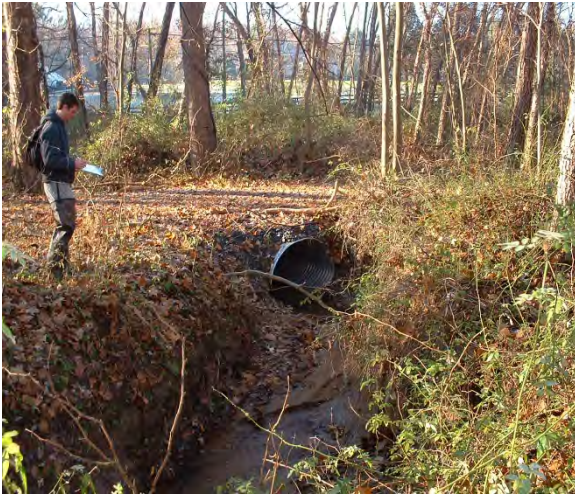
Photo 3.24 Located near Leigh Mill Road has downstream and upstream bank erosion and minor bed erosion (DFDF019.C001).

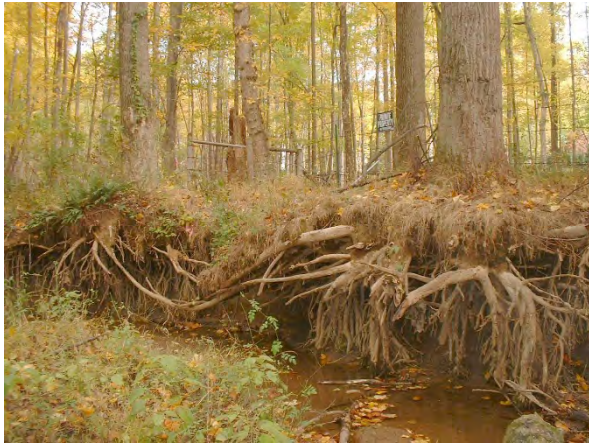
Photo 3.34 Eroding bank located east of the Lawns of Towlston Community (DFSP002.E001)

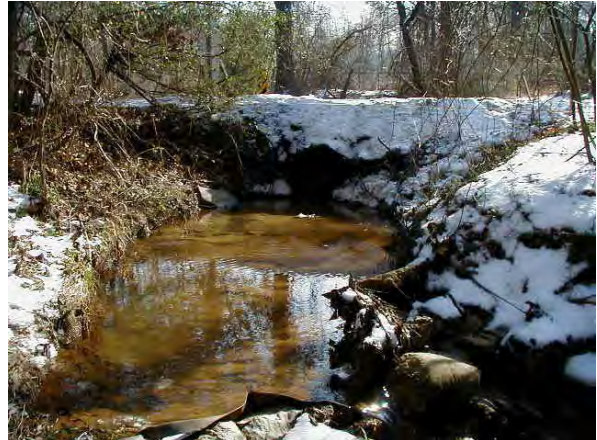
Photo 3.37 Sharpers Run mainstem at Bellview Road.

Culvert #80 (Photo 3.37) overtopped for all events except the one and two-year. Bellview Road carries through traffic, so it is considered a primary road. This means that it must pass the 25-year event.

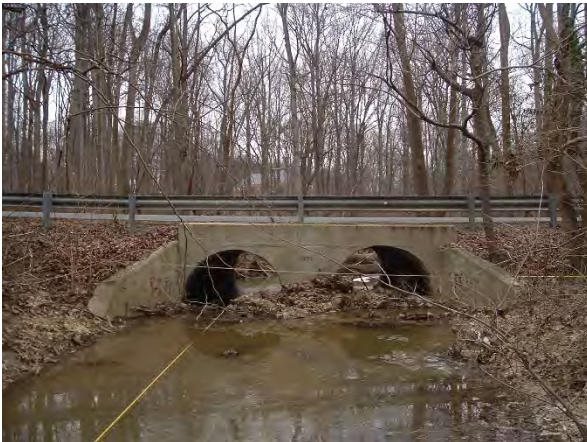
Photo 3.41 Culvert 74 at Brook Road on Rocky Run mainstem.

Culvert #74 (Photo 3.41) overtopped for the 25, 50, and 100-year events. Since Brook Road does not allow through traffic, it is classified as a local road, which has to pass the 10-year

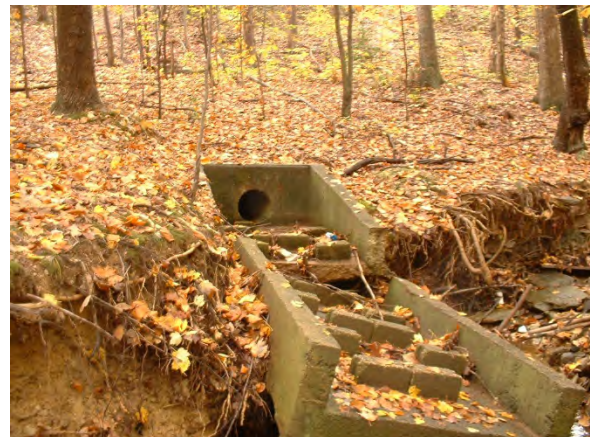
Photo 3.45 Erosion at a 12-inch outfall located just south of North Shore Drive (DFCR013.P003).

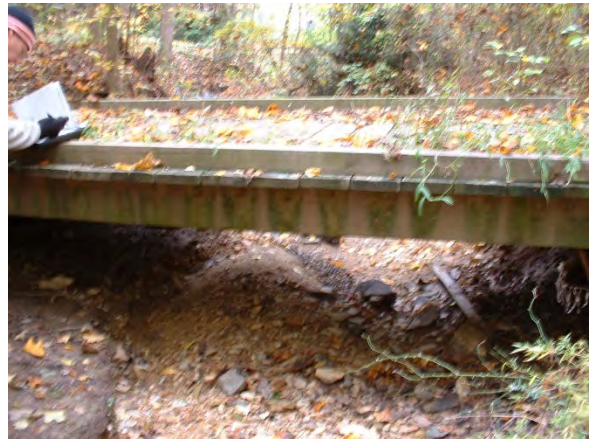
Photo 3.64 Wooden bridge where stream flow is causing moderate erosion. Located just off of Bassett Lane (DFGL008.C004).

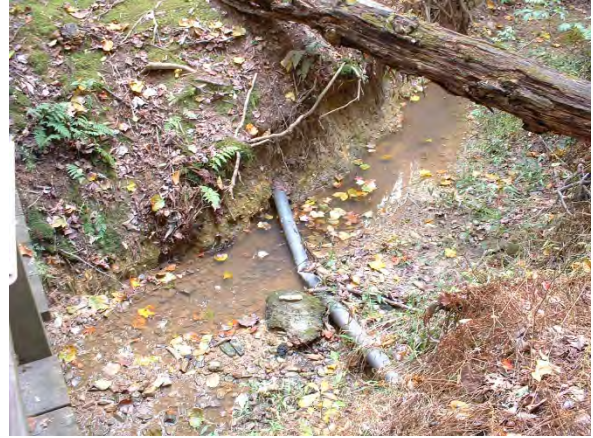
Photo 3.69 Utility line located just off of Stirrup Road on an upstream reach of the subwatershed (DFGL009.U001).

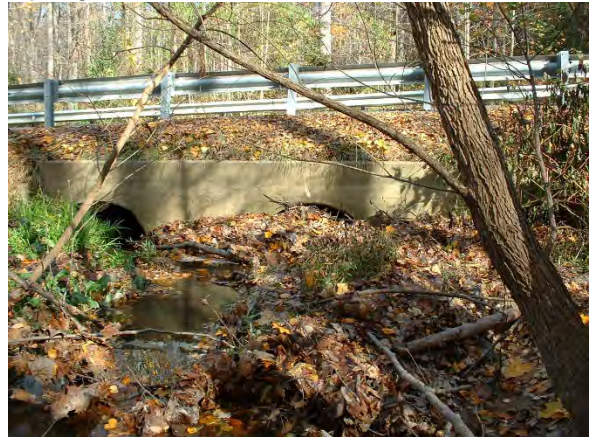
Photo 3.94 Crossing under Fox Mill Road north of Shady Mill Lane. Crossing has excessive sedimentation (DFLD015.C002).

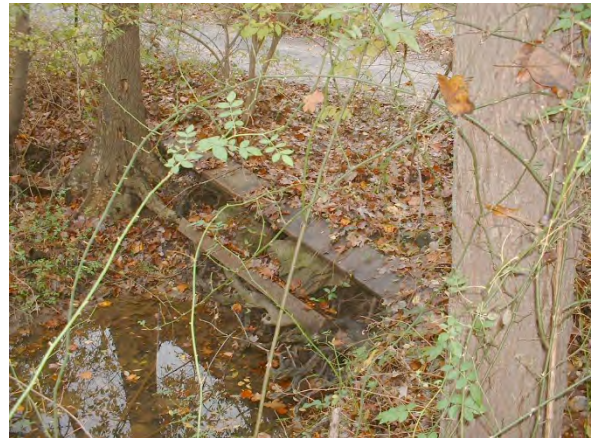
Photo 3.109 Pipe culvert at the headwaters of Angelico Branch. This is the only crossing in the watershed that has more than a moderate impact on the stream. (DFAB002.C003)

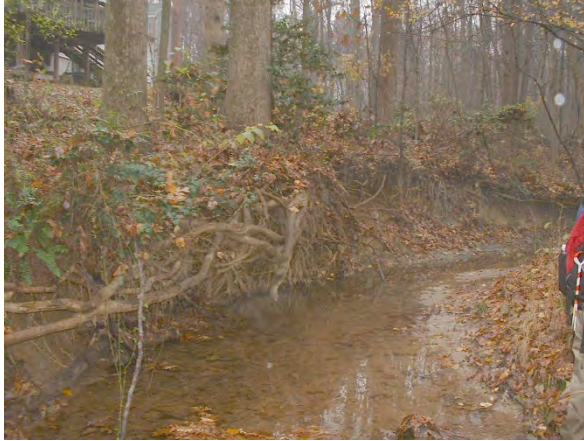
Photo 3.117 Eroding reach located directly south of Saint Helena Drive in the Vale Park West community (DFSF014.E001).

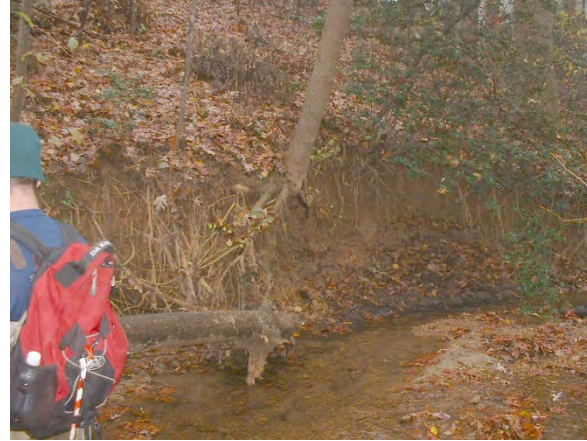
Photo 3.118 Located south of Photo 3.3 in Vale Park West and north of the Difficult Run Stream Valley Park (DFSF014.E002).

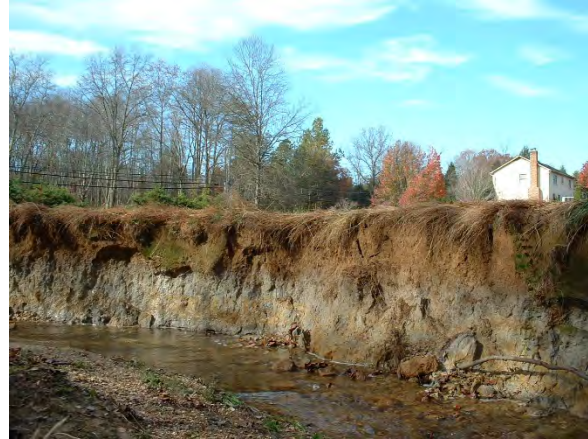
Photo 3.119 Heavily eroding bank on the South Fork Run mainstem, directly north of the intersection with Fox Mill Road and Deerfield Drive (DFSF007.E001).

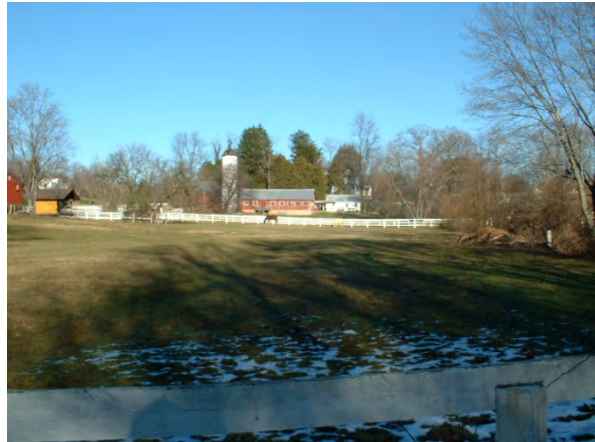
Photo 3.129 Buffer encroachment on a tributary south of Marbury Road in the Hunting Hills subdivision (DFRB016.B002).

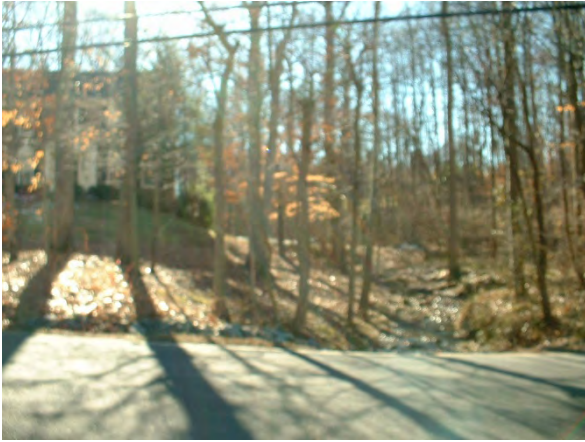
Photo 3.130 Buffer impairment south of Miller Road in the Windsong community (DFRB014.B001).

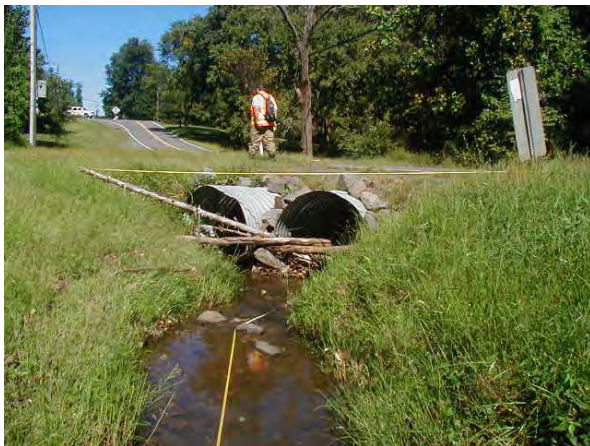
Culvert #17 (Photo 3.132) overtopped for events less frequent than the 5-year storm. This can be classified as a local road, which means the culvert should be able to pass the 10-year event.

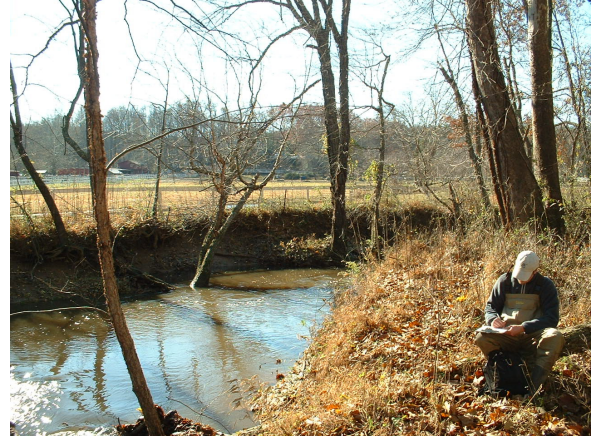
Photo 3.135 Erosion along Difficult Run located just east of Hunter Mill Road and south of the Washington and Old Dominion Railroad Trail (DFDF008.E002).
