Chapter 3: Subwatershed Conditions

3.1 Upper Popes Head Subwatershed

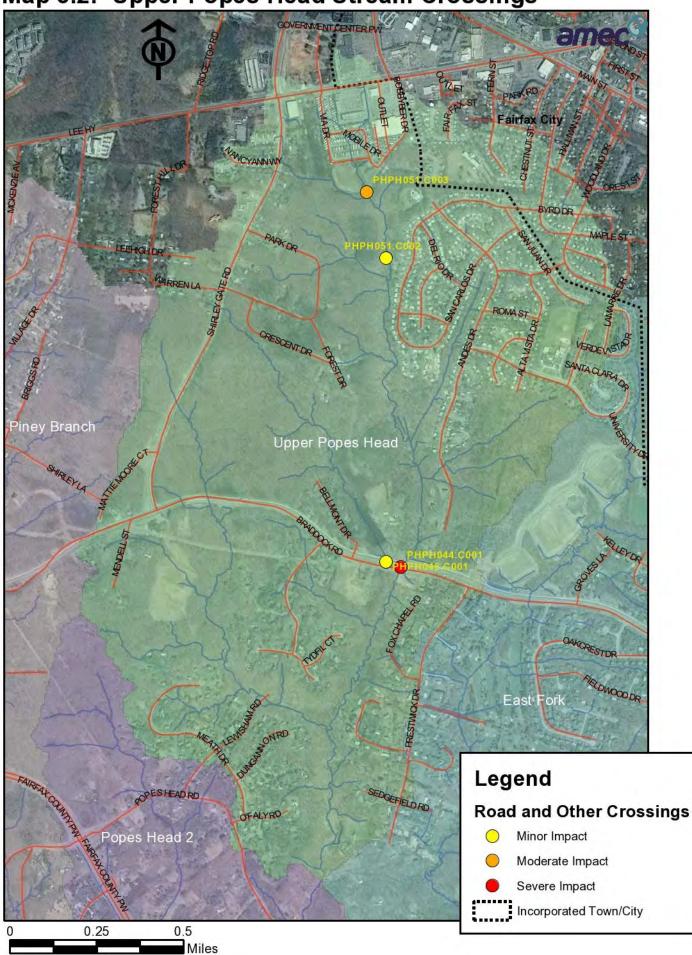
Map 3.2: Upper Popes Head Stream Crossings

Map 3.2 shows the location of the four stream crossings that have an impact on the stream. Crossings that do not have an impact on the stream are not listed. The major crossings in this subwatershed, starting from the upstream end of Upper Popes Head, are described as follows:

- Via Drive: A four-foot diameter circular concrete culvert (PHPH051.C003) has a moderate impact on the main stem.
- West of Byrd Road: A five-foot wooden footbridge (PHPH051.C002) has a minor impact on the main stem.
- Braddock Road: A two-foot diameter circular concrete culvert (PHPH046.C001) has a minor impact on the main stem. To the east, a three foot by five foot, triple box

concrete culvert (PHPH044.C001) has a severe impact on the main stem, as shown in Photo 3.1.

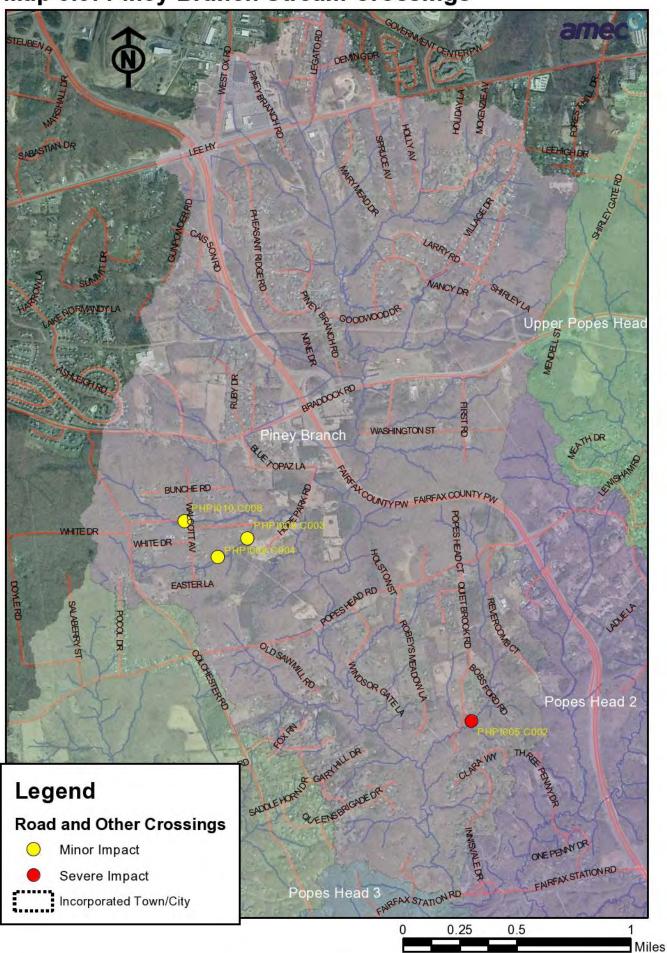
Map 3.8: Piney Branch Stream Crossings

Map 3.8 shows the location of three stream crossings that have an impact on the stream. Crossings that do not have an impact on the stream are not listed. The major crossings in this subwatershed, starting from the upstream end of Piney Branch, are described as follows:

- Rochester Drive: A one-foot diameter, two barrel CMP culvert (PHPI008.C003) has a minor impact on a western tributary.
- Walcott Avenue: A 12-foot natural ford (PHPI008.C004) has a minor impact on the stream, as shown in Photo 3.2
- Quiet Brook Road: A three-foot diameter circular CMP culvert (PBPI005.C001) has no impact on an eastern tributary. To the northeast, a two-foot diameter circular concrete culvert (PHPI005.C002) has a severe impact on the same tributary, as shown in Photo 3.3

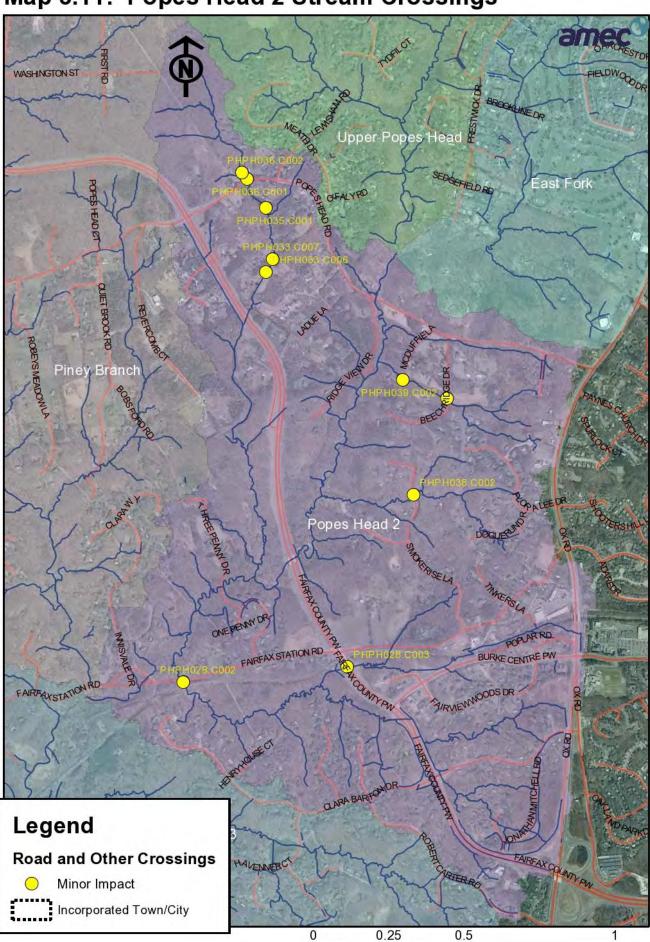
Map 3.11: Popes Head 2 Stream Crossings

- Smoke Rise Lane: A six-foot diameter circular CMP culvert (PHPH038.C002) has a minor impact on an eastern tributary.
- Fairfax Station Road: A four-foot diameter elliptical concrete culvert (PHPH028.C002) has a minor impact on the main stem, as shown in Photo 3.6.

- Fairfax County Parkway: A six-foot by six-foot box concrete culvert (PHPH028.C003) has a minor impact on an eastern tributary, as shown in Picture 3.7.

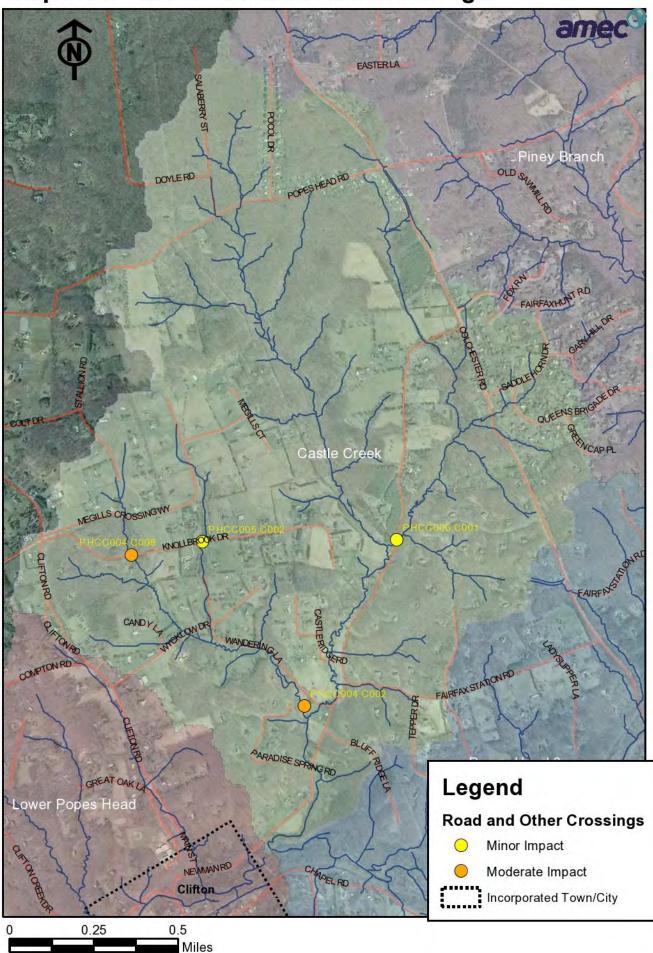
Map 3.14 shows the location of four stream crossings that have an impact on the stream. Crossings that do not have an impact on the stream are not listed. The major crossings in this subwatershed, starting from the upstream end of Castle Creek, are described as follows:

- Knollbrook Drive: A three-foot diameter circular concrete culvert (PHCC004.C008) has a moderate impact on a western tributary, as shown in Photo 3.8.
- Knollbrook Drive: A two-foot diameter circular CMP culvert (PHCC005.C002) has a minor impact on a western tributary, as shown in Photo 3.9.
- Newman Road: A two-foot diameter, circular CMP culvert (PHCC006.C001) has a minor impact on the main stem, as shown in Photo 3.10.
- Wandering Lane: A two-foot diameter circular concrete culvert (PHCC004.C002) has a moderate impact on the main stem, as shown in Picture 3.11.

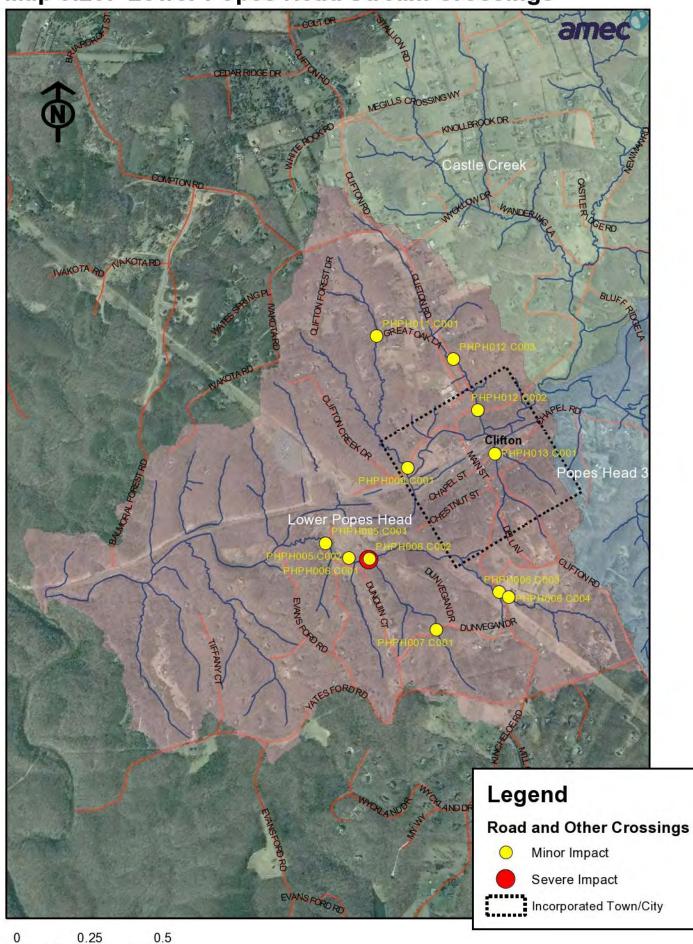
Map 3.20: Lower Popes Head Stream Crossings

- Chapel Road: A two-foot diameter circular CMP culvert (PHPH013.C001) has a minor impact on a southern tributary.
- Dunquin Court: A two-foot diameter circular clay culvert (PHPH005.C001) has a minor impact on a southern tributary, as shown in Photo 3.19. To the southeast, a three-foot by two-foot elliptical concrete culvert (PHPH005.C002) has a minor impact on the same tributary. To the southeast, a two-foot diameter circular concrete culvert (PHPH006.C002) has a minor impact on the same tributary. Adjacent, a two-foot diameter circular concrete culvert (PHPH006.C001) has a severe impact on the same tributary, as shown in Photo 3.20.

- Dunvegan Drive: A four-foot diameter circular CMP culvert (PHPH007.C001) has a minor impact on a southern tributary.
- Kincheloe Road: A three-foot diameter circular CMP culvert (PHPH006.C003) has a minor impact on the southeastern tributary. To the southeast, a two-foot diameter circular CMP culvert (PHPH006.C004) has a minor impact on the same tributary.
