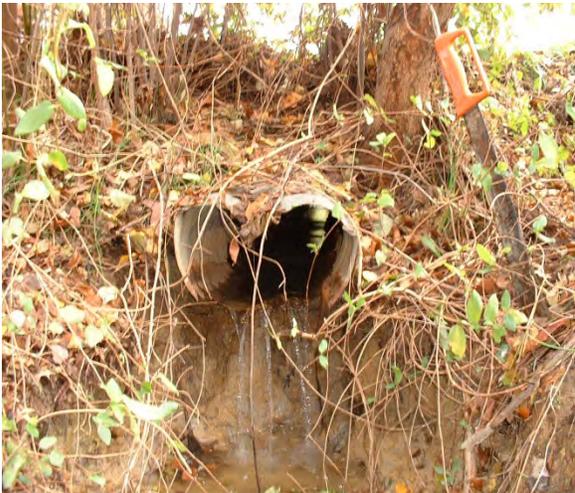
*Photo 3.1 Erosion at the end of stormwater pipe located off of Collin Farm Land (DFCH021.P003).*

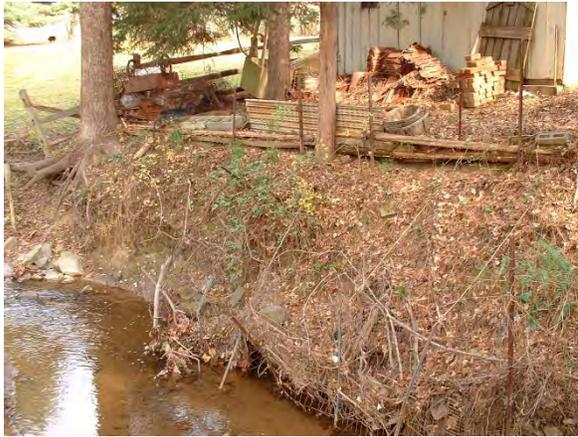
*Photo 3.3 Erosion on the right bank of Captain Hickory Run near the end of Constellation Drive (DFCH010.E001)*

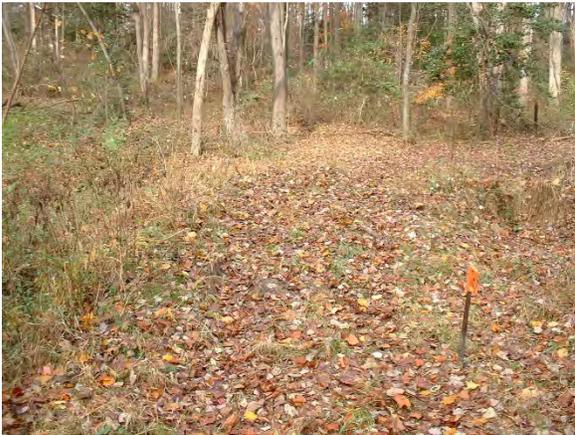
*Photo 3.5 Earthen berm located in the upper reaches of Captain Hickory Run near Thunderhill Court (DFCH009.T001)*

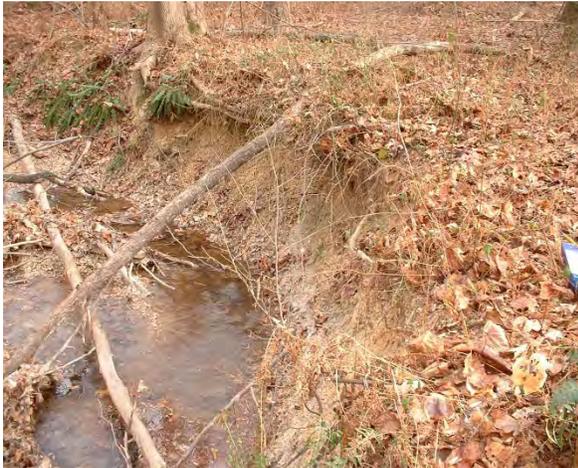
*Photo 3.9 Erosion located south of Georgetown Pike, East of Kimberly Place (DFDG001.E002).*

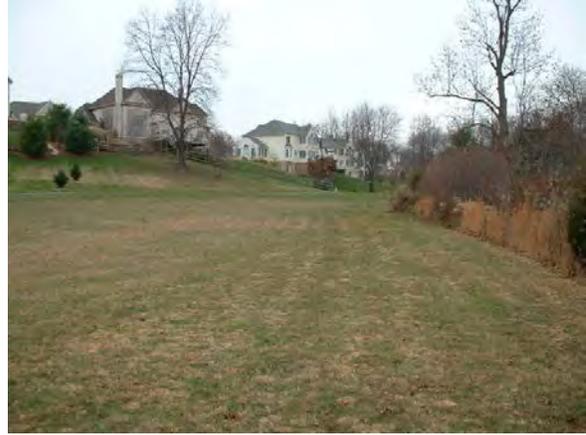
*Photo 3.11 Deficient buffer located in the Estates at Wyndham Hills. (DFDG002.B001).*

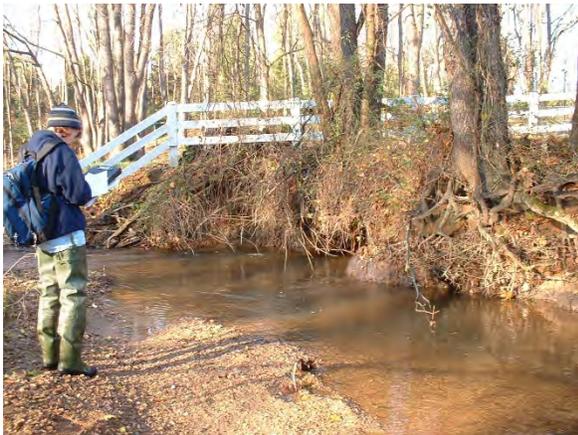
*Photo 3.12 Erosion just south of Eisenhower Lane (DFPR005.E001).*

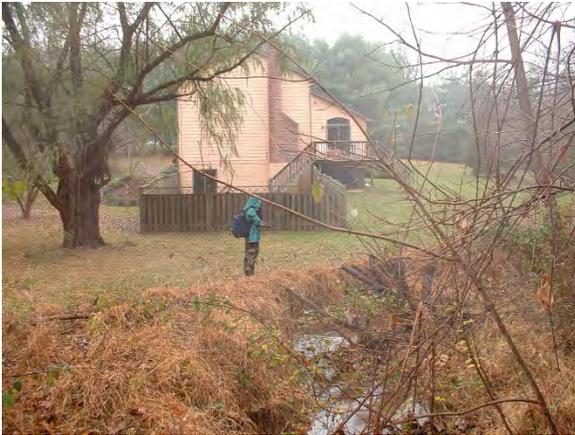
*Photo 3.14 Example of deficient buffer located south of Good Spring Avenue (DFPR009.B003).*

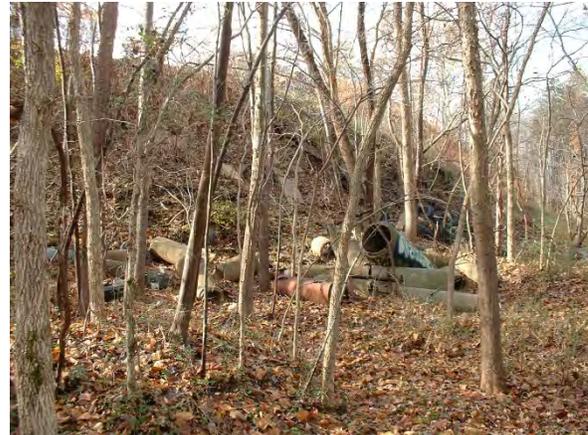
*Photo 3.15 Dump site located just north of Springvale Court (DFPR005.M001).*

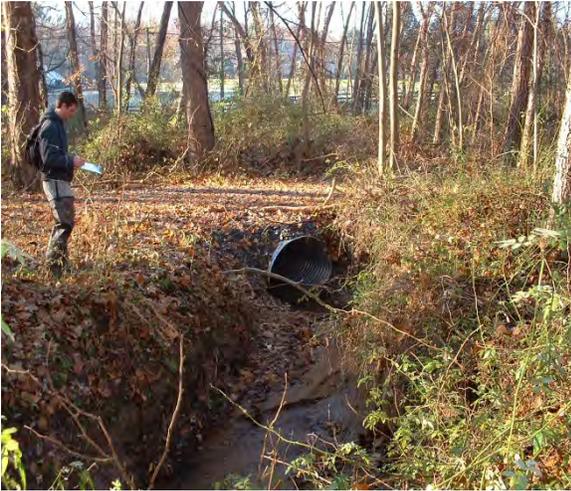
*Photo 3.24 Located near Leigh Mill Road has downstream and upstream bank erosion and minor bed erosion (DFDF019.C001).*

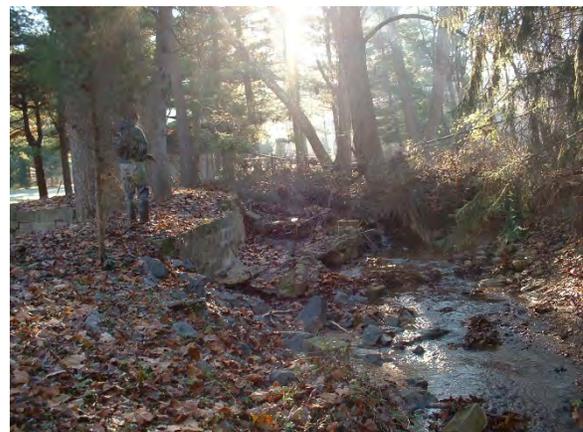
*Photo 3.29 Stream blockage near Ramey Lane cul-de-sac (DFDF019.T001).*

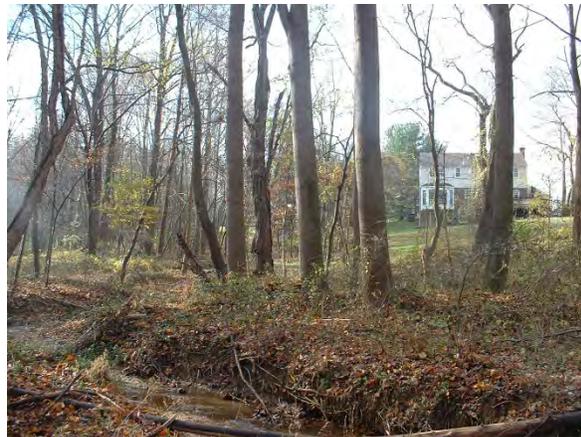
*Photo 3.30 Buffer impact on a tributary west of Hidden Creek Drive (DFDF020.B001).*

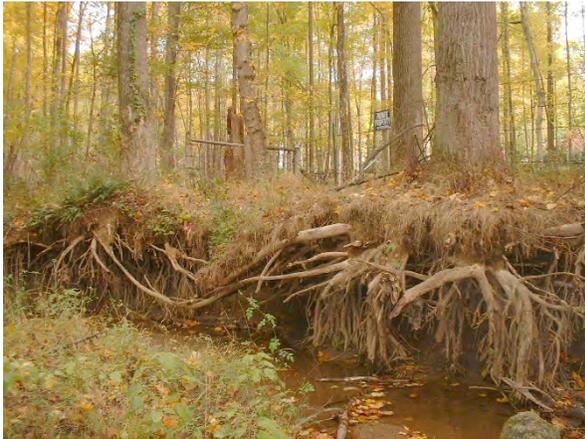
*Photo 3.34 Eroding bank located east of the Lawns of Towlston Community (DFSP002.E001)*

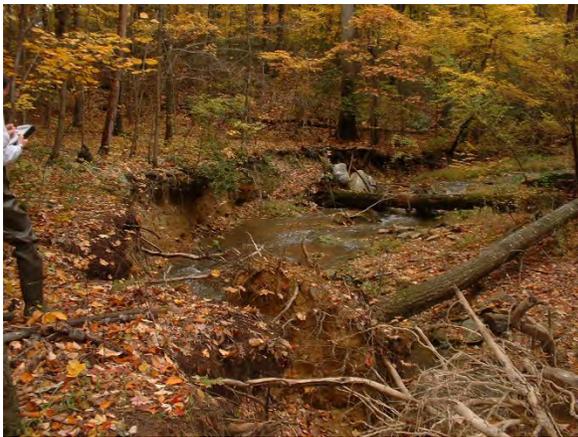
*Photo 3.38 Significant erosion on the mainstem between Woodside Drive and Orlo Drive (DFRR013.E001).*

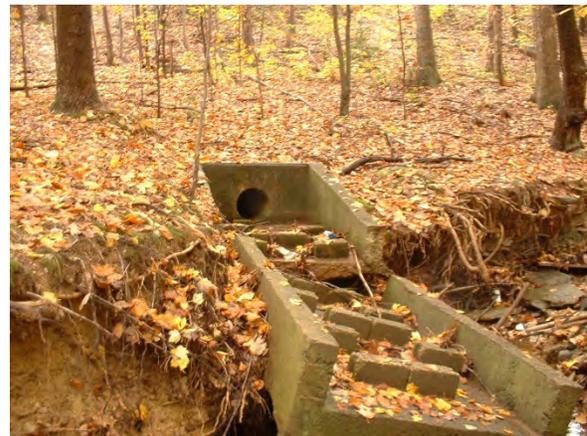
*Photo 3.45 Erosion at a 12-inch outfall located just south of North Shore Drive (DFCR013.P003).*

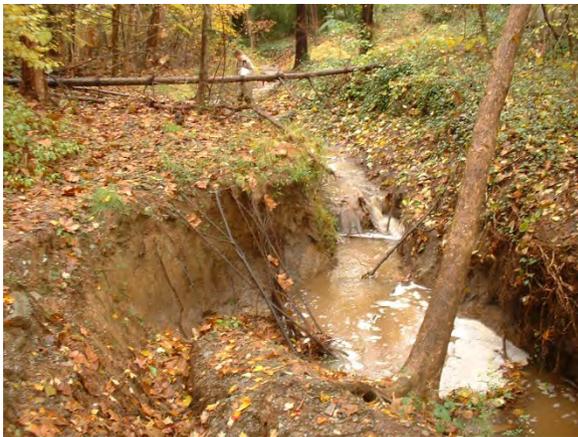
*Photo 3.46 Erosion located on a tributary to Colvin Run between Buttermilk Lane and Hunt Club Road (DFCR012.E002)*

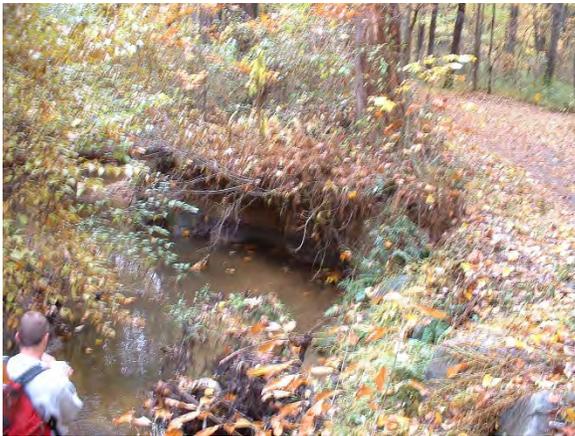
*Photo 3.58 Erosion located south of South Lakes Drive (DFSB012.E001).*

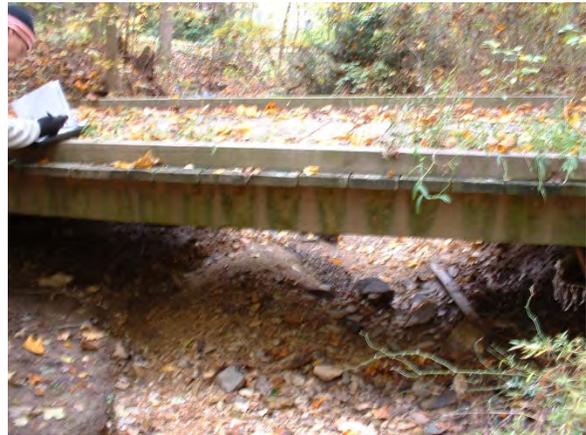
*Photo 3.64 Wooden bridge where stream flow is causing moderate erosion. Located just off of Bassett Lane (DFGL008.C004).*

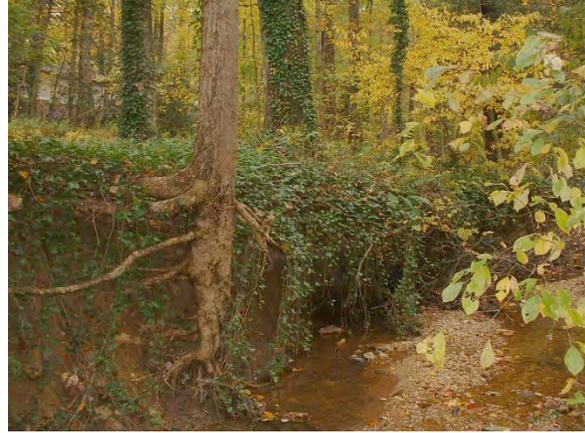
*Photo 3.66 Located north of Lawyers Road between Pegasus Lane and Charlestown Lane (DFGL005.E001).*

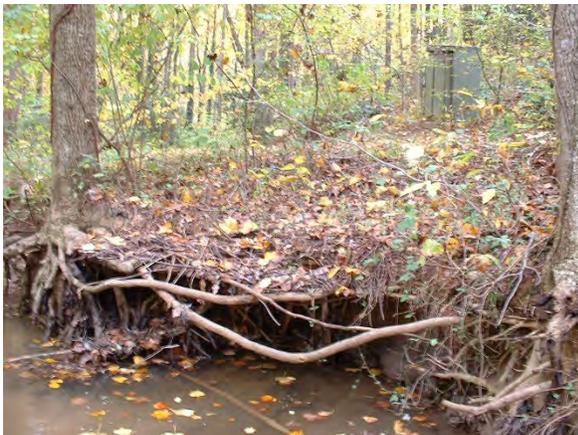
*Photo 3.67 Erosion north of Lawyers Road near Pinoak Lane (DFGL006.E001)*

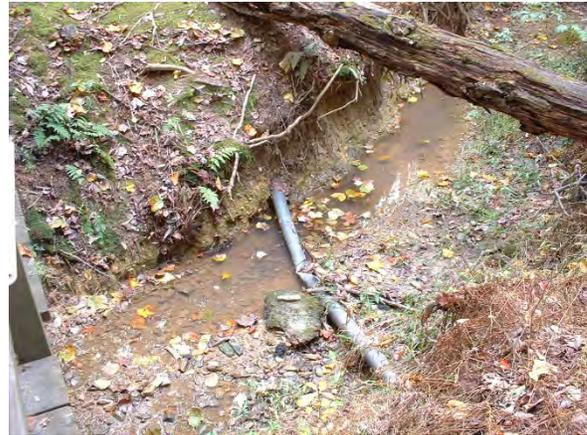
*Photo 3.69 Utility line located just off of Stirrup Road on an upstream reach of the subwatershed (DFGL009.U001).*

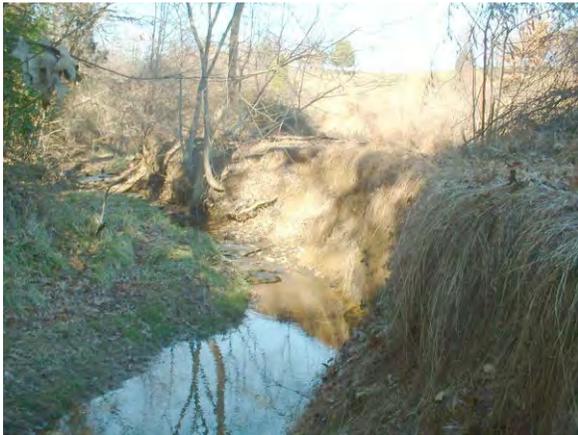
*Photo 3.70 Eroding channel located between Brittenford Drive and Hunt Country Lane (DFDF049.E002).*

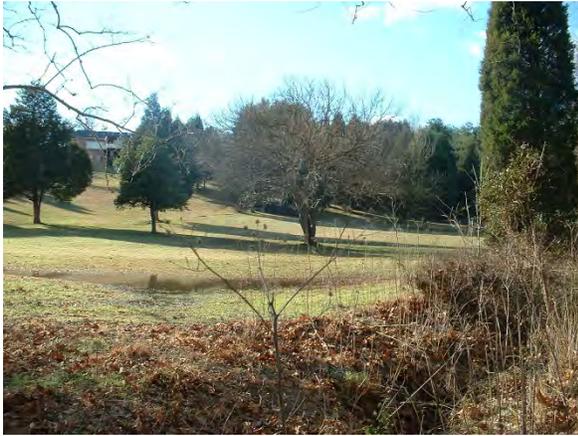
*Photo 3.76 Buffer impact south of Windy Knoll Lane (DFDF053.B001).*

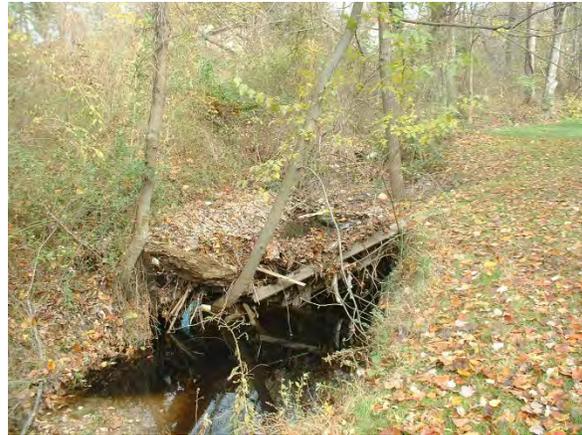
*Photo 3.79 A severe obstruction located upstream of Chain Bridge Road near Echols Street (DFWC028.T001).*

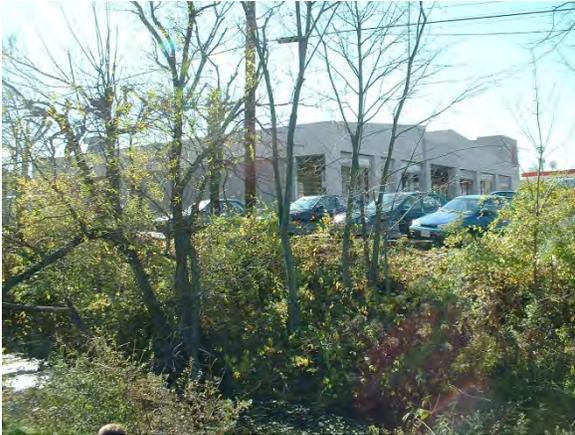
Photo 3.80 Buffer encroachment with high impact near Maple Avenue. (DFWC019.B002).

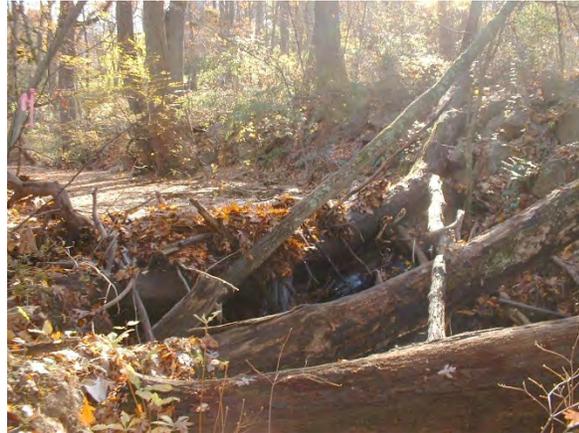
*Photo 3.85 Stream blockage with a severe impact on the stream (DFOR701.T001).*

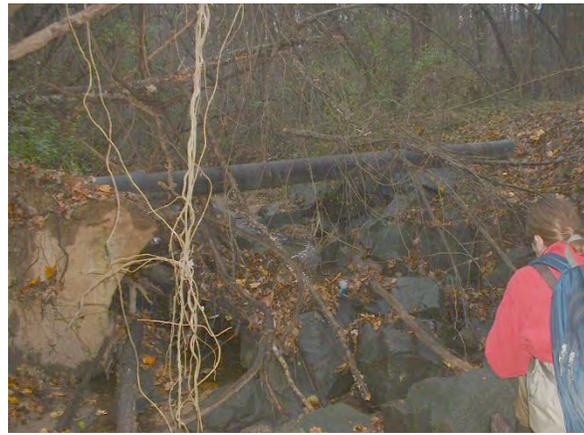
*Photo 3.89 Sanitary line crossing the stream above the baseflow (DFPB010.U001).*

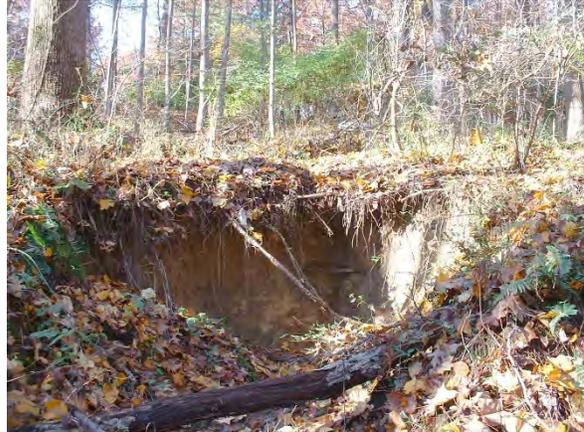
*Photo 3.93 Pipe near the end of Checkerberry Court near Blue Smoke Trail (DFLD014.P001)*

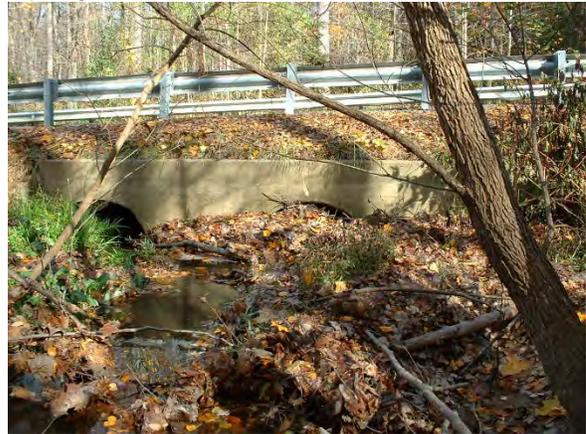
*Photo 3.94 Crossing under Fox Mill Road north of Shady Mill Lane. Crossing has excessive sedimentation (DFLD015.C002).*

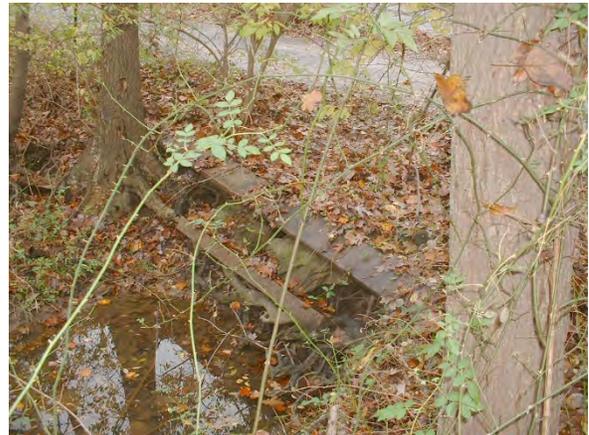
*Photo 3.109 Pipe culvert at the headwaters of Angelico Branch. This is the only crossing in the watershed that has more than a moderate impact on the stream. (DFAB002.C003)*

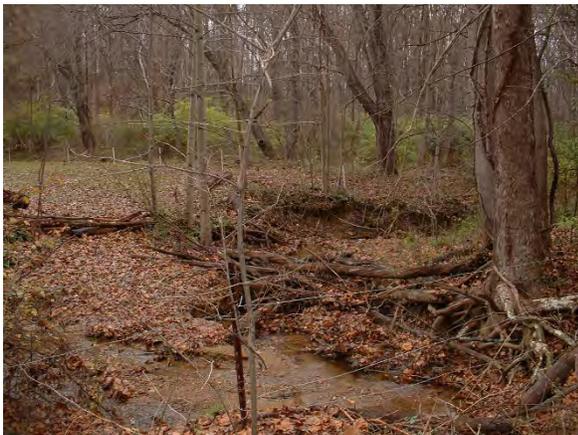
*Photo 3.111 Obstruction located just west of Whippoorwill Road (just downstream of erosion shown in Photo 3.2) (DFAB001.T001)*

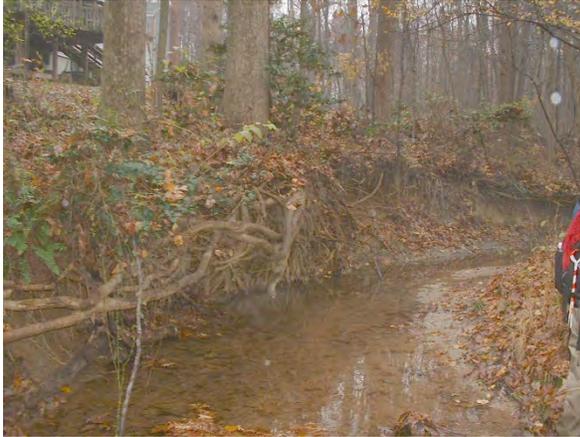
*Photo 3.117 Eroding reach located directly south of Saint Helena Drive in the Vale Park West community (DFSF014.E001).*

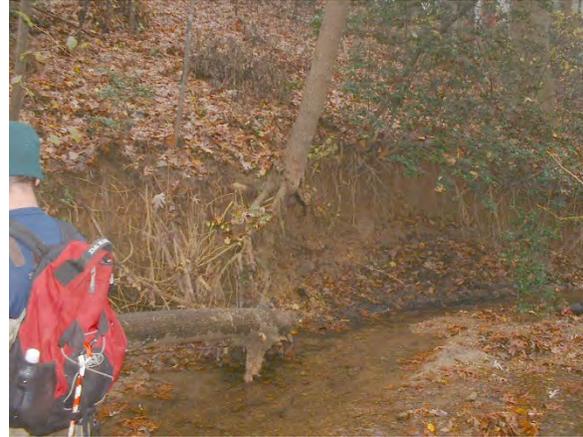
*Photo 3.118 Located south of Photo 3.3 in Vale Park West and north of the Difficult Run Stream Valley Park (DFSF014.E002).*

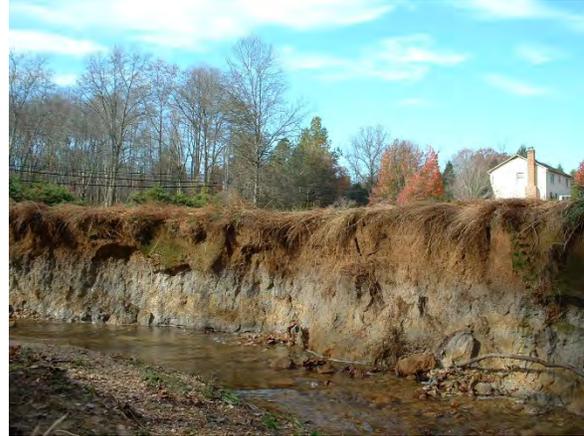
*Photo 3.119 Heavily eroding bank on the South Fork Run mainstem, directly north of the intersection with Fox Mill Road and Deerfield Drive (DFSFO07.E001).*

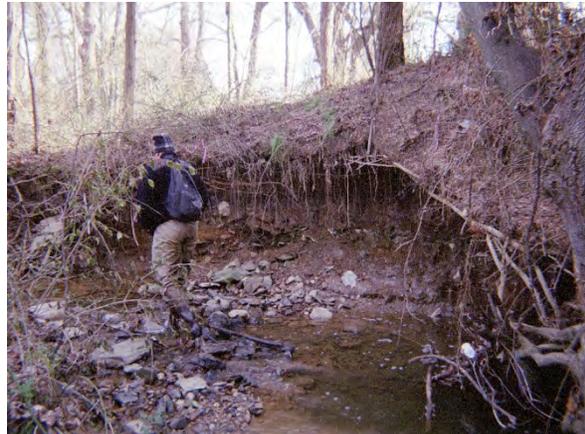
*Photo 3.123 Erosion point on a tributary off of the mainstem of Rocky Branch. East of Oakton Ridge Court in the Oakton Mill Estate subdivision (DFRB010.E001)*

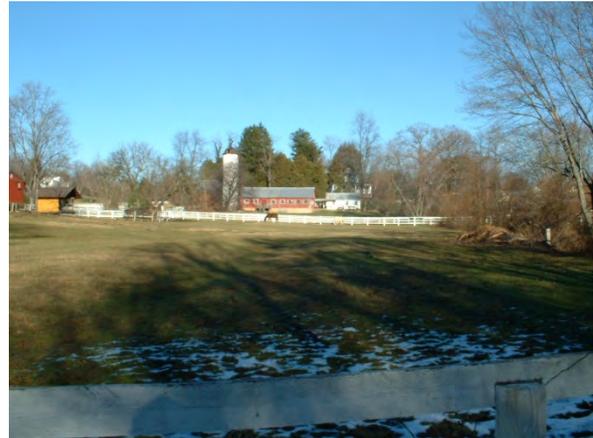
*Photo 3.129 Buffer encroachment on a tributary south of Marbury Road in the Hunting Hills subdivision (DFRB016.B002).*

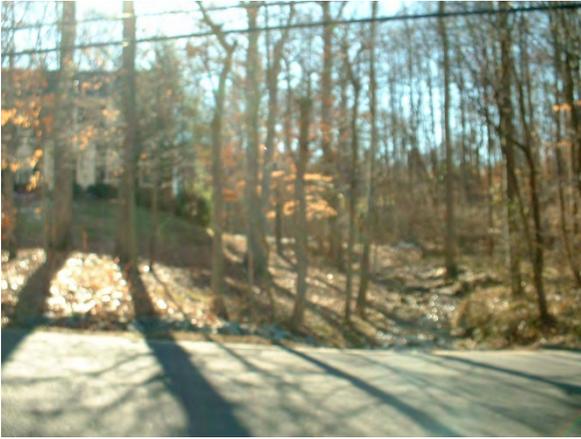
*Photo 3.130 Buffer impairment south of Miller Road in the Windsong community (DFRB014.B001).*

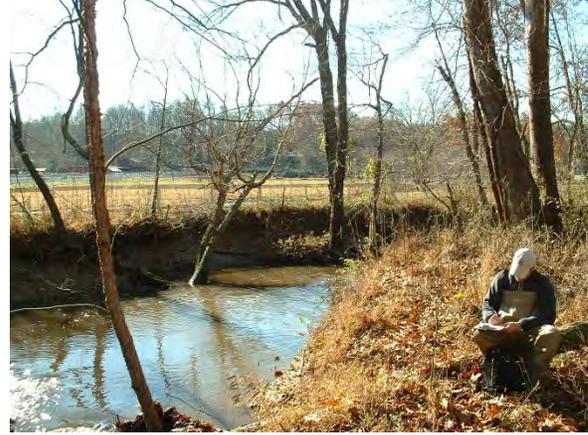
*Photo 3.135 Erosion along Difficult Run located just east of Hunter Mill Road and south of the Washington and Old Dominion Railroad Trail (DFDF008.E002).*

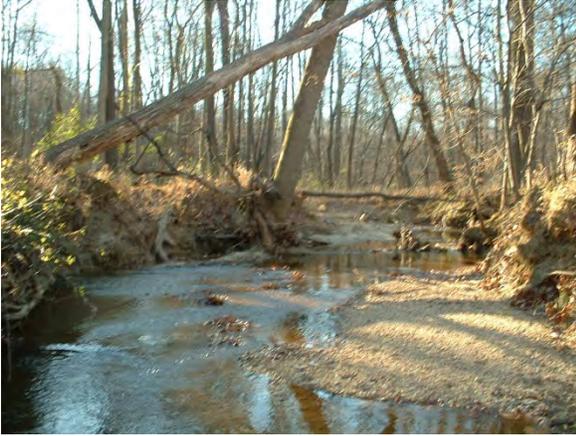
*Photo 3.137 Severe erosion with moderate restoration potential located near the end of Lapham Drive (DFDF028.E001).*

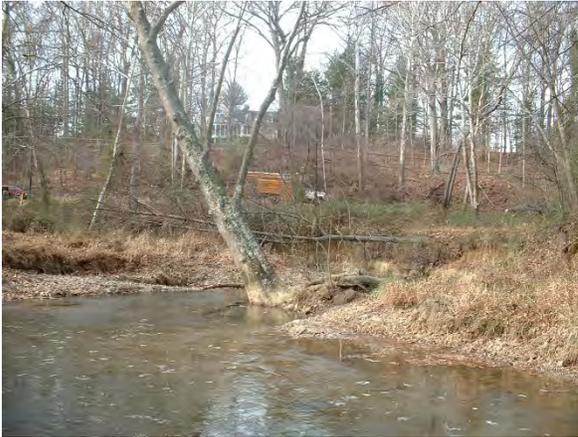
*Photo 3.140 Roadway buffer encroachment near Waples Mill Road (DFDF034.B001).*
