Trails in Stream Valley Parks

OVERVIEW AND NEED FOR
IMPROVEMENTS FOR STREAM VALLEY
TRAILS

Fairfax County Park Authority
Planning & Development Division

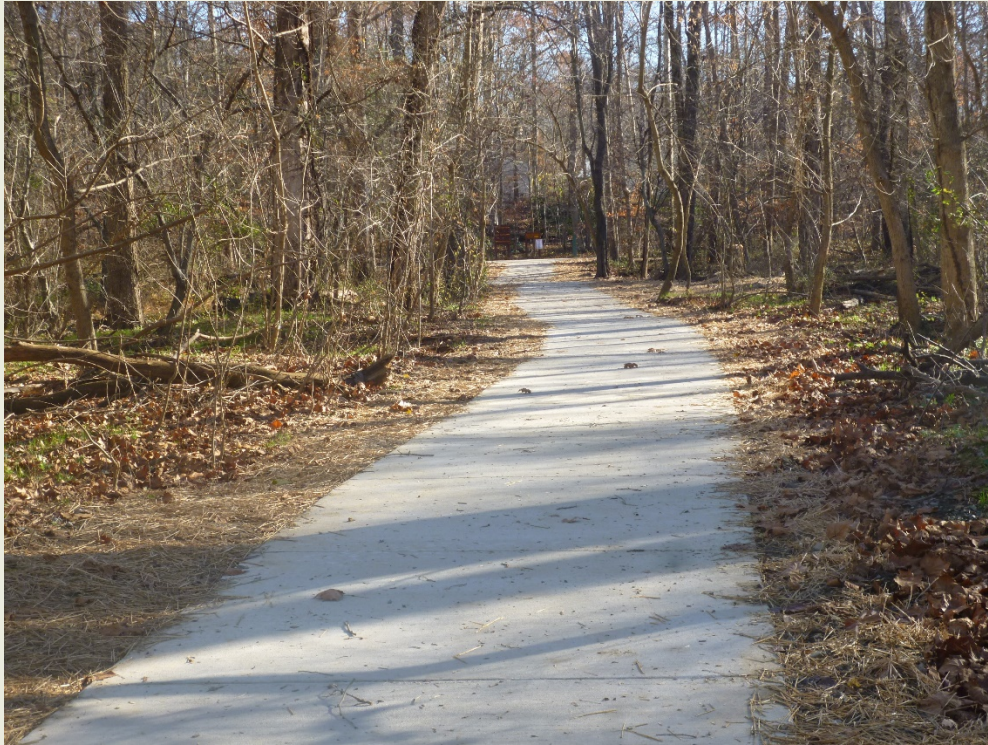
Accotink Stream Valley Park

Concrete

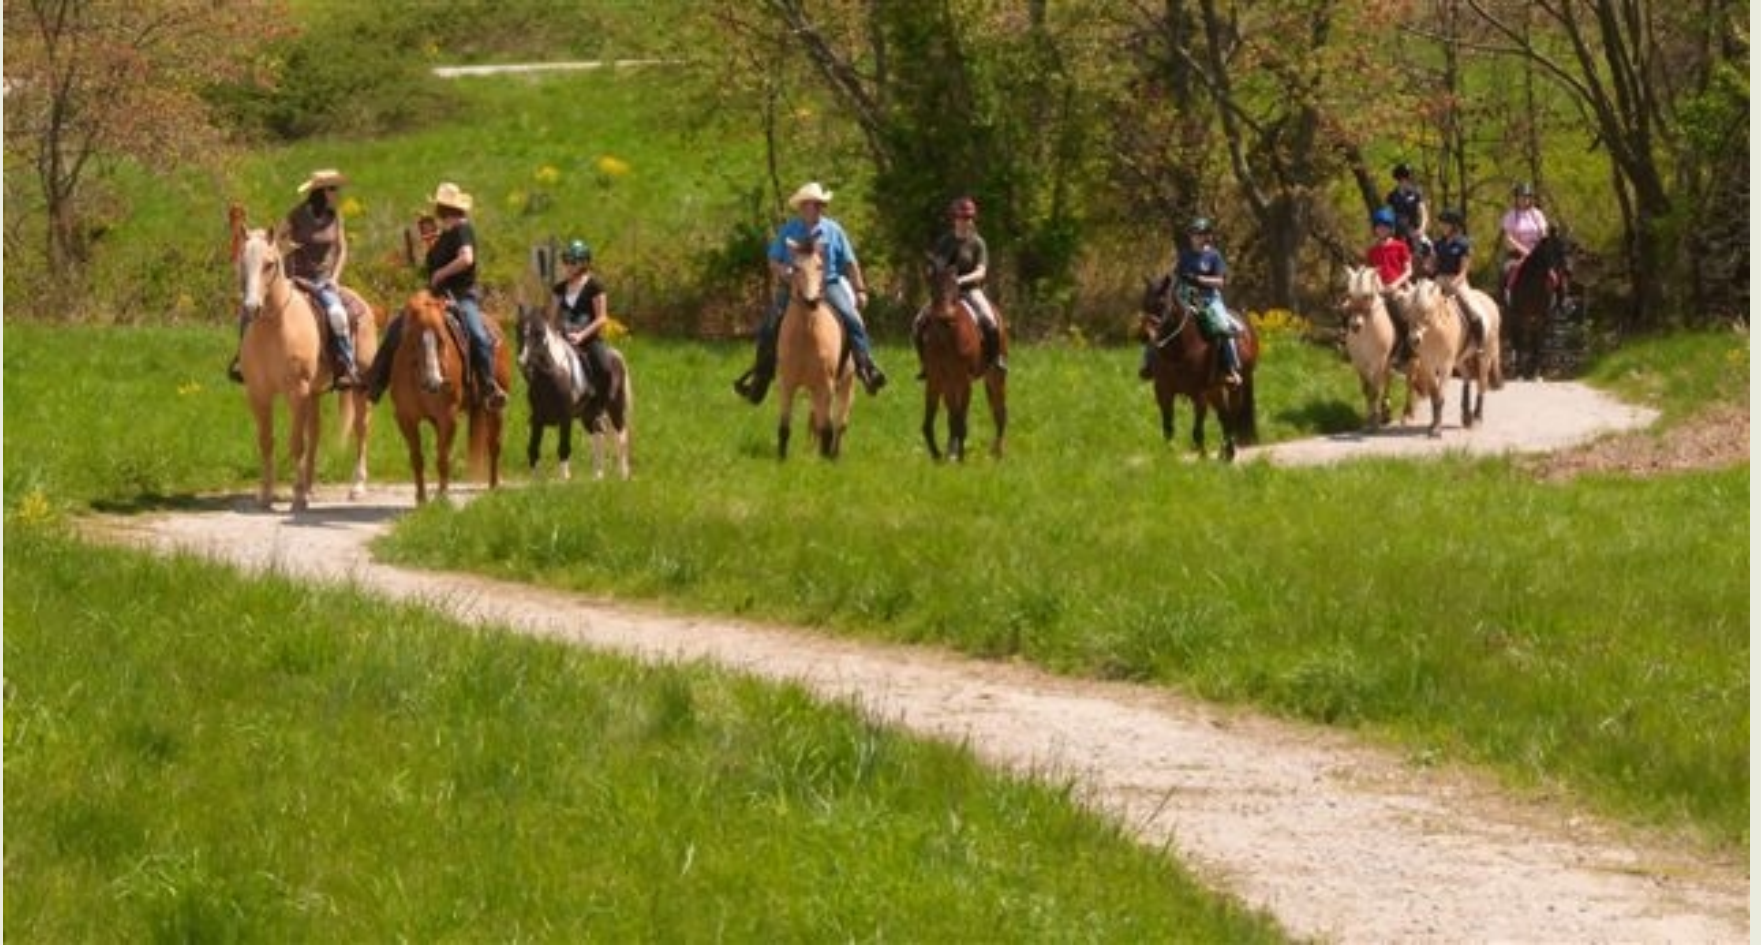
Laurel Hill Park

20% Gravel/Stone Dust Surface

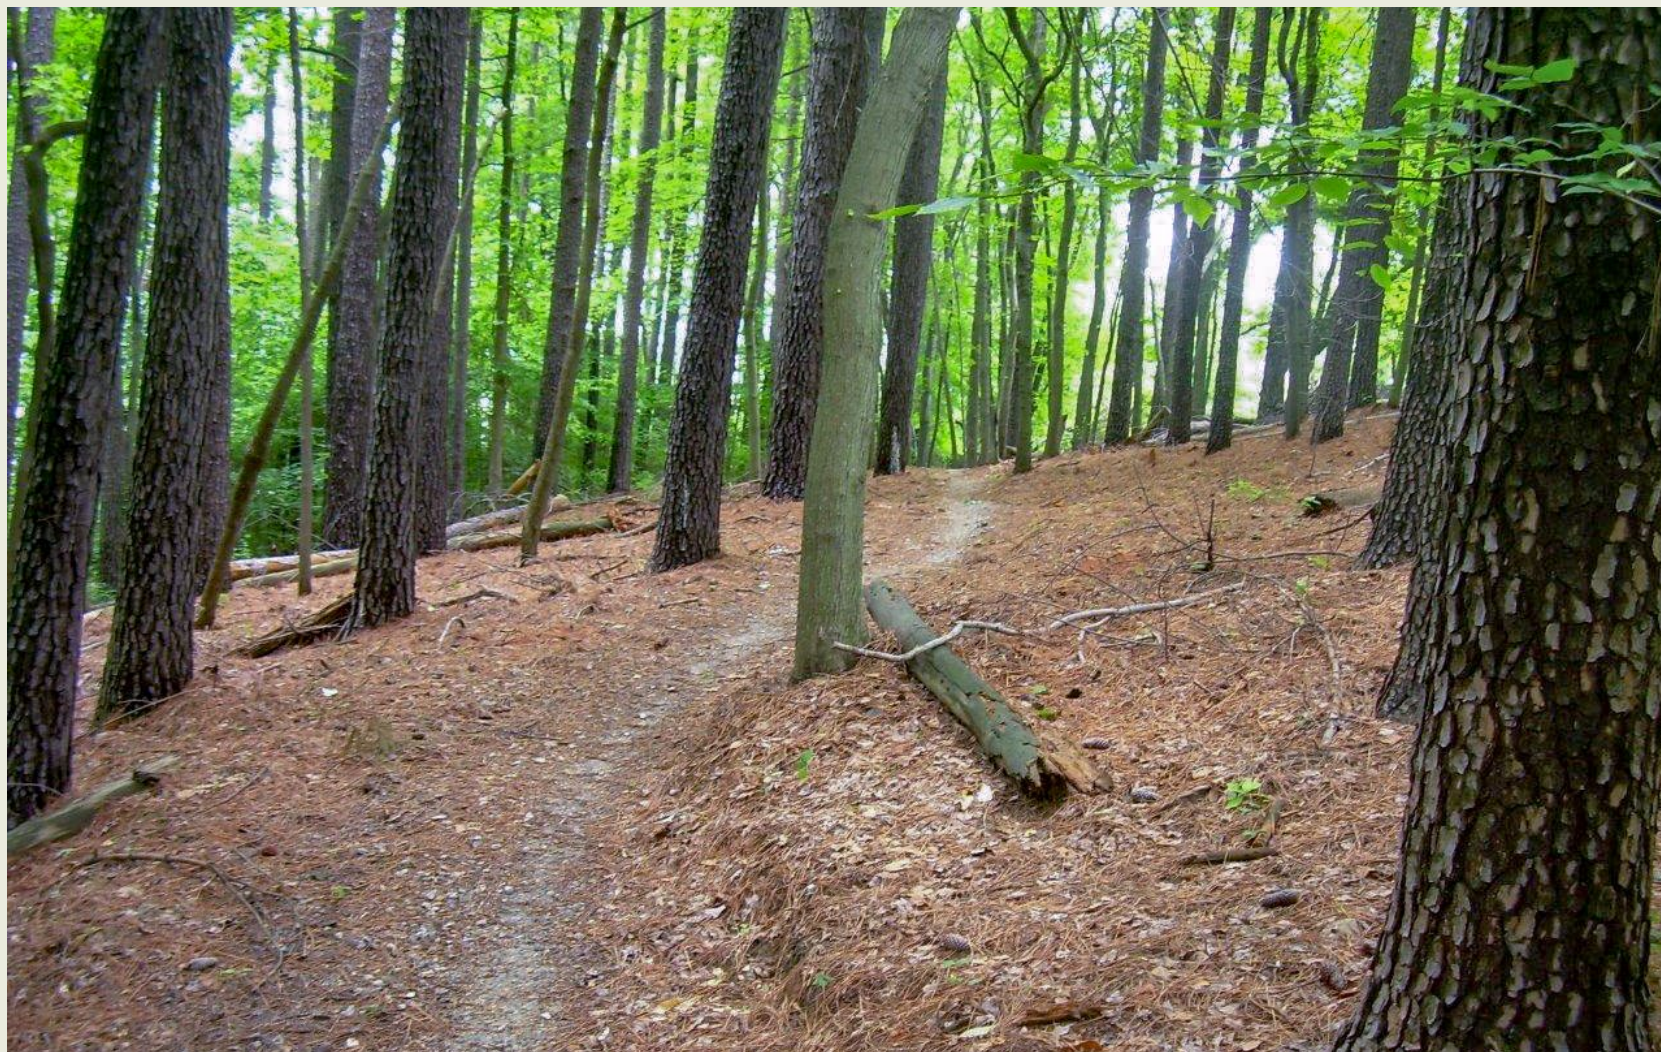
Laurel Hill Park

40% Natural Surface

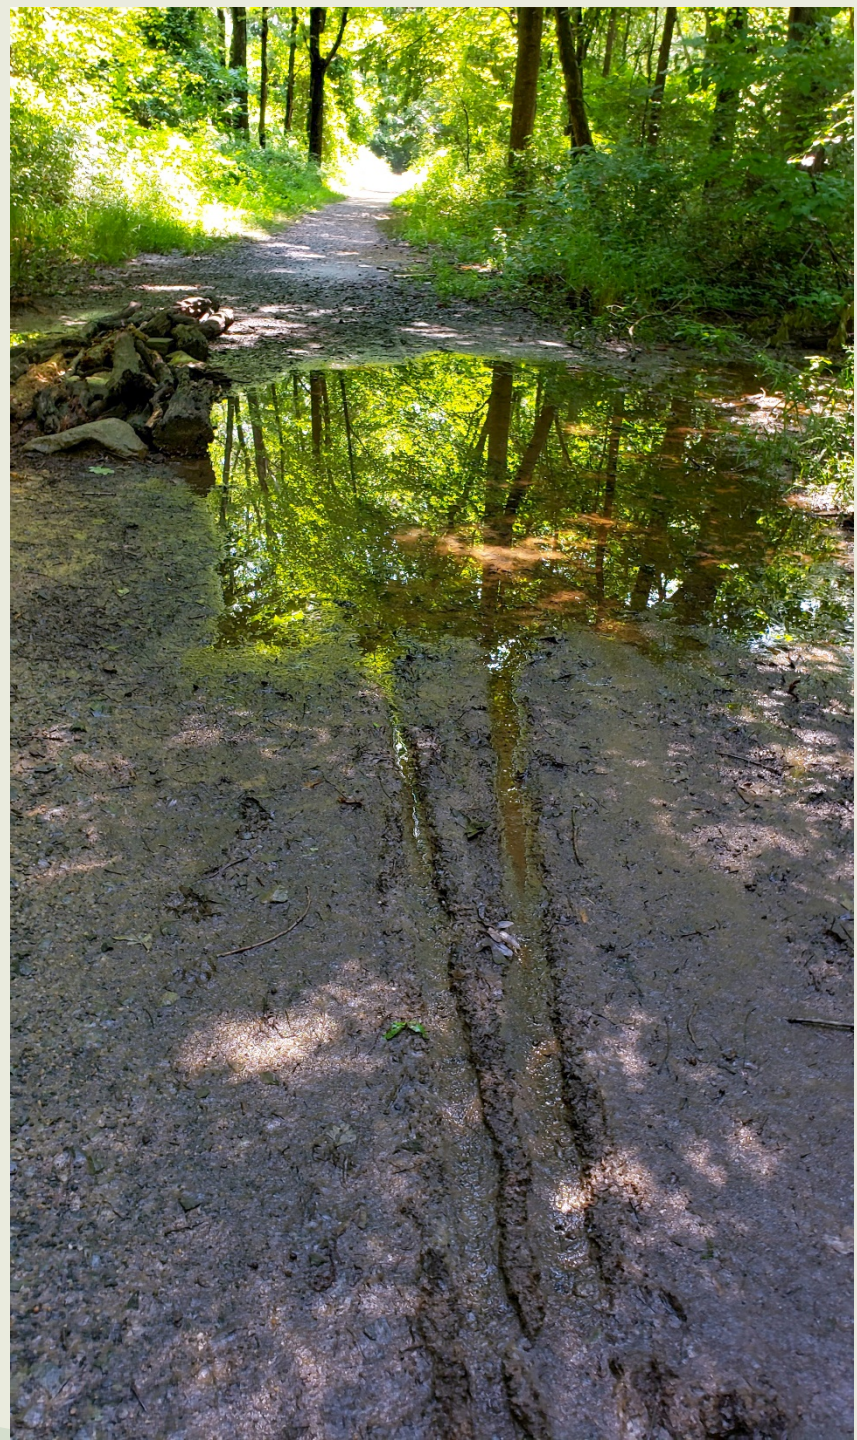
Widened Area

- Trail users avoiding obstacles & wet areas, walk around the edges of the trail, trampling vegetation along the edge of the trail

- Loss of habitat & erosion

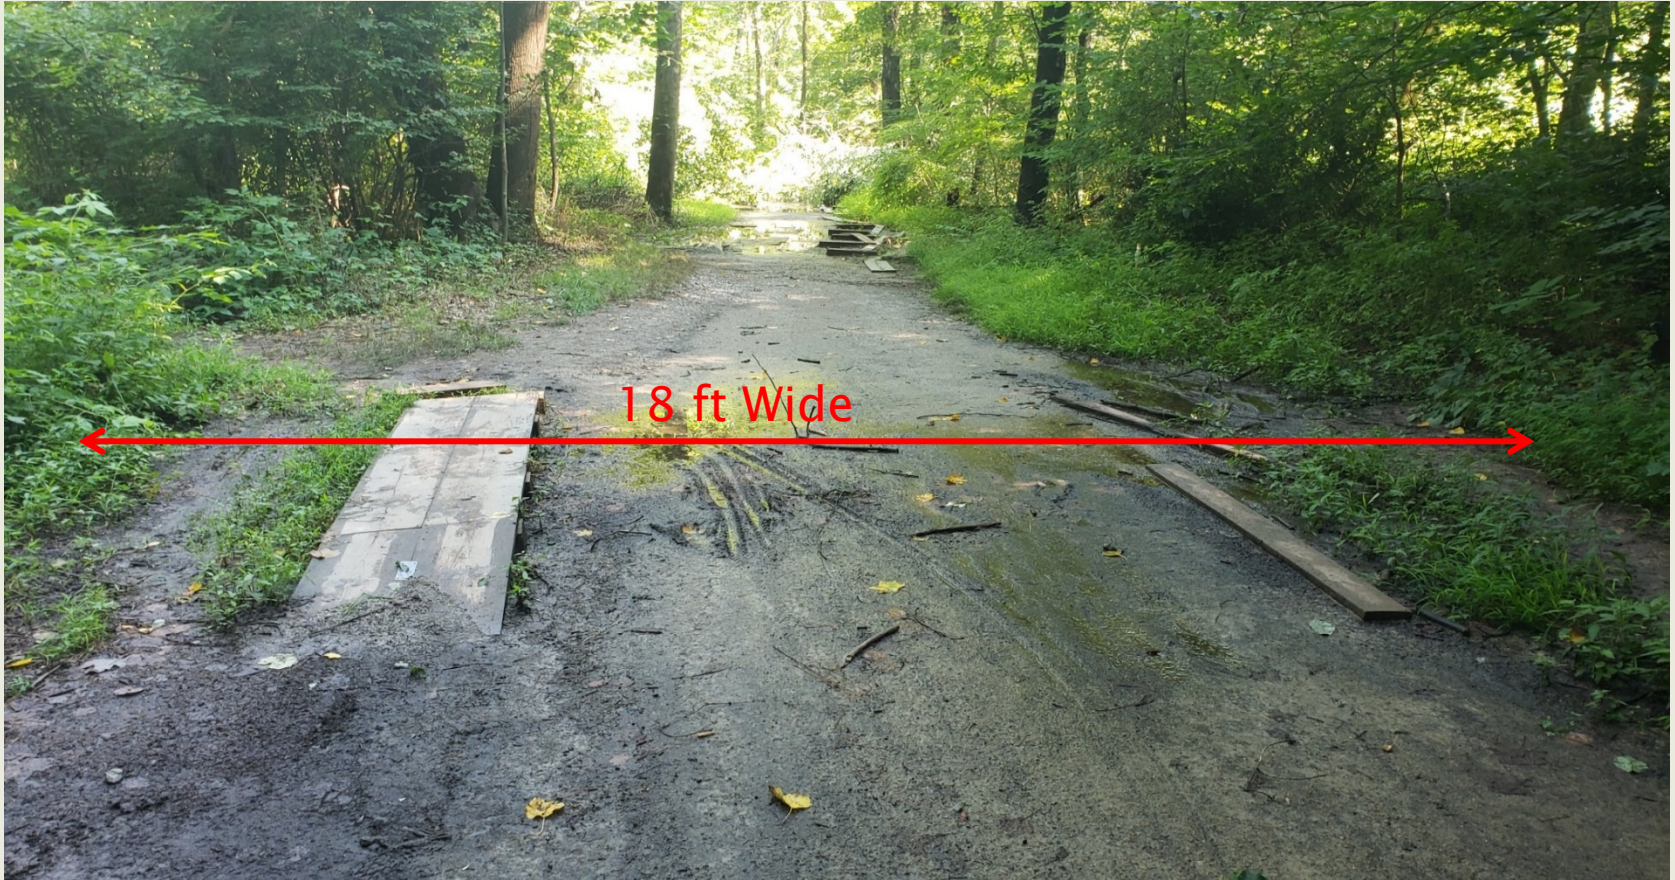
Long Branch Stream Valley

Causes

Impacts

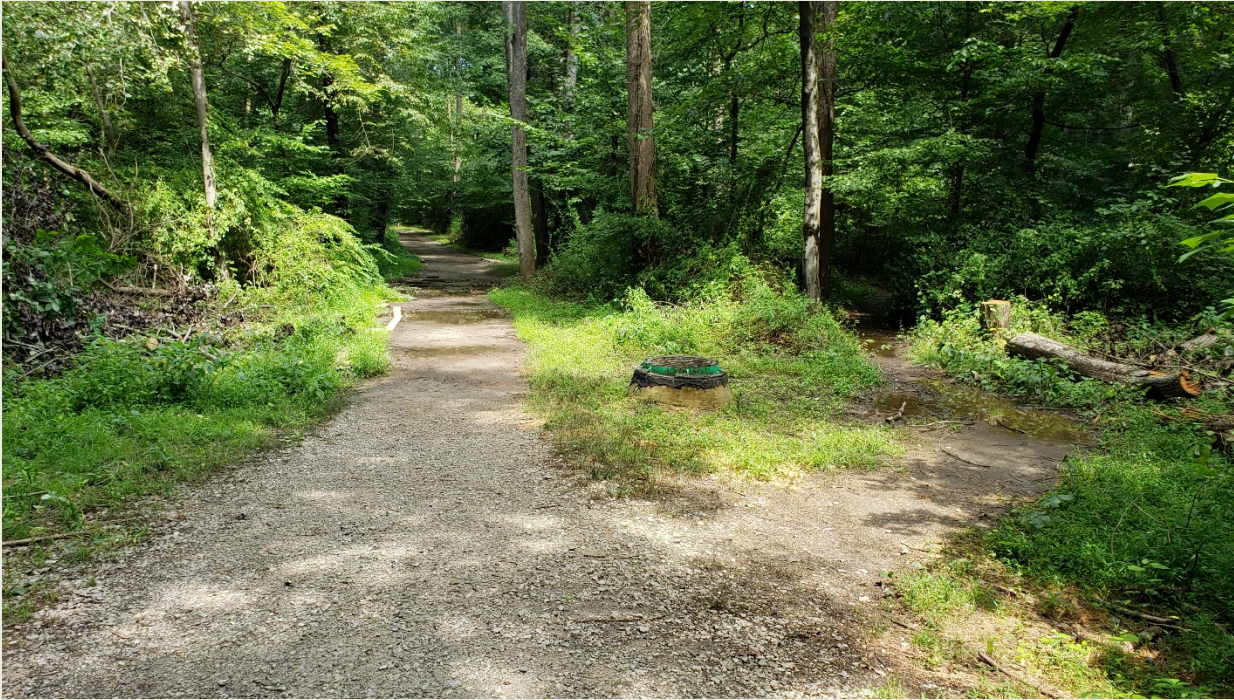
Braiding

- Trail users avoiding obstacles/wet areas create entirely new trails parallel to existing trail

- Encroachment into natural areas causes loss of habitat and erosion

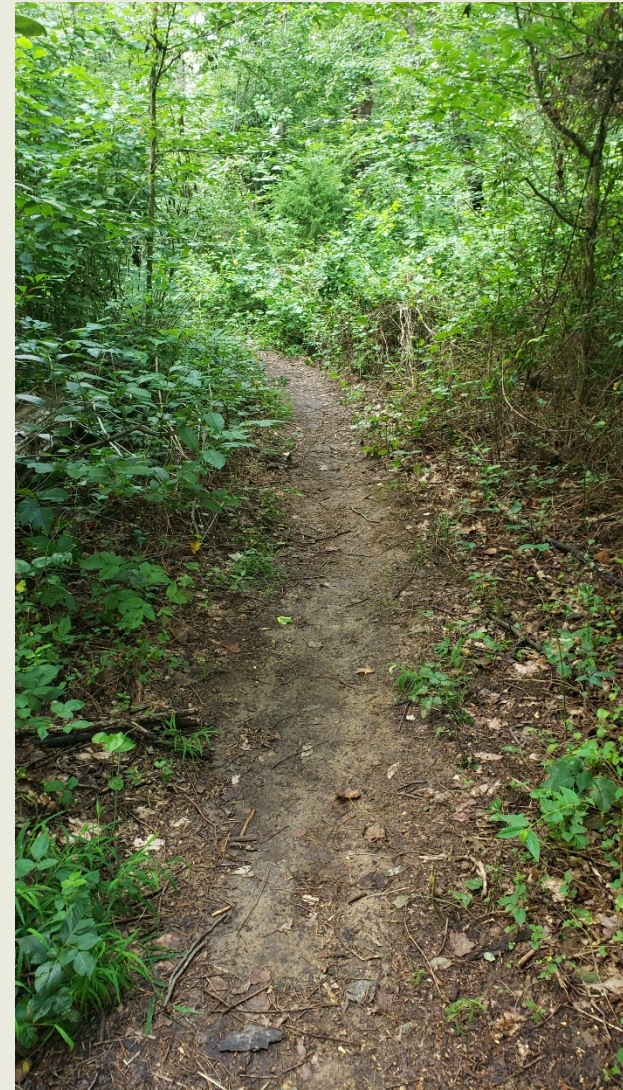
Frequently Flooded Sections

- Compacted earth and gravel is impervious like asphalt. Water will not percolate or drain through the surface
- Constant loss of trail material and natural sedimentation of the vegetated areas lowers the trail relative to the surrounding area, causing large low sections

- Flooding creates mud, which causes soil erosion and loss of gravel as it mixes and is transported with the mud. Loss of habitat from widening and braiding of trail by users. Loss of use by user groups unable to navigate flooding

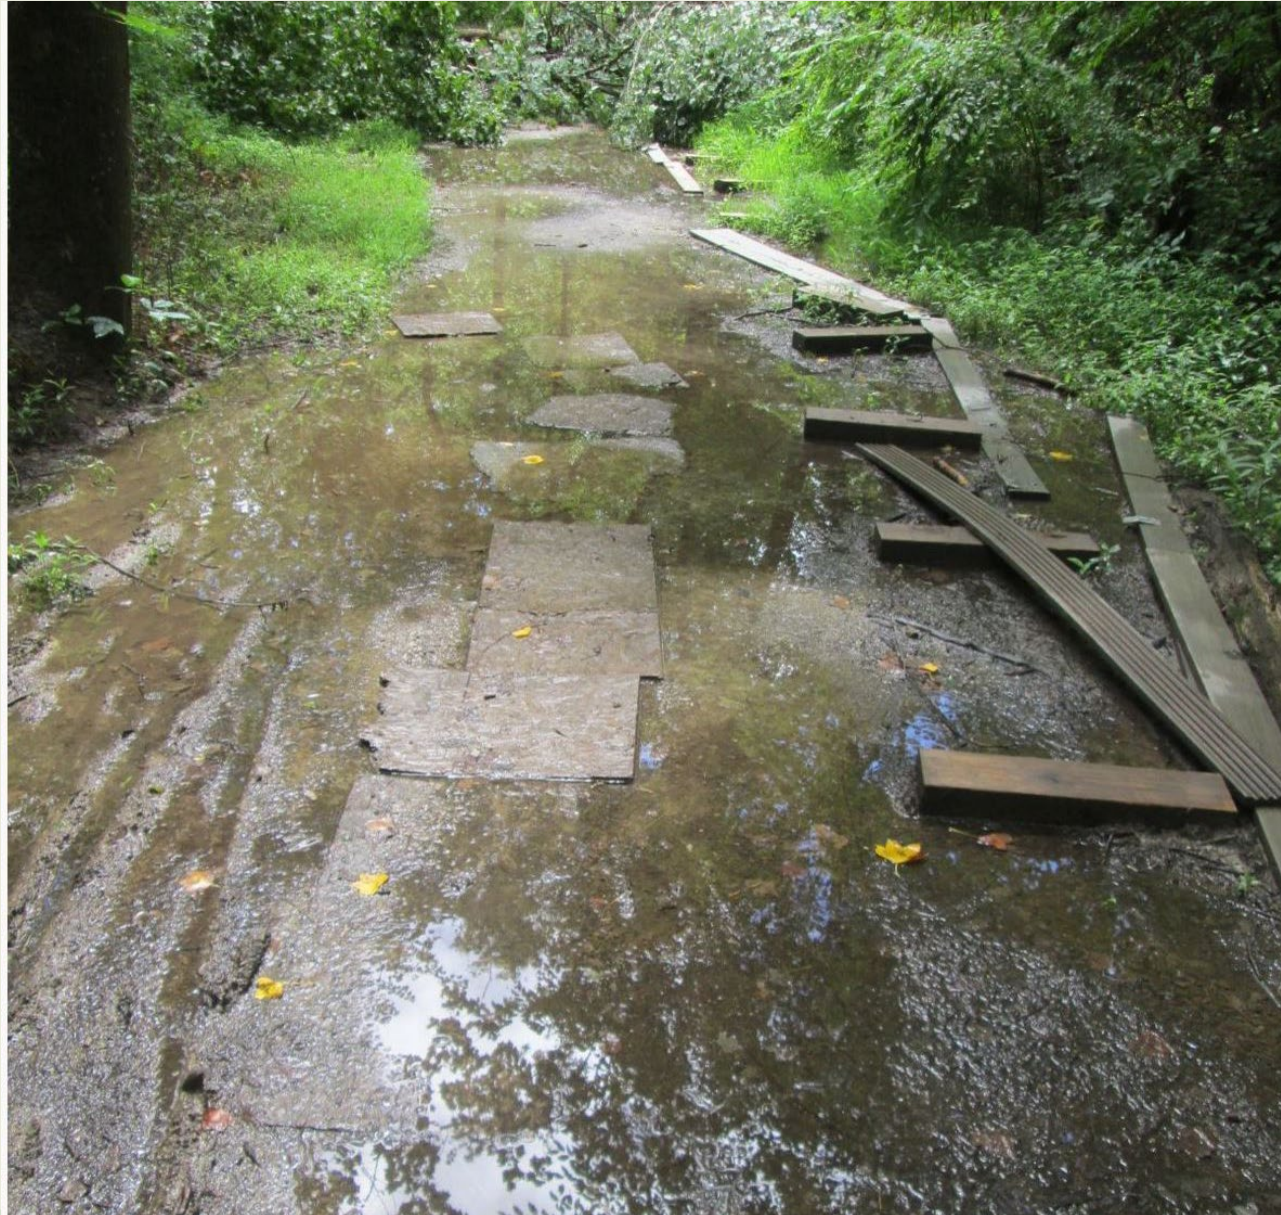
Long Branch Stream Valley

Causes

Impacts

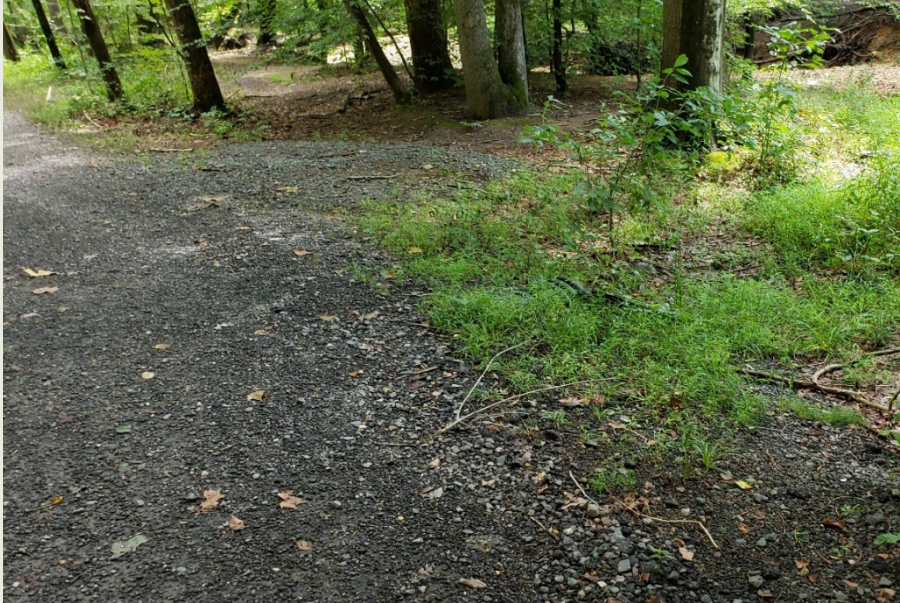
Loss of Surface Material

- Compacted gravel is a highly erodible mix of fine stone dust and small stones.

- Stonedust and stones are deposited into the creek during flooding events, which causes poor water quality in the streams. This material is then transported to the Potomac River and Chesapeake Bay. This adds to the Total Maximum Daily Load (TMDL) of Total Suspended Solids (TSS) for these creeks.
- Significant cost of maintenance to replace stone material after flooding events.

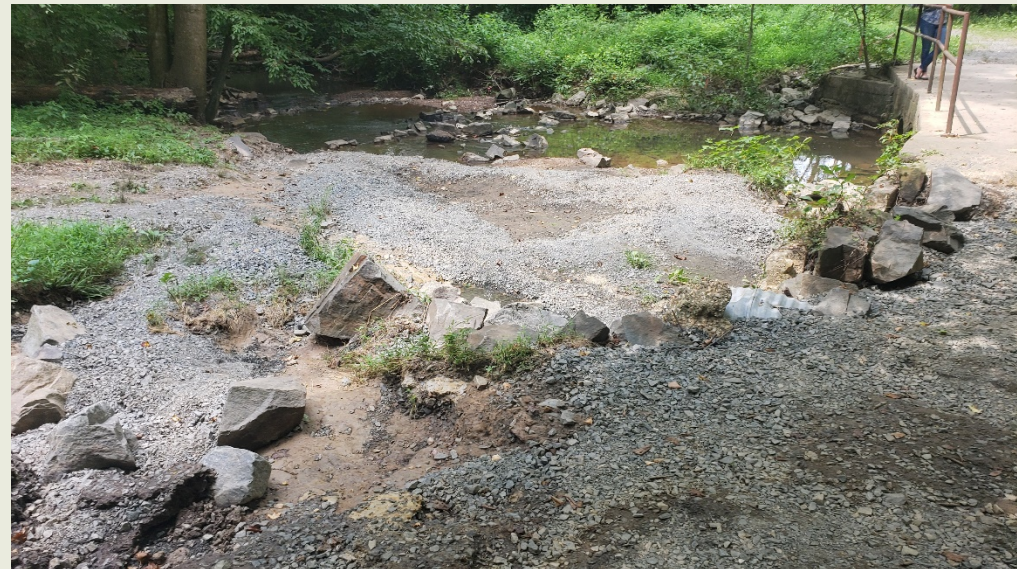
Rocky Run Stream Valley

Causes

Impacts

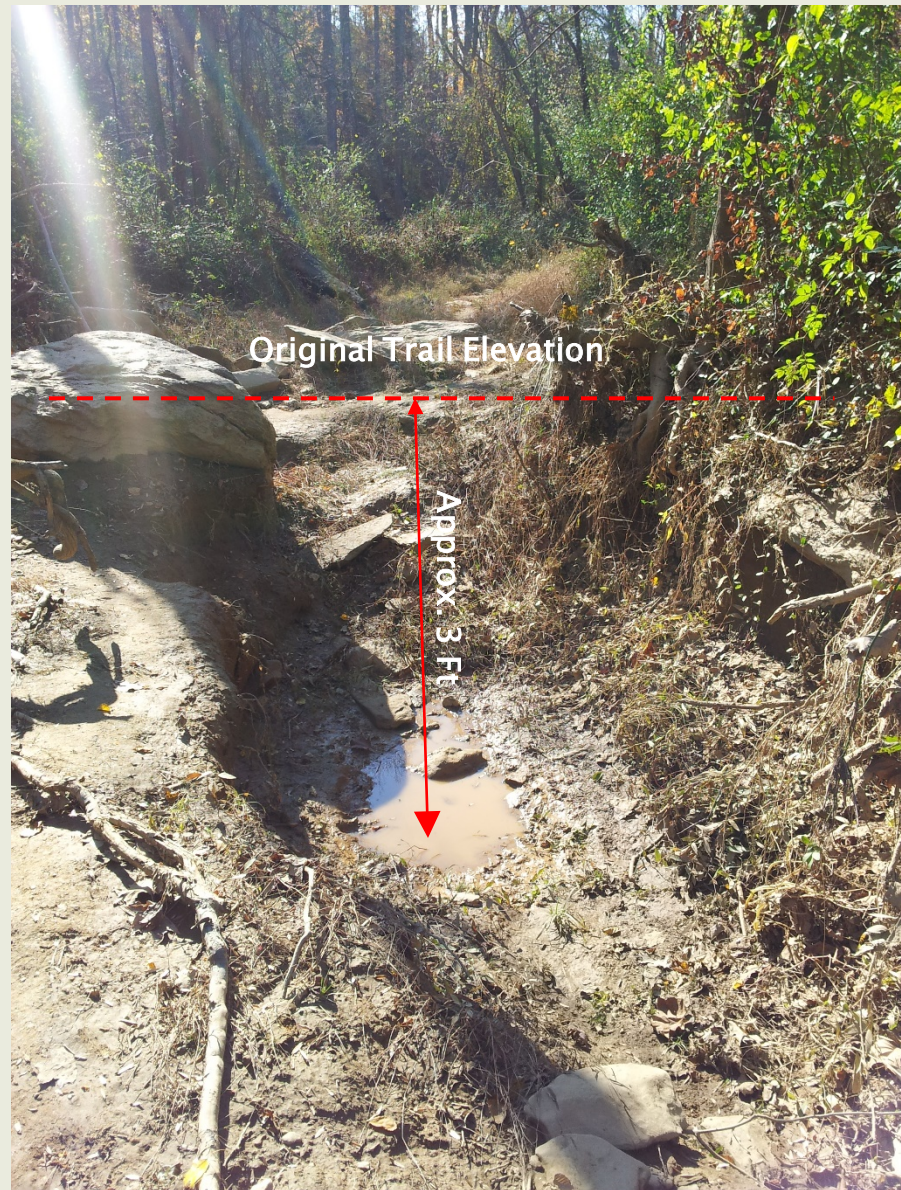
Erosion of Base Material

- Once the gravel surface is removed, erosion removes the native soil of most stream valleys

- Sediment from soil erosion is deposited into the creek during flooding events, which results in poor water quality in the streams. This material is then transported downstream to the Potomac River and Chesapeake Bay. In addition to the gravel material, this also adds to the Total Suspended Solids (TSS) impairment for these creeks
- Repairs require hauling in new fill material with construction equipment
- Sediment deposits require dredging of local lakes

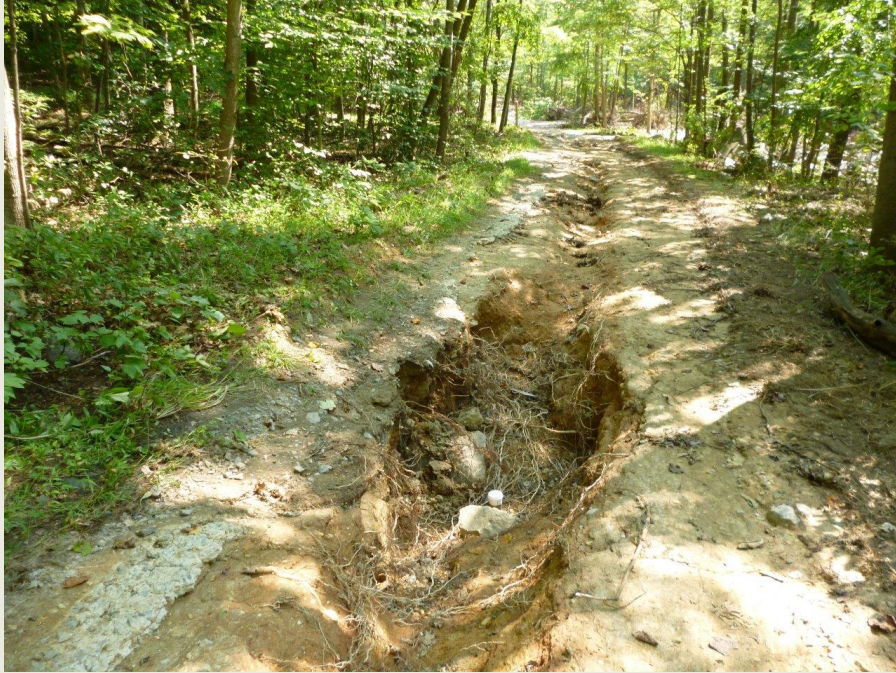
Heavily Damaged Gravel Section

- Complete loss of gravel and underlying material resulting in significant addition to sediment loading in local waterways
- Significant cost to rebuild
- Asphalt trails will not erode when the flow of water is parallel to the trail. Concrete trails will not erode regardless of water flow direction

- Stream Valley trails are, by nature, within the 100-year floodplain of the associated stream. They also typically run parallel to the flow of the creek. In these storms, the entire floodplain is inundated with fast moving water. Water flows down the trail, quickly removing the gravel and severely eroding the underlying soil

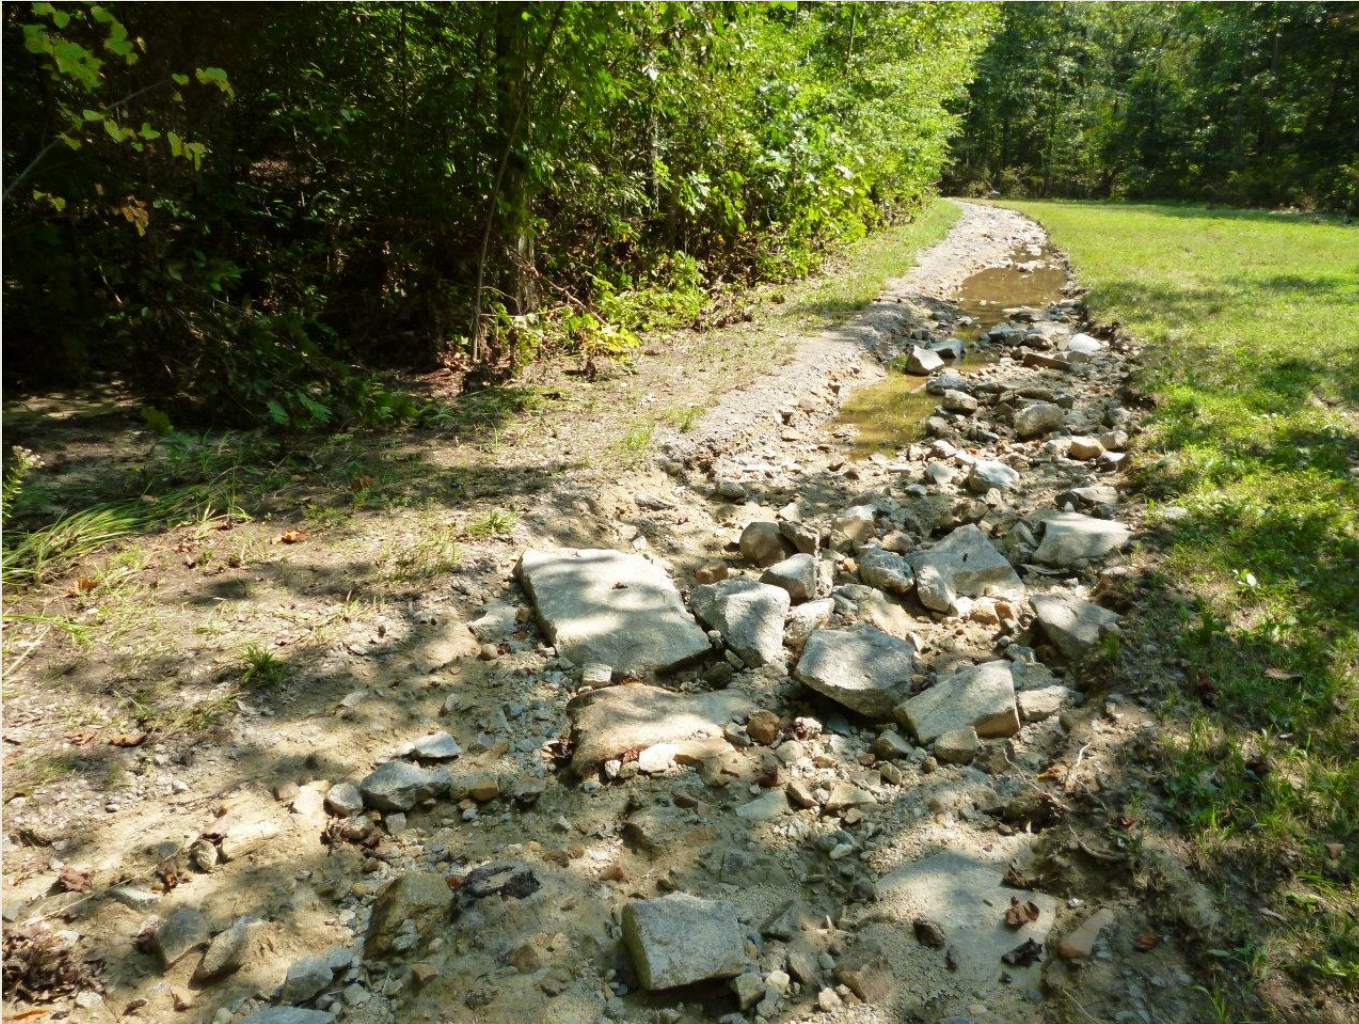
Larger Storms Create Significant Damage

- Large storms remove gravel and base material from trails

- Erosion/sedimentation
- Significant cost to repair
- Loss of use of trail for park patrons

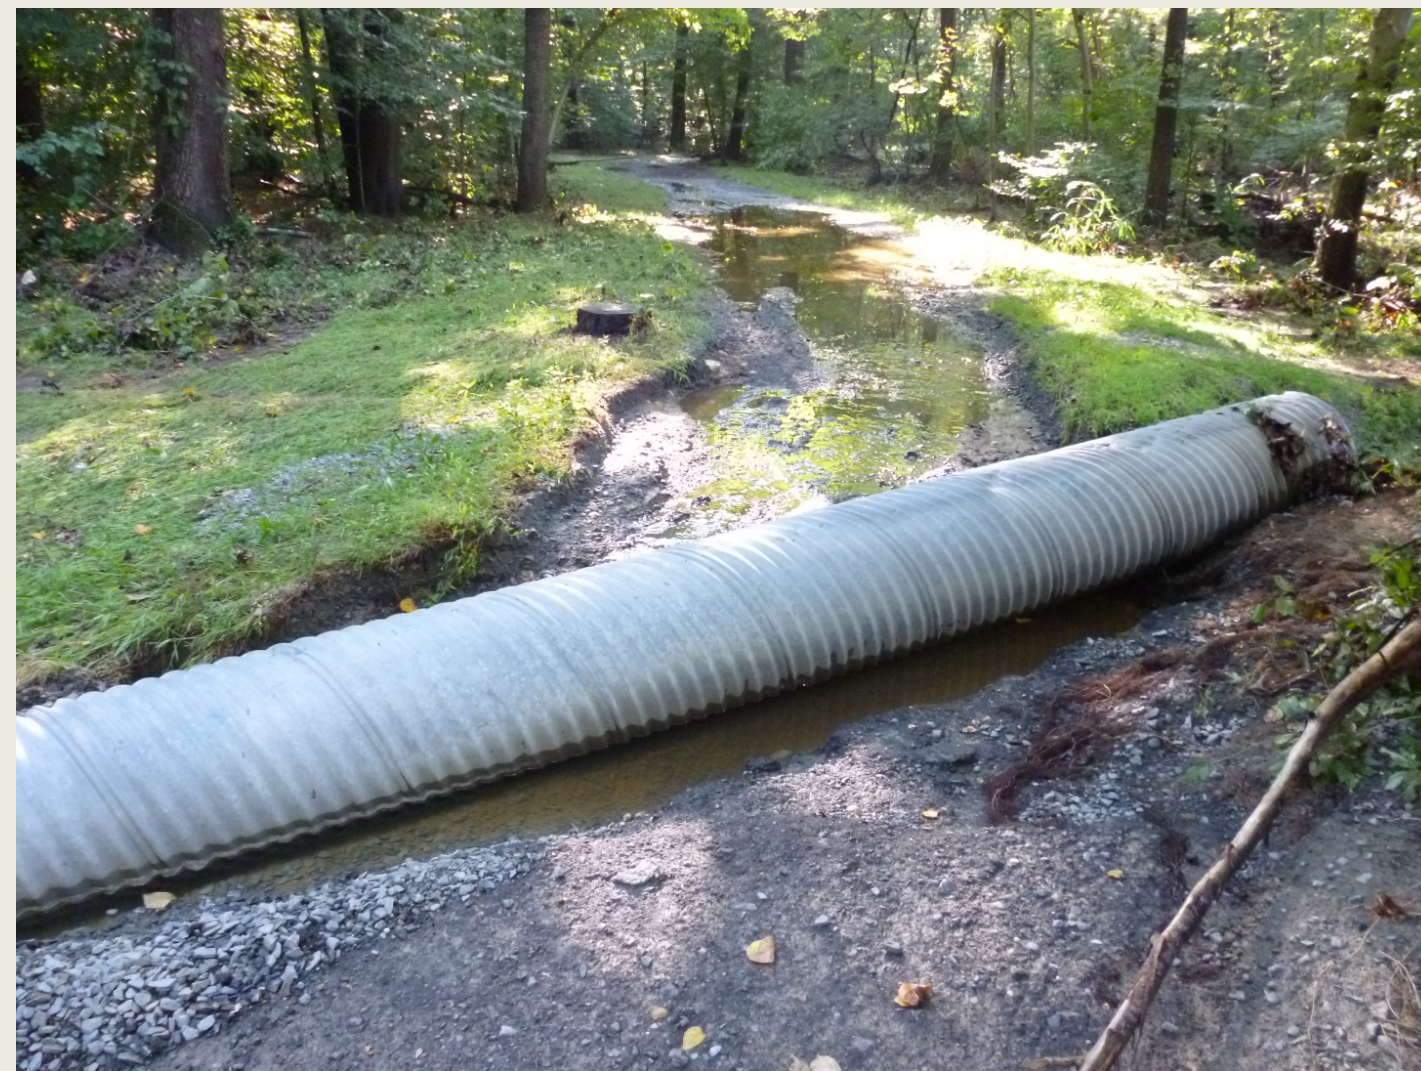
Long Branch Stream Valley

Larger Storms Create Significant Damage

Causes

- Large storms remove gravel and base material from trails

Impacts

- Erosion/sedimentation
- Significant cost to repair
- Loss of use of trail for park patrons

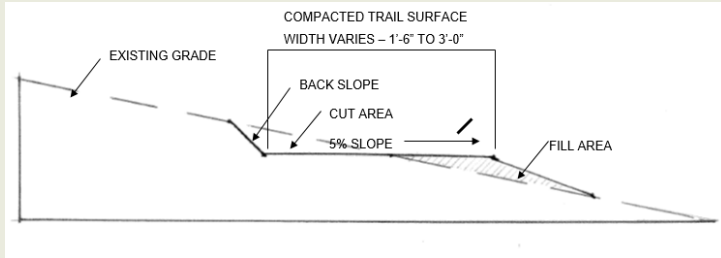
NATURAL SURFACE TRAIL

- Sustainable natural surface and gravel trails for areas with good soils and no heavy runoff

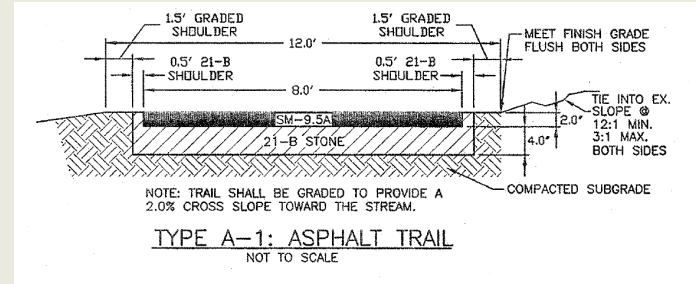
TYPE A-1: ASPHALT TRAIL
NOT TO SCALE

- Asphalt Trails of varying thickness for different soil conditions. Good for areas with moderate flooding

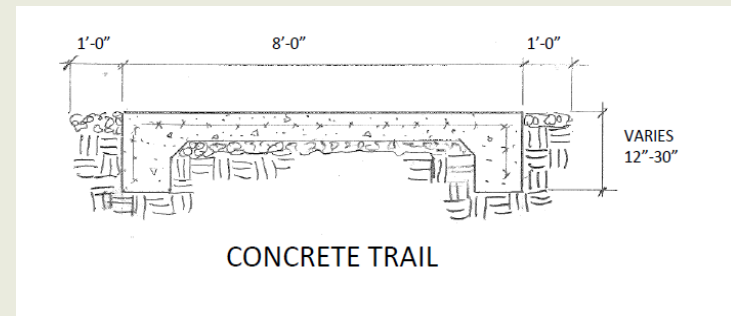
CONCRETE TRAIL

- Concrete Trails with turndowns for maximum durability. Will resist significant flooding

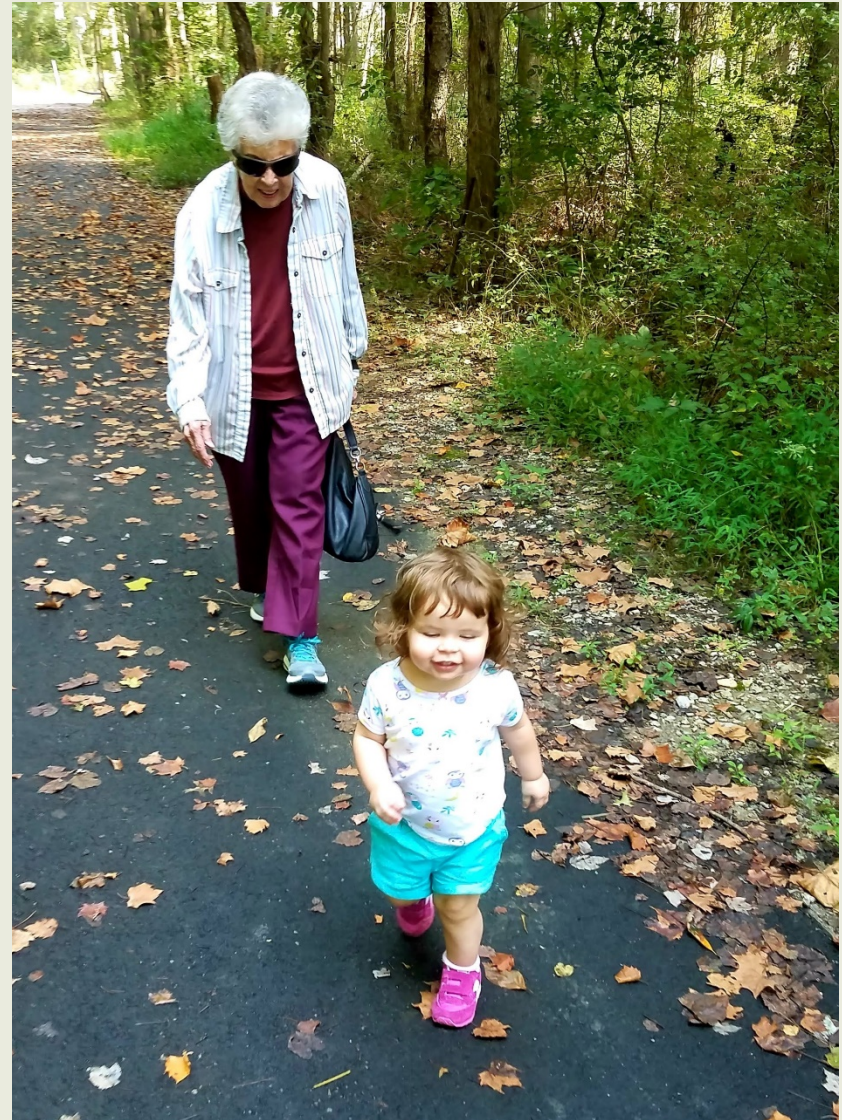
Asphalt/Gravel Lifecycle Cost Comparison

- Initial cost of construction for asphalt trails is slightly higher than gravel
- Anticipated lifecycle of a gravel trail is 10 years. Anticipated lifecycle of an asphalt trail is 20 years
- Gravel trails cost more per year to maintain than asphalt trails. After 10 years, the cost difference in the initial construction is lost.
- Gravel trails will need to be rebuilt/replaced at the end of 10 years at slightly less than the cost of original construction
- Asphalt trails will require an overlay of new asphalt in 20 years

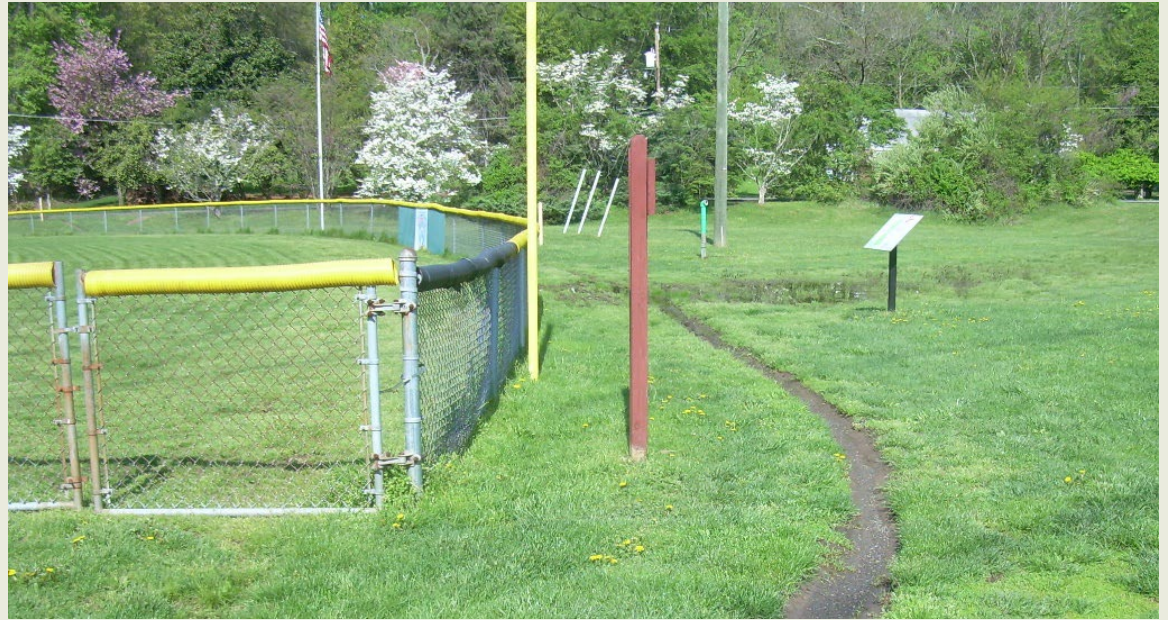
BEFORE

- Trail is part of the Gerry Connolly Cross County Trail
- Staff received numerous complaints regarding persistent flooding of this section of trail
- All weather asphalt surface replaced frequently flooded natural surface trail

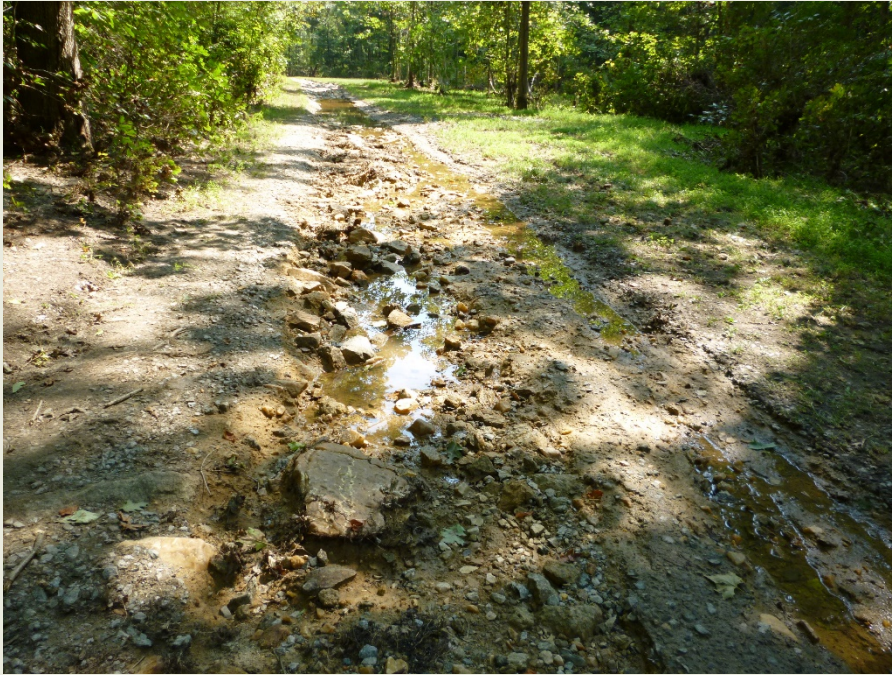
BEFORE

- Popular trail in narrow part of stream valley prone to flooding. Trail required frequent heavy maintenance with construction equipment
- Asphalt surface eliminated loss of gravel material and frequent need for heavy maintenance resulting in cost savings

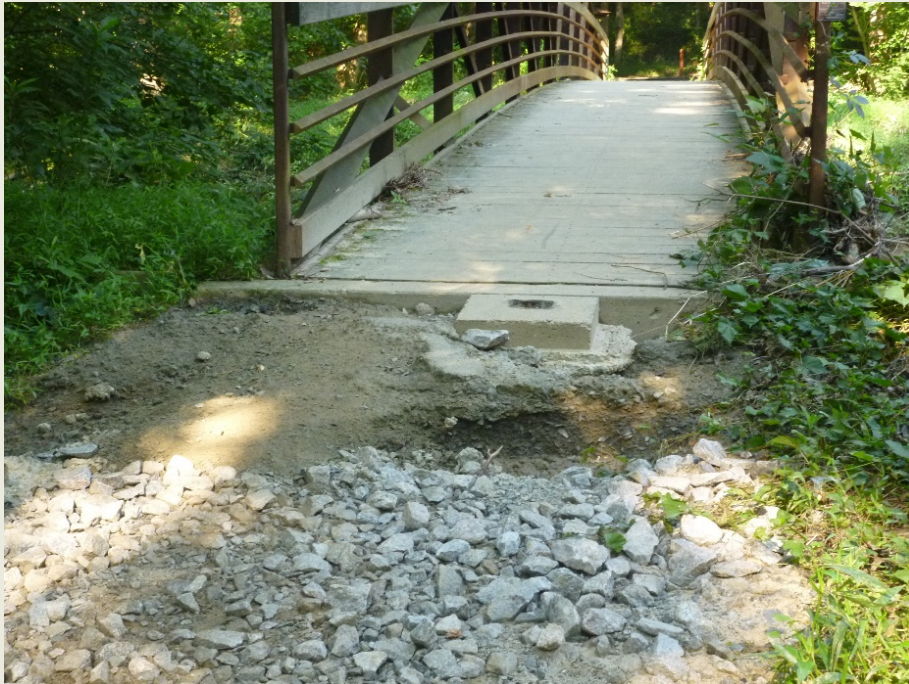
BEFORE

- Approaches to bridge frequently washed out, leaving an unsafe drop at the ends of the bridge. Drop was a potential danger for bicyclist and persons with mobility issues and required regular maintenance.

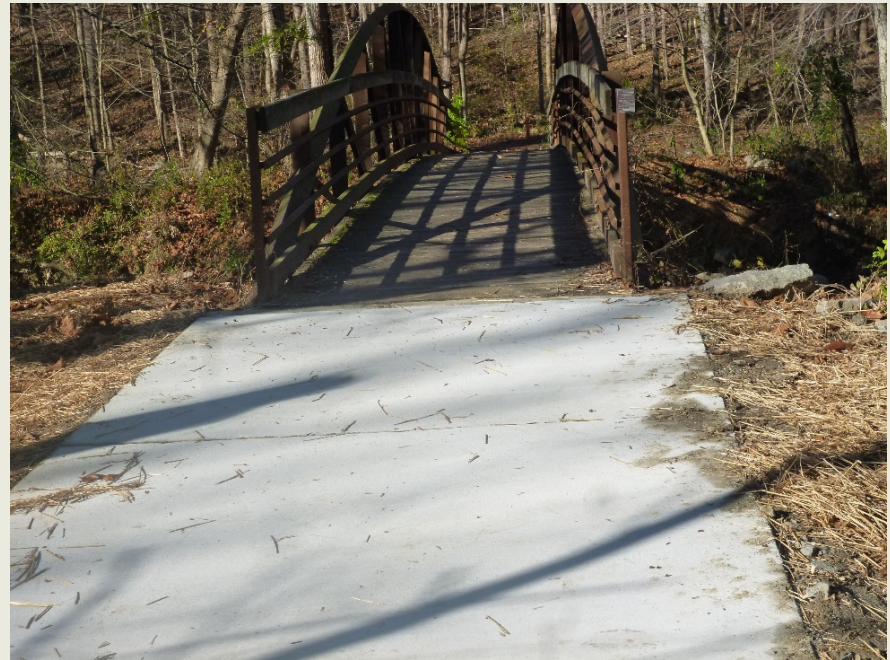
AFTER

- Concrete approach ramps created a permanently level transition to the bridge that requires no maintenance.
- Improved accessibility of trail for users of all abilities.
