Fairfax County, Virginia 2023 Municipal Separate Storm Sewer System (MS4) Program Plan and Annual Report

Reporting Period: July 1, 2022 through June 30, 2023

Permit No: VA0088587
Effective Date: April 1, 2015
Expiration Date: March 31, 2020
(Administratively Continued)

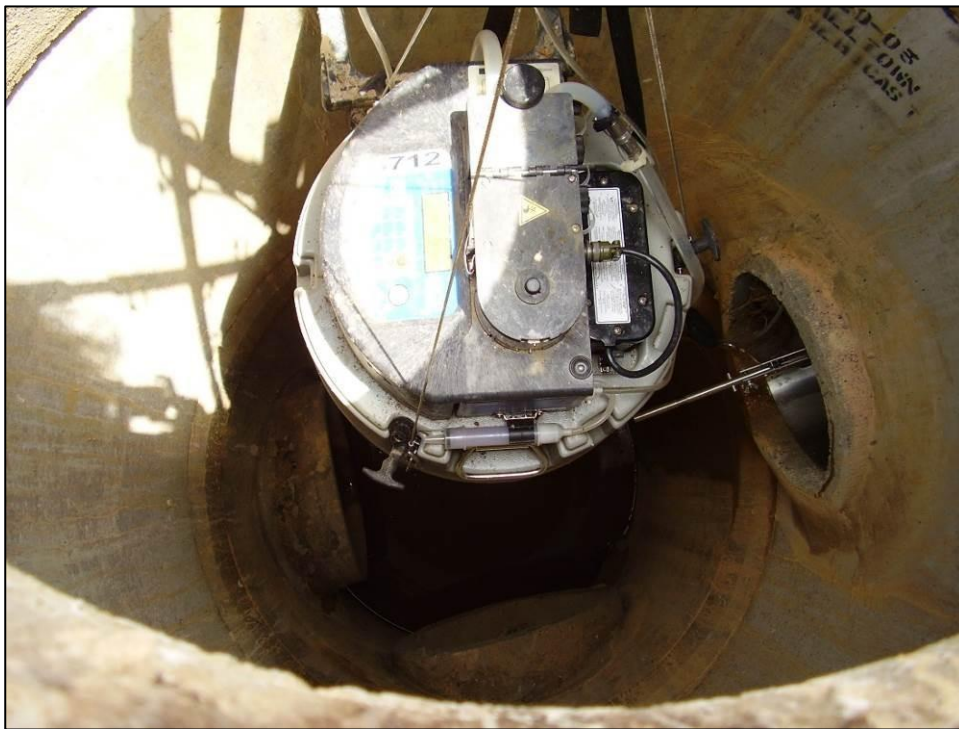
The automated sampler to be employed will be an ISCO Model 6712 portable sampler capable of collecting up to 24 1000-mL water samples. The samples are contained in Propak liners constructed of polyethylene which are inserted into plastic frames to provide rigidity. The size of the samples and number of bottles will assure that several bottles will be filled corresponding to all portions of the storm event hydrograph. The automated sampler will be transported to the sampling sites prior to the storm event and removed after event conclusion. During the event, each sampler will be covered by a lid to protect it from the effects of weather. The samplers will be powered by 12 volt 100Ah rechargeable marine batteries. The sampler will be secured against theft when practical using bicycle locks attached to fixed objects such as fence posts.

Should site conditions require, an ISCO Model 6712C compact portable sampler may be used. This sampler is of a size and configuration that will allow it to be inserted and retrieved from a manhole and suspended using a pro-hanger and appropriate harness (for manholes 18 to 24 inches in diameter). Alternatively, the samplers may be secured using rebar loops inserted into the ground and combination bicycle locks to discourage theft.

Automated sampler placed in manhole using hanger and spring ring
