**LAKE BARCROFT'S**

**DREDGING**

**EXPERIENCE**

Lake Barcroft WID General Manager

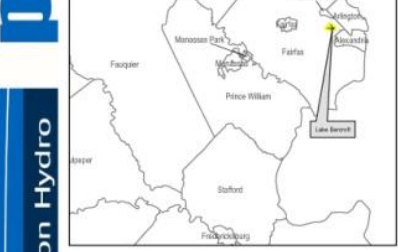
# Lake Barcroft Bathymetry

**BATHYMETRIC SURVEY OF LAKE BARCROFT**  
 PREPARED FOR:  
 LAKE BARCROFT  
 WATERSHED IMPROVEMENT DISTRICT  
 FAIRFAX COUNTY  
 COMMONWEALTH OF VIRGINIA

**LAKE STATISTICS:**  
 Total Area of Lake - 5,892,920 ft<sup>2</sup> (135.3 ac)  
 Total Water Volume - 91,587,987 ft<sup>3</sup> (2102.6 ac-ft)  
 Total Volume of Unconsolidated Sediment - 1,085,785 ft<sup>3</sup> (24.9 ac-ft)  
 Average Lake Water Depth - 15.52 ft  
 Average Unconsolidated Sediment Thickness - 0.184 ft (2.2 in)

- SOURCES:**
1. Aerial image obtained in digital format from Fairfax County GIS Department.
  2. In-lake sediment contouring and grid analysis derived from collected bathymetric points using ESRI's ArcGIS 3-D Analyst module; contours in feet.
  3. Bathymetric data collected on lake by Princeton Hydro personnel on July 11, 12, & 13, 2005 using Knudsen 320BP Echosounder with Hyback Software and Trimble Pro-XRS GPS unit.
  4. Virginia counties data obtained from the US Census Bureau Geography Department website.

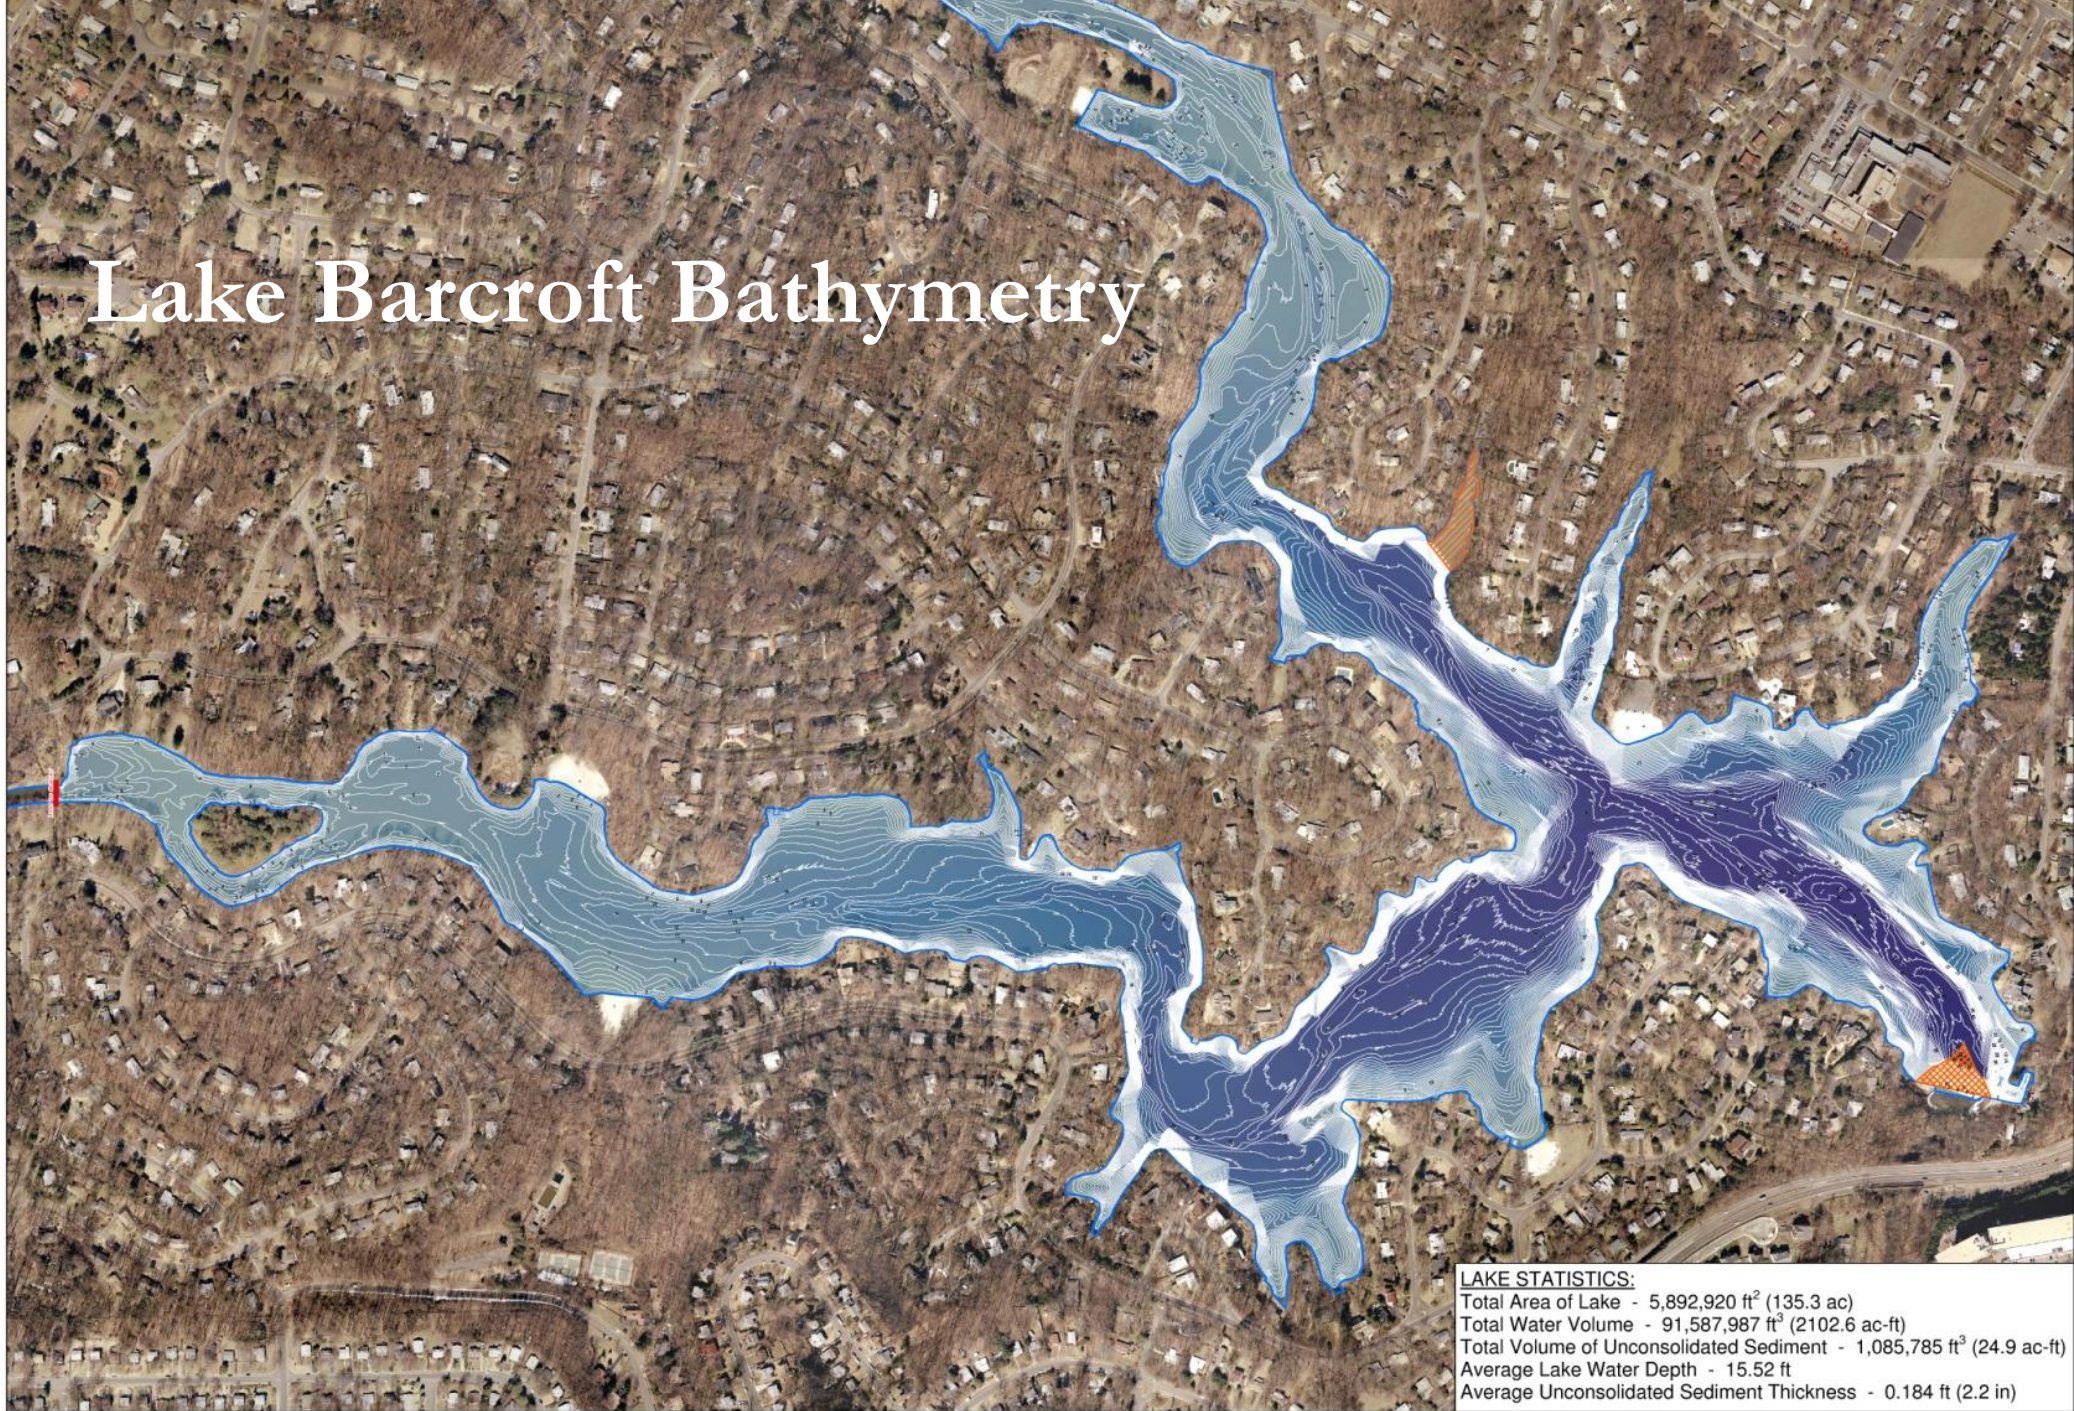
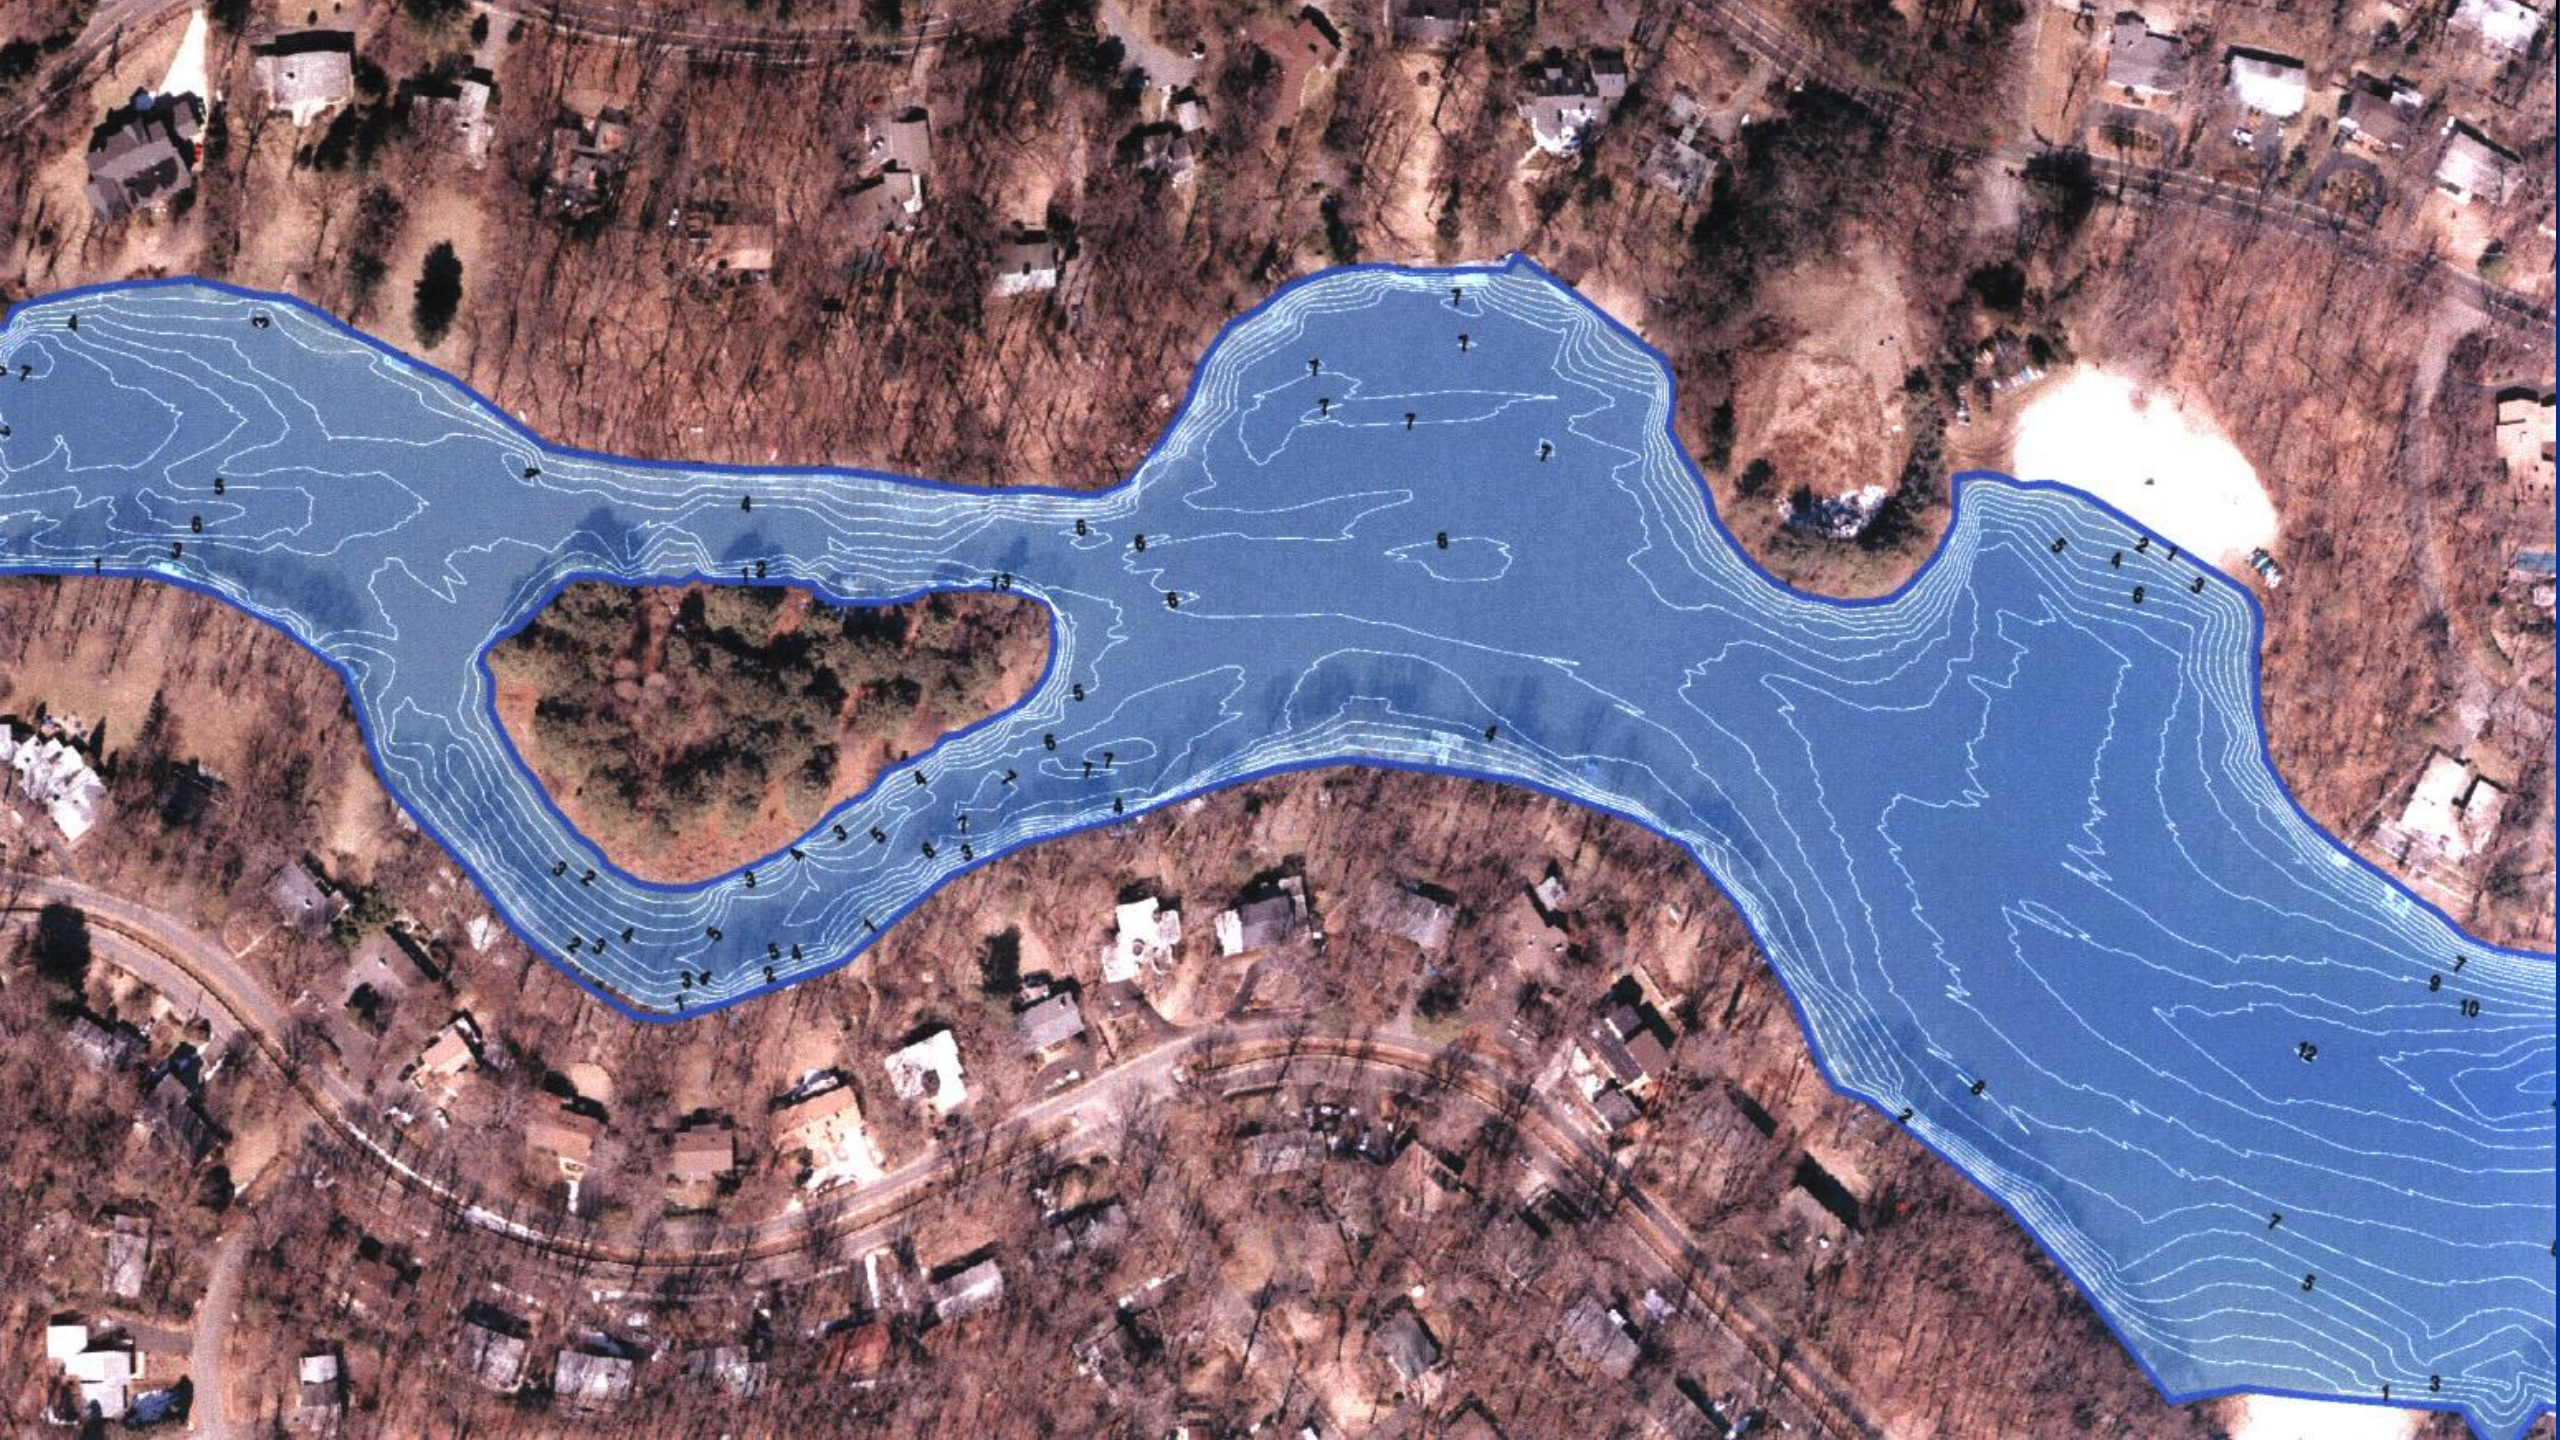
ATTACHMENT A  
RFP#: LBWID-2006-01

CONTOUR LINES AT  
1'-0" INTERVALS

BLACK CONTOURS: PRESENT BOTTOM PROFILE  
RED CONTOURS: REQUIRED END RESULTS OF DREDGING  
ESTIMATE 1650-1700 CUBIC YARDS TO BE REMOVED

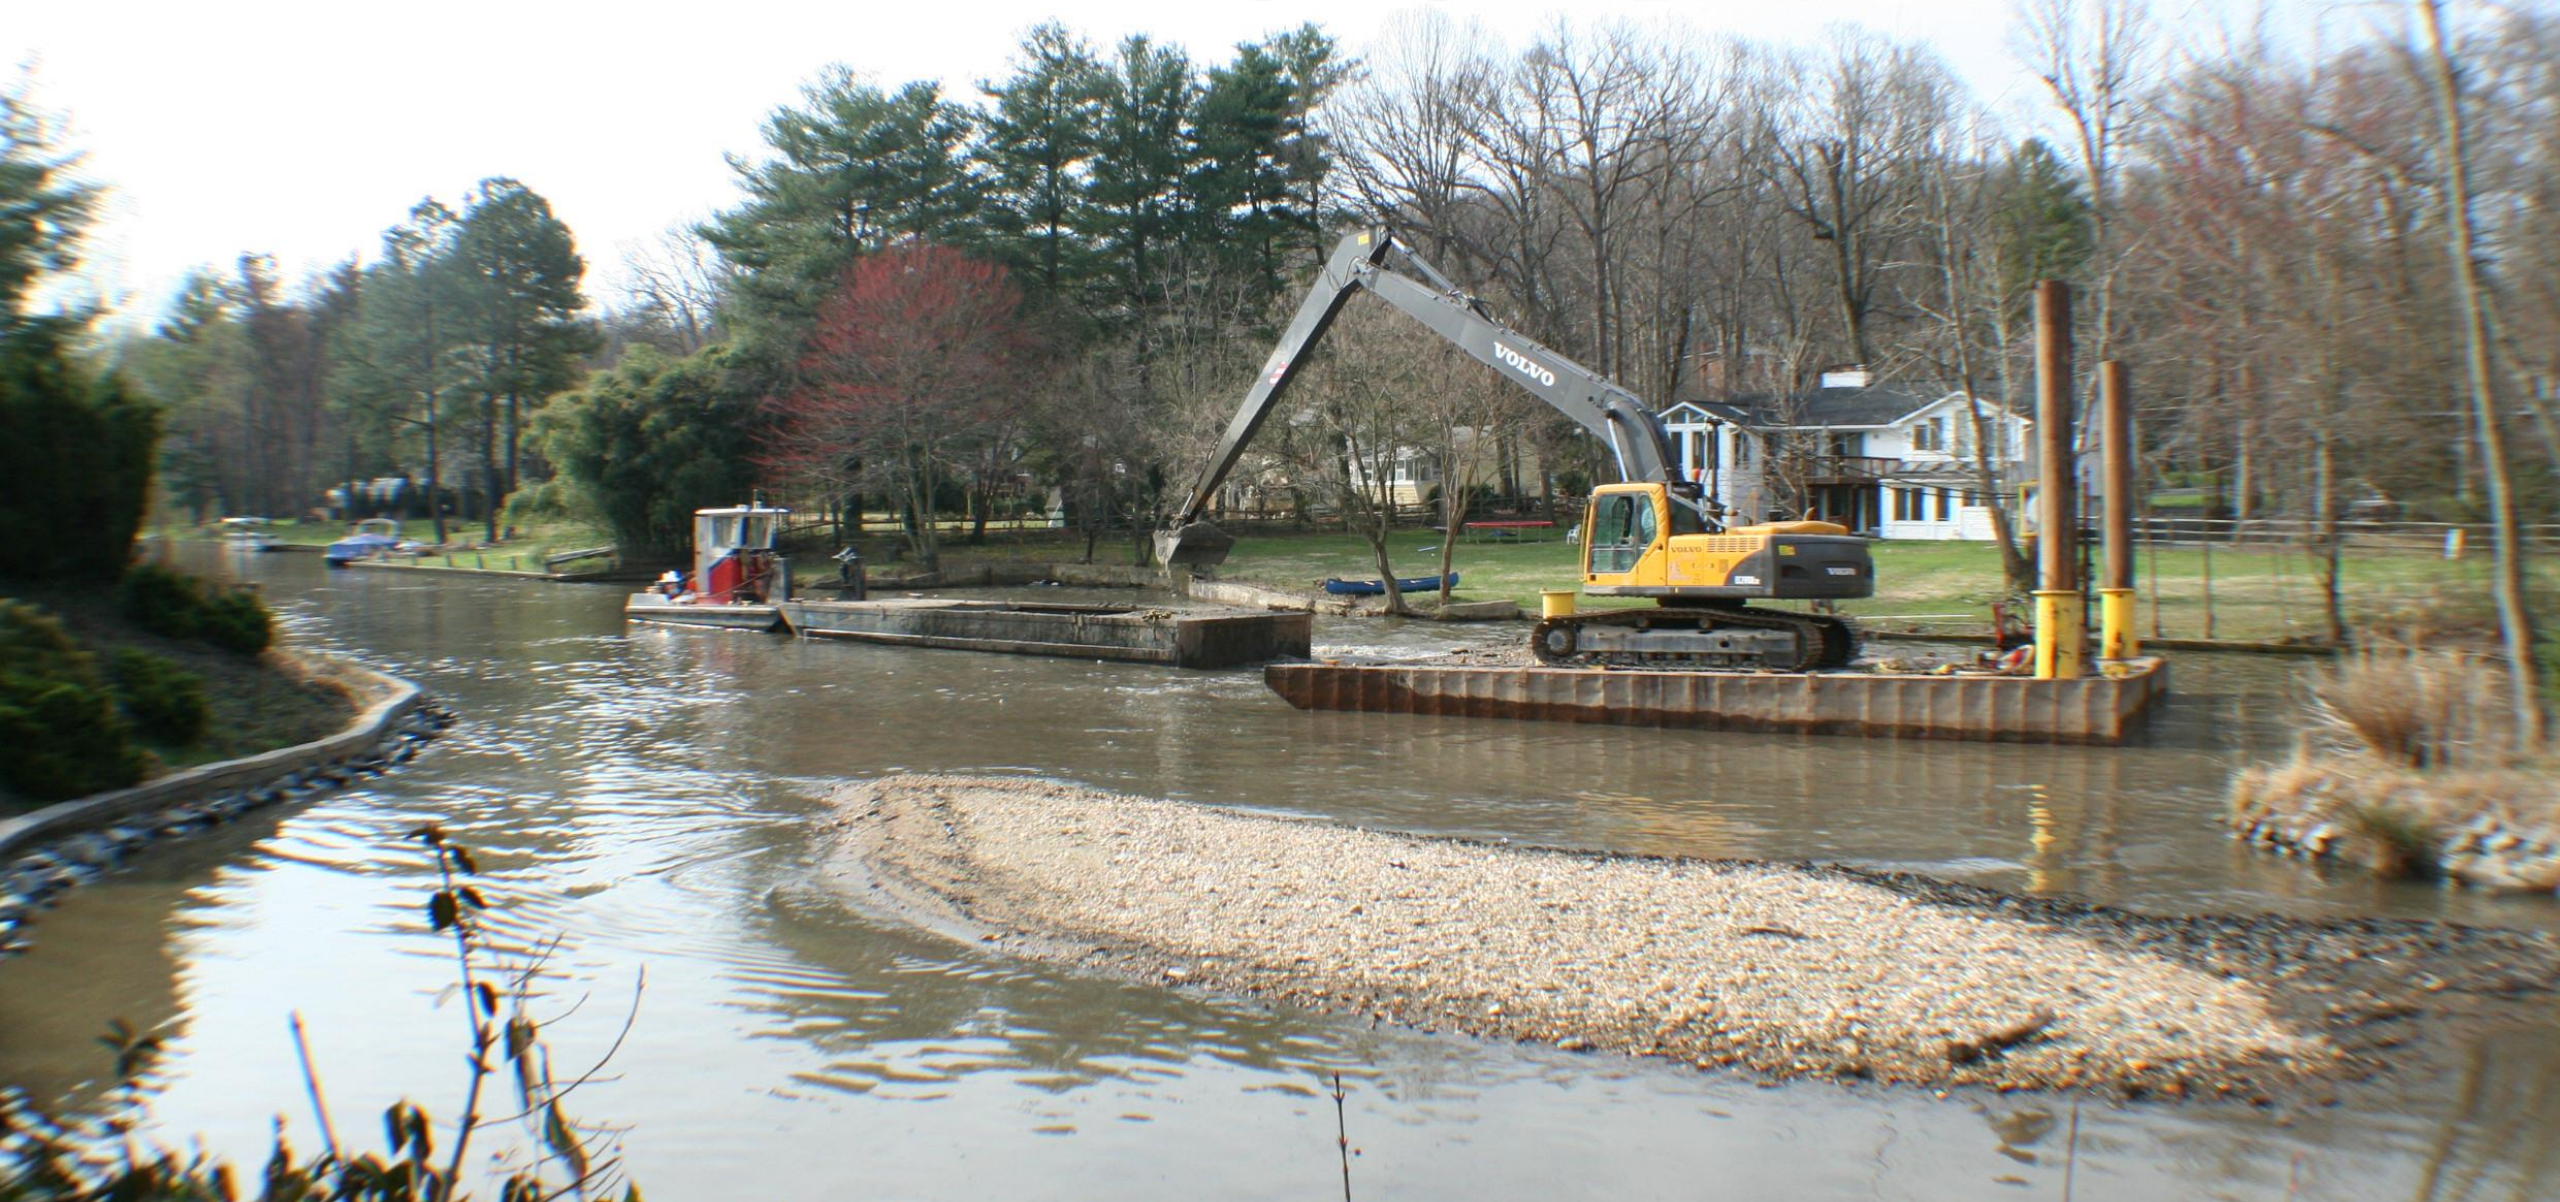
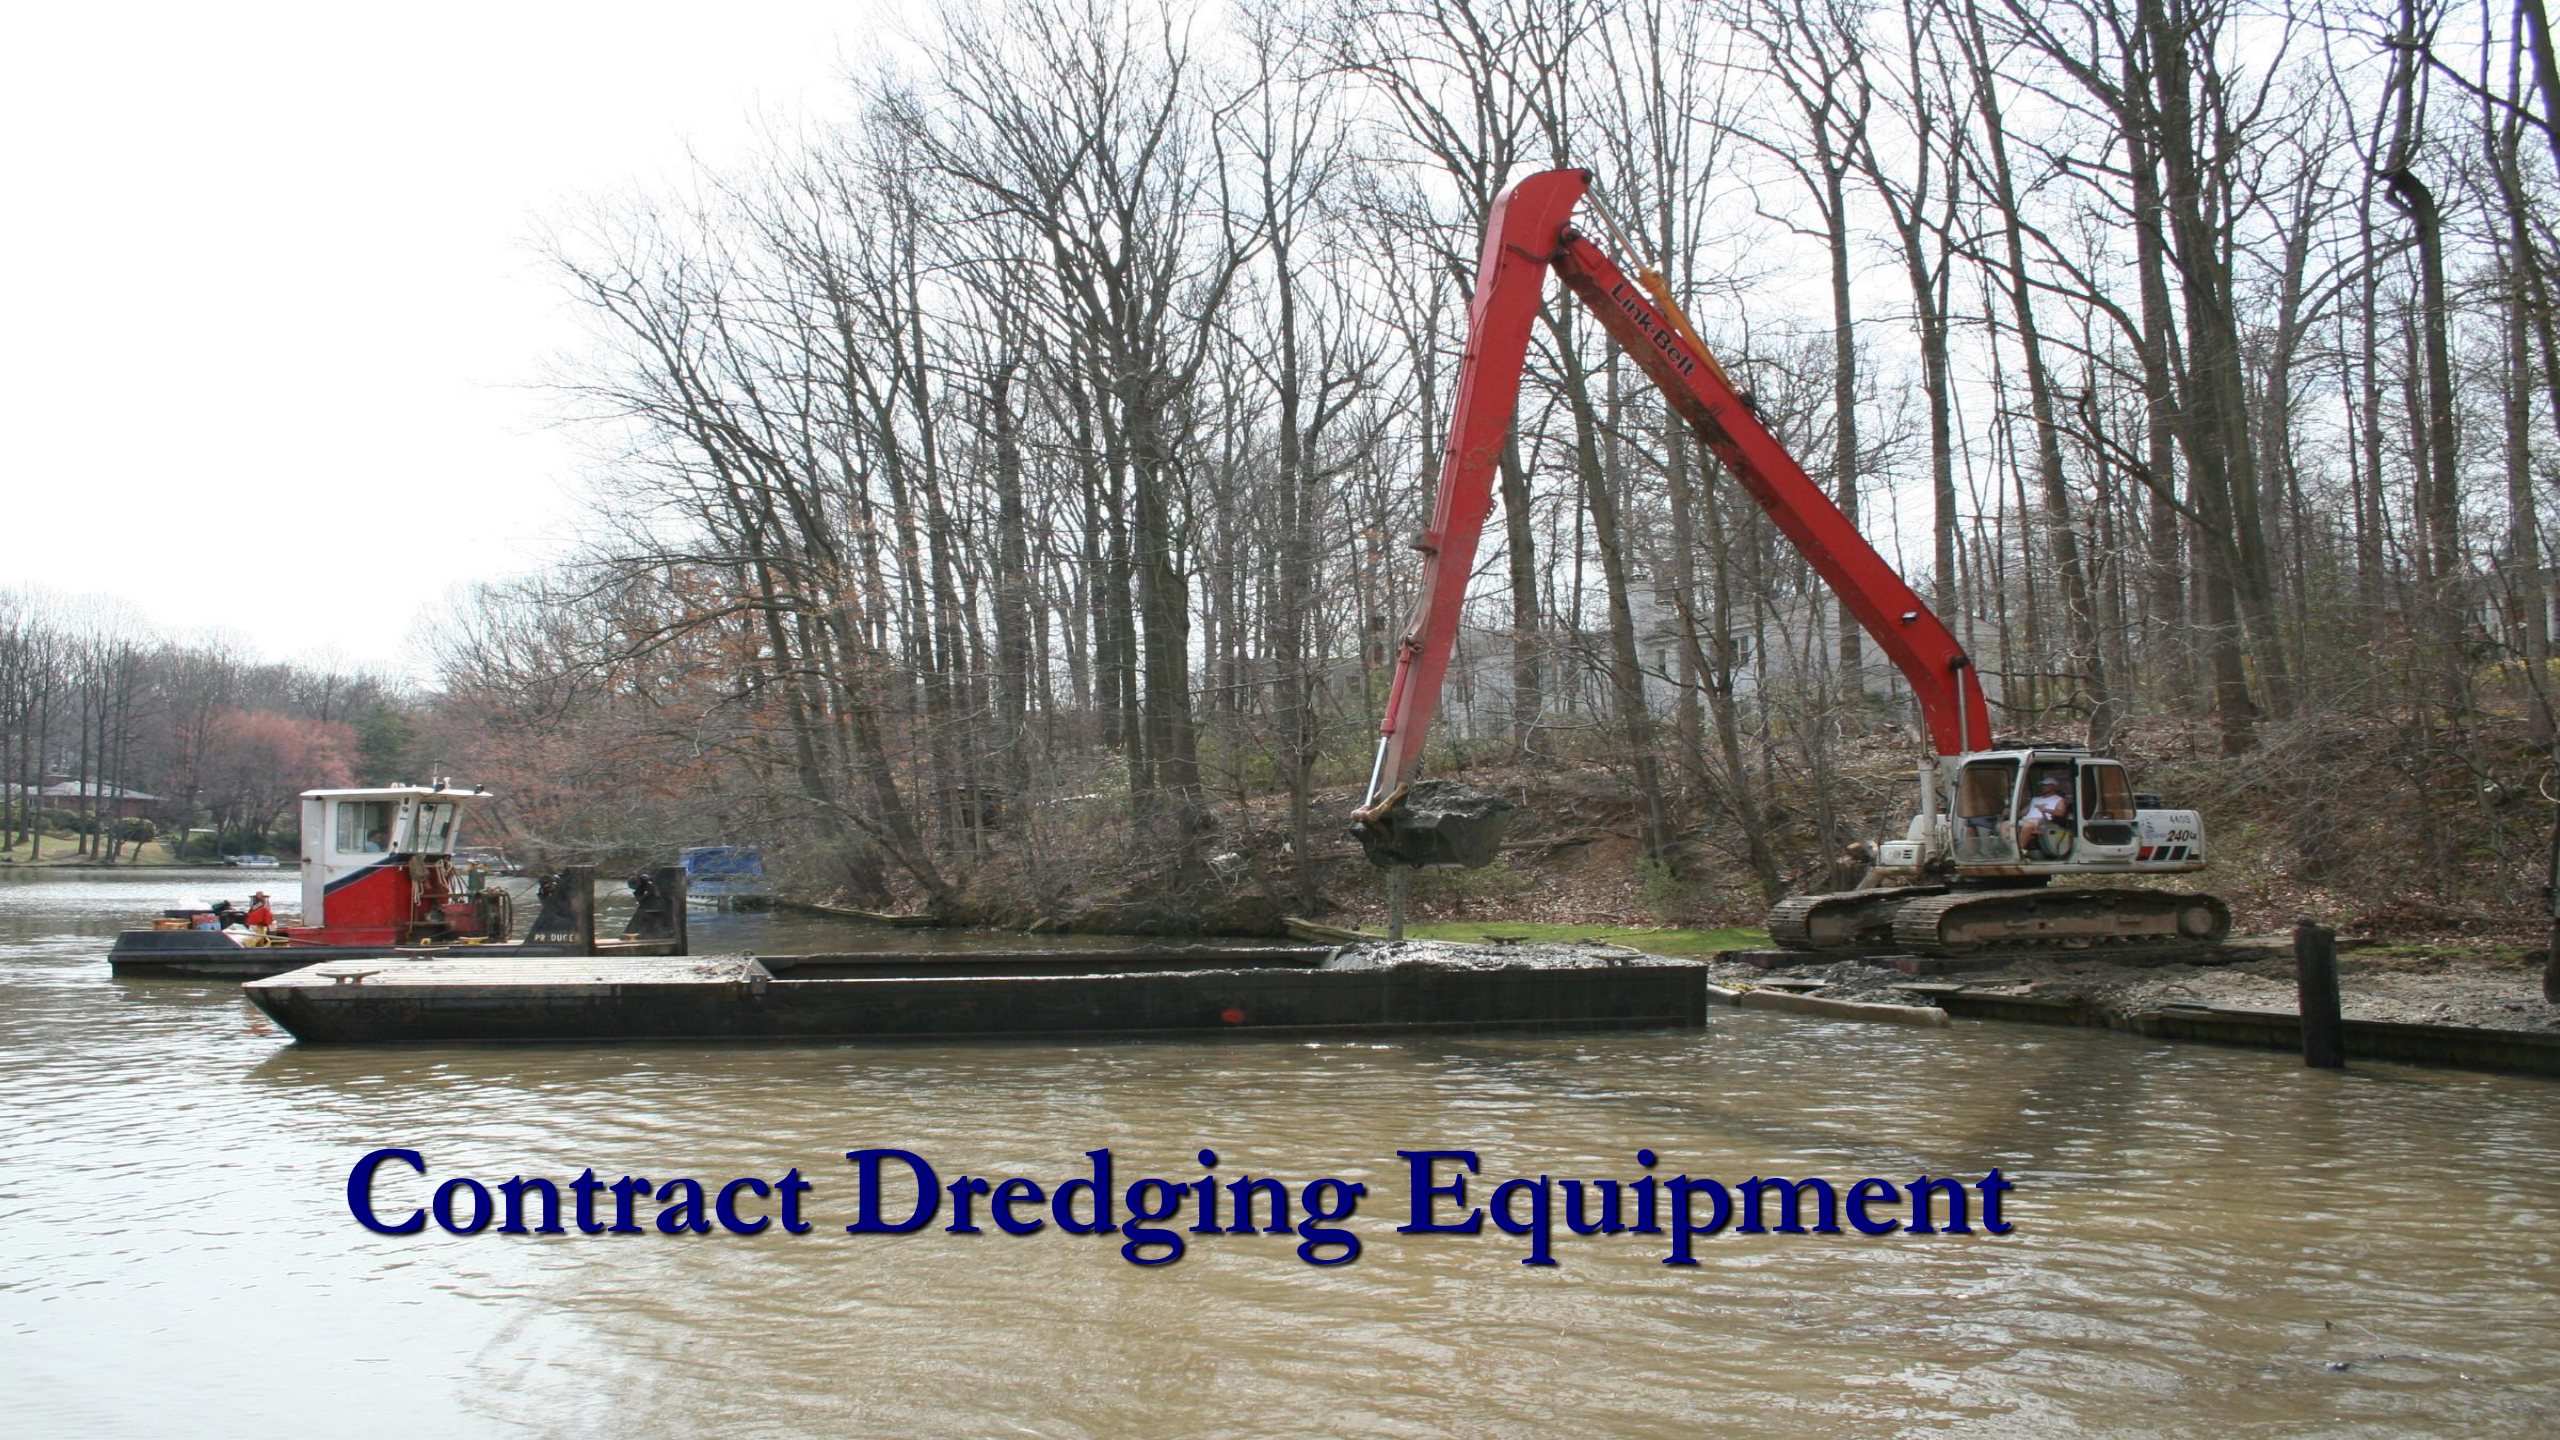
# Contract Dredging Equipment

- Planned dredging every 4 to 5 years
  - 10,000 to 12,000 cy of sediment dredged each event
- Expensive equipment mobilization cost and uncertainty of contractor availability
- Difficulty in disposing of larger quantities of dredge spoils
- Increased intensity of storms could leave parts of the Lake filled in for several years, in between dredging events.

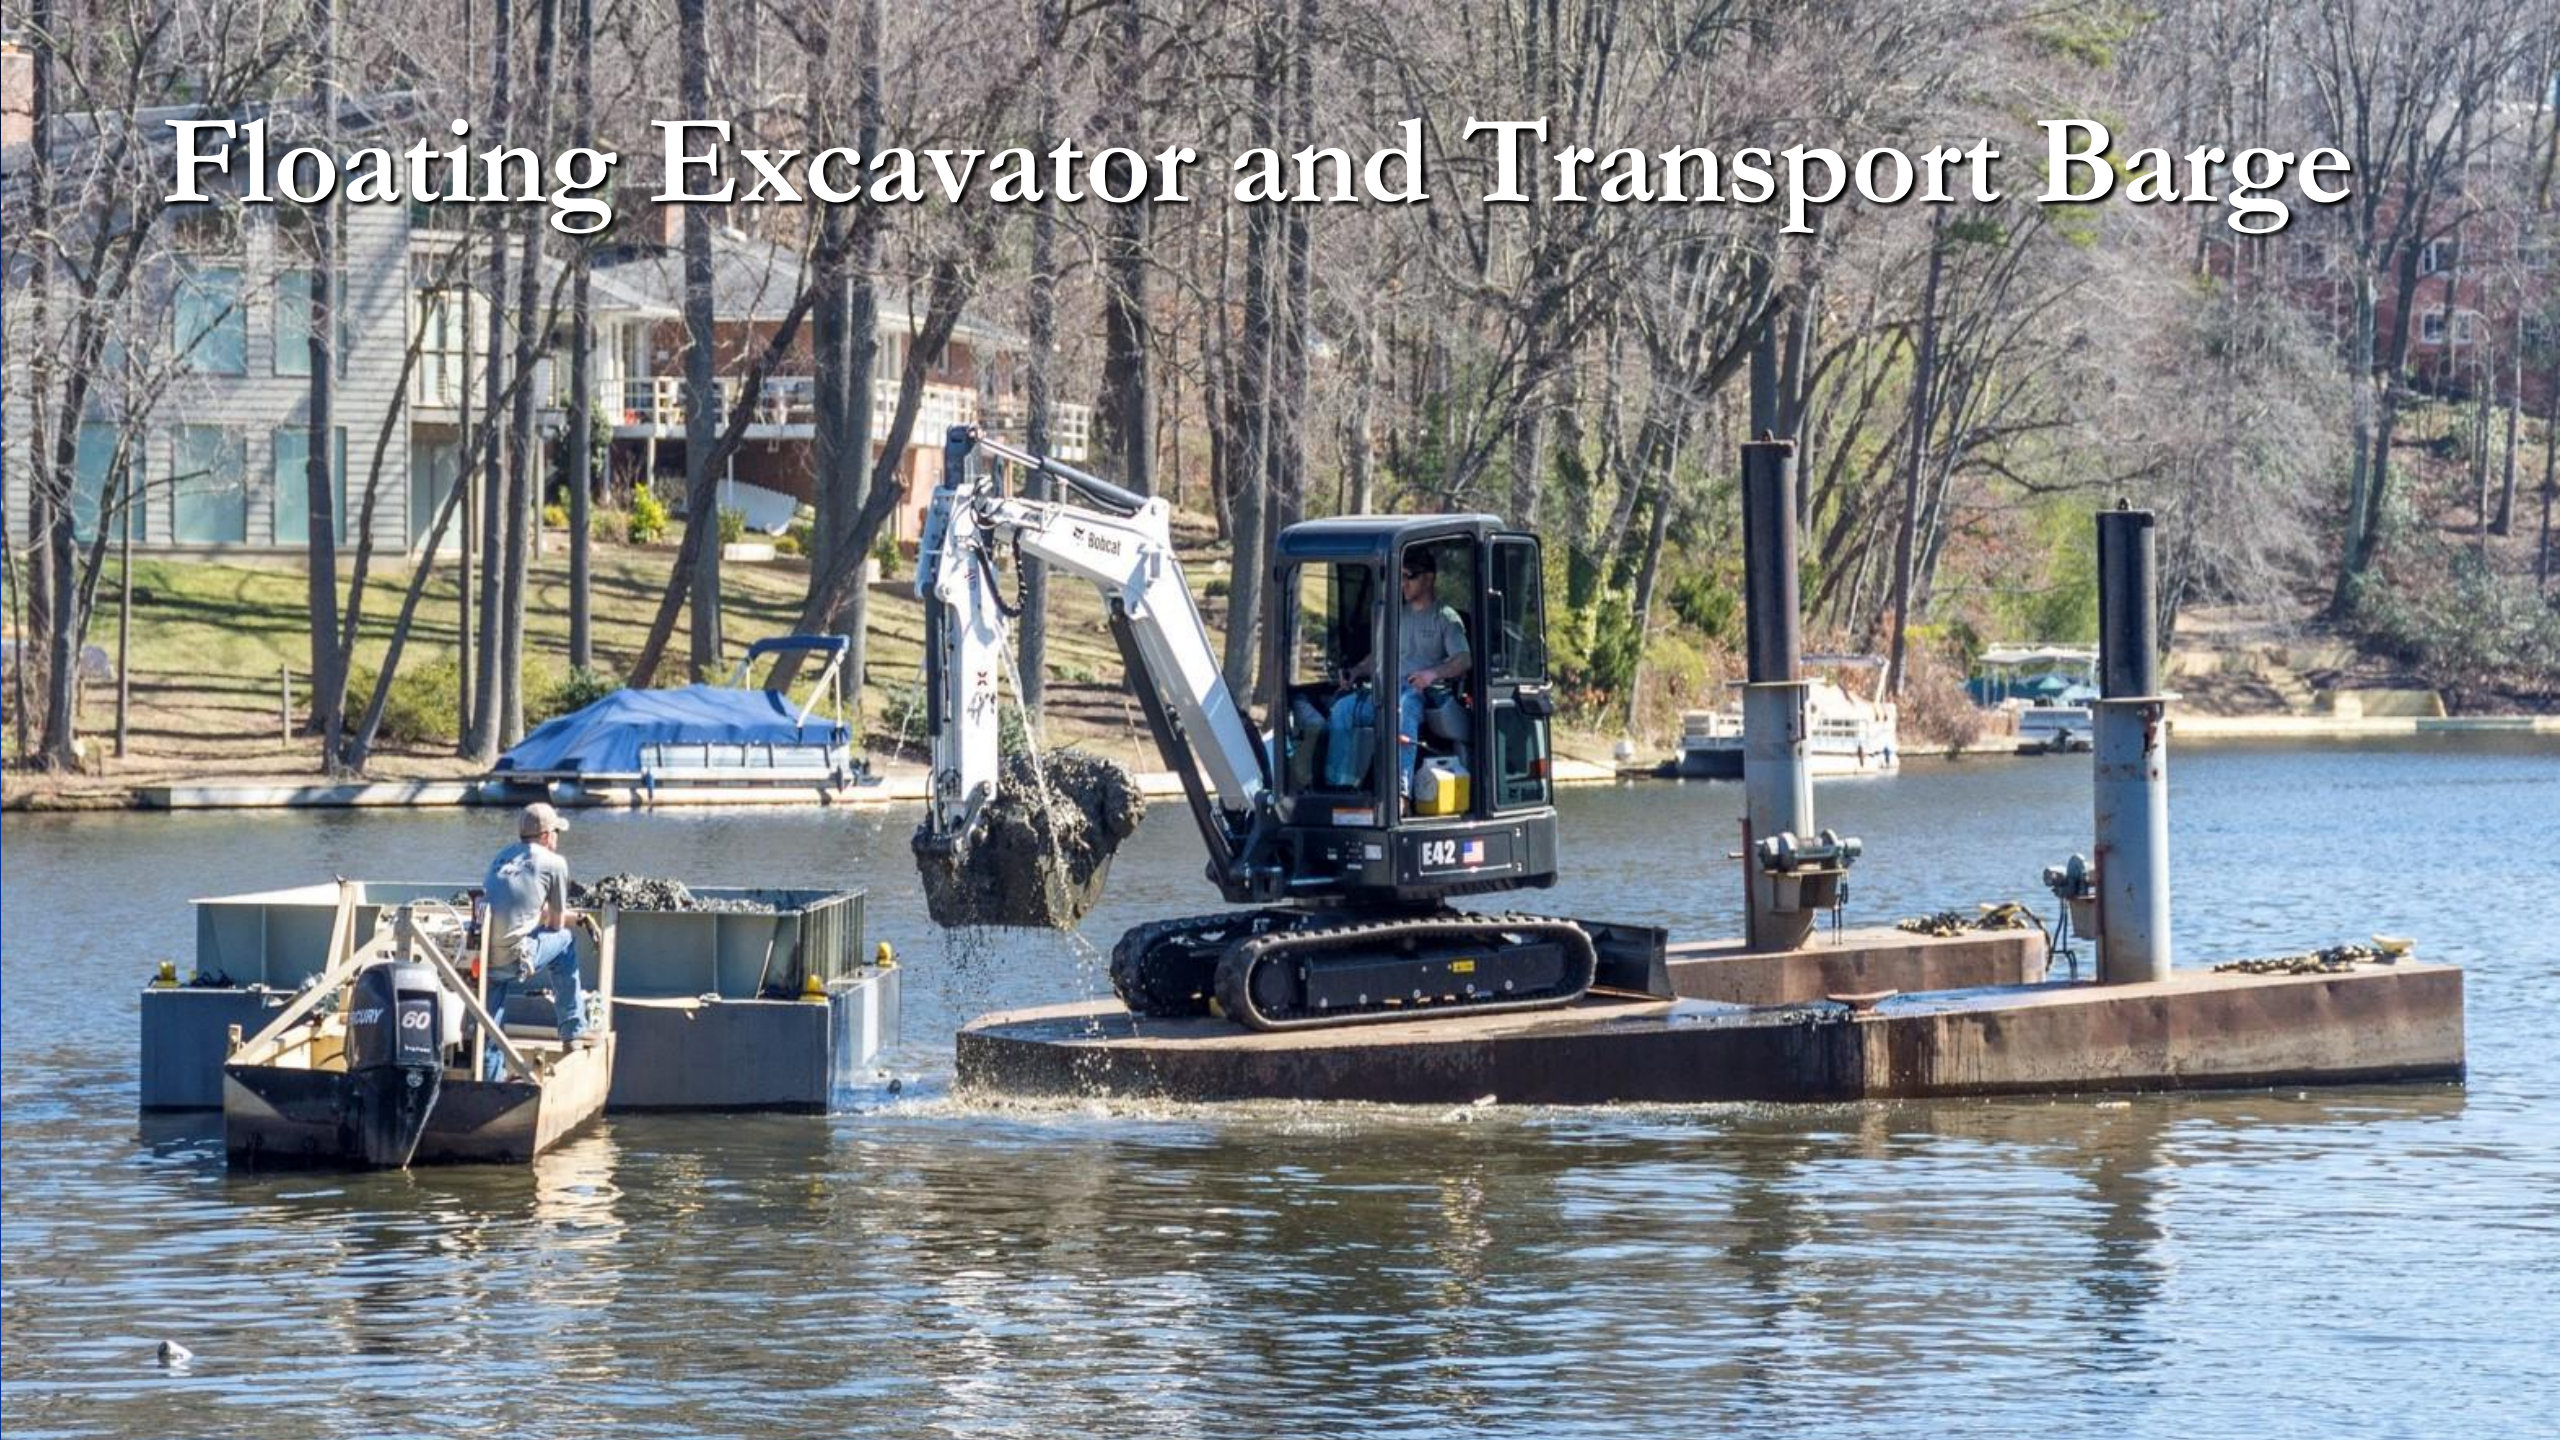
# Floating Excavator and Transport Barge

- Dredging is now done each spring and fall
  - 4 weeks of dredging done each season
  - A combined total of 3,500 to 4,000 cy of sediment is dredged each year.
- Available to respond to infill from large storm events
- Annually disposing of smaller amounts of dredge spoils
- Eliminated equipment mobilization cost
- Equipment can be used for other lake enhancement projects
