**LAKE BARCROFT'S**

**DREDGING**

**EXPERIENCE**

Lake Barcroft WID General Manager

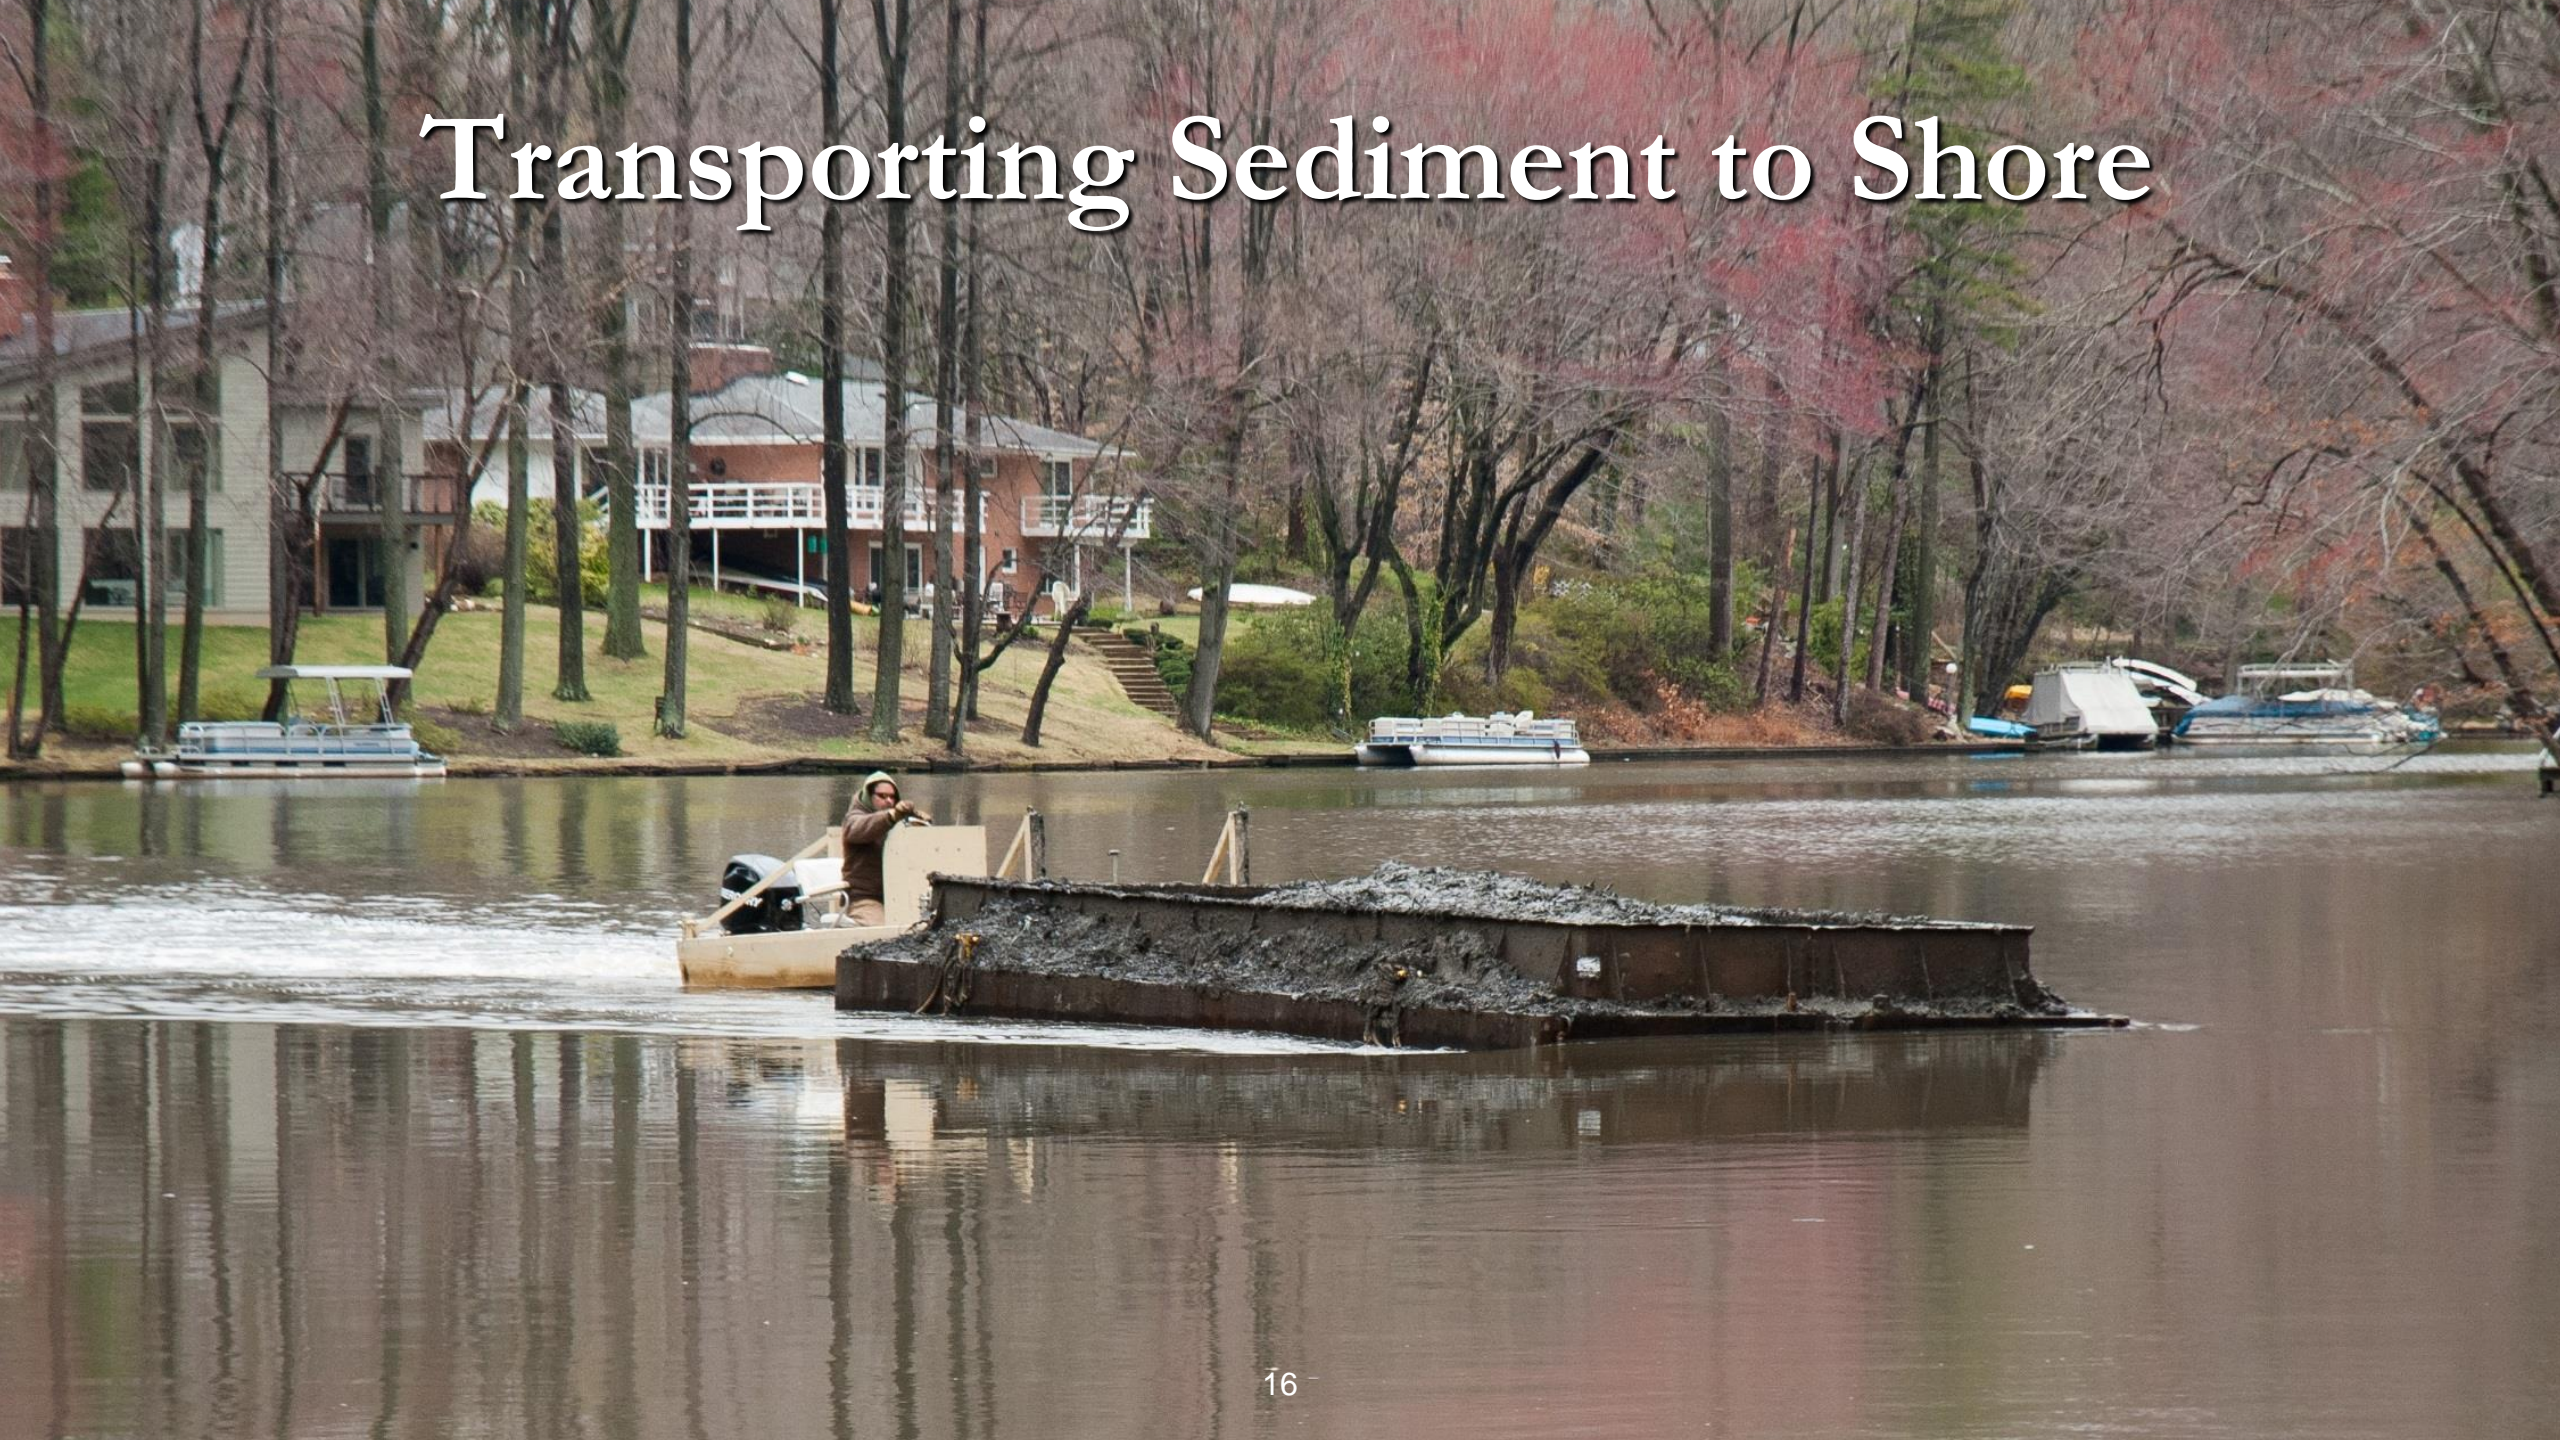
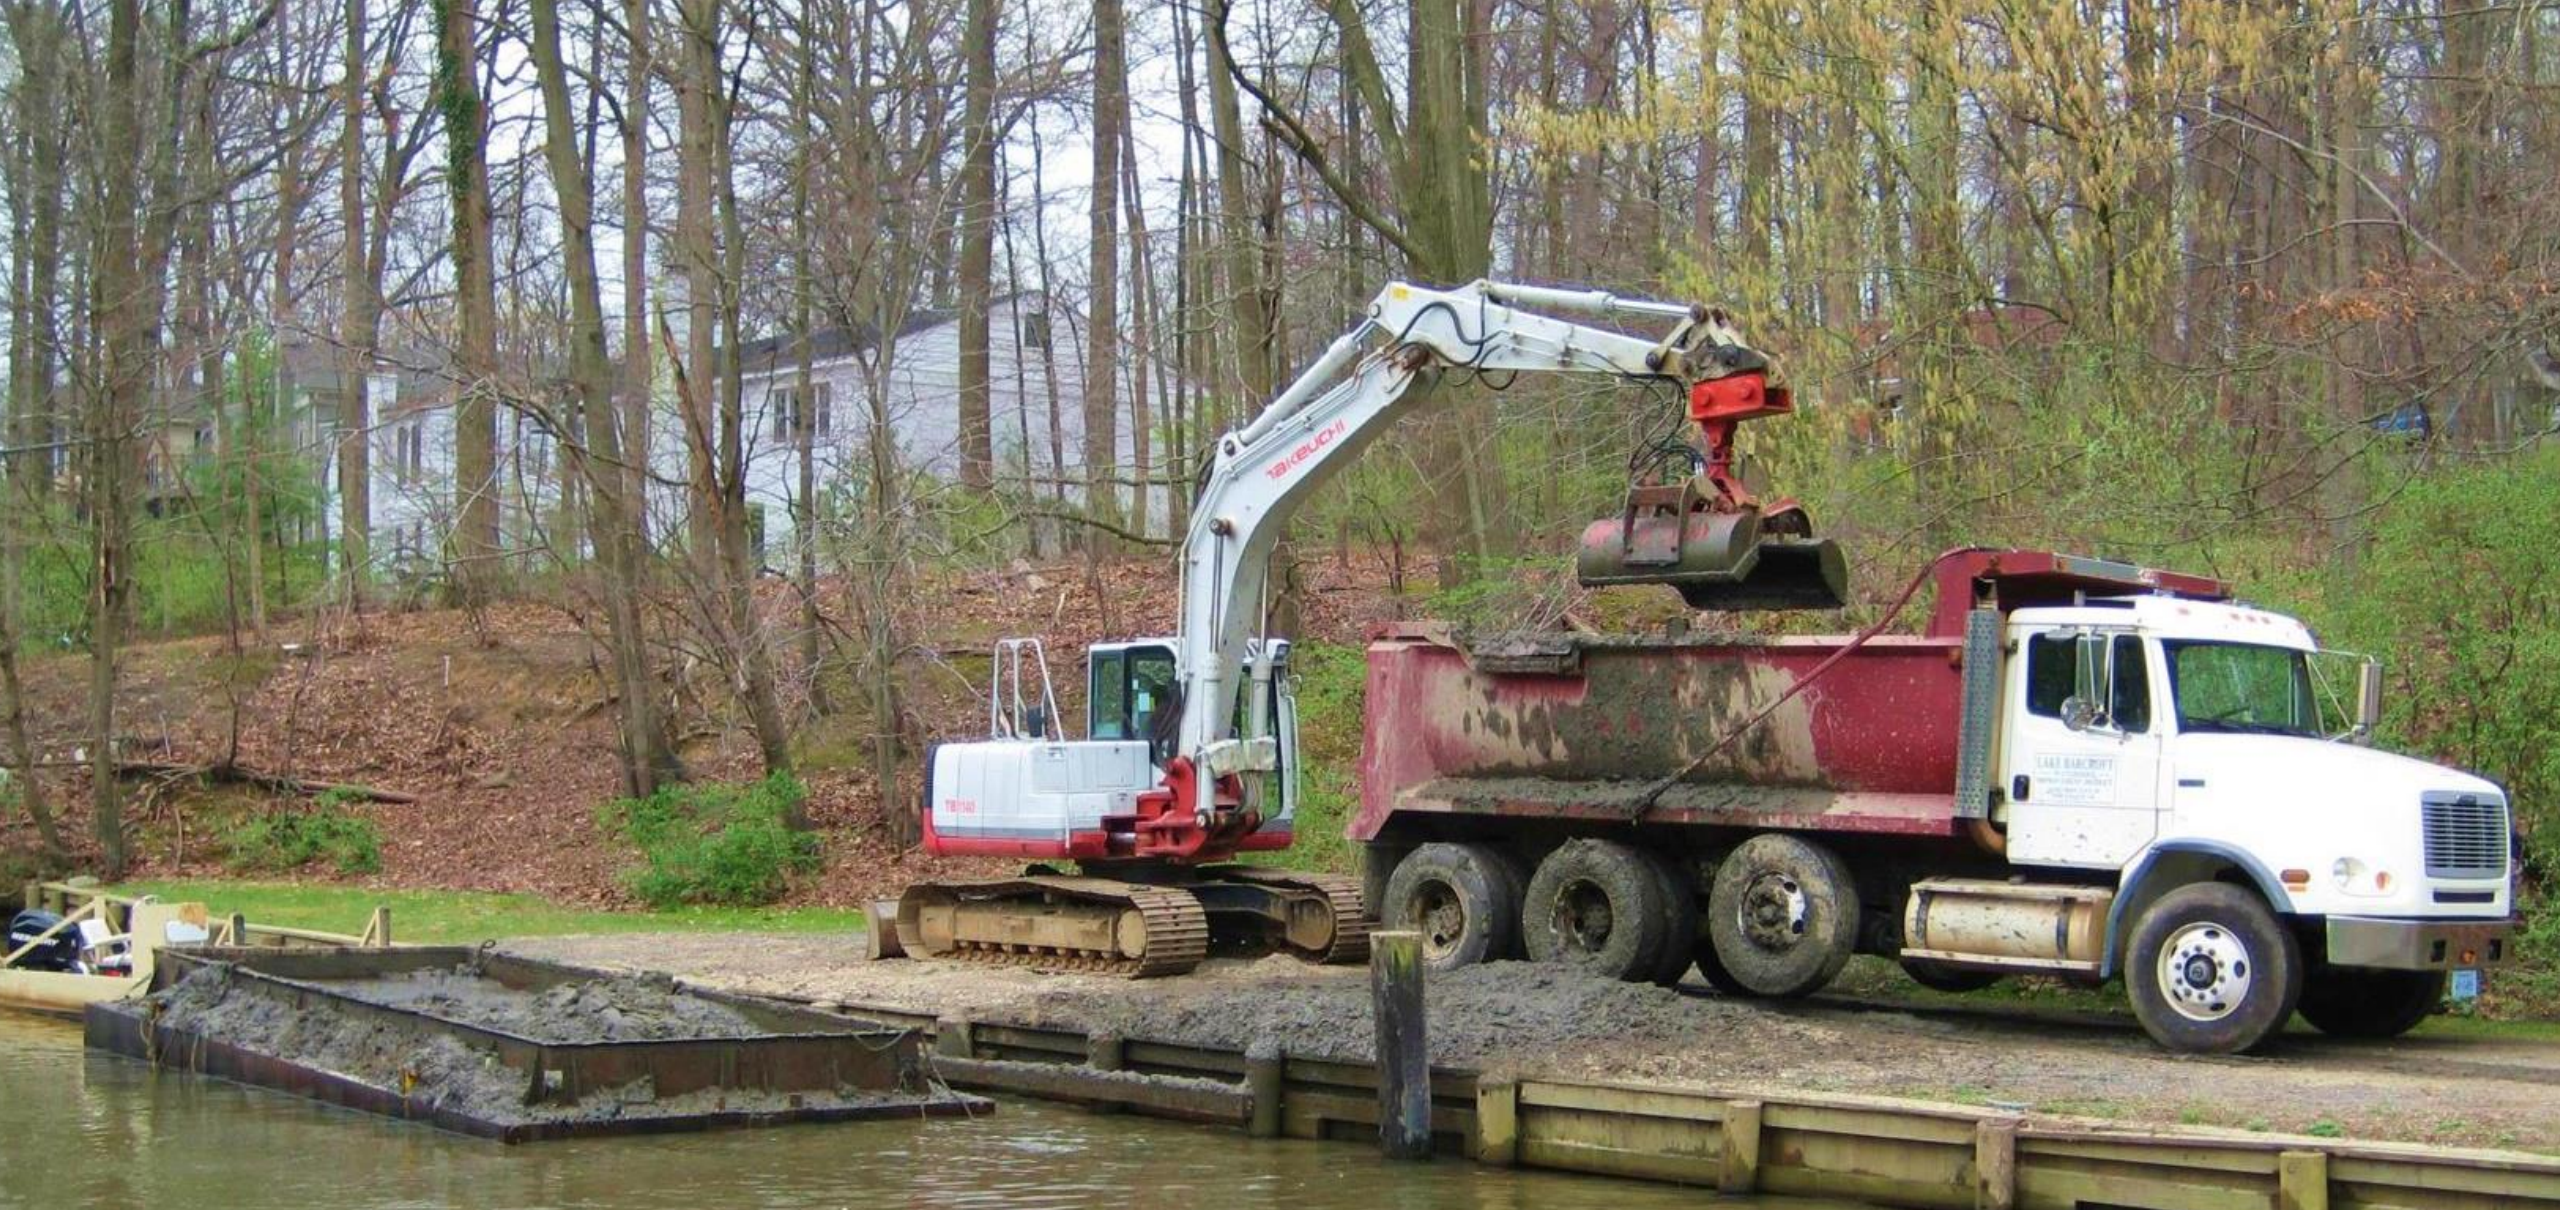
# Transporting Sediment to Shore

# Off-Loading Transport Barges

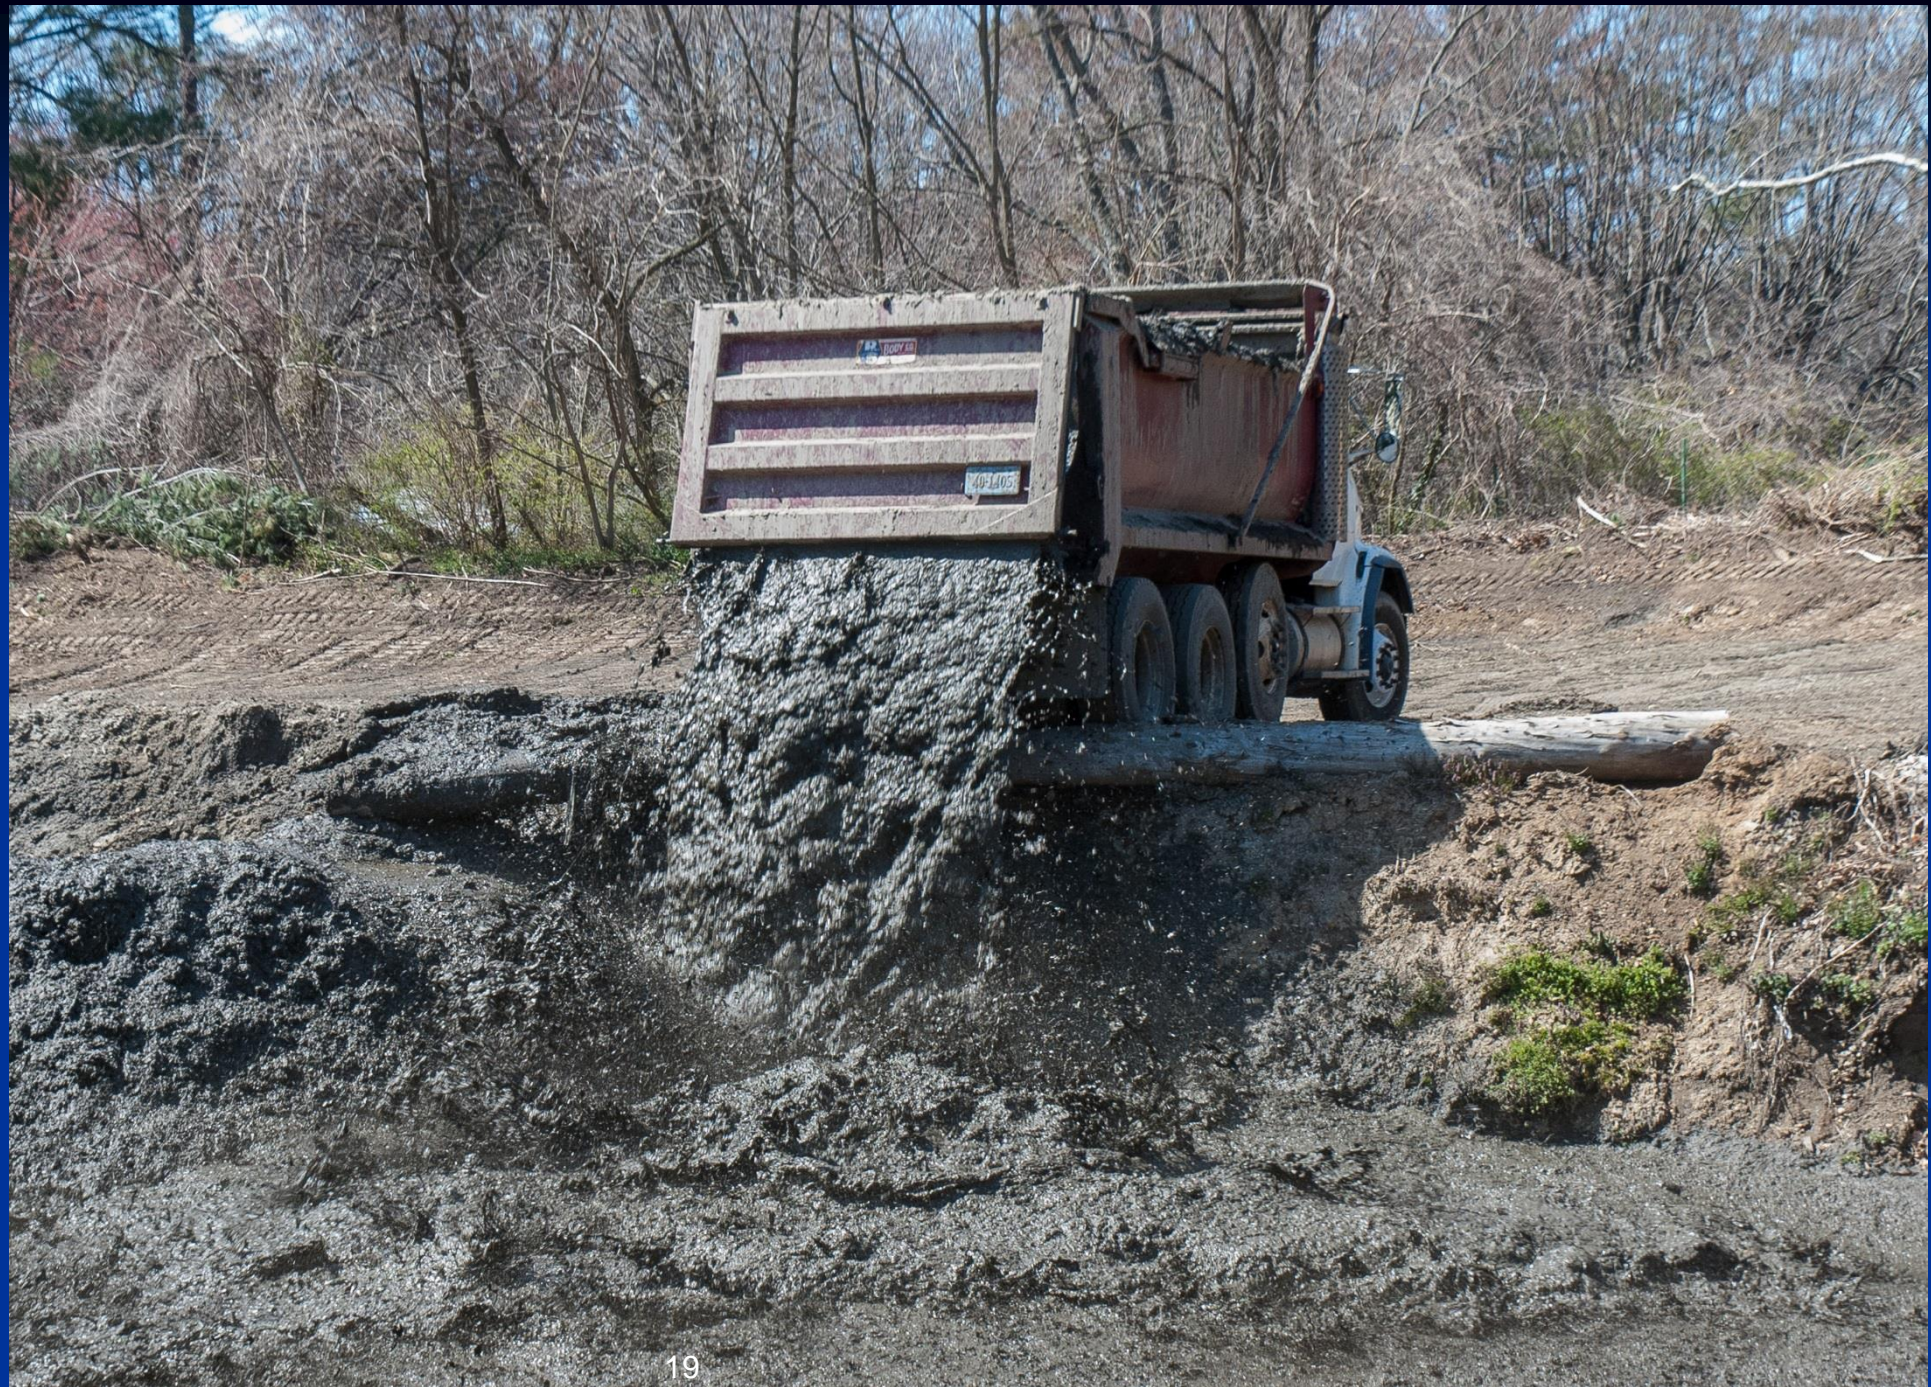
# Dredge Spoils Drying

- Two on-site decanting basins
  - Combined volume of 12,000 cy
  - Dredge spoils stay in the basin for approximately 8 to 10 months to dry out
- Dried dredge spoils are then trucked away for permanent disposal
  - Each passing year presents an increased challenge for locating a disposal location
  - In recent years we are trucking the material as far as 50 miles for disposal
  - Increased fuel cost and traffic has significantly increased the cost of trucking
  - The lack of disposal sites has significantly increased tipping/disposal fees

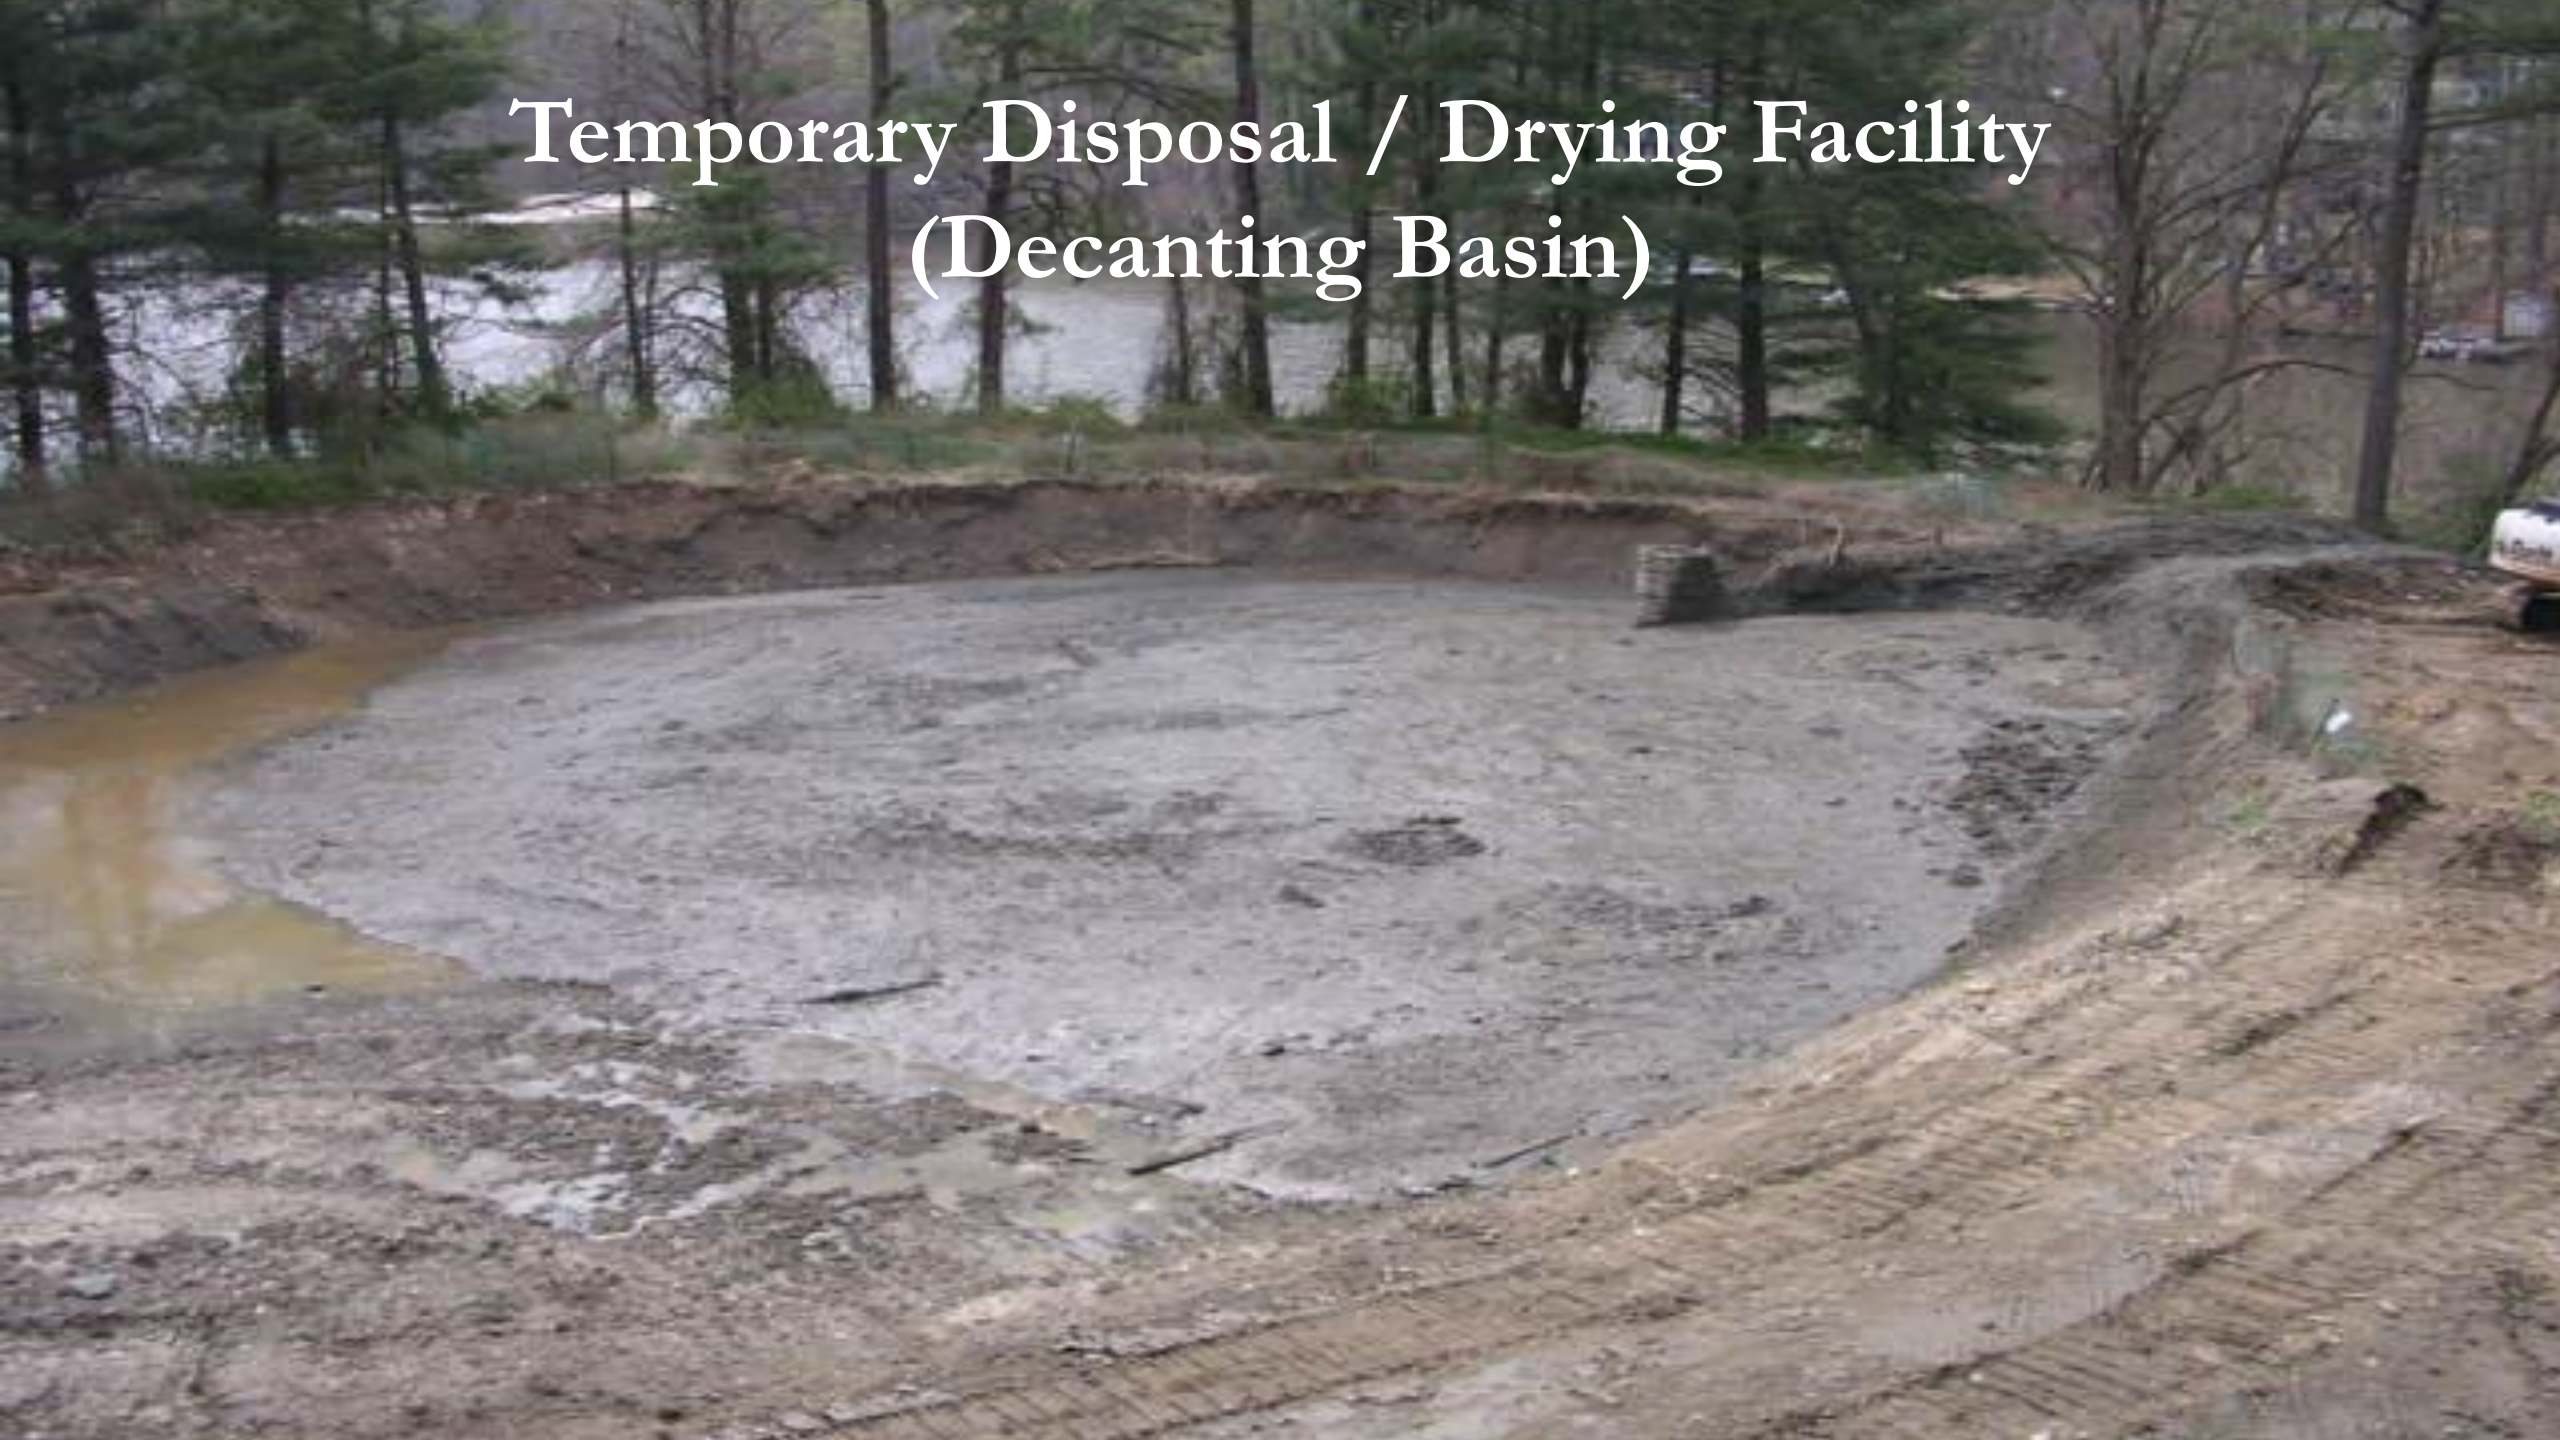
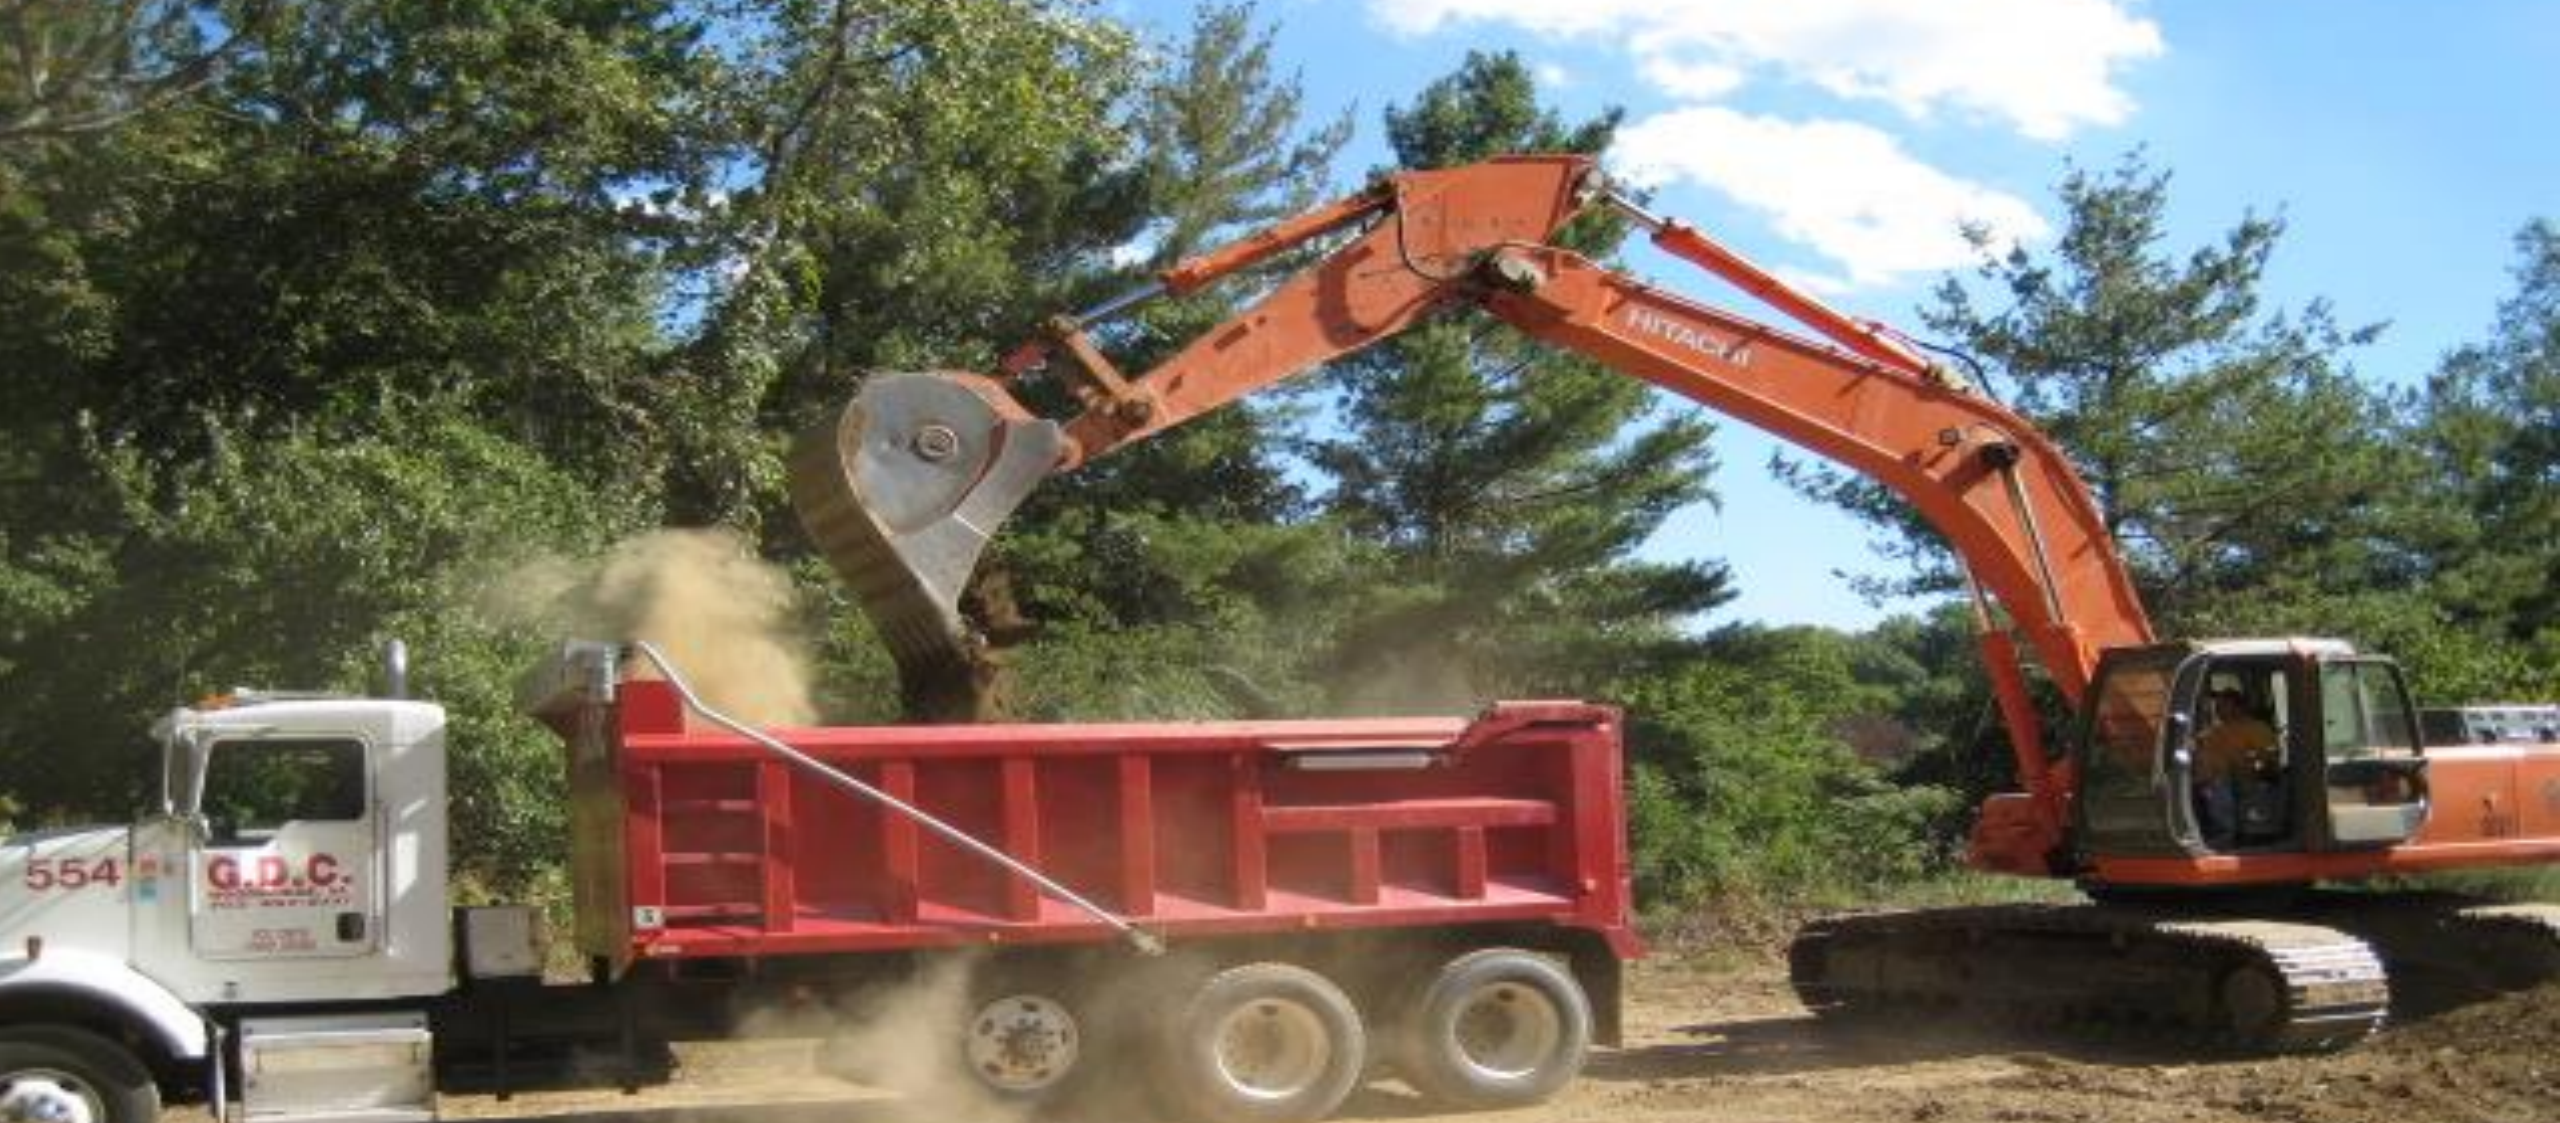
# Temporary Disposal / Drying Facility (Decanting Basin)

Dried sediment being loaded  
for permanent disposal
