Southern Drive – Slurry Pipeline Options

Dewatering Location Evaluation Summary As of December 2021

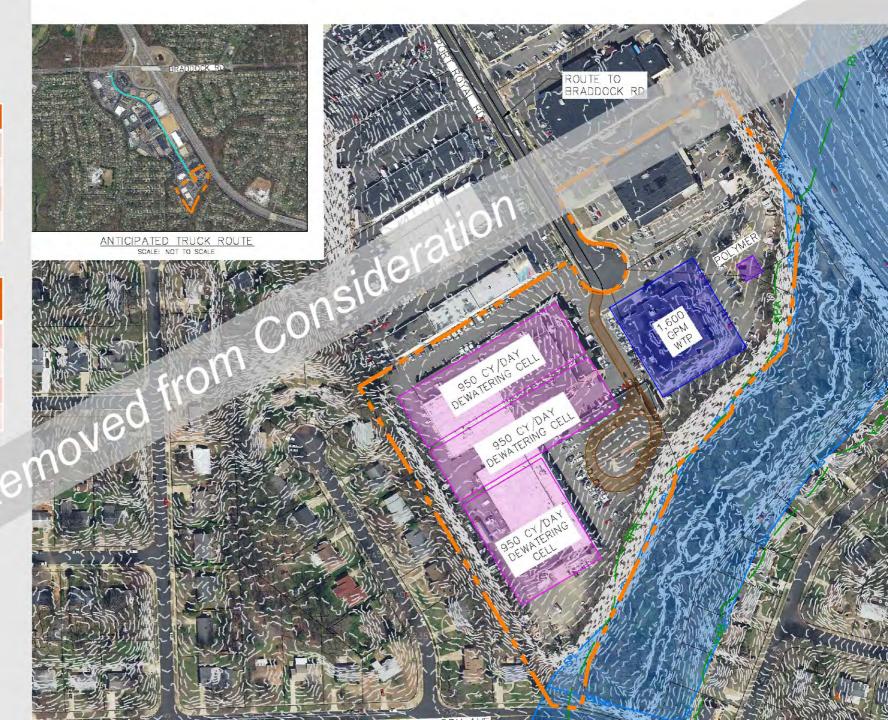
Port Royal Road

Туре	Acreages
Maximum Limits of Disturbance	12.4
Wetlands	0
Floodplain	0.3
Resource Protection Area	0.5

Production (cy/day) Slurry Solids	950 7%	950 15%	1250 7%	1250 15%
Passive	Yes	Yes	Yes	Yes
Passive w/ Desanding	Yes	Yes	Maybe	Maybe
Mechanical	Yes	Yes	Maybe	Maybe
Drying Agent	No		No

- Building conditions (e.g., basements, asbestos)
- Use & maintenance of site between dredging

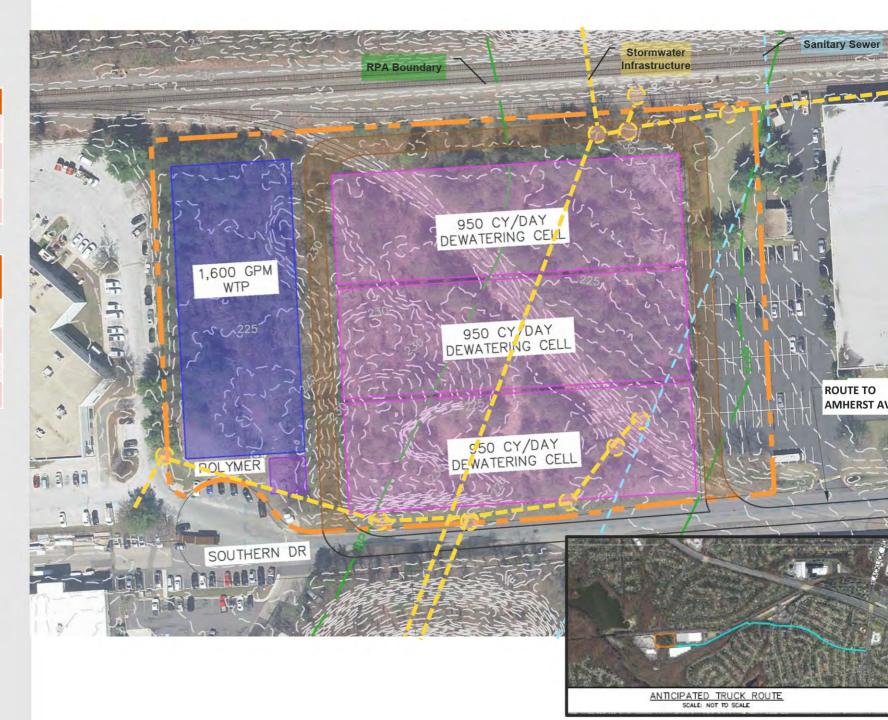
Southern Drive Areas

Туре	Acreages		
Maximum Limits of Disturbance	6.4		
Wetlands	0		
Floodplain	0		
RPA	3.1

Production (cy/day) Slurry Solids	950 7%	950 15%	1250 7%	1250 15%
Passive	Yes	Yes	No	No
Passive w/ Desanding	No	No	No	No
Mechanical	Maybe	Yes	No	Maybe
Drying Agent	No		No

- · Property purchase/leasing/easement terms
- Environmental impacts
- Railroad spur / utility offsets or restrictions

Southern Drive – Resource Impacts

- Fairfax County mapped perennial stream with possible adjacent wetlands
 - Although stream has been piped, a formal wetland delineation (and possible survey) will be needed to confirm presence or absence of wetlands.
 - Although typically removed for piped streams, the "stream" has a mapped RPA - will need to confirm RPA.
- Similar search for endangered and threatened species as other sites considered

- No previously recorded archaeological sites mapped within or adjacent to the dewatering site (based on VDHR online data)
- No indication that the site has previously been subject to cultural resources survey
- Phase I cultural resources investigation of the area will be required.

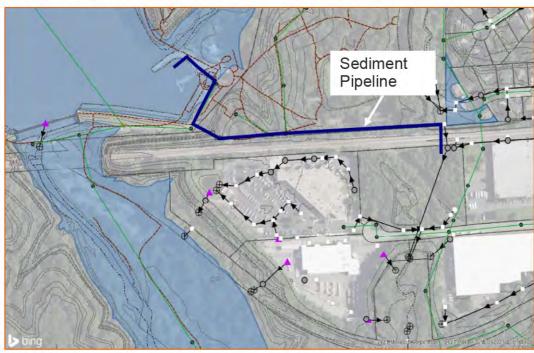
Service Road / North of RR

- **RR** Coordination
- Short term park impact during construction **High Compatibility Considerations**
- Shortest alignment
- No anticipated environmental impacts
- No neighborhood impacts during construction

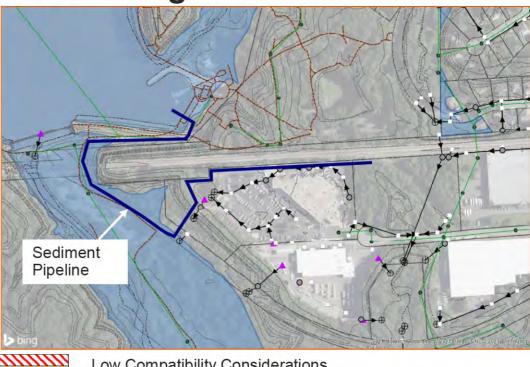
Under Bridge / South of RR

Low Compatibility Considerations

- RR and private property coordination
- Potential aquatic habitat impacts
- Short term park impact during construction

High Compatibility Considerations

- Short alignment
- No neighborhood impacts during construction

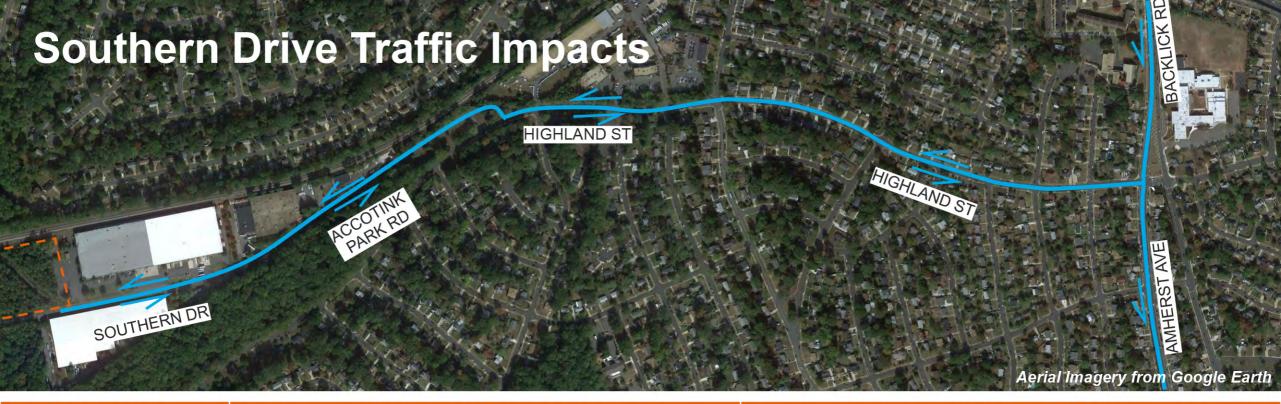
Roadway Name	VDOT 2019 Traffic Data		Estimated Values			
	Average Daily Traffic (One Way Trips)	Percent Trucks	Number of Trucks	Daily Truck Traffic (One Way Trips)	Increase in Trucks	Increase in Traffic
Accotink Park Rd	2,400 to 2,600	NA	NA	190	NA	7% to 8%
Highland St	4,000 to 5,600	4.4%	176 to 246	190	77% to 108%	3% to 5%
SR-617 (Backlick Rd / Amherst Ave)	15,000 to 35,000	1.5% to 1.6%	240 to 525	95	18% to 40%	<1%
