Little Rocky Run Johnny Moore Creek

Watershed Workbook Draft

Fairfax County
Stormwater Planning Division
Department of Public Works and
Environmental Services

October 2008

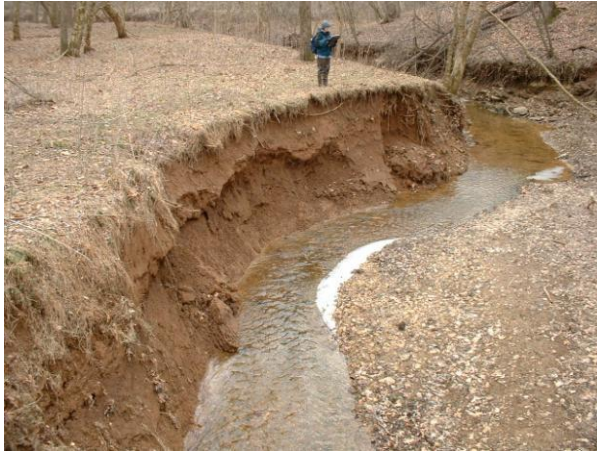
Figure 2-3: Erosion area near confluence with Bull Run

The SPA noted two areas of moderate to extreme erosion on Johnny Moore Creek. One near the confluence with Bull Run and one approximately 800 feet downstream of Balmoral Greens Avenue. Photos of the two areas are shown in Figures 2-3 and 2-4 below.

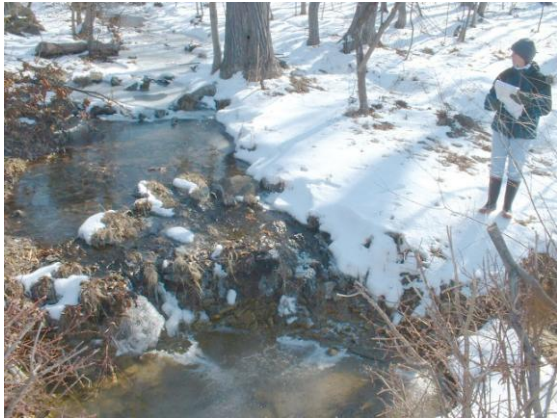
Figure 2-5: Headcut on tributary located on Twin Lakes Golf Course

The following pictures show some of the impacts found in the WMAs during the 2005 SPA.

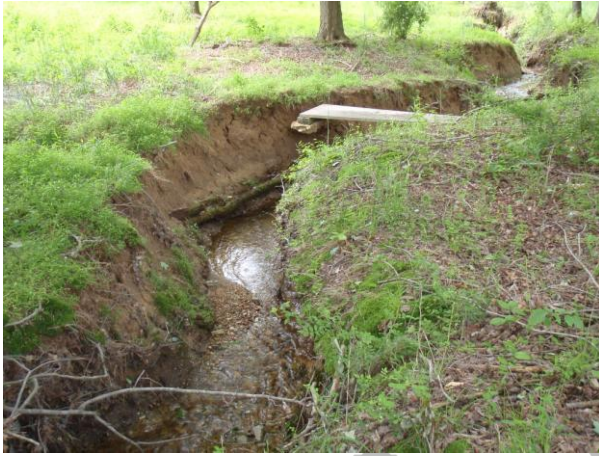
Figure 2-8: Bank erosion in excess of 3ft on small tributary near Cedar Ridge Drive

Severe erosion was observed on tributaries as well as the main stem of Johnny Moore Creek. The tributary located near the intersection of Clifton Road and Cedar Ridge Drive is experiencing severe erosion and headcuts. The following pictures show the erosion near the intersection.

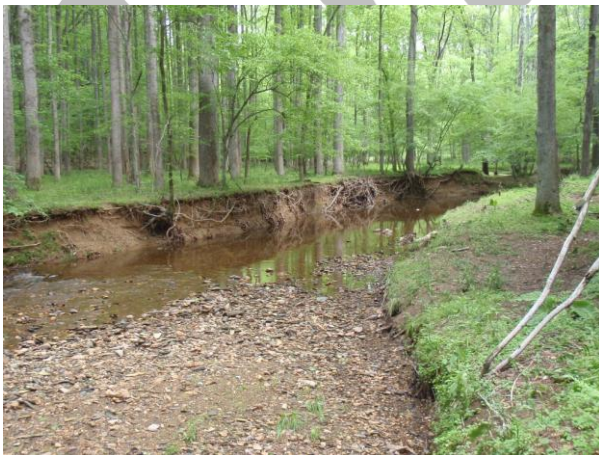
Figure 2-10: Bank erosion in excess of 3ft on Johnny Moore Creek near Balmoral Greens Subdivision

Severe bank erosion was also observed along the main channel of Johnny Moore Creek near the Balmoral Greens neighborhood in the same location as noted in the 2005 SPA. The following pictures show an update of erosion occurring in this area.

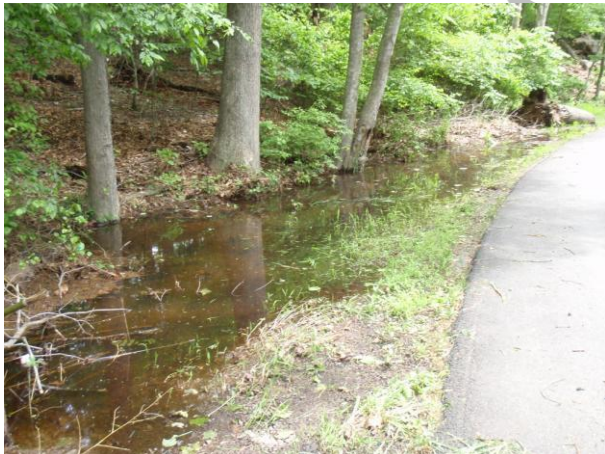
Figure 2-12: Standing water encroachment along Compton Rd.

The following pictures show examples of other significant impacts found in the watershed.

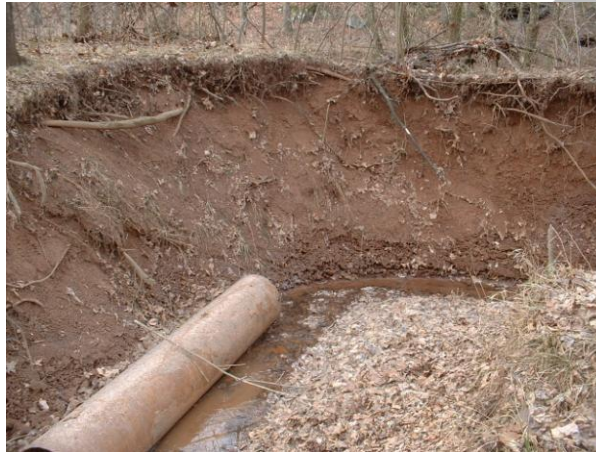
Figure 2-16: Erosion area on tributary in Little Rocky Run - Bull Run

There were two noted areas of moderate erosion, one on Little Rocky Run approximately 1,800 feet upstream of the confluence with Bull Run and one on a tributary in the Little Rocky Run – Bull Run WMA. A photo of the Little Rocky Run – Bull Run erosion area is shown below.

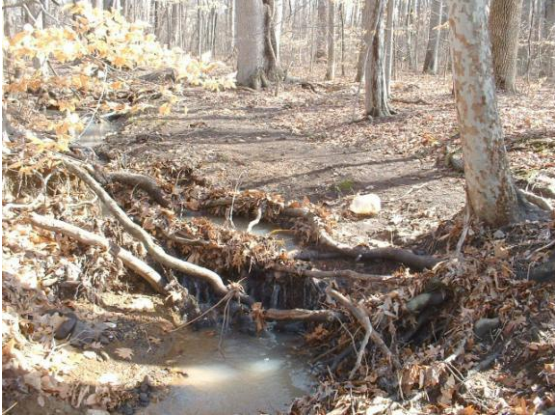
Figure 2-17: Headcut on tributary located upstream of South Springs Drive

The following pictures show some of the more significant impacts found in the watershed during the SPA.

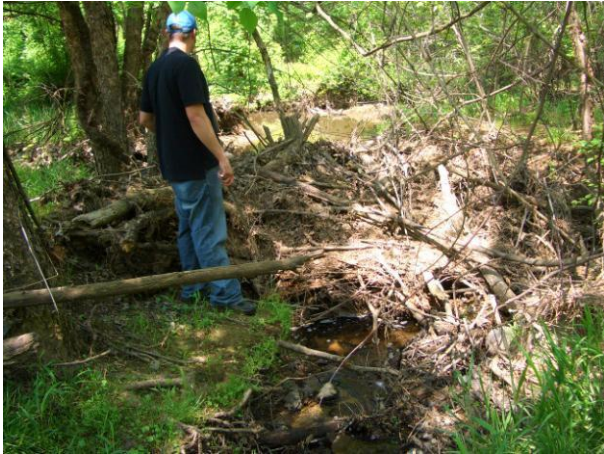
Figure 2-23: Major debris obstruction at the confluence of a tributary and Little Rocky Run behind the Little Rocky Run subdivision

The poor tributary segment observed in 2005 near the intersection of Union Mill Road and Braddock Road has poorly vegetated and swampy buffers as well as several obstructions. These problems exist in areas downstream of the intersection and past the tributary's confluence with Little Rocky Run. The following photos show two debris blockages located in this area.

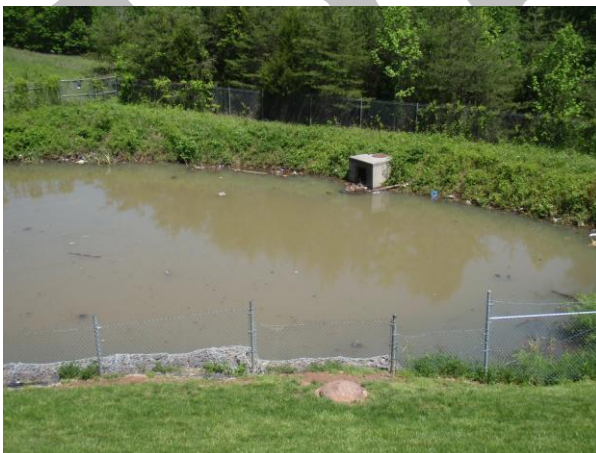
Figure 2-25: Wet Pond with significant amount of litter near Compton Valley Way

The following pictures show examples of other significant impacts found in the watershed.

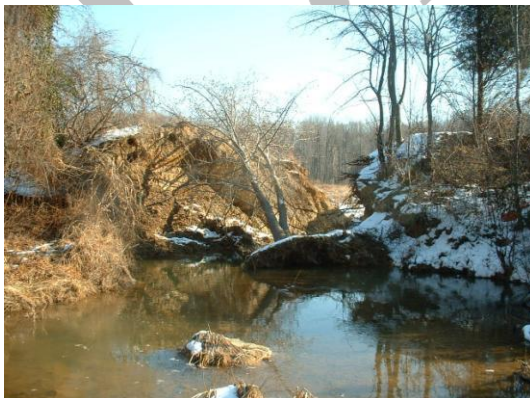
Figure 2-27: Erosion area on Little Rocky Run upstream of Willow Springs Branch

A severe erosion site was located on Little Rocky Run just upstream of its confluence with Willow Springs Branch. The picture below shows that this is a dam that appears to have failed. There was also an area of moderate erosion noted on Willow Springs Branch approximately 1,400 feet upstream of Ashleigh Road.

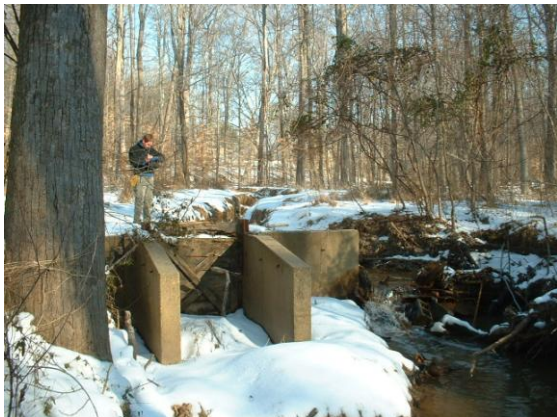
Figure 2-29: Moderate to Severe Obstruction on Little Rocky Run

The following pictures show some of the more significant impacts found in the watershed during the SPA.

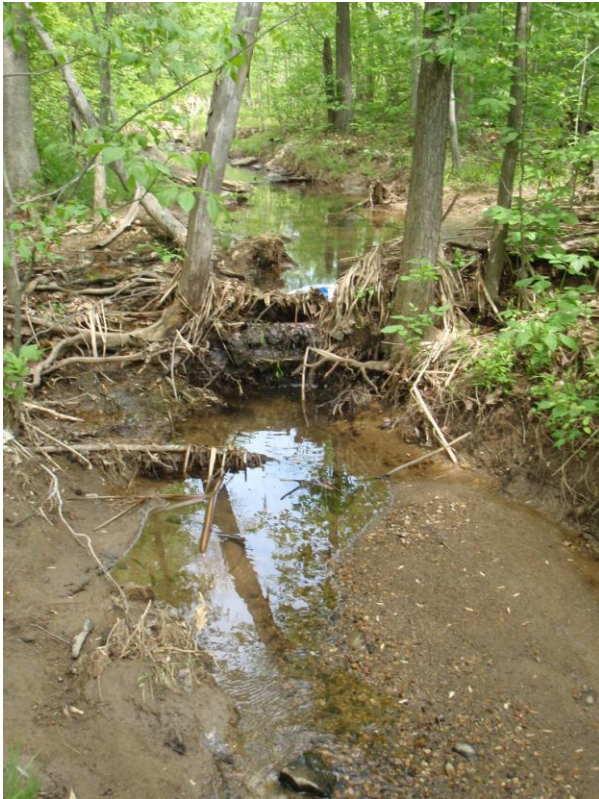
Figure 2-39: Obstruction in small tributary next to Village Drive

The following pictures show examples of other impacts found in the WMA.
